***Grinding Noise from Right Side of the Printer and or 13.05 Paper Jams  
HP LaserJet P4014/P4015/P4515/M4555MFP Printers***

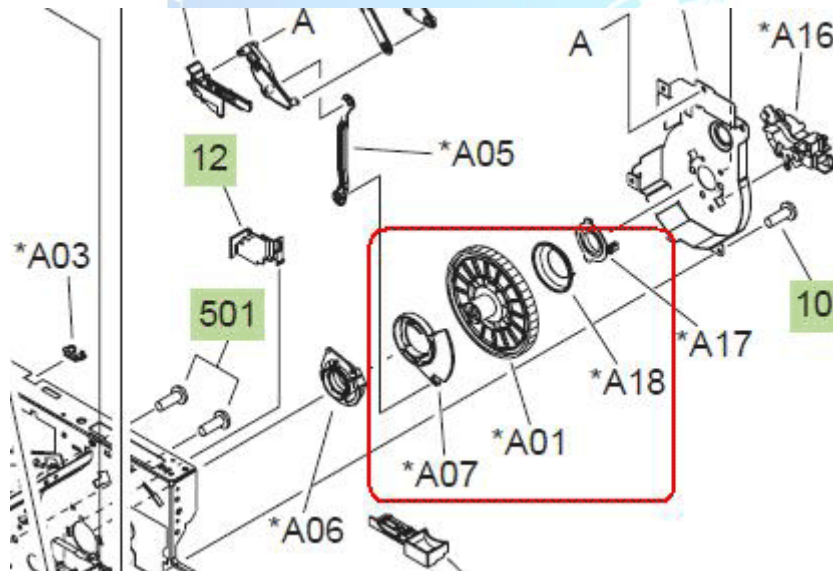
**NOTE:** A01 gear, 193T. The picture and reference was taken from Printer Service Manual: Internal components - Figure 8-6 Internal components (1 of 3) – Pg. 358 Chapter 8 Parts.

For this specific issue, verify that the 193T gear (A01) shown in pictures below is working fine and without damage.

The drum drive assembly (includes: Guide, gear shift A, Guide, gear shift B, Gear 193T, Spring compression, bushing, Side plate drum drive, and Cap drum gear) is set up as a service part, part number RM1-8493-000CN.

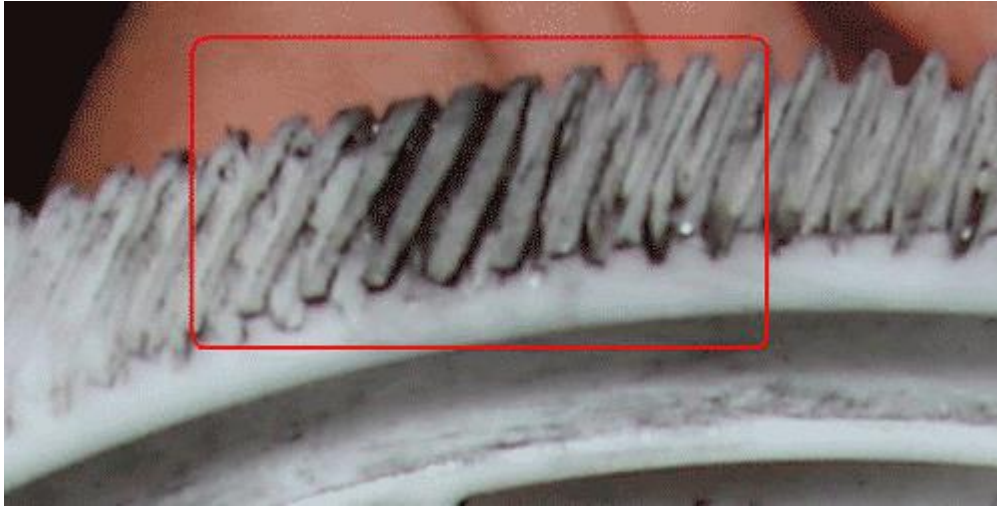
## Example of 193T gear damage Teeth

HP has seen some incidents of the main drum drive gear assembly wearing out prematurely or the cartridge gears breaking. This damage can cause a grinding noise and/or a 13.05 jam with paper stopping directly under the cartridge.

The premature wear or breakage of the drum drive assembly is most prevalent in printers installed in highly contaminated environments such as manufacturing plants, and/or industrial areas. The contamination coats the gears and gets into the grease causing increased friction and torque on the gears.

The cartridge gear that engages the print cartridge and rotates the image drum may also prematurely wear out or break from the contamination and excessive force when installing the print cartridge.
