13.B2.Dx, 41.03.xx, 60.0x or “Tray 2 overfilled or roller issue” Message

HP M607/M608/M609/M610/M611/M612/
E60055/E60065/E60075/E60155/E60165/E60175

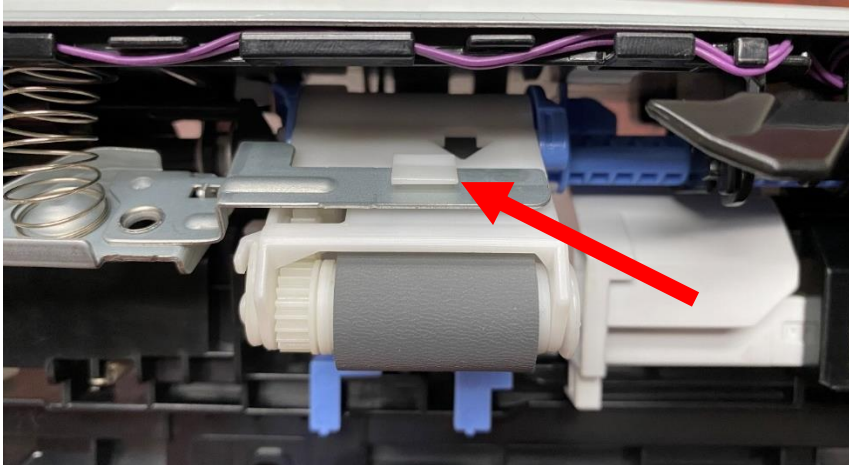
1. Check if the pickup rollers are installed correctly.
 - a. Check that the roller's white tab is hooked onto the metal pick up arm:

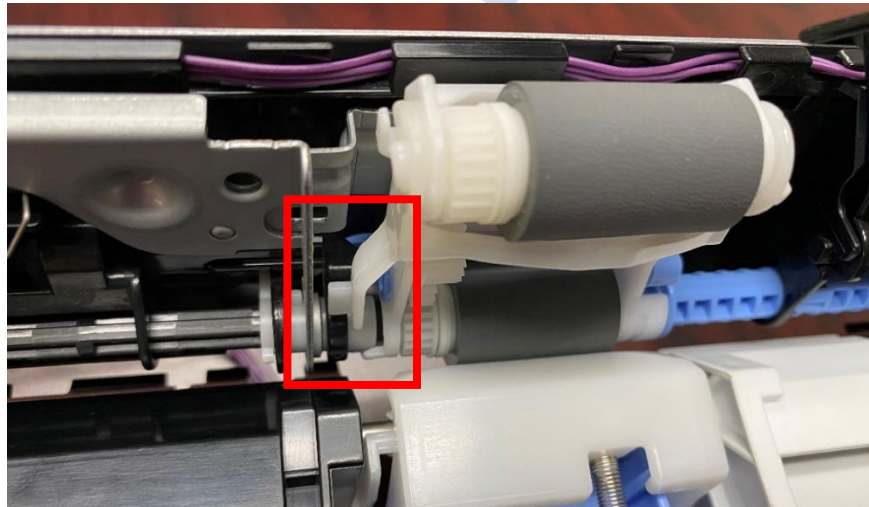
- b. Check the white roller actuator lifts up the black flag for the printer to recognize the tray has lifted:
 - i. Correct installation:

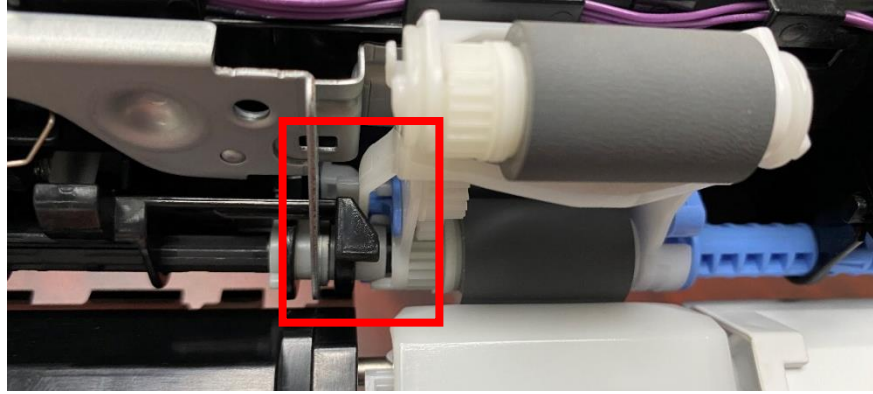
ii. Incorrect installation:

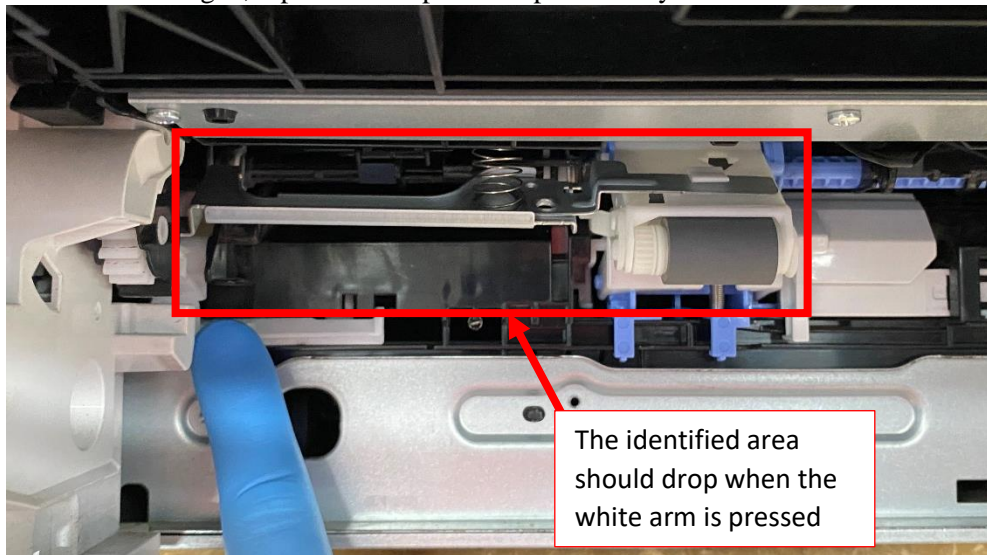
2. Check that when you push the left white arm in, the roller bracket drops down. If roller bracket does not drop down or is damaged, replace the Paper Pickup Assembly **RM2-6771**:

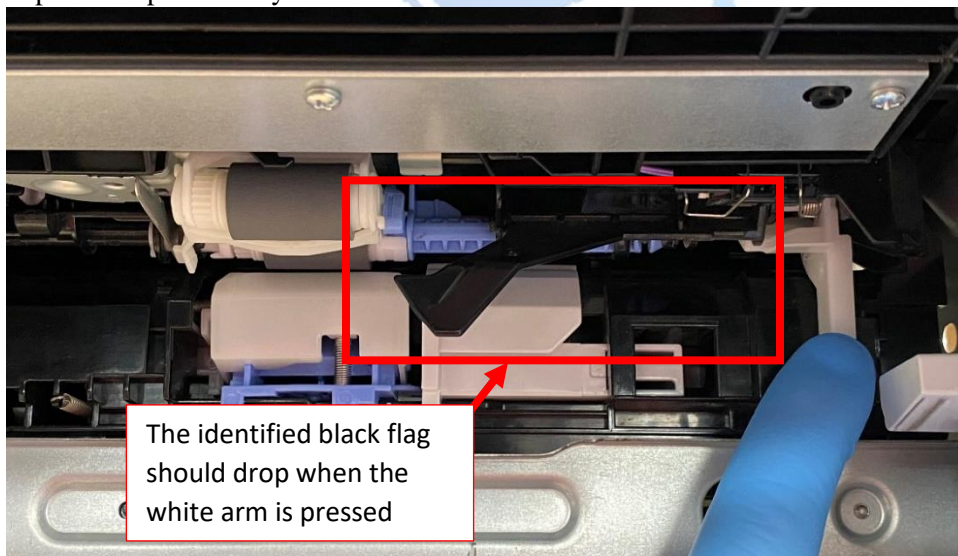
3. Check that the printer displays “tray 2 empty”, when the tray is empty. If not, check that the black flag drops down when the right white arm is pushed in. If the paper sensor flag is missing, damaged, or dislodged replace the Paper Pickup Assembly **RM2-6771**.
