HP M607/M608/M609/M610/M611/M612/E60055/E60065/E60075

**13.B2.D2, 41.03.xx or “Tray 2 overfilled or roller issue” message
when printing from tray 2**

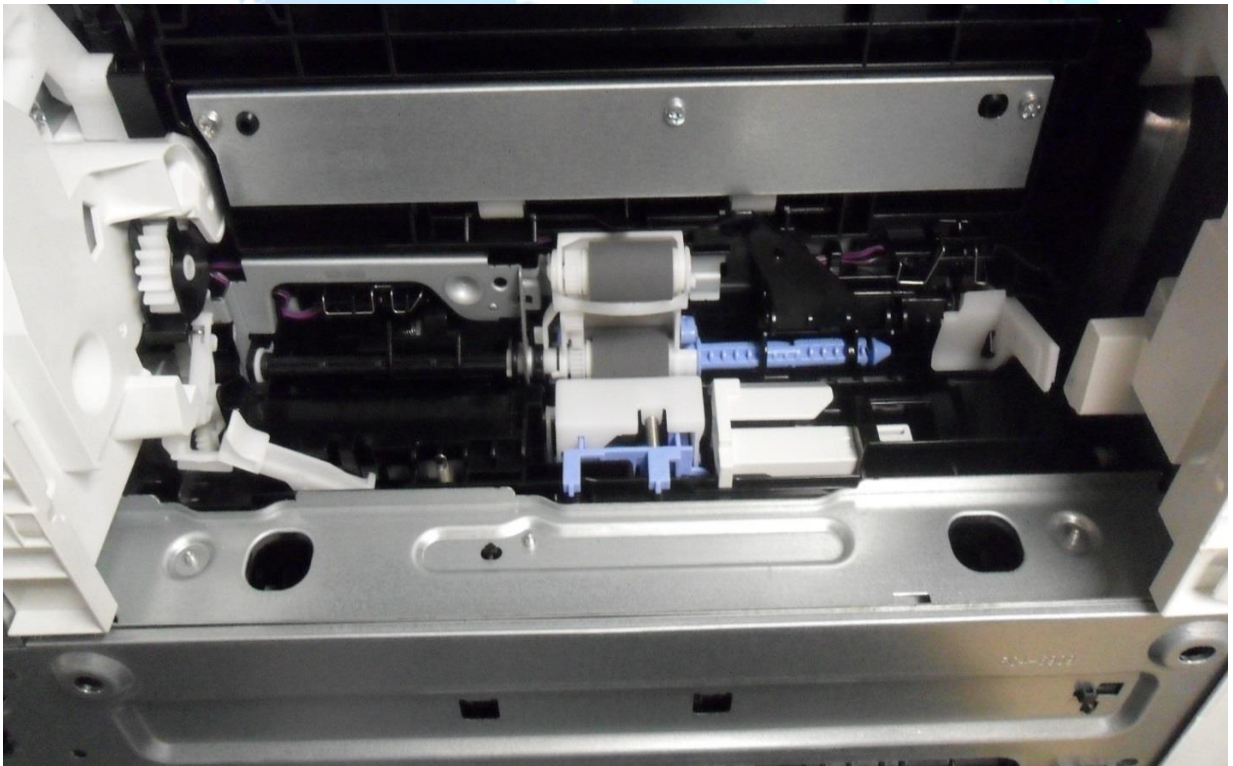
1. Check if the pickup rollers are installed correctly as shown:

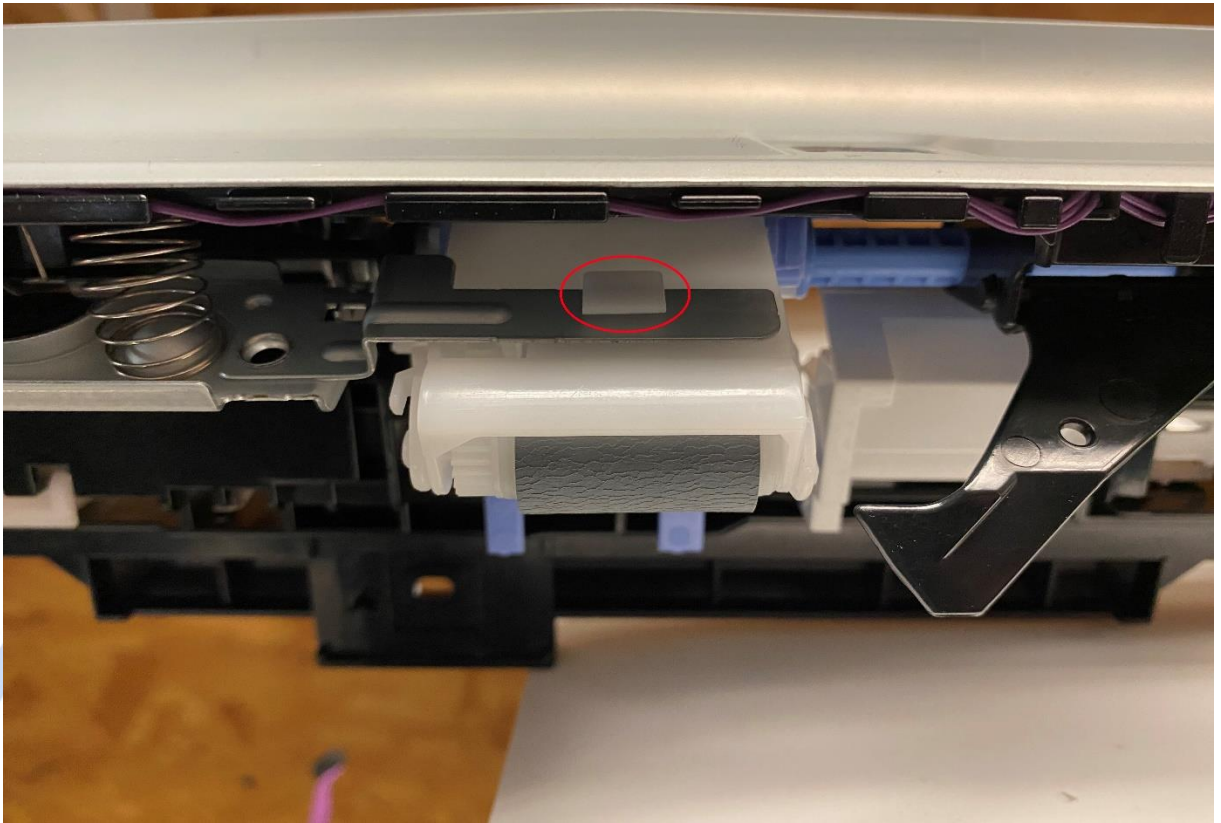
Note the roller's white tab hooks onto the metal pick up arm

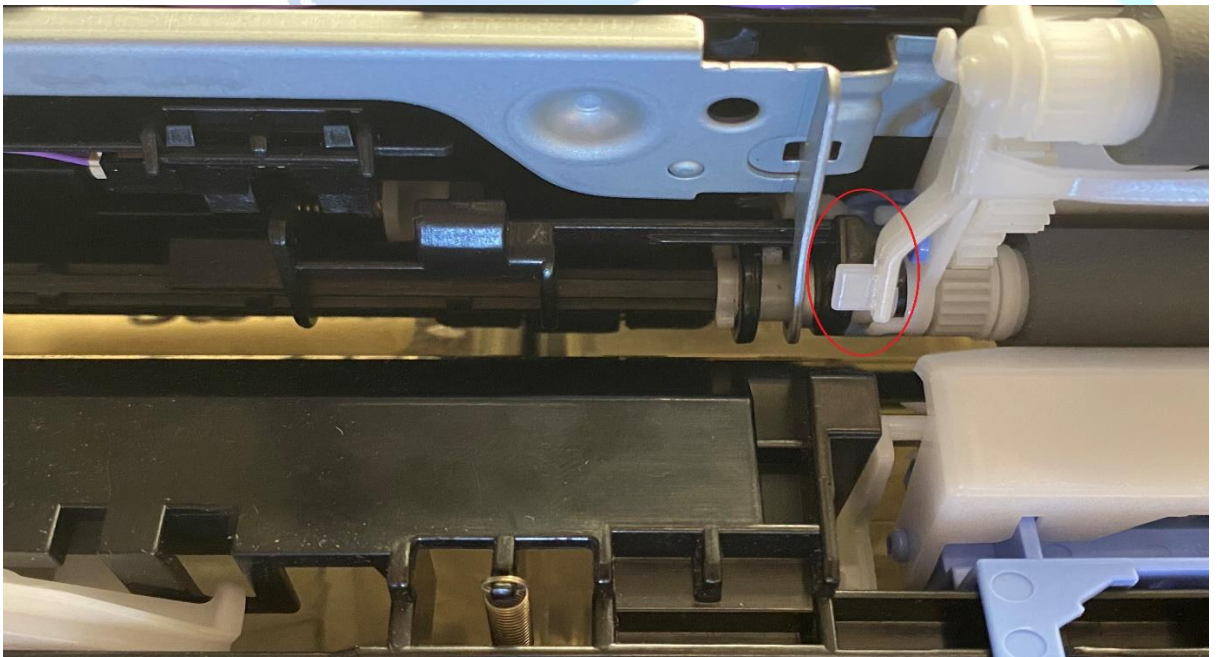
The white roller actuator should lift up the black flag for the printer to recognize the tray has lifted

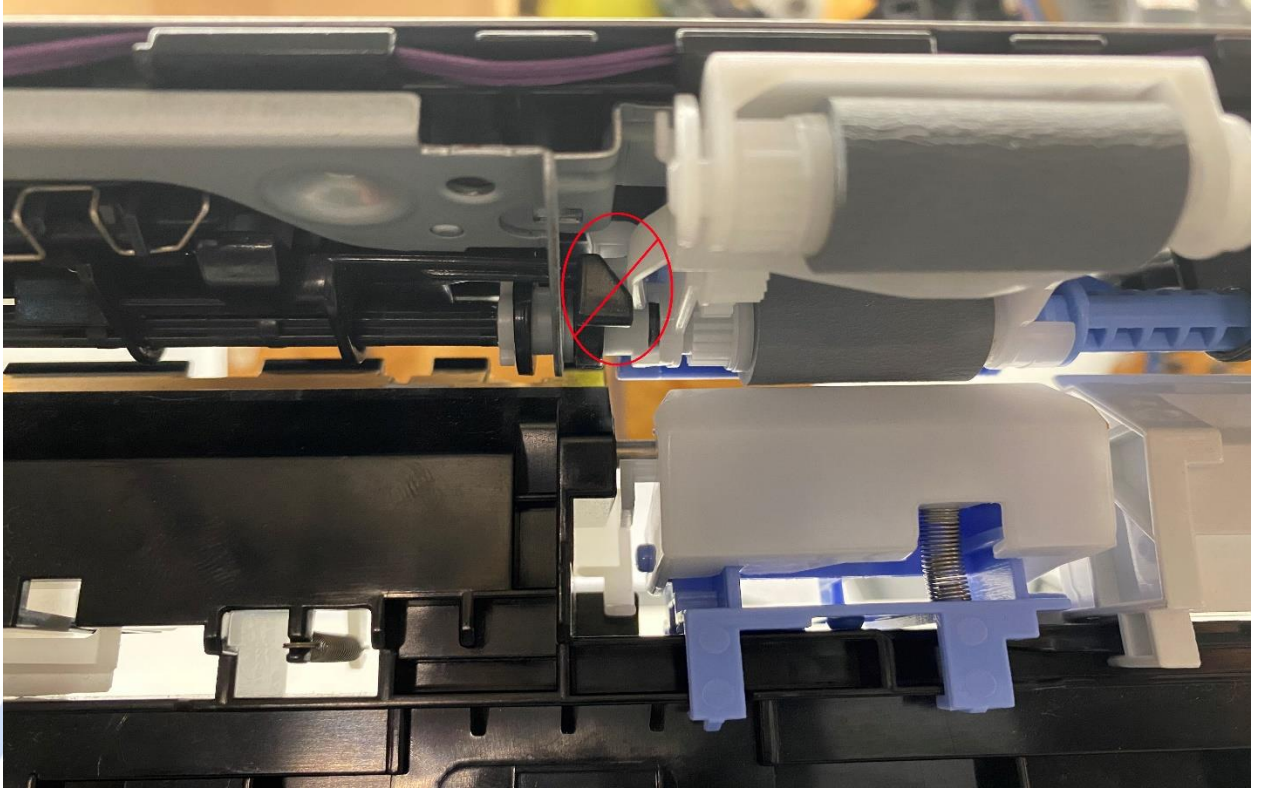
Shown installed incorrectly:

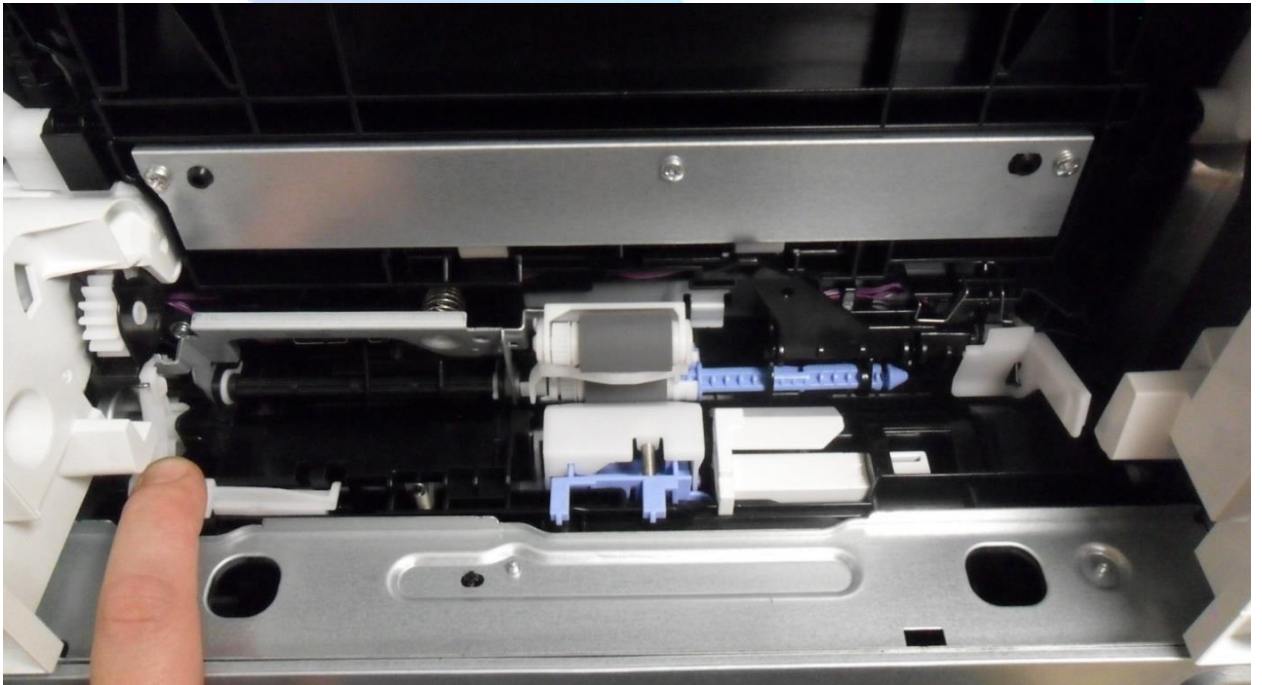
If the left white arm is pushed in, the roller bracket should drop down:

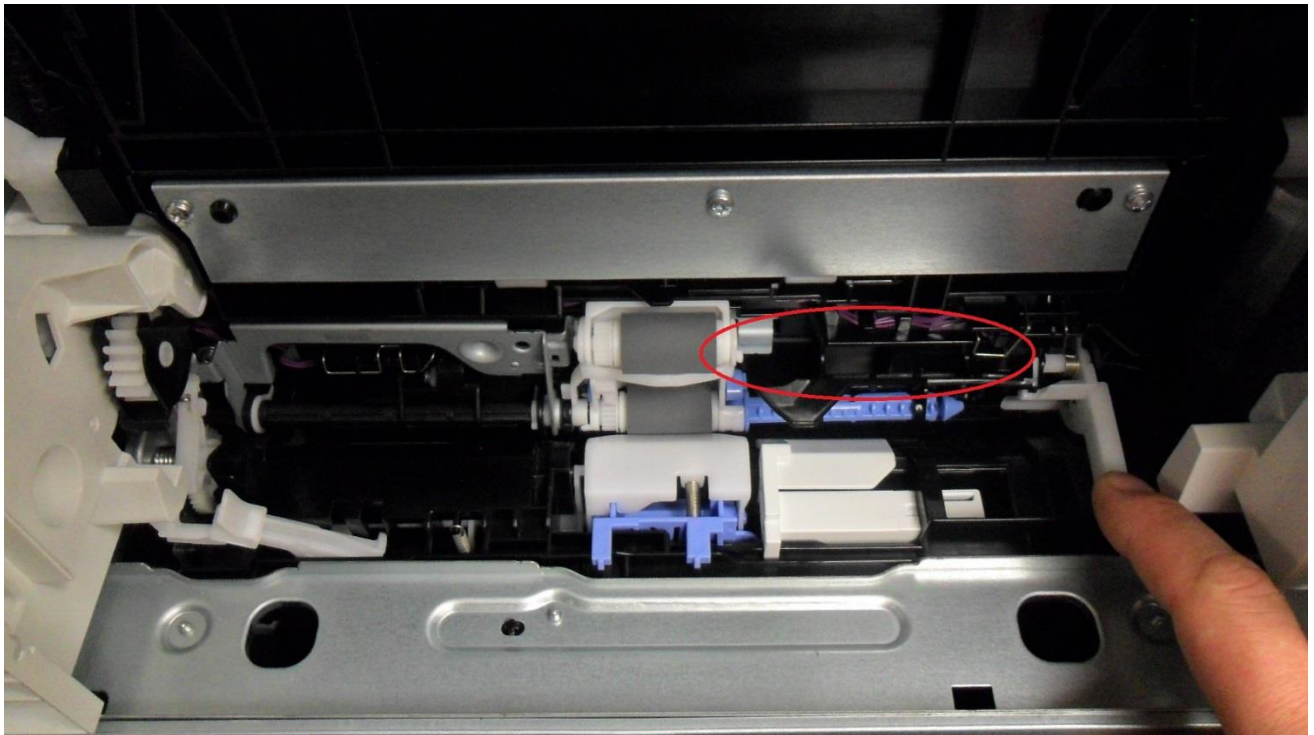
If the right white arm is pushed in, the black flag should drop down for correct operation.

If the paper sensor flag is missing, damaged, or dislodged replace the Paper Pickup Assembly **RM2-6771**.
