59.0C/59.00.0C

HP CP5225, CP5525, M750, M775MFP

Issue:

The CP5525, M750 and M775 may display a 59.00.0C error.

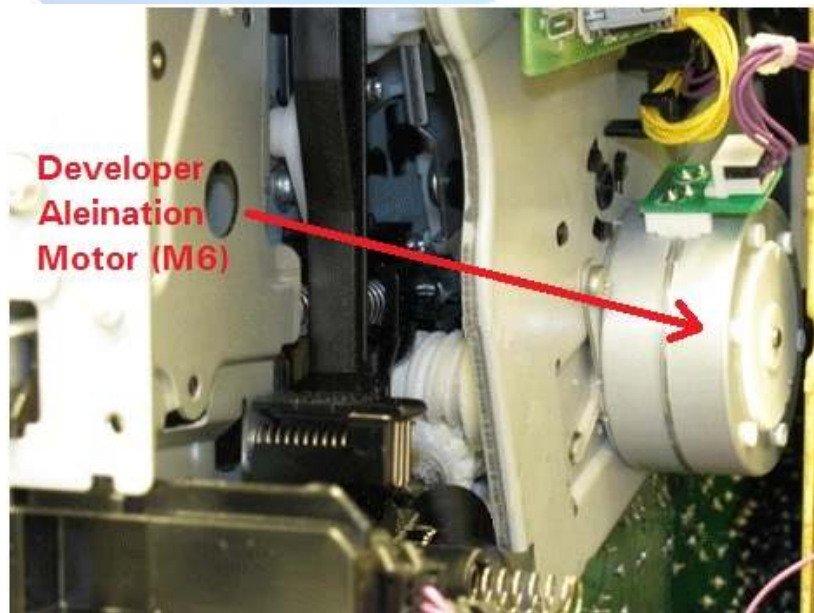
Check that the Developer Alienation Motor (M6) rotates during power-up

Figure 1: Check that the Developer Alienation Motor rotates when powering on the printer

2. Reseat the connectors to and from the motor if it does not rotate.

3. If the motor continues to not rotate when powering on the printer, replace it: Developer Alienation Motor (M6) (HP Part #: RK2-3298).
4. If the motor rotates, continue troubleshooting below.

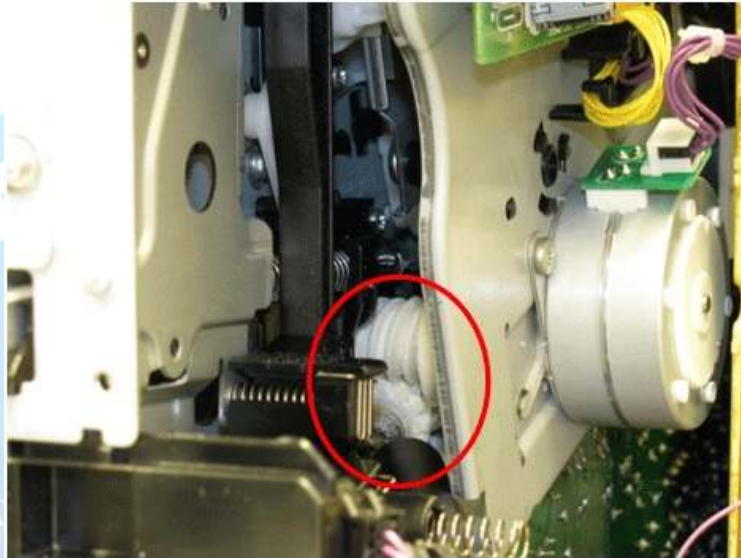
An issue was identified with the material in one of the gears in the Main Drive Assembly for some of the early production units. This issue would cause excessive wear on the gear that eventually results in a 59.0C/59.00.C0 error. This issue typically shows up later in printer life.

Figure 2: Plastic debris on or around these gears indicate excessive wear

2. If the gear shows wear, replace the Main Drive Assembly:

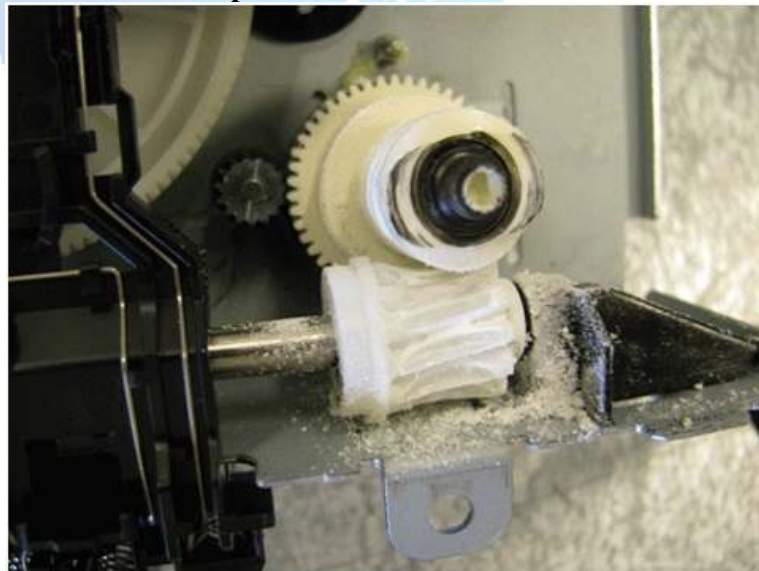
Figure 3: This is an extreme example of wear

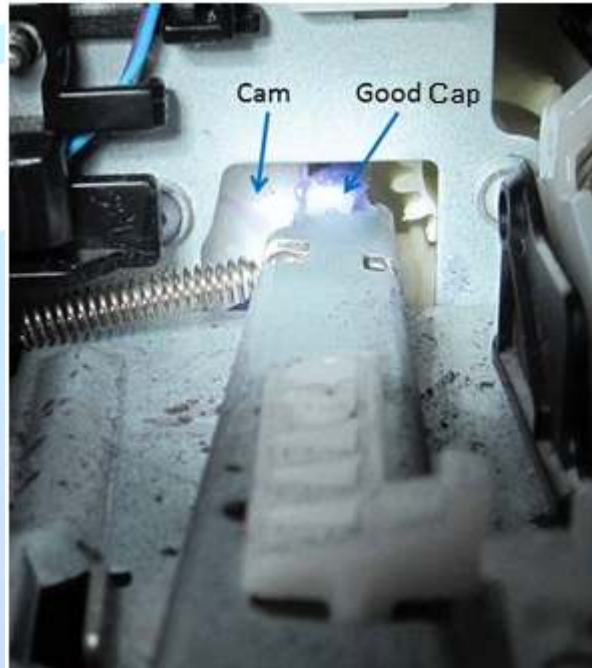
Figure 4: In this picture, the Developer Alienation Lever Cap is properly in place at the end of the shutter arm (check all 4 shutter arms)

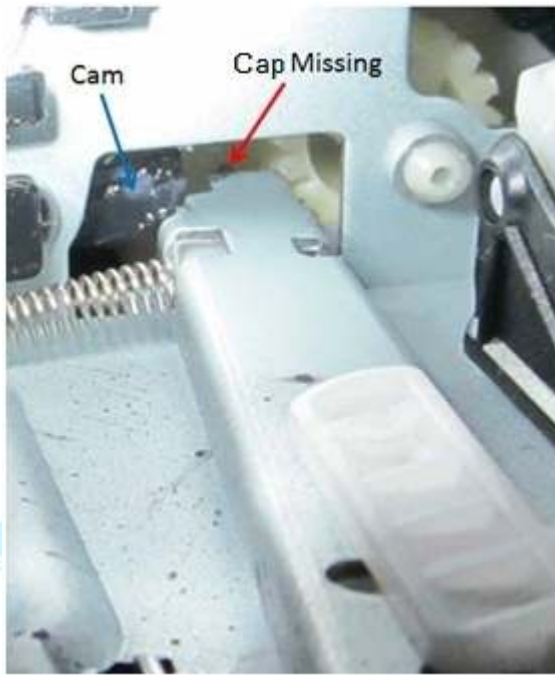
Figure 5: In this picture, the Developer Alienation Lever Cap has broken off the end of the shutter arm (check all 4 shutter arms)

3. If lever caps are found broken or missing, replace the caps: Tab, Laser Shutter Arm (HP Part #: RC2-6847).

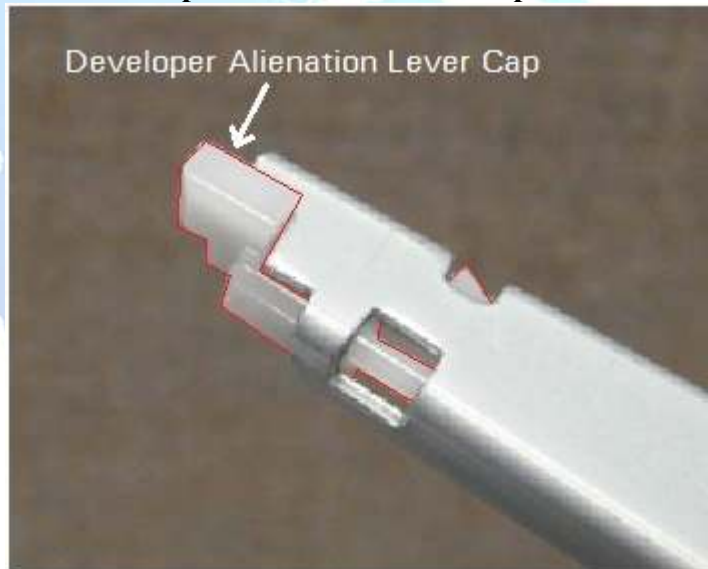
Figure 6: Close-up of the Developer Alienation Lever Cap on the end of a shutter arm

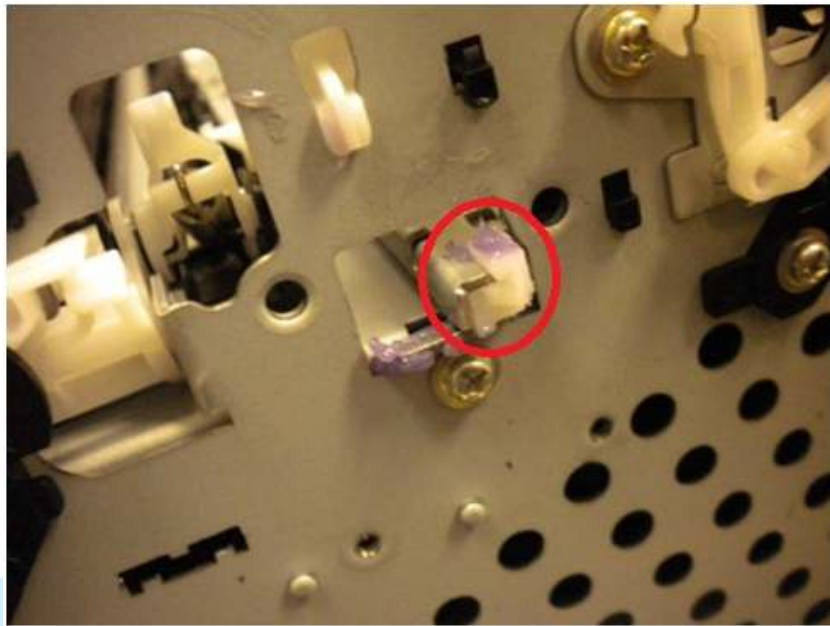
Figure 7: View of the Developer Alienation Lever Cap attached to the end of a shutter arm with the Main Drive Assembly removed
