**HP M607/M608/M609/E60055/E60065/E60075**  
**Cartridge Leaking and Printing Light**

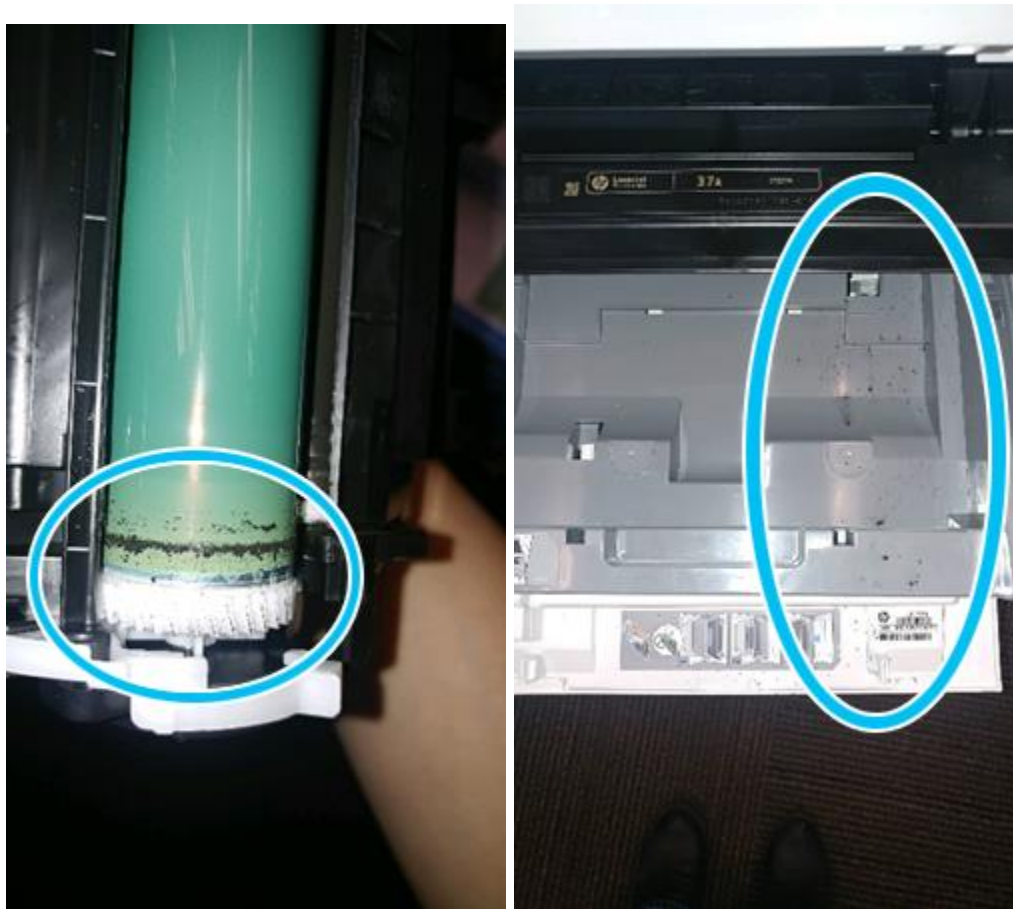
Toner leaking on edge of OPC and into tray producing pages with light print.  
Some cartridges produced a light vertical streak in the first 100 pages printed.

**Figure:** Examples of leaking

The root cause is the developer end seal not being properly seated during the manufacturing process.

The first four characters of the lot code correspond to the year, month and day. For example, 7A16 indicates the cartridge was manufactured 20170116. If the first four characters of the lot code are 7C28 (20170328) **or before** and the customer is experiencing toner leaking and light print, the cartridge should be replaced.

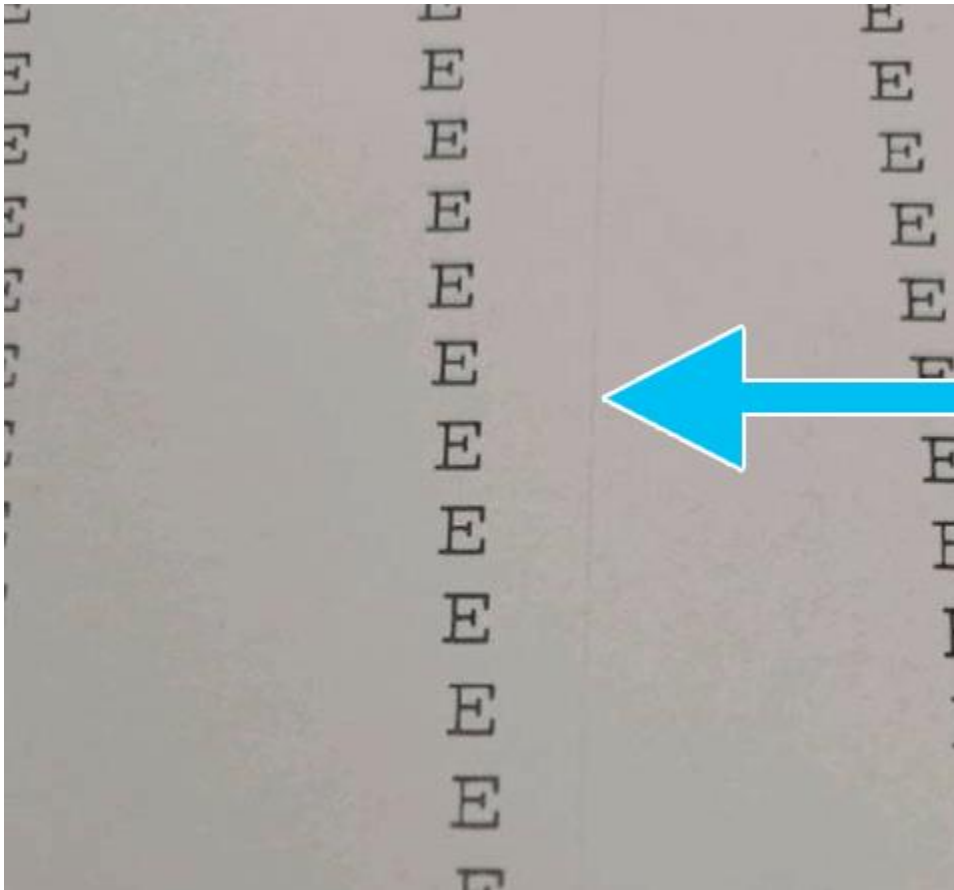
**Figure:** Vertical Streak example
