Imaging Drum Issue: Color Missing From Printouts and 59.6X Errors HP CP6015/CM6030MFP/CM6040MFP

An emerging issue has been detected with the imaging drums for the CP6015, CM6040MFP and CM6030MFP.

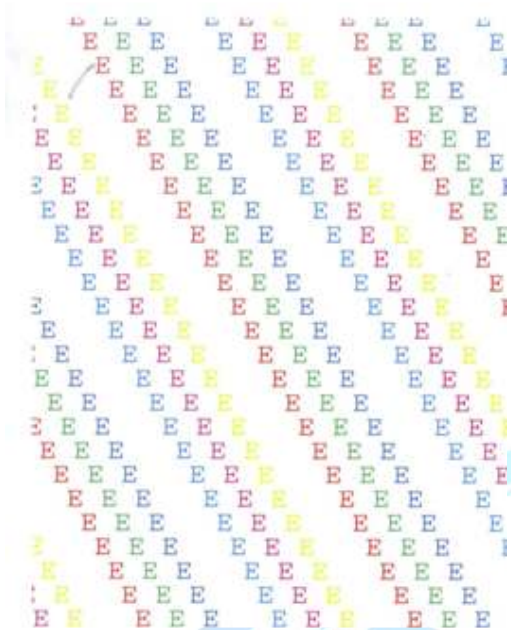
The issue can best be described as areas of missing print (specific color), which can occur on text documents as well as print areas with solid fill. It is important to note that the pages can be completely void of any print at all. Please refer to the examples below and on the following pages. Additionally, this issue can also generate a 59.6X error, which is an error code related to the Motor that moves the Drum Cartridge, where X refers to the specific color (0=Black, 1= Cyan, 2= Magenta and 3 = Yellow). If the root cause of the problem is a defective image Drum, then the motor is ok, but not able to rotate because the internal auger in the image Drum is broken and stall.

Figure 2: Missing Print (absence of black “E”)

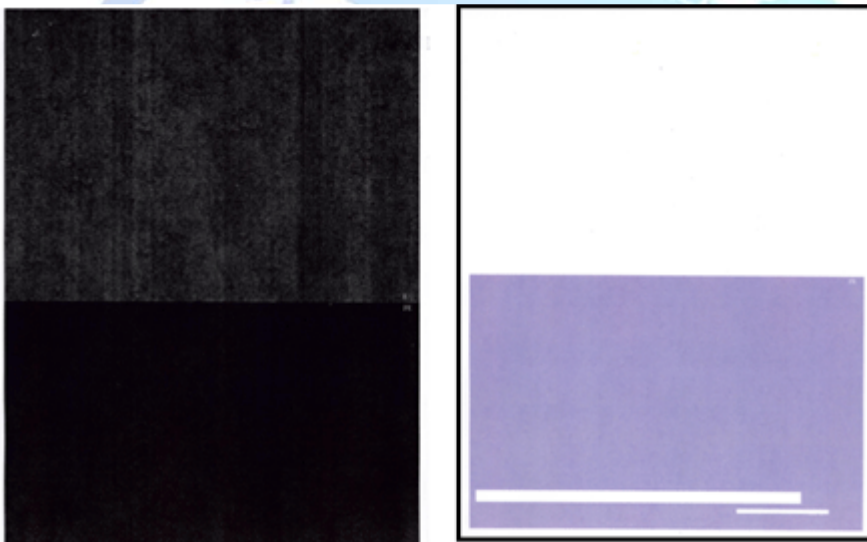
Figure 3: Missing Print (solid and blank areas)
