HP 9000MFP/9040MFP/9050/9050MFP/M9040MFP/M9050MFP/CLJ9500

13.11.05 Input Device Paper Jam – Tray 4 print

Common component: C8531A - Tray 4 High Capacity 2000 sheet feeder

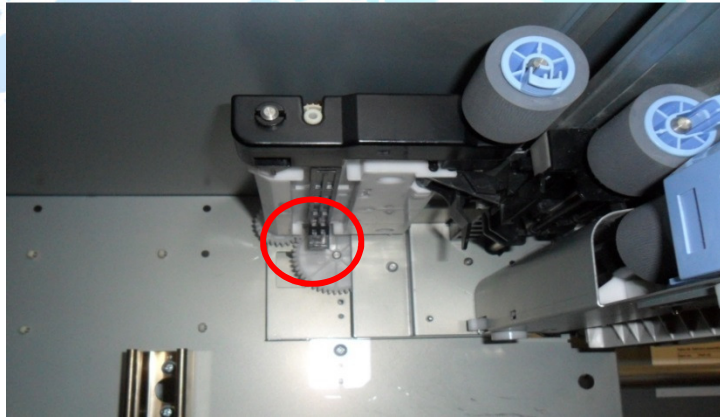
fig1

The tray 4 pick up assembly has a tab that is depressed when the cassette itself is completely closed to lower and engage the pick up roller. (figure 1)

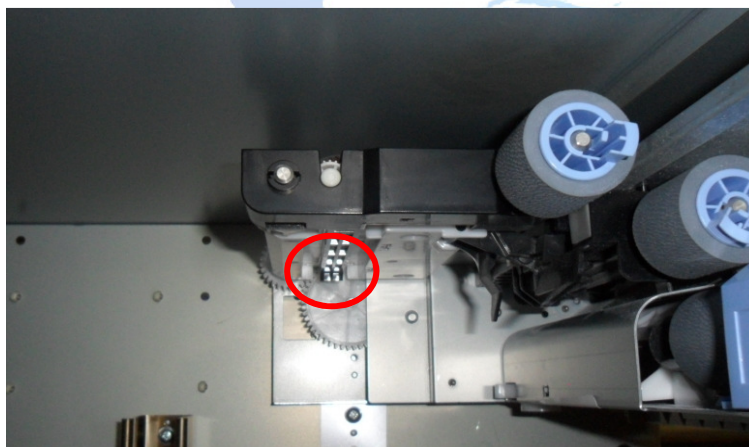
fig2

Common Cause: Broken Pick up assembly RG5-6208

This tab however is known to break (shown in figure 2), which then will not allow the roller to drop resulting in constant 13.11.05 paper jams.

The corrective action is to replace the paper pick up assembly RG5-6208
