HP CLJ 4600/4650 - Blank pages-Disengaging Rod

Problem: Document does not print and no error code is displayed

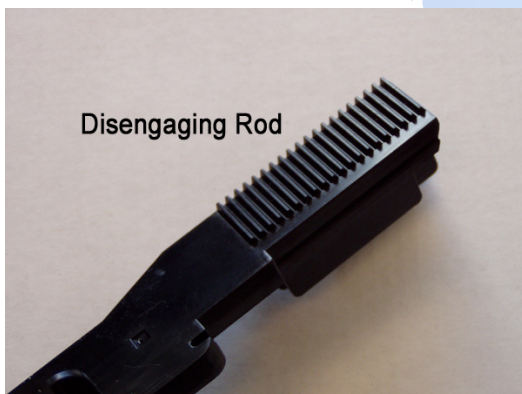
Remove the top and left cover, then put the top cover back on and run a print job. You should hear and see the developing motors start.

The developing disengaging rod will raise approx. an inch, pause for 2 seconds, and then raise a second time.

If on the second lift the disengaging rod skips teeth or does not move, this indicates the disengaging rod needs to be replaced

Note: The disengaging rod along the bottom is a 2" row of teeth that tend to actually break off causing the cartridges not to engage, requiring the rod to be replaced.

1. Remove metal retaining plate (6 screws), exposing the disengaging rod
2. Remove the return spring from the bottom of the disengaging rod
3. Raise the rod to its maximum lift point, and pull upward and outward to remove.

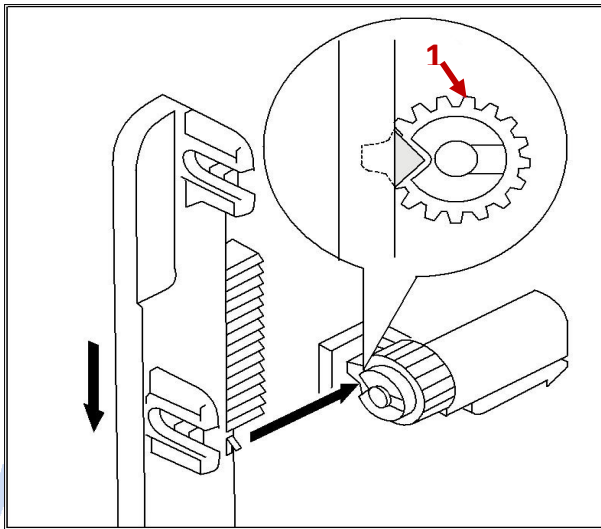
You cannot rotate the white gear unless all of the print cartridges are removed.

- 1 When reinstalling the developing disengaging rod, be sure to rotate the white gear (located between the black and magenta drum-drive units) clockwise until it comes to a complete stop (*image 1*).
