HP CP5525/CP5225/M750/M775MFP Missing Color(s)

Missing colors have been reported on the Color LaserJet CP5225, CP5525, M750, and M775MFP

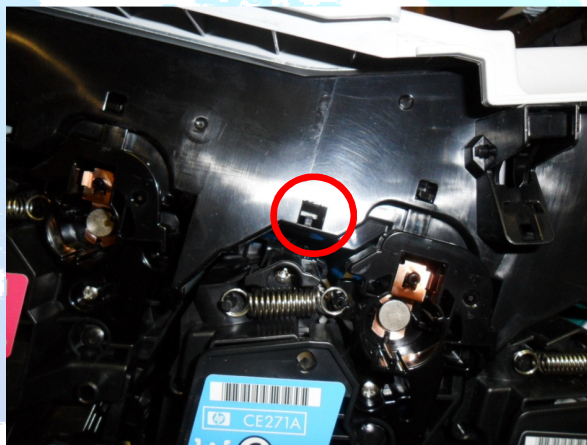
Printers diagnosed with the missing color are caused by the Upper Cartridge Guide Assembly being pulled out slightly from the front of the printer. Typically this is most visible at the center protrusion of the guide - between the Magenta and Cyan cartridges and usually will affect the operation of the front door, not closing completely flush to the frame. Photo with incorrect positioning: Notice lock tab visible on front side of frame
