Grinding from Fuser Drive area

HP M5025MFP, M5035MFP, M712 and M725MFP

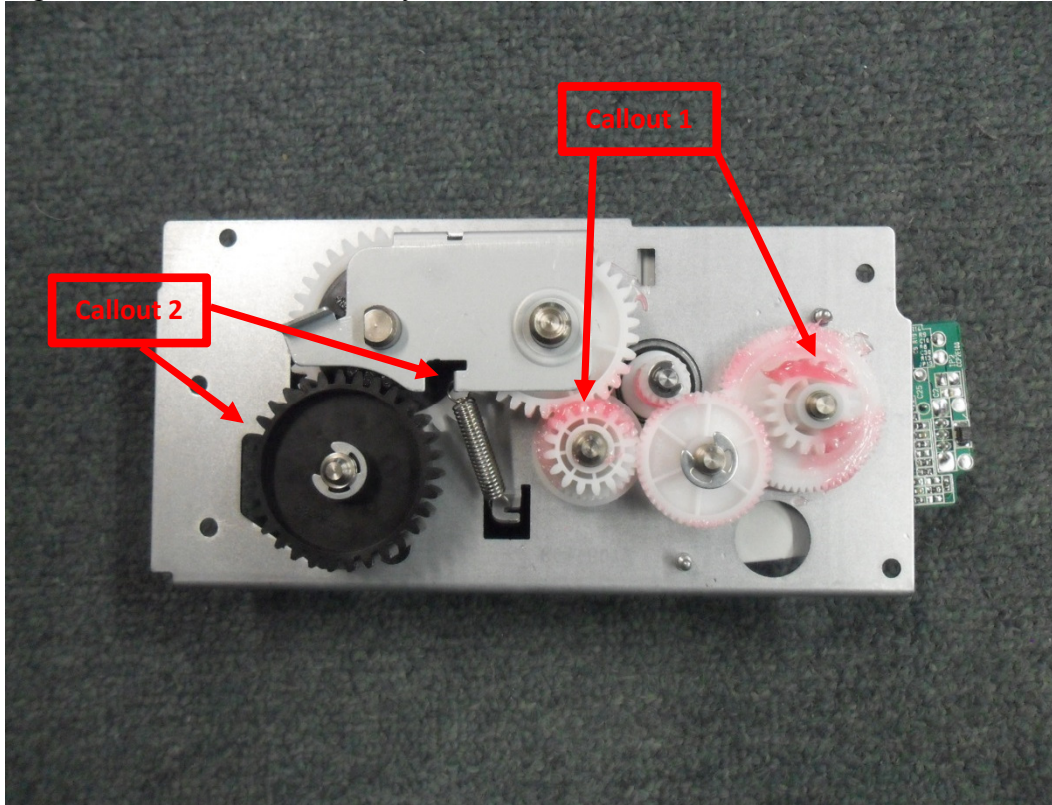
Figure 1: Fuser Drive Assembly

The black gears on the fuser drive assembly are impregnated with specialized lubrication by design. The grease which is applied to the white gears of the drive assembly is not compatible with the impregnated lubrication and will cause the materials of the impregnated gears to break down

Be sure replacement Fuser Drive Assembly does not have excessive grease on large white gear. There should not be any grease on the black gears

Callout 1 - Remove excessive GREASE from white gears. Leave only a very light coating on the teeth of white gears

Callout 2 - Clean off ANY grease from the surface/teeth of the Two (2) black gears.
