**HP CP4025/CP4525/CM4540MFP/M551/M570MFP
M575MFP/M552/M553/M577MFP
Missing Color(s)**

Missing colors have been reported on the above printer models

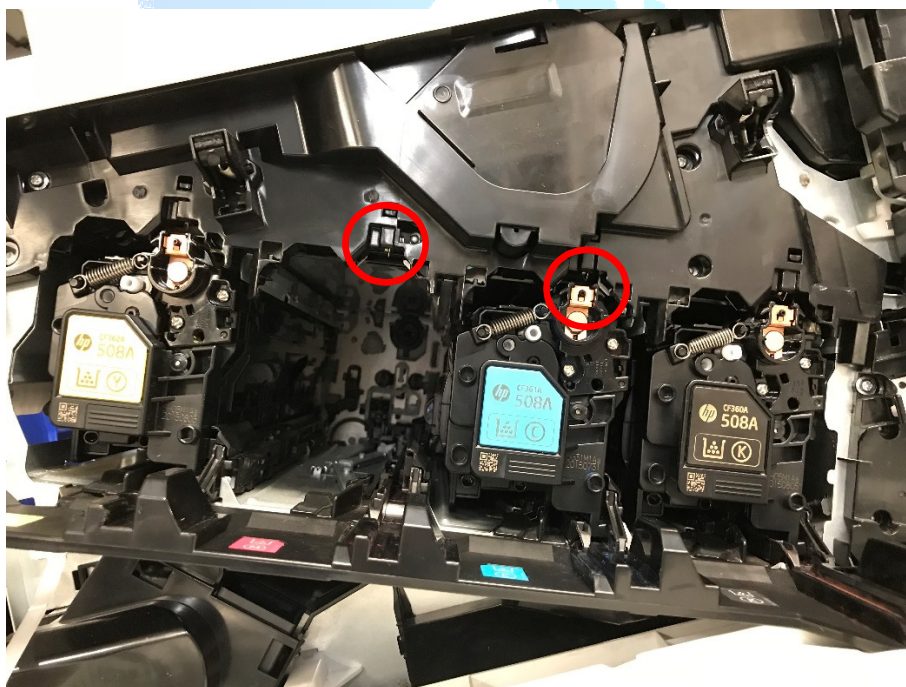
Printers diagnosed with the missing color are caused by the Upper Cartridge Guide Assembly being pulled out slightly from the front of the printer. When this occurs, grounding springs do not line up with toner cartridge. Typically this is most visible at the center protrusion of the guide - between the Magenta and Cyan cartridges and usually will affect the operation of the front door, not closing completely flush to the frame.

Photo shows grounding springs to the copper contact on the toner cartridge

This issue may be addressed by snapping the guide back into position. In order to do this, it may be necessary to remove screws and use a small flat-blade screwdriver and firmly press to lock the guide to the sheet metal frame.
