HP P3015 and M525 Series printers Error TRAY 2 OPEN

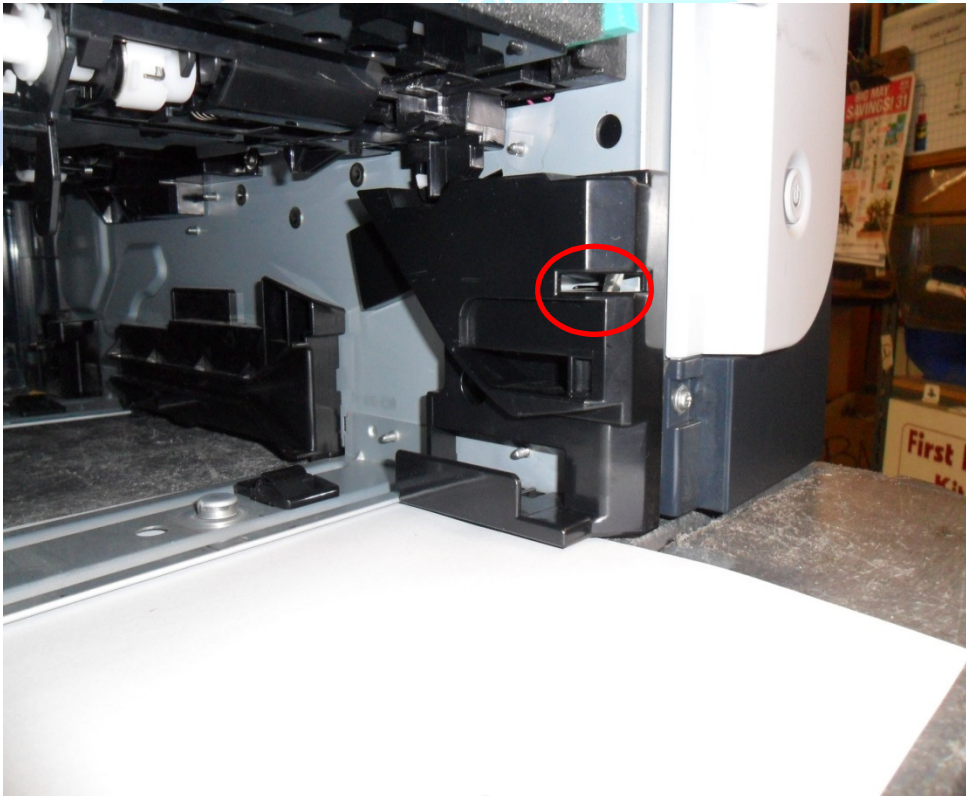
FIG1

In most occurrences we have found the only problem to be a weakened leaf spring – which is responsible for depressing a micro-switch to signal the DC Controller when the cassette is closed.

To verify this, with the printer on and the cassette removed, simply use a small object to press in on the metal leaf spring located within the right cassette guide (FIG 1) and note the control panel:

2) If the printer displays “TRAY 2 EMPTY” the leaf spring would need to be slightly bent to make a better contact with the micro switch itself.
