HP CP6015/CM6030MFP/CM604MFP Internal Door 2 Open Error

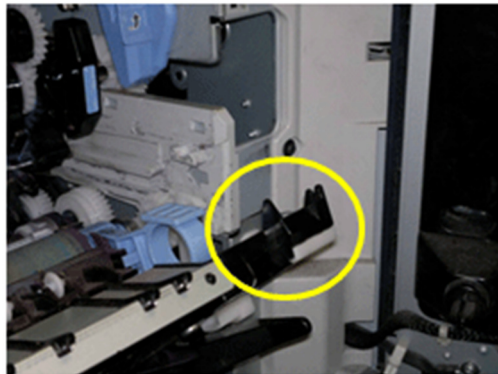
Figure 1: Secondary transfer assembly

1. T2 door sensor (SR33) that detects the position of the secondary transfer assembly is damaged.
 1. Test the sensor by performing a manual sensor test. Diagnostics > Manual sensor test.
 2. Open the right door and remove the fuser.
 3. Then open and close the secondary transfer assembly. The sensor value (letter R) should change from 0 to 1 and vice versa.
 4. If the value does not change, check the right end of the Secondary Transfer Assembly. It has two tips that push the door sensor when closing this assembly. This part might break and cause the error message. If it is broken, proceed to replace the Secondary Transfer Assembly.

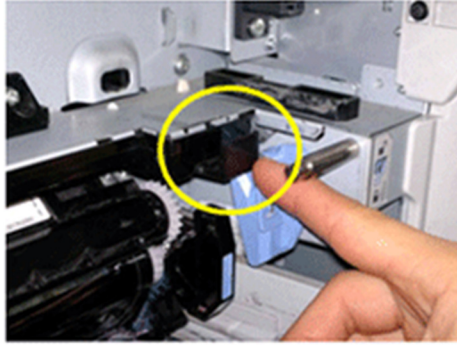
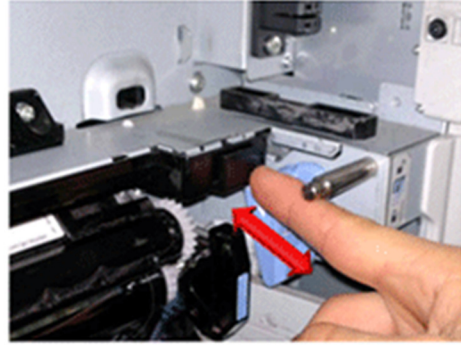
Figure 2: Sensor

5. If the secondary transfer assembly is not damaged, push the sensor manually. Ensure the sensor springs back. If the sensor value (letter R) still does not change, replace the photo sensor.

6. If the sensor value (letter R) changes but the sensor does not spring back, replace the Intermediate transfer belt (ITB) duct assembly.
2. Two springs in the right lower door that might become dislodged. These two springs need to be reinstalled in the correct location in the right lower door; there are two buttons front and rear.

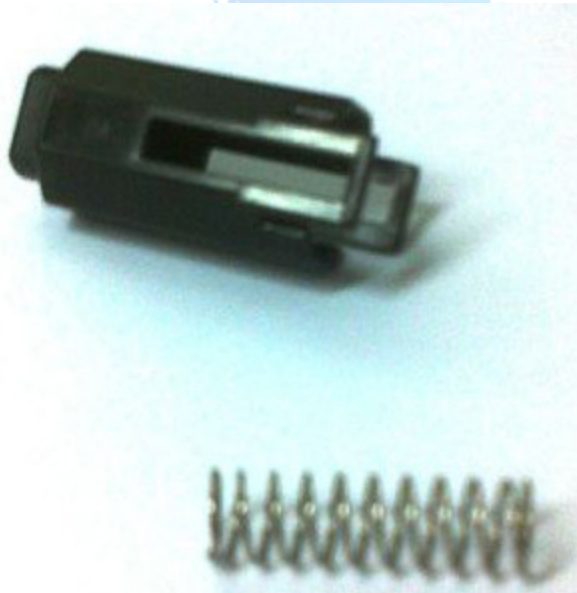
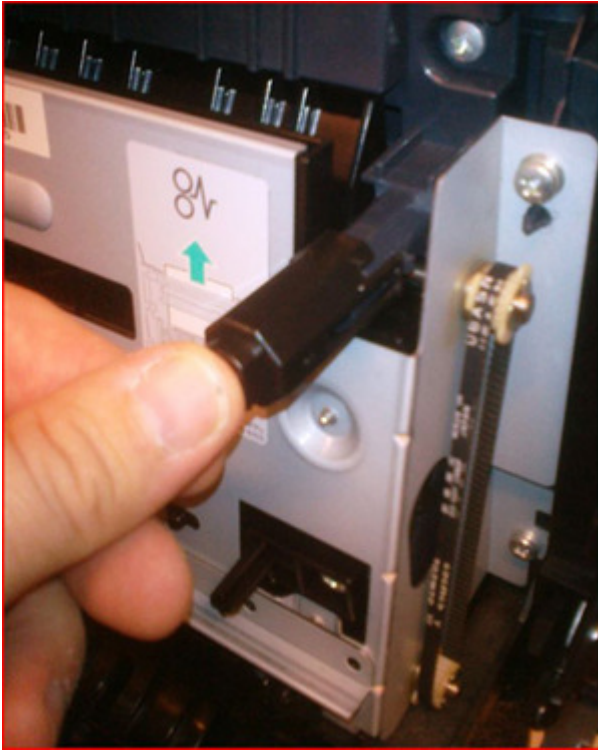
See following figures (located on the right lower door and removed items).

Put the springs back in their placement in the right lower door by pushing them correctly.

NOTE: Do not replace the right lower door for this issue.
