Print quality problems due to toner contact

P4015 series and M600 series

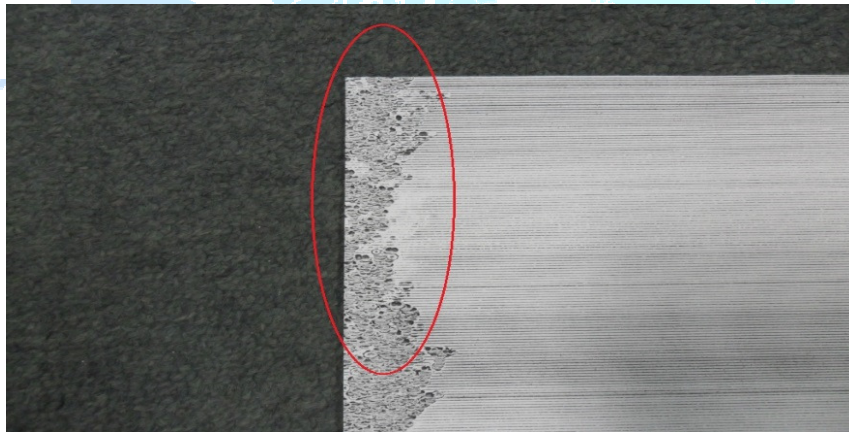
The most common defect is usually referred to as “circle” or “bubble print” with varying severities from a thin row down the side(s) of the page (shown below) or mostly full page, depending on how far out of position the contact is.

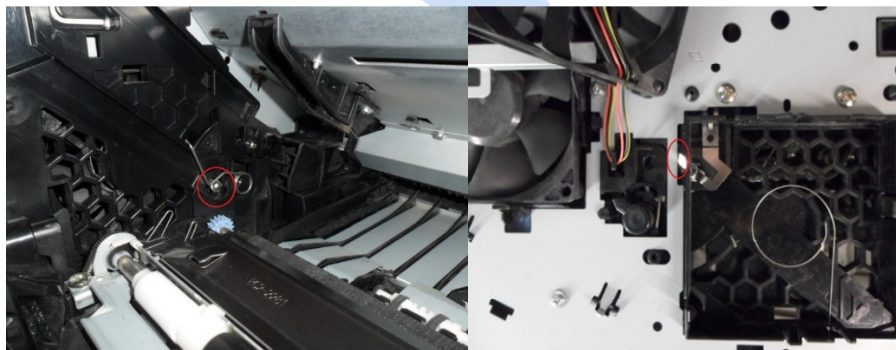
The main culprit for this is a drum ground contact either bent out of position or pressed in and caught on the printer frame – shown in correct position from inside toner cavity and outside left, with fan removed. Most often times can be manually adjusted back into place.
