## *Print Defect - Black Band*

### *HP 42x0 and HP 43x0 Series*

This document describes a print quality defect and some possible actions that may eliminate the Print Quality defect.

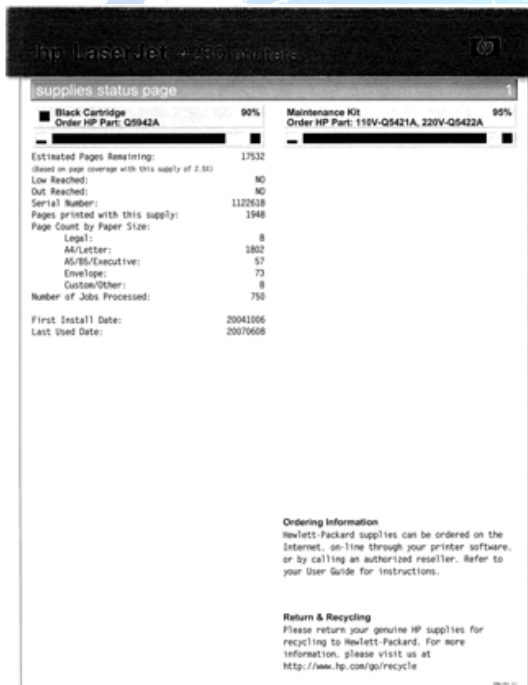
**Figure 1:** Sample of top bar defect

The illustrations below show a print quality defect the industry has encountered. The defect runs across the entire width of the paper (edge to edge). In this situation the print quality defect occurs on the first page printed after the printer has come out of Power Save. The print quality defect goes away after the first page has been printed.

Unplugged your printer from the ac outlet. In most situations, this print quality defect was corrected by cleaning (using canned air) the Developer and Charge Roller contacts. Push on the spring contacts to ensure they “flex” appropriately and spring forward to contact the Toner Cartridge once it is installed in the printer.
