PS112 Media Width Sensor Failure Modes and Diagnostics HP 4345MFP and M4345MFP

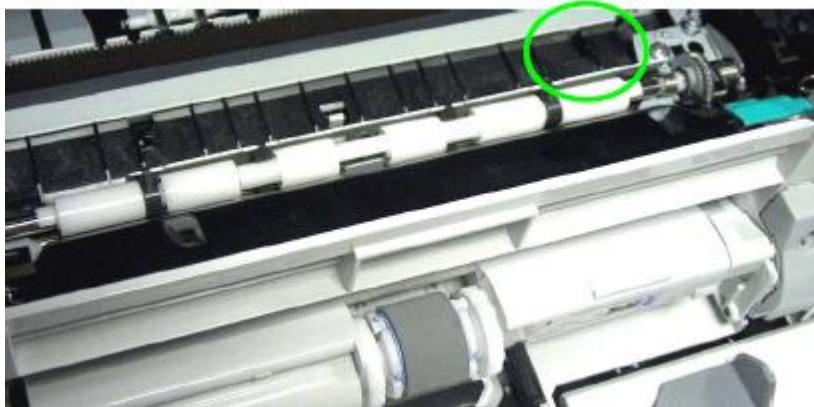
Figure 1: Paper width sensors (PS106 and PS112)

PS112 is a photo sensor used by the device to sense media that is narrower than 7.4 inches (188mm) as well as residual media present in the paper path.

The photo sensor is made up of two components, a light emitting diode and a receptor. The PS112 photo sensor is actuated by a flag which can be impacted if one or both of these components fail. Photo sensors can have two failure modes:

- **The light emitting diode fails.** If this happens, the photo sensor behaves like the flag is engaged and the light path is always closed.
- **The receptor or sensor flag fails.** This cause is rarely seen (*Corner Case, Rarely Seen*). If this happens, the photo sensor behaves like the flag is never engaged and the light path is always open.

We have seen instances where the PS112 sensor fails because of toner buildup in the sensor. In the cases we have investigated, this is due to toner dumping caused by remanufactured toner cartridges. We have had success in resolving the failure by cleaning the sensor using compressed air.

A change to DC Controller firmware was implemented in version 17 to correct these issues, but the behavior is ultimately cause by a defective PS112 sensor.

The page width sensor PS112 is part of the central printer block and this part is not replaceable. To resolve the issue, the entire printer should be replaced. The DC Controller should *not* be replaced.
