"Tray X overfilled" Error Message

HP CP4025/CP4525/CM4540MFP/M4555MFP

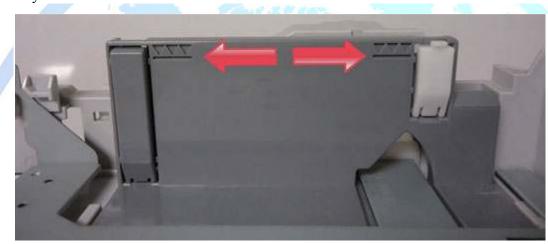
1.Check the paper stack height in the tray and ensure it does not exceed the limit of the tray.

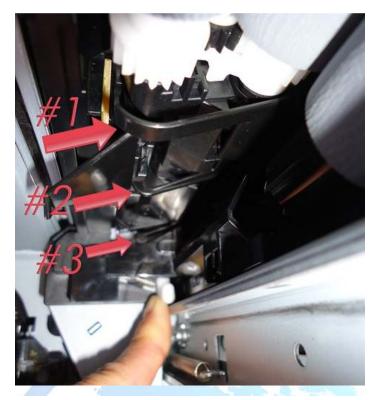
The paper surface sensor flag can be found by uninstalling tray 2. The flag is a black plastic piece that has 3 tabs. The tab that is closer to the pickup roller is the one that senses the paper stack height (call out #1). The second flag is the one that slides to activate the photo sensor [SR4] (call out #2) and the third one is at the very back and gets moved by the Tray-closed tab (call out #3).

If the tray is inserted and the issue occurs please look for a small piece of jammed paper underneath the third tab.

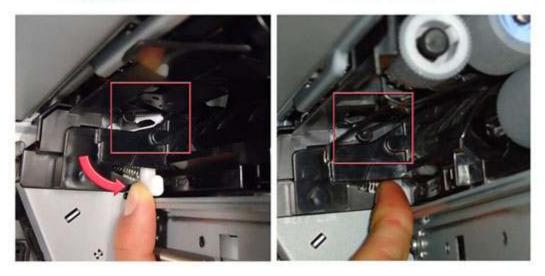
Media Jammed

Jam Cleared

2.Remove any piece of paper found in the tray-closed tab area. Manually push the white tab towards the right to lower the sensor flag down, this will allow you to see underneath the rear side of the media stack sensor. Push the white tab several times, the sensor flag can occasionally get stuck and this movement will help to release it.
