## HP CP4025, CP4525, CM4540 – 59.F0 Error

### **Description:**

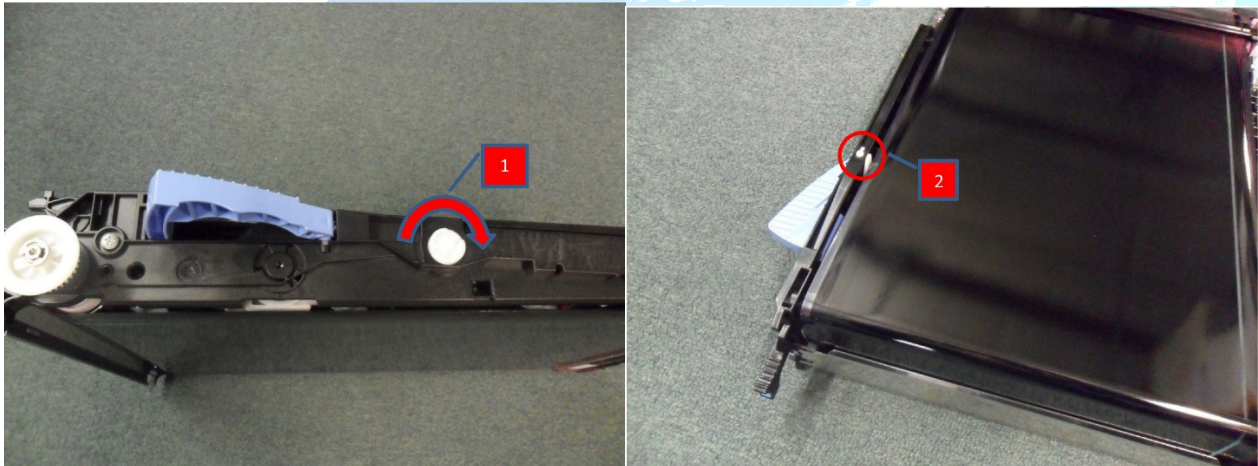
This error is primarily caused by a transfer alienation failure in which the ITB is stuck and unable to rotate, the SR9 sensor (the primary transfer roller disengagement sensor) has gone bad or the fuser drive assembly has failed.

1. Reseat the ITB.
2. If the issue persists, remove the ITB completely from the unit and manually test the ITB gear and flag.
3. Rotate the gear (1) and check that the flag actuates (2) when the white gear is turned.

4. If the ITB flag is broken or damaged, or if the flag does not move, replace the ITB.
5. If the ITB gear and flag are working properly, test the Primary transfer roller disengagement sensor SR9 (Sensor K) by using the MANUAL SENSOR TEST in the TROUBLESHOOTING MENU.
6. Remove the ITB and fuser assembly to locate Sensor SR9 (3) inside the fuser cavity.

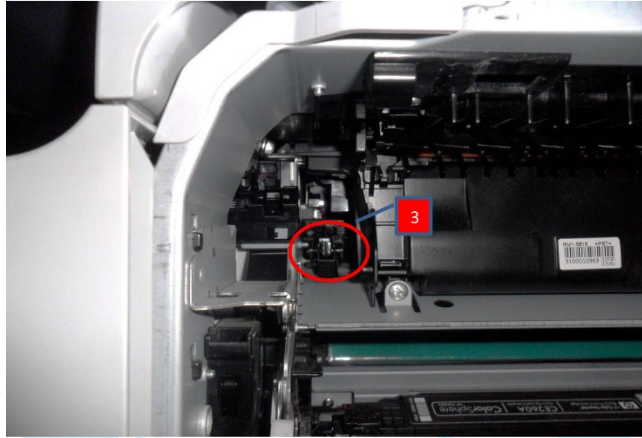
7. From inside the fuser cavity, press and release the SR9 flag to actuate the sensor
8. While pressing and releasing the flag, check the control panel display for sensor response (under K) and confirm the sensor toggles between 0 and 1 (0 is the normal state)
9. If the value does not toggle between 0 and 1, replace the sensor (WG85696000CN)

If Sensor SR9 is working properly, the error would then be the result of the fuser/transfer drive assembly not rotating the belt. Replace the fuser drive assembly.
