Missing or Light Color Planes on Printouts

HP M551/M570MFP/CP3525/CP4025/CP4525/

M575MFP/CM3530MFP/CM4540MFP/M651/M680MFP Printers

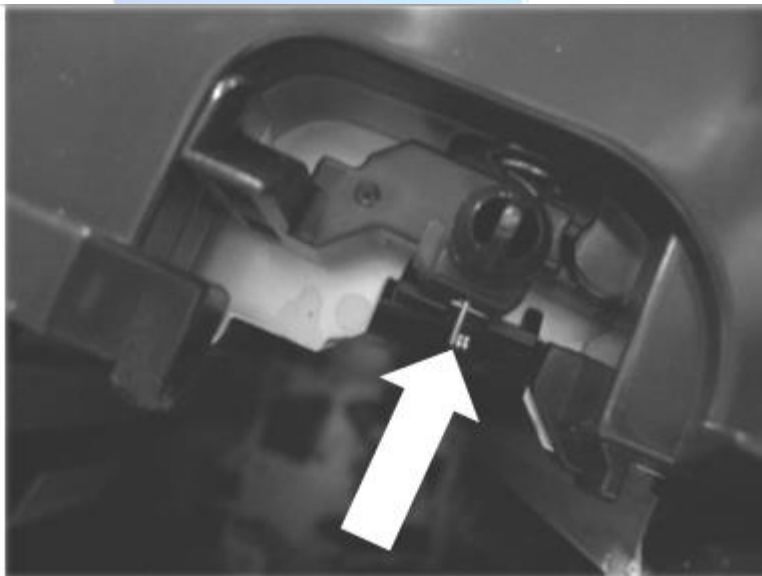
Figure: Ground Contact Spring Installed Properly

If the Ground Contact at the printer or cartridge is missing, dirty or blocked the color will be light or missing from printouts as well. See the following Figures for how the ground contact looks in place properly and where it has been dislodged.

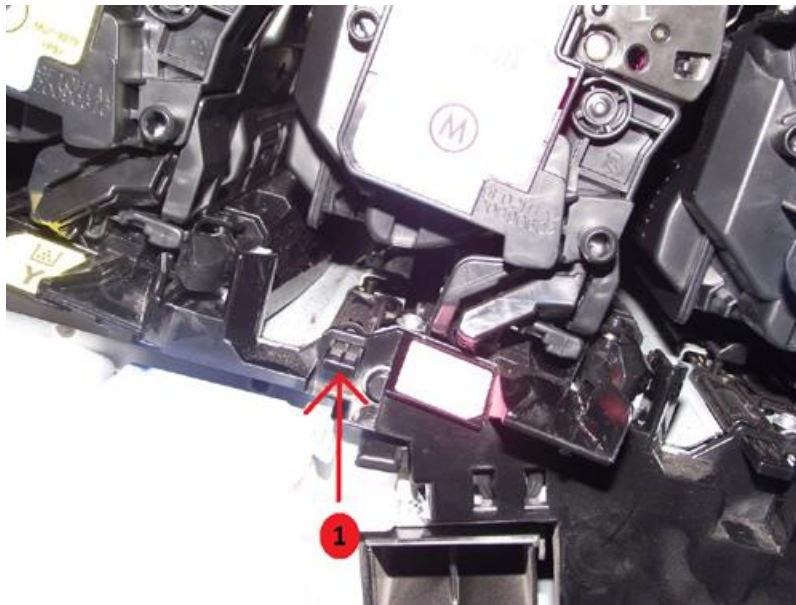
Figure: PGC (protective glass cleaner)

8. Do a Laser Scanner Shutter Test by defeating the PGC (protective glass cleaner).

9. Push tab in to verify the shutter opens. Compare process with a working color slot.
10. It is possible the PGC (protective glass cleaner) actuator (see Figure below) at the door is missing or the front door is not in the correct position. Replace front door assembly.

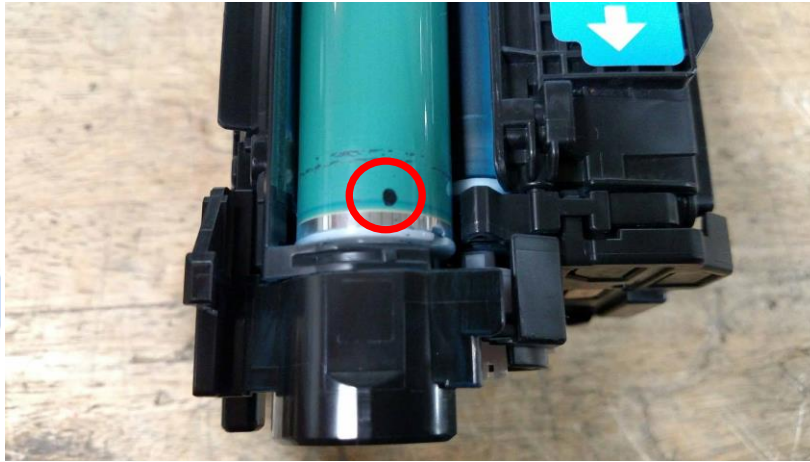
Figure: Dot on drum

Use a pen, pencil or marker to draw a dot on the white area on the edge of the drum, then close the door and wait for the printer to finish the self-check process. Now check to see if the dot moved, see the Figure below.

- If the dot moved, replace the laser scanner assembly
- If the dot does not move, perform the same step on a different slot as well and test. If none of the dots move, there must be a cartridge engagement issue, replace MDA (main drive assembly).
