Troubleshooting 13.20 Errors

HP 4200/4300/4250/4350/4345MFP/M4345MFP

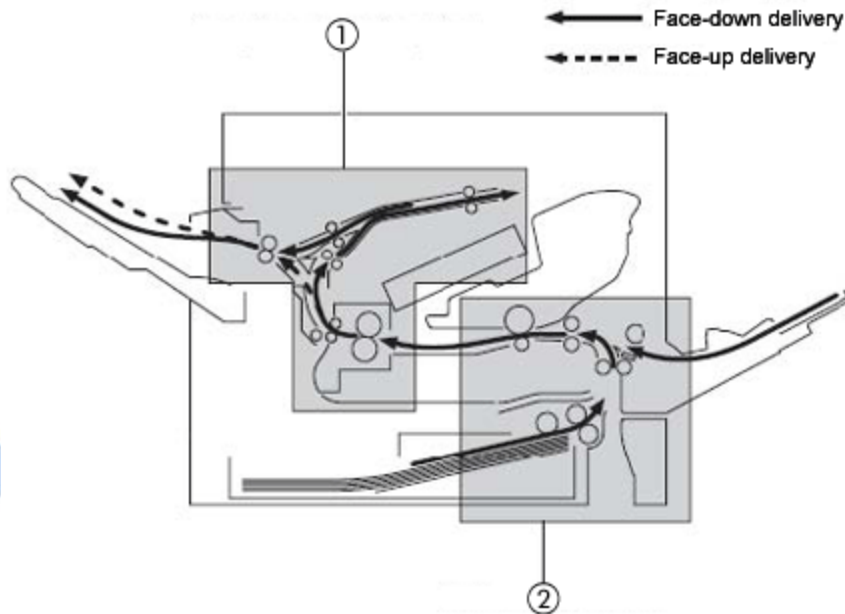
Figure: Paper delivery path

1. *Fusing/Reversing/Delivery block*
2. *Paper pickup/feed block*

1. Ensure all media is removed from the paper path.
