Broken Transfer Belt Locks
HP CP5525, CP5225, M775MFP, M750

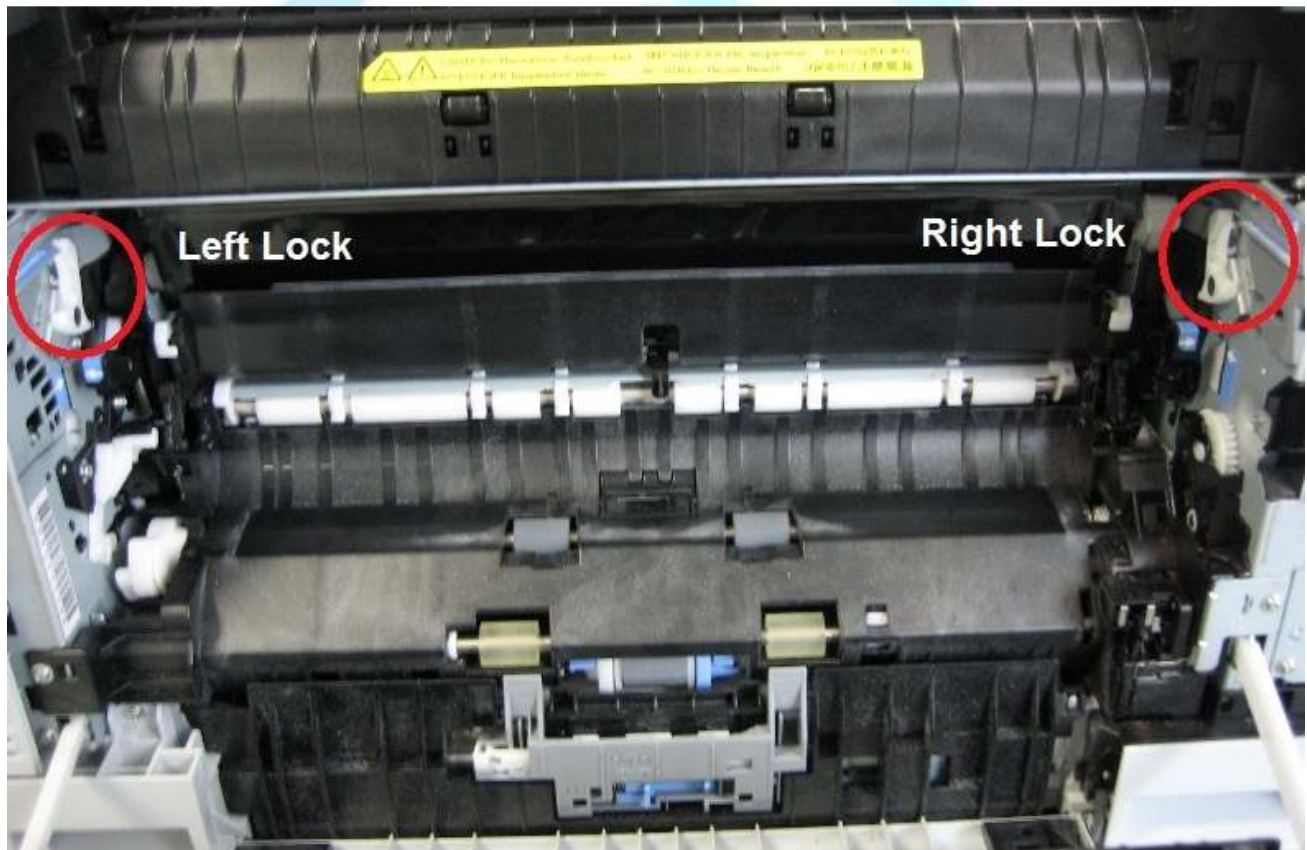
Figure 1: Lever Locations

The locking levers that hold the ITB (Intermediate Transfer Belt) in place may break. The location of these levers is indicated in <Figure 1> below:

Service parts have been set up to replace these broken locks. Order the appropriate part as indicated in <Figures 2 & 3> below and replace it.
