***Close Left Door Error Message  
HP M712/M725MFP LaserJet Printer***

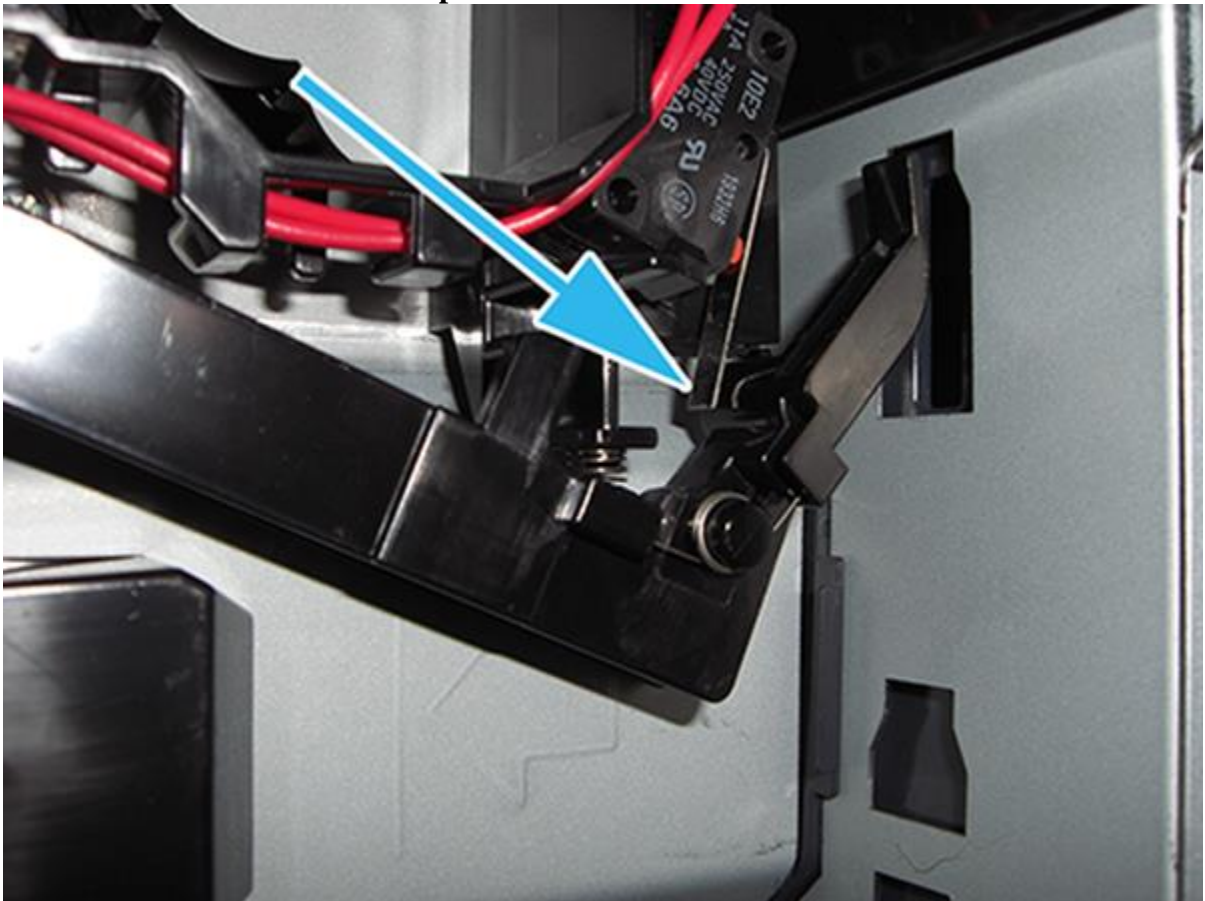
**Door actuator switch in correct position:**

**The metal switch finger should be "in Front" of the plastic rock arm.**

**Before replacing any parts check the left door switch actuator arm to make sure it is positioned in front of the rocker as shown in following image.**

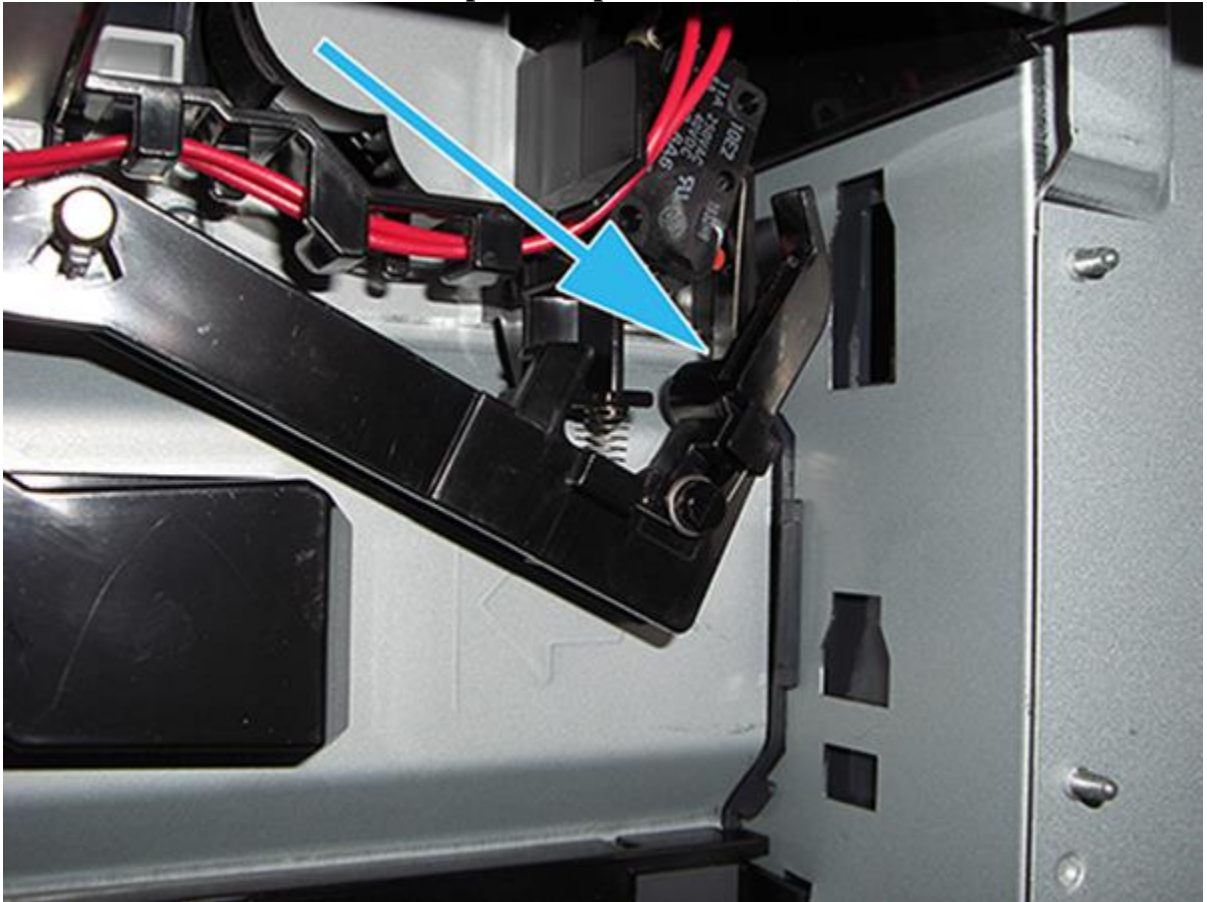
**Door actuator switch in incorrect position (pictured below):**

- Notice how the Metal finger is behind the plastic rocker arm

If the message persists, verify the J35 connector is fully seated on the DC controller PCA. Use the Manual Sensor Test menu to verify the left-door sensor functionality. If necessary, replace the sensor.
