**Front Door and Cartridge Tray Will Not Open or Close  
HP CM2320MFP/CP2025/M475MFP/M375MFP/M451/M351/M476MFP**

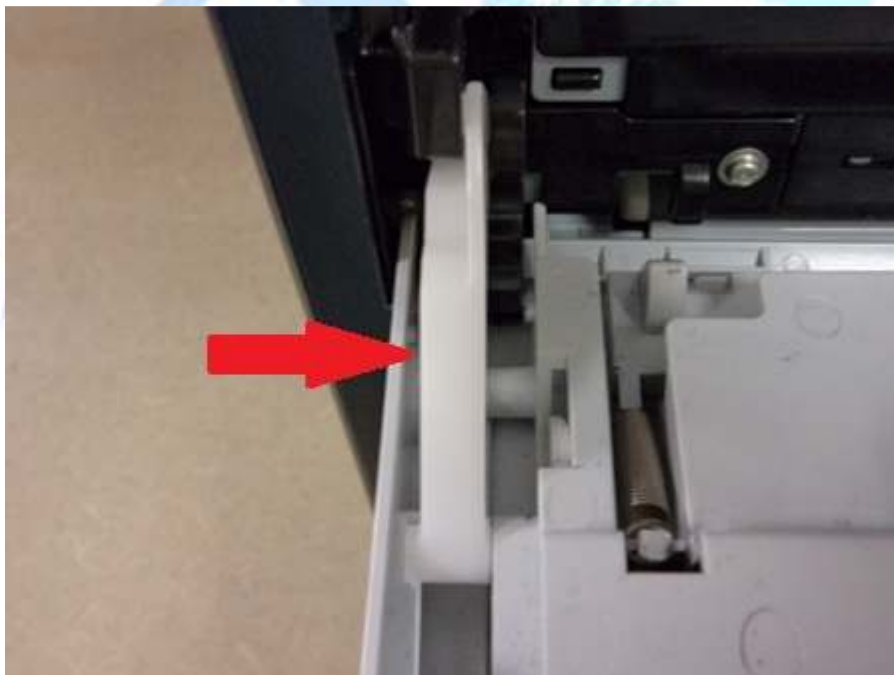
door pin.jpg

1. Open the front door as far as possible.
2. Inspect the door, look for damaged or dislodged door pins or links (see image below).
  - a. If dislodged: Secure the parts back in place
  - b. If damaged: Front door assembly needs to be replaced

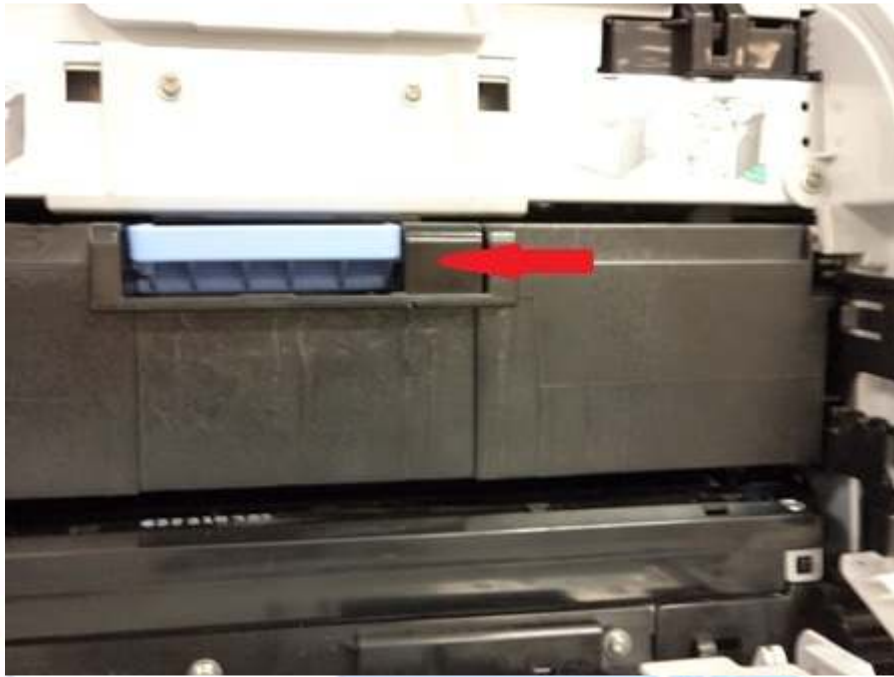
cartridge tray latch.jpg

1. Open the front door.
2. Check for damaged or dislodged door pins or links. If so, go back to "Front door can't be opened / closed" section.
3. Inspect the cartridge tray latch (see image below), if the latch does not release the tray. The cartridge tray assembly needs to be replaced.

NOTE: During normal operation when the cartridge tray latched is pressed a spring retracts the tray lock.

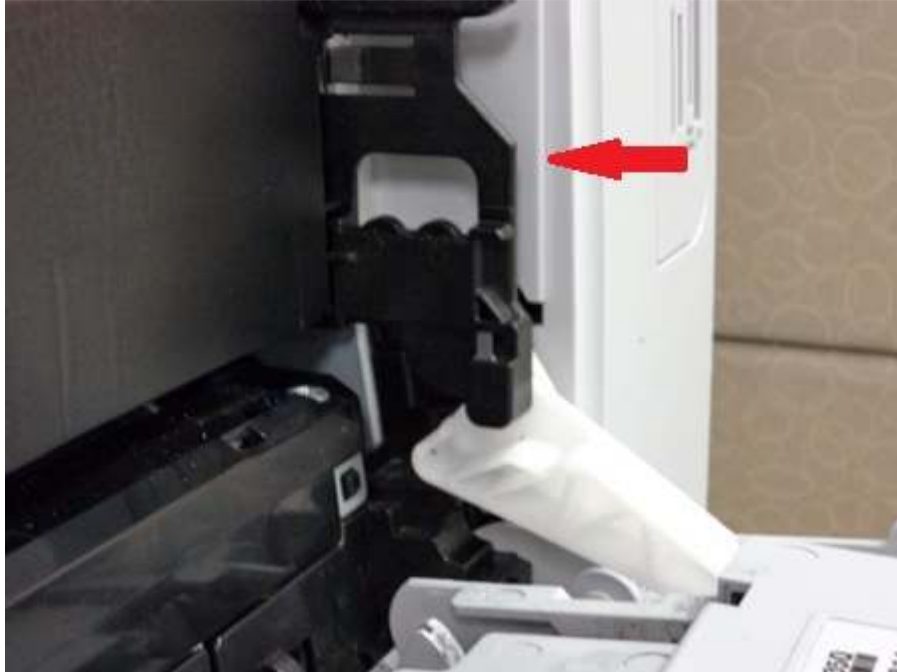
cartridge tray guides.jpg

4. Inspect the cartridge tray sliding guides (see image below). If the cartridge tray sliding guides are damaged the whole unit needs to be replaced since this is not an orderable part (follow standard elevation process for whole unit replacement).
