### Paper Jam in Rear Door

#### HP CP2025, CM1312MFP, CM2320MFP, M375MFP, M475MFP, M476MFP, M351, M451

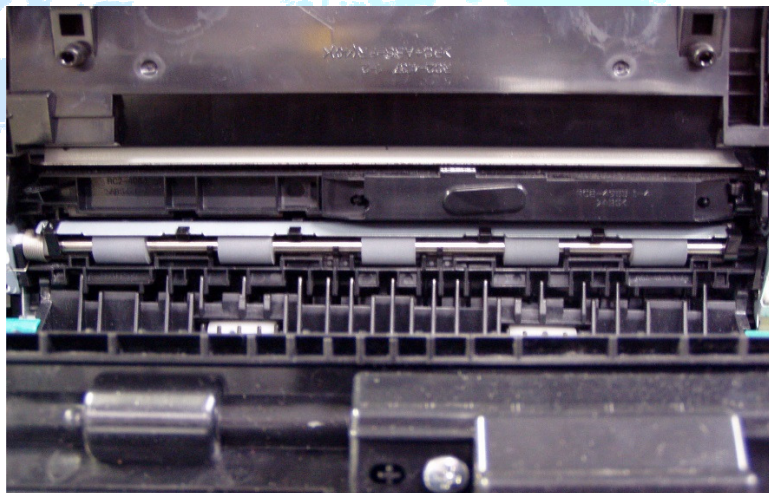
This problem is caused by the guide on top of the registration assembly in the back of the printer being out of position. Physical damage to that specific part because of a paper jam causes the printer to show a **false** paper jam in the back door. This problem can be seen from the back of the machine. Check the registration roller and make sure it is in the right position as shown in the picture below.

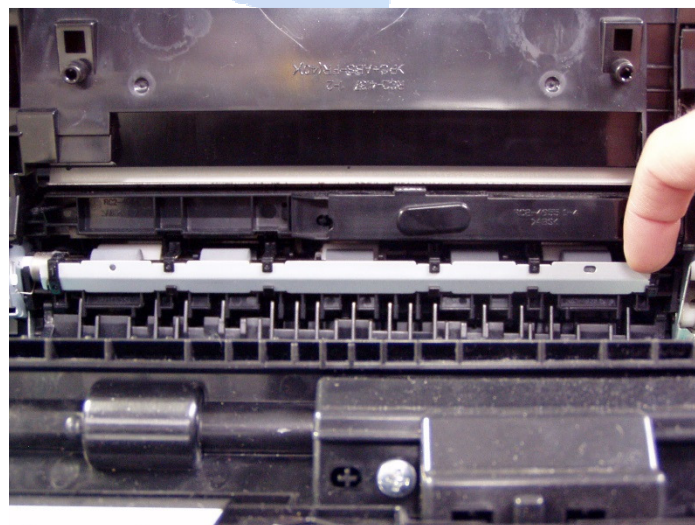
If there is a problem with the registration, you will see the guide is not all the way up and it does not go back to the original position right away, see picture below.

If the issue is confirmed, carefully move the guide to left or right to see if it will go to its home position. If not, a close look will be needed to determine the cause of the problem and may need to contact LPI tech support for further diagnosis.
