HP M712/M725MFP Close left door message

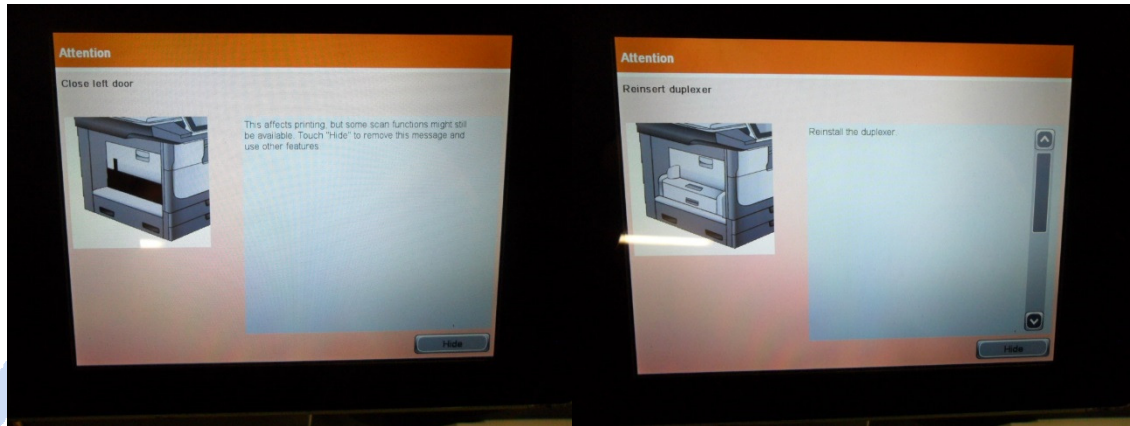
There have been a few cases where the printer will display one of the above messages without the ability to print. The cause of this has been the rear fuser lock tab being just out of the locked position, which will intern cause the linkage to the switch “SW1 fuser/left door” incomplete.

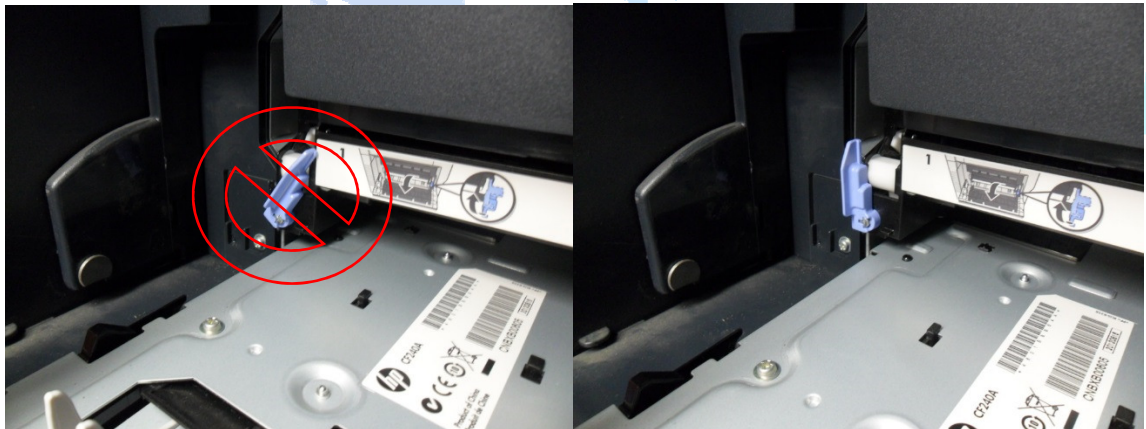
Below are incorrect and correct positions for the rear fuser lock tab:
