## HP LaserJet P3005/M3027MFP/M3035MFP Grinding

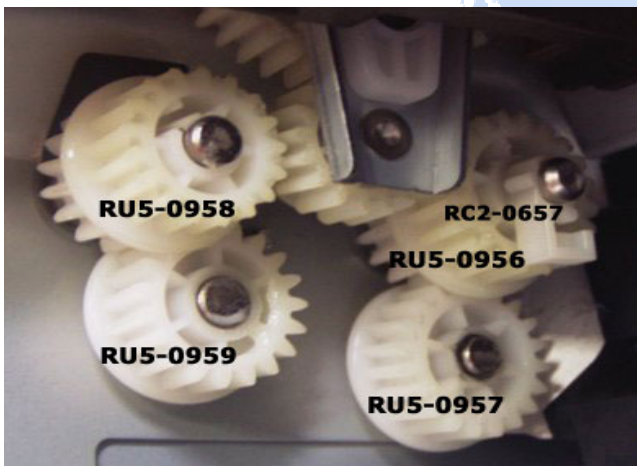
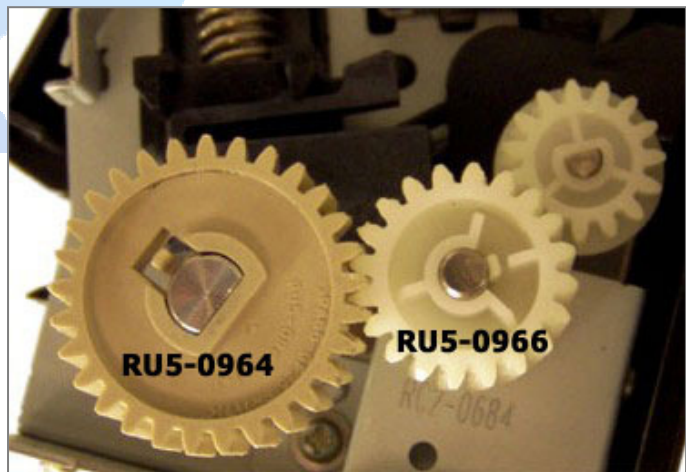
**NOTE:** when replacing the plastic Thrust Stopper Clip (RC2-0657), be sure to have the longer part pointing down (see image). Failure to do so will cause paper to jam at the fuser or to jam when printing duplex mode.

The parts to replace:

Cluster of Fuser Driver Gears: RU5-0956, RU5-0957, RU5-0958 & RU5-0959

Fuser Thrust Stopper (Clip) - RC2-0657

Fuser Gear - RU5-0966

Fuser Pressure Roller Gear - RU5-0964

All of these parts (7) can be purchased together from Laser Pros International using part #P3005-GK
