50.3 Error

HP LaserJet P3015 Printer

Current troubleshooting steps do not include checking for proper functioning of the pendulum assembly. This document includes these steps into the troubleshooting procedure.

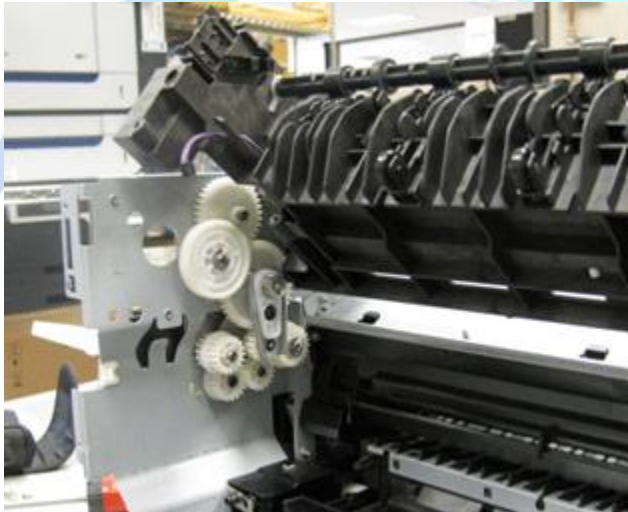
Figure 2: Releasing the output roller assembly

3. Release the output roller assembly and rotate up and around to clear the area around the Pendulum Assembly.

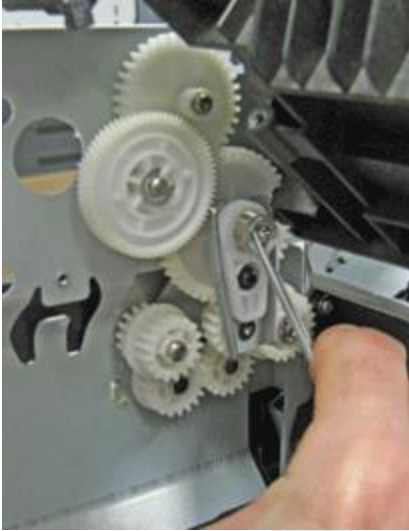
Figure 3: Releasing the e-clip

4. Release the e-clip to obtain access to the spring, washer and pendulum assembly.

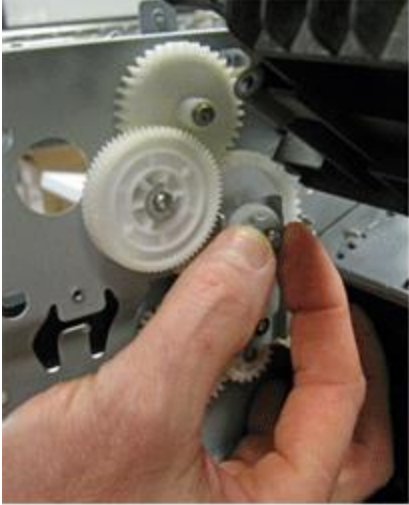
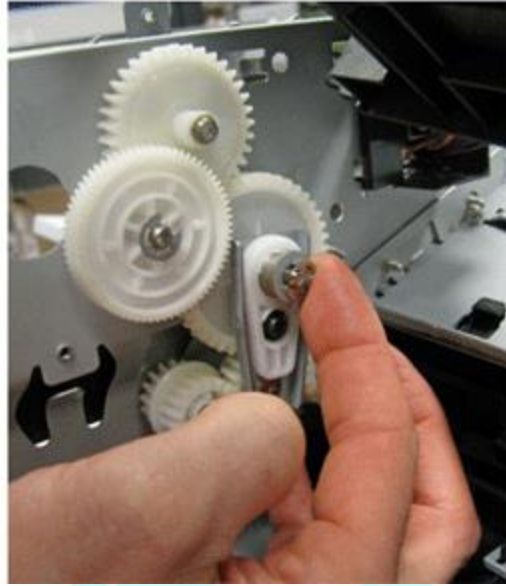
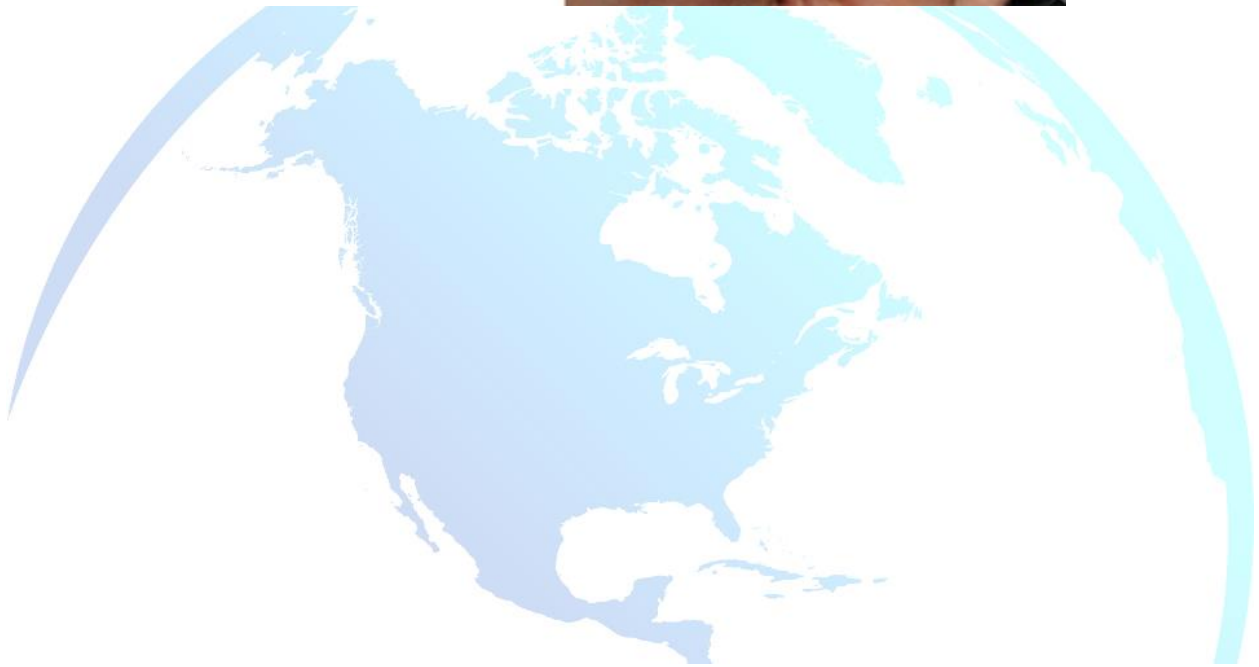
Figure 5: Reinstalling the e-clip

6. Reinstall the spring. Place the washer on next, hold and place the e-clip on. Re-assemble the printer.

NOTE: Remember to align the output roller assembly locator pins when installing.
