## **Grinding from the fuser or back of the printer**

**HP LaserJet P4014, P4015 and P4515**

**HP LaserJet M601, M602 and M603**

**HP LaserJet M604, M605, and M606**

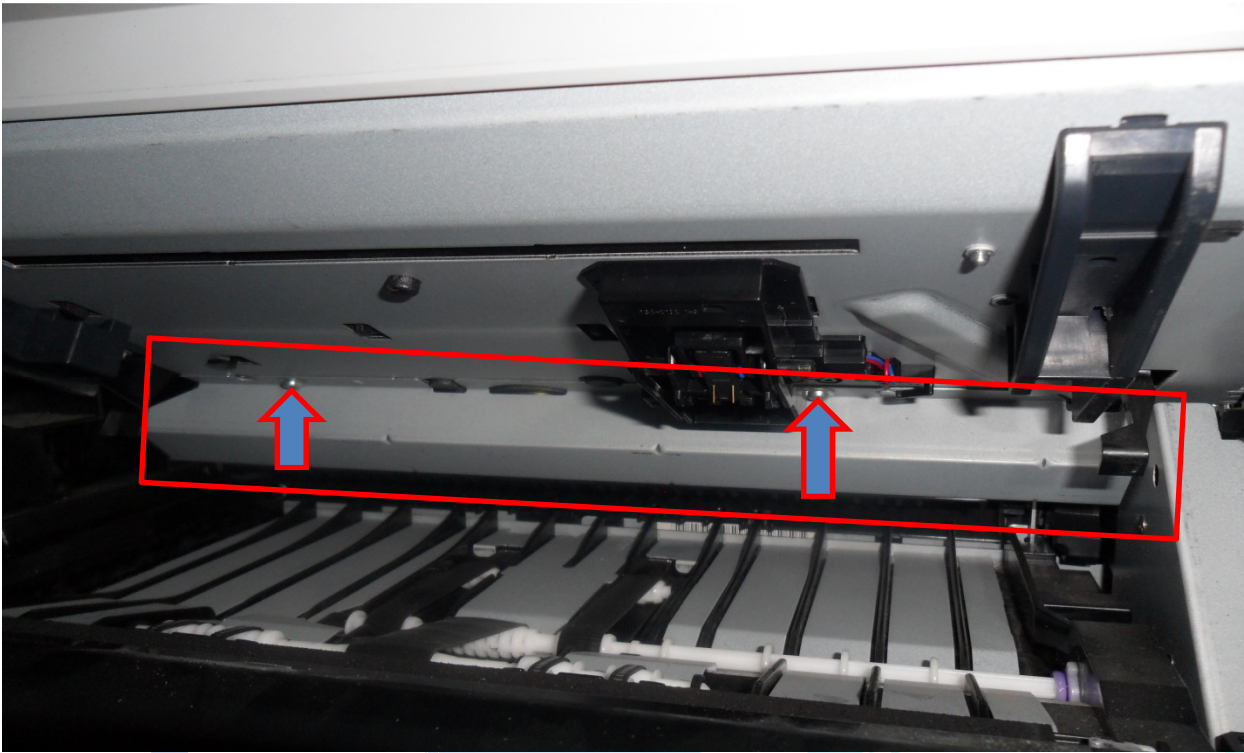
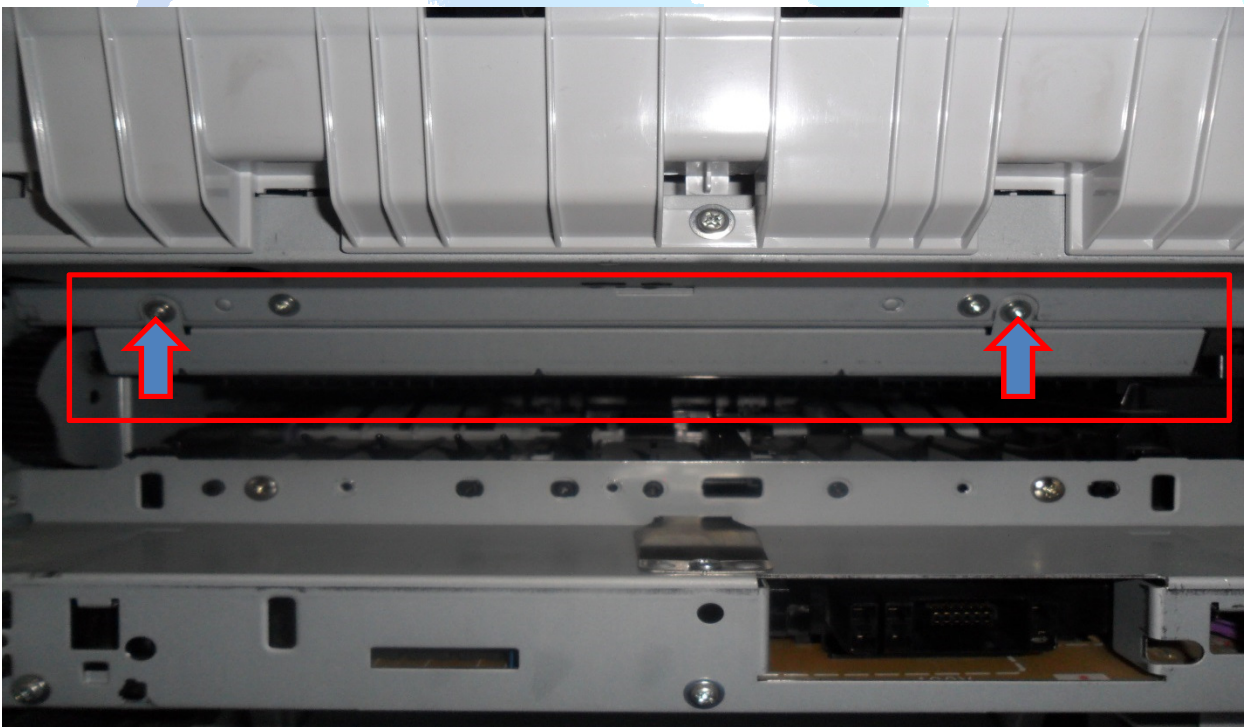
addition of a 4<sup>th</sup> screw on the front end of the assembly. The procedure also requires removal of a metal guide from the bottom of the laser scanner cross member (2 screws from each front and back side) as shown below:

The repair procedure is very similar to replacing the swing plate on the LJ4250/4350 series where all covers and power supply must be removed (see service manual) however the P4014-FDA and M600-FDA have the
