HP LaserJet CP2025, CM2320, M351, M451, M375, M475, M476

Paper Jam in Rear Door

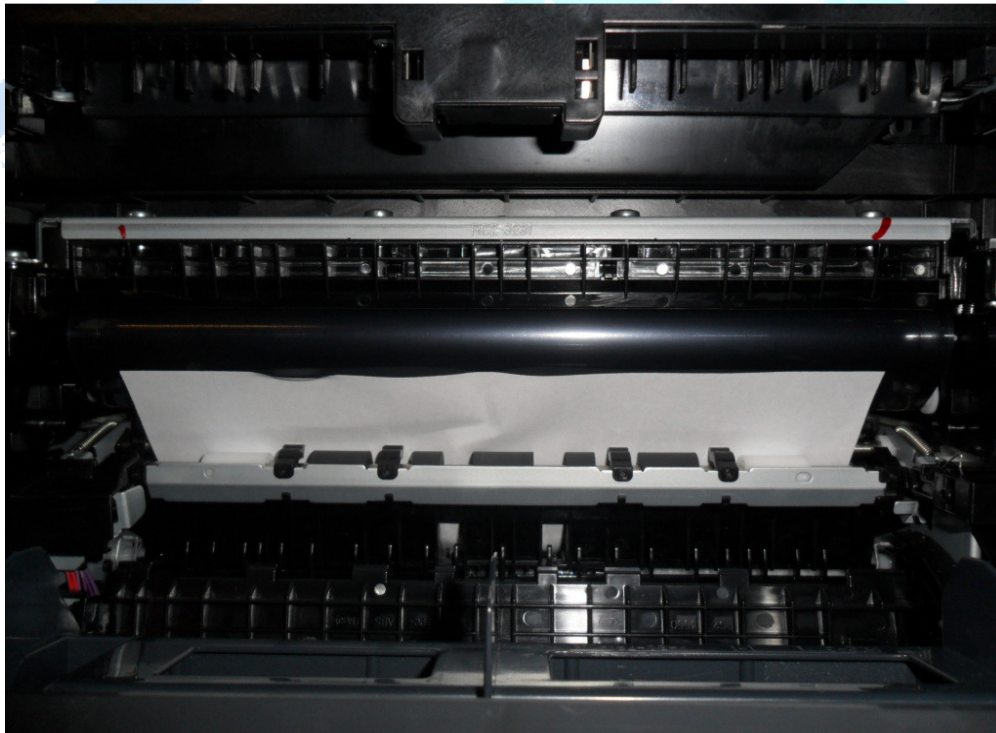
The symptom is that the printer will reach the ready state, start to process the print job, initiate pick up & pull the page about 3 inches into the paper path up to the transfer belt and then display “jam in rear door”.
(Shown in image below with rear door open)

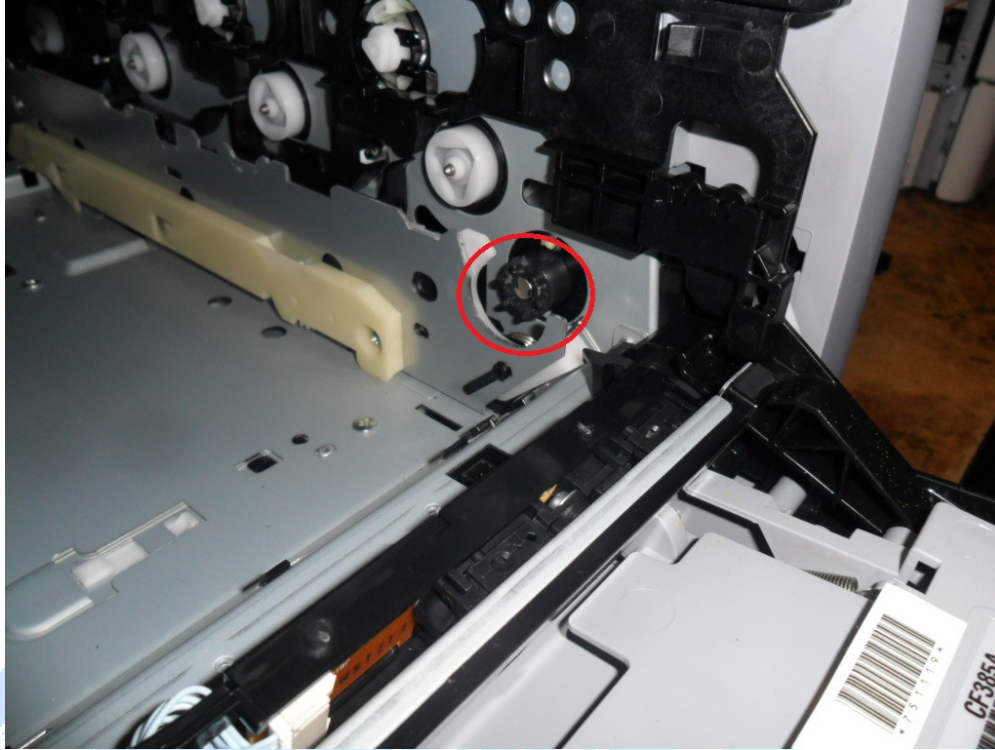
The cause for this paper jam is that the transfer belt is *not* rotating within the printer.

The cause for the belt not rotating is a broken gear on the Main Drive Assembly. The circled gear is supposed to have 6 teeth (shown below with belt removed) that extend out to drive the transfer belt but in these cases the teeth shear off to a smooth surface and at that point require the Main Drive Assembly (MDA) to be replaced.

The service manuals for these models do not list a part # for the MDA as the value of the printer is not worth the 2-3 hour repair time to change it and for most cases the printer is replaced. However it is available through Laser Pros International via part #:

CM2320-GT-R for models CP2025 and CM2320

M475-GT-R for models M351, M451, M375, M475, M476.
