Samsung MultiXpress Laser MFP SCX-8123, SCX-8128 - Error Code and Troubleshooting

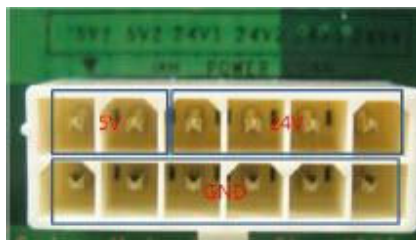
- ii. If the checked result is normal, replace the BLDC motor (JC93-00448A) with a new one.
- iii. If the checked result is abnormal, check the following:

If 24V power is not being generated, replace the SMPS PCA (JC44-00100A (220V) / JC44-00093A (110V)) with a new one.

- If the control signal is abnormal, replace the main PCA (JC92-02452A) with a new one.

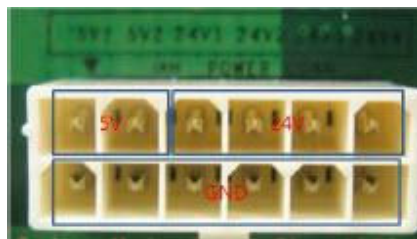
- ii. If the checked result is normal, replace the BLDC motor (JC31-00123B) with a new one.
- iii. If the checked result is abnormal, check the following:
 - If 24V power is not being generated, replace the SMPS PCA (JC44-00100A (220V) / JC44-00093A (110V)) with a new one.

- if the control signal is abnormal, replace the main PCA (JC92-02452A) with a new one.

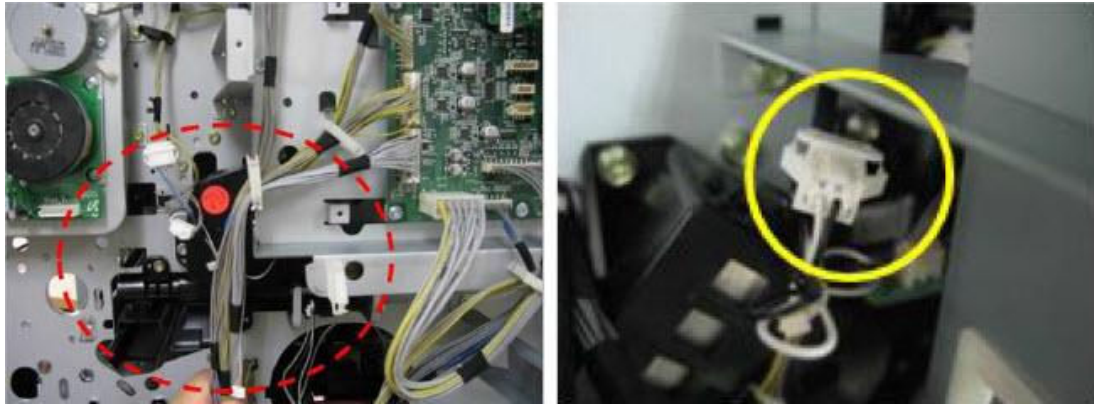
Measure 2 points together.

- a. If 24V power is being generated, replace the toner supply motor (JC31-00123B) with a new one.
- b. If 24V power is not generated , check the SMPS and main PCA.
 - i. If 24V power is not generated, replace the SMPS PCA (JC44-00100A (220V) / JC44-00093A (110V)) with a new one.

- ii. If the control signal is abnormal, replace the main PCA (JC92-02452A) with a new one.

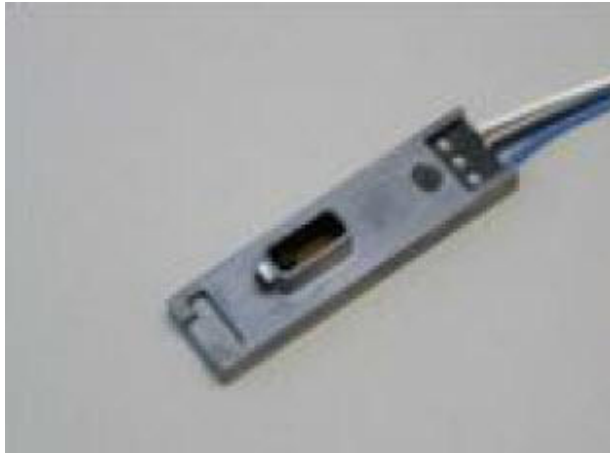
The NC sensor in the fuser unit is not working normally. / The sensor signal is abnormal due to a defective cable.

2. Remove and disassemble the fuser unit.

3. Measure the resistance value of the thermistor (1404-001453). If the measured value is out of range of 307K Ω ~430K Ω @25°C, replace the thermistor with a new one.

4. If the error persists, replace the fuser unit (JC91-01049A(220V) / JC91-01050A (110V)) with a new one.
5. If the error persists after replacing fuser unit, replace the main PCA (JC92-02452A) with a new one.

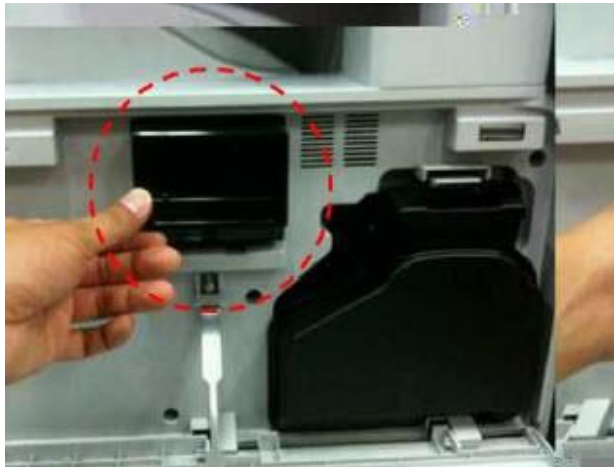
The toner cartridge is at the end of its life. Toner cartridge is empty, replace toner cartridge.

1. Print the supply information report.
2. Check to see the remaining life of the toner cartridge.
3. If its at end of life, then turn the machine off and open the front door.
4. Replace the toner cartridge with new one (MLT-D709S).

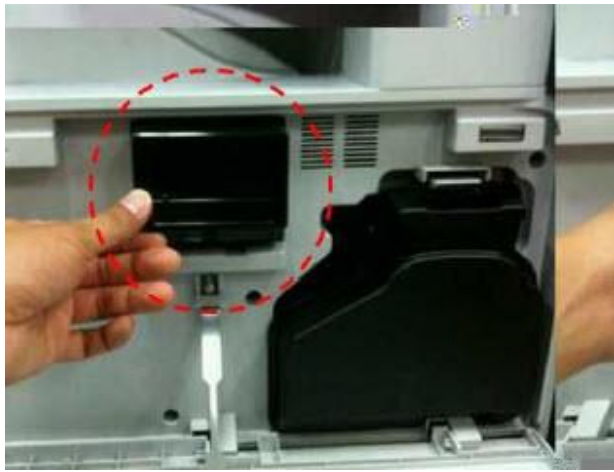
1. Turn the machine off. Open the front door.
2. Remove the toner cartridge. Lightly shake the toner cartridge five or six times to distribute the toner evenly inside the cartridge.
3. If the error persists, check the following:
 - a. Check to see if the toner supply drive unit (JC93-00436A) is working normally.
 - b. Check to see if the toner duct drive unit (JC93-00451A) is working normally.
4. If the error persists, replace the toner cartridge (MLT-D709S) with a new one.

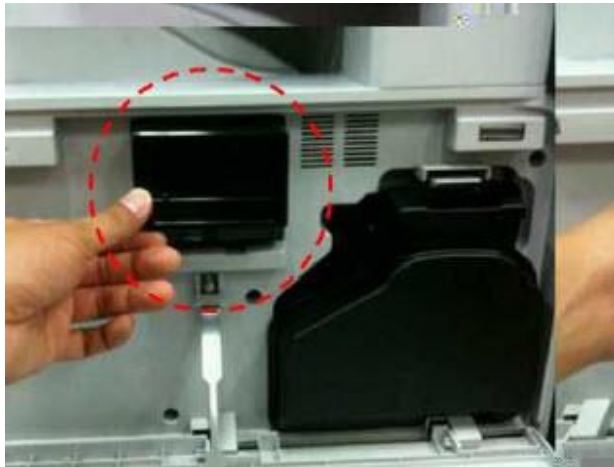
1. Open the front door. Check to see if the toner cartridge is installed.

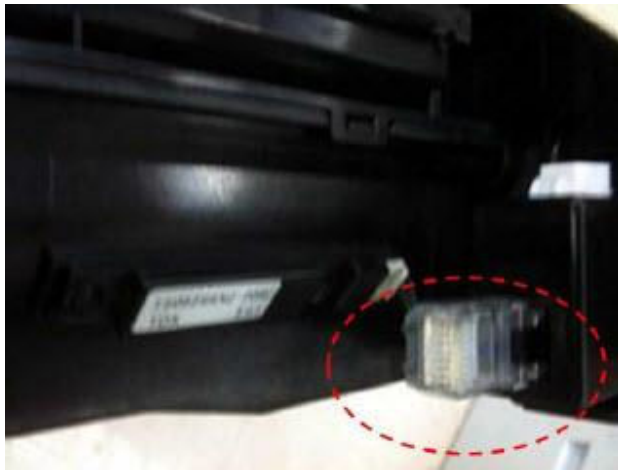
2. Remove and reinstall the toner cartridge.
3. If the error persists, check to see if the toner cartridge modular jack is contaminated or damaged.

4. Replace the toner cartridge with a new one (MLT-D709S).

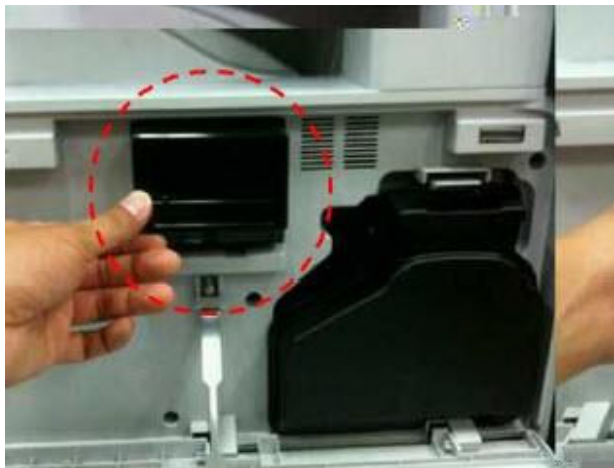
1. Open the front door. Remove the toner cartridge and reinstall it.
2. Print the supply information report. Check the toner cartridge supply information.
3. If the toner cartridge is not a genuine Samsung, replace it with a genuine Samsung toner cartridge (MLT-D709S).

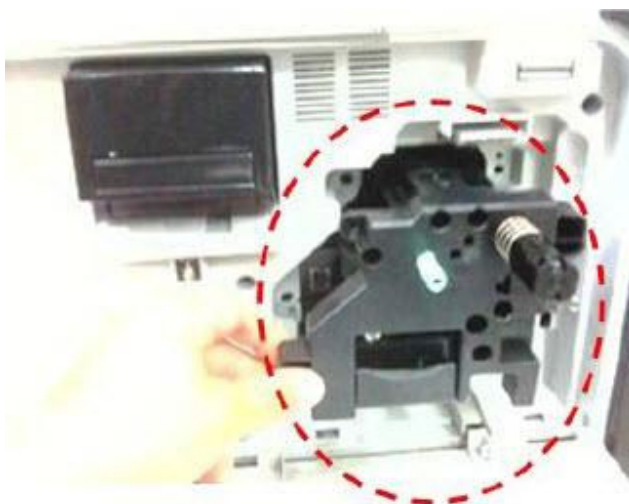
1. Open the front door and remove the waste toner container.
2. Remove the drum unit.
3. If imaging unit is at its end of life, turn the machine off and replace the imaging unit (MLT-R709) with new one.

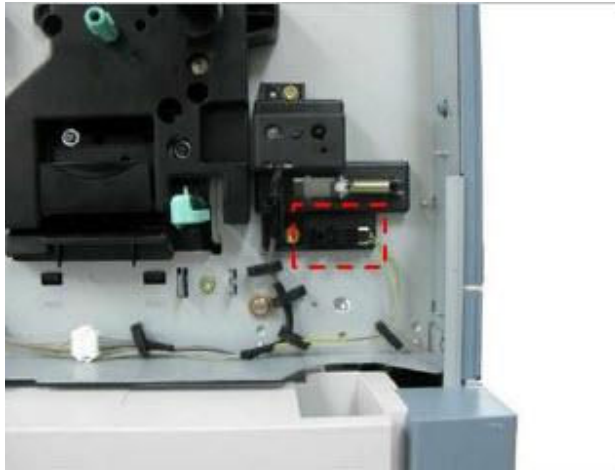
1. Open the front door and check to see if the waste toner container is installed correctly.
2. Check to see if the waste toner container sensor is working normally.

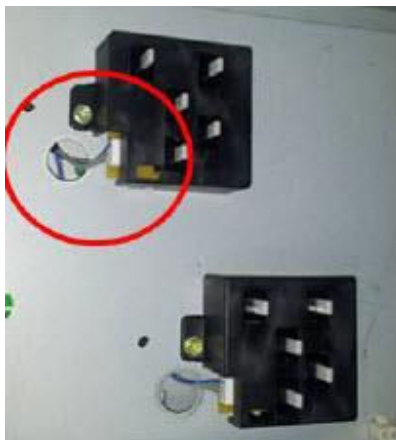
1. Remove and reinstall Tray 3.
2. If the error persists, remove both Tray 3 and Tray 4. Look inside the cavity of the machine.
3. Check to see if the auto size sensor cable is connected correctly. Disconnect and reconnect it.

4. If the connection is OK, replace the auto size sensor (JC93-00018A) with a new one.
5. If the error persists, replace the DCF PCA (JC92-02453A) with a new one.

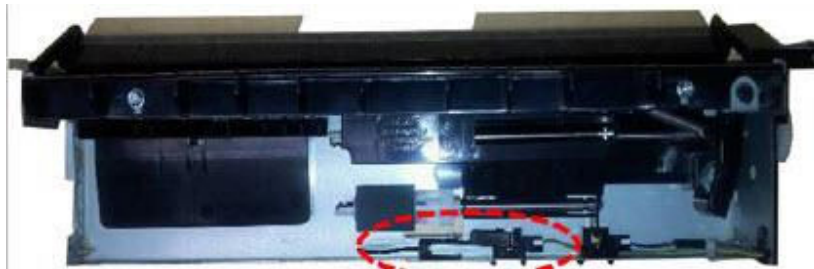
1. Remove Tray 3. Load paper into Tray 3.
2. If paper is loaded but error persists, check the following:
 - a. Remove the DCF pickup unit 1.
 - b. Check to see if the photo sensor in the DCF pick up unit 1 is contaminated. If so, clean it with a soft, lint-free cloth.
 - c. If the photo sensor (0604-001393) is not working normally, replace the photo sensor with a new one.
 - d. If the actuator (JC66-03199A) is not working normally, replace actuator with a new one.

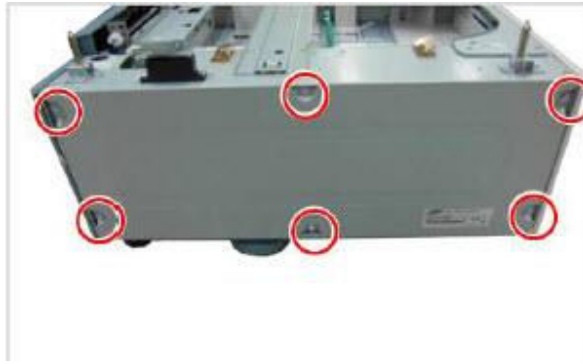
1. Remove and reinstall Tray 3.
2. Turn the machine off and then on.
3. If the error persists, turn the machine off.
4. Remove 6 screws, and then remove the bracket rear cover.

5. Check to see if the connection between the DCF pickup drive and DCF PCA is connected correctly.

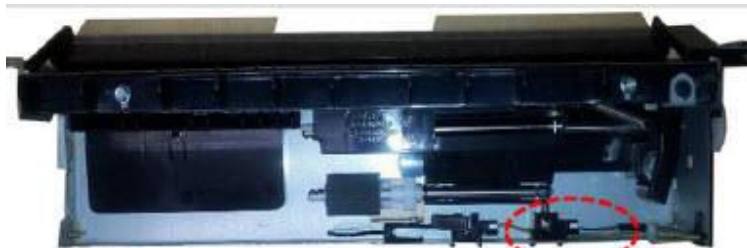
6. If the connection is OK, replace the pickup drive unit (JC93-00442A) with a new one.
7. If the error persists, check the following:
 - a. Remove the DCF pick up unit 1.
 - b. Check to see if the photo sensor in the DCF pickup unit 1 is contaminated. If so, clean it with a soft, lint-free cloth.
 - c. If the photo sensor (0604-001393) is not working normally, replace the photo sensor with a new one.

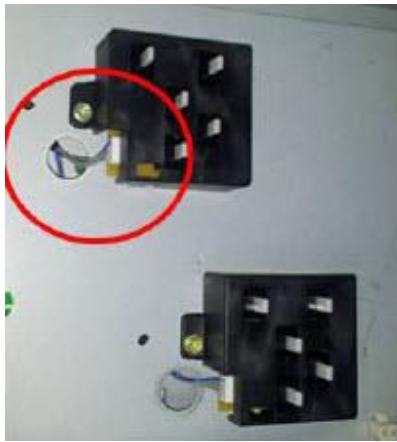
1. Remove and reinstall Tray 4 correctly.
2. If the error persists, remove both Tray 3 and Tray 4. Look inside the machines cavity.
3. Check to see if the auto size sensor cable is connected correctly. Disconnect and reconnect it.

4. If the connection is OK, replace the auto size sensor (JC93-00018A) with a new one.
5. If the error persists, replace the DCF PCA (JC92-02453A) with a new one.

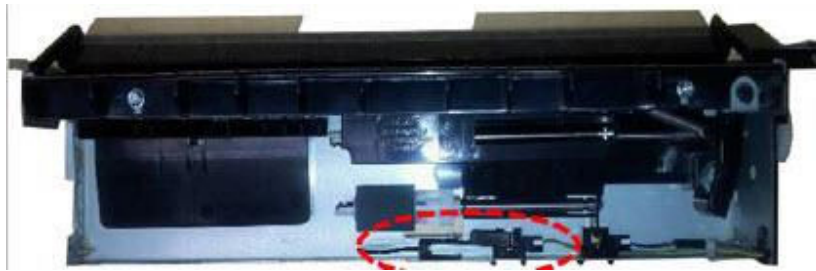
1. Remove Tray 4. Load paper into Tray 4.
2. If paper is loaded but error persists, check the following:
 - a. Remove the DCF pickup unit 2.
 - b. Check if the photo sensor in the DCF pickup unit 2 is contaminated. If so, clean it with a soft, lint-free cloth.
 - c. If the photo sensor (0604-001393) is not working normally, replace the photo sensor with a new one.
 - d. If the actuator (JC66-03199A) is not working normally, replace the actuator with a new one.

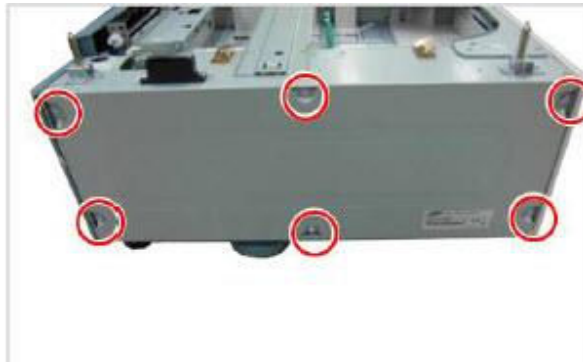
1. Remove and reinstall Tray 4.
2. Turn the machine off and then on.
3. If the error persists, turn the machine off.
4. Remove 6 screws, and then remove the bracket rear cover.

5. Check to see if the connection between the DCF pickup drive and DCF PCA is connected correctly.

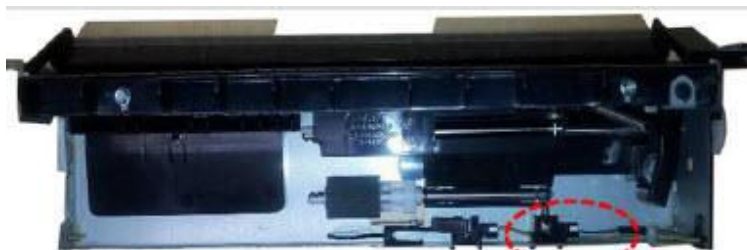
6. If the connection is OK, replace the pickup drive unit 2 (JC93-00442A) with a new one.
7. If the error persists, check the following:
 - a. Remove the DCF pickup unit 2.
 - b. Check to see if the photo sensor in the DCF pickup unit 2 is contaminated. If so, clean it with a soft, lint-free cloth.
 - c. If the photo sensor (0604-001393) is not working normally, replace the photo sensor with a new one.

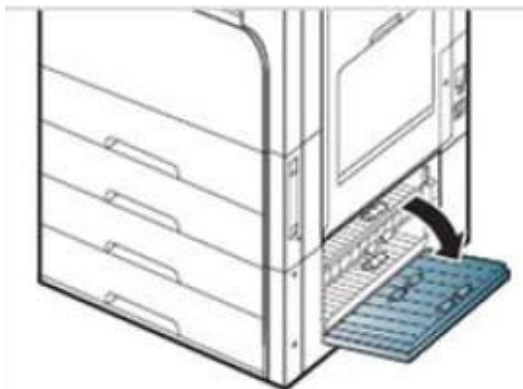
1. Open and close the DCF take-away-door.

2. If the error persists, check the following:
 - a. Check to see if I/L-switch (cable-DCF door open) (JC39-01696A) is working normally. If it is not working normally, replace the I/L switch with a new one.

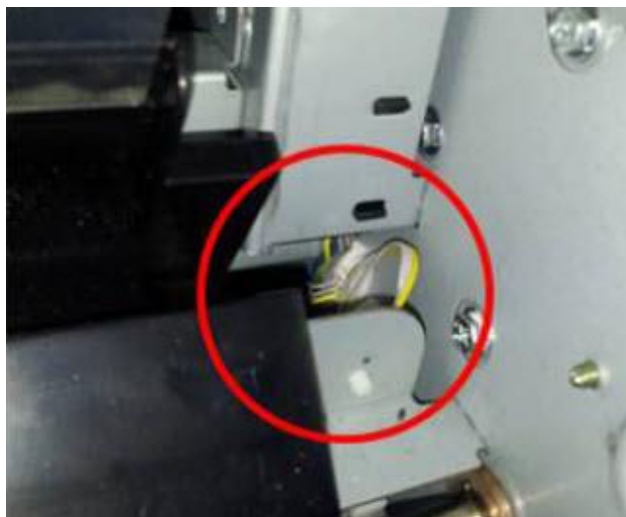
- b. If the pickup/ reverse/ forward rollers are worn or contaminated, clean the rollers with a lint free cloth or replace the defective roller (JC93-00540A) with a new one.
4. If the error persists, check the pickup unit and the feed sensor.
 - a. Check to see if the pickup unit and the feed sensor are working normally.
 - b. Check to see if the cable from the pickup unit to main PCA is connected correctly.
 - c. Check to see if the connector of the guide-feed assembly is connected correctly.
 - d. Check to see if the cable of pickup unit and feed sensor is disconnected.

5. If the error persists, check the pickup unit.
 - a. Remove the pickup unit and check the connection of the actuator and the actuator-sensor.
 - b. Push the pickup-lever and check to see if it is working normally.

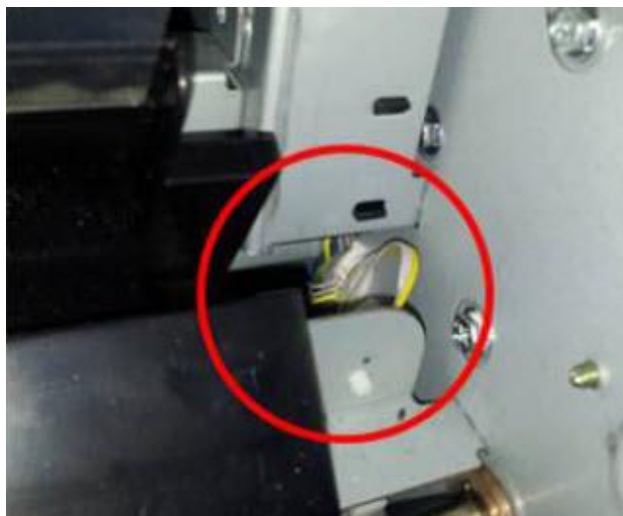
- a. Check to see if the pickup/ reverse/ forward rollers are assembled correctly.
 - b. If the pickup/ reverse/ forward rollers are worn or contaminated, clean the rollers with a soft, lint-free cloth or replace the defective roller (JC93-00540A) with a new one.
4. If the error persists, check the pickup unit and the feed sensor.
- a. Check to see if the pickup unit and feed sensor is working normally.
 - b. Check to see if the cable from pickup unit to main PCA is connected correctly.
 - c. Check to see if the connector of the guide-feed assembly is connected correctly.
 - d. Check to see if the cable of pickup unit and feed sensor is disconnected.

5. If the error persists, check the pickup unit.
- a. Remove the pickup unit and check the connection of the actuator and the actuator-sensor.
 - b. Push the pickup-lever and check if it is working normally.

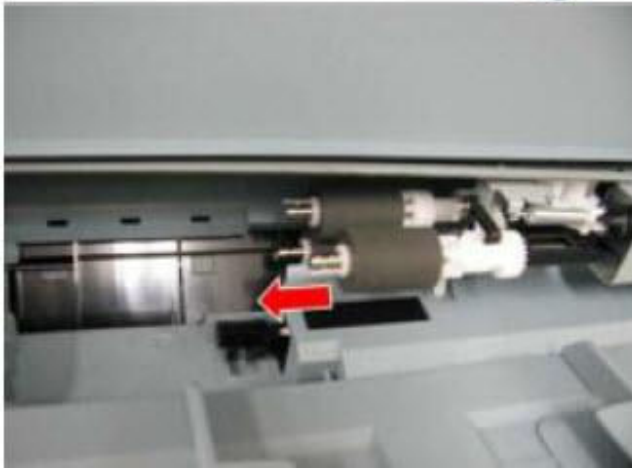
- Open the right door. Remove the paper jam from the MP tray.
- If this jam error persists, check the rollers of the MP unit.

- a. Check to see if the MP pickup/ reverse/ forward rollers are assembled correctly.
 - b. If the MP pickup/ reverse/ forward rollers are worn or contaminated, clean the rollers with a soft, lint-free cloth or replace the defective roller (JC93-00540A) with a new one.
3. If the error persists, check to see if the MP solenoid is working normally.
- a. Enter the Service-mode, and then check to see if solenoid is working normally.

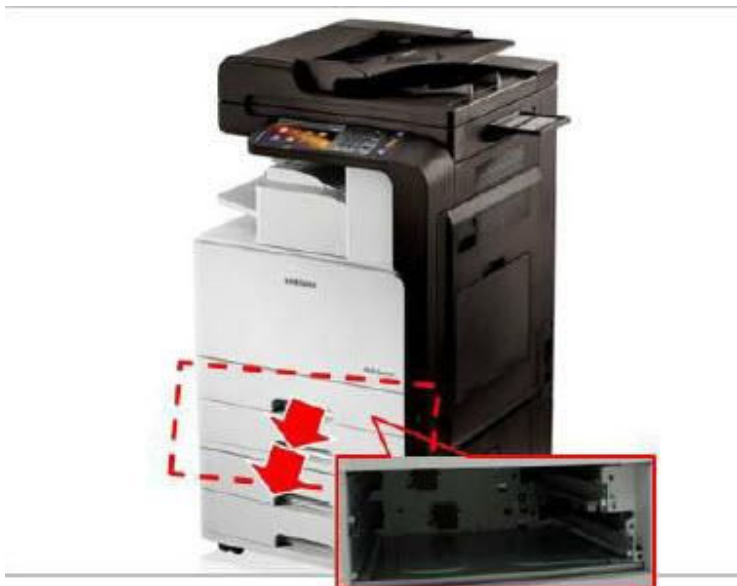
1. Remove Tray 1 .
2. Reinstall Tray 1.
3. If Tray 1 is not locked or opened without holding the locking lever, remove Tray 1.
4. Check to see if there are any obstacles or paper is inside Tray 1. If so, please all paper or obstacles.
5. If the error persists, check that auto size sensor is connected correctly.

6. If the error persists, replace the main PCA (JC92-02430A) with a new one.

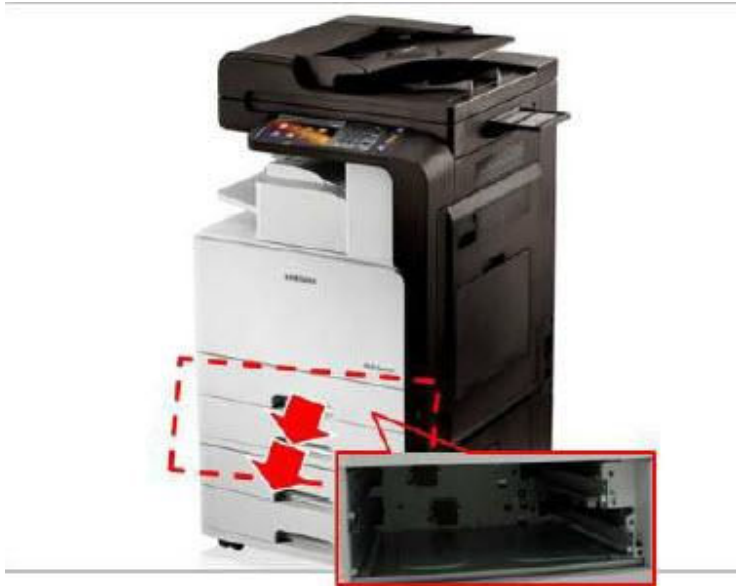
1. Remove Tray 2.
2. Reinstall Tray 2.
3. If Tray 2 is not locked or opened without holding the locking lever, remove Tray 2.
4. Check to see if there are any obstacle or paper is inside the Tray 2. If so, remove all paper and obstacles.
5. If the error persists, check that auto size sensor is connected correctly.

6. If the error persists, replace the main PCA (JC92-02430A) with a new one.

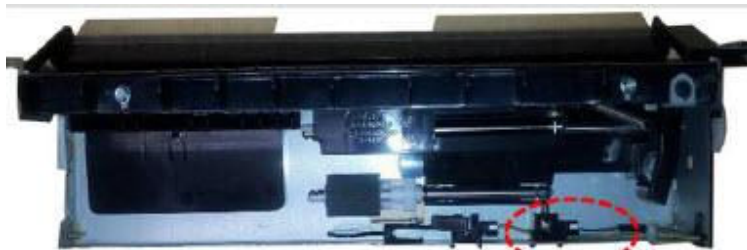
- c. If the error persists, replace the pickup drive unit (JC93-00442A) with a new one.
5. If the error persists, check the pickup unit.
 - a. Check the photo sensor in the pickup unit is working normally.

- b. Check to see if the sensor is working normally.
- c. If the error persists, replace the photo sensor (0604-001393) with a new one.

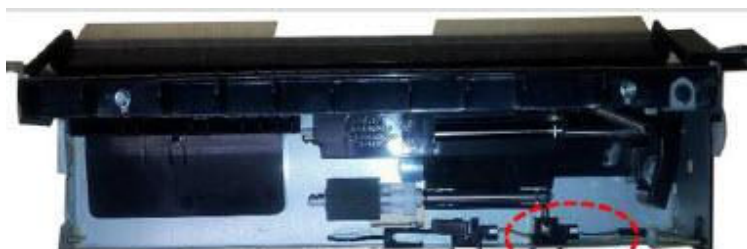
1. Remove Tray 2 and reinstall Tray 2.
2. Load the paper into Tray 2.
3. If paper is loaded but error message persists, check the following:
 - a. If the photo sensor is contaminated, clean it with a soft, lint-free cloth.

- b. If the photo sensor is not working normally, replace the sensor (0604-001393) with a new one.
- c. If the actuator is not working, replace the actuator (JC66-03199A) with a new one.

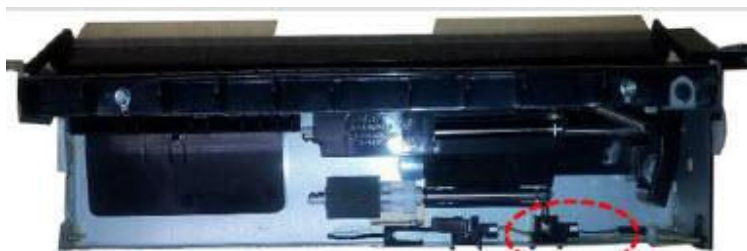
1. Remove Tray 2 and reinstall Tray 2
2. Load the paper in Tray 2.
3. If paper is loaded but error message persists, check the following:
 - a. If the photo sensor is contaminated, clean it with a soft, lint-free cloth.

- b. If the photo sensor is not working normally, replace the sensor (0604-001393) with a new one.
- c. If the actuator is not working normally, replace the actuator (JC66-03199A) with a new one.

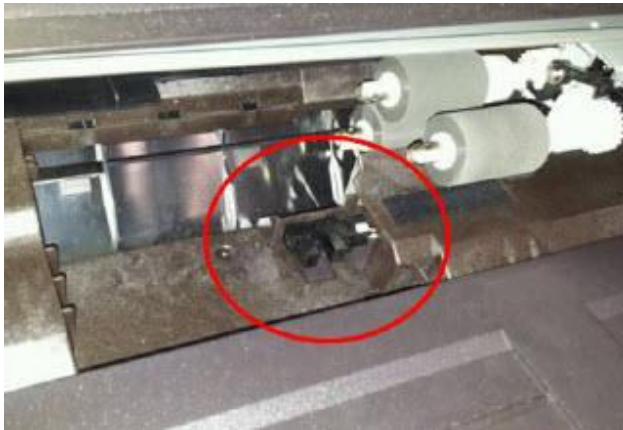
1. Remove the MP Tray and reinstall the MP Tray.
2. Load the paper in the MP Tray.
3. If paper is loaded but error message persists, check the following:
 - a. If the photo sensor is contaminated, clean it with a soft, lint-free cloth.

- b. If the photo sensor is not working normally, replace the sensor (0604-001393) with a new one.

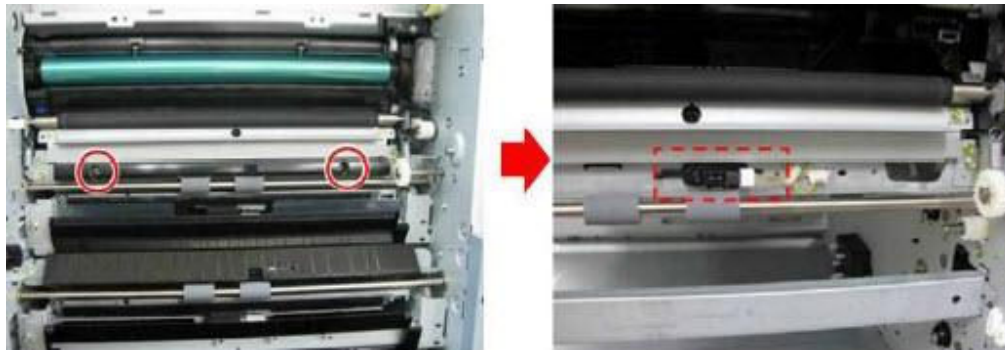
- d. If the feed motor operation is working normally, check the feed 2 sensor.
- e. If the sensor operation is not working normally, check the cable.

- f. If the connection is OK, replace the feed sensor 2 (0604-001381) with a new one.

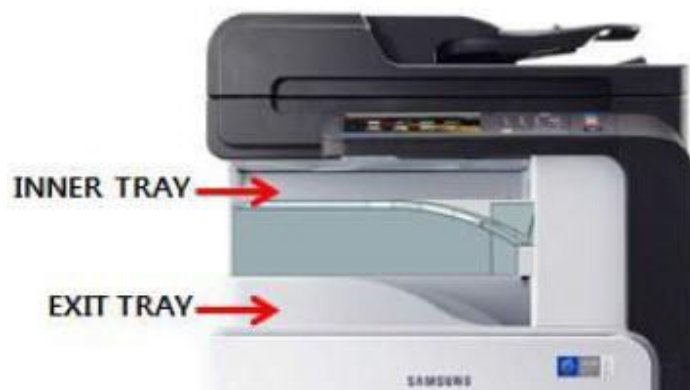
1. Remove the paper in the output bin tray or the inner tray.

2. If the error persists, check the following:

- a. Check to see if the bin-full sensor and actuator is assembled correctly.

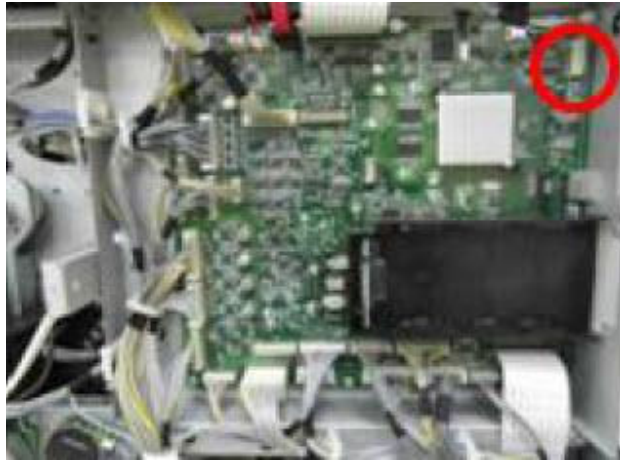
1. Install the FBI device.
2. If the FBI device is already installed, update the firmware for the main PCA.
3. Check the connection between FBI device and main PCA.
 - a. Remove the rear cover.
 - b. Check the connection between FBI unit and main PCA are connected correctly.

4. If FBI unit is not working normally, replace the FBI unit (CL-KIT10) with a new one.
5. If the error persists, replace the main PCA (JC92-02452A) with a new one.

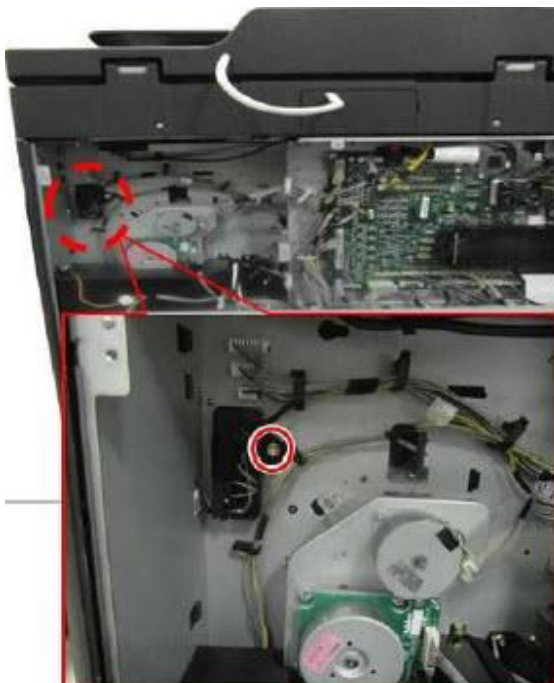
1. Close the right door.
2. Check to see if the cover open sensor connector is connected correctly. If not, reconnect it.
3. If the sensor is not working normally, replace the cover open sensor with a new one.

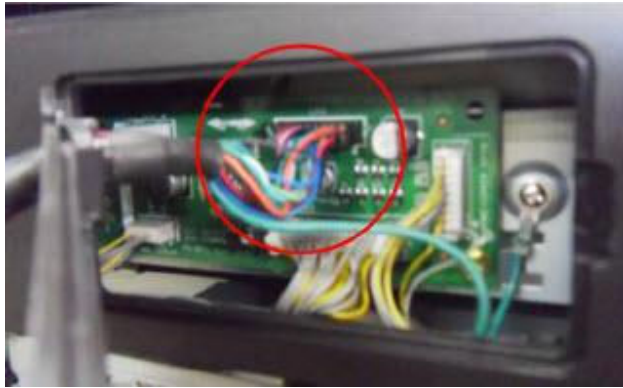
1. Turn the power off and then turn on.
2. If the error persists, check the DAD unit connection.

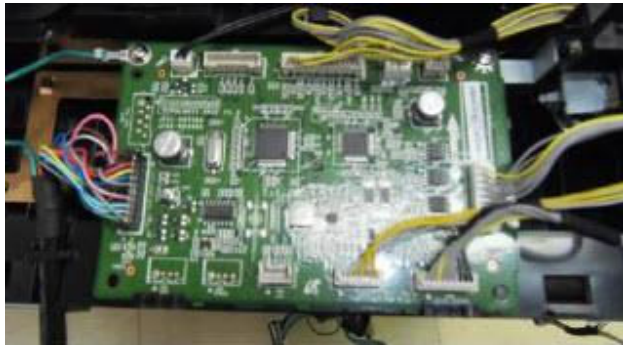
3. If the error persists, remove the DAD unit then locate the parts that are not working normally.
4. Remove the DAD rear cover. Check to see if the connector on DAD PCA is connected correctly.

5. If the connection is OK, replace the DAD PCA (JC92-02446A) with a new one.

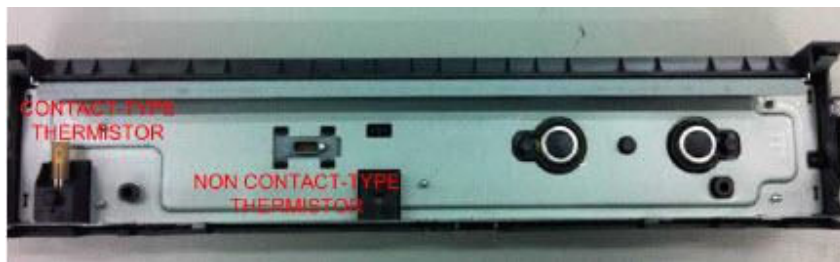
3. Check to see if the contact type thermistor (1404-001567) or non-contact type thermistor is damaged.

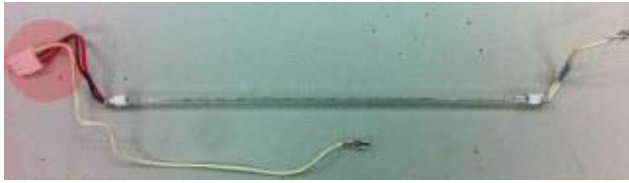
3. If the error persists, check the following:
 - a. Check to see if the halogen lamp (110V : 4713-001632 / 220V : 4713-001633) is damaged or disconnected.
 - b. Check to see if the AC connection on the halogen lamp is disconnected or contaminated.

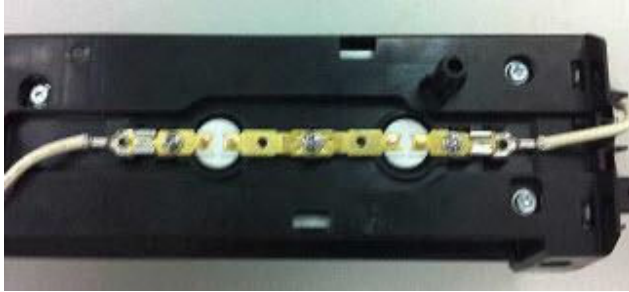
- c. Check to see if the thermostat (4712-001098) is disconnected.

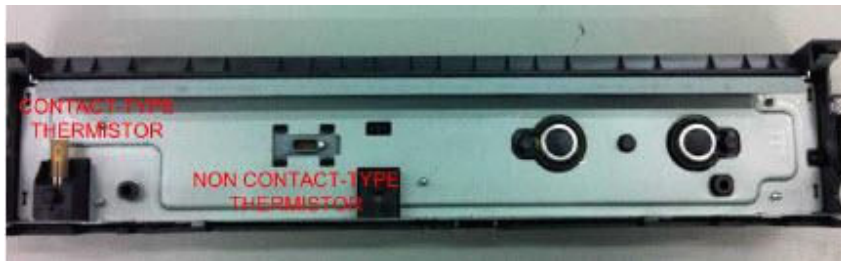
- d. Check to see if the contact type thermistor (1404-001567) or non-contact type thermistor (1404-001453) is damaged.

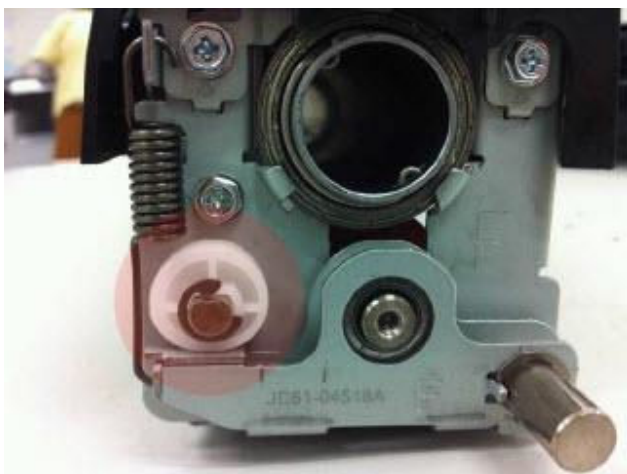
1. Turn the machine off. Reinstall the fuser unit, then turn the machine on.
2. If the error persists, check the following:
 - a. When closing the right door, check to see if the pressure control unit makes noise.
 - b. Check to see if the parts on the pressure control unit are damaged.
 - Check to see if the shape of the cam-rear (JC66-03178A) is damaged.
 - Check to see if there are any damaged parts on the pressure control unit.

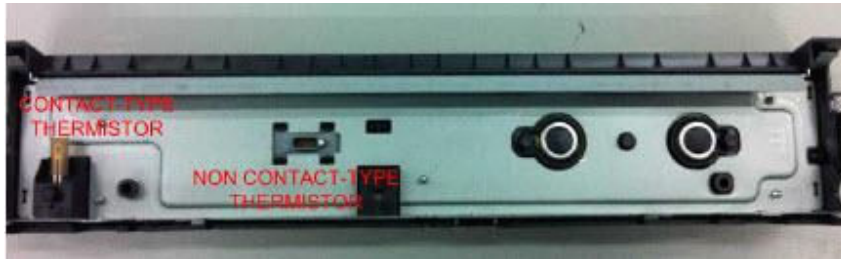
- d. Check to see if the contact type thermistor (1404-001567) or non-contact type thermistor (1404-001453) is damaged.

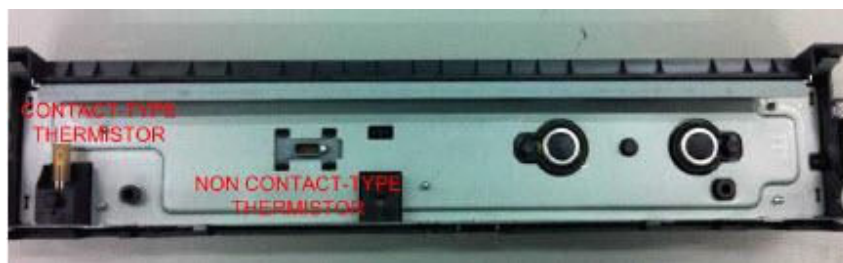
4. If the error persists, check the following:
 - a. Check to see if the contact type thermistor (1404-001567) or non-contact type thermistor is damaged.

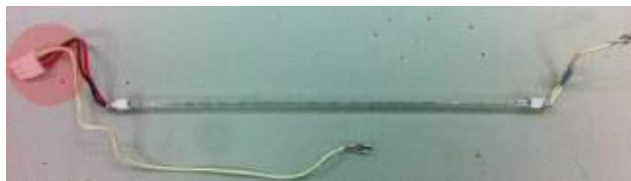
1. Turn the machine off. Reinstall the fuser unit, then turn the machine on.
2. Check if the power voltage is normal. Is the voltage during the normal operation $\pm 10\%$ of the rated voltage?
3. If the error persists, check the following:
 - a. Check to see if the halogen lamp (110V : 4713-001632 / 220V : 4713-001633) is damaged or disconnected.
 - b. Check to see if the AC connection on the halogen lamp is disconnected or contaminated.

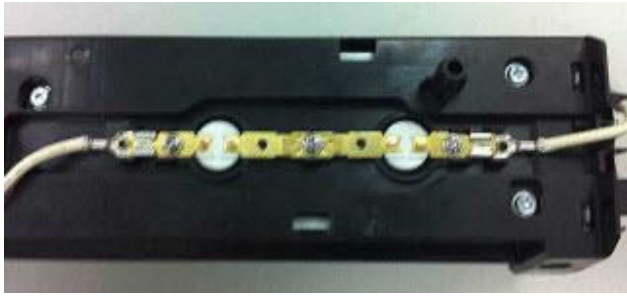
- c. Check to see if the thermostat (4712-001098) is disconnected.

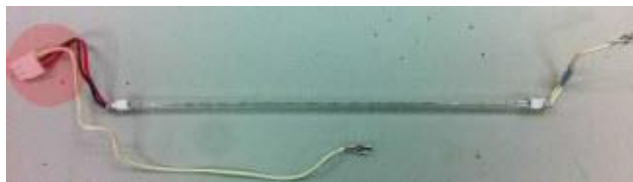
4. If the error persists, check the following:
 - a. Check to see if the halogen lamp (110V : 4713-001632 / 220V : 4713-001633) is damaged or disconnected.
 - b. Check to see if the AC connection on the halogen lamp is disconnected or contaminated.

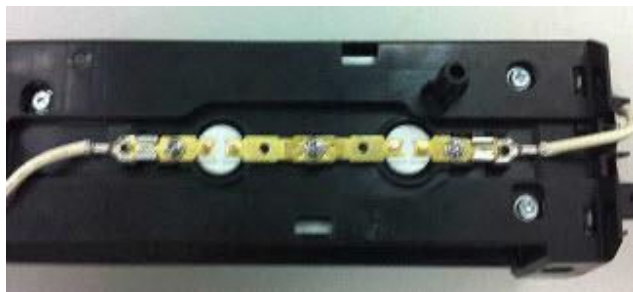
- c. Check to see if the thermostat (4712-001098) is disconnected.

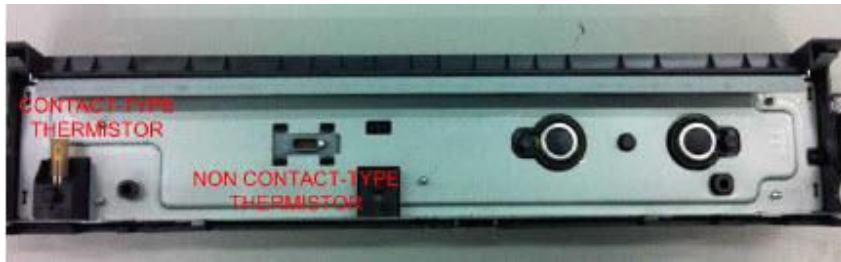
- d. Check to see if the contact type thermistor (1404-001567) or non-contact type thermistor is damaged.

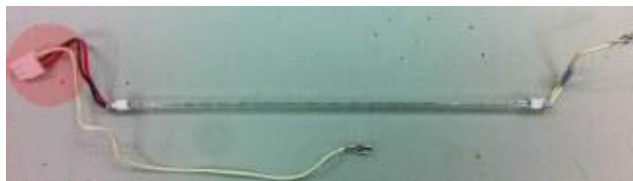
4. If the error persists, check the following:
 - a. Check to see if the halogen lamp (110V : 4713-001632 / 220V : 4713-001633) is damaged or disconnected.
 - b. Check to see if the AC connection on the halogen lamp is disconnected or contaminated.

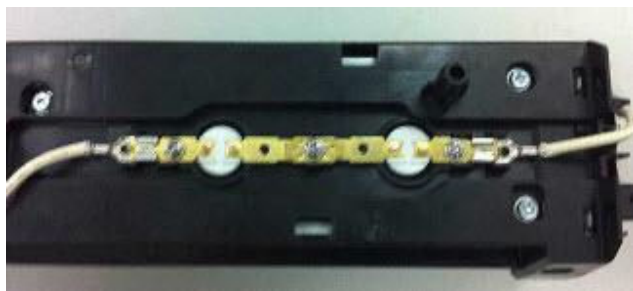
- c. Check to see if the thermostat (4712-001098) is disconnected.

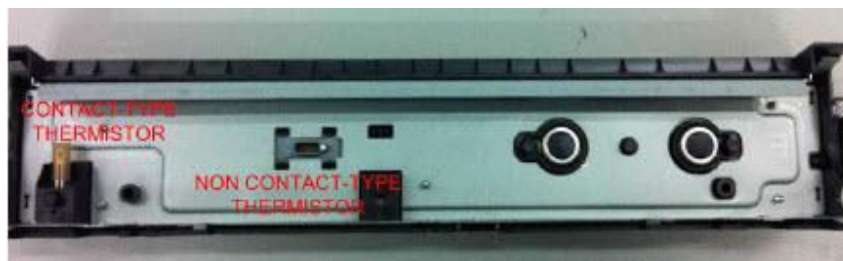
- d. Check to see if the contact type thermistor (1404-001567) or non-contact type thermistor (1404-001453) is damaged.

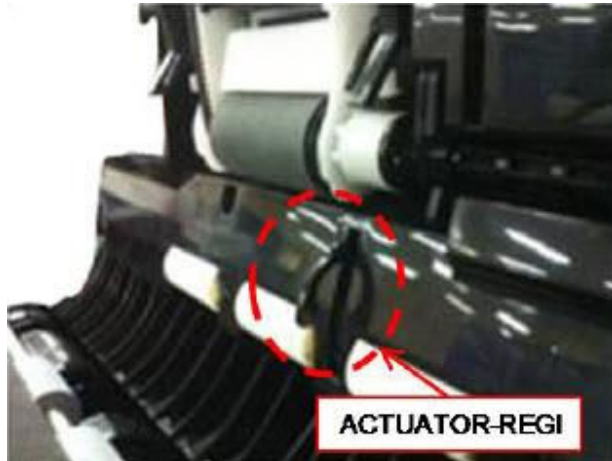
1. Open the DADF cover. If there is a paper jam, remove the paper jam.
2. If the error persists, check the DADF regi-sensor (0604-001393) and regi-actuator (JC66-03148A). If either is not working normally, replace a defective part with a new one.

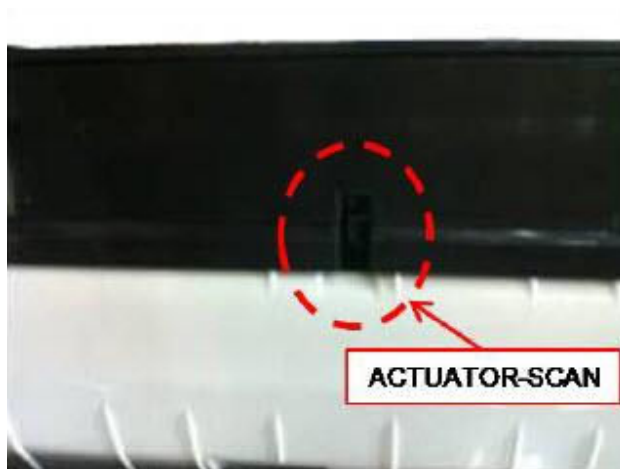
3. If the regi-sensor is OK, check the scan-sensor (0604-001393) and scan-actuator (JC66-03210A). If either is not working normally, replace a defective part with a new one.

4. Check to see if the regi-clutch is working normally. Check to see if the clutch cable is connected correctly. If the clutch (JC47-00033A) is not working normally, replace the clutch with a new one.

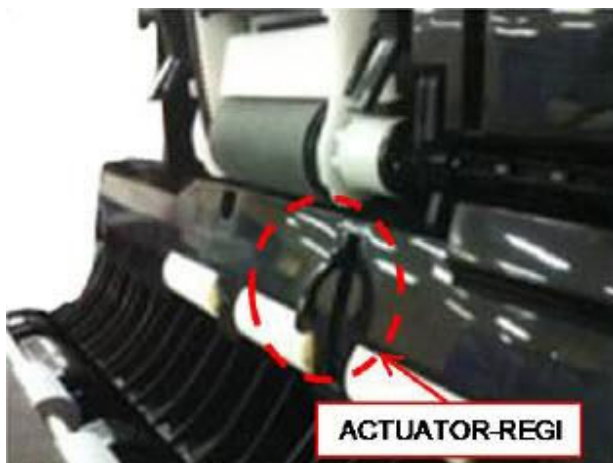
1. Open the DADF cover. If there is a paper jam, remove the paper jam.
2. If this error persists, check the following:
 - a. Check to see if the regi-actuator (JC66-03148A) is working normally.

- b. Check to see if the regi-sensor cable is connected correctly.
 - c. If the connection is OK, replace the regi-sensor (0604-001393) with a new one.

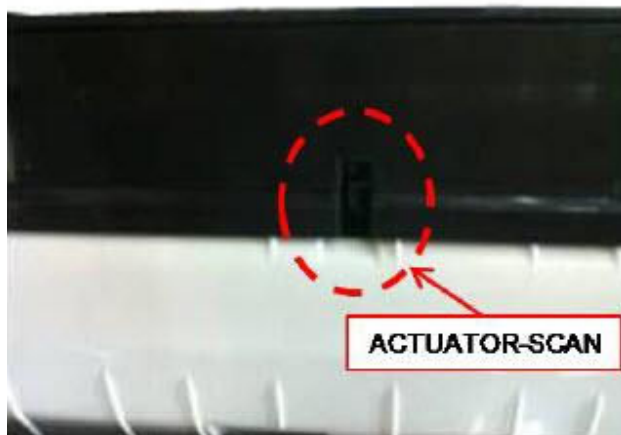
1. Open the DADF cover. If there is a paper jam, remove the paper jam.
2. If this error persists, check the following:
 - a. Check to see if the scan-actuator (JC66-03210A) is working normally.

- b. Check to see if the scan-sensor cable is connected correctly.
- c. If the connection is OK, replace the scan-sensor (0604-001393) with a new one.

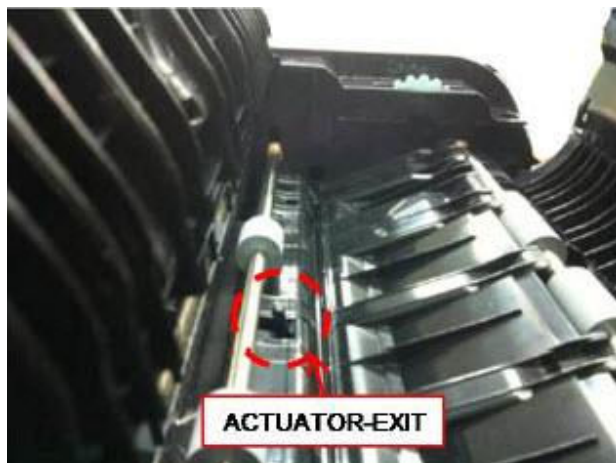
1. Open the DADF cover. If there is a paper jam, remove the paper jam.
2. If this error permits, check the following:
 - a. Check to see if the exit actuator (JC66-03184A) is working normally.

- b. Check to see if the exit sensor cable is connected correctly.

- c. If the connection is OK, replace the exit sensor (0604-001393) with a new one.
