# 13.20.00 Jam Right Door

HP CP4025, CP4525, M651, M680MFP

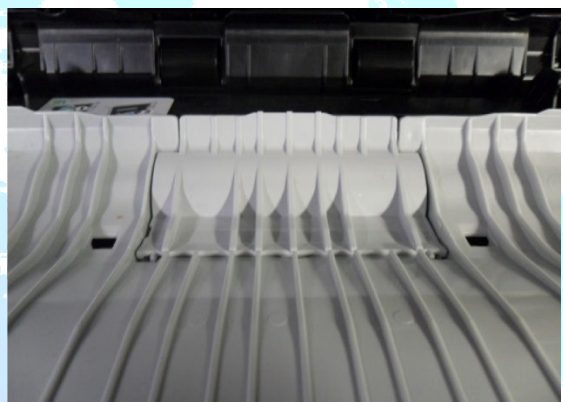
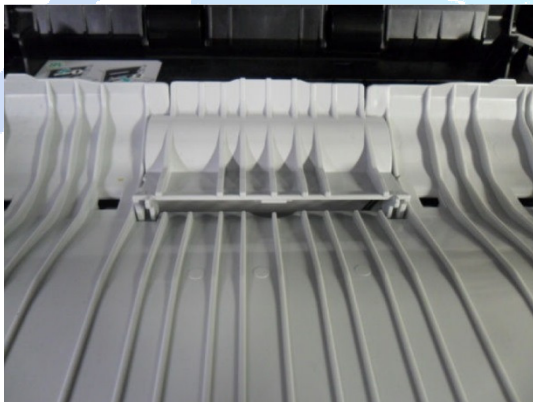
The above listed printers may produce a 13.20.00 'jam in right front door' error code. While there may be no paper visible, this is usually caused by a dislodged tray 1 pickup roller cover which disrupts proper positioning of the duplex refeed sensor flag. This can be determined by simply checking the roller access cover to make sure it is locked in proper position.

This also can be determined by entering the DIAGNOSTICS MENU and selecting the MANUAL SENSOR TEST – this will show sensor "E" with a position of "1" instead of position of "0"
