**HP M607/M608/M609/E60055/E60065/E60075**  
**Cartridge Leaking and Printing Light**

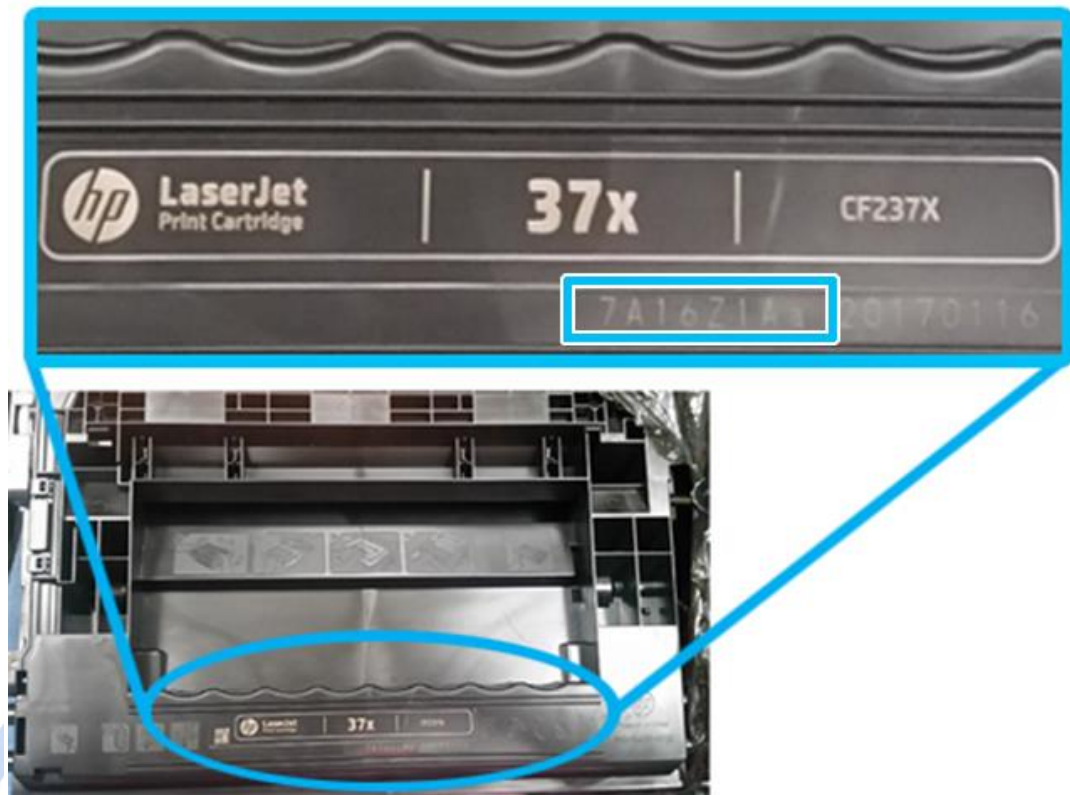
**Figure:** Location of Lot Code on toner cartridge

The first four characters of the lot code correspond to the year, month and day. For example, 7A16 indicates the cartridge was manufactured 20170116. If the first four characters of the lot code are 7C28 (20170328) **or before** and the customer is experiencing toner leaking and light print, the cartridge should be replaced.
