Missing or Light Color Planes on Printouts

HP M551/M570MFP/CP3525/CP4025/CP4525/

M575MFP/CM3530MFP/CM4540MFP/M651/M680MFP Printers

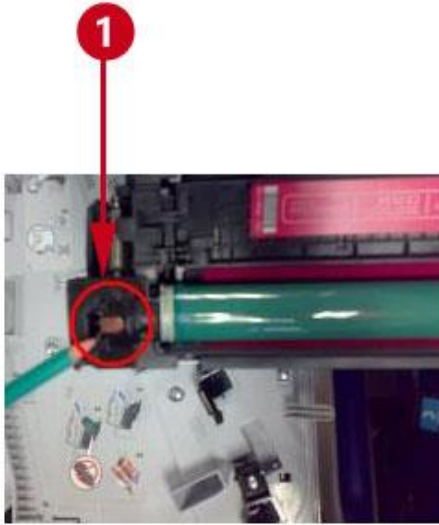
1. Calibrate the Printer from the control panel.
2. Get color samples and attach to case along with Config Page, Event Log and Supplies Status Page.
3. Use “**Disable Cartridge Check**” with a working toner cartridge in place of the missing or light color and print.
 - If the other print cartridge prints properly (the color now appears on printouts), then check the non-working cartridge grounding contact (see Figure below). Replace the toner cartridge if damage is found or any pieces are missing.
 - If the problem persists, the issue follows the slot. Go to next step.

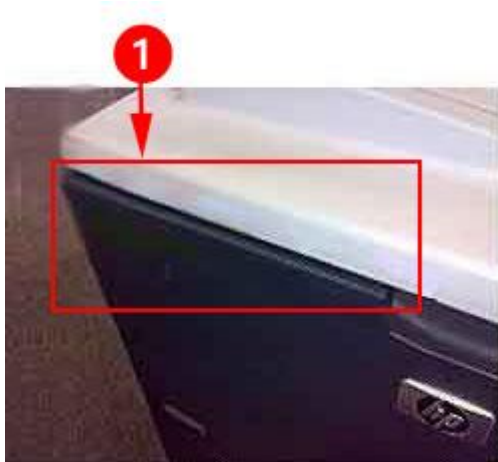
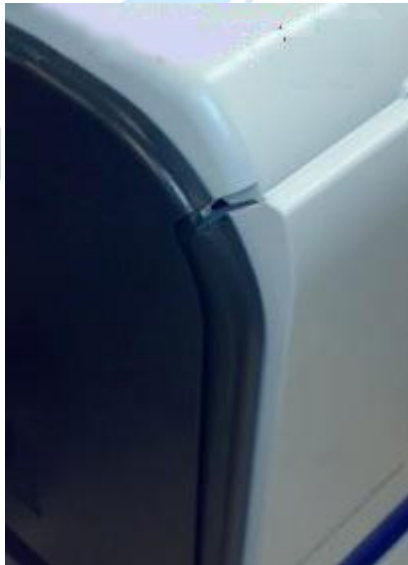
4. Clean the High Voltage contacts in the printer. If the problem remains after cleaning, check the contacts for damage. Replace any deformed or damaged parts.
5. Try “**Print Stop Test**” to isolate HVPS functionality.
 - At 1550 milliseconds. Check toner cartridge drum and check the image looks faint or missing, if so replace HVPS-D (developer).
 - At 1800 to 1900 milliseconds watch the ITB for toner image check if the image on the belt looks faded or missing. If so replace HVPS-T (transfer).
6. Do an Engine Test without the Formatter installed to determine if the color causing the problem is printing or not.
7. If issue is related to Yellow/cyan, make sure front door is closed correctly from the left side (there should not exist any gap). If door is not well closed or there is a gap please try reseating the Toner Collection Unit (TCU) and the door. If issues persist go to next step.
