Paper Jam Error 13.B2.FF

HP LaserJet Enterprise M806/M830MFP

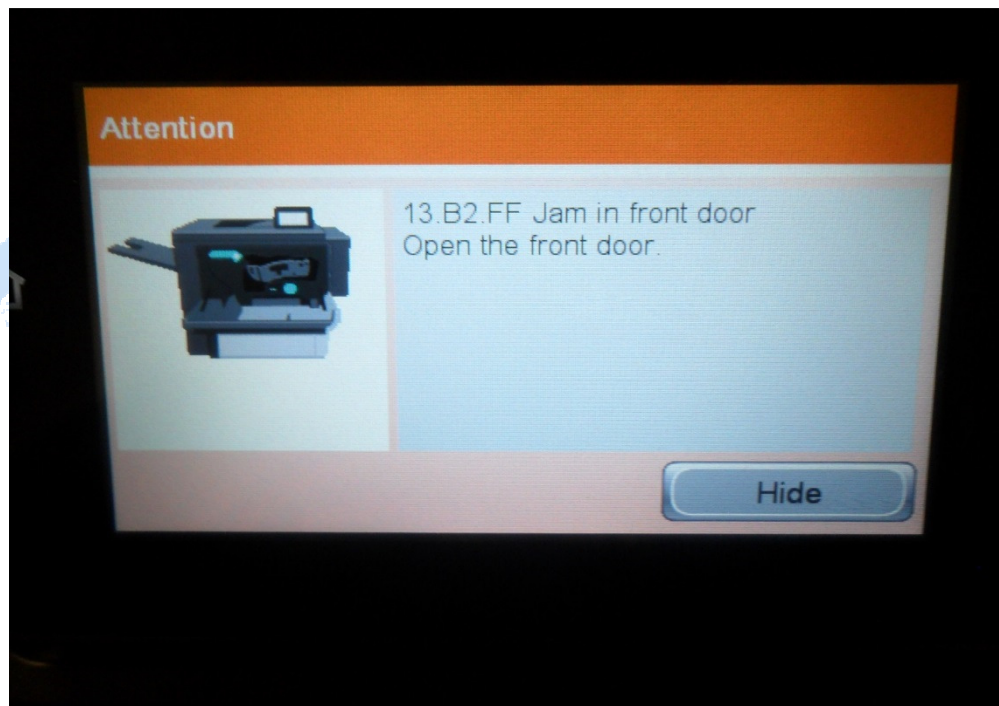
The registration in the M806/M830 series contains 4 paper sensors – three of which are paper width sensors (PS1, PS2 and PS3) and also top of page sensor (PS4). The registration also has an access plate that lifts (green tab) to expose the sensor flags. Any of the 4 flags obstructed at power on will produce 13.B2.FF where the plate would need to be lifted for inspection as any paper obstruction may not be visible otherwise.
