Xerox® AltaLink® C8170F Service Manual

705P01438

Initial Issue

May 2020

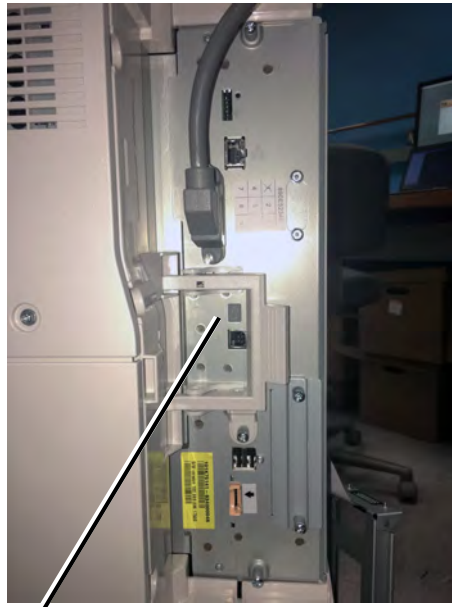
1. Locate the SBC PWB 7-segment display, Figure 1 , then cycle system power.
2. Observe activity on the 7-segment display and compare it with the expected display sequence. A failure is indicated by additional codes being displayed during the test, or by stopping on one or more codes. Pay careful attention to the codes as they display, since failure codes may not persist and may clear if the test is able to proceed. Follow the indicated service action.

7 Segment display

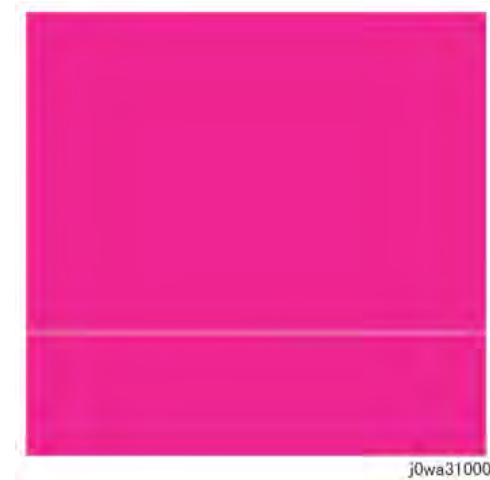
At Cin50% and Cin30%, the lines in the process direction have reversed black and white colors. Width is approximately 1mm.

Figure 1 1mm Lines Defect Sample

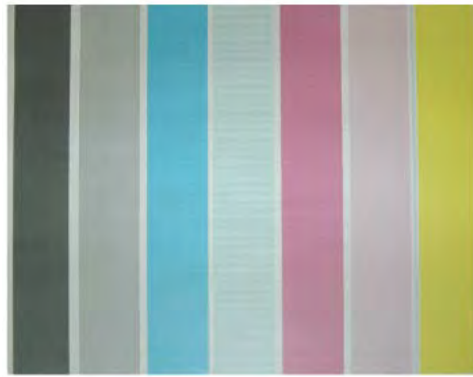
j0wa31003

Process Speed	Pitch
175mm	9.5mm
121mm	6.1mm
79mm	4.2mm

Figure 1 Defect Sample

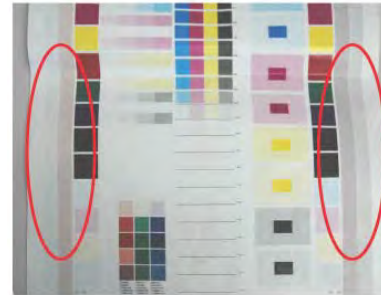
j0wa31004

The densities vary from the inboard to outboard edges.

Figure 1 IN-OUT Density Difference Defect Sample

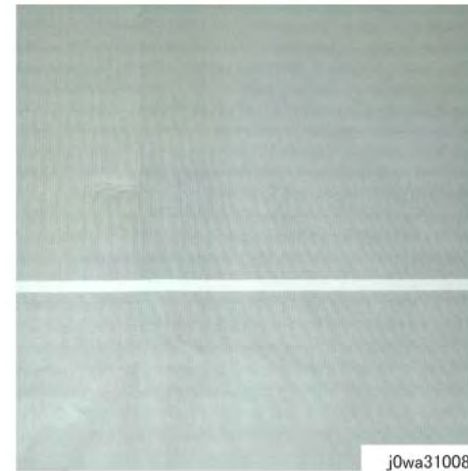
There are blank areas. Their size is proportional to the size of the contaminants as in [Figure 1](#).

Figure 1 Contamination Lines Defect Sample

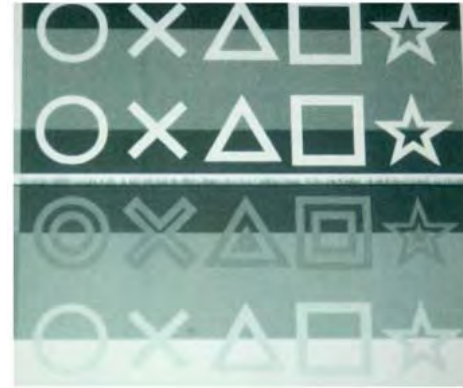
j0wa31010

Black lines and blank areas (lines) appear repeatedly in half-chip units of 2.7mm in width.

Figure 1 SLED Transfer Failure Defect Sample

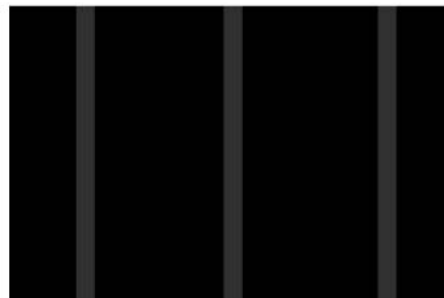
j0wa31013

This image quality defect occurs in the BCR and Photoreceptor NIP sections. The defect may appear as thin white lines in the Inboard-to Outboard direction on the highlight portion at the Charging Roll Pitch as in [Figure 1](#).

This problem may occur with New Drum CRU that has been stored for a long time. It also occurs when the MC has rested in a high temperature environment for a long time. (Halftone image)

Figure 1 Charging Roll Pitch White Lines (type 1) Defect Sample

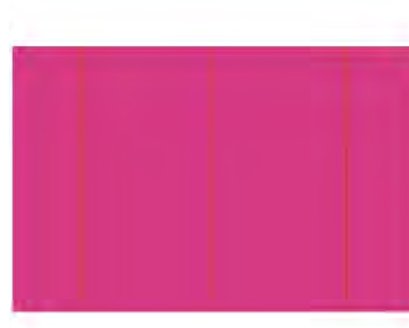
j0wa31015

Vibrations during the Drum CRU transportation may cause scrapes and friction in the BCR and the Photoreceptor, resulting in leftover electrostatic memory on the Photoreceptor that generates thin white streaks in the Inboard-to Outboard direction on the highlight portion at the Photoreceptor Pitch. This problem may occur right after the replacement of Drum CRU (occurs at Halftone image quality).

Figure 1 Photoreceptor Pitch Color Lines Defect Sample

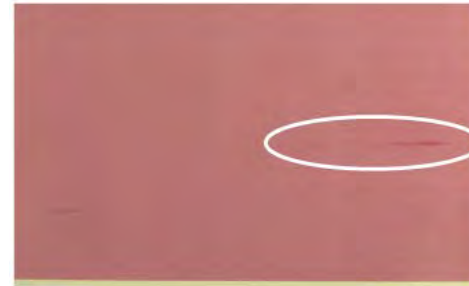
j0wa31016

At Pre Near or Near Empty state, if a customer had removed the Cartridge and knocked on it to collect the toner towards the exit in attempt to use the very last bit of toner, it may cause color stripe deterioration.

Figure 1 Toner Empty Detection Color Lines Defect Sample

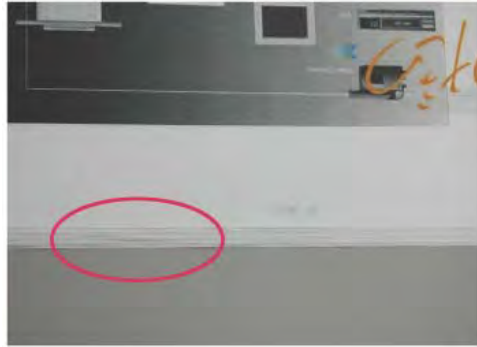
j0wa31020

Lead Edge: Paper lead edge contacts the Belt when it is transported from Registration to Transfer.

Trail Edge: The trail edge of Paper that loops between the Transfer-Fusing sections, at the release of the Secondary Transfer NIP, moves opposite to the feed direction and contacts the BTR surface, or bounds up and contacts the Belt

Figure 1 Toner Contamination at Lead/Trail Edge Defect Sample

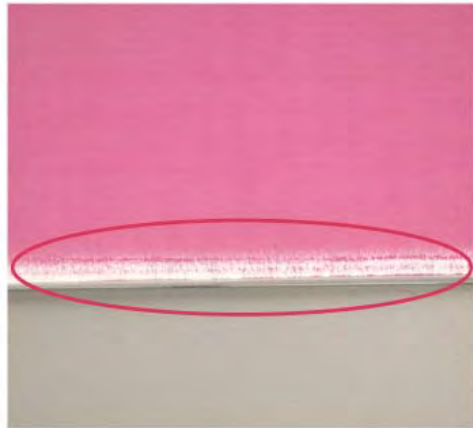
j0wa31022

This RAP troubleshoots for an image defect that looks like a rough image or blank area (in Lead Edge-to Trail Edge direction) that occurs for images within 10mm (including margins) from the paper trail edge.

The paper trail edge, after the Secondary Transfer NIP has been released, bounded up due to the fusing stroke effect and re-transfers to the Transfer Belt.

Figure 1 Trail Edge Transfer Failure Defect Sample

Check customer print to verify an image defect that looks like a rough image or blank area (in Lead Edge-to Trail Edge direction) that occurs for images within 10mm (including margins) from the paper trail edge as in [Figure 1](#).

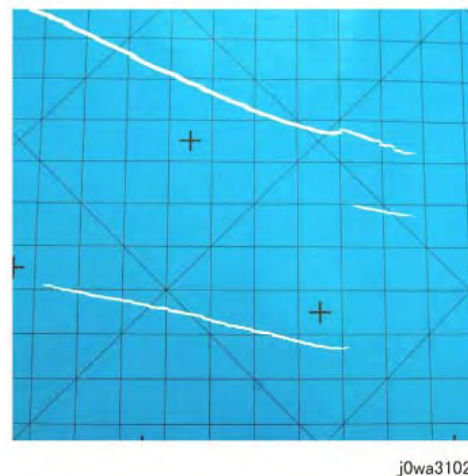
Ripples in partially moist paper become wrinkled in the Transfer section, causing blank areas to appear.

Figure 1 Transfer Blank Areas (Partially Moist Paper) Defect Sample

Check customer print to verify defect in paper that has uneven moisture content as in [Figure 1](#).

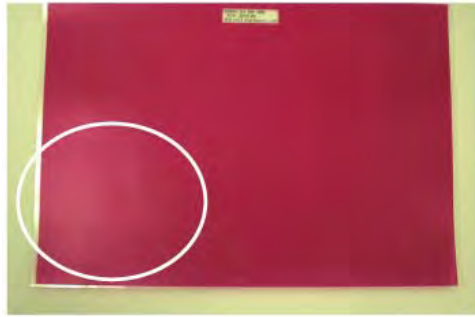
j0wa31026

When using transparencies, slight lines may appear at the Fuser Heat Roll Pitch as in [Figure 1](#).

Figure 1 Nip Marks Defect Sample

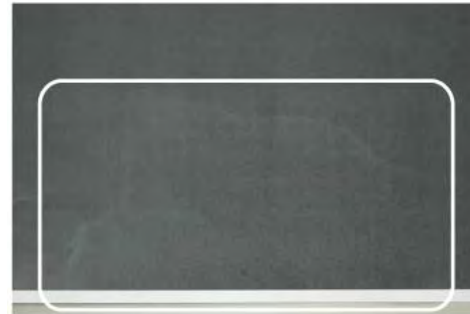
j0wa31027

Distorted image may appear at one side or both sides of the paper trail edge when printing half-tone fill as in [Figure 1](#).

Figure 1 Moisture Defect Sample

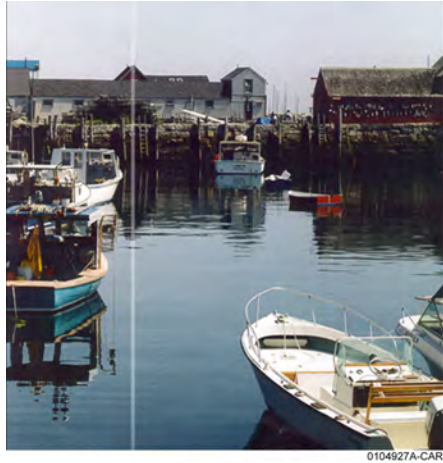
Contamination of LPH, damage to or contact with Transfer Belt or Drum Cartridge.

Figure 1 Streak Deletion Defect Sample

- Check customer print to verify Process Direction Bands, Streaks, and Smears as in the following:
 - Figure 1
 - Figure 2
- Clean the Transfer Belt Cleaner. Check for wear or damage
- Clean the Fuser. Check the metal stripper baffle in the Fuser for contamination.
- Check the 2nd BTR and the Detack Sawtooth (DTS) for Toner contamination.
- Use the LPH Cleaner to clean the LPH.

The defect is full-width (LE - TE) Figure 1.

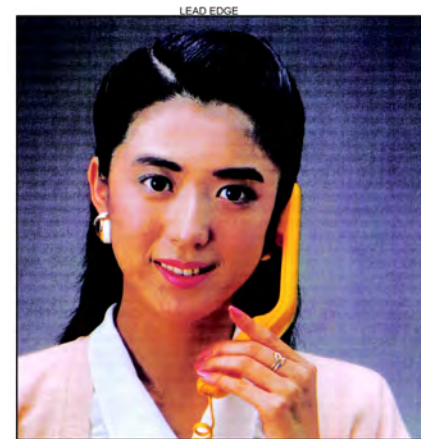
Faulty Photoreceptor/Developer Housing gear or bearing problem.

Figure 2 High Frequency Bands Defect Sample

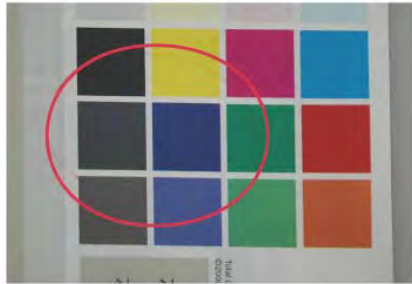
j0wa31021

Paper that has had its Side 1 fused has a reduced percentage of moisture content, which increases its electric resistance. Since the resistance in the Secondary Transfer section also increases by lower humidity or over time, the required electrical field may not be attained, especially in the early mornings (low humidity environment).

Due to the characteristics of the EA-ECO Toner, high Rsys (in the early morning low temperature and low humidity environment) requires a transfer voltage for the areas where multiple transfers and MWS cannot be used at the same time. Because the machine is adjusted for Multiple Transfer Priority by default, MWS may be visible from Side 1.

Figure 1 Multi Color Transfer Failure Defect Sample

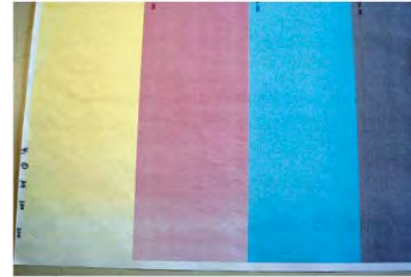
Figure 1 j0ki31016

IQ50 White Streaks in Process Direction/Dropping Density (XERO/CLN)

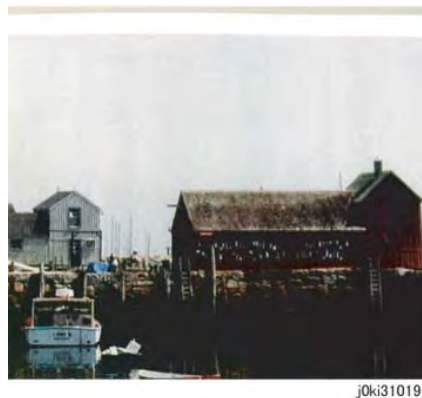
A phenomenon like background (e.g. background color or document bleed) may occur depending on the document.

The default background suppression function is unable to fully remove the background.

Figure 1 Background (IPS)

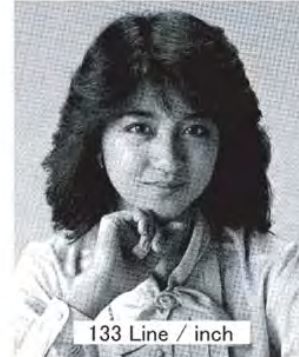
Figure 1 j0ki31015

When a document with tint on the whole paper or a background image is scanned using Fax Text mode in High Quality (Fine), the file size or the Fax transmission time may increase drastically.

As the Text mode is designed to highlight texts, it generates halftone dot moire.

Fax fine 133 line half tone Screen Image
j0ki31015

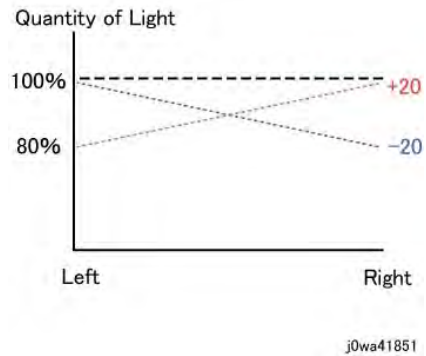
Figure 2 j0wa41851

*Although there is also an adjustment range at the positive side, it only involves reducing the brightness at the IN side or the OUT side and therefore will not have any correction that goes above 100%.

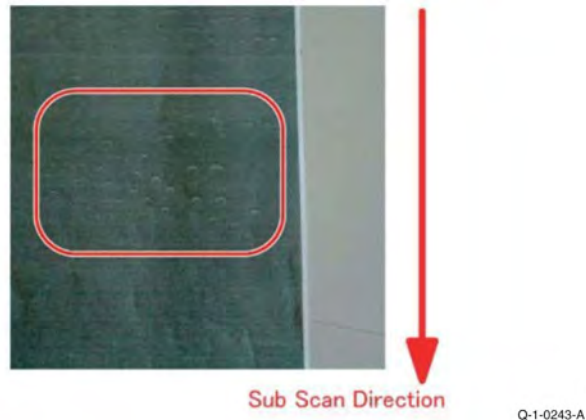
When paper exits the secondary transfer zone, toner can scatter in a semicircular pattern if the toner charge is low. This defect may also occur when the discharge from the paper is not sufficient, [Figure 1](#) and [Figure 2](#).

Figure 1 Circular Stamping Marks Defect

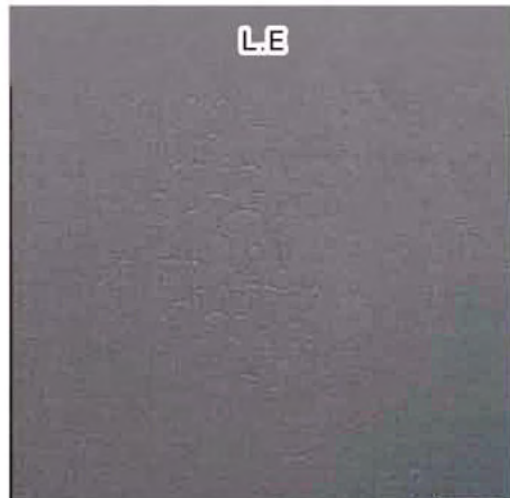
Figure 2 Scale-Like Defect

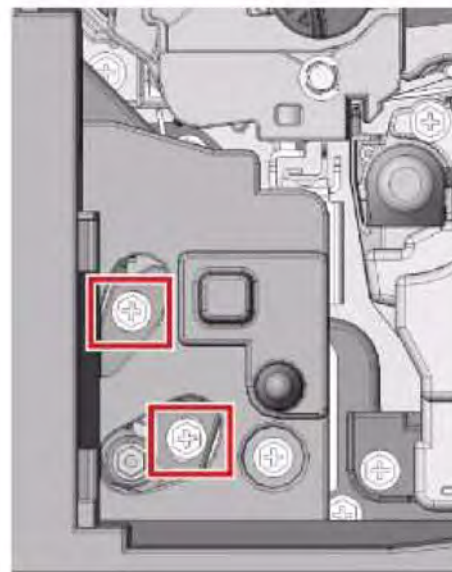
Q-1-0272-A

- b. At the front of the machine, remove the Waste Toner Transport Assembly ([PL 90.15](#)) and loosen the screws (x2) that secure the Alignment Bracket, [Figure 5](#).

Figure 5 Loosen the Screws (2) (Front Cover open, Waste Tone Transport removed)

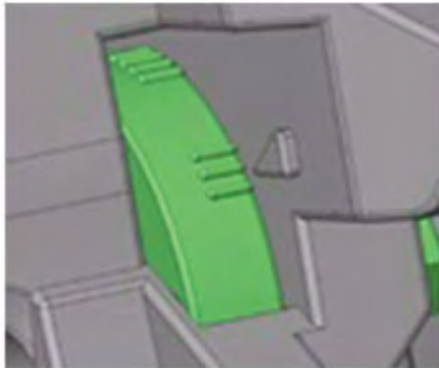
Q-1-0257-A

Figure 8 Indication for second pass of Registration Roll Alignment

4. Check the scale of the Cam while looking from the left side. Ensure that the cam is set so that 2 lines on the green indicator are aligned with the arrow on the housing, [Figure 7](#). If this is the second pass through the Registration Roll Alignment procedure, ensure that the cam is set so that three lines are showing, [Figure 8](#).

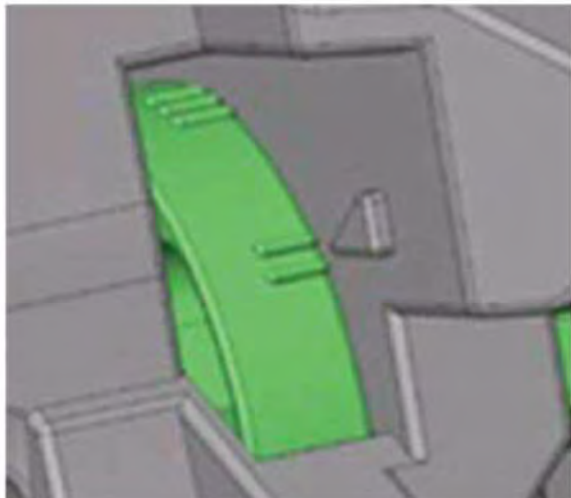
Q-1-0282-A

If this is the second pass through the Registration Roll Alignment procedure, ensure that the cam is set so that three lines are showing, [Figure 14](#).

Figure 14 Indication for second pass of Registration Roll Alignment

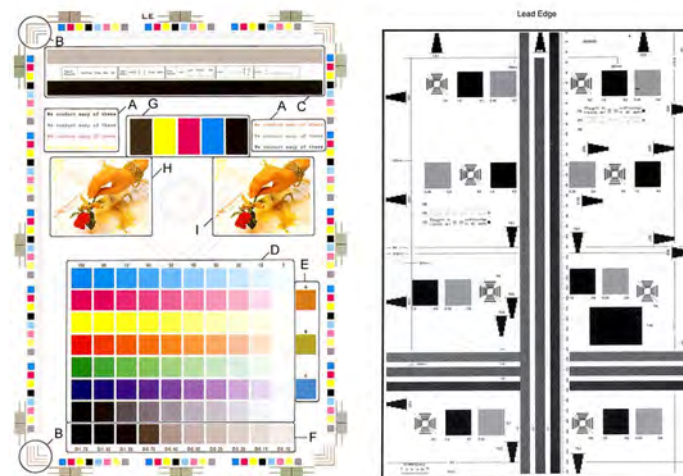
Q-1-0237

Figure 2 Color and Geometric Test Patterns

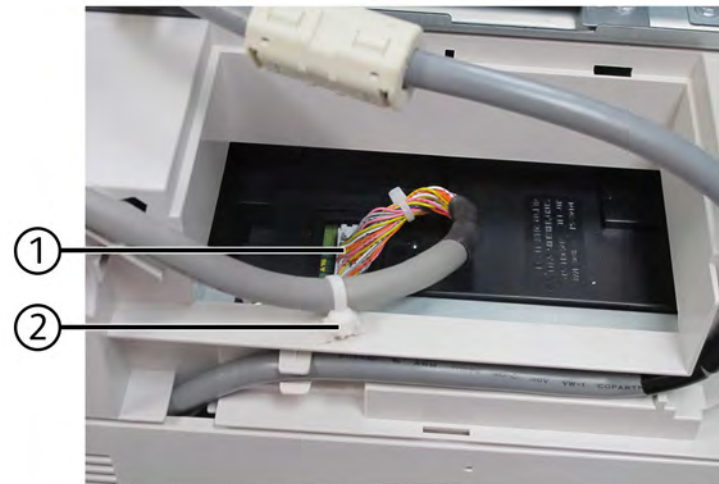
L-1-0588-A

1. Remove the ESS rear cover, [PL 28.10](#).
2. Remove the DADF IF cover, [PL 60.15](#).
3. Disconnect the IIT-DADF cable connector, [Figure 1](#).
 - a. Disconnect the IIT-DADF cable connector (1).
 - b. Remove the clamp (2) securing the cable.

Figure 1 IIT-DADF Cable

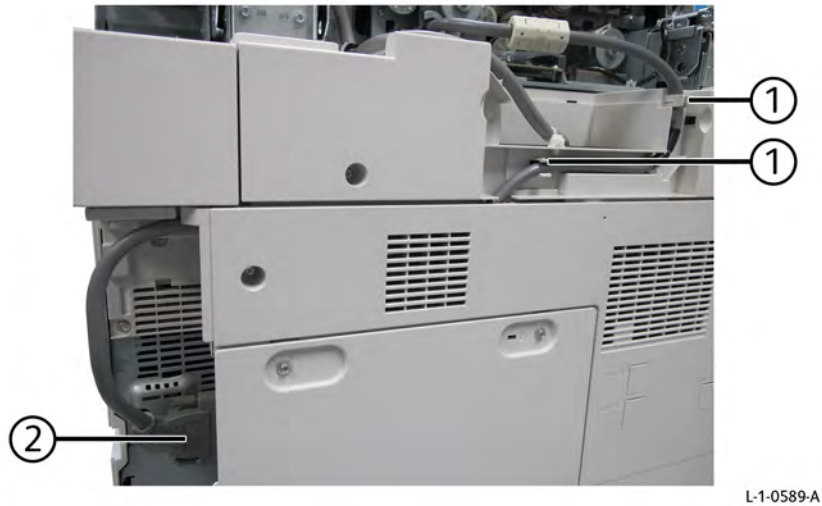
L-1-0589-A

4. Disconnect the DADF controller cable connector, [Figure 2](#).
 - a. Release the controller cable from the guides (1).
 - b. Disconnect the controller cable connector (2).

Figure 2 DADF controller cable

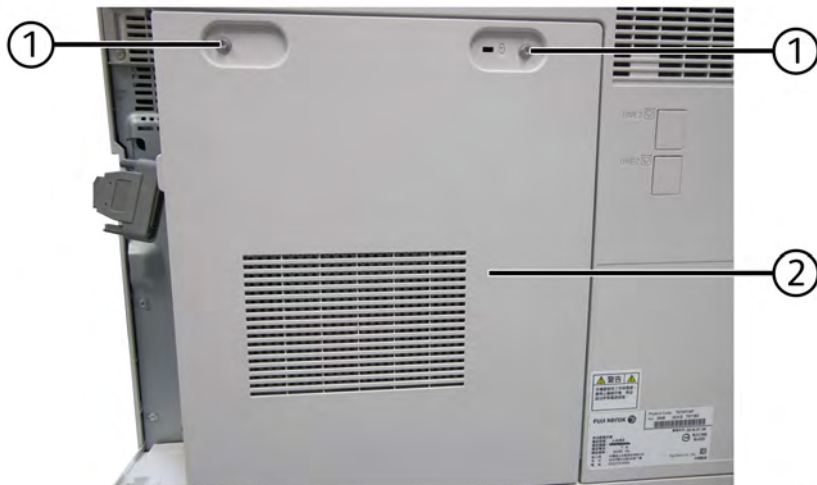
L-1-0578-A

5. Remove the left rear cover, [PL 28.10](#).
6. Remove the UFP filter assembly, [PL 40.15](#).
7. Remove the controller cover, [Figure 3](#).
 - a. Remove two thumb screws (1).
 - b. Remove the controller cover (2).

Figure 3 Controller cover removal

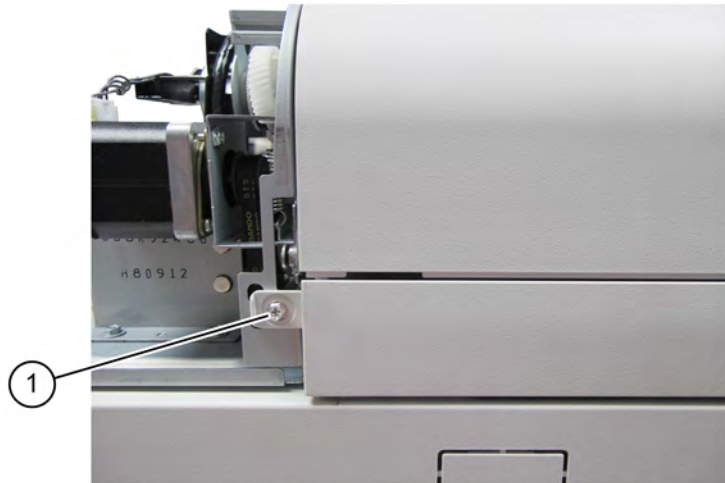
L-1-0517-A

1. Remove the DADF rear cover, [REP 5.5](#).
2. Remove one screw (1), [Figure 1](#).

Figure 1 Left lower cover screw removal

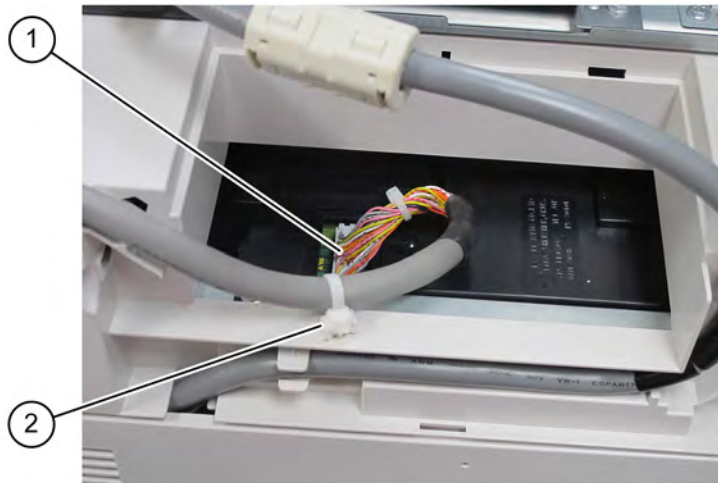
L-1-0501-A

1. Remove the DADF IF cover, [PL 60.10](#).
2. Disconnect the IIT-DADF cable connector, [Figure 2](#).
 - a. Disconnect the IIT-DADF cable connector (1).
 - b. Remove the clamp (2) securing the cable.

Figure 2 Disconnect IIT-DADF cable connector

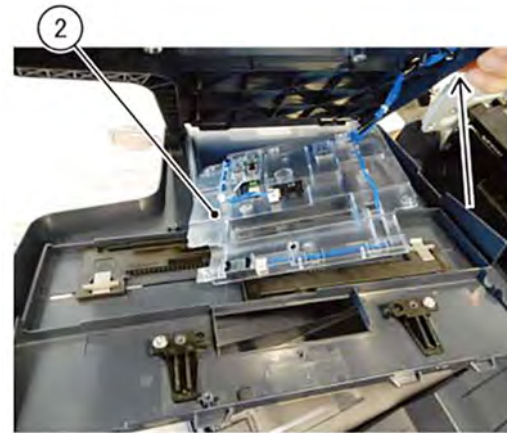
L-1-0262-A

Note: Remove the inner cover (2) by opening the bottom tray assembly, [Figure 4](#).

Figure 4 Inner cover removal

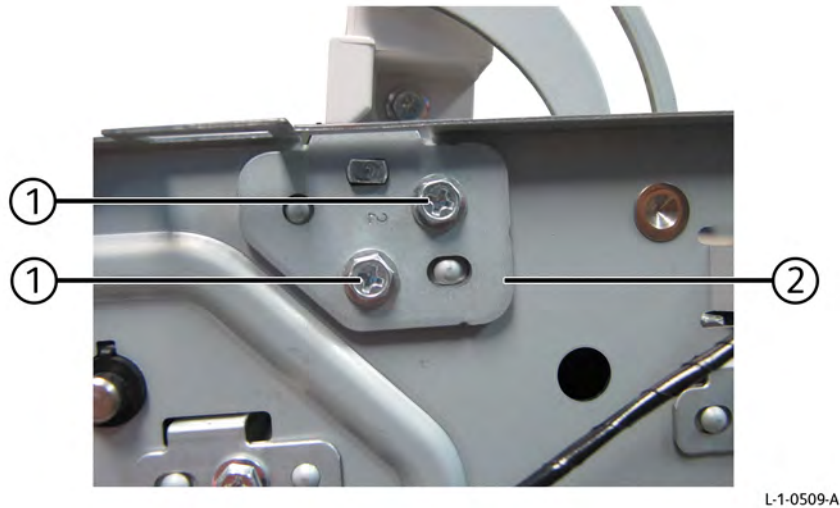
L-1-0509-A

- a. Remove two screws (1).
- b. Remove the front hinge (2).

Figure 3 Front hinge removal

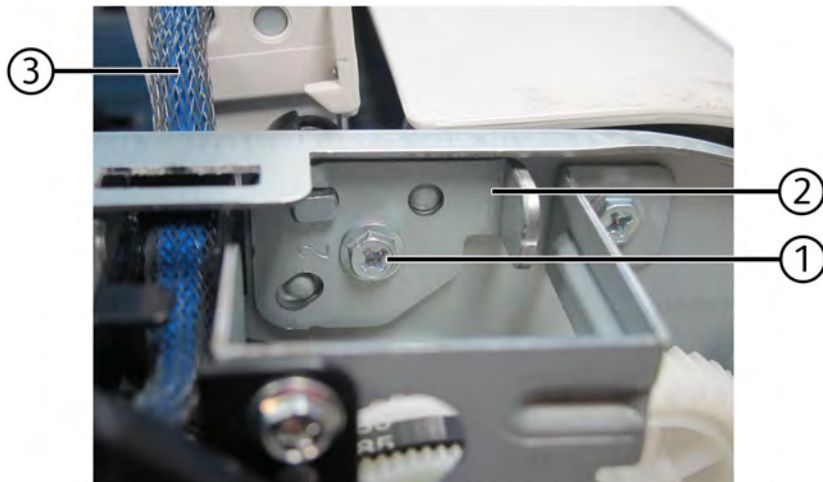
L-1-0510-A

6. Remove the rear hinge, [Figure 4](#).

- a. Remove one screw (1).
- b. Remove the rear hinge (2).
- c. Pull out and remove the wire harness (3) from the frame hole.

Figure 4 Rear hinge removal

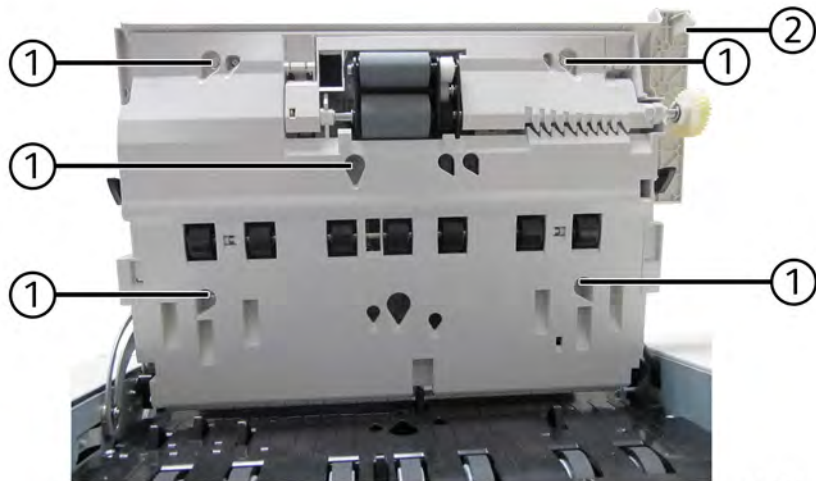
L-1-0526-A

1. Open the DADF feeder cover assembly.
2. Remove the upper feeder cover, [Figure 1](#).
 - a. Remove five screws (1).
 - b. Remove the upper feeder cover (2).

Figure 1 Upper feeder cover removal

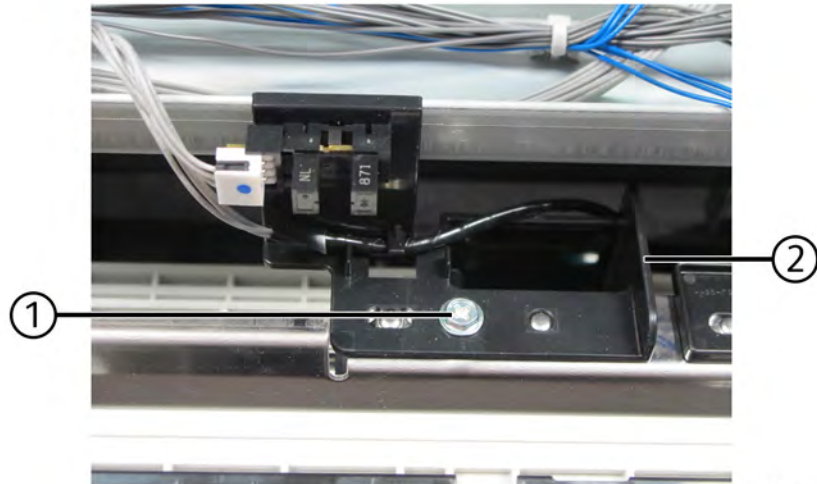
L-1-0566-A

1. Remove the DADF pre registration in chute assembly, [REP 5.47](#).
2. Remove the lead registration sensor bracket, [Figure 1](#).
 - a. Remove one screw (1).
 - b. Remove the lead registration sensor bracket (2).

Figure 1 Lead registration sensor bracket removal

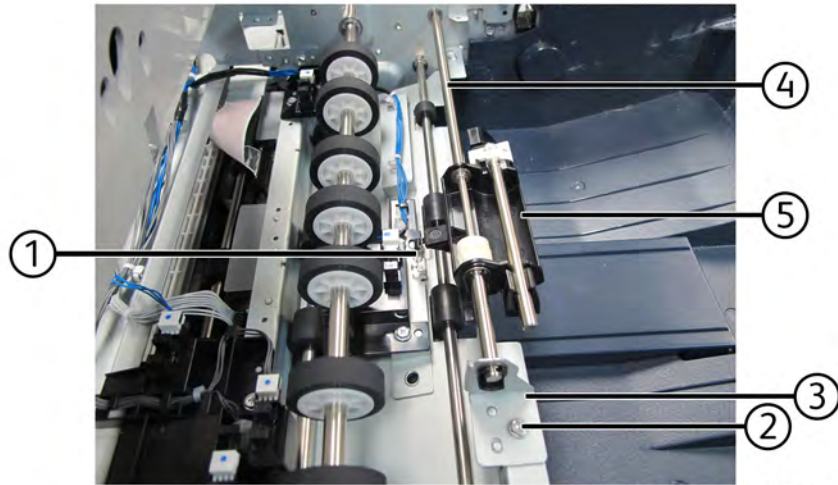
L-1-0575-A

7. Remove the pivot shaft and retard holder assembly, [Figure 2](#).
 - a. Remove the spring (1).
 - b. Remove the screw (2) securing the pivot shaft mounting bracket (3) to the frame.
 - c. Remove the pivot shaft (3) and retard holder (4) as assembly from the frame.

Figure 2 Pivot shaft and retard holder assembly removal

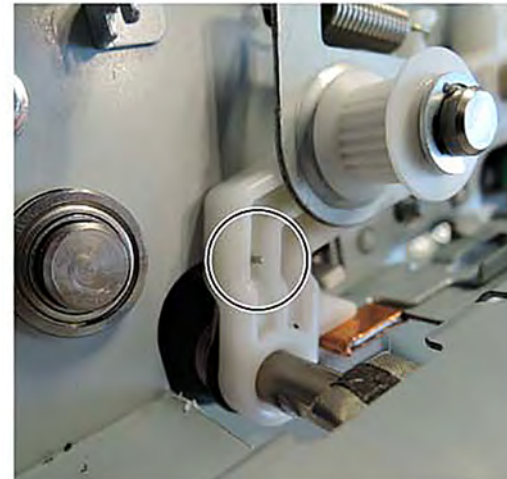
L-1-0246-A

Note: When installing the platen high roll assembly, remember to install the spring into the hole of the platen high roll assembly, [Figure 3](#).

Figure 3 Spring installation location

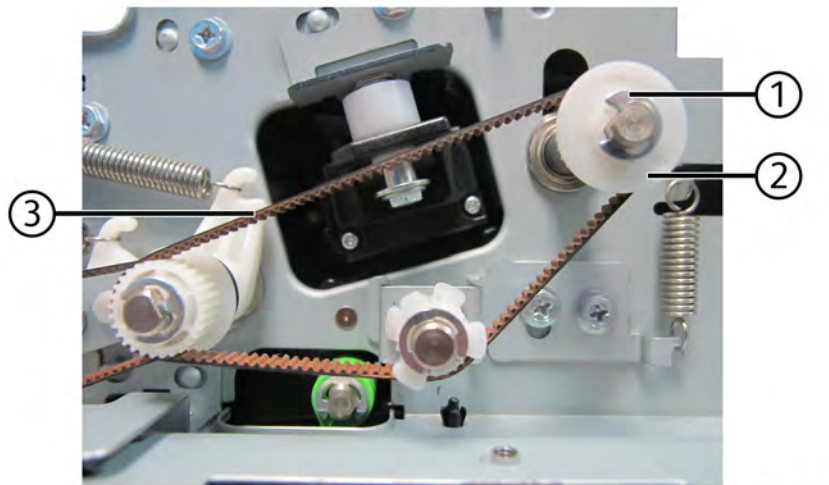
L-1-0538-A

1. Remove the DADF front cover, [REP 5.3](#).
2. Remove the exit 1 belt, [Figure 1](#).
 - a. Remove the E-clip (1).
 - b. Remove the gear (2).
 - c. Remove the exit 1 belt (3).

Figure 1 Exit 1 belt removal

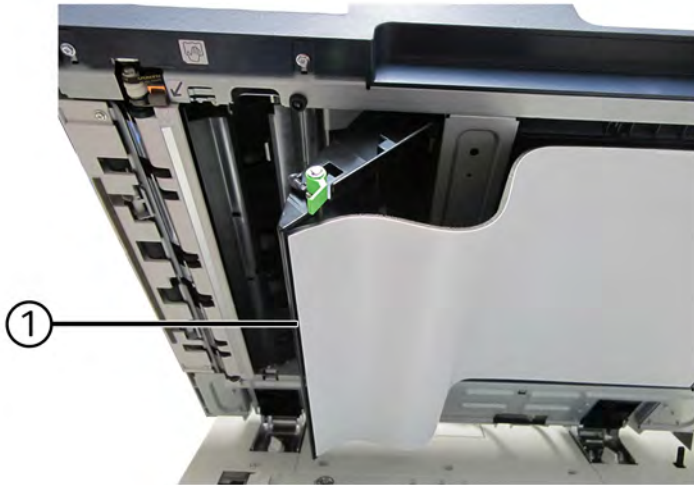
L-1-0522-A

1. Open the DADF.
2. Open the exit lower chute assembly (1), [Figure 1](#).

Figure 1 Exit lower chute assembly

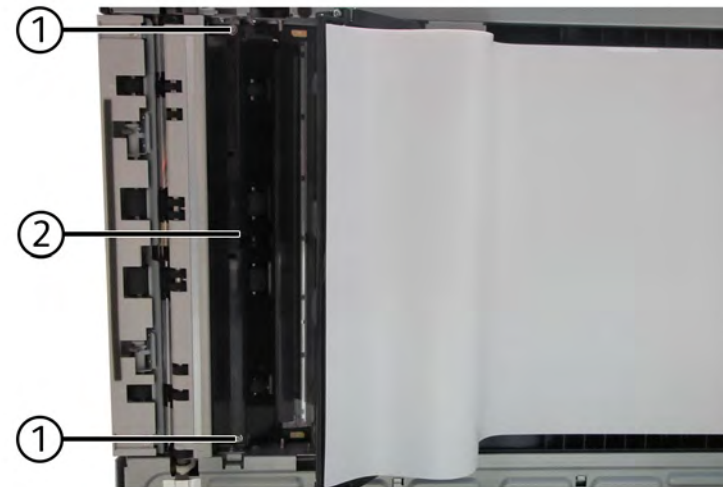
L-1-0523-A

3. Remove the out chute assembly, [Figure 2](#).
 - a. Remove two screws (1).
 - b. Remove the out chute assembly (2).

Figure 2 Out chute assembly removal

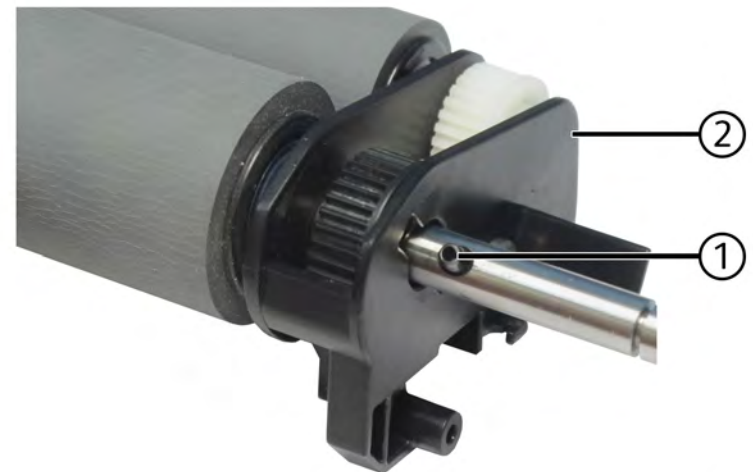
L-1-0557-A

Note: Ensure that the pin (1) on the feed shaft align with groove on the nudger housing (2) during installation, [Figure 7](#).

Figure 7 Feed shaft installation

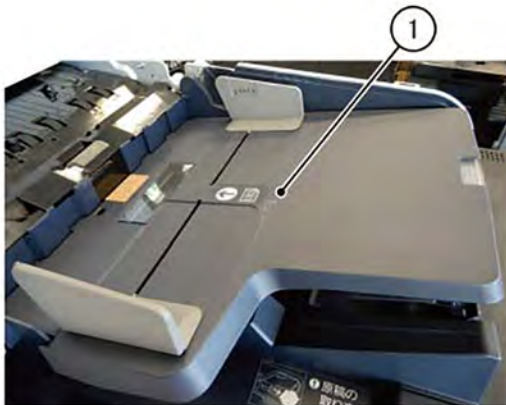
L-1-0260-A

5. Remove the DADF document tray, Figure 4.

Figure 4 DADF document tray removal

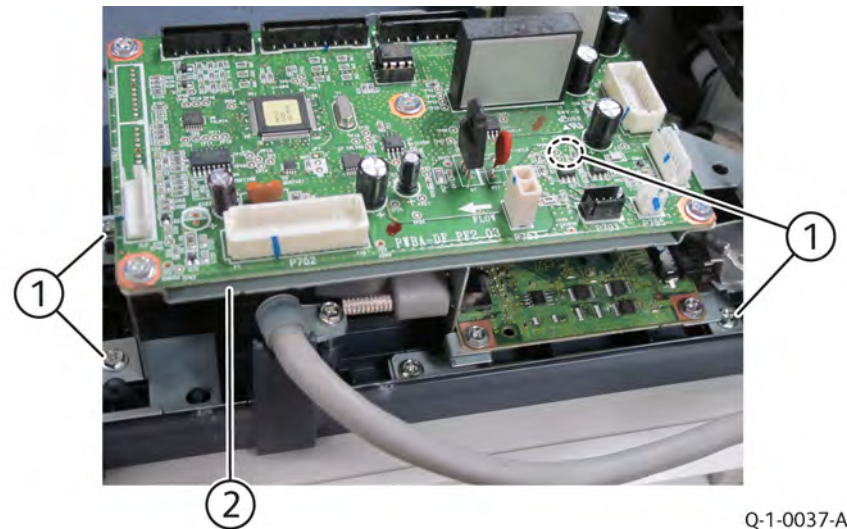
Q-1-0037-A

6. Remove the PWB bracket, [Figure 5](#).
 - a. Remove four screws (1) securing the PWB bracket.
 - b. Remove the PWB bracket (2).

Figure 5 DADF PWB

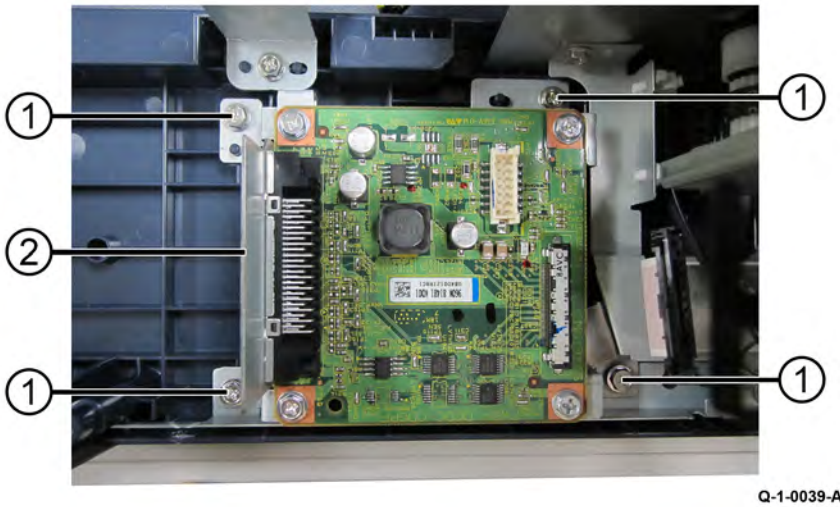
8. Remove the DC/DC PWB bracket, Figure 7.

- a. Remove four screws (1) securing the DC/DC PWB bracket.
- b. Remove the DC/DC PWB bracket (2).

Figure 7 DC/DC PWB bracket removal

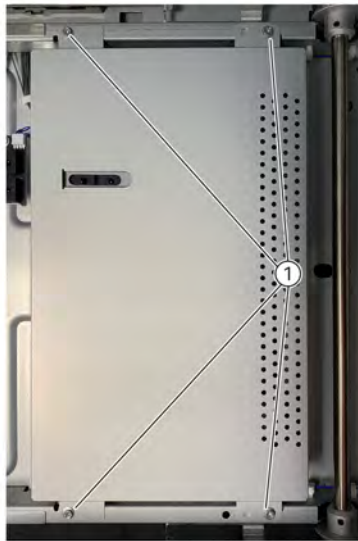
Figure 1 Lens Cover Screw location

1. Switch off the power and disconnect the power cord.
2. Remove the Right Plate. [PL 60.15](#)
3. Remove the Platen Glass by lifting it up from the right side. [PL 60.15](#)
4. Remove the four Lens Cover screws (1). Refer to [Figure 1](#)
- 5.

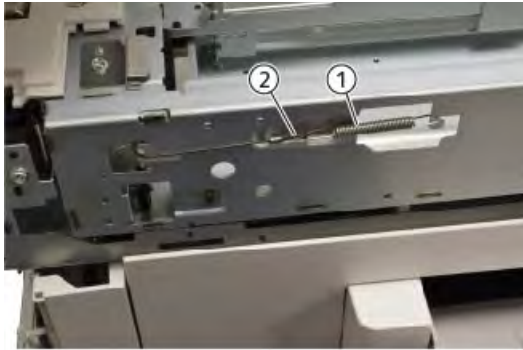
Figure 4 Preparation

10. Prepare to remove the carriage cable. [Figure 5](#)
 - a. Unhook the extension spring (1) from the frame.
 - b. Detach the cable (2) from the extension spring.

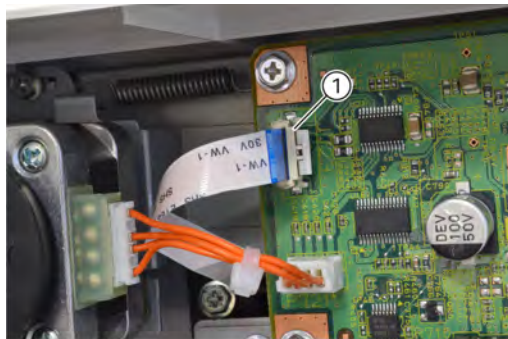
Figure 6 Cable assembly disconnection (3)

9.
 - a. Disconnect the FFC LED cable assembly from the IIT Trans PWB (1) [PL 60.45](#) Refer to [Figure 6](#)

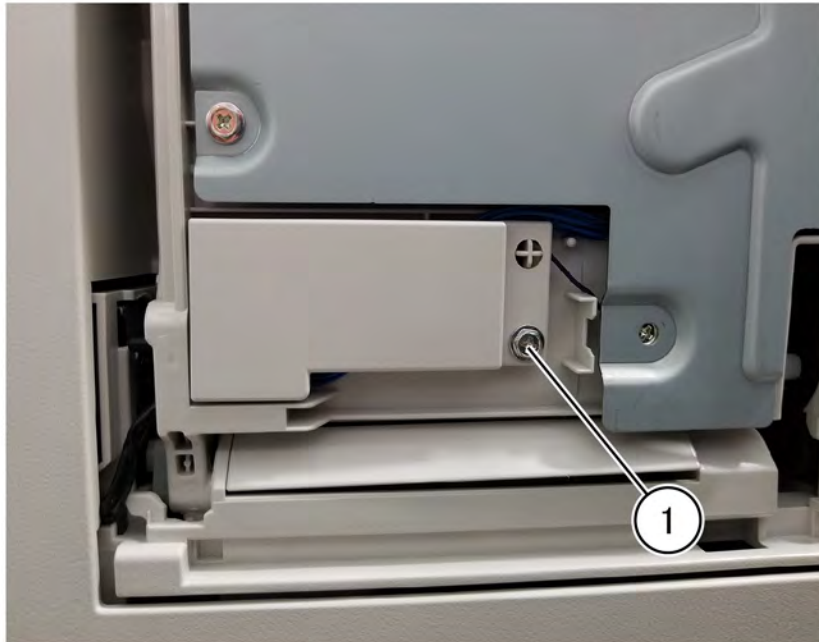
F-1-0356-A

3. Remove the screw (1) then remove the connector cover, [Figure 2](#).

Figure 2 Connector cover removal

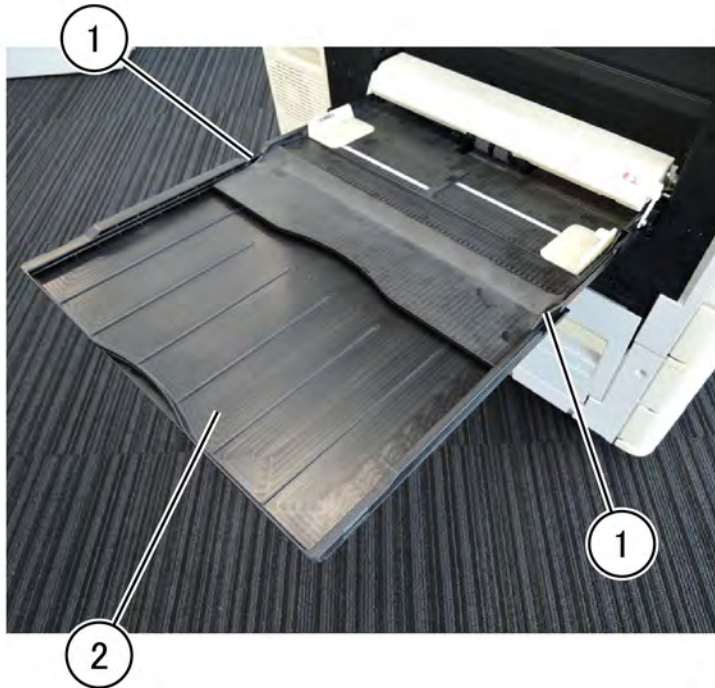
F-1-0271-A

1. Fully extend the extension tray.
2. Using firm pressure, pull the extension tray (2) from the bypass tray (1) to remove, [Figure 1](#).

Figure 1 Extension tray removal

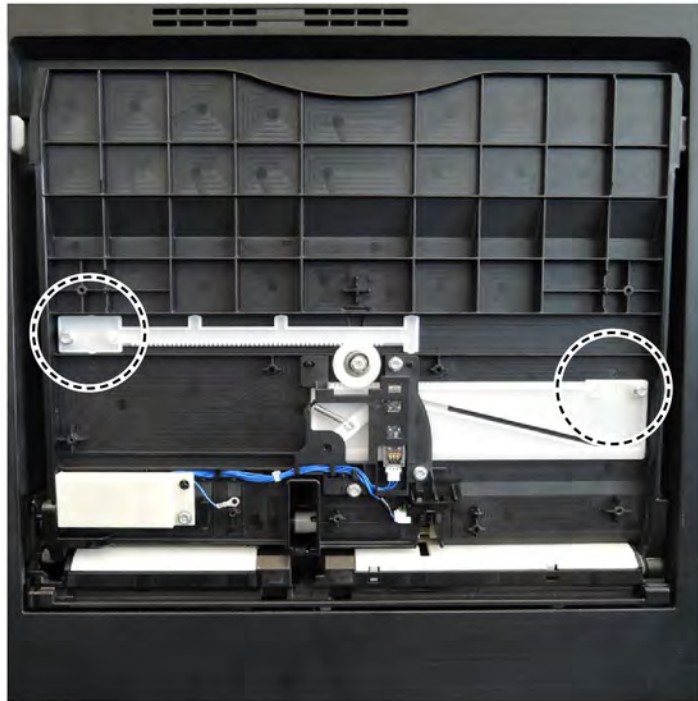
F-1-0275-A

2. When installing the gear, align the marks on the front/rear rack to the marks on the bypass tray, [Figure 5](#).

Figure 5 Gear alignment

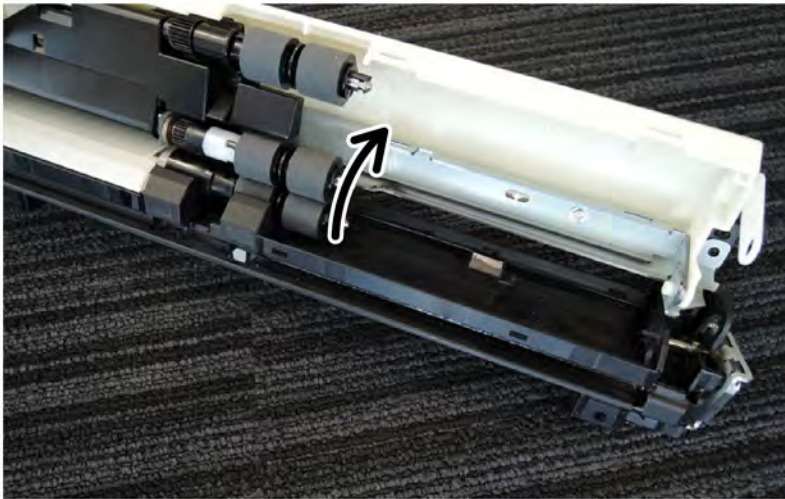
F-1-0308-A

1. Remove the bypass feedhead assembly, [REP 80.19](#).
2. Remove the bypass tray roll kit.
 - a. Lift the top cover of the upper frame assembly in the direction of the arrow (1), [Figure 1](#).

Figure 1 Lift the cover

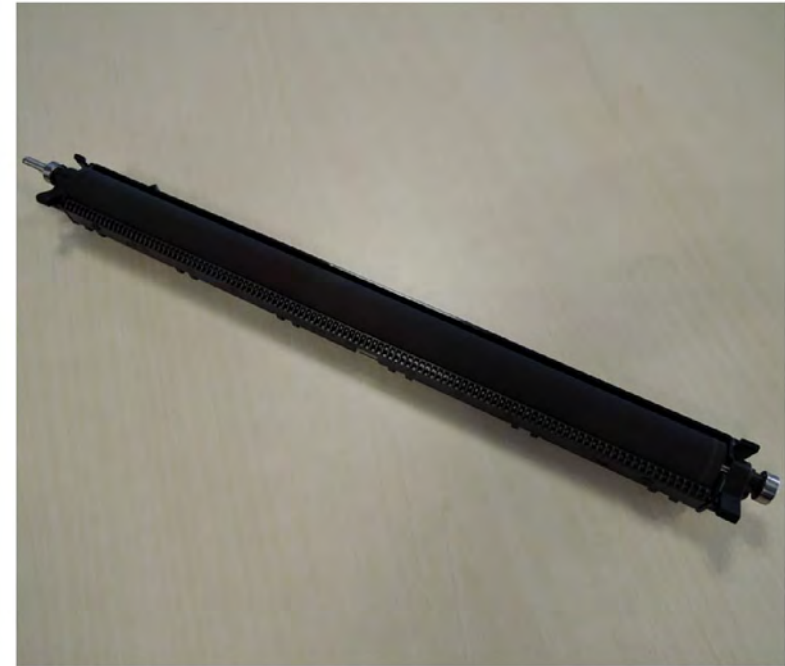
F-1-0317-A

Figure 2 2nd BTR roll removed

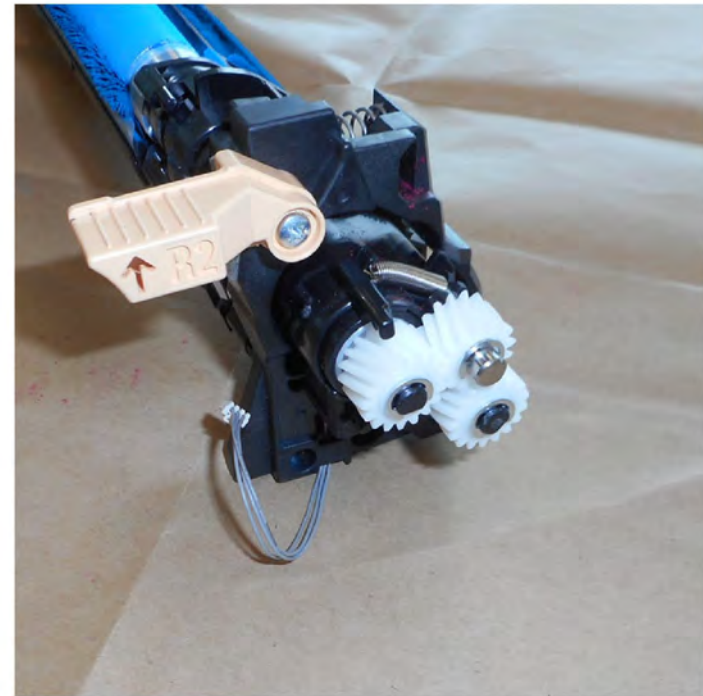
F-1-0367-A

4. Inspect and clean all toner from the developer assembly gear before installing or banding and excessive wear of the gear will occur, [Figure 4](#).

Figure 4 Gear inspection

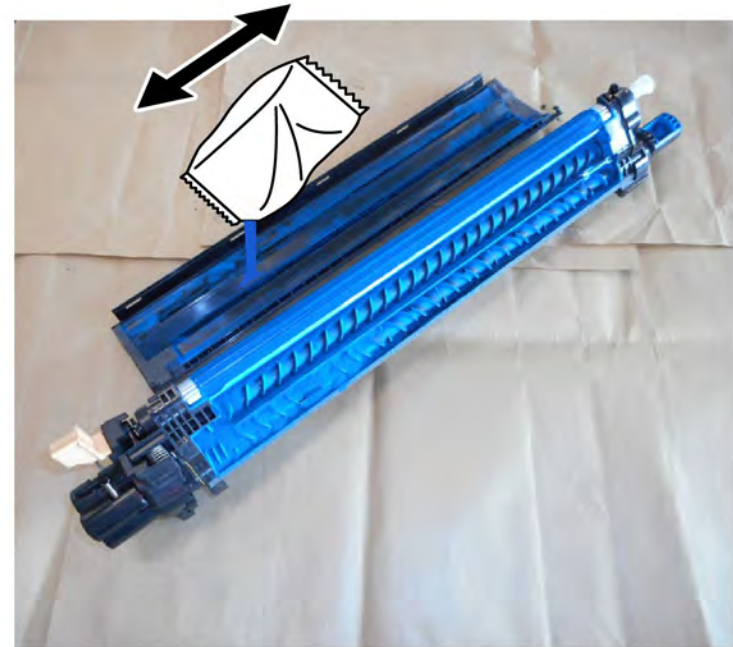
F-1-0375-A

10. Install the triumph plate back into the developer housing assembly, [Figure 2](#).
11. Open the bag of new developer carefully, then slowly add new developer to the magnetic roller side, [Figure 4](#).

Figure 4 Add new developer

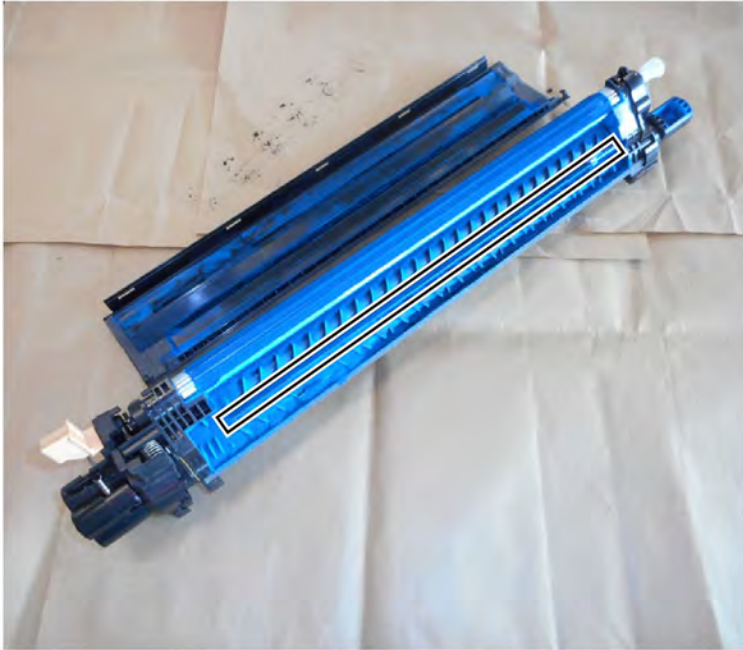
F-1-0378-A

13. Clean any developer or toner from the location indicated by the black dashed area outlined in [Figure 7](#).

Figure 7 Clean housing area

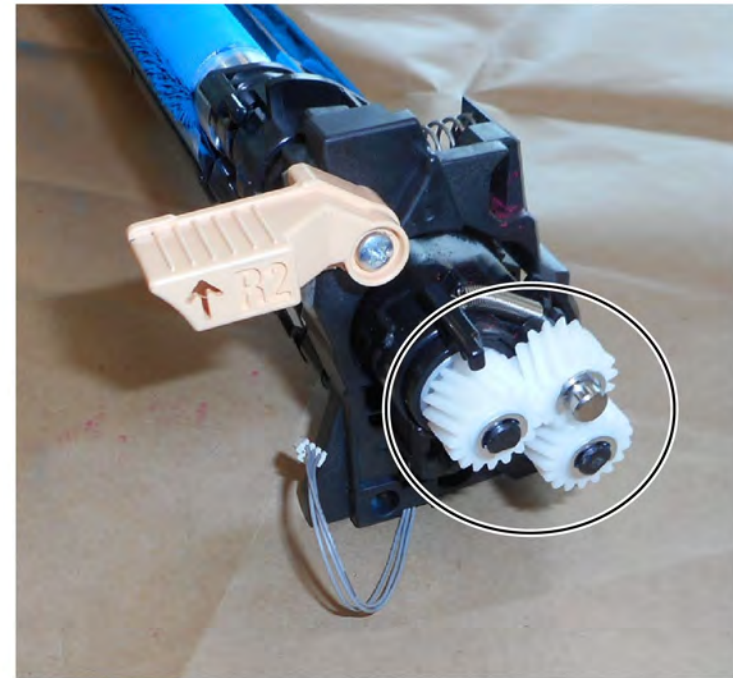
F-1-0381-A

17. Inspect and clean all developer or toner from the gear by turning the gear clockwise, [Figure 10](#).

Figure 10 Clean the gear

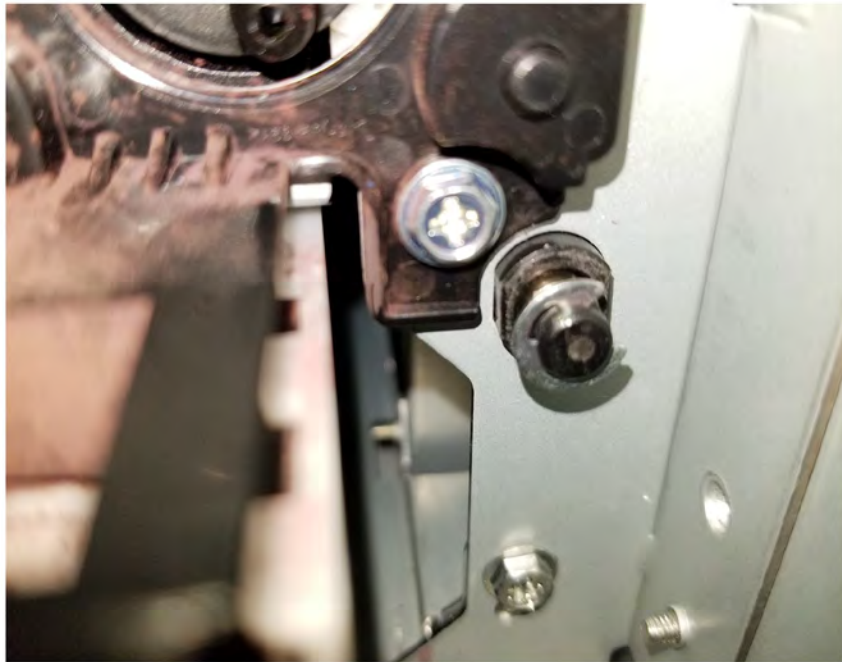
F-1-0395-A

Note: The flanged end of the sleeve bearing seats against the gear on both ends, [Figure 3](#). The shaft of the sleeve bearing seats inside the frame hole, [Figure 4](#).

Figure 4 Sleeve bearing in the frame

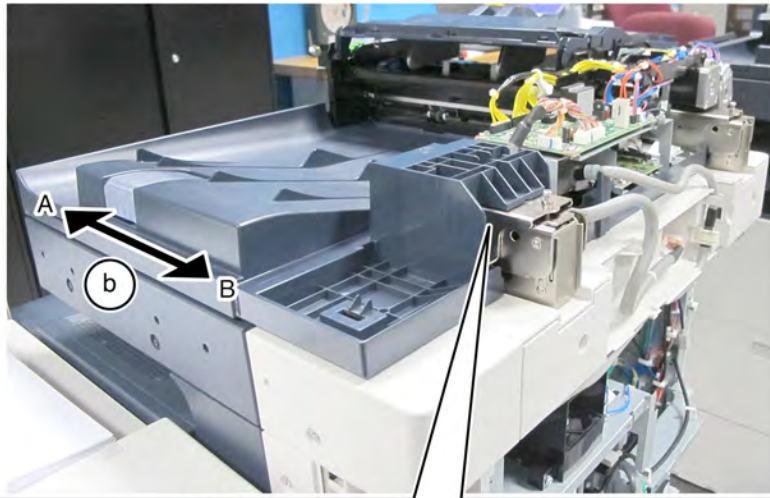
2. Adjust the position of the DADF by moving the DADF in direction A or B. (Figure 2).
 - a. Loosen the screws (4).
 - b. Move the DADF in direction A (Figure 3) or B (Figure 4).
 - c. Tighten the screws (4).

Figure 2 Skew Adjust

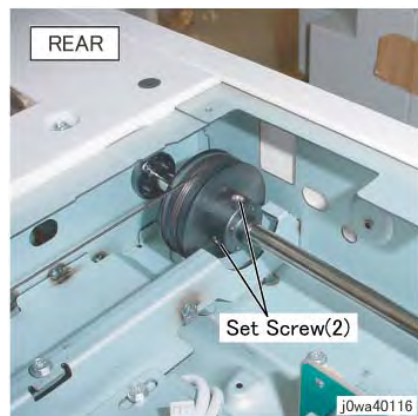
9. Loosen the set screws (2) that secure the pulley at the rear side. (Figure 3)

Figure 3 Loosen the rear pulley

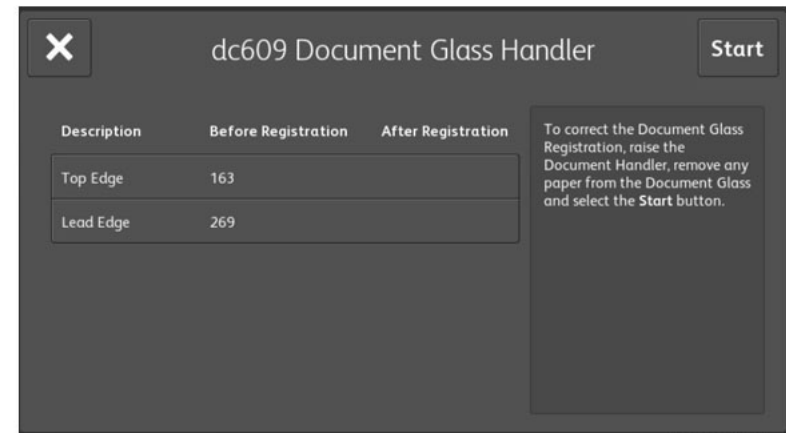
Figure 1 dc609 Document Glass Handler screen

1. Enter **Service Diagnostic Mode**.
2. Select **Adjustments**.
3. Scroll to and select **dC609 Document Glass Registration...**
The screen displays the current registration values. (**Figure 1**)

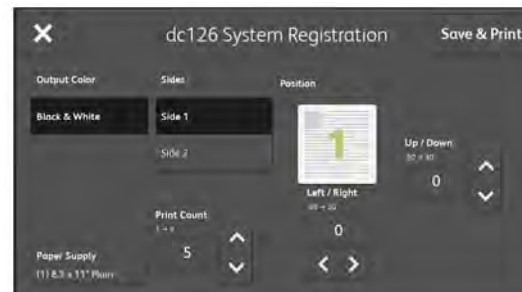
Figure 1 dC126 Paper Registration screen

3. Enter **Service Diagnostic Mode**.
4. Select **Adjustments**.
5. Select **dC126 Paper Registration....** (Figure 1)
