Xerox® AltaLink® C8170F Service Manual

705P01438

Initial Issue

May 2020

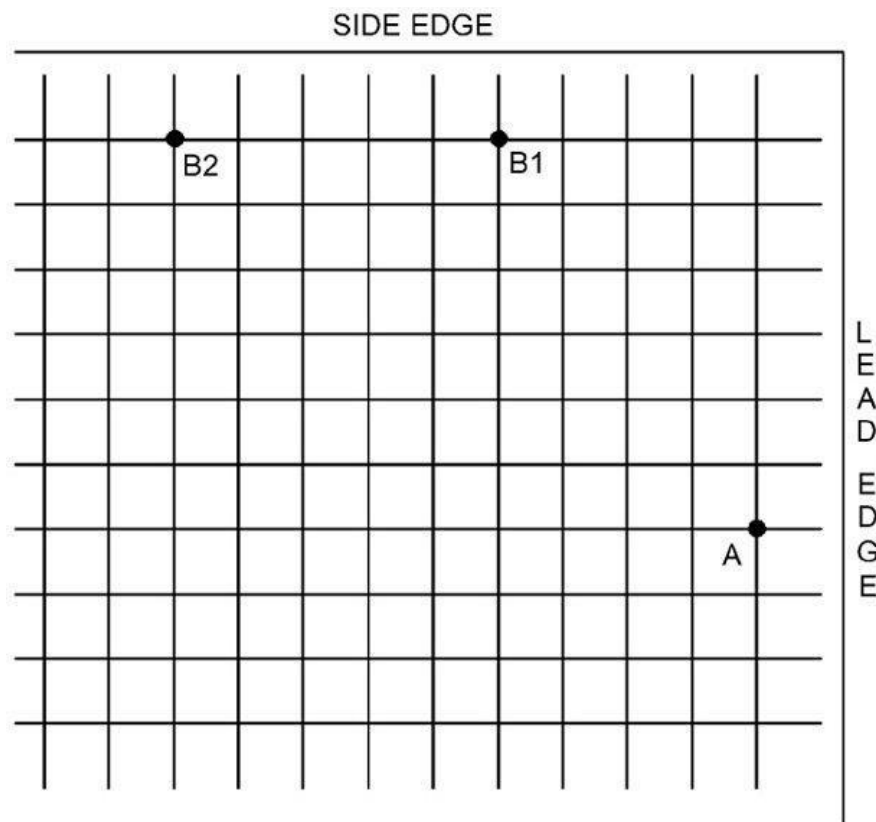
Figure 2 Test Pattern Measurement Points

1. Make the following selections:
 - a. Select **Side 1**.
 - b. Set **Paper Supply** to (1).
 - c. Set **Print Count** to 5.
2. Select **Save & Print**.
3. Take the third print from the output tray and label the lead edge.
4. Orient the paper as shown in **Figure 2** and measure from the lead edge to point A. Point A is at the intersection of the 7th line from the side edge and the 1st line from the lead edge.
5. If the measured value is not 10±1.5mm, perform the **Adjustment** for **Lead Edge**.
6. If the Check is OK, proceed to **Side 2 Lead Edge Registration (Trays 1-4 & 6)**.

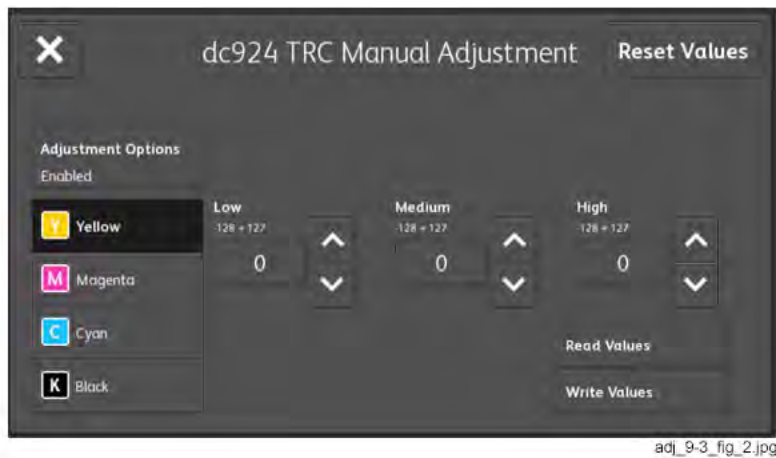
Figure 1 dc924 TRC Manual Adjustment screen

1. Ensure that there is 11 x 17"/A3 paper in Tray 1.
2. Enter **Service Diagnostic Mode**.
3. Select **Adjustments**.
4. Select **dC924 TRC Manual Adjustment**. (Figure 1)
Set the values at the midpoint.

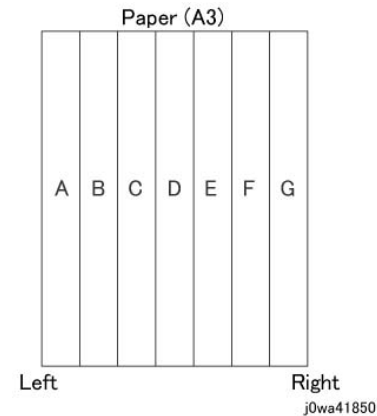
Figure 1 Correction Areas

The LPH Exposure Amount Fine Adjustment adjusts the LPH exposure to correct uneven density in the cross process direction that arose due to various causes in the vicinity of the Drum for each YMCK color individually.

The LPH Exposure Amount Adjustment can be performed as negative correction within the range of 0 to -20 (%).

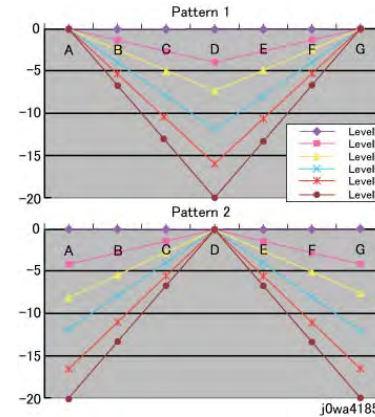
Figure 3 Patterns 1 and 2 selection

The selected Pattern (Table 4) and Level (Table 5) are reflected as LPH Brightness Correction by changing the following NVM values.

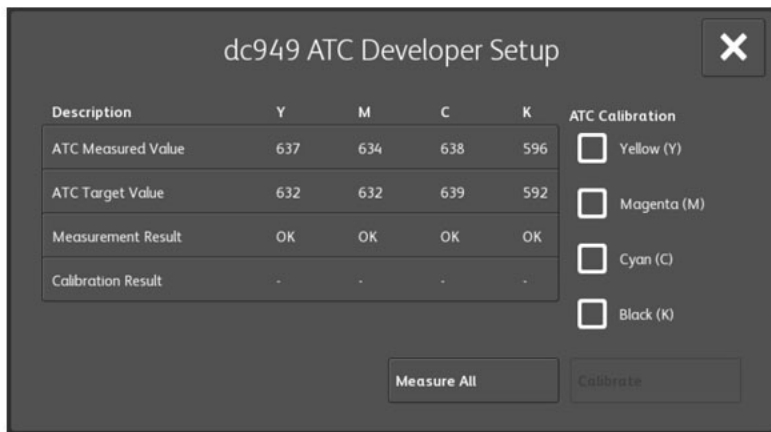
Figure 2 Measurement Result OK

4. Select the **Measure All** button. When the measurement process completes, check the display. (Figure 2)
 - If any colors are showing a **Measurement Result** that is not **OK**, continue with step 5.
 - If all colors are **OK**, the process is complete.

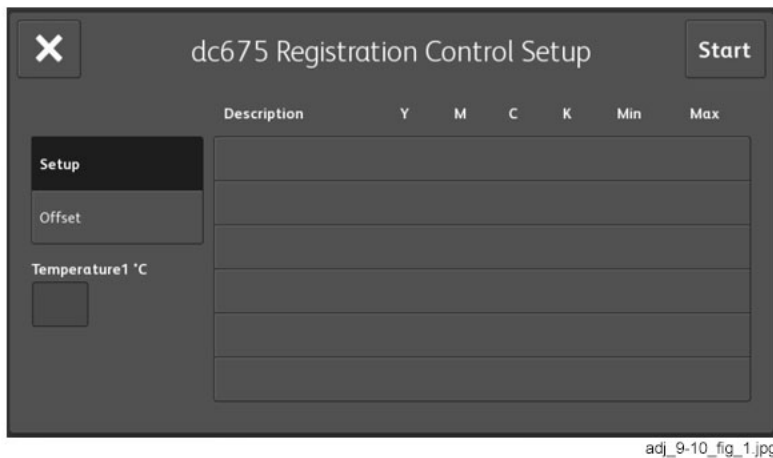
Figure 1 dc975 Registration Control Setup screen

1. Enter **Service Diagnostic Mode**.
2. Select **Adjustments**.
3. Select **dC675 Registration Control Setup...**
4. Select **Setup** . (Figure 1)
5. Select **Start** . (Figure 1)

The shift amount for each color is corrected automatically.

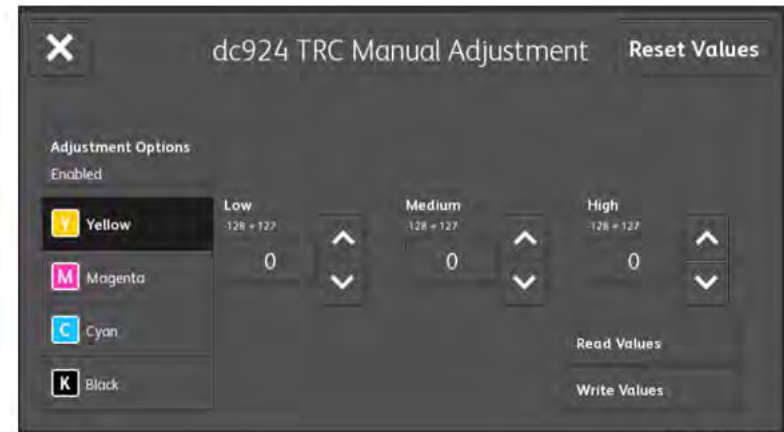
Figure 1 dc924 TRC Manual Adjustment screen

2. Print 2 copies of the customer file that they are using as their image quality standard and mark them "Before."
3. Enter [Service Diagnostic Mode](#).
4. Select **Adjustments**.
5. Select **dC919 Color Balance Adjustment...** and perform the following:
 - a. Press the **Read Values** button, and read the low, medium and high density values for C M Y and K. If all values are zero, proceed to step 7.
 - b. Record any values that are not zero.
 - c. Select Reset Values.
6. Close dC919 and select dC924.
7. Select **Adjustment Options > Enabled** . ([Figure 1](#))

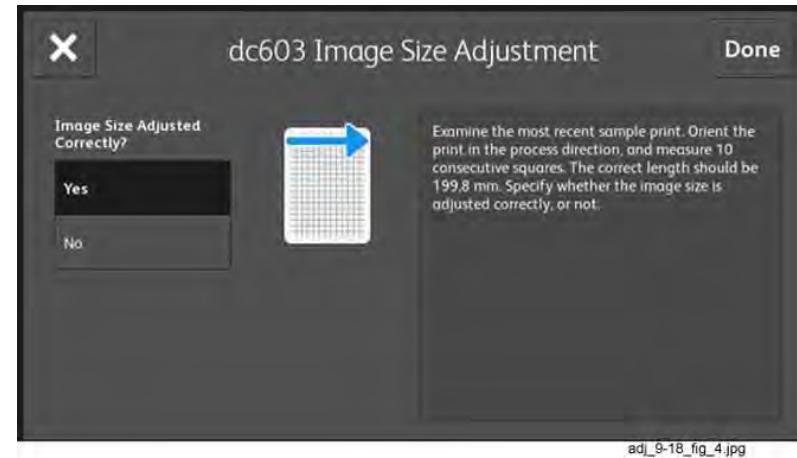
Figure 2 Image Size OK

- Total range of adjustment is -1.0mm to +1.0mm. The actual range of adjustment is limited by the current setting.
 - Successful adjustment is indicated with a message in the upper left corner of the UI.
1. If the measurement was not within specification, select **No** (Figure 2).

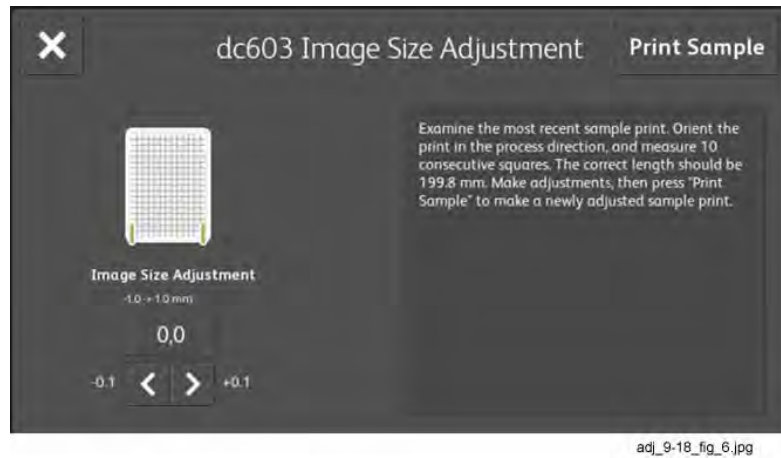
Figure 4 Adjust Image Size

3. Enter the required amount of adjustment using the arrow buttons, then select the **Print Sample** button (Figure 4).

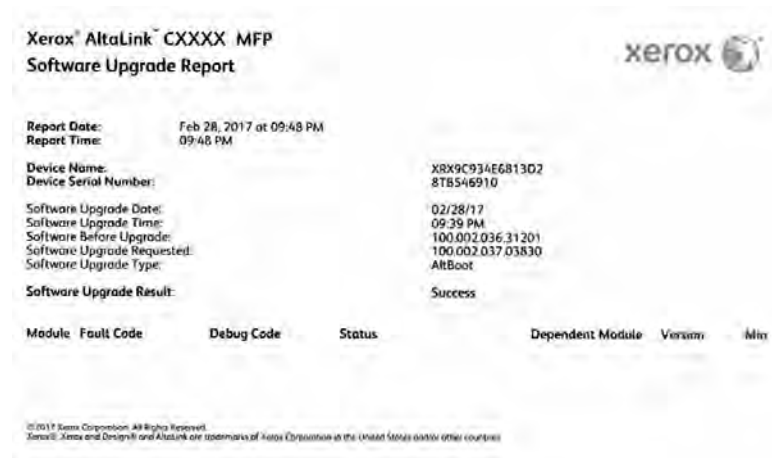
Figure 1 Software Upgrade Report

6. Do not remove the USB drive until the message **Software upgrade is completed** displays on the UI.
7. The system upgrade process may take up to 60 minutes to complete.
8. If the process fails, use a Forced AltBoot procedure to recover.
9. The system reboots several times before returning to a ready state.
10. After the software has upgraded, a software upgrade report prints. (Figure 1)

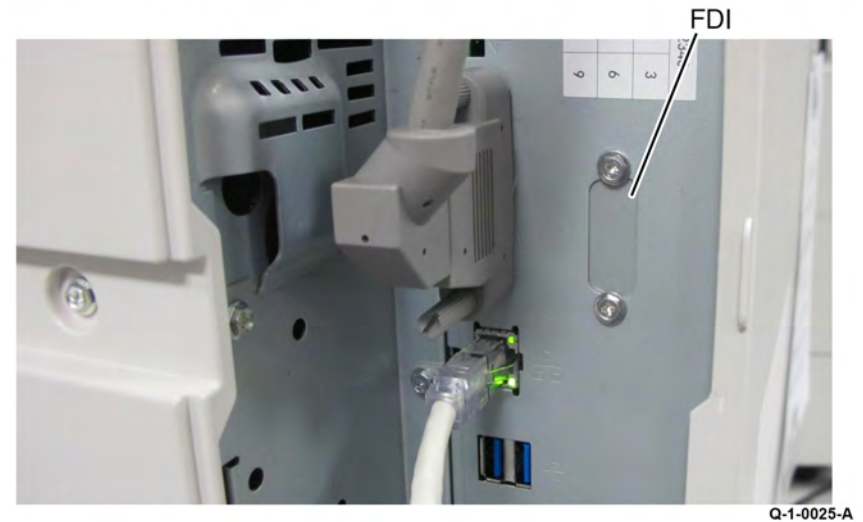
Q-1-0025-A

Figure 1 FDI cut out cover

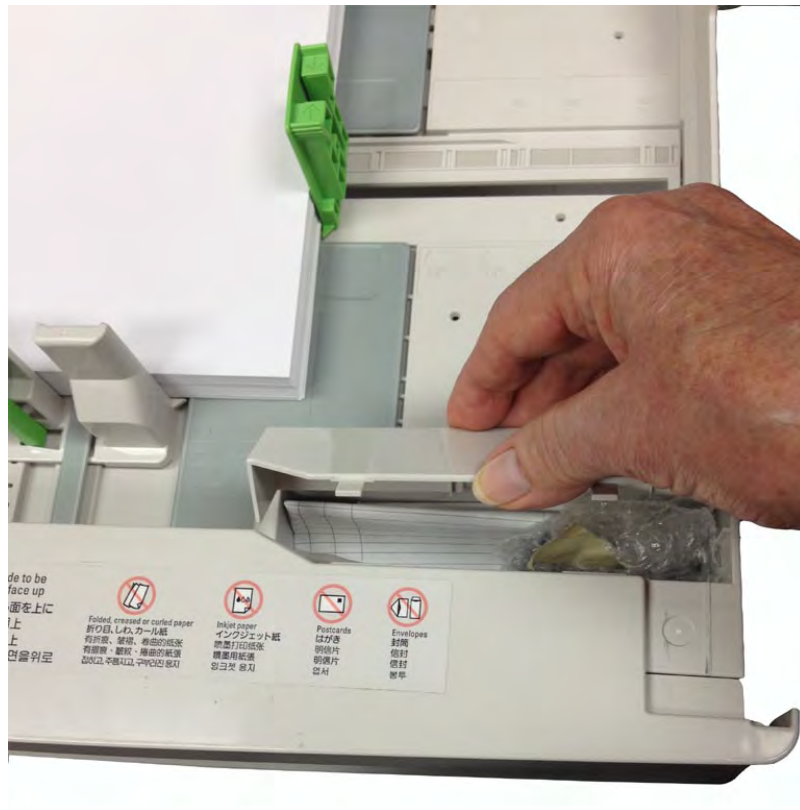
During some service procedures it may be necessary to restore NVM to the original factory settings. This can be done using the values entered on the NVM Setting Value List stored in the compartment located in the front right corner of Tray 1.

Figure 1 Tray 1 Storage Compartment

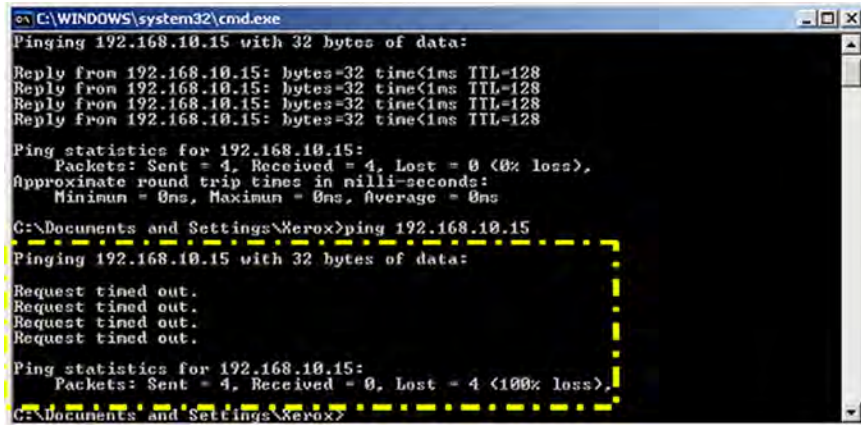
6. If the ping command is unsuccessful, a timed out message will be received, [Figure 2](#).

C:\WINDOWS\system32\cmd.exe
Pinging 192.168.10.15 with 32 bytes of data:
Reply from 192.168.10.15: bytes=32 time<1ms TTL=128
Reply from 192.168.10.15: bytes=32 time<1ms TTL=128
Reply from 192.168.10.15: bytes=32 time<1ms TTL=128
Reply from 192.168.10.15: bytes=32 time<1ms TTL=128

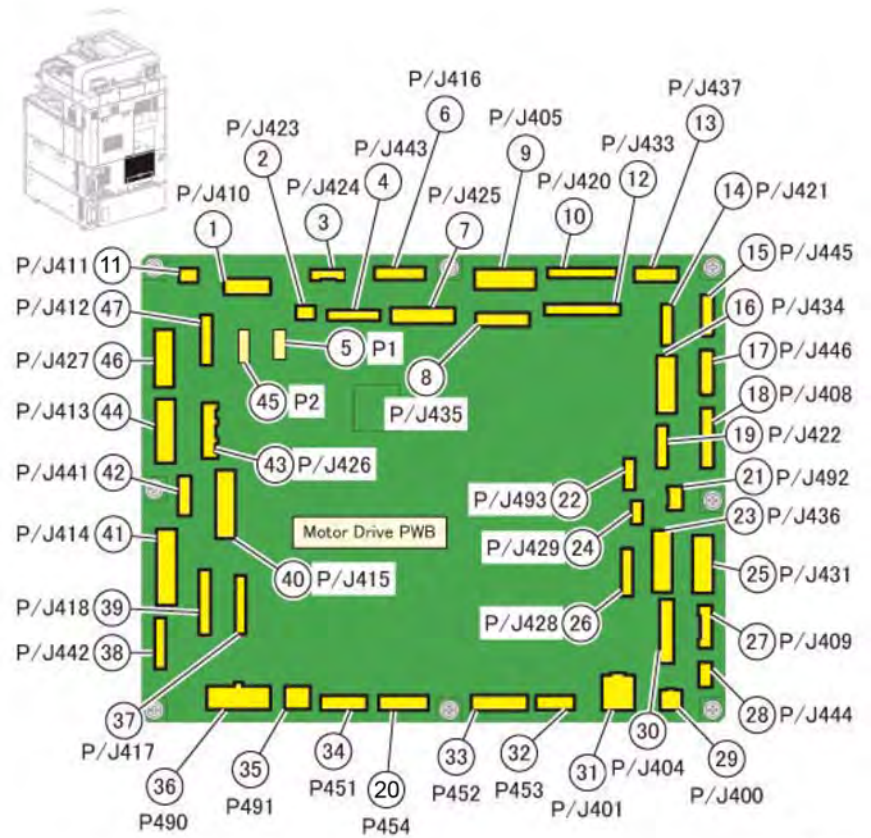
TQ-1-0257-A

Figure 4 Motor Drive PWB

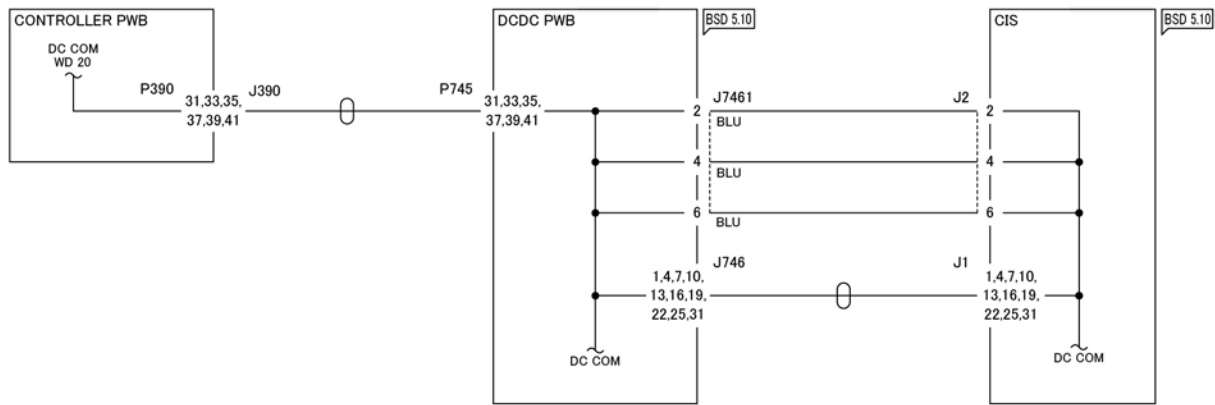
Figure 1 Wiring Diagram 44 DADF 250 Return (2 of 2)

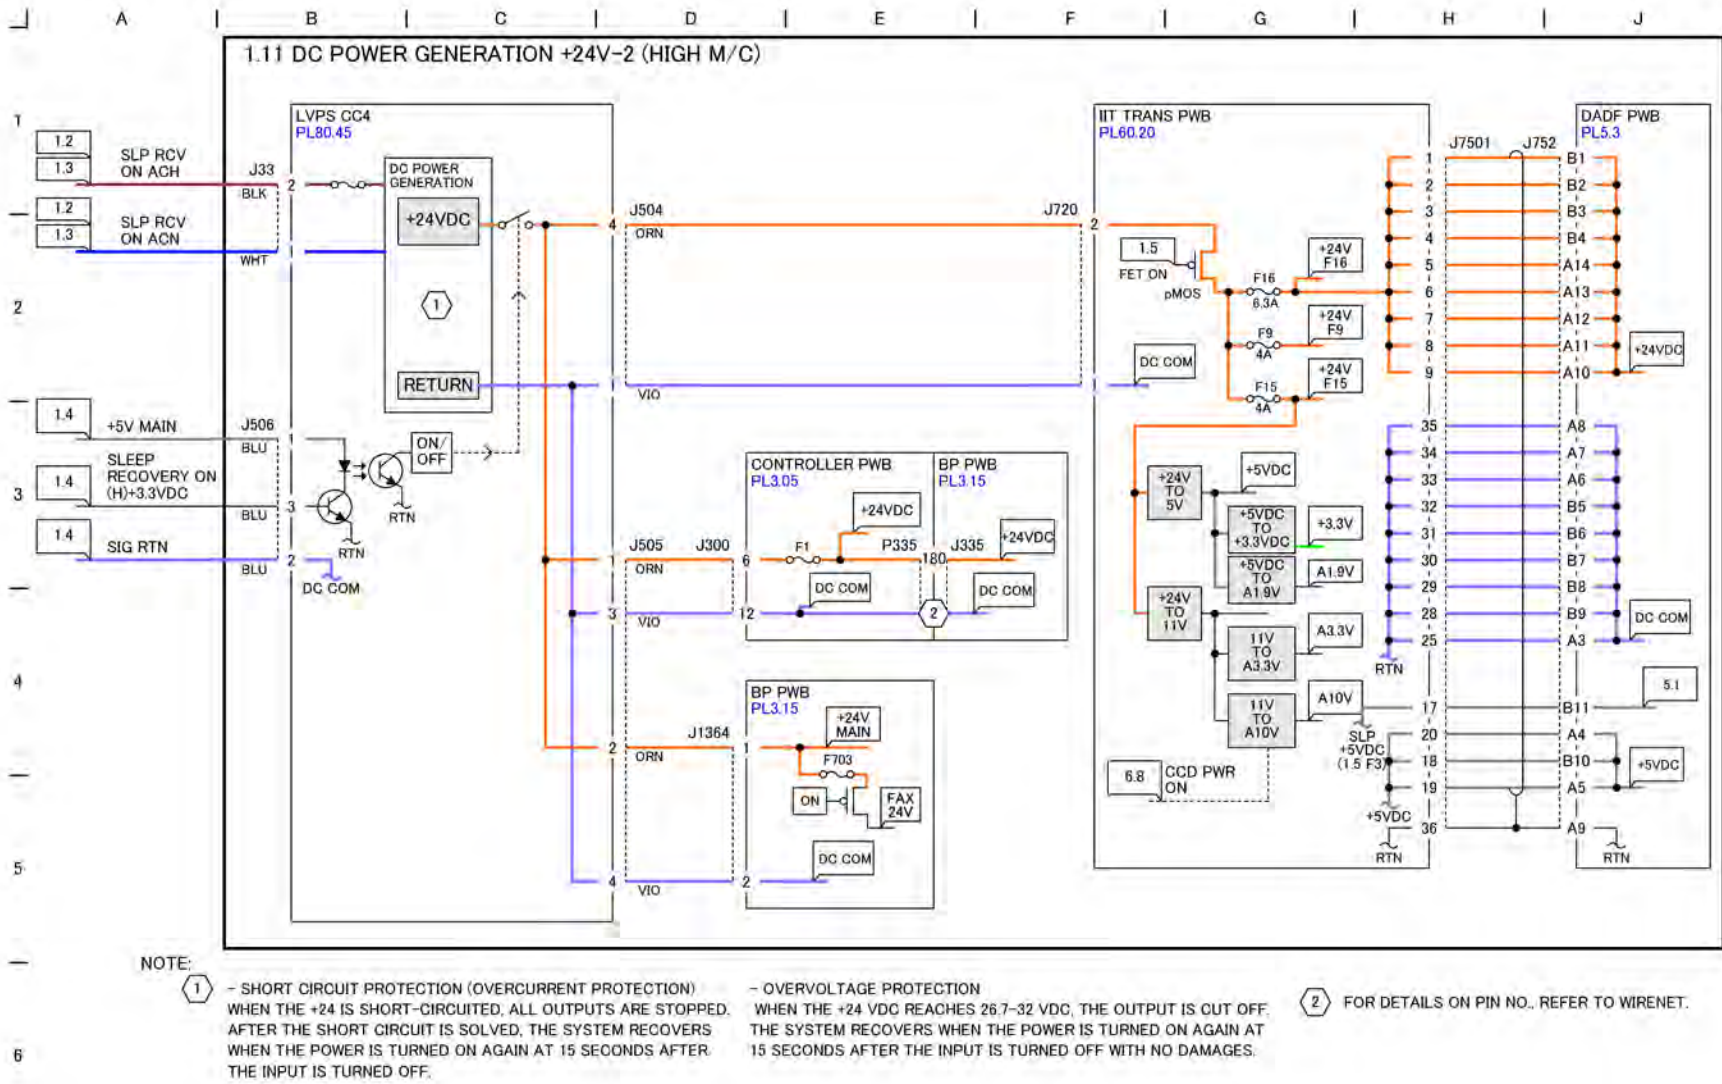
Figure 1 BSD 1.11 DC Power Generation +24V (2 of 2) (High)

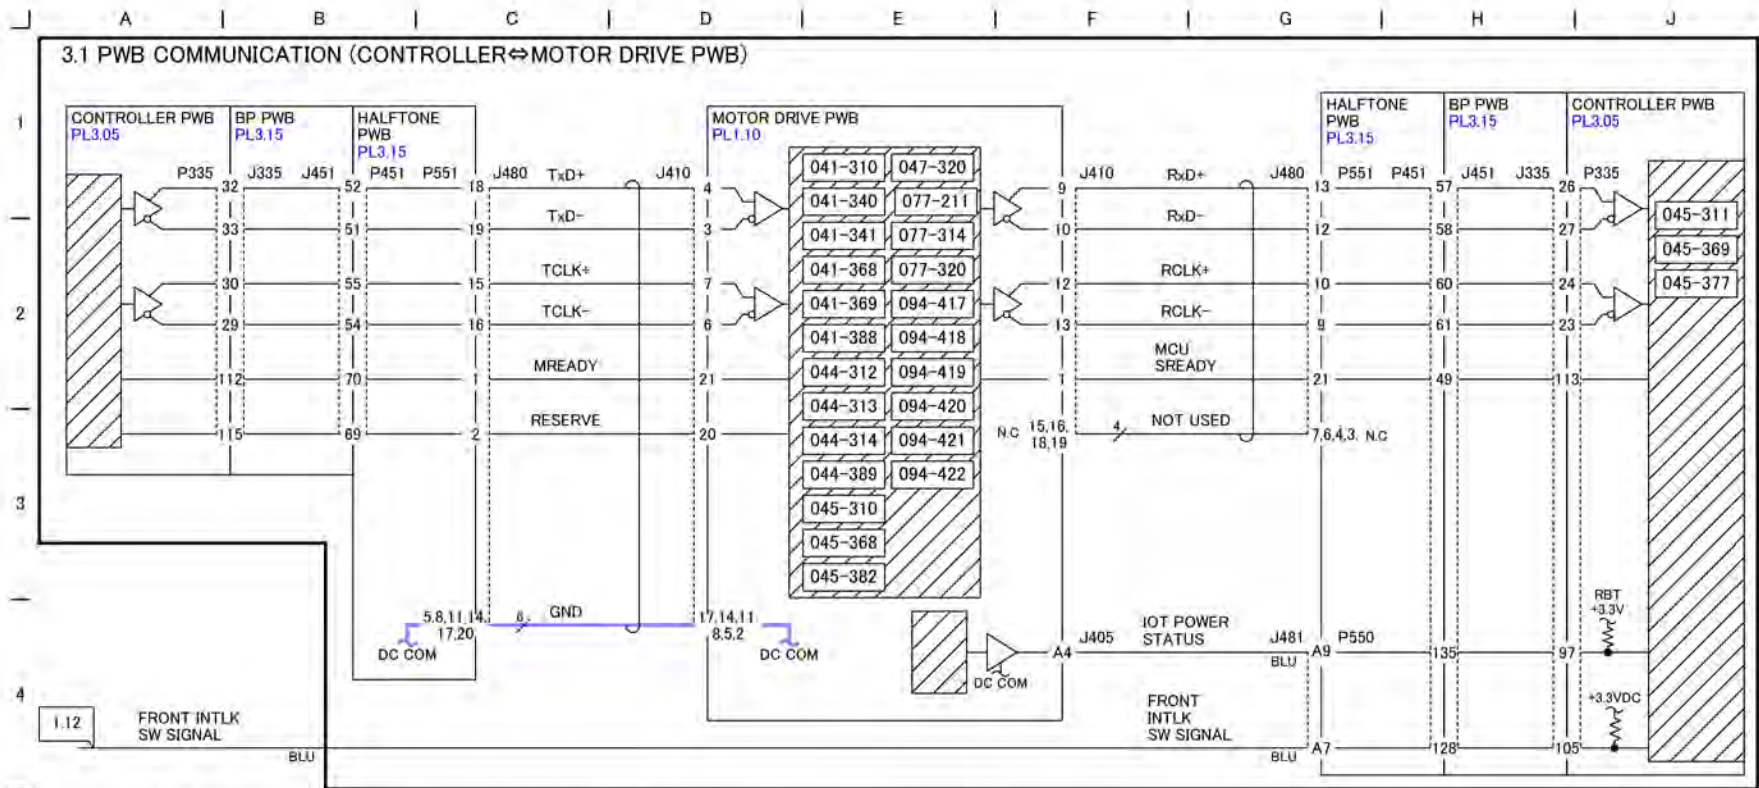
BSD 3.1 PWB Communications (Controller to Motor Drive PWB)

010-617	Fusing Unit Paper Quality Operation Mistake Warning	044-312	MK Timeout Fail	045-382	MCU NVM (EEPROM) Write Verify Fail	094-417	IBT Unit Near End Warning
041-310	IM Logic Fail	044-313	PH Timeout Fail	045-377	SBM Slave Communication Fail	094-418	IBT Cleaner Unit Near End Warning
041-340	MCU NVM (EEPROM) Data Fail	044-314	Pitch Skip Fail	047-320	ALL Destination Tray Broken	094-419	2nd BTR Unit Near End Warning
041-341	MCU NVM (EEPROM) Access Fail	044-389	MK Out put Check Fail	058-335	Fusing Heavy Paper Quality Operation Mistake Fail	094-420	IBT Unit End Warning
041-368	MCU -SW Firmware Mismatch	045-310	Image Ready NG	058-337	Fusing Unit Paper Quality Operation Mistake Fail	094-421	IBT Cleaner Unit End Warning
041-369	MD Type Mismatch	045-311	Controller Communication Fail	077-211	Tray Module Kind Mismatch	094-422	2nd BTR Unit End Warning
041-388	Marking Logic Fail	045-368	SBM Initialize Fail	077-314	PsurasshuH Module Logic Fail

045-369	SBM Master Communication Fail	077-320	All Feed Tray Broken Fail

Figure 1 BSD 3.1 PWB Communication (Controller to Motor Drive PWB)

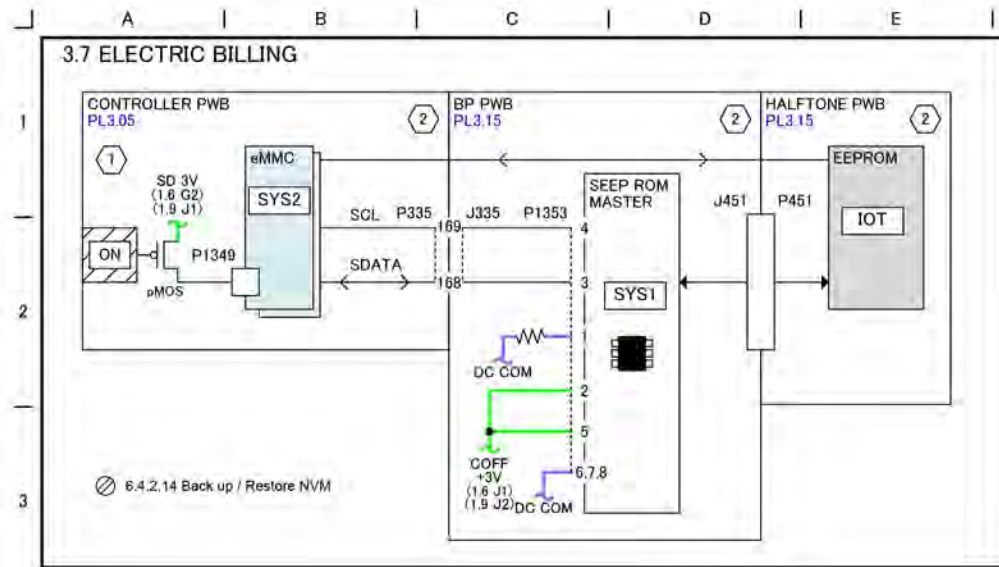
024-600	124-314	124-324
024-601	DC132 01	All Billing Mismatch
024-602	124-315	124-325
024-603	DC132 02	Billing Restoration Fail
024-604	124-316	
024-605	DC132 03	
124-310	124-317	
DC132 11	DC132 04	
124-311	124-318	
DC132 09	DC132 07	
124-312	124-319	
DC132 12	DC132 08	
124-313	124-322	
DC132 10	DC132 05	
	124-323	
	DC132 06

- When HALFTONE PWB is replaced
- When CONTROLLER PWB is replaced
- When BP PWB is replaced
- When Fail Code [124-324] (count value is different for 3) has occurred
- When Fail Code [124-325] (failed to automatically restore count value) has occurred

2 Only 1 PWB can be replaced.
It is not possible to replace 2 or more PWBs at the same time.
(3 errors can not be recovered by market.)

Figure 1 BSD 3.7 Electric Billing

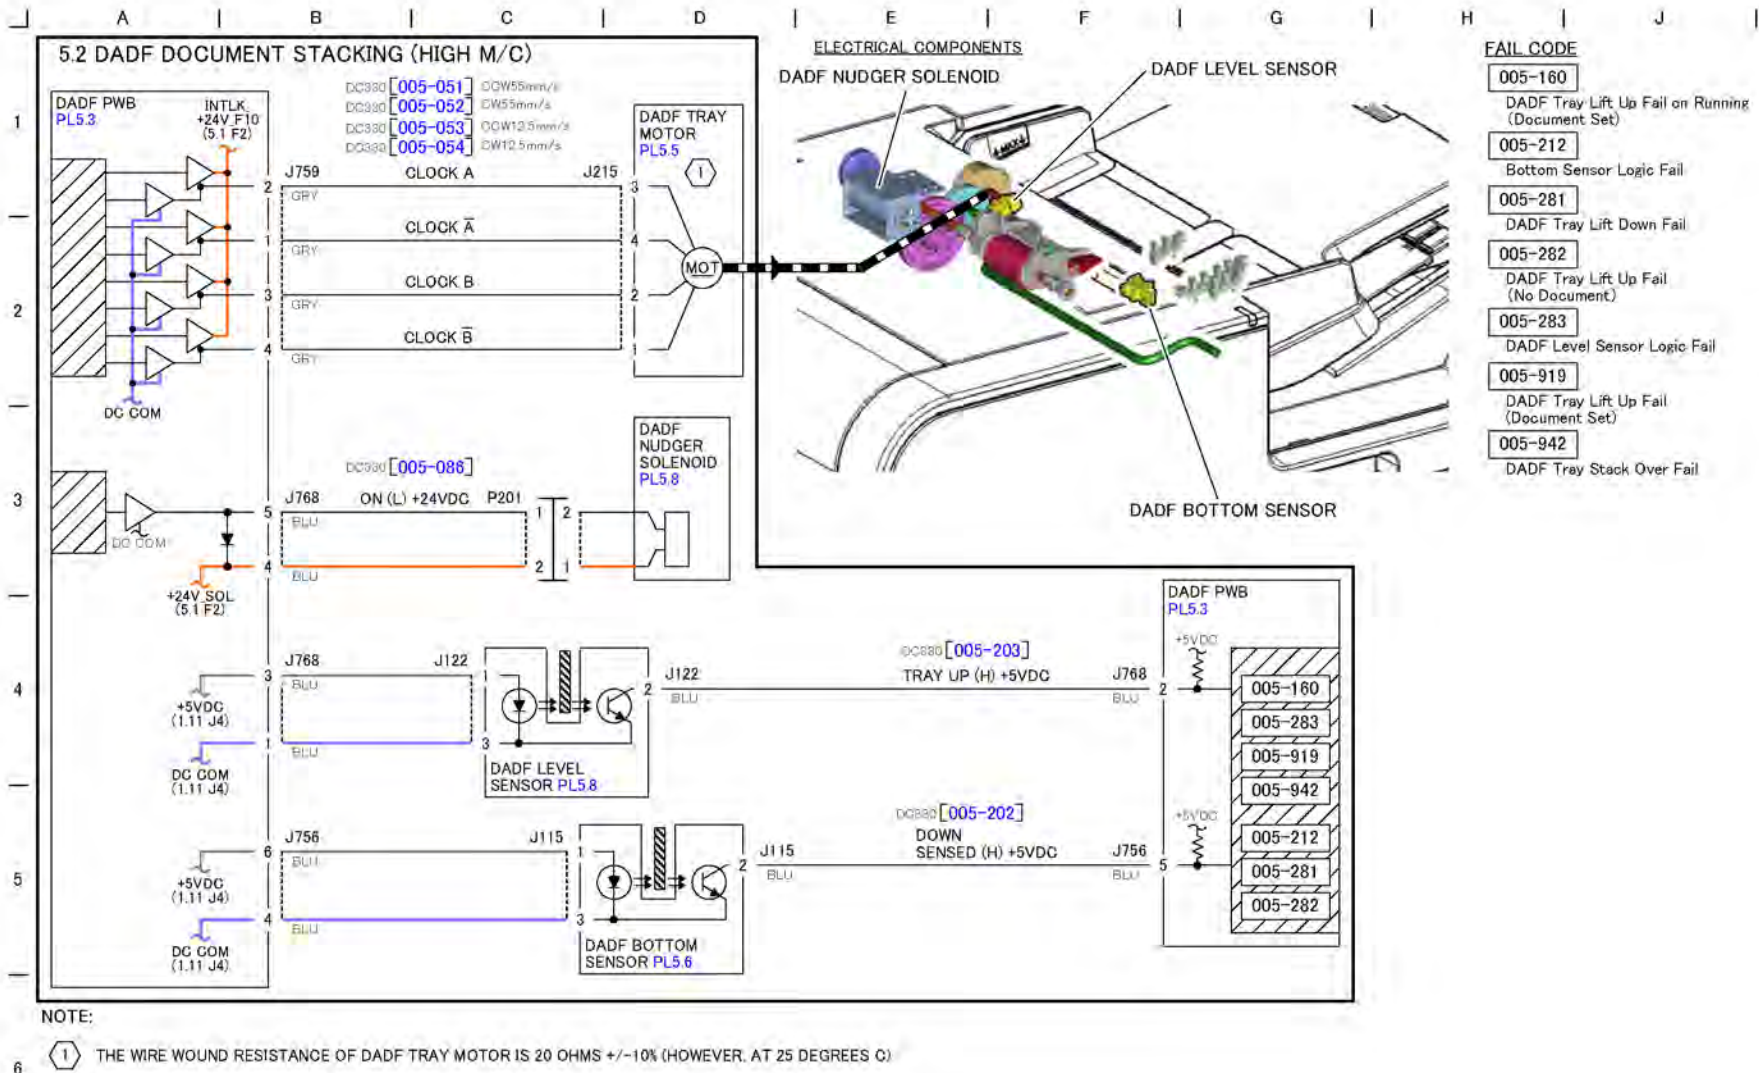
Figure 1 BSD 5.2 DADF 250 Document Stacking

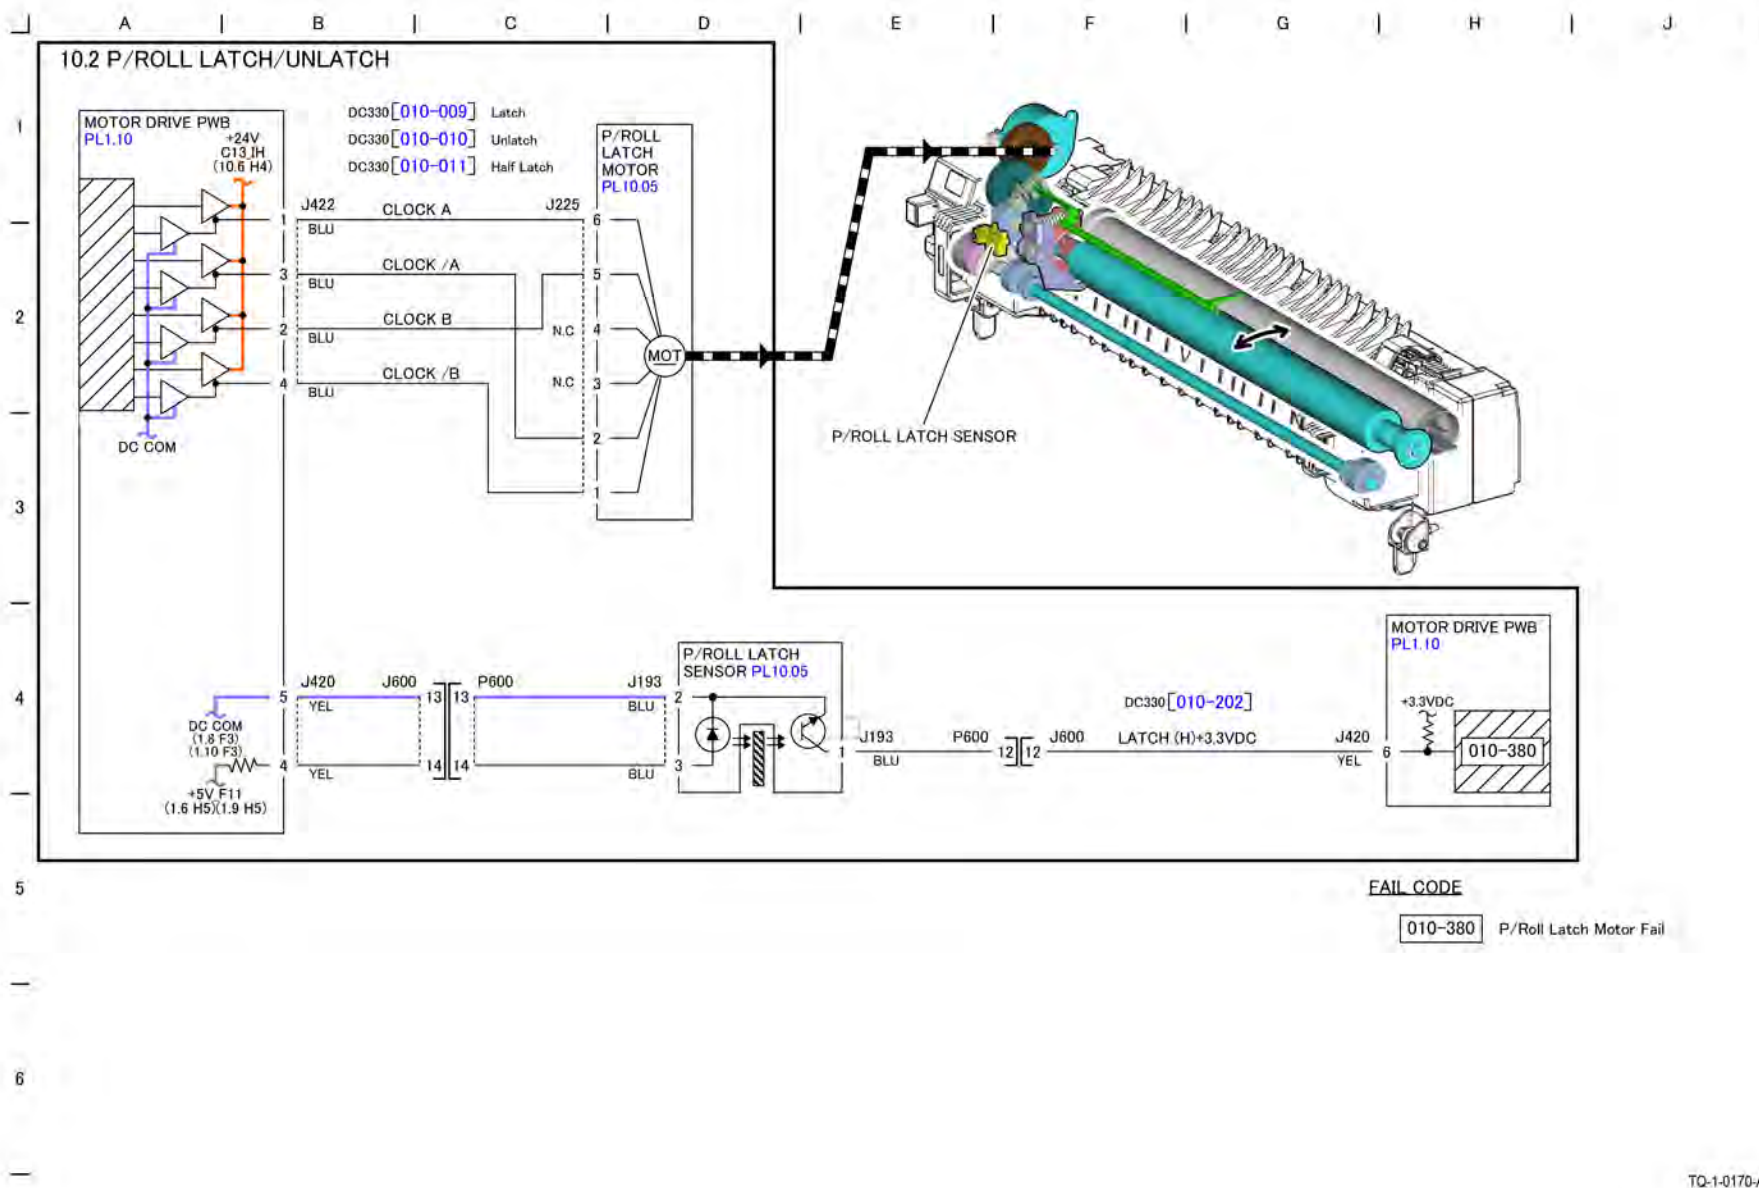
Figure 1 BSD 10.2 Pressure Roll Latch/Unlatch

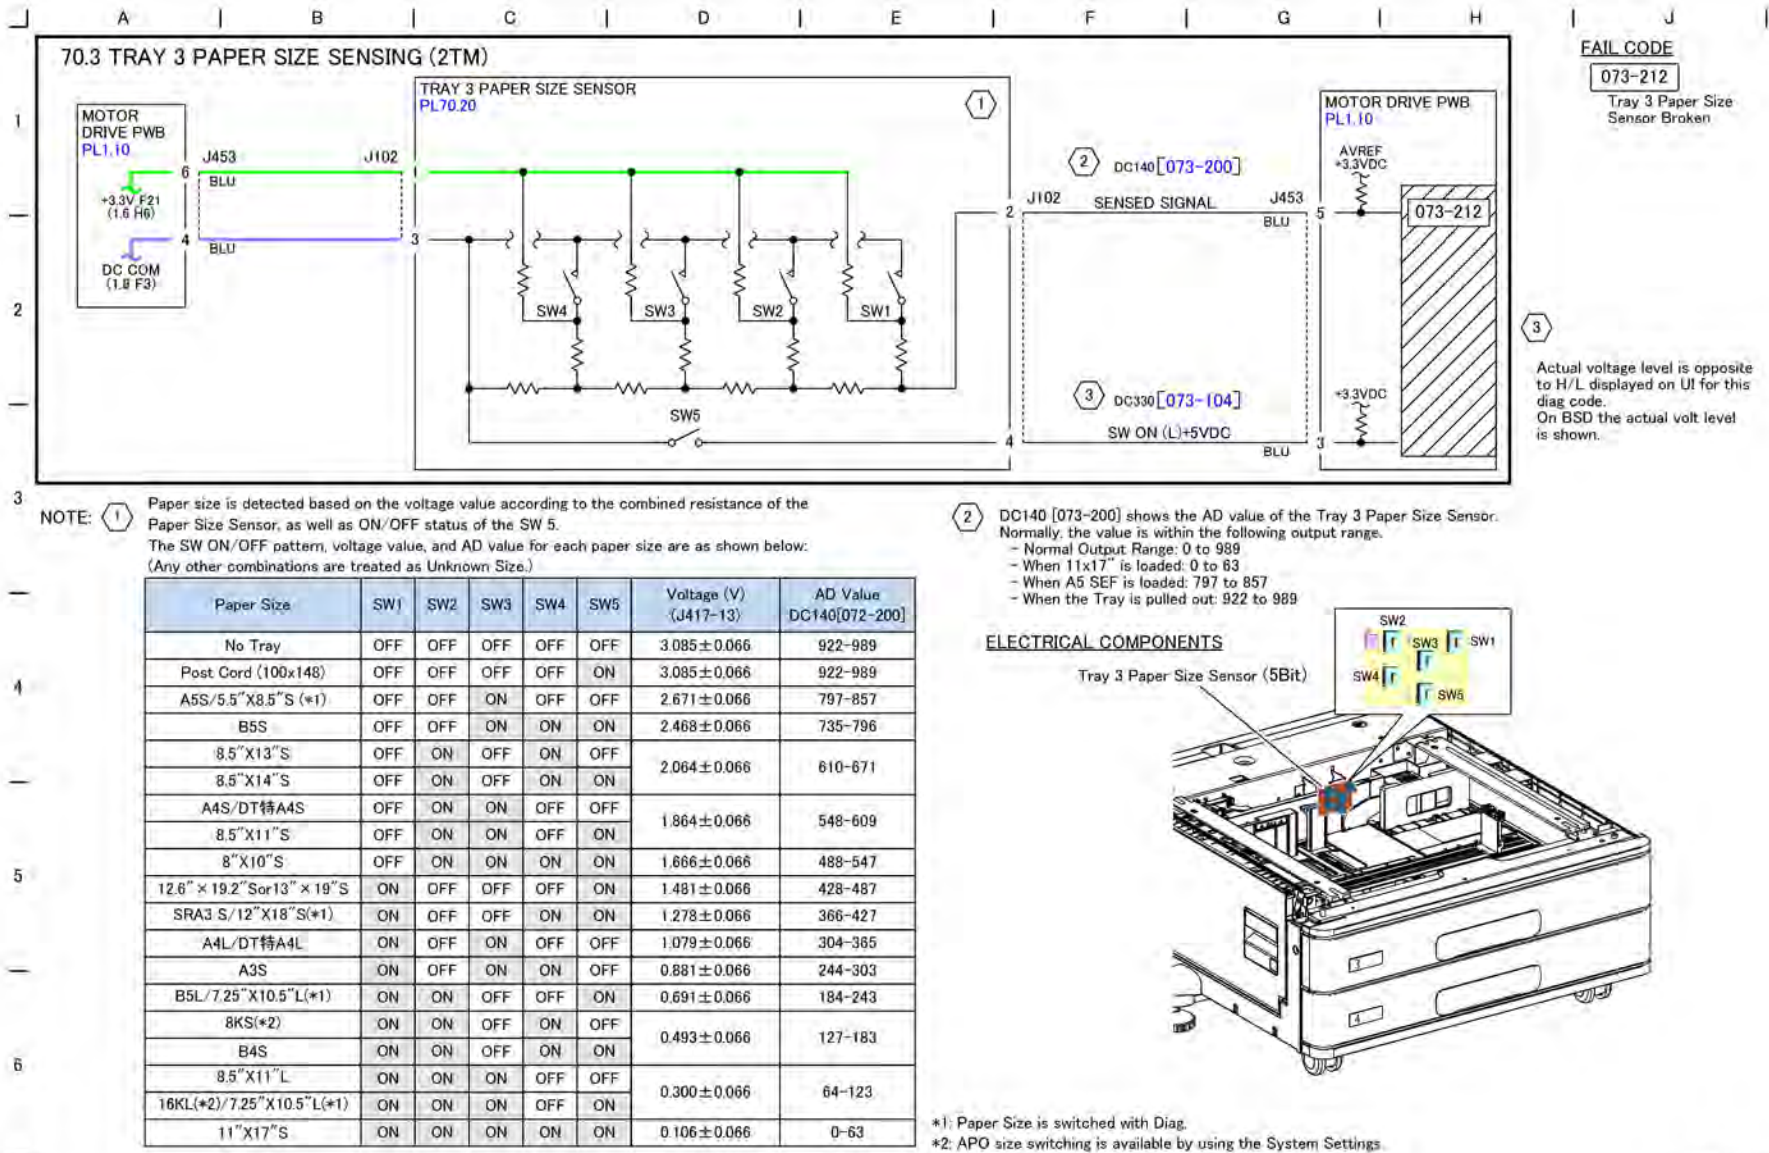
Figure 1 BSD 70.3 Tray 3 Paper Size Sensing (2TM)

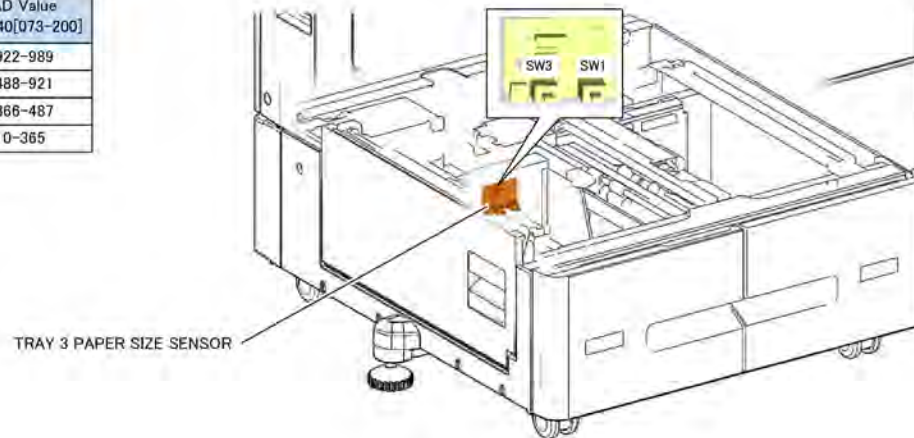
NOTE: ① Paper size is detected based on the voltage value according to the combined resistance of the Paper Size Sensor. The SW ON/OFF pattern, voltage value, and AD value for each paper size are as shown below. (Any other combinations are treated as Unknown Size.)

Paper Size	SW1	SW3	Voltage (V) (J453-5)	AD Value DC140[073-200]
No Tray	OFF	OFF	3.085 ± 0.066	922-989
B5L/7.25"X10.5"L(*1)	OFF	ON	2.671 ± 0.066	488-921
8.5"X11"L	ON	OFF	1.481 ± 0.066	366-487
A4L	ON	ON	1.079 ± 0.066	0-365

- Normal Output Range: 0 to 989
- When A4 LEF is loaded: 0 to 365
- When 8.5x11" is loaded: 366 to 487
- When B5 LEF is loaded: 488 to 921
- When the Tray is pulled out: 922 to 989

Figure 1 BSD 70.4 Tray 3 Paper Size Sensing (TTM)

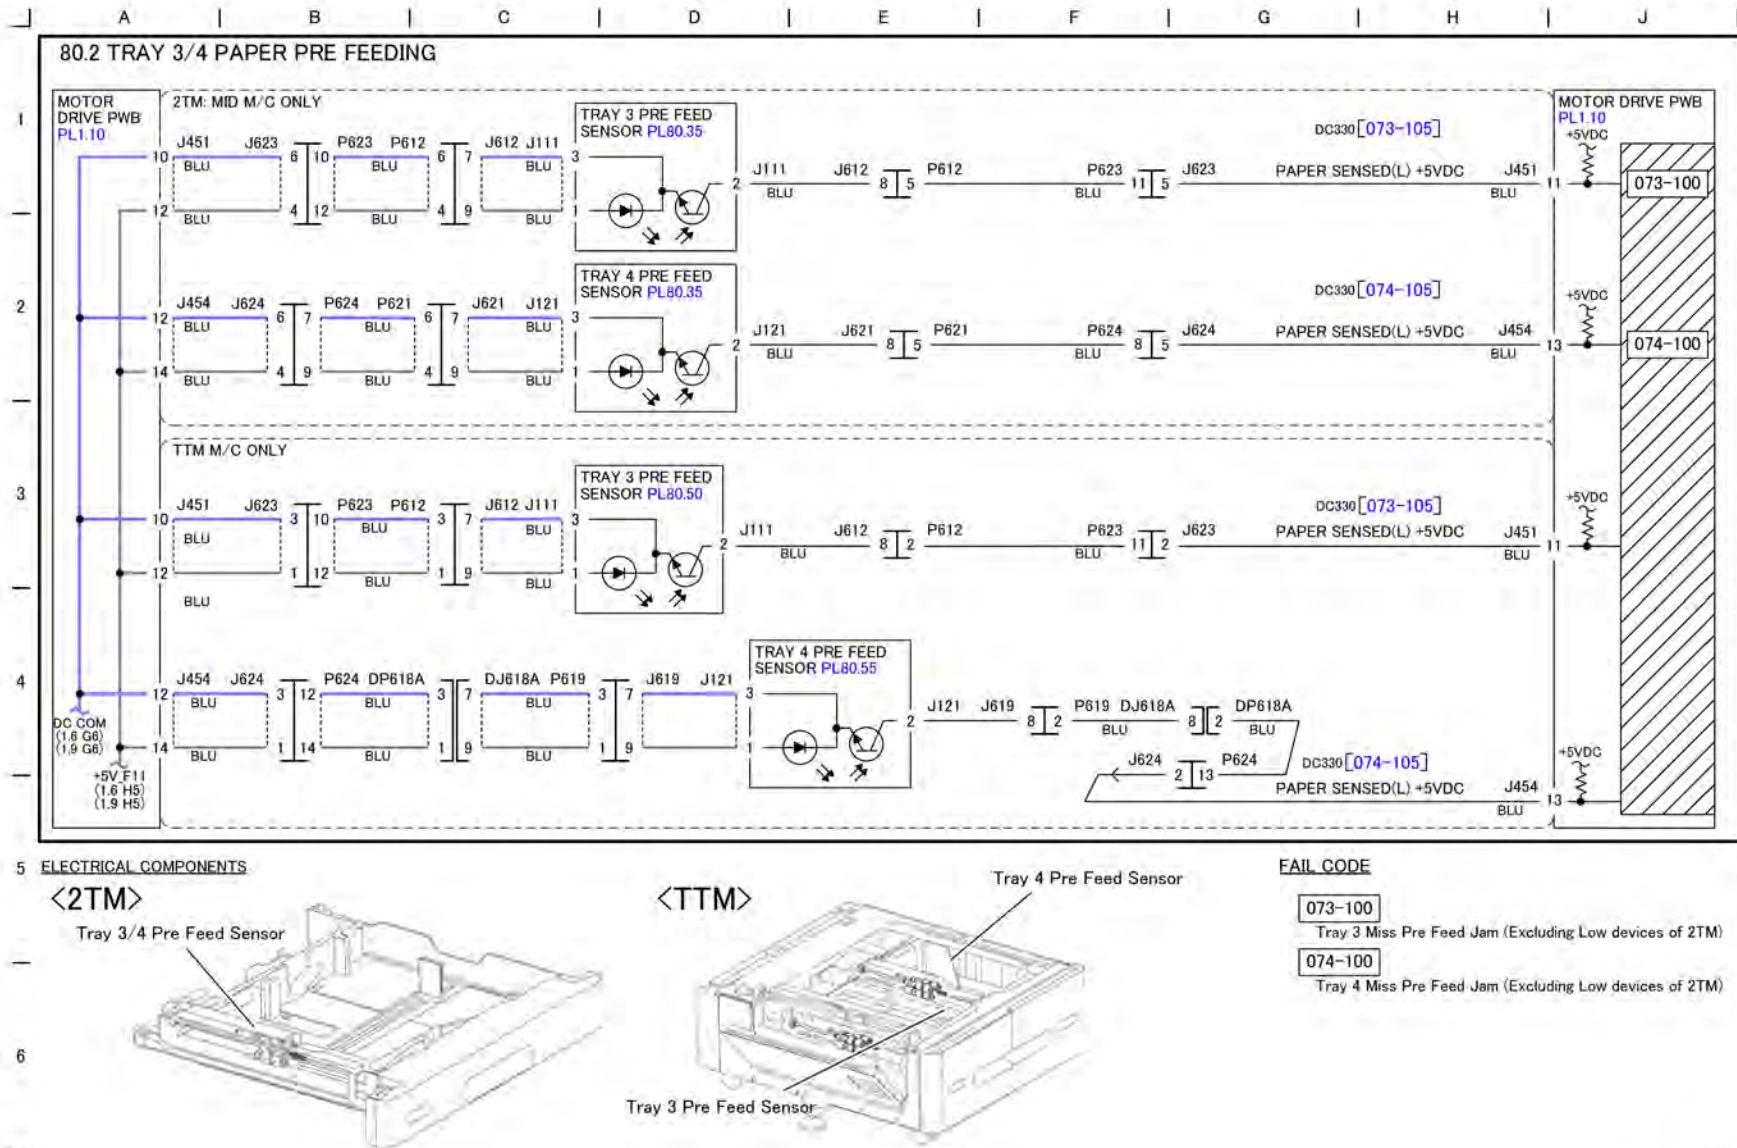
Figure 1 BSD 80.2 Tray 3 and 4 Paper Pre-Feeding

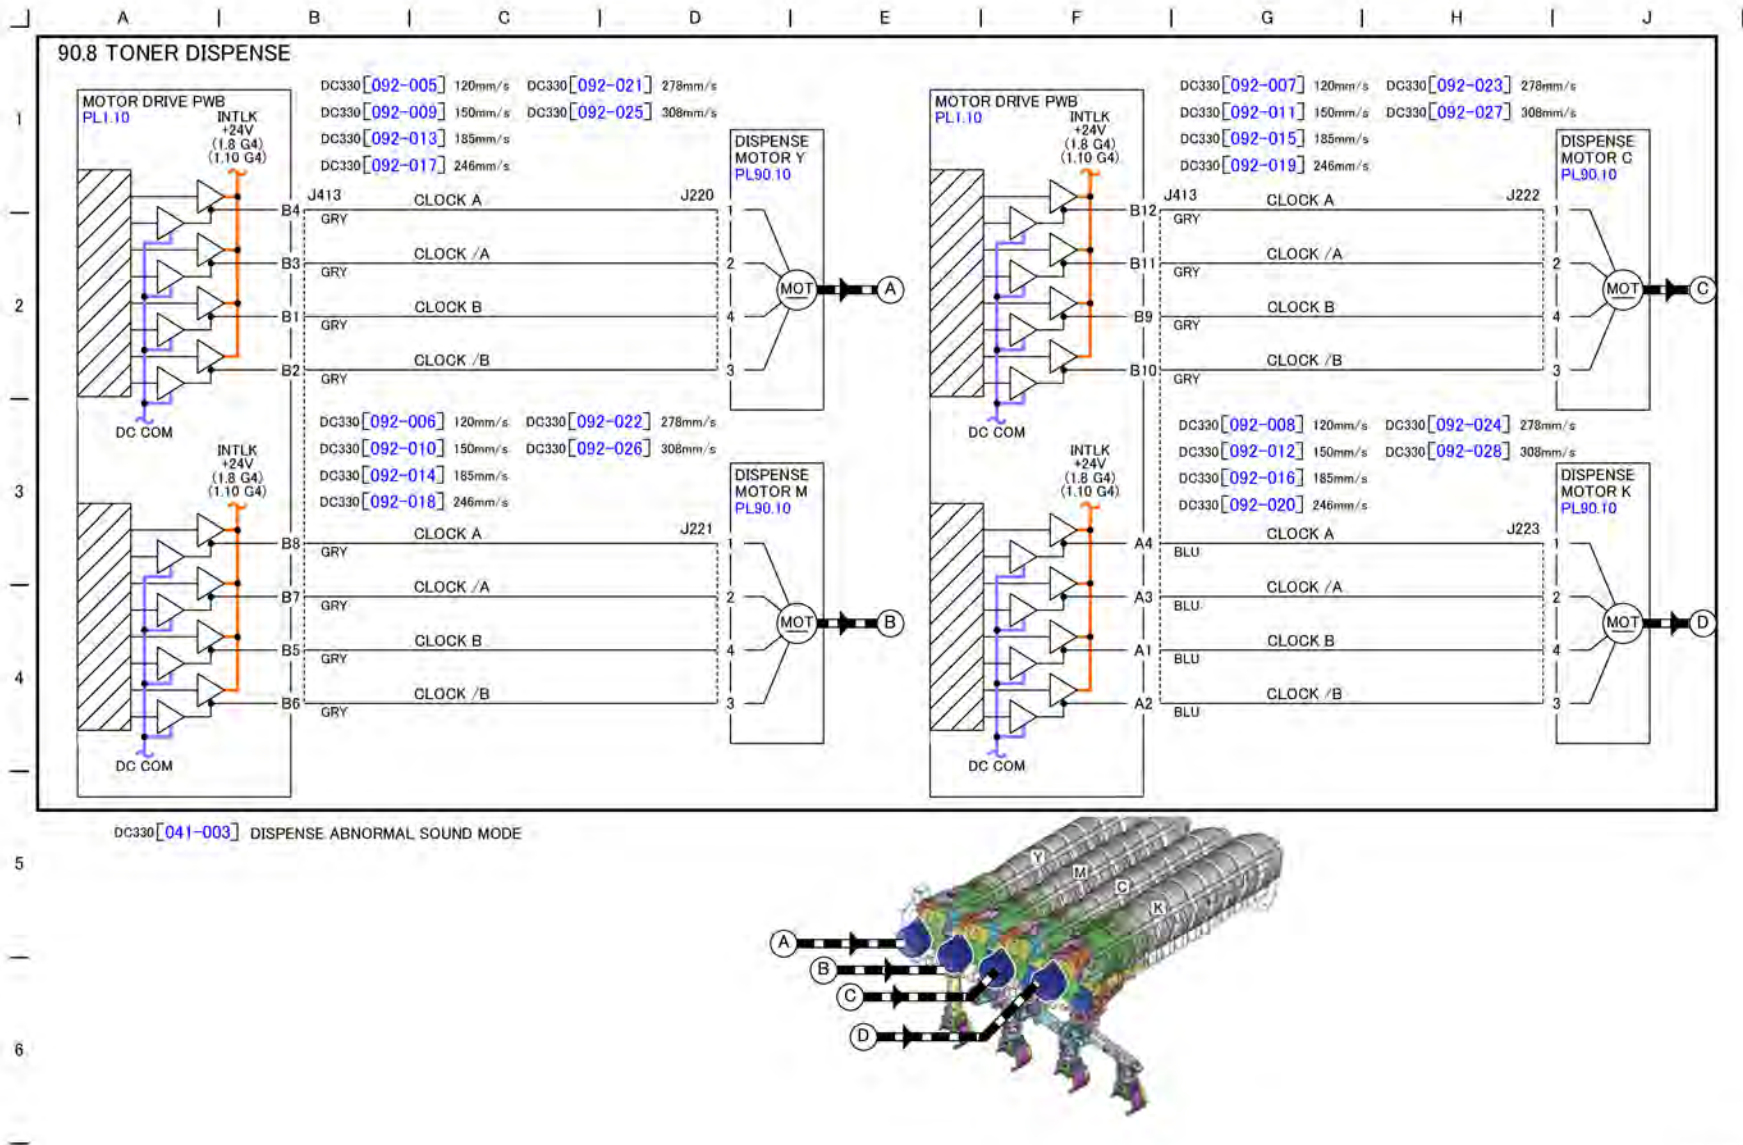
Figure 1 BSD 90.8 Toner Dispense

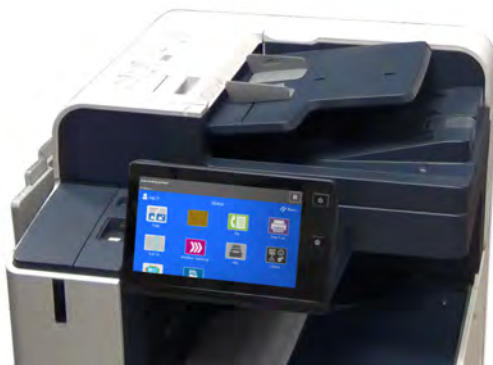
P-1-0002

Job programming and other user functions are controlled from the User Interface (UI), which uses two forms of input: the touch screen and the panel buttons. These buttons and screens are used to perform user and service activities.

Figure 4 User interface

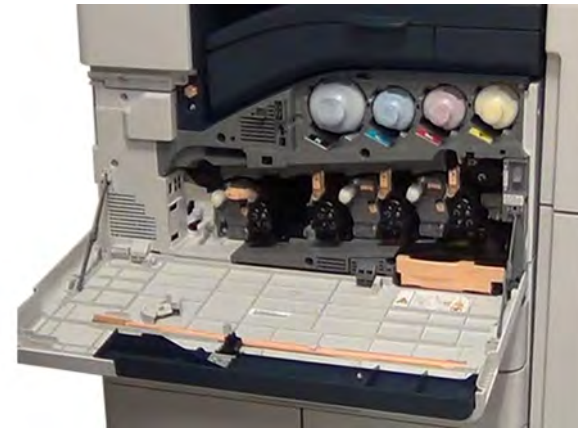
P-1-0003

The Drum Cartridge Module is located under the Toner Cartridges. It contains the four Drum Cartridges that are customer replaceable and the four Developer Modules that are not customer replaceable.

Figure 5 Xerographics section

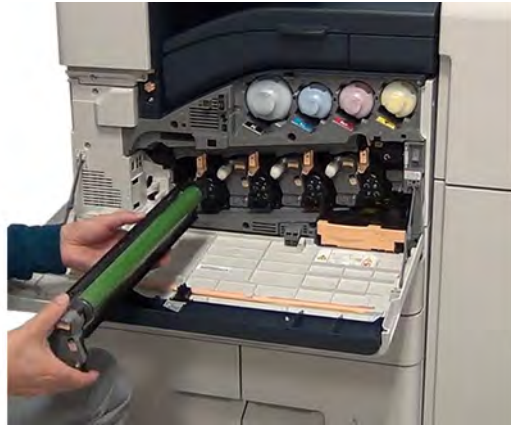
P-1-0004

Each drum is charged by a Bias Charge Roll (BCR).

Figure 6 DRUM cartridges
