Xerox® AltaLink® C8170F Service Manual

705P01438

Initial Issue

May 2020

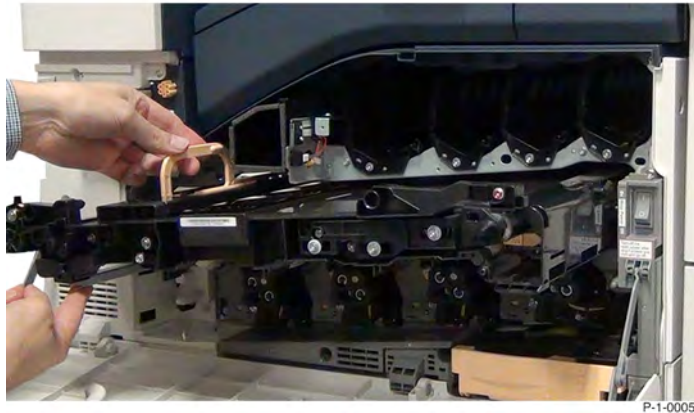
P-1-0005

The developed image from each of the four (C, M, Y, and K) photoreceptor drums is applied to the Intermediate Belt Transfer Assembly (IBT) as a complete registered image. The image is then transferred from the IBT to the registered paper at the second Bias Transfer Roll (BTR).

Figure 7 Image transfer belt (IBT) assembly

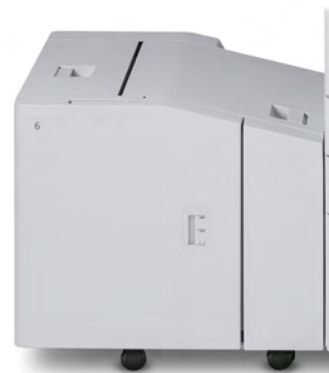
P-1-0011

- 3000 sheets of 8.5x11 in. media (A4)

Figure 10 High capacity feeder

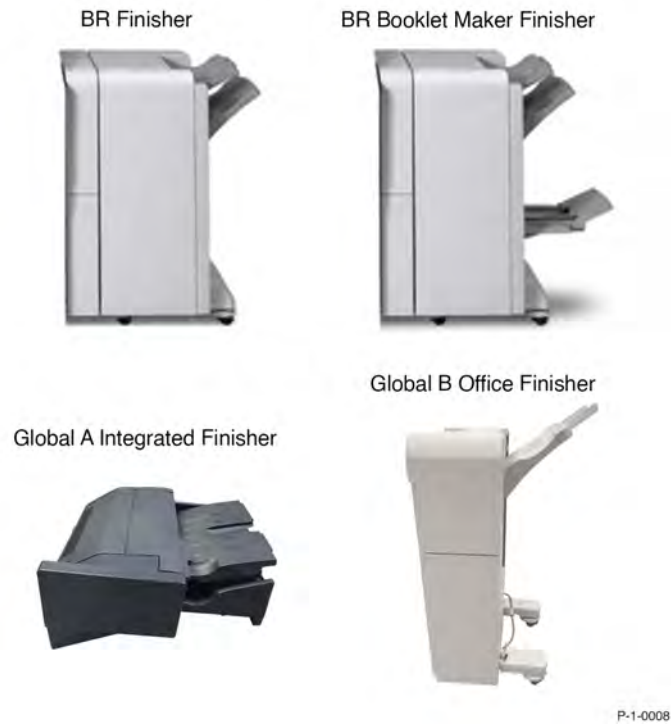
- Stacking: 2000 sheets unstapled, 1000 sheets single-stapled, or 250 sheets dual-stapled. Multiple-position stapling: 50 sheets. Hole Punch: Optional 2–3 or 2–4 Hole Punch.
- Includes transport module
- Optional Book Creaser and Hole Punch

Figure 11 Finisher options

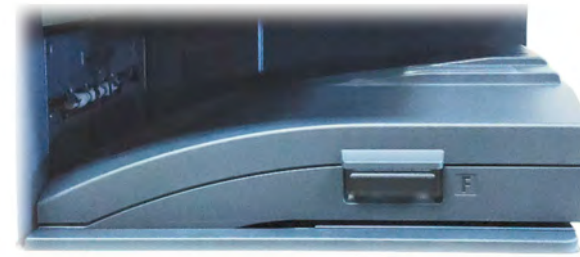
The interface between the IOT and the BR Finishers, and between the IOT and the Global B Office Finisher is called the Horizontal Transport (H-Transport). The H-Transport moves the print from the output of the IOT to the input of the finisher. There are two different models of H-Transports. One is used for the BR Finishers and the other is used for the Global B Office Finisher.

Figure 12 Horizontal transport

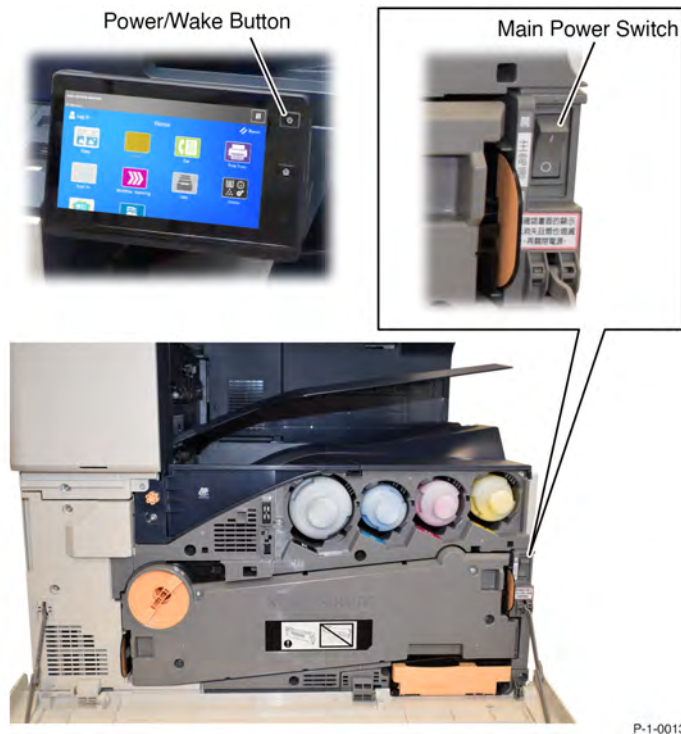
1. Press and release the Power/Wake button on the UI. Wait until the UI is dark.
2. Open the Front Cover Assembly and switch OFF the Main Power Switch.

Figure 2 Power switch locations

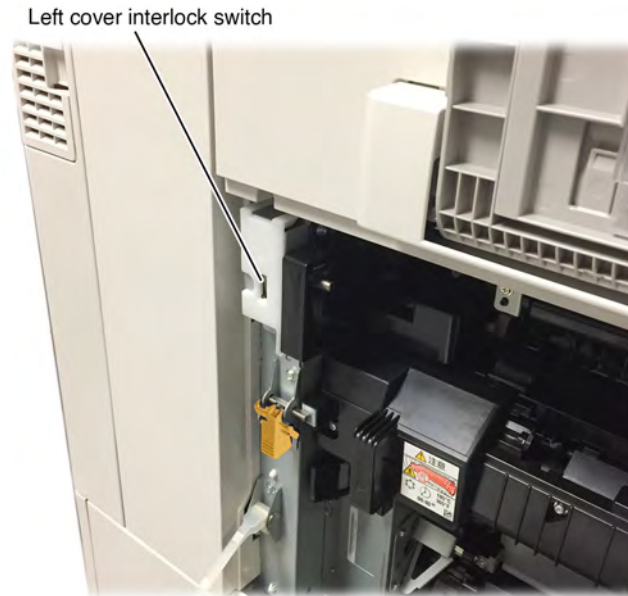
P-1-0022

The left cover interlock switch is monitored by the Motor Drive PWB. It is wired in series with the front cover interlock switch so it cuts power to the 24V interlocked supply.

Figure 11 Left cover interlock switch

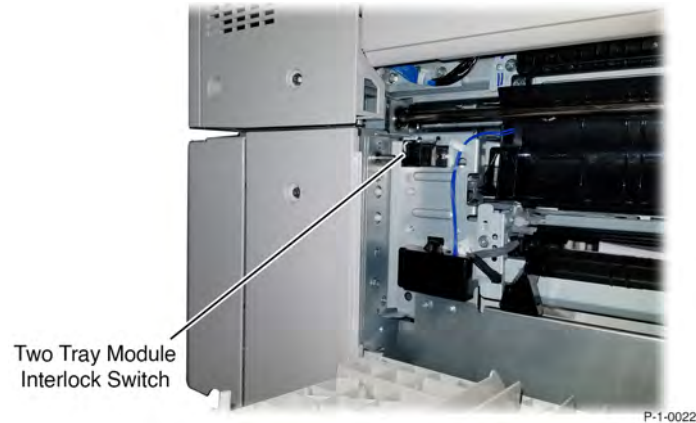
The same circuit is used in the 2TM and the TTM.

Figure 12 Two tray module interlock switch

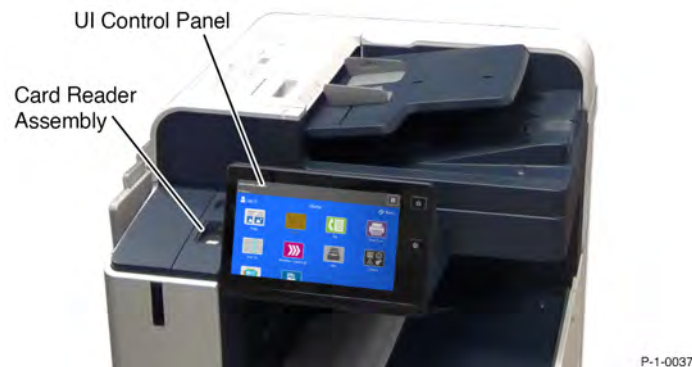
- LCD tablet-like display
- Power button
- Home button
- Card reader assembly
- Customer USB port

Figure 1 User Interface

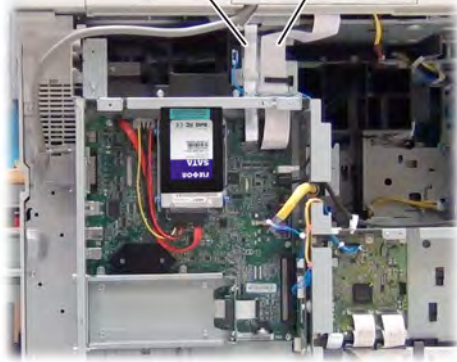
P-1-0133

The IIT Controller I/O Flat Cable is a flat ribbon cable that connects the Scanner CCD PWB to the IIT PWB, and then to the Controller (SBC) PWB. This is a communication cable that communicates commands for scanner control and NVM data transfer. Refer to Figure 10.

CCD Controller Video Flat Cable IIT Controller I/O Flat Cable

Figure 10 IIT Scanner Control and Video Cable

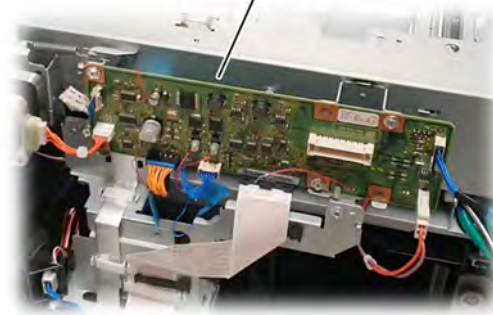
P-1-0135

Figure 12 IIT Transport PWB (Mid/Low)

- It is one of 3 places on the MFP that has a non-removal EEPROM that contains proprietary information, such as machine speed, toner contract and serial number.
- Connects to and provides power to the DADF.
- Connects to the Scanner CCD PWB through the IIT Controller I/O Flat Cable.

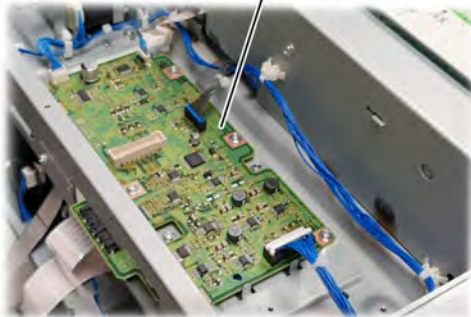
P-1-0134

Figure 11 IIT Transport PWB (High)

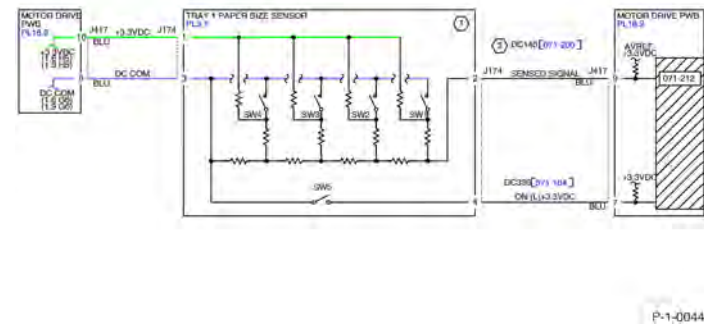
The Motor Drive PWB, detects the paper size from the analog and digital signals generated by the Paper Size Sensors. Different combinations of S/W1 to S/W4 changes the total internal resistance of the Paper Size Sensor circuit, Figure 4.

This changes the corresponding output Analog voltage input to the Motor Drive PWB. The digital signal from S/W5 is sent to the Motor Drive PWB as a high or low signal. Adding a digital signal in this manner has the effect of doubling the number of combinations that can be used for detecting paper sizes. Refer to Figure 4

Figure 4 Paper size sensing signaling

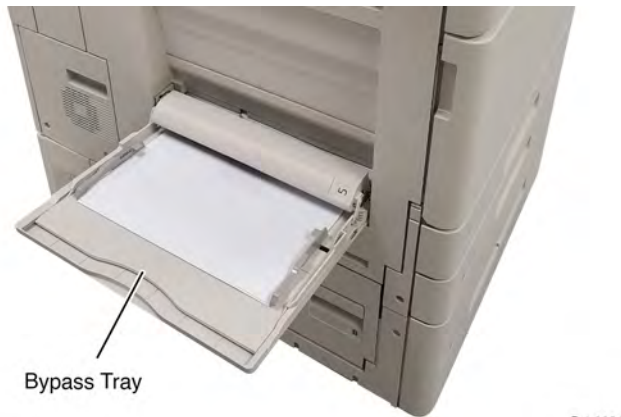
P-1-0051

Figure 14 Tray 5 / Bypass tray location

Tray 5 is located on the left side of the machine and enables feeding of special paper stock and envelopes as well as standard paper stock and sizes. Paper capacity for Tray 5 is 100 sheets of 20lb (75gsm) paper, Figure 14.

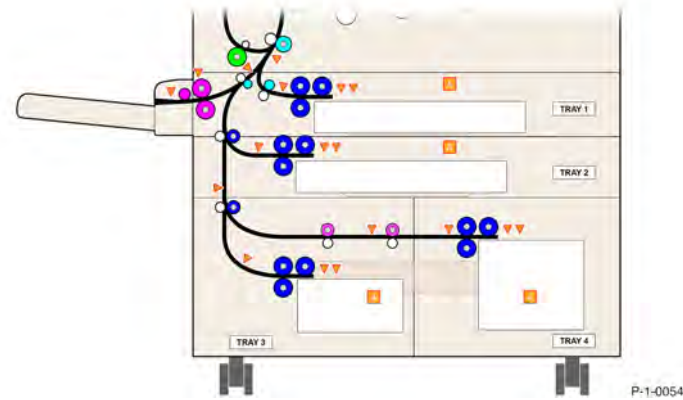
Figure 2 Paper path from TTM configuration

Tray 1 and Tray 2. Refer to [Figure 1](#) or [Figure 2](#).

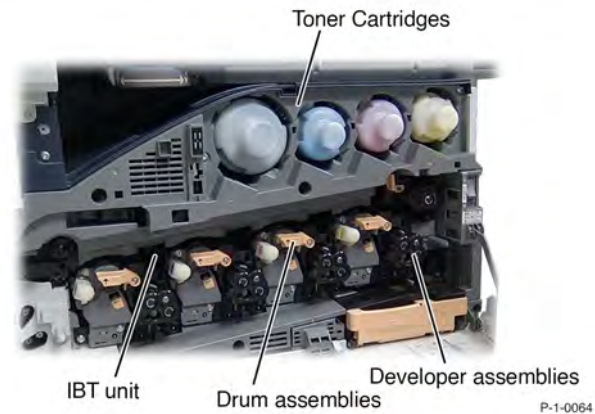
Figure 1 shows the main xerographic components as viewed from the front of the machine, with the waste toner bottle removed.

Figure 1 Main Xerographics components

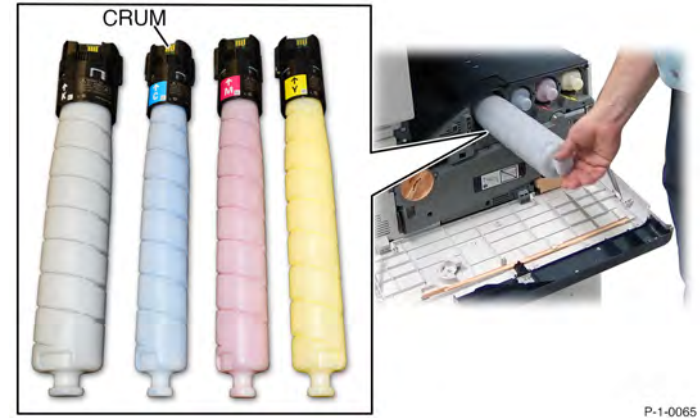
The toner cartridges are customer replaceable units (CRU). The larger black toner cartridge carries a higher capacity of toner than the yellow, cyan and magenta cartridges due to the expected higher use of black toner, Figure 2.

Figure 2 Toner cartridges and CRUM location

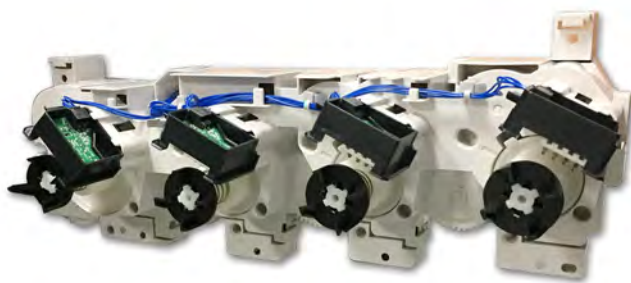
P-1-0064

Each toner cartridge is installed in a toner dispenser. Toner is transported from the toner cartridge to each developer. The four dispensers are driven by the dispense motor assembly. There is one dispense motor for each color within the toner dispense motor assembly. The toner dispense motors are controlled by the Motor Drive PWB, [Figure 3](#).

Figure 3 Toner dispense motor assembly

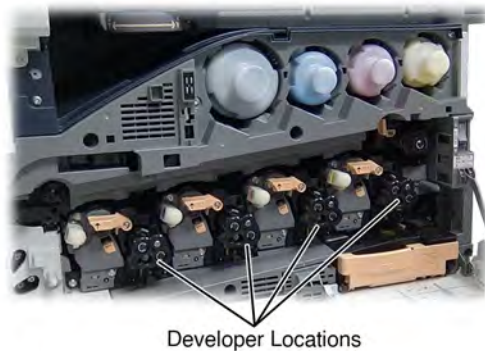
P-1-0068

The four developer units are engineer replaceable units (ERU), [Figure 6](#). The machine will stop operation when developer unit end of life is reached and will generate a fault code. Refer to the HFSI data in dC135 for developer unit life span.

Figure 6 Developer locations

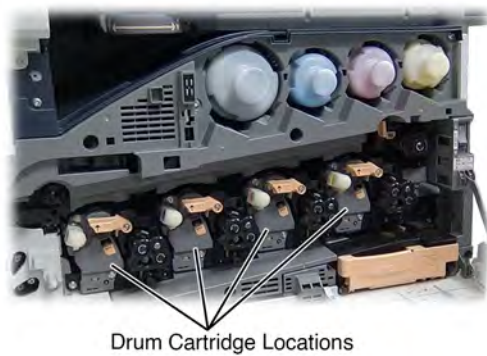
P-1-0069

Each of the four drum cartridges contains the following components: [Figure 7](#)

- Photoreceptor drum
- Bias charge roll (BCR)
- Drum cartridge CRUM
- Waste toner auger

Drum Cartridge Locations

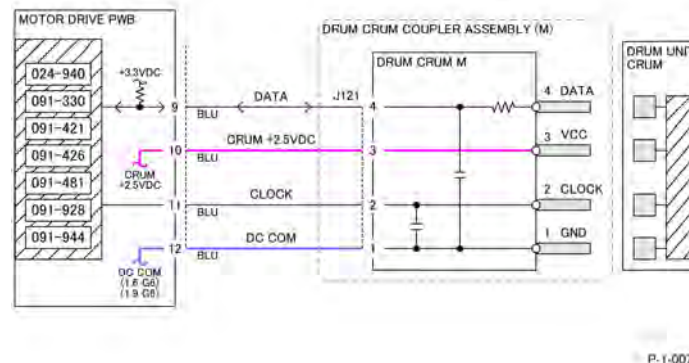
The CRUM consists of two components - a CRUM coupler assembly and a CRUM PWB. The CRUM PWB is mounted at the rear of the drum cartridge, [Figure 10](#).

Figure 10 Drum cartridge CRUM and CRUM coupler assembly

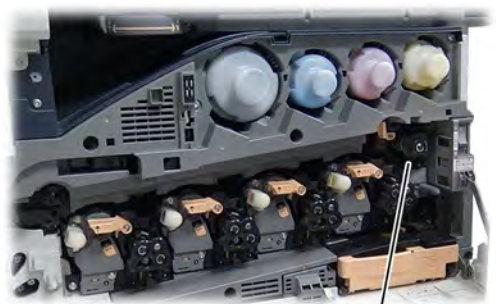
P-1-006B

The Intermediate Belt Transfer (IBT) Unit is cleaned by the customer-replaceable IBT belt cleaner assembly. Waste toner is transported by an auger to the front of the IBT belt cleaner assembly into the waste toner transport assembly. The waste toner from the belt joins the waste from the drums and is transported into the waste toner bottle assembly, [Figure 16](#).

Transfer Belt Cleaning

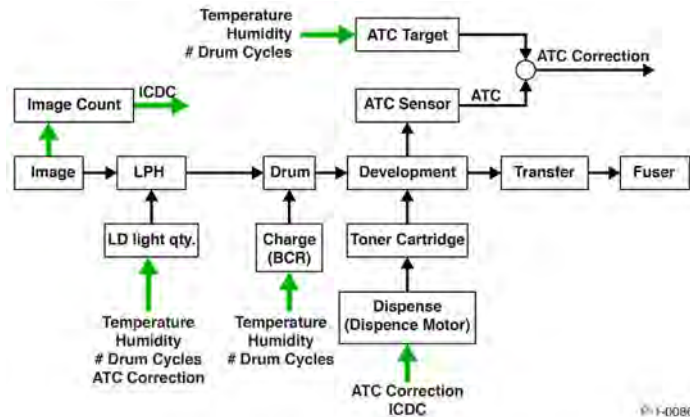
This control function supplies toner from the Toner Cartridges to the Photoreceptor Drum Assembly to maintain optimum toner concentration. The control logic calculates the dispensing time using image count dispense control (ICDC) and automatic toner control (ATC). See Figure 22.

Figure 22 Toner dispensing control

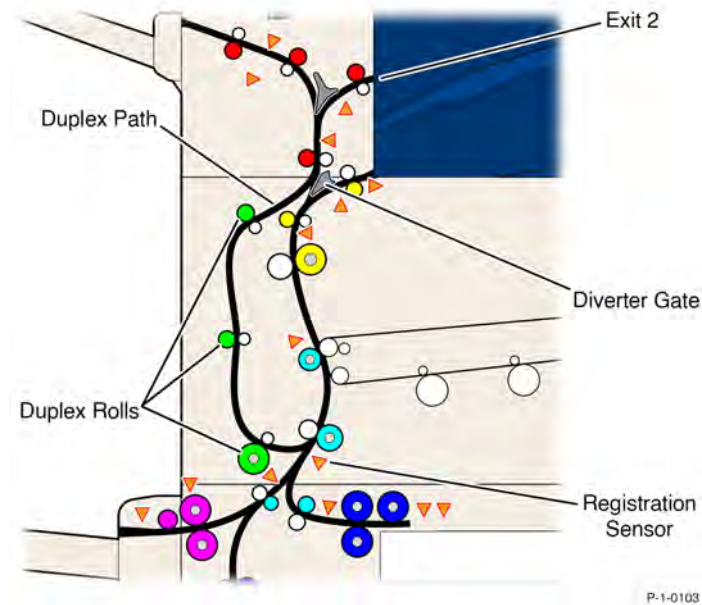
After the trail edge of the sheet passes the diverter gate the sheet is drawn back into the machine. The junction to the duplex path is straight so the sheet automatically passes into the duplex path via the duplex rolls. At the end of the duplex path the sheet arrives at the registration sensor to begin the process of printing the second side, [Figure 8](#).

Figure 8 Duplex path
