# Xerox® VersaLink® B400 & B405 Family Multifunction Printer Service Manual

VersaLink B400 and B405 Family Multifunction Printer Service Manual

708P91373

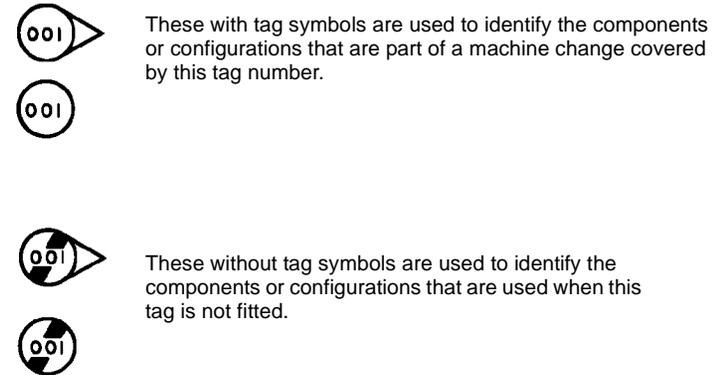
B-1-0364-A

Figure 1 shows the Mod/Tag identification symbols.

Figure 1 Mod/Tag identification symbols

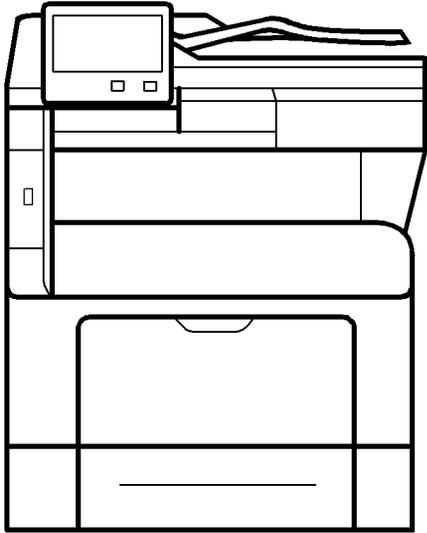
B-1-0304-A

Figure 1 Xerox® VersaLink® B405

- Xerox® VersaLink® B405, [Figure 1](#).
- Xerox® VersaLink® B400, [Figure 2](#).

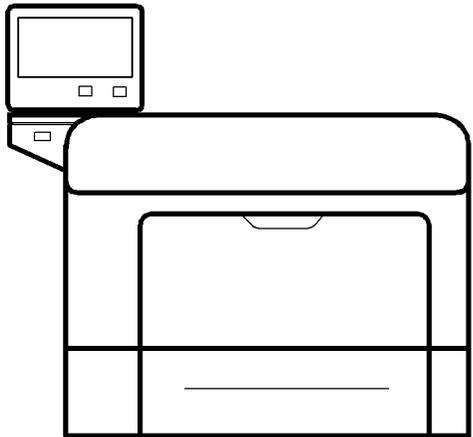
B-1-0303-A

Figure 2 Xerox® VersaLink® B400

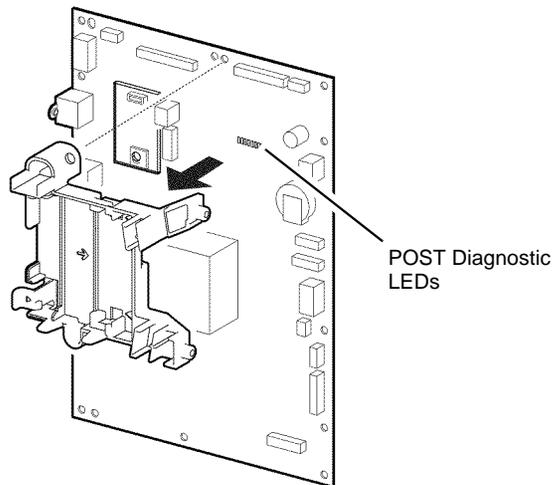
B-1-0365-A

1. Switch off, then switch on the machine, [GP 10](#).
2. To view the LEDs, remove the option HDD, [PL 18.1A Item 91](#) (B400) or [PL 18.1B Item 91](#) (B405), and HDD bracket, [PL 18.1A Item 4](#) (B400) or [PL 18.1B Item 4](#) (B405) if fitted, [Figure 1](#).

Figure 1 POST Diagnostic LEDs

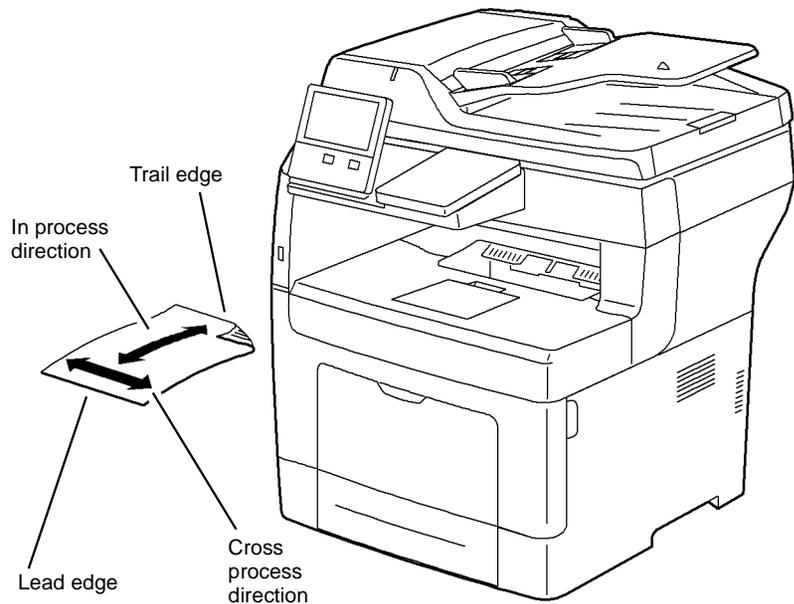
B-1-0322-A

Figure 1 Print/copy definitions

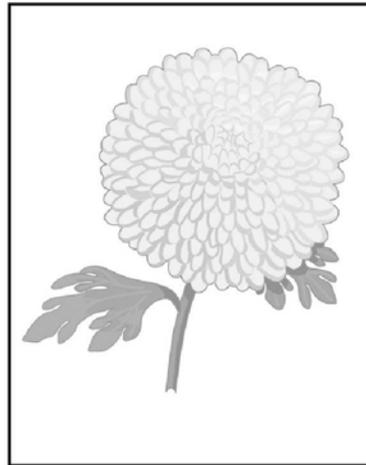
B-1-0305-A

The overall image density is too light, [Figure 1](#).

Figure 1 Light or undertone print

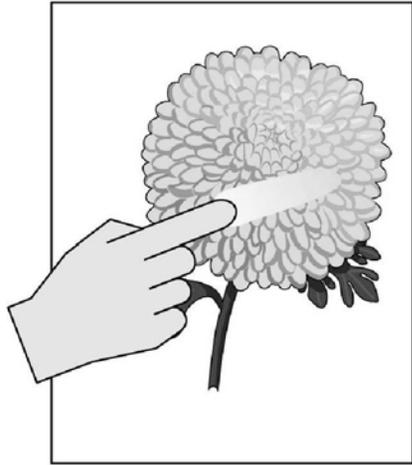
B-1-0306-A

The printed image is not fully fused to the paper, [Figure 1](#). The image rubs off easily. A cold environment affects the warm-up time, while high humidity has an adverse effect on fusing. Also, media weight and composition affect fusing performance.

Figure 1 Unfused image

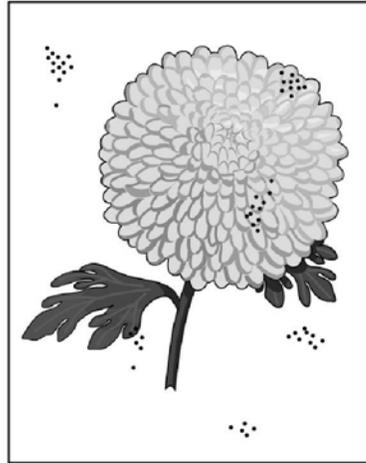
B-1-0307-A

There are spots of toner randomly scattered on the page, [Figure 1](#).

Figure 1 Random spots

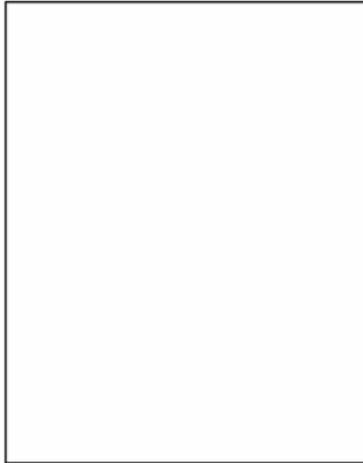
B-1-0323-A

No visible image anywhere on the output, [Figure 1](#).

Figure 1 Blank print

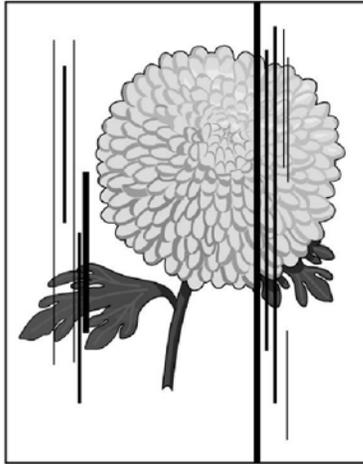
B-1-0308-A

Extraneous dark lines or bands in the process direction, [Figure 1](#).

Figure 1 Streaks

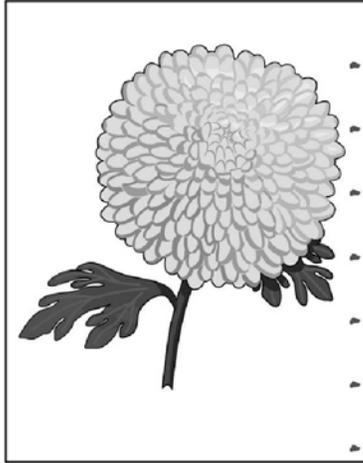
B-1-0309-A

Recurring dots or spots in the process direction, [Figure 1](#).

Figure 1 Pitched dots

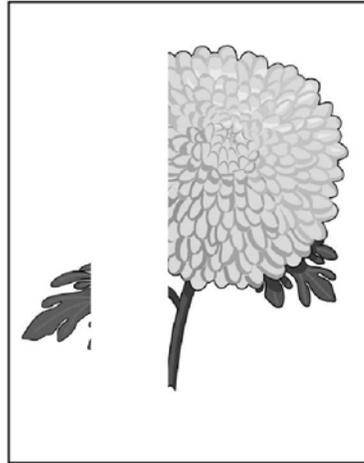
B-1-0310-A

Deletions in the process direction, [Figure 1](#).

Figure 1 Deletions

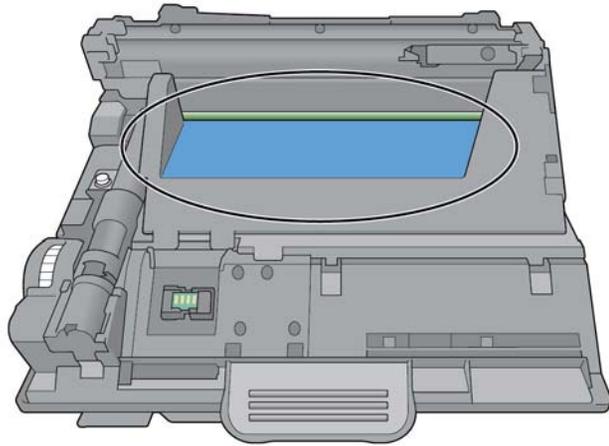
B-1-0325-A

Figure 2 Drum cartridge

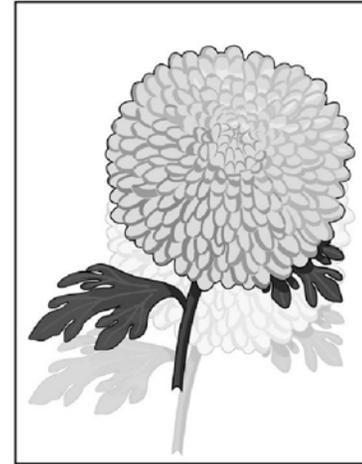
B-1-0311-A

The residual image from a previous print, or previous page in the same print job appears on the current print, [Figure 1](#).

Figure 1 Ghosting

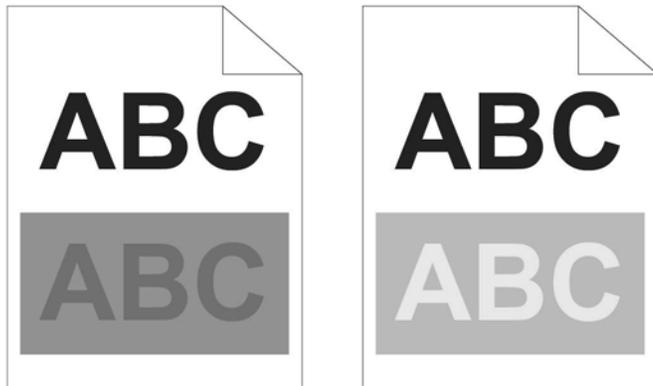
B-1-0327-A

Figure 2 Ghosting type

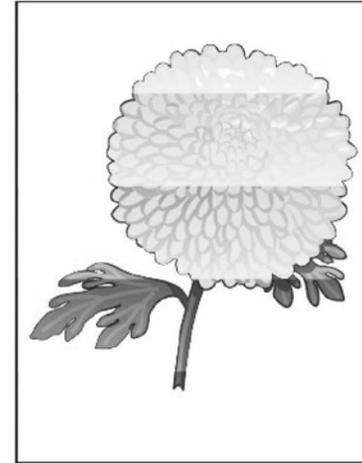
B-1-0312-A

Light fatigue pattern appearing across image, [Figure 1](#).

Figure 1 Light induced fatigue

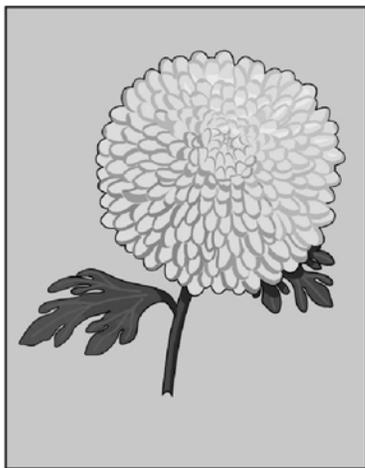
B-1-0313-A

There is toner contamination on all or part of the page, [Figure 1](#). The contamination appears as a very light dusting or fog.

Figure 1 Background defect

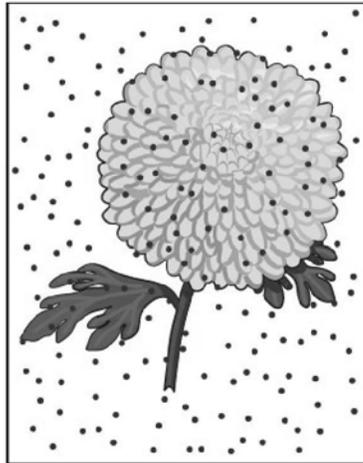
B-1-0314-A

Multiple dots appearing across image, [Figure 1](#).

Figure 1 Bead carry-out

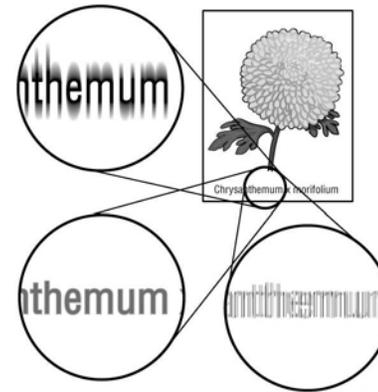
B-1-0315-A

Text in image is fuzzy or blurry, [Figure 1](#).

Figure 1 Jagged characters

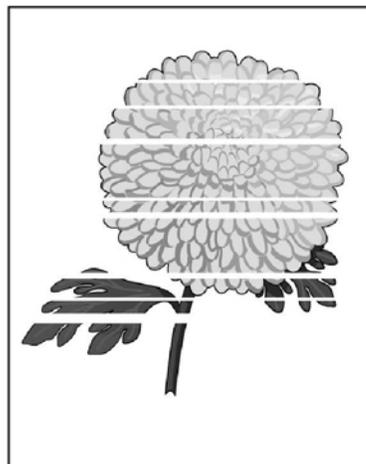
B-1-0316-A

Use this procedure to correct defects that appear as areas of cross process bands, [Figure 1](#).

Figure 1 Cross process bands

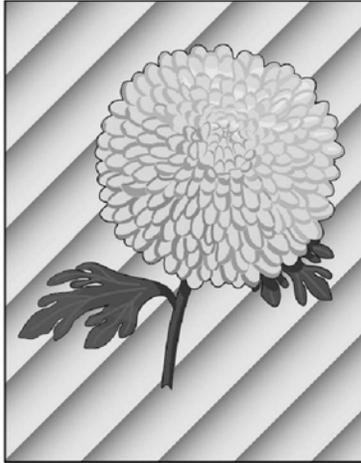
B-1-0317-A

Auger marks appear across output, [Figure 1](#).

Figure 1 Auger marks

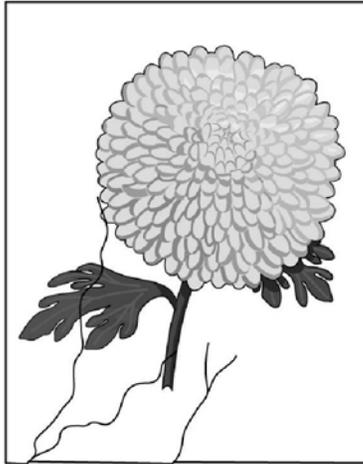
B-1-0318-A

Prints are either wrinkled, creased, stained or torn, [Figure 1](#).

Figure 1 Wrinkled paper

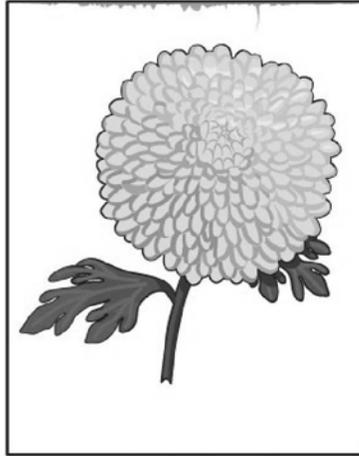
Output has lead edge damage, [Figure 1](#)

Figure 1 Lead edge damage

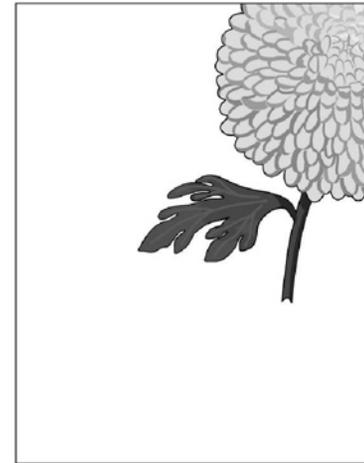
B-1-0319-A

Image prints outside of the page margins, [Figure 1](#).

Figure 1 Incorrect margins

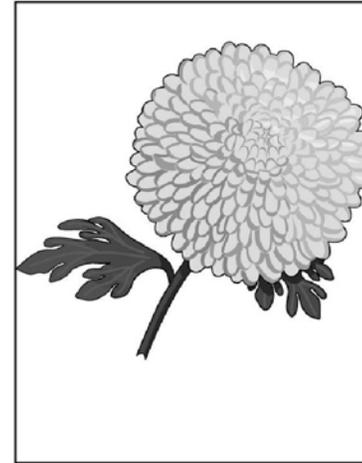
B-1-0321-A

Images are not parallel to the edge of the printed sheet, [Figure 1](#).

Figure 1 Skewed image

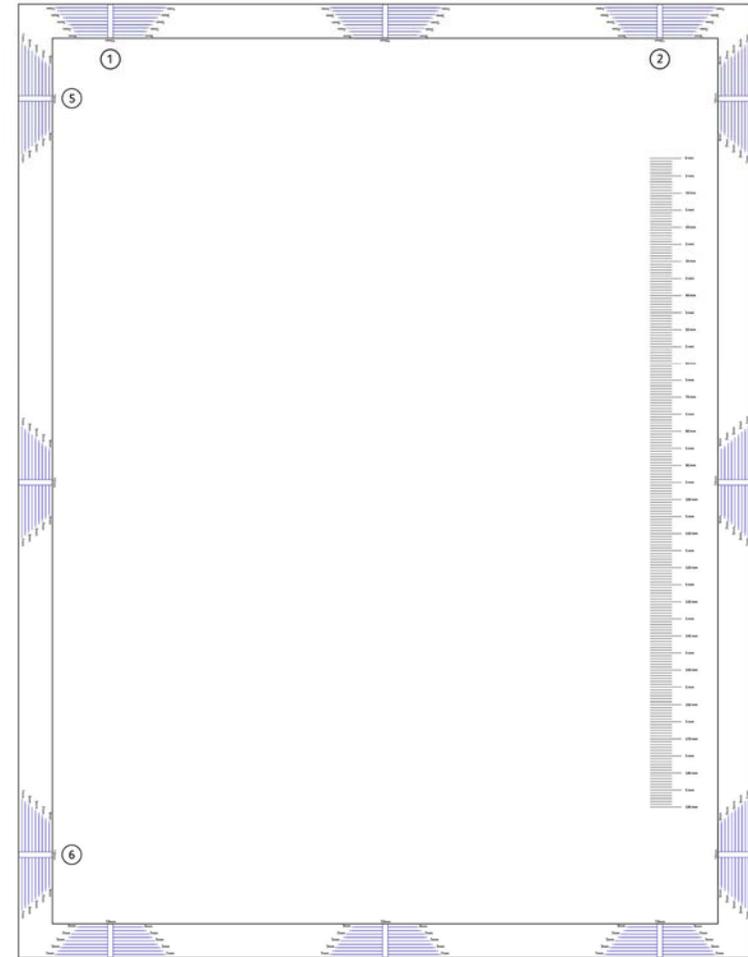
B-1-0360-A

| | Flatbed Copy<br>(From Platen) | DADF Copy | IIT Scan from platen to file | IIT + DADF (Scan) Scan to file | IOT (Internal Print) |
|---|---|---|---|---|---|
| Lead Edge (180mm edge) | ±1.3mm | ±2.7mm | ±0.6mm | ±2.4mm | ±1.1mm |
| Side Edge (280mm edge) | ±2.2mm | ±3.5mm | ±0.9mm | ±2.8mm | ±2.0mm |

**Figure 1 Skew Check**

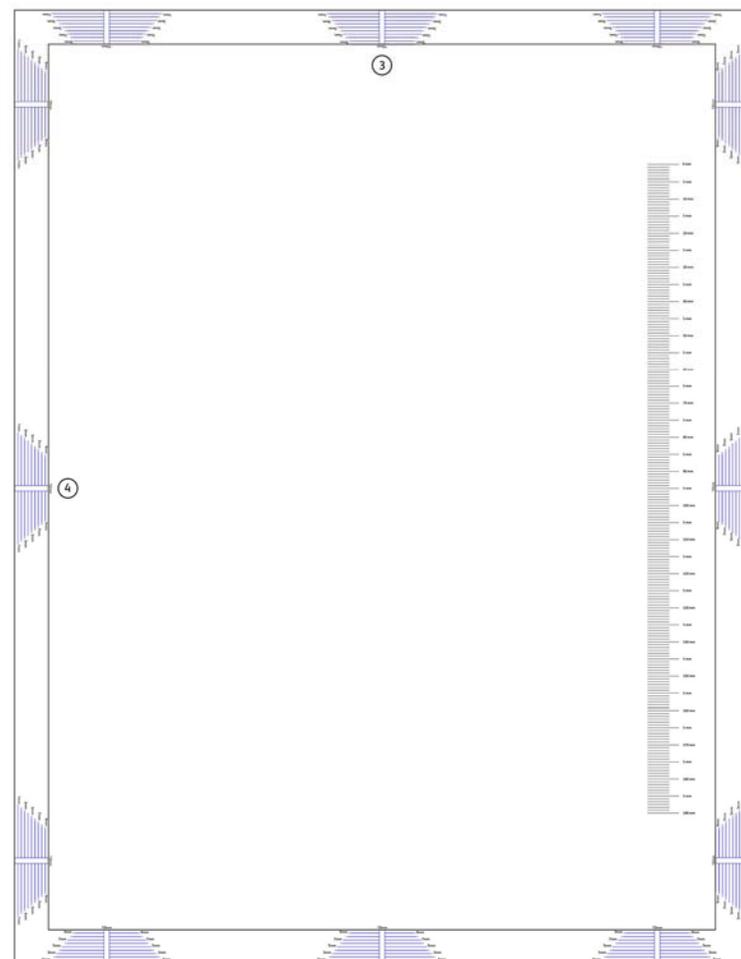
B-1-0361-A

| | Flatbed Copy<br>(From Platen) | DADF Copy | IIT Scan from<br>platen to file | IIT + DADF<br>(Scan) Scan<br>to file | IOT (Internal<br>Print) |
|--|---|---|---|---|---|
| Lead Edge<br>(180mm<br>edge) regis-<br>tration | ±2.3mm | ±2.9mm | ±1.0mm | ±2.0mm | ±2.0mm |
| Side Edge<br>(280mm<br>edge)<br>Registration | ±2.7mm | ±3.0mm | ±1.0mm | ±1.5mm | ±2.5mm |

**Figure 1 Registration Check**

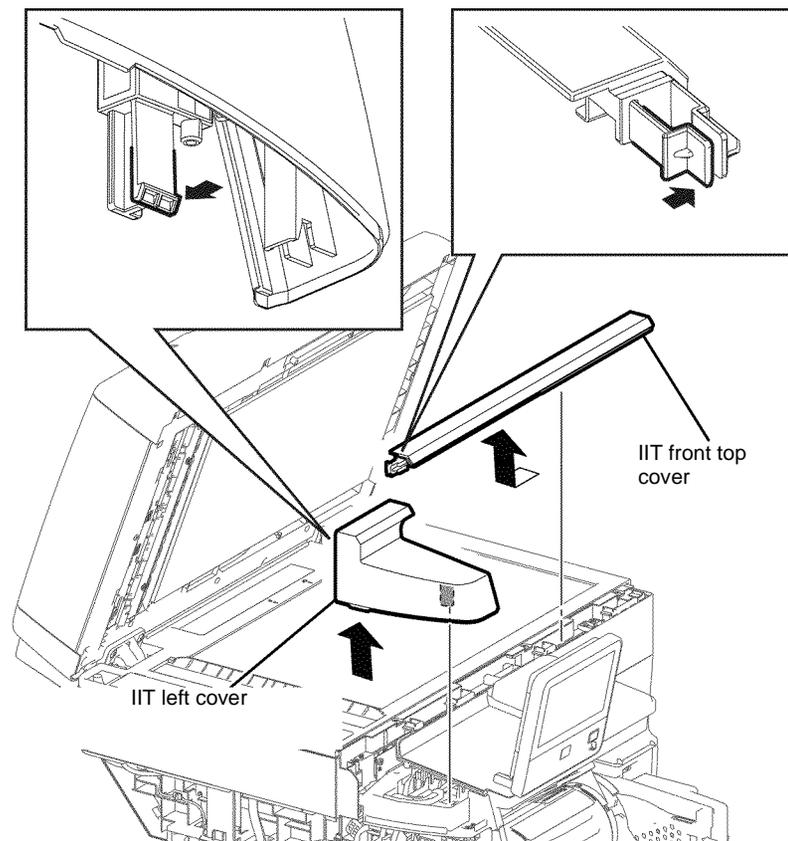
B-1-0001-A

1. Remove the left cover, [REP 19.11](#).
2. Remove the IIT left cover, [Figure 1](#).

3. Remove the IIT front top cover, [Figure 1](#).

Figure 1 IIT cover removal

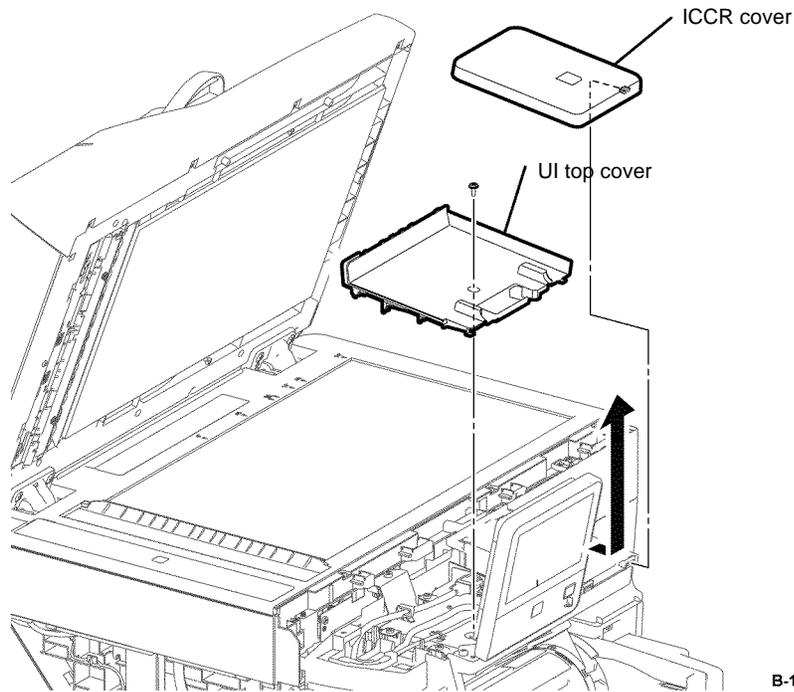
B-1-0002-A

4. Remove the ICCR cover, [Figure 2](#).
5. Remove one screw (black, tapping, 6mm), then remove the UI top cover, [Figure 2](#).

**Figure 2 ICCR and UI cover removal**

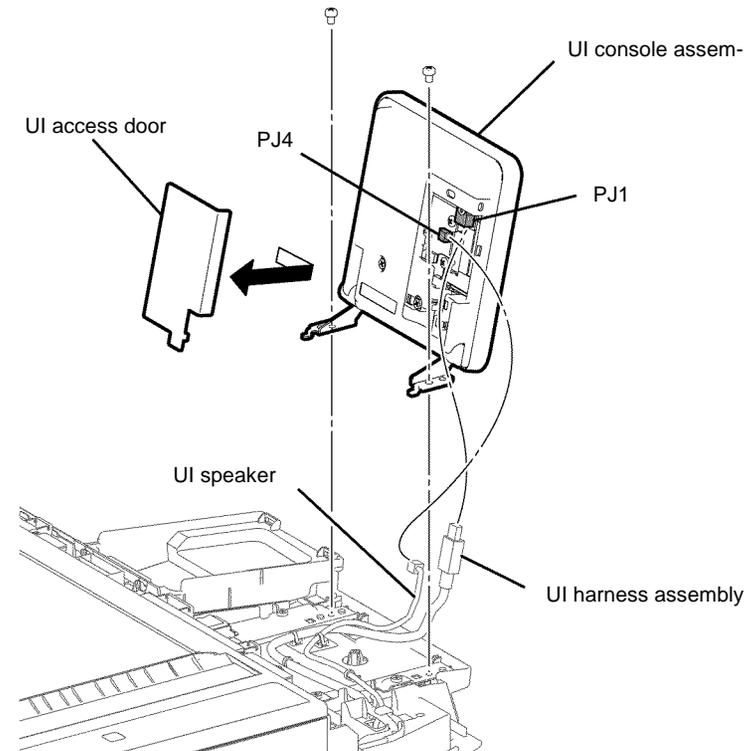
B-1-0003-A

6. Slide the UI access door in the arrowed direction, then remove it from the UI console assembly, [Figure 3](#).
7. Disengage PJ1 of the UI harness assembly, [Figure 3](#).
8. Disengage PJ4 of the UI speaker, [Figure 3](#).
9. Remove two screws (silver, M4, 6mm), then remove the UI console assembly, [Figure 3](#).

**Figure 3 UI console assembly removal**

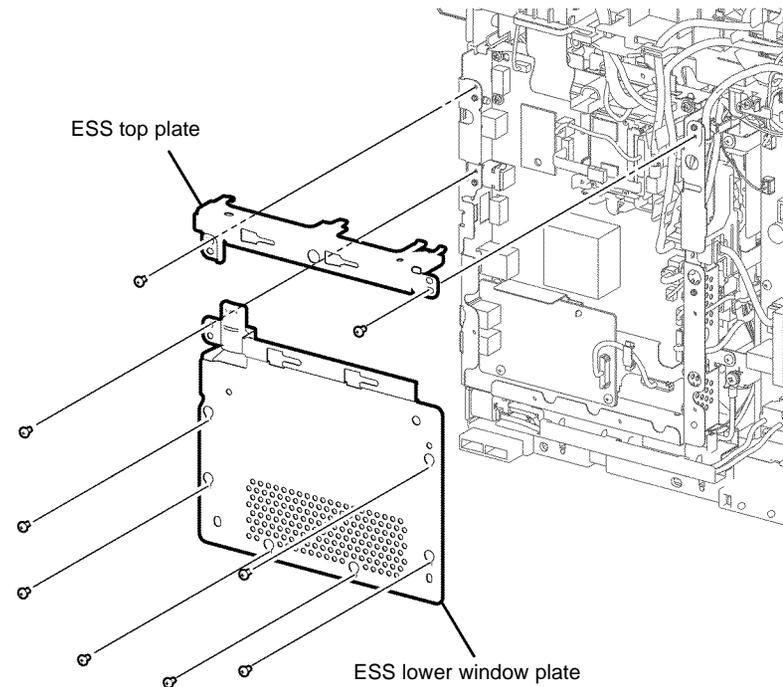
B-1-0004-A

1. Open the MSI cover, [PL 13.2 Item 3](#).
2. Pull the MSI tray assembly, [PL 13.2 Item 9](#), out of the printer.
3. Remove the front cover, [REP 19.1](#).
4. Remove the rear cover assembly, [REP 19.13](#).
5. Remove the ESS window cover assembly, [REP 19.3](#).
6. Remove the WIFI cap cover, [REP 19.19](#).
7. Remove the UI access door, UI console assembly, ICCR cover, UI top cover IIT front top cover and IIT left cover, [REP 1.1](#).
8. Remove the left cover, [REP 19.11](#).
9. Remove seven screws (silver, M3, 6mm), then remove the ESS lower window plate and the WIFI release lever, [Figure 1](#).
10. Remove two screws (silver, M3, 6mm), then remove the ESS top plate, [Figure 1](#).

Figure 1 ESS Top and lower plate removal

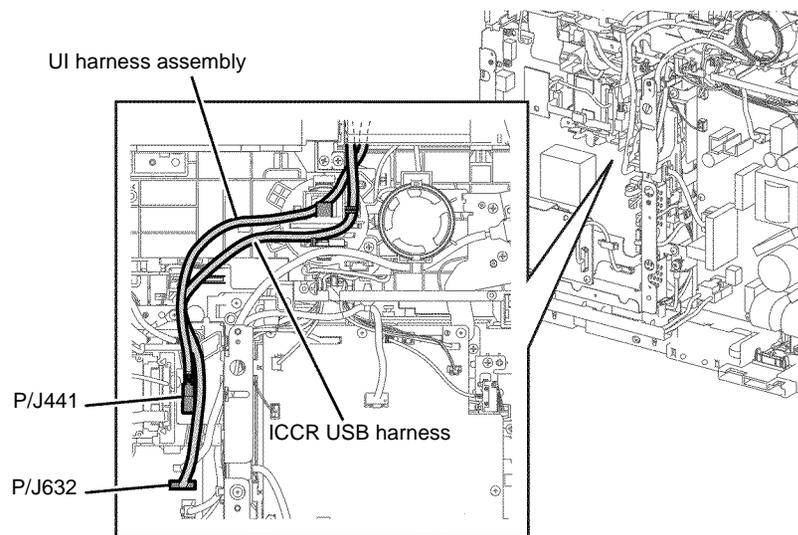
B-1-0005-A

11. Disengage P/J632, then release the ICCR USB harness from the harness guide, [Figure 2](#).
12. Disengage P/J441, then release the UI harness assembly from the harness guide, [Figure 2](#).

**Figure 2 ICCR USB and UI harnesses disengage**

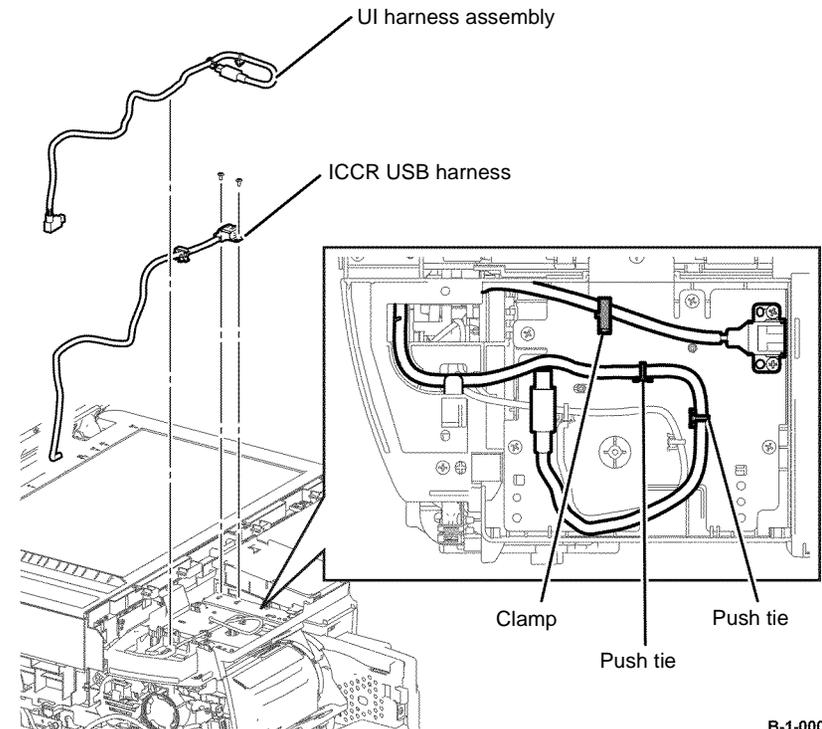
B-1-0006-A

13. Release one clamp, remove two screws (silver, M3, 6mm), then remove ICCR USB harness, [Figure 3](#).
14. Release two push ties, then remove the UI harness assembly, [Figure 3](#).

**Figure 3 ICCR USB and UI harnesses removal**

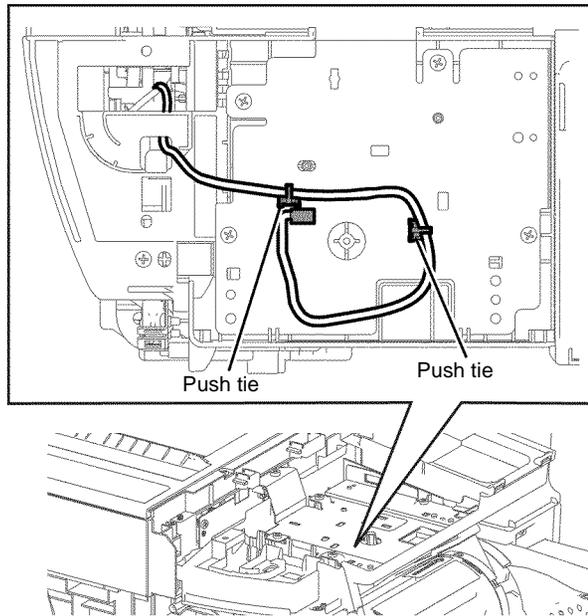
B-1-0007-A

15. Release the two push ties of the UI speaker, [Figure 4](#).

**Figure 4 Speaker push ties release**

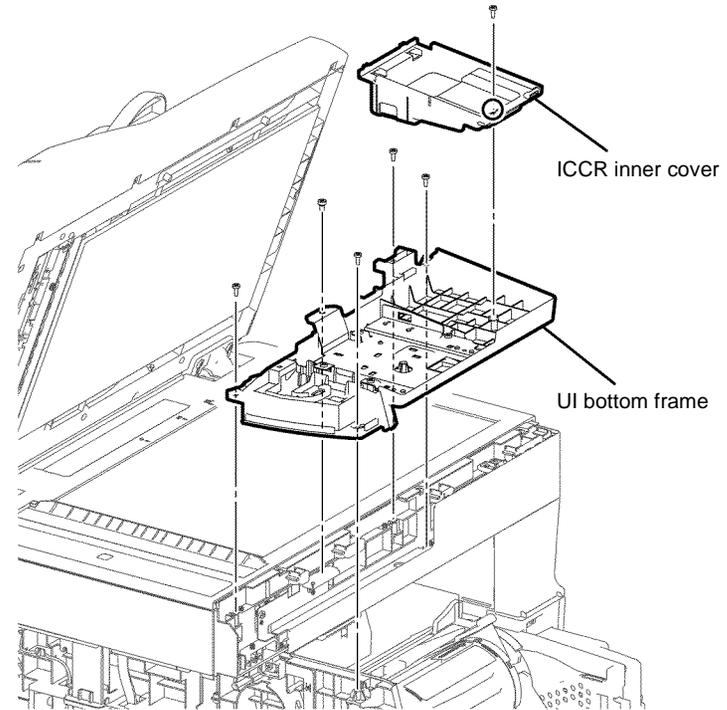
B-1-0008-A

16. Remove one screw (silver, tapping, 8mm), then remove the ICCR inner cover, [Figure 5](#).

17. Remove five screws (silver, tapping, 8mm), then remove the UI bottom frame, [Figure 5](#).

**Figure 5 Inner ICCR cover and UI bottom frame removal**

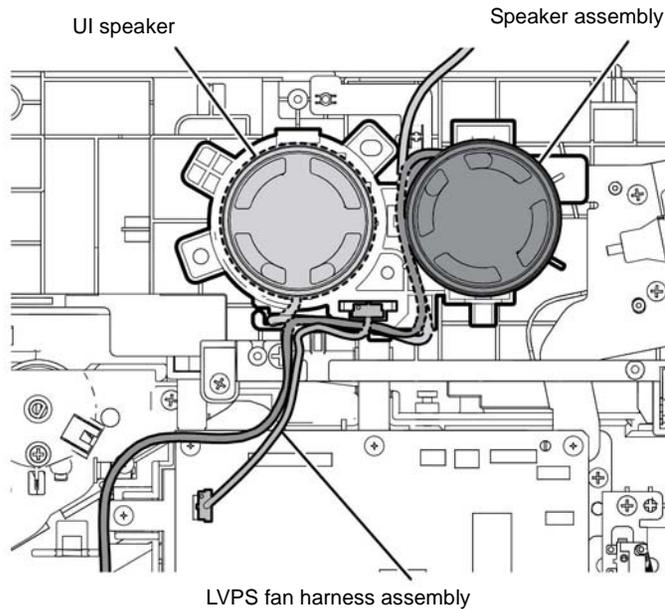
B-1-0009-A

1. The replacement is the reverse of the removal procedure.
2. If the speaker cover, [PL 18.1B Item 20](#), is accidentally removed. Install the speaker cover, with the LVPS fan harness assembly, the UI speaker and the speaker assembly. Refer to [Figure 6](#).

Figure 6 Replacement

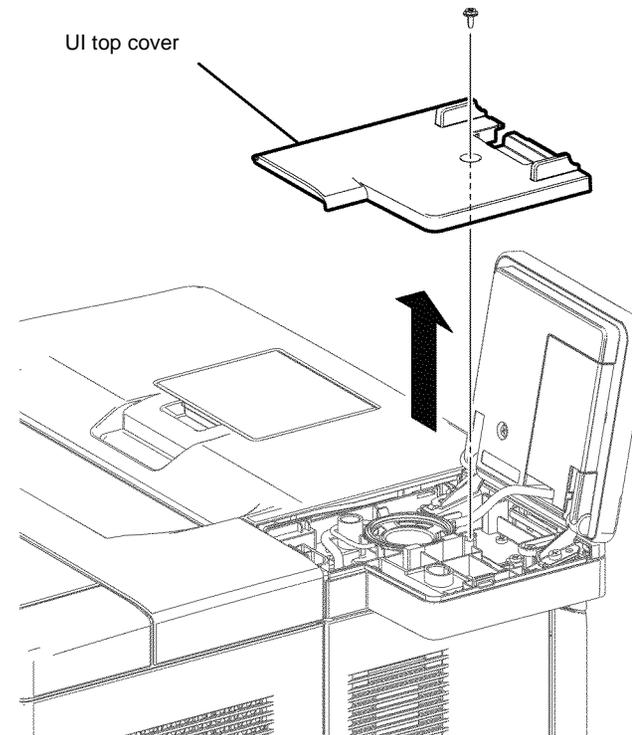
B-1-0082-A

1. Remove one screw (black, tapping, 6mm), then remove the UI top cover, [Figure 1](#).

Figure 1 UI Top cover removal

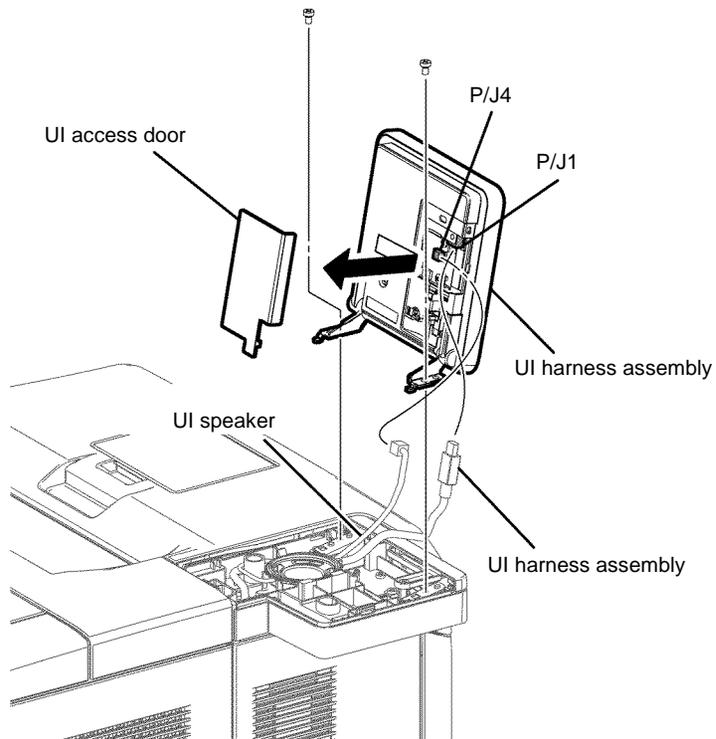
B-1-0083-A

- Slide the UI access door in the direction shown, then remove it from the UI console assembly, [Figure 2](#).
- Disengage P/J1 of the UI harness assembly, [Figure 2](#).
- Disengage P/J4 of the UI speaker, [Figure 2](#).
- Remove two screws (silver, M4, 6mm), then remove the UI console assembly, [Figure 2](#).

Figure 2 UI console assembly removal

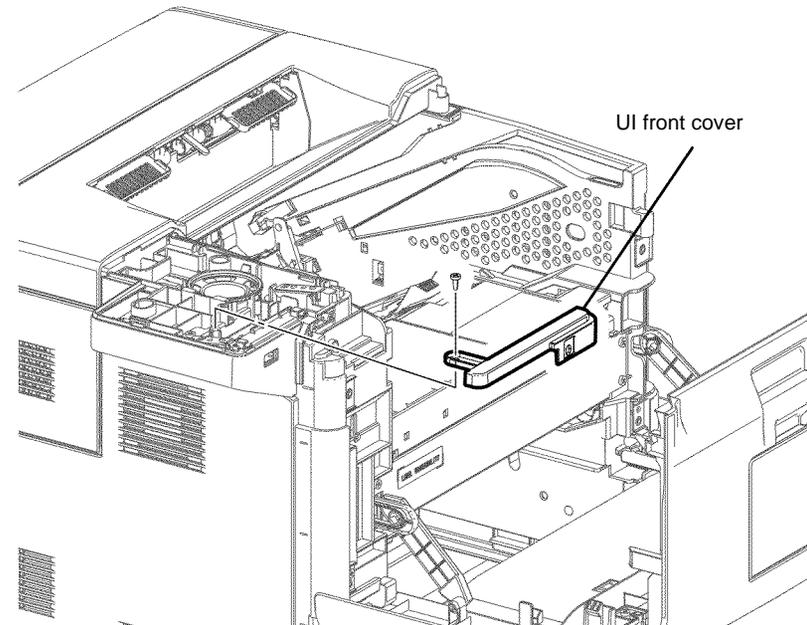
B-1-0084-A

- Remove the UI console assembly, [REP 1.3](#).
- Open the front cover, [PL 19.1A Item 2](#).
- Remove one screw (silver, tapping, 8mm), then remove the UI front cover, [Figure 1](#).

Figure 1 UI front cover removal

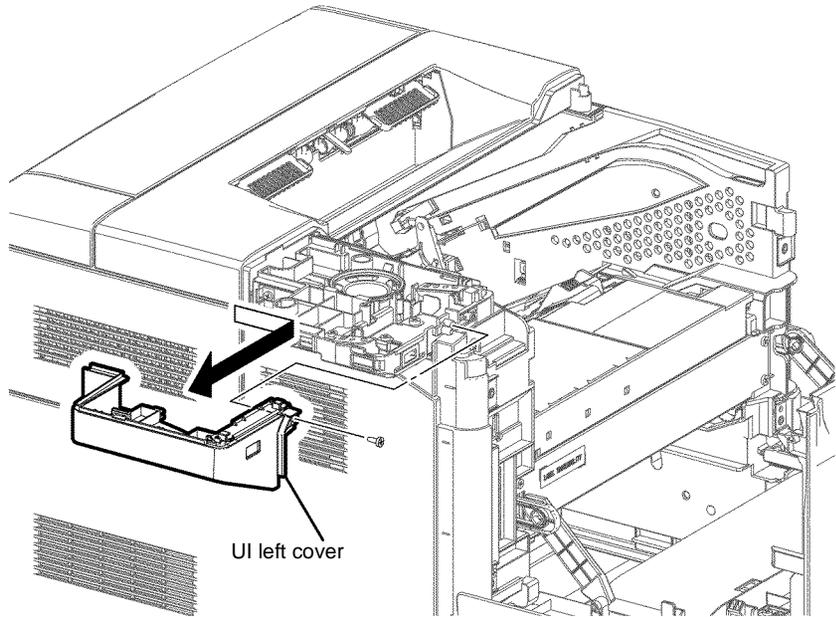
B-1-0085-A

Figure 2 UI left cover removal

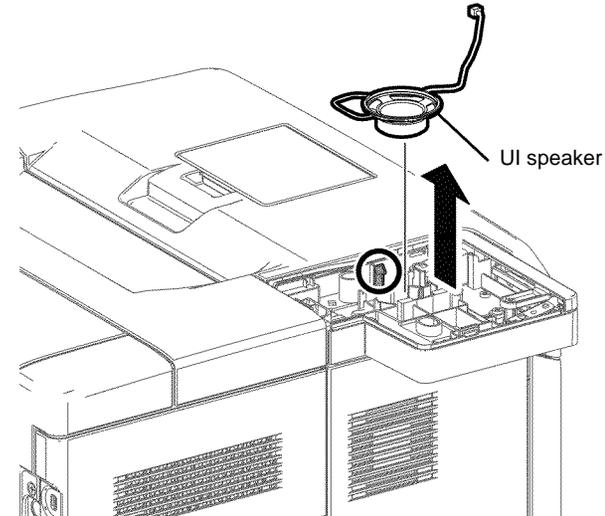
B-1-0086-A

1. Remove the UI console assembly, [REP 1.3](#).
2. Release the hook, then remove the UI speaker, [Figure 1](#).

Figure 1 UI speaker removal

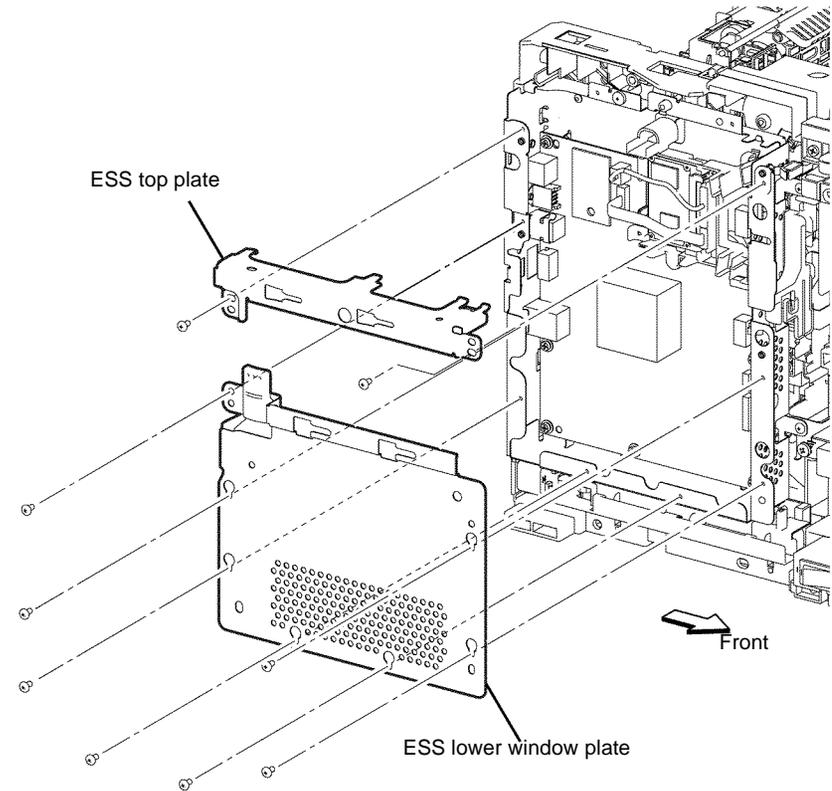
B-1-0087-A

12. Remove two screws (silver, M3, 6mm), then remove the ESS top plate, [Figure 1](#).

Figure 1 ESS top and lower window plate removal

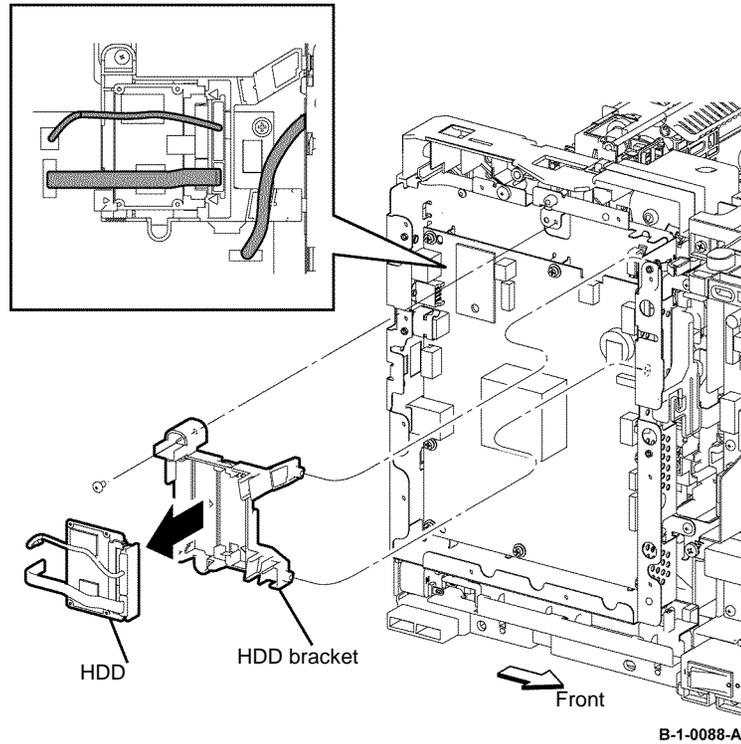
13. Disengage P/J631, then release the harness from the HDD bracket, [Figure 2](#).
14. Disengage P/J302 and P/J310, then remove the optional HDD, [Figure 2](#).
15. Remove one screw (silver, M3, 6mm), then release the three bosses to remove the HDD bracket, [Figure 2](#).

**Figure 2** Optional HDD and bracket removal

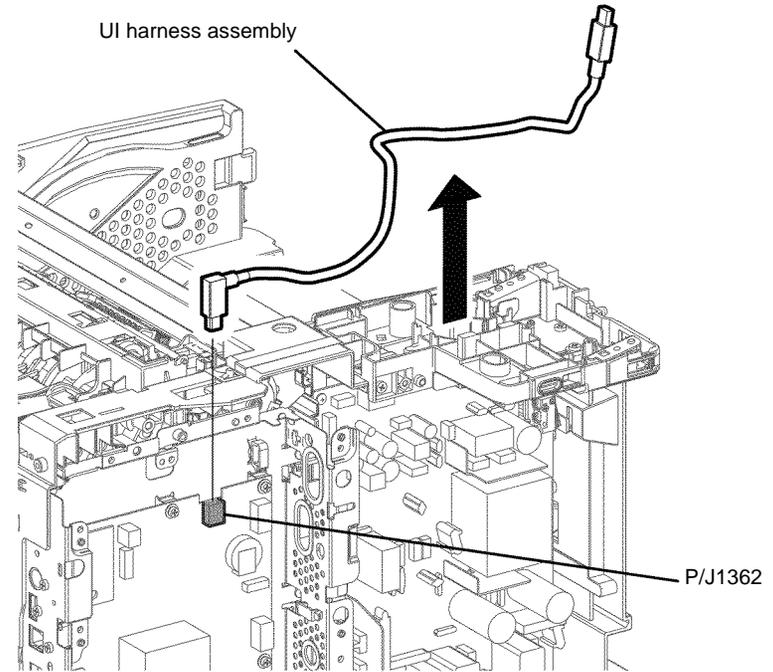
16. Disengage P/J1362, release one push tie, then remove the UI harness assembly, [Figure 3](#).

**Figure 3** UI harnesses assembly removal

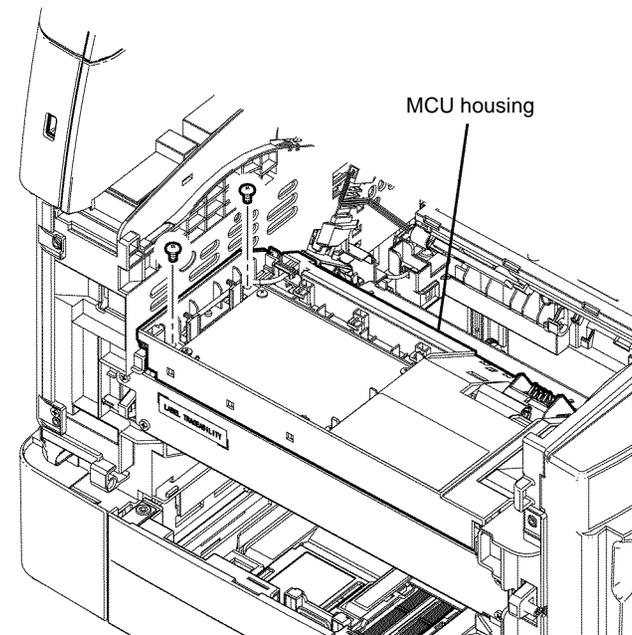
B-10010-A

4. Remove two screws (silver, M3, 6mm) that fix the MCU housing, [Figure 2](#).

Figure 2 MCU housing location

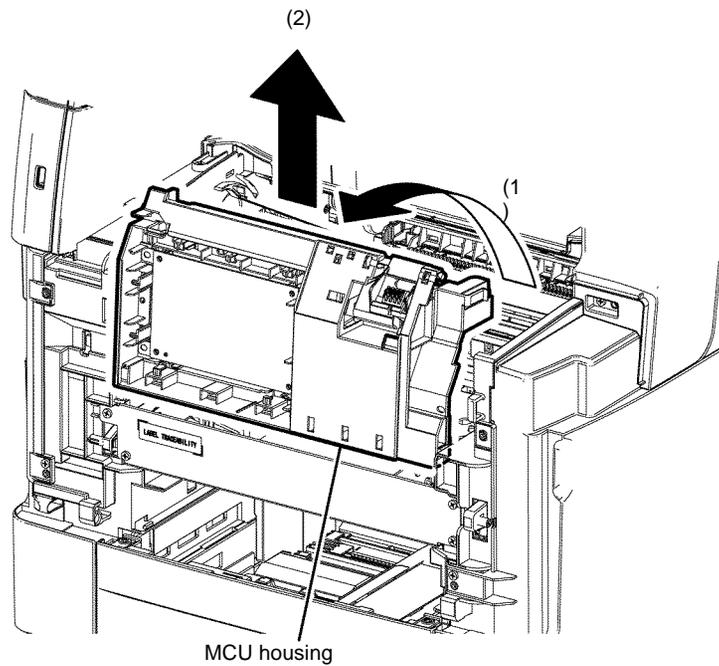
B-1-0011-A

- Rotate the MCU housing in the arrowed direction, release the hook, then remove the MCU housing from the printer, [Figure 3](#).
- Remove the four screws (silver, flanged, M3, 10mm) that fix the ROS assembly, disengage P/J502, then remove the ROS assembly from the printer, [Figure 4](#).

Figure 3 MCU housing removal

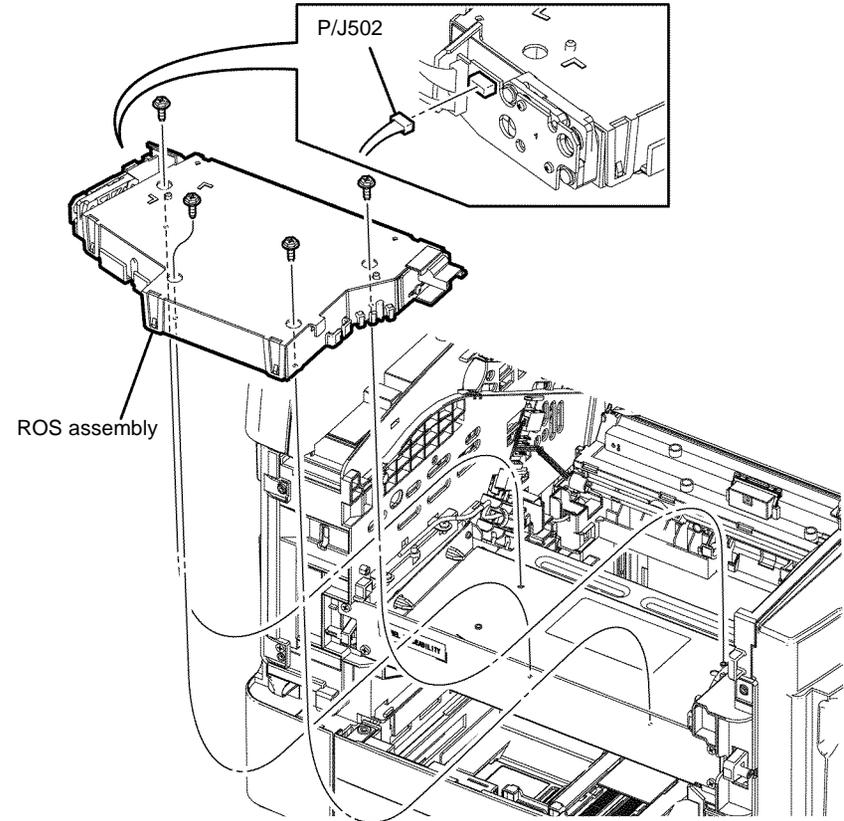
B-1-0012-A

Figure 4 ROS assembly removal

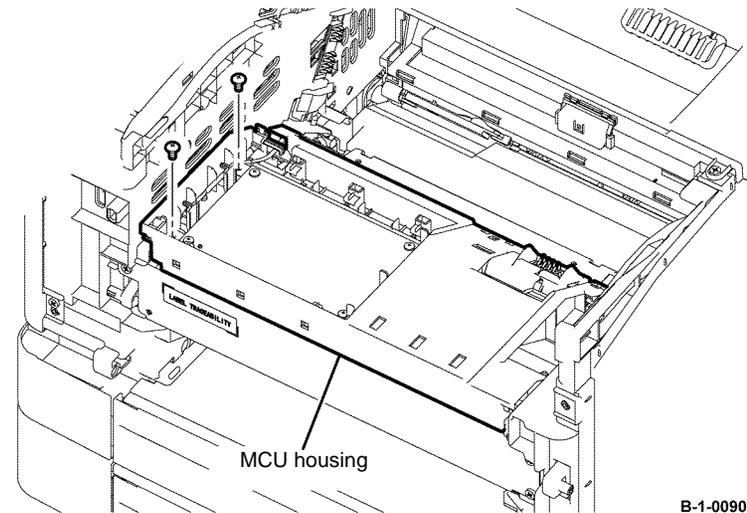
4. Remove two screws (silver, M3, 6mm) that fix the MCU housing, [Figure 2](#).

Figure 2 MCU housing location

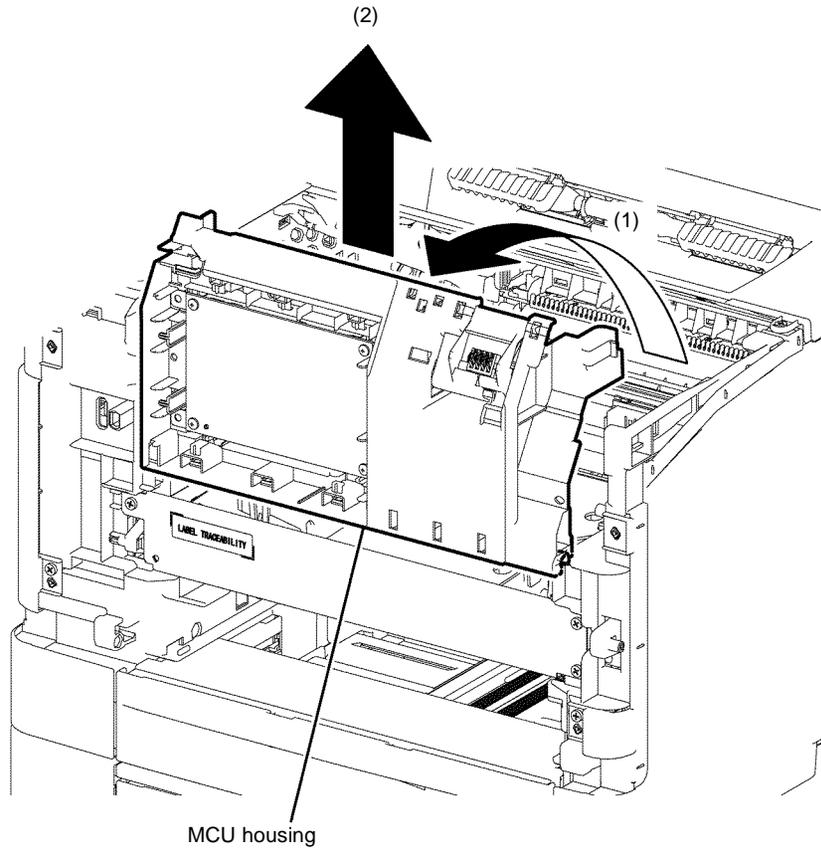
B-1-0091-A

5. Rotate the MCU housing in the arrowed direction, release the hook, then remove the MCU housing from the printer, [Figure 3](#).

Figure 3 MCU housing removal

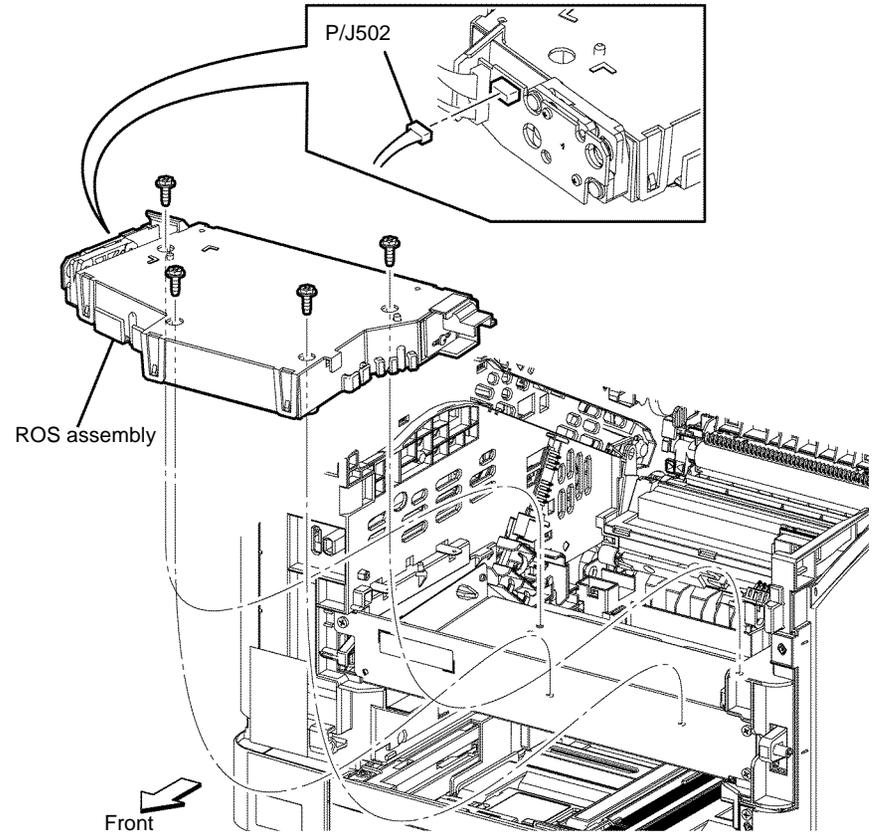
6. Remove four screws (silver, flanged, M3, 10mm) that fix the ROS assembly, disengage P/J502, then remove the ROS assembly from the printer, [Figure 4](#).

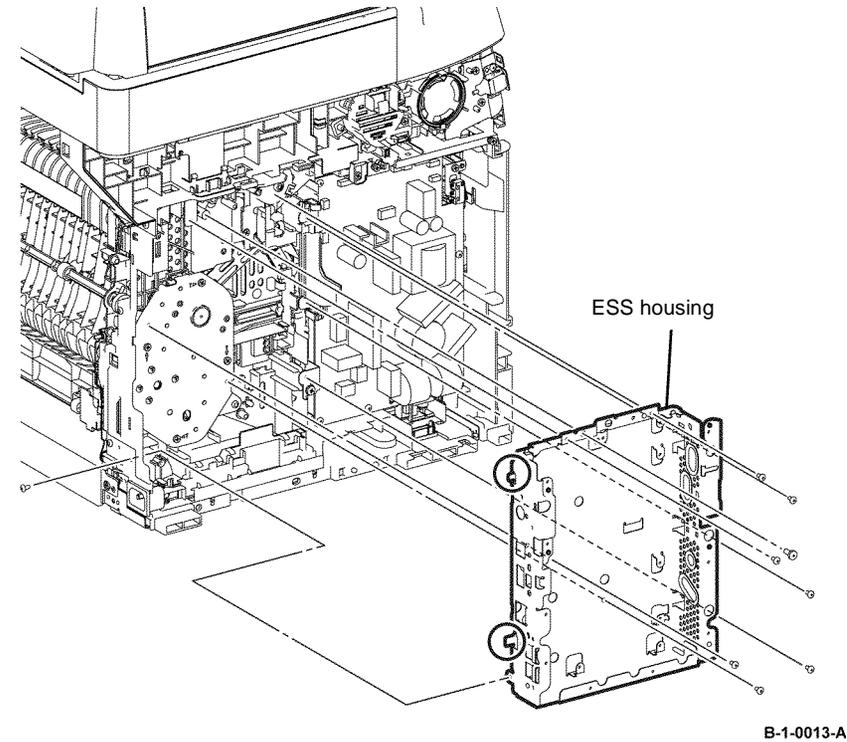
10. Remove six screws (silver, M3, 6mm) and one screw (silver, tapping, M4, 10mm), that fix the ESS housing, then remove the ESS housing from the printer, [Figure 1](#).

Figure 1 ESS housing removal

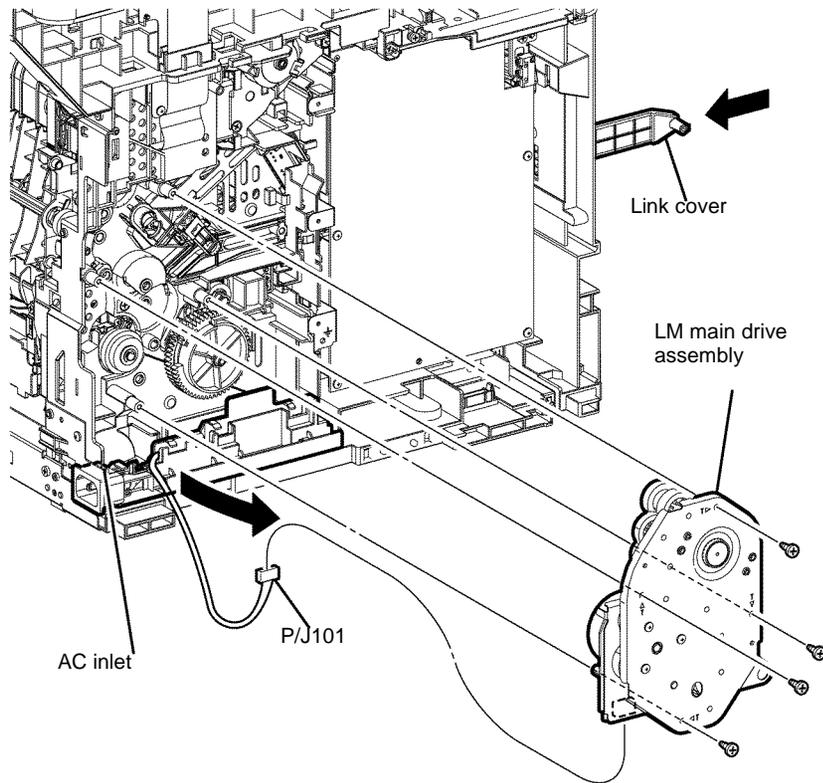
B-1-0014-A

12. Remove the four screws (silver, tapping, 8mm) that fix the main drive assembly, then remove the LM main drive assembly from the printer, [Figure 2](#).
13. Disengage P/J101 from the LM main drive assembly, [Figure 2](#).

Figure 2 Main drive assembly removal

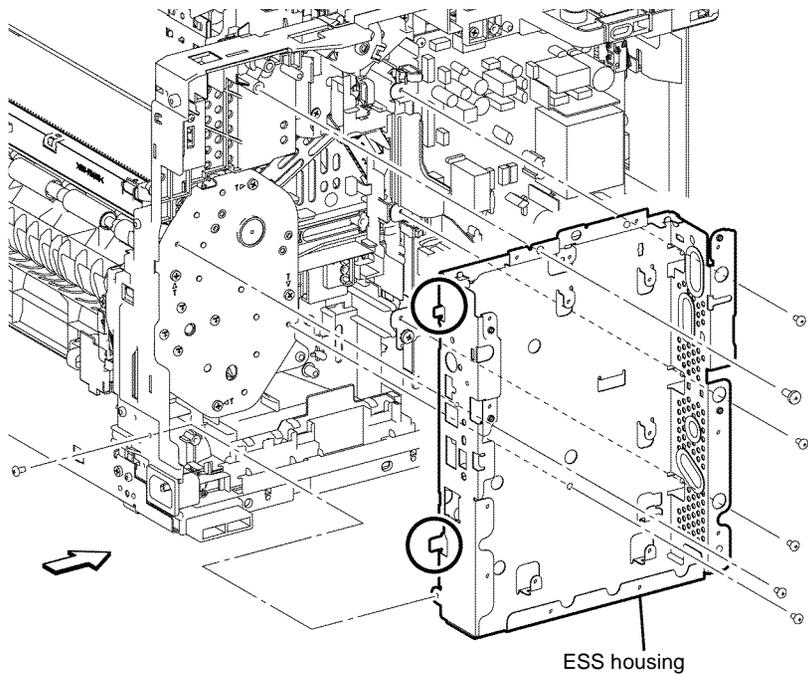
- Remove six screws (silver, M3, 6mm) and one screw (silver, tapping, M4, 10mm), that fix the ESS housing. Release the two tabs from the frame, then remove the ESS housing from the printer, [Figure 1](#).

**Figure 1 ESS housing removal**
