# Xerox® VersaLink® B400 & B405 Family Multifunction Printer Service Manual

VersaLink B400 and B405 Family Multifunction Printer Service Manual

708P91373

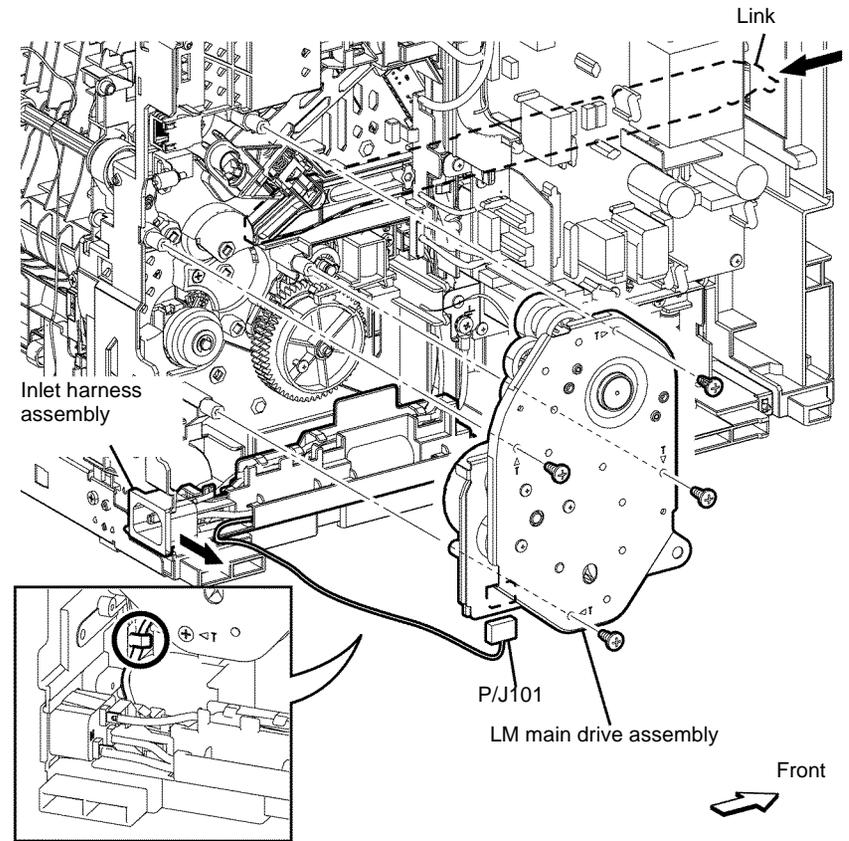
- Remove four screws (silver, tapping, 8mm) that fix the main drive assembly, then remove the LM main drive assembly from the printer, [Figure 2](#).
- Disengage P/J101 from the LM main drive assembly, [Figure 2](#).

**Figure 2 Main drive assembly removal**

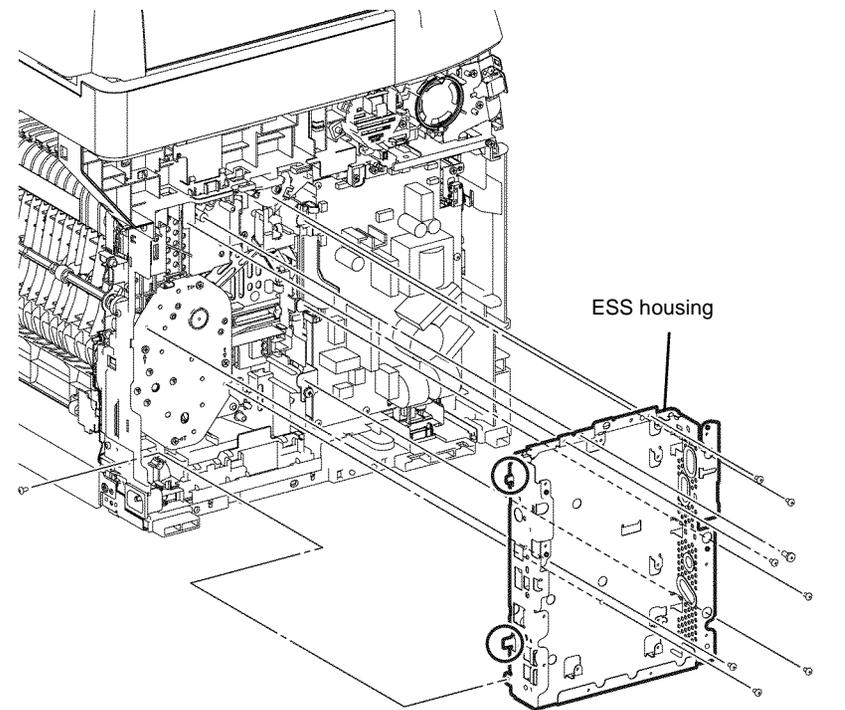
B-1-0013-A

11. Remove six screws (silver, M3, 6mm) and one screw (silver, tapping, M4, 10mm), that fix the ESS housing. Release the two tabs from the frame, then remove the ESS housing from the printer, [Figure 1](#).

Figure 1 ESS housing removal

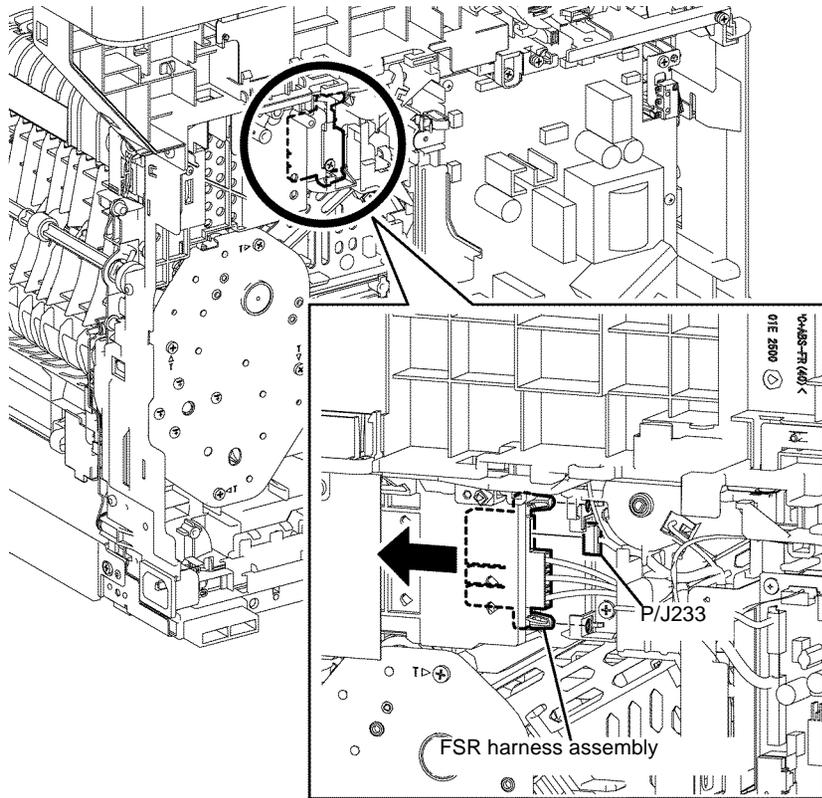
B-1-0015-A

12. Release the hook that fixes the FSR harness assembly from above, then move the FSR harness assembly in the arrowed direction, **Figure 2**.
13. Disengage P/J233 from the FSR harness assembly, **Figure 2**.

**Figure 2 FSR harness assembly removal**

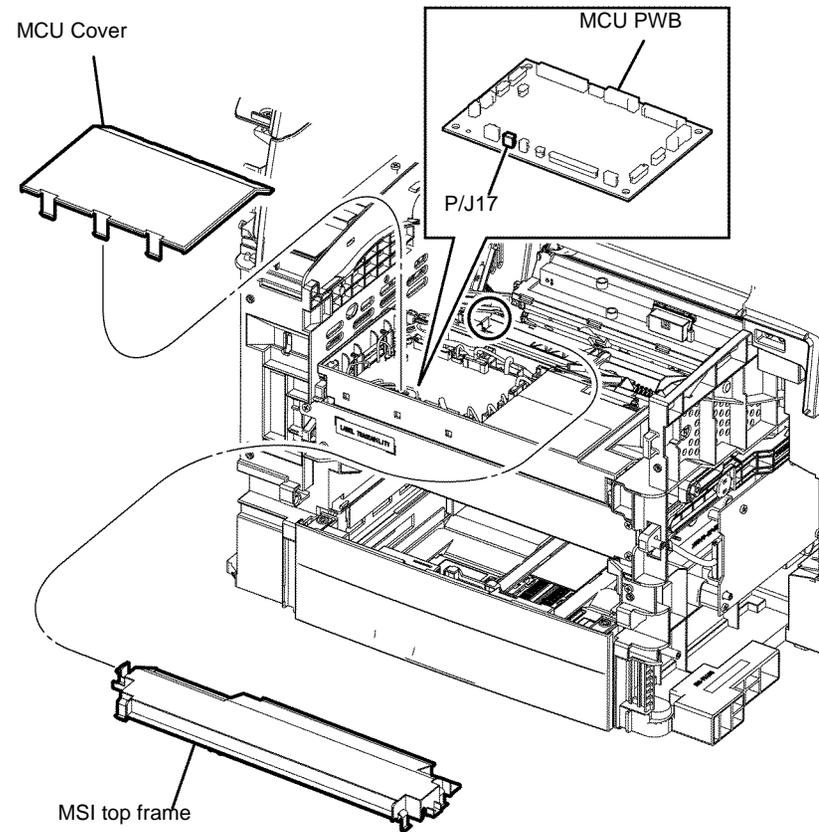
B-1-0016-A

14. Release the four hooks that fix the MSI top frame, then remove the MSI top frame, **Figure 3**.
15. Remove the MCU cover by releasing the hook. Disengage P/J17 from the MCU PWB, then release the harness of the T21 exit clutch assembly from the harness guide, **Figure 3**.

**Figure 3 T21 exit clutch harness assembly release**

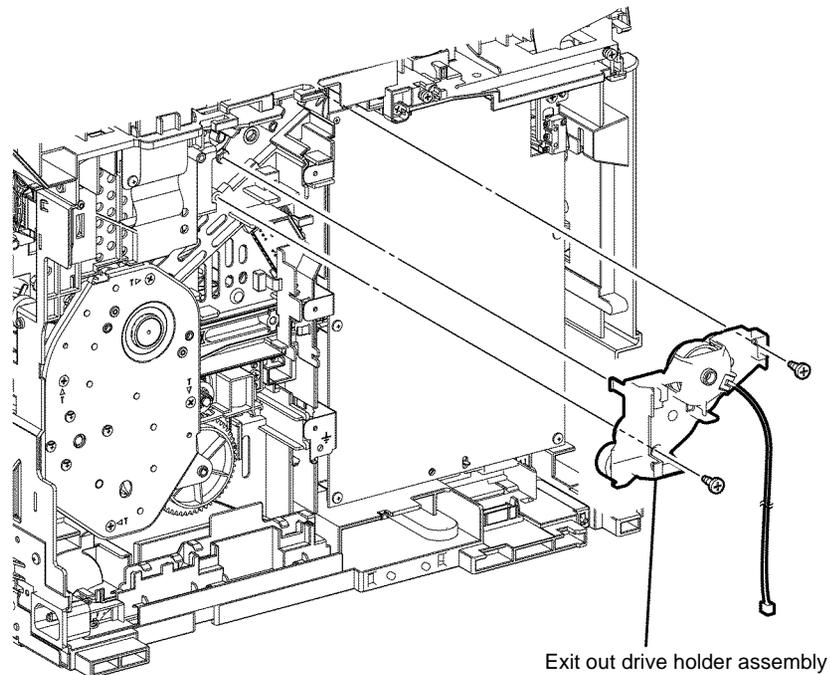
B-1-0017-A

17. Remove two screws (silver, tapping, 8mm) that fix the exit out drive holder assembly. Release the harness from the harness guide installed on the exit out drive holder assembly, then remove the exit out drive holder assembly by releasing the hook, [Figure 4](#).

Figure 4 Exit out drive holder assembly removal

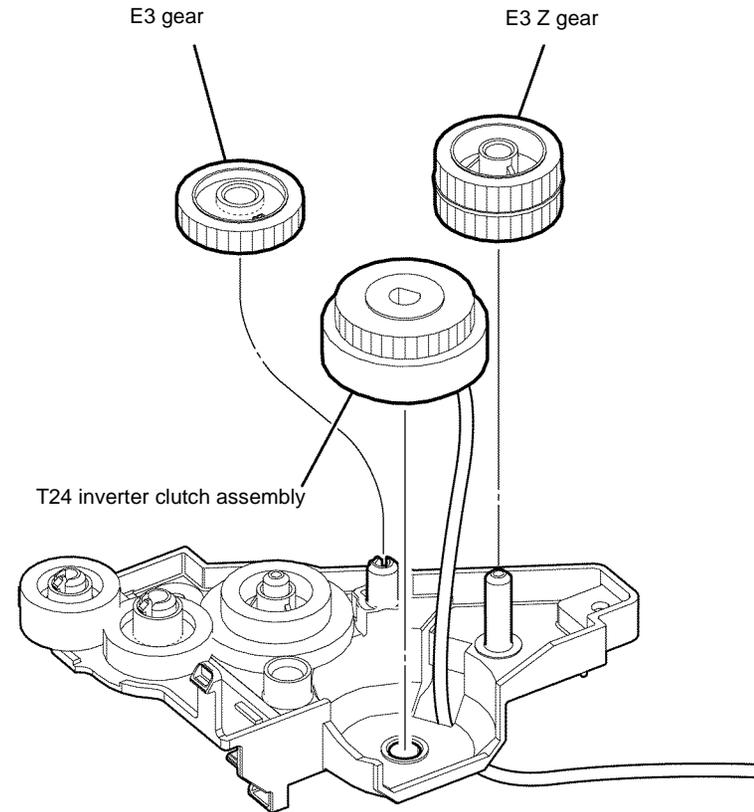
B-1-0018-A

18. Release the hook that fixes the E3 gear, from the exit out drive holder assembly. Remove the E3 gear and E3 Z gear. Remove the T24 inverter clutch assembly, [Figure 5](#).

Figure 5 T24 inverter clutch assembly removal

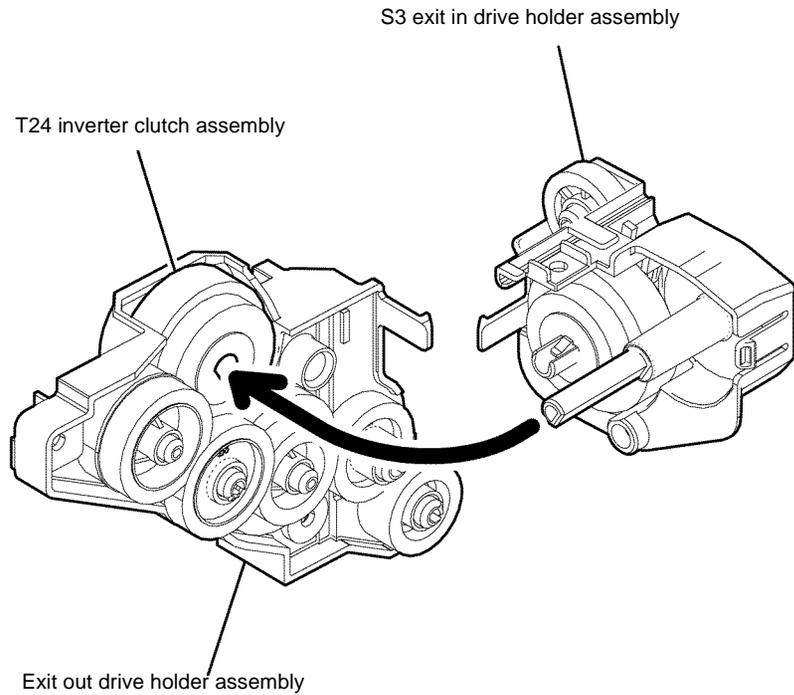
B-1-0019-A

3. When installing the exit out drive holder assembly, fit the D-shaped shaft of the exit in drive S3 holder into the D-shaped hole of the T24 inverter clutch assembly, **Figure 6**.

**Figure 6 Exit out drive holder assembly installation**

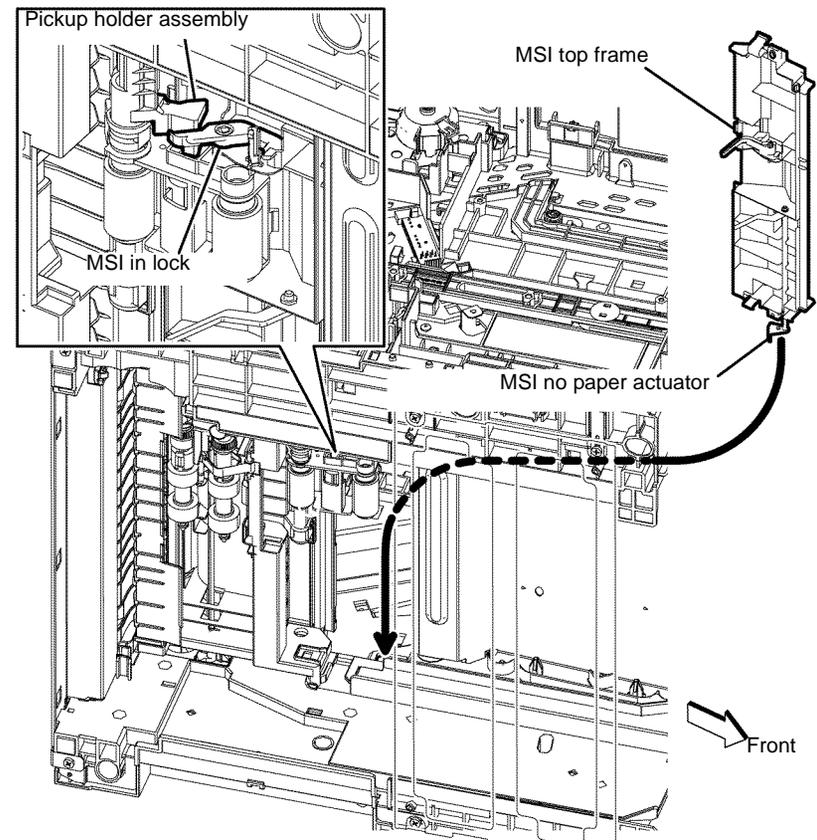
B-1-0020-A

4. When installing the MSI top frame, position the printer to be resting on its right side. Ensure that the MSI no paper actuator, coupled with the MSI top frame fits into the hole on the printer and the MSI in lock touches the pickup holder assembly, **Figure 7**.

**Figure 7 MSI top frame installation**

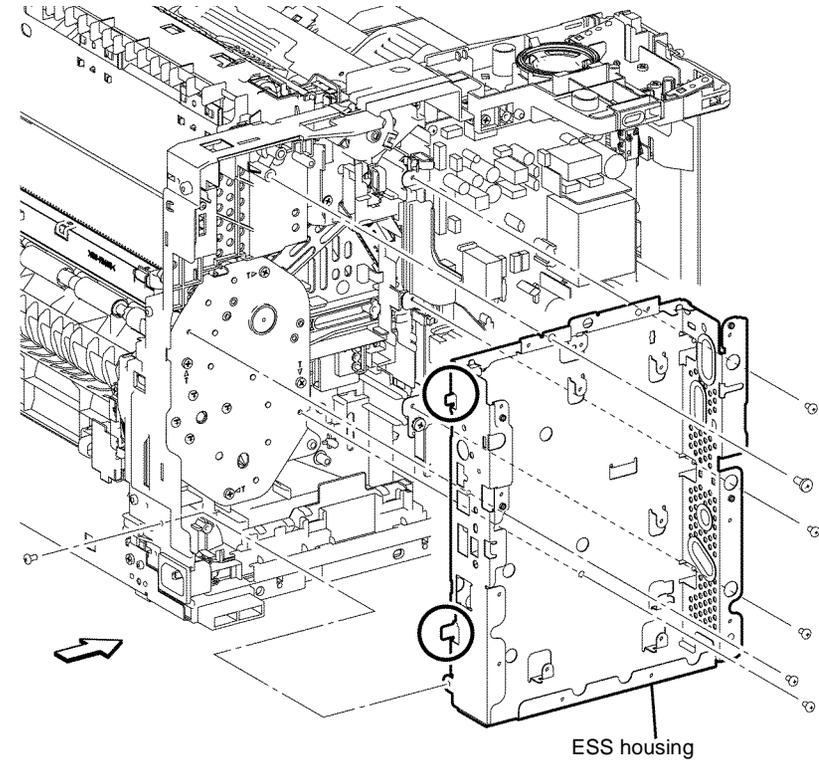
B-1-0095-A

14. Remove six screws (silver, M3, 6mm) and one screw (silver, tapping, M4, 10mm), that fix the ESS housing. Release the two tabs from the frame, then remove the ESS housing from the printer, [Figure 1](#).

Figure 1 ESS housing removal

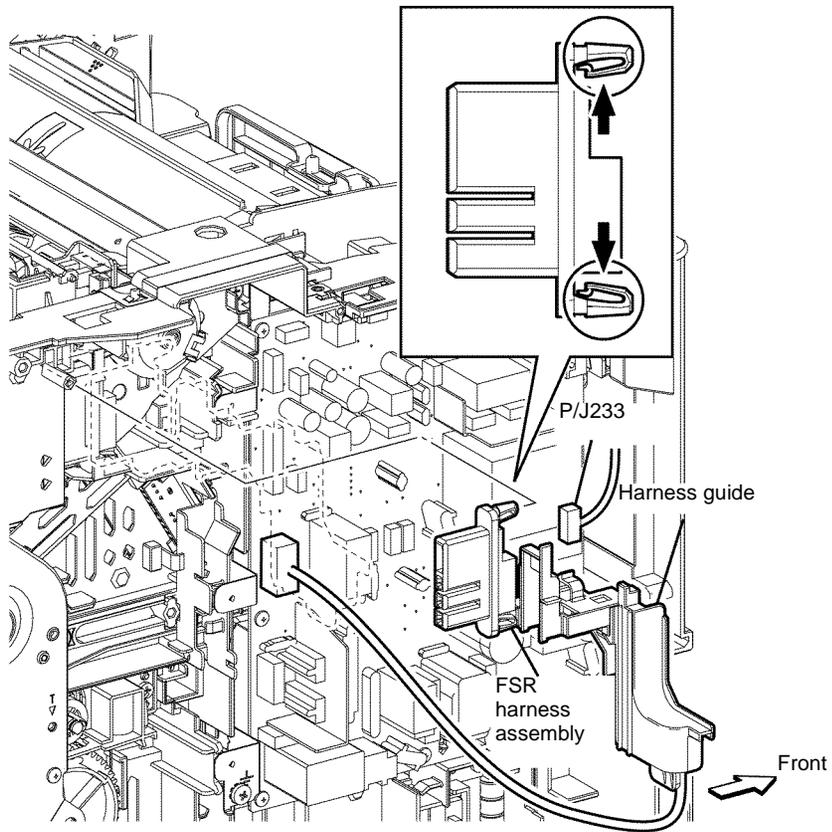
B-1-0096-A

15. Release the hook that fixes the FSR harness assembly from above. Disengage P/J233 from the FSR harness assembly, [Figure 2](#).
16. Release the two hooks that fix the harness guide to the printer. Remove the harness guide, [Figure 2](#).

Figure 2 FSR harness assembly removal

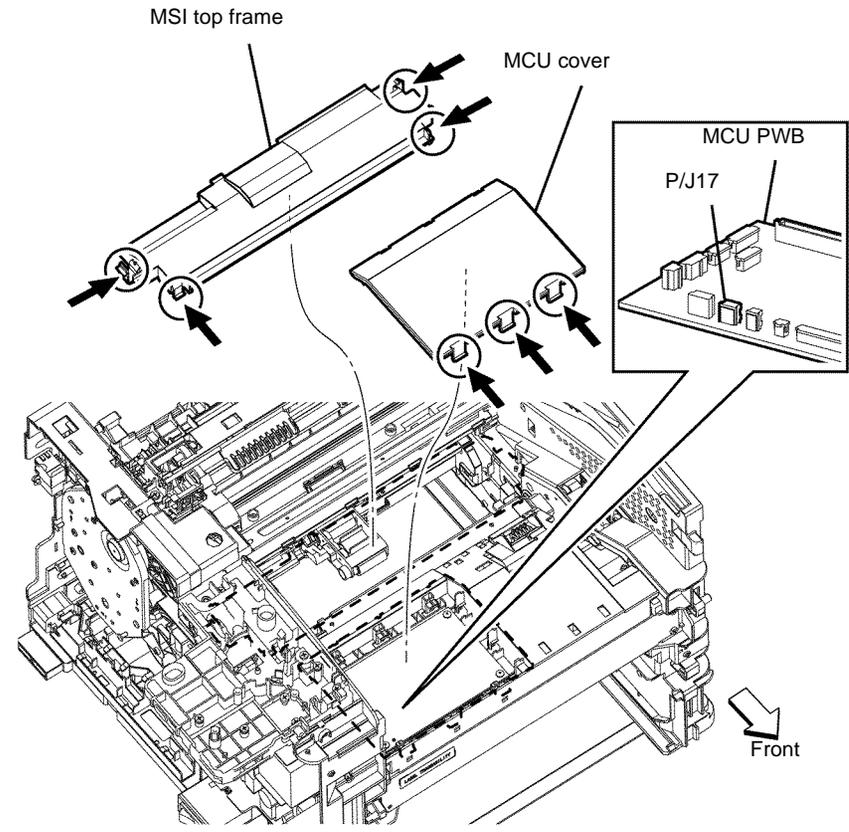
B-1-0097-A

17. Release the four hooks that fix the MSI top frame. Remove the MSI top frame, [Figure 3](#).
18. Release the three hooks that fix the MCU cover to the printer. Disengage PJ17 from the MCU PWB, then release the harness of the T21 exit clutch assembly from the harness guide, [Figure 3](#).

Figure 3 T21 exit clutch harness assembly release

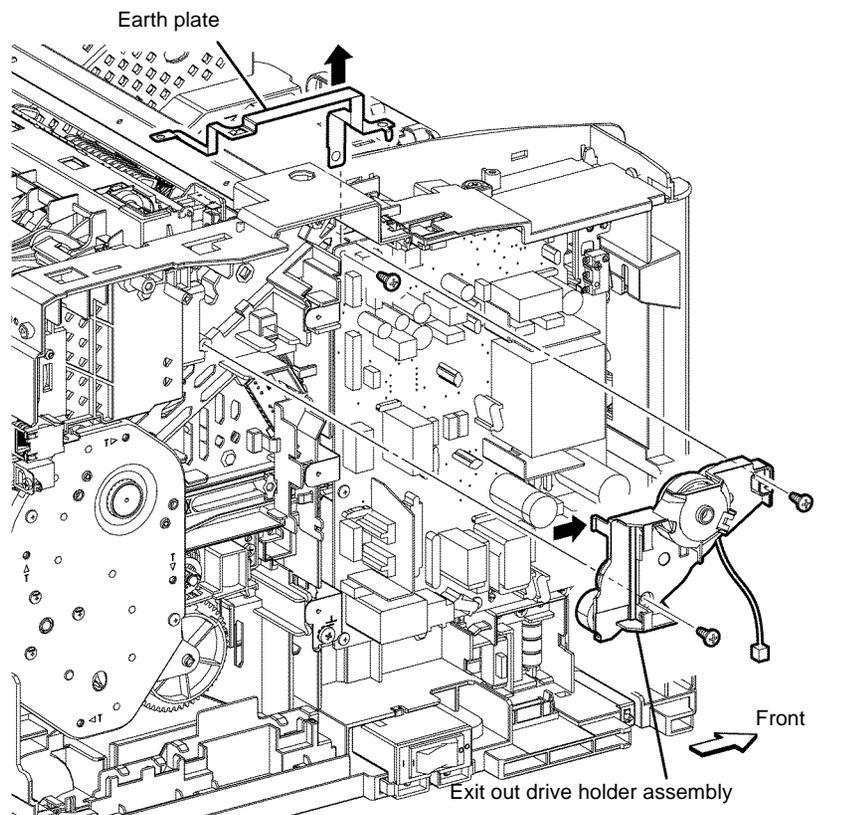
B-1-0098-A

19. Remove one screw (silver, M3, 6mm) that fixes the left upper corner of the LVPS PWB, then lift the earth plate [Figure 4](#).
20. Remove two screws (silver, tapping, 6mm) that fix the exit out drive holder assembly to the printer. Release one hook, then release the harness of the T21 exit clutch assembly. Remove the exit out drive holder assembly, [Figure 4](#).

**Figure 4** Exit out drive holder assembly removal

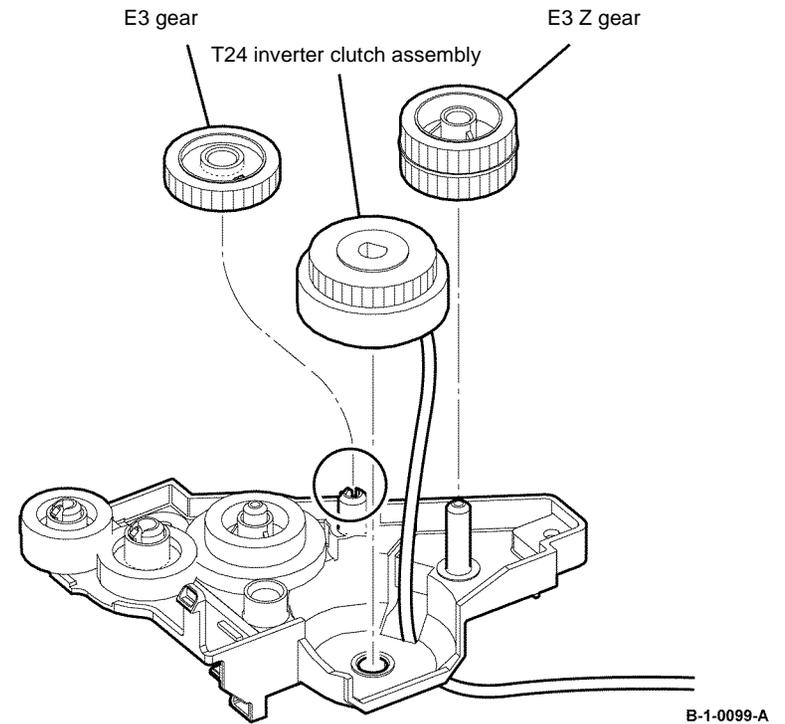
B-1-0099-A

21. Release the hook that fixes the E3 gear to the exit out drive holder assembly. Remove the E3 gear and E3 Z gear. Remove the T24 inverter clutch assembly, [Figure 5](#).
22. Remove the T24 inverter clutch assembly, [Figure 5](#).

**Figure 5** T24 inverter clutch assembly removal

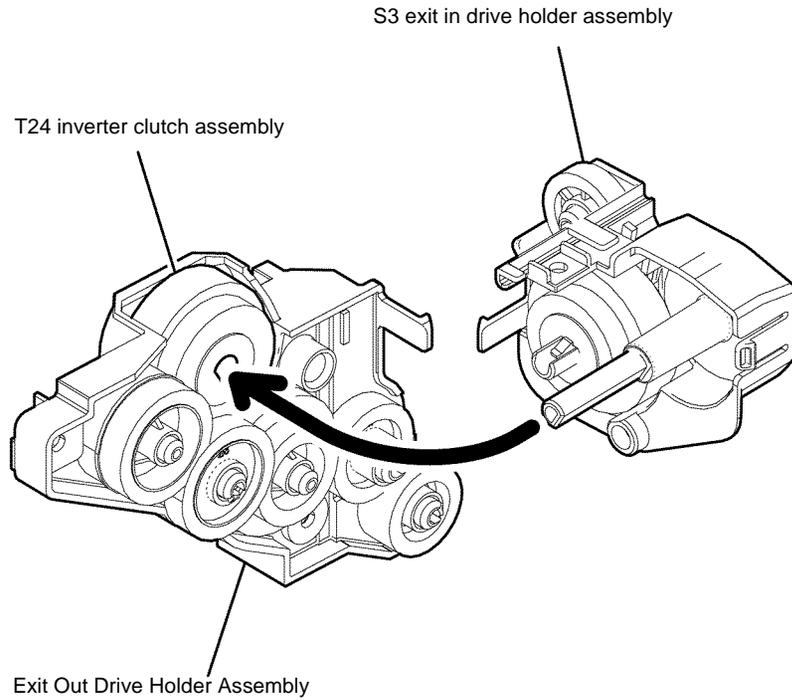
B-1-0100-A

- When installing the exit out drive holder assembly, fit the D-shaped shaft of the exit in drive S3 holder into the D-shaped hole of the T24 inverter clutch assembly, [Figure 6](#).

**Figure 6 Exit out drive holder assembly installation**

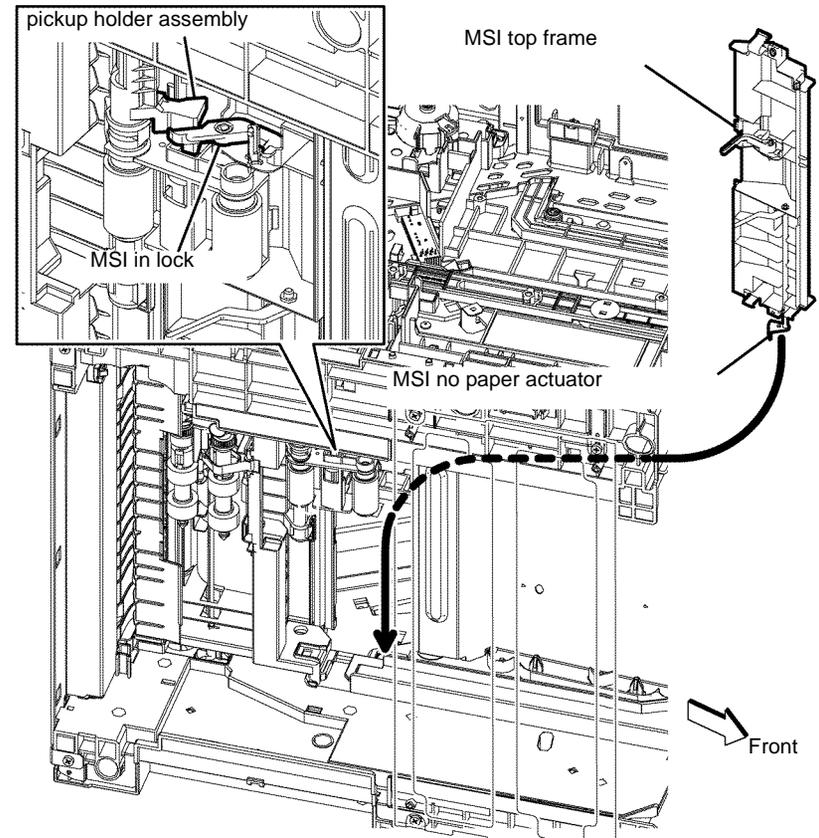
B-1-0101-A

- When installing the MSI top frame, position the printer to be resting on its right side. Ensure that the MSI no paper actuator, coupled with the MSI top frame fits into the hole on the printer and the MSI in lock touches the pickup holder assembly, [Figure 7](#).

**Figure 7 MSI top frame installation**

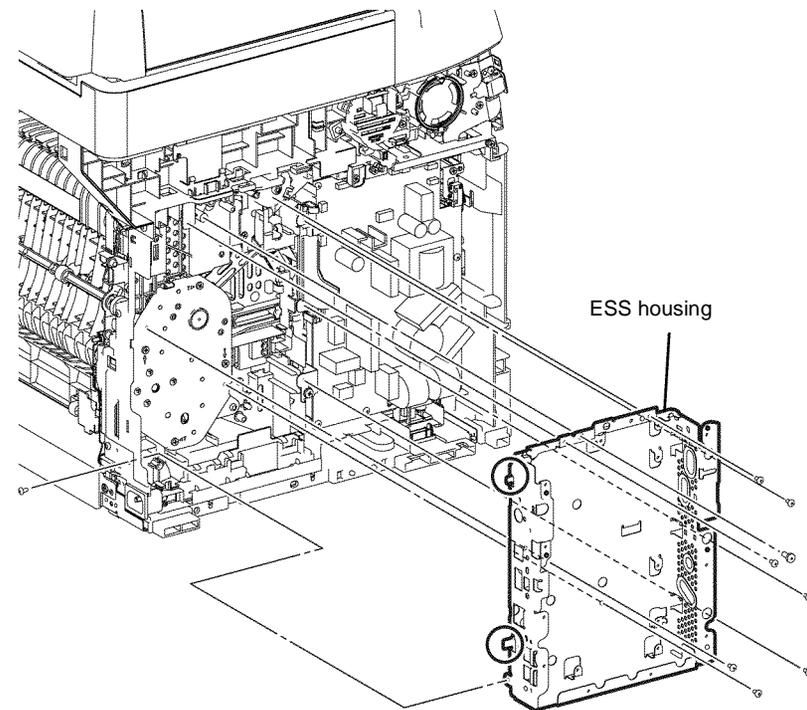
12. Remove six screws (silver, M3, 6mm) and one screw (silver, tapping, M4, 10mm) that fix the ESS housing. Release the two tabs from the frame, then remove the ESS housing from the printer, [Figure 1](#).

Figure 1 ESS housing removal

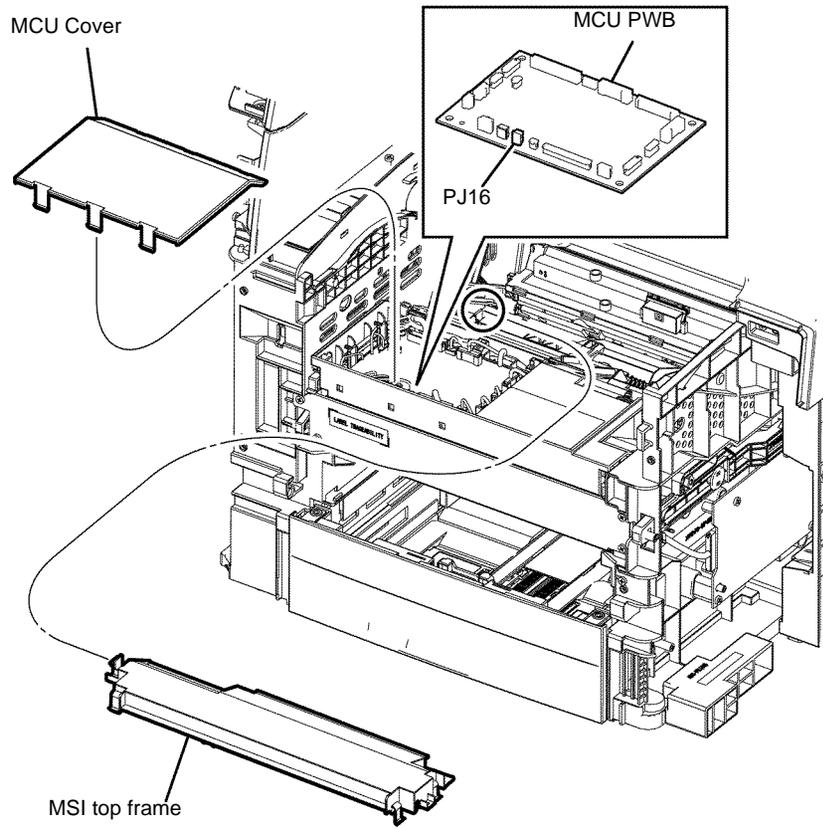
B-1-0102-A

13. Release the four hooks that fix the MSI top frame, then remove the MSI top frame, [Figure 2](#).

- Remove the MCU cover by releasing the hook. Disengage PJ16 from the MCU PWB, then release the harness of the T24 inverter clutch assembly from the harness guide, [Figure 2](#).

**Figure 2 T24 inverter clutch assembly harness release**

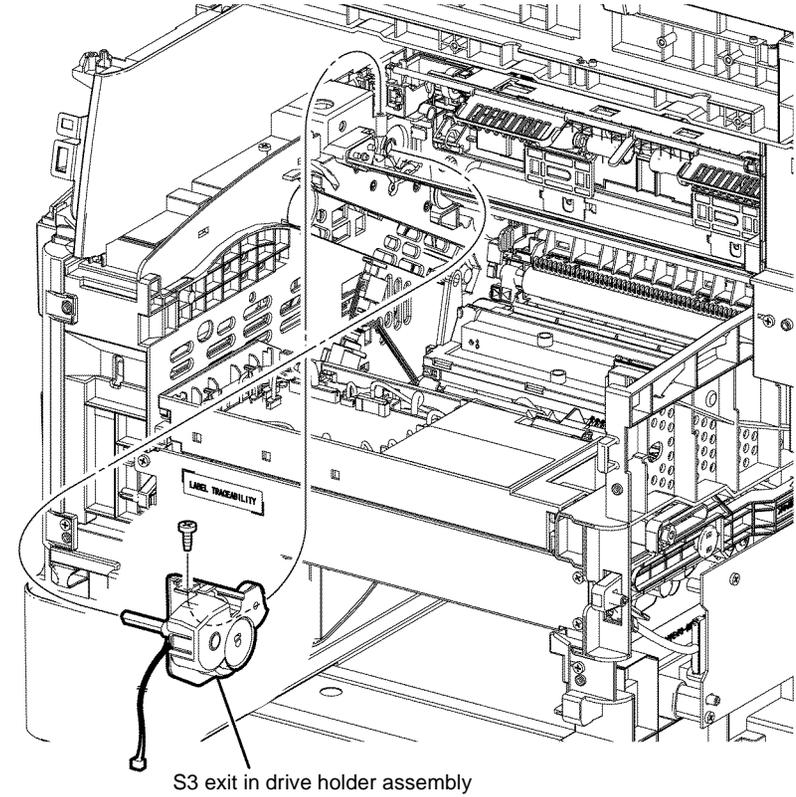
B-1-0021-A

- Remove one screw (silver, tapping, 8mm) that fixes the exit in drive holder assembly, then remove the exit in drive holder assembly from the printer, [Figure 3](#).

**Figure 3 Exit in drive holder assembly removal**

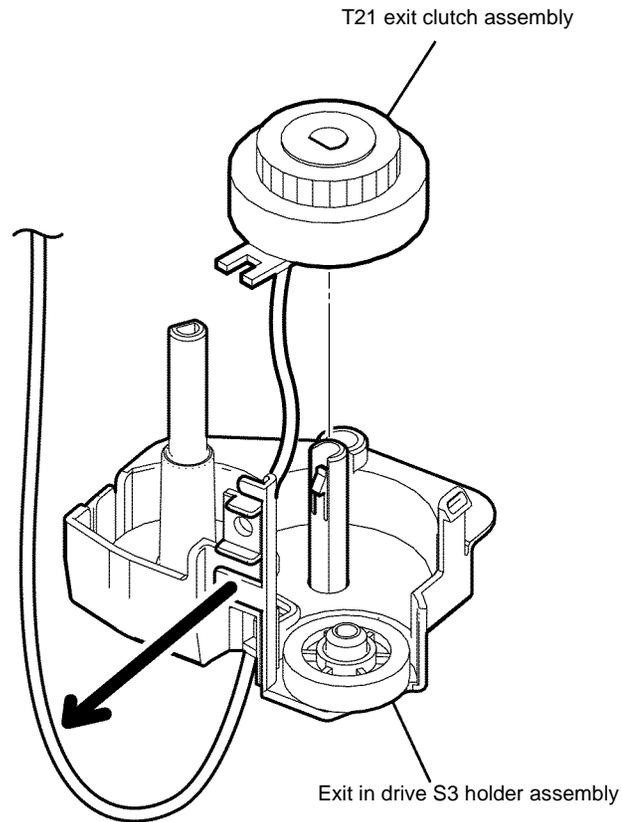
B-1-0022-A

17. Release the hook on the shaft, and then remove the T21 exit clutch assembly, **Figure 4**.

**Figure 4 T21 exit clutch assembly removal**

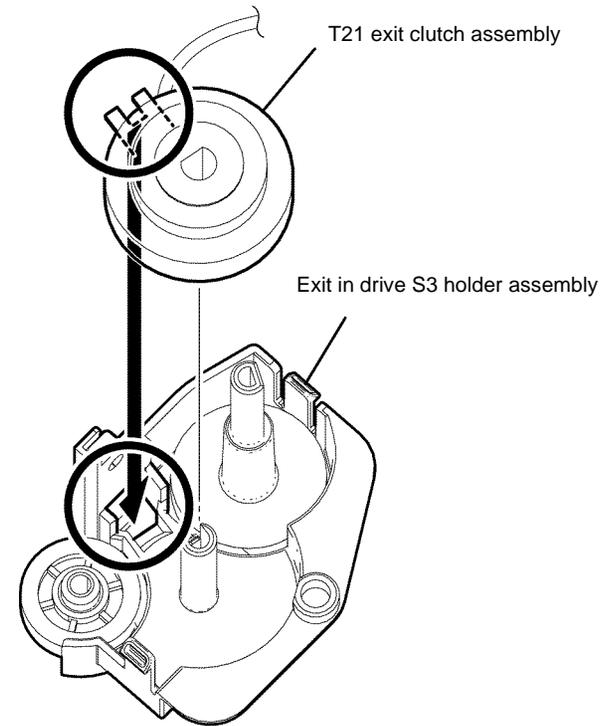
B-1-0023-A

2. When installing the T21 exit clutch assembly, fit the tab into the stopper of the exit in drive holder assembly, **Figure 5**.

**Figure 5 T21 exit clutch assembly installation**

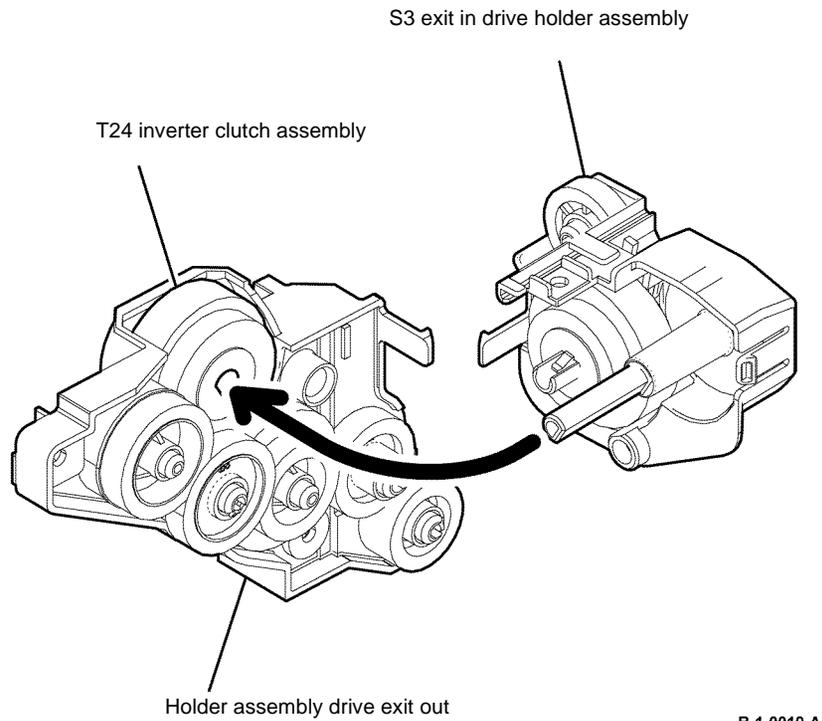
- When installing the exit in drive holder assembly, fit the D-shaped shaft of the exit in drive holder assembly into the D-shaped hole of the T24 inverter clutch assembly, [Figure 6](#).

**Figure 6 Exit in drive holder assembly installation**

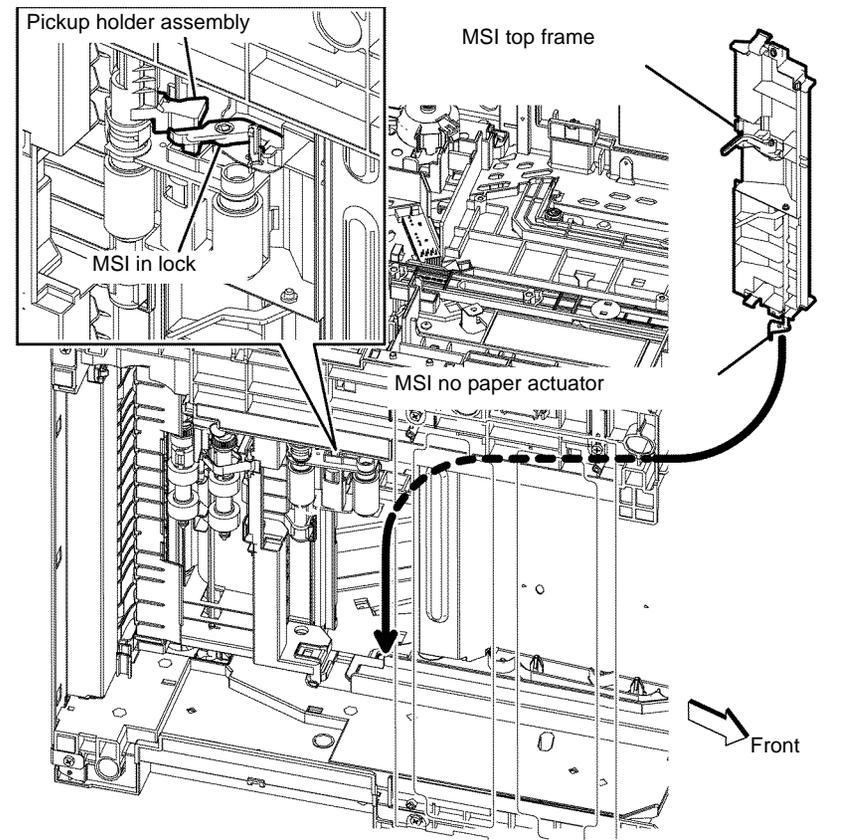
- When installing the MSI top frame, position the printer to be resting on its right side. Ensure that the MSI no paper actuator, coupled with the MSI top frame fits into the hole on the printer and the MSI in lock touches the pickup holder assembly, [Figure 7](#).

**Figure 7 MSI top frame installation**

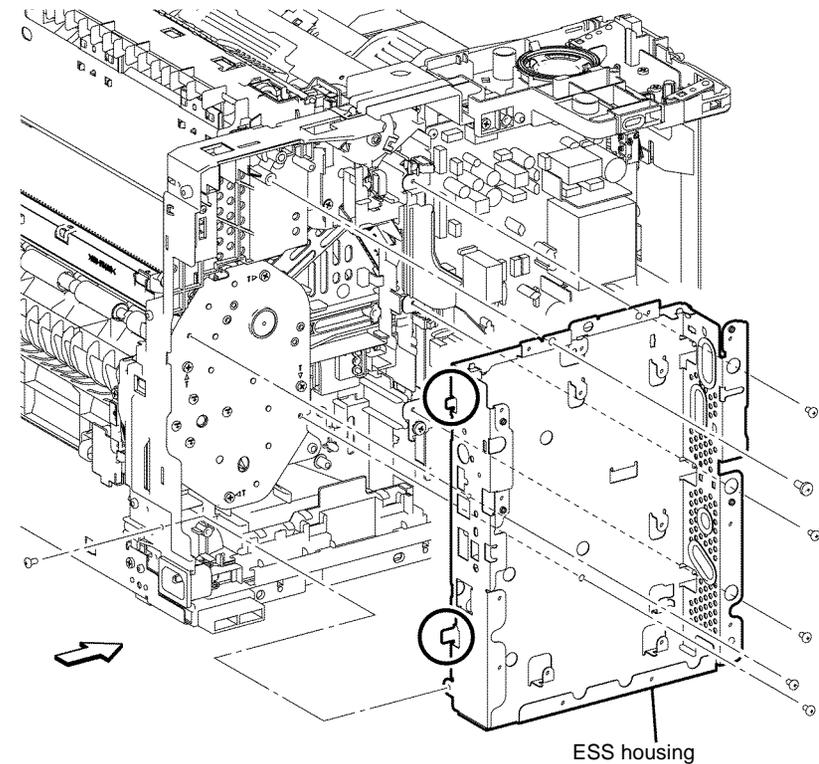
B-1-0103-A

12. Remove six screws (silver, M3, 6mm) and one screw (silver, tapping, M4, 10mm) that fix the ESS housing. Release the two tabs from the frame, then remove the ESS housing from the printer, [Figure 1](#).

Figure 1 ESS housing removal

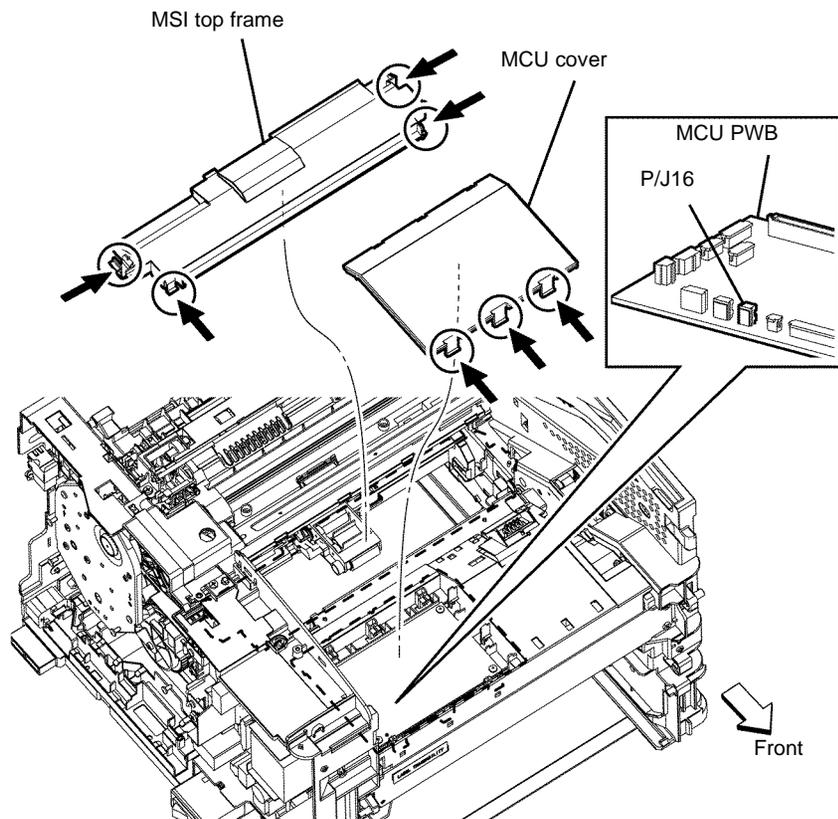
B-1-0104-A

13. Release the four hooks that fix the MSI top frame, then remove the MSI top frame, [Figure 2](#).
14. Remove the MCU cover by releasing the three hooks. Disengage P/J16 from the MCU PWB, then release the harness of the T24 inverter clutch assembly from the harness guide, [Figure 2](#).

**Figure 2 T24 inverter clutch harness assembly release**

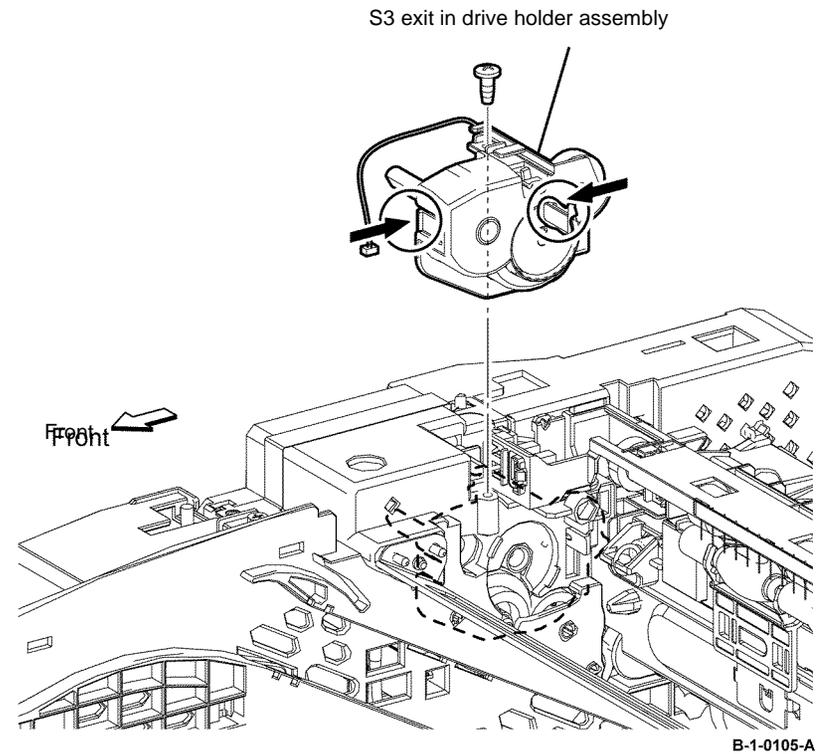
B-1-0105-A

15. Remove one screw (silver, tapping, 6mm) that fixes the exit in drive holder assembly to the printer. Release the two hooks, release the harness of the T21 exit clutch assembly, then remove the exit in drive holder assembly from the printer, [Figure 3](#).

**Figure 3 Exit in drive holder assembly removal**

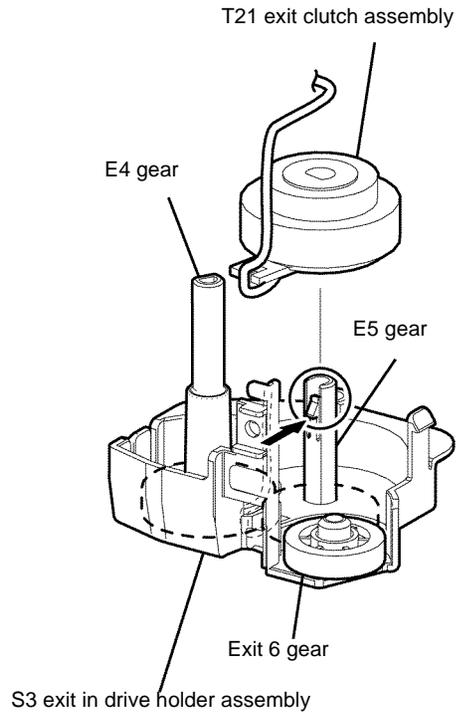
B-1-0106-A

17. Release the hook on the E5 gear, then remove the T21 exit clutch assembly, [Figure 4](#).

Figure 4 T21 exit clutch assembly removal

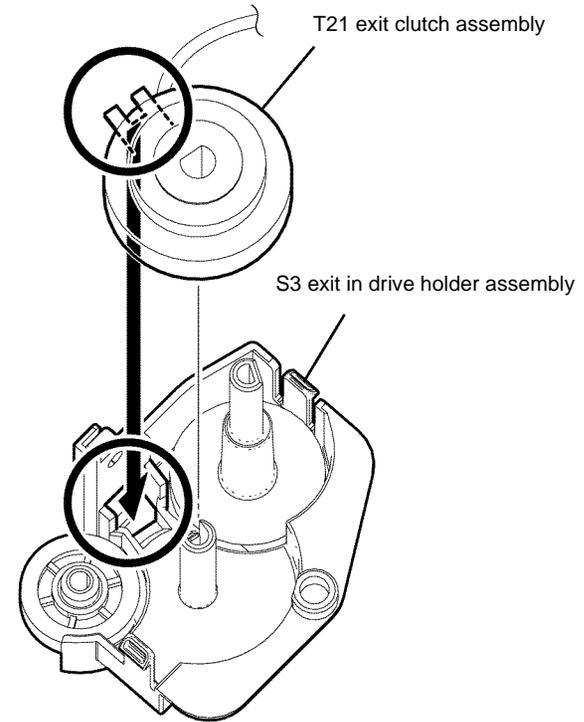
B-1-0107-A

2. When installing the T21 exit clutch assembly, fit the tab into the stopper of the exit in drive holder assembly, [Figure 5](#).

Figure 5 T21 exit clutch assembly installation

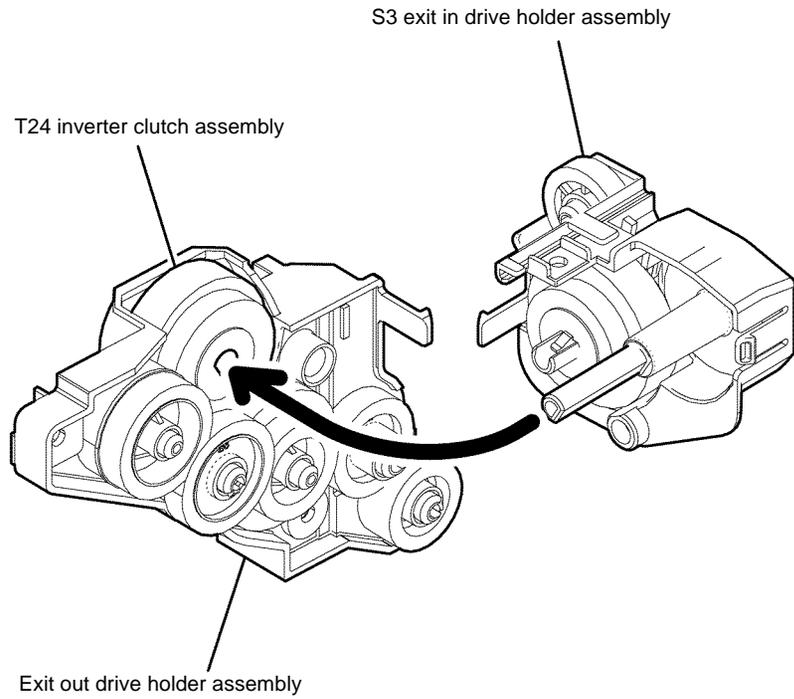
B-1-0108-A

- When installing the exit in drive holder assembly, fit the D-shaped shaft of the exit in drive holder assembly into the D-shaped hole of the T24 inverter clutch assembly, [Figure 6](#).

**Figure 6 Exit in drive holder assembly installation**

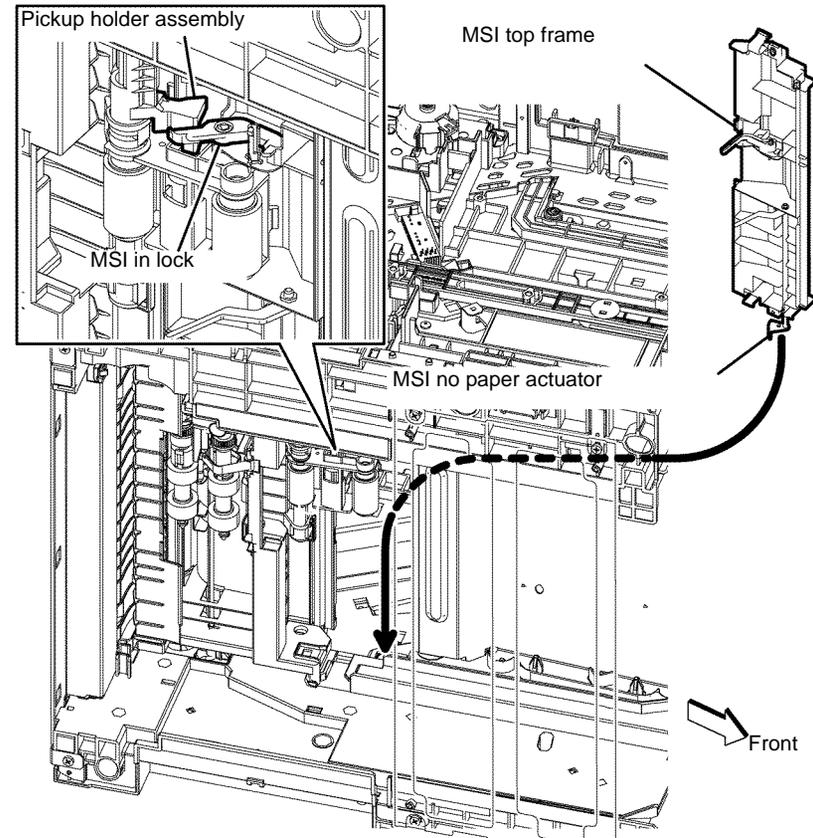
B-1-0109-A

- When installing the MSI top frame, position the printer to be resting on its right side. Ensure that the MSI no paper actuator, coupled with the MSI top frame fits into the hole on the printer and the MSI in lock touches the pickup holder assembly, [Figure 7](#).

**Figure 7 MSI top frame installation**

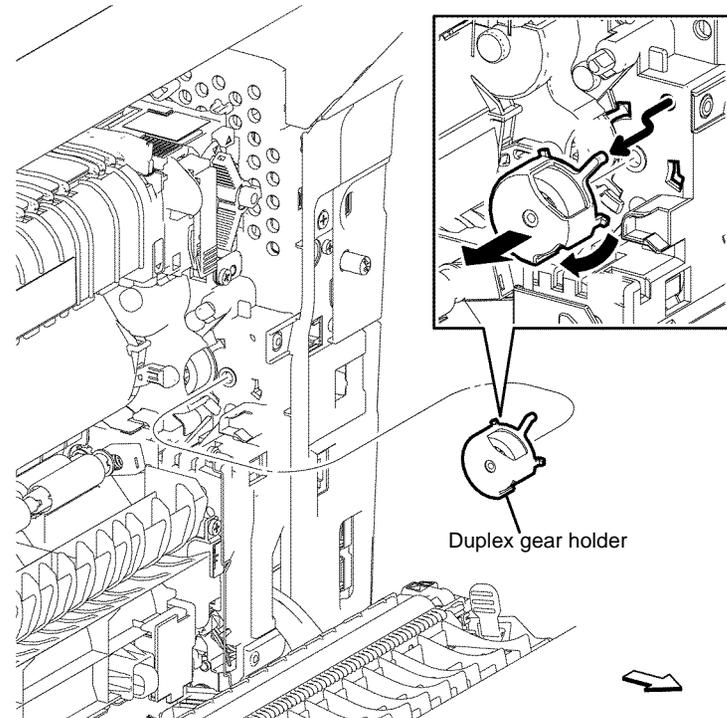
B-1-0024-A

2. Rotate the duplex gear holder, clockwise while pulling the tab, [Figure 1](#).

Figure 1 Duplex gear holder removal

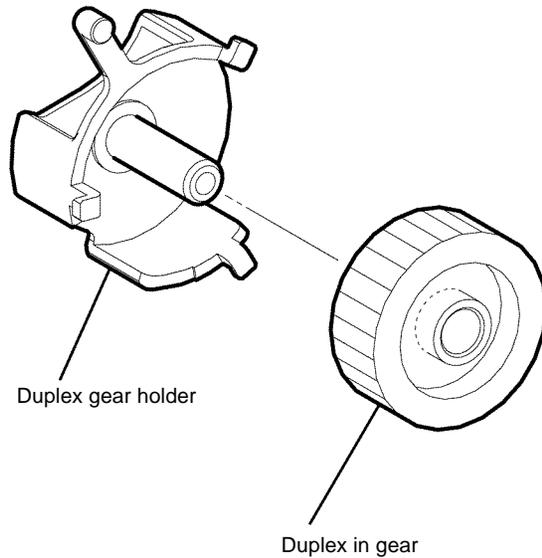
B-1-0025-A

3. Remove the duplex in gear from the duplex gear holder, [Figure 2](#).

**Figure 2 Duplex in gear removal**

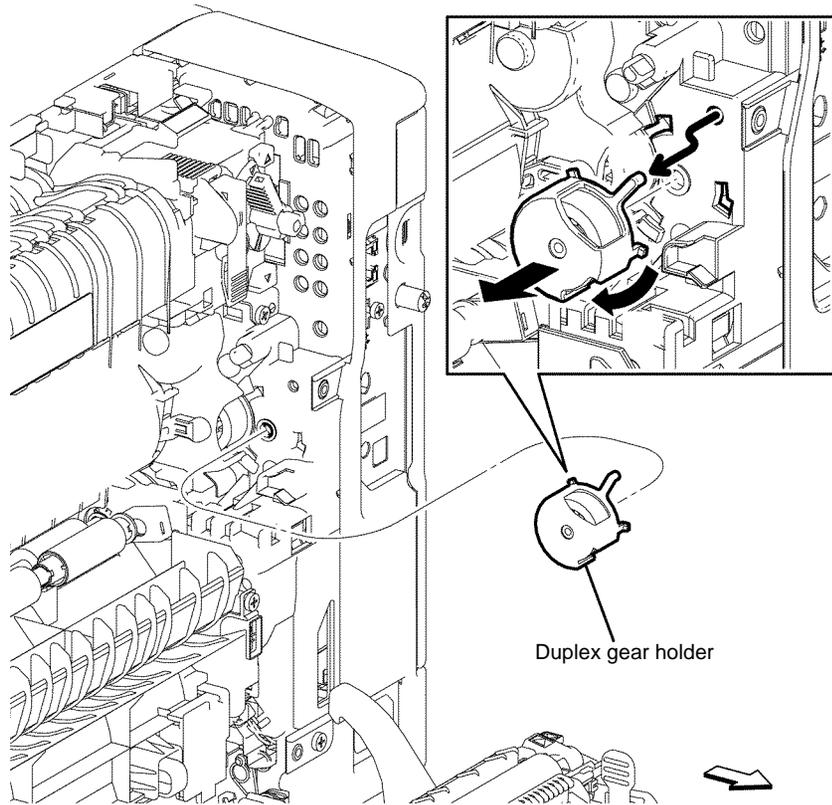
B-1-0110-A

2. Rotate the duplex gear holder, clockwise while pulling the tab, **Figure 1**.

**Figure 1 Duplex gear holder removal**

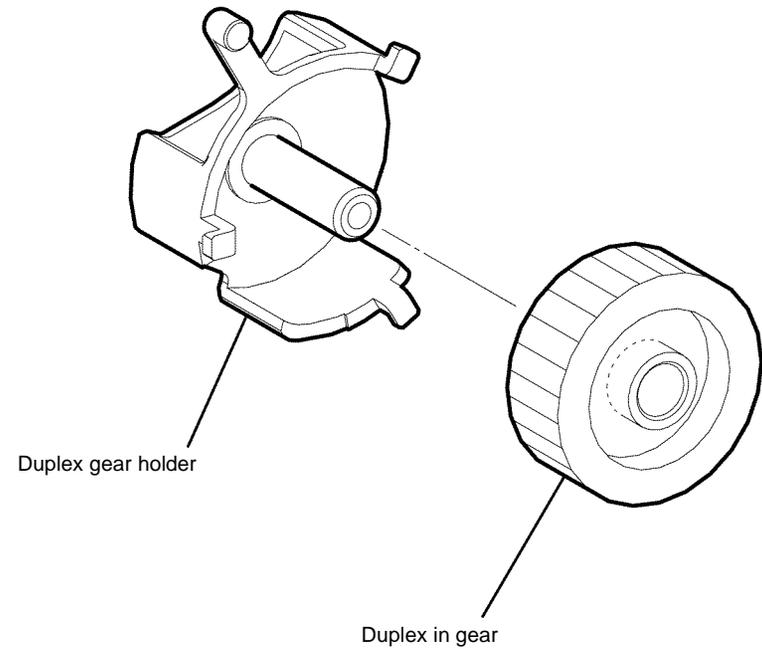
B-1-0111-A

3. Remove the duplex in gear from the duplex gear holder, **Figure 2**.

**Figure 2 Duplex in gear removal**

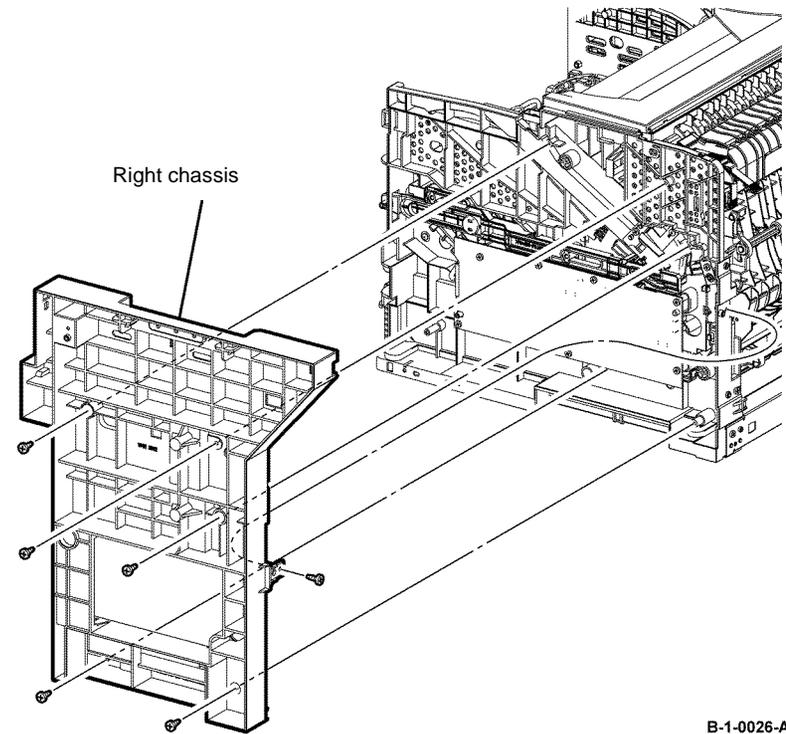
7. Remove the six screws (silver, tapping, 8mm) that fix the right chassis, release the hole on the right chassis from the boss on the frame, and then remove the right chassis from the printer, [Figure 1](#).

Figure 1 Right chassis removal
