# Xerox® VersaLink® B400 & B405 Family Multifunction Printer Service Manual

VersaLink B400 and B405 Family Multifunction Printer Service Manual

708P91373

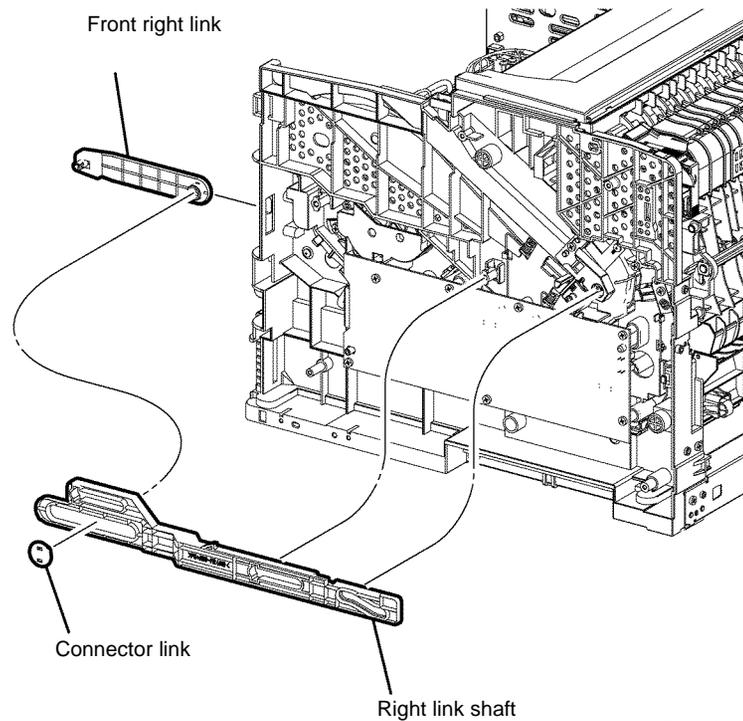
9. Remove the right link shaft by bending it outside from inside the printer, [Figure 2](#).

Figure 2 Right link shaft removal

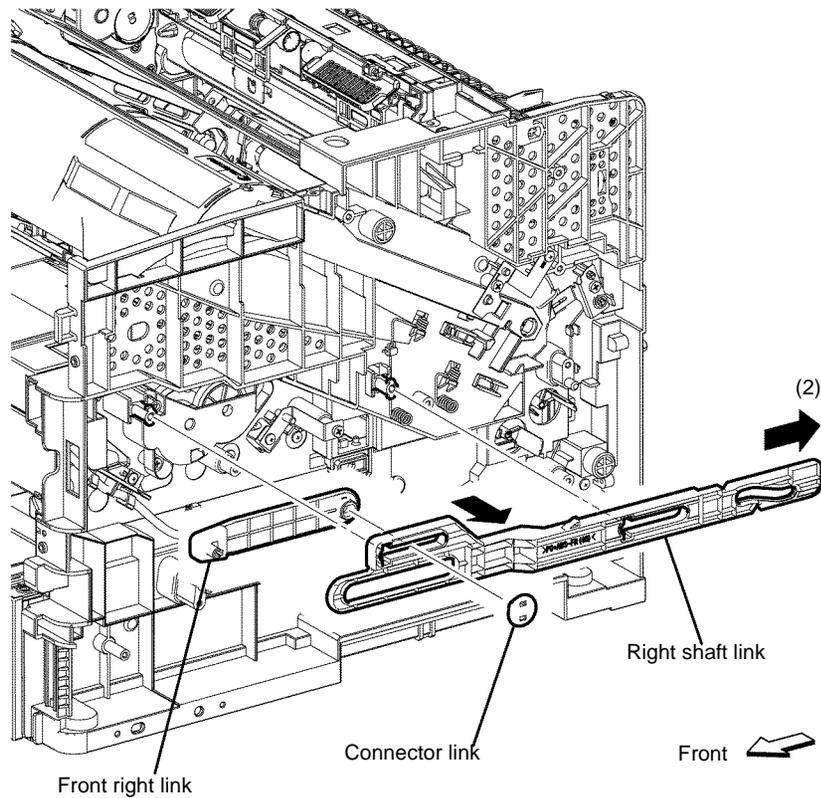
B-1-0112-A

9. Remove the right shaft link by bending it outside from inside the printer, [Figure 1](#).

Figure 1 Right link shaft removal

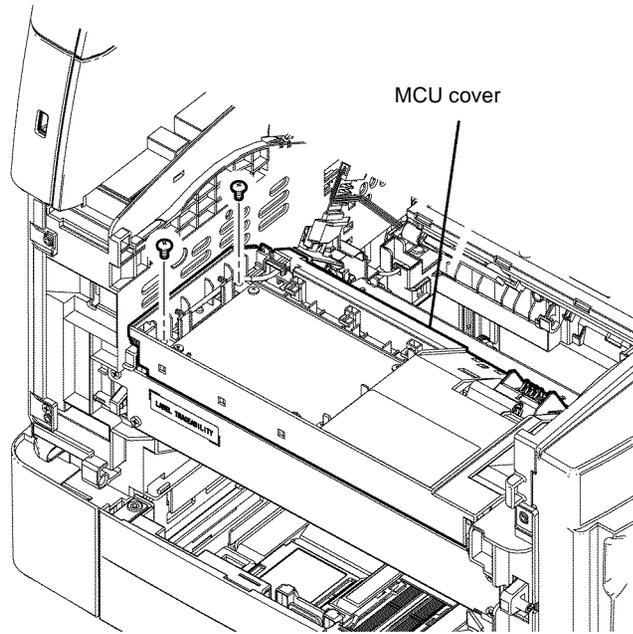
B-1-0028-A

12. Remove the MCU cover, then remove two screws (silver, M3, 6mm) from the left side, [Figure 1](#).

Figure 1 MCU cover removal

1. The replacement is the reverse of the removal procedure.
2. When installing the MCU cover, do not pinch the wire with the screws.

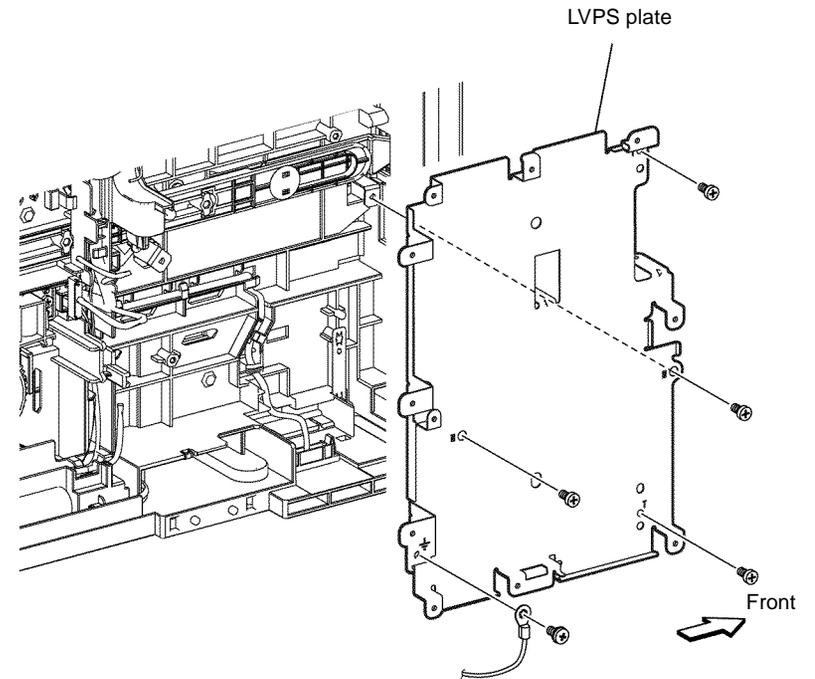
B-1-0029-A

13. Remove the LVPS plate, [Figure 2](#).

Figure 2 LVPS plate removal

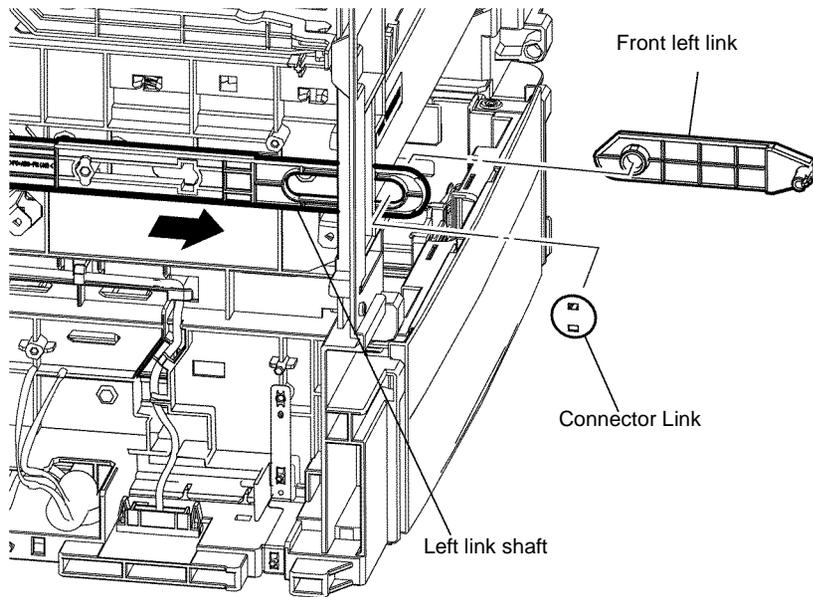
B-1-0030-A

14. Pull out the left link shaft toward the front of the printer, then remove the connector link and the front left link, [Figure 3](#).

**Figure 3 Front left link removal**

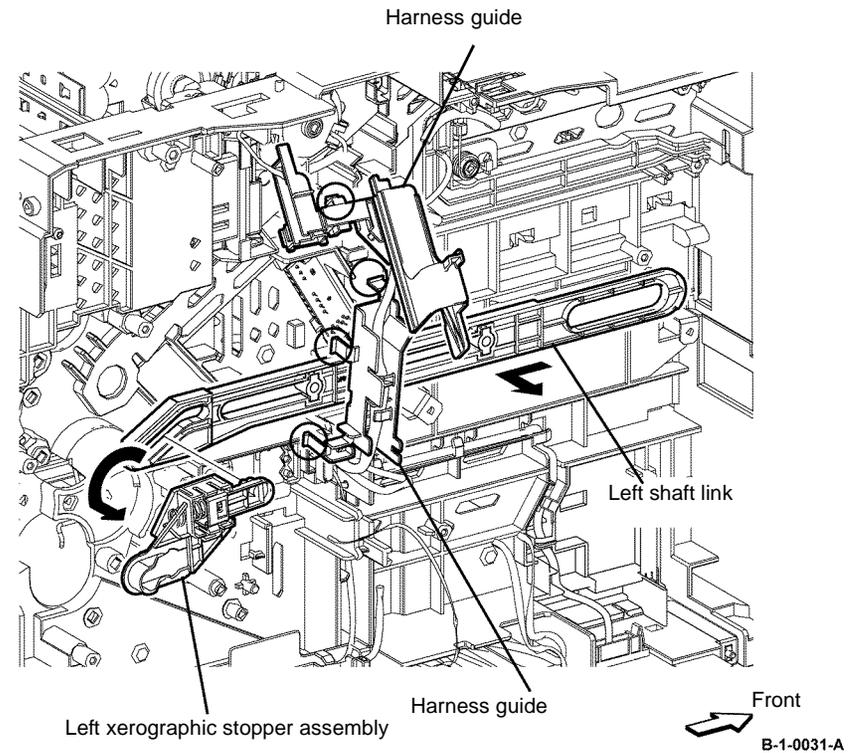
B-1-0031-A

17. Remove the left link shaft by bending it outside from inside the printer, [Figure 4](#).

**Figure 4 Left link shaft removal**

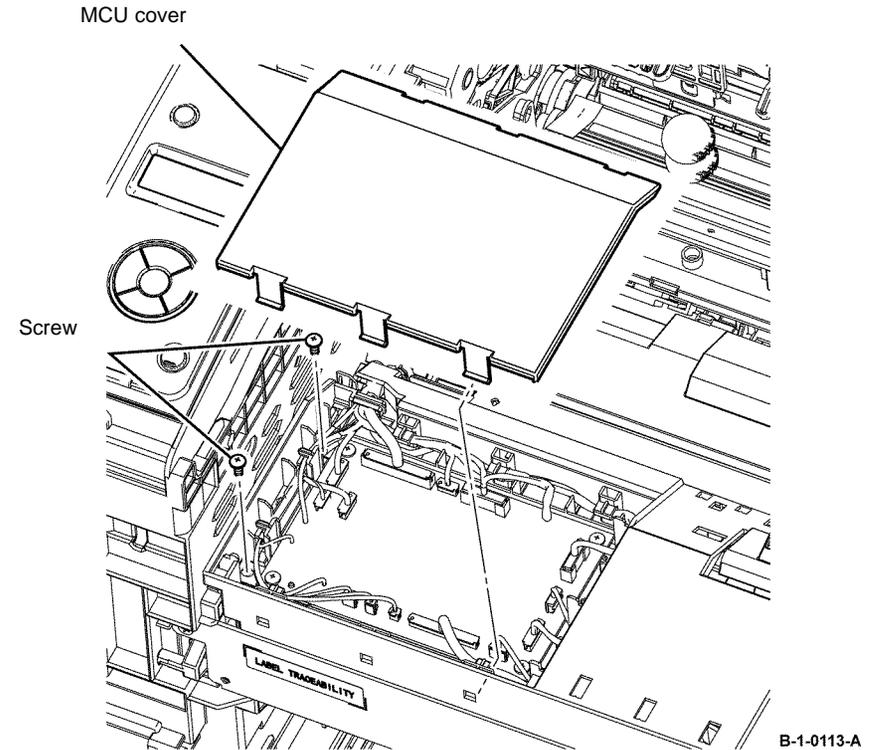
14. Remove the MCU cover, then remove two screws (silver, M3, 6mm) from the left side, Figure 1.

Figure 1 MCU cover removal

1. The replacement is the reverse of the removal procedure.
2. When installing the MCU cover, do not pinch the wire with the screws.

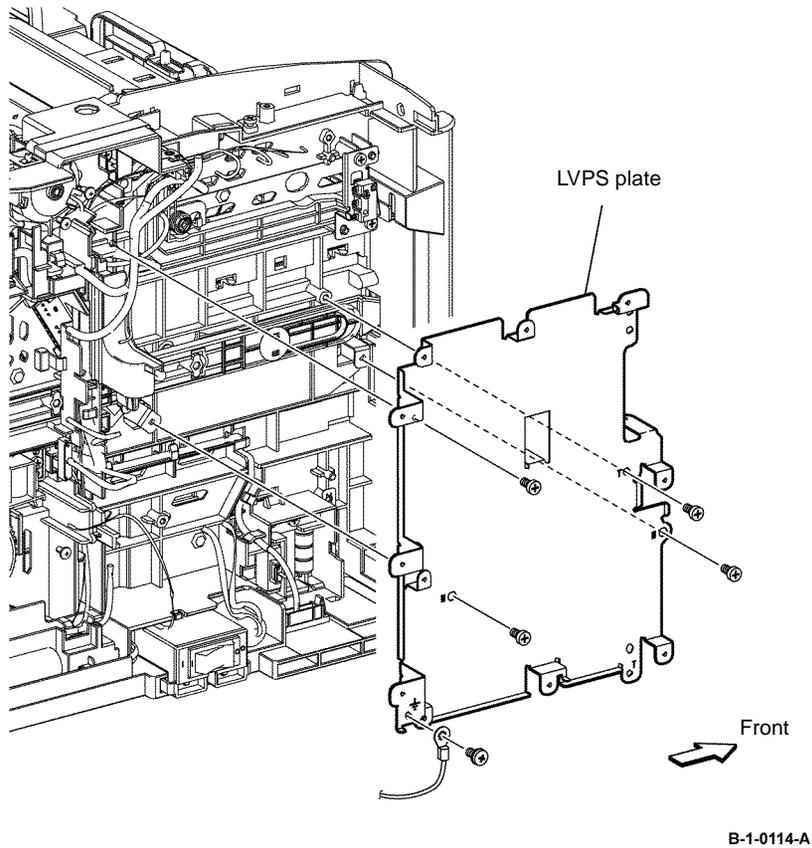
15. Remove the LVPS plate, [Figure 2](#).

Figure 2 LVPS plate removal

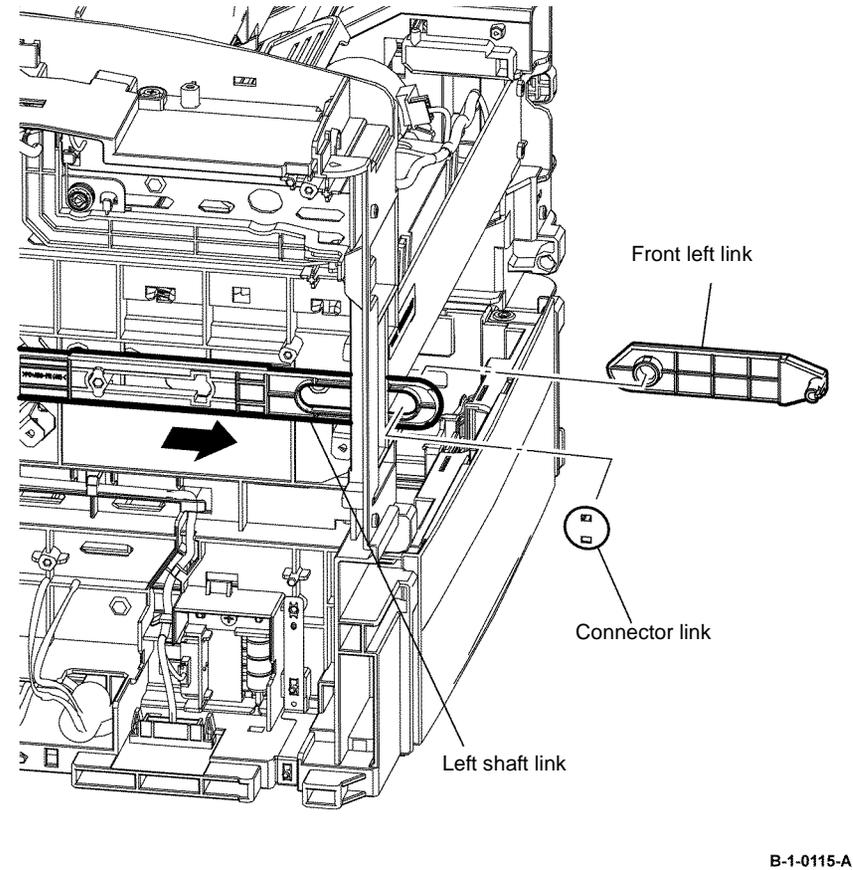
16. Pull out the left link shaft toward the front of the printer, then remove the link connector and the front left link, [Figure 3](#).

Figure 3 Front left link removal

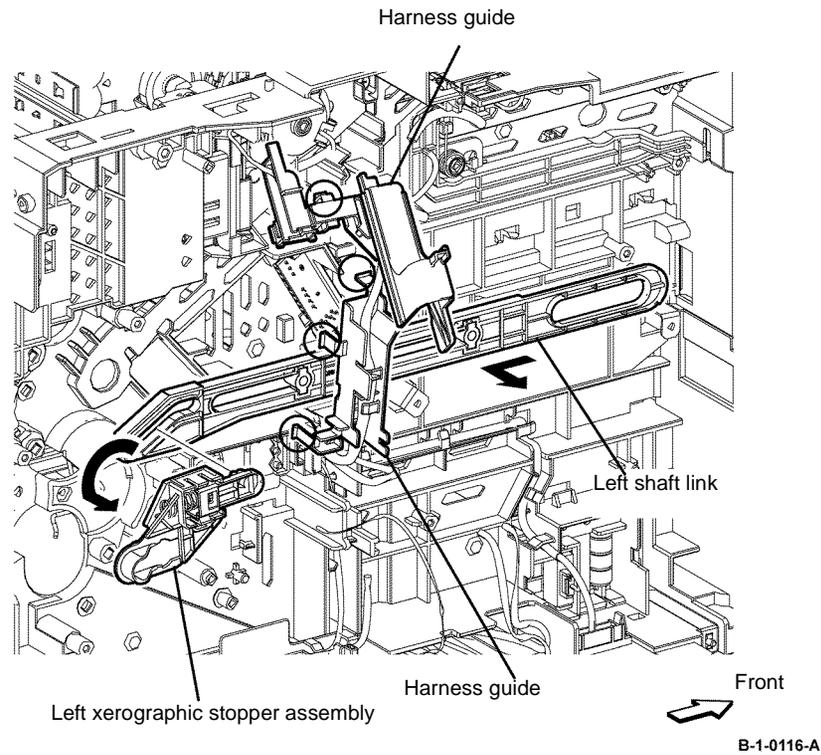
19. Remove the left link shaft by bending it outside from inside the printer, [Figure 4](#).

**Figure 4 Left link shaft removal**

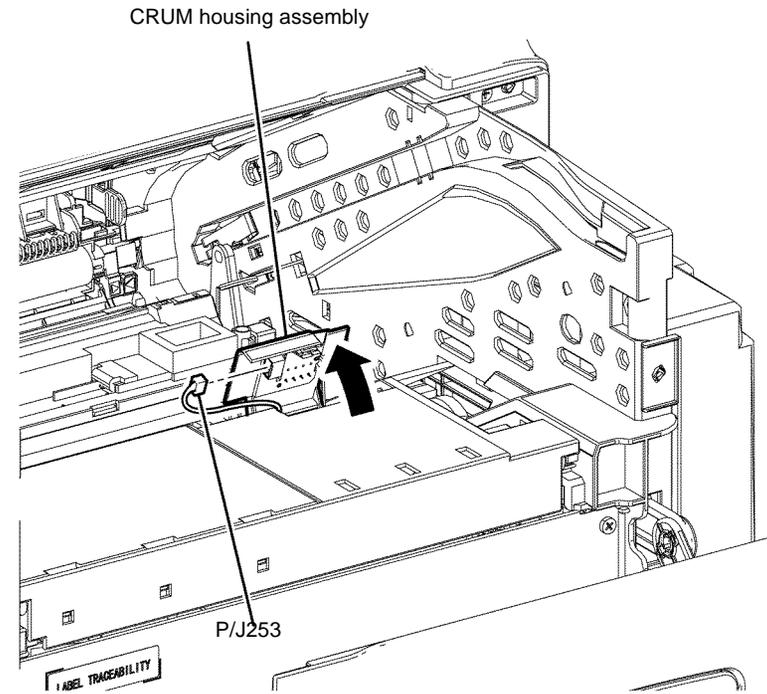
B-1-0032-A

3. Release the hook, open the CRUM housing assembly, [Figure 2](#).
4. Remove the toner CRUM connector assembly, from the CRUM swing housing, [Figure 2](#).
5. Disengage P/J253, [Figure 2](#).

Figure 2 Toner CRUM connector assembly removal

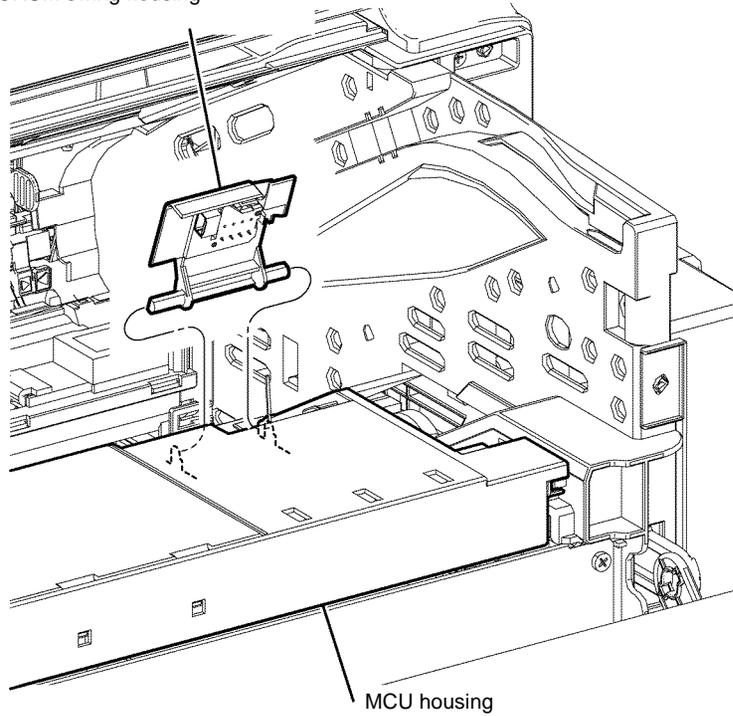
B-1-0033-A

6. Release one boss of the CRUM swing housing, then remove the CRUM swing housing from the printer, [Figure 3](#).

Figure 3 CRUM swing housing removal

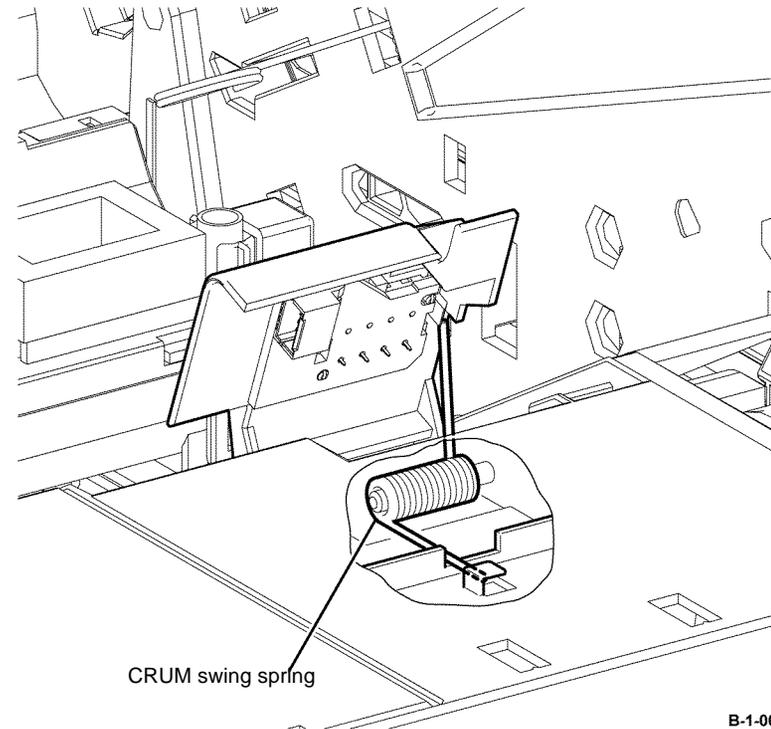
B-1-0034-A

2. When closing the CRUM housing assembly, ensure the CRUM swing spring is installed as shown, [Figure 4](#).

Figure 4 CRUM swing spring installation

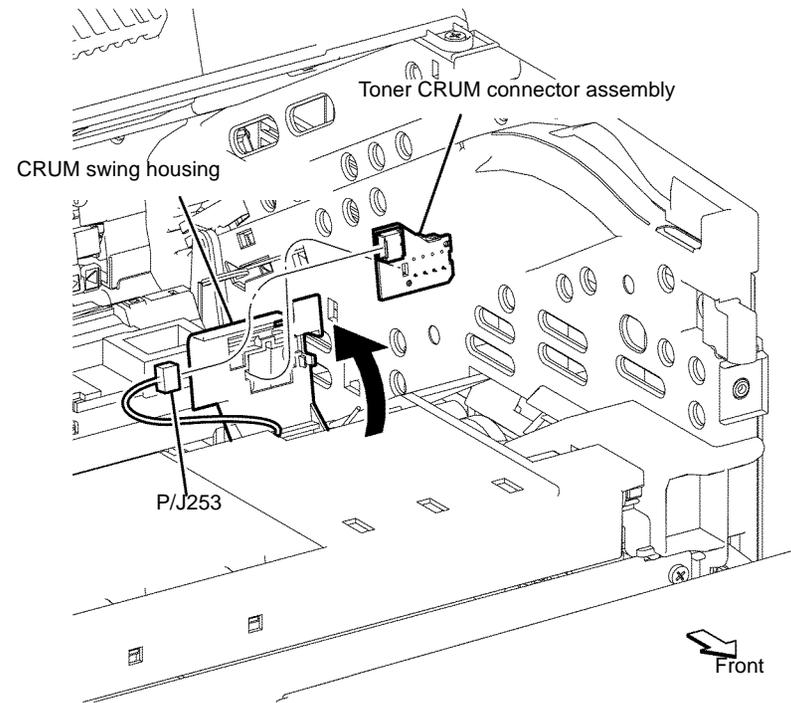
B-1-0117-A

3. Release the hook, open the CRUM housing assembly, Figure 2.
4. Remove the toner CRUM connector assembly, from the CRUM swing housing, Figure 2.
5. Disengage P/J253, Figure 2.

Figure 2 Toner CRUM connector assembly removal

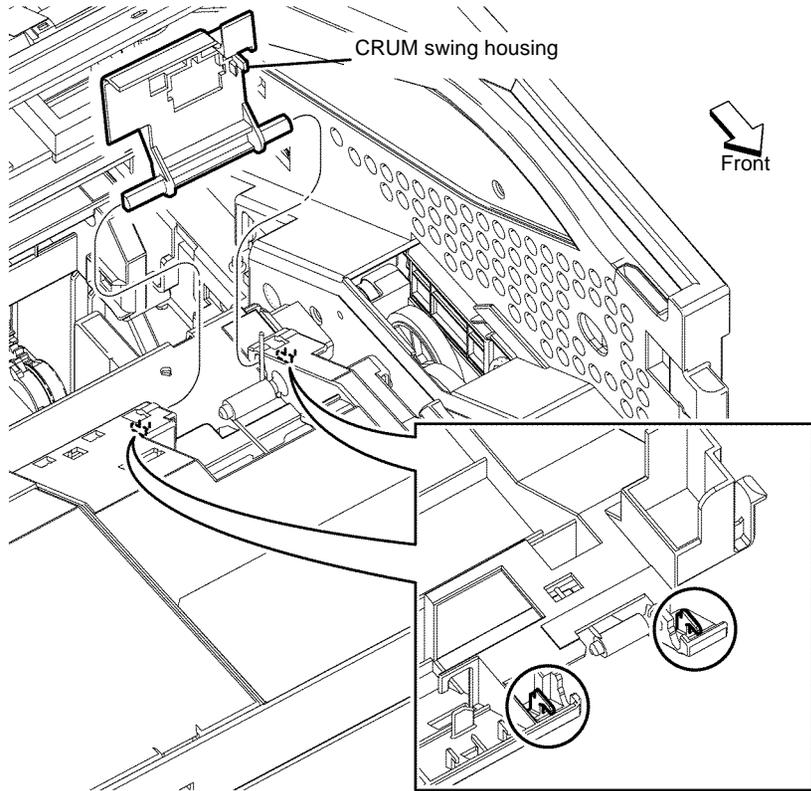
B-1-0118-A

6. Release two bosses of the CRUM swing housing, then remove the CRUM swing housing from the printer, [Figure 3](#).

Figure 3 CRUM swing housing removal

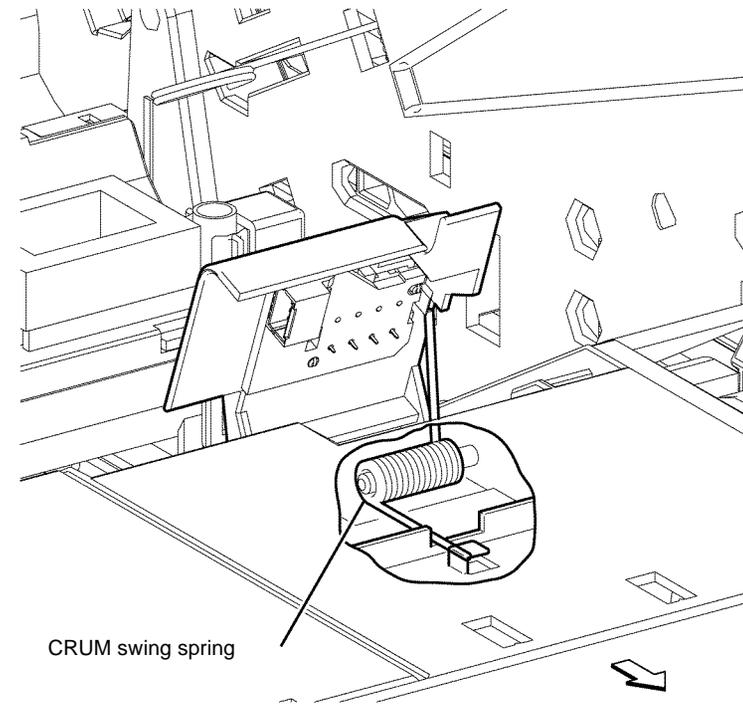
B-1-0119-A

2. When closing the CRUM housing assembly, ensure the CRUM swing spring is installed as shown, [Figure 4](#).

Figure 4 CRUM swing spring installation

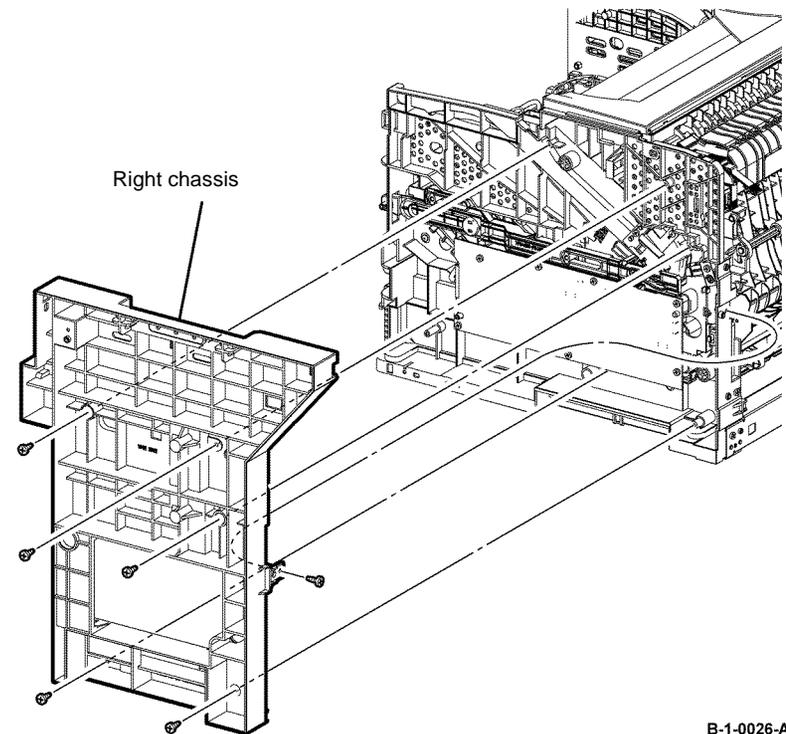
B-1-0026-A

7. Remove the six screws (silver, tapping, 8mm) that fix the right chassis, release the hole on the right chassis from the boss on the frame, and then remove the right chassis from the printer, [Figure 1](#).

Figure 1 Right chassis removal

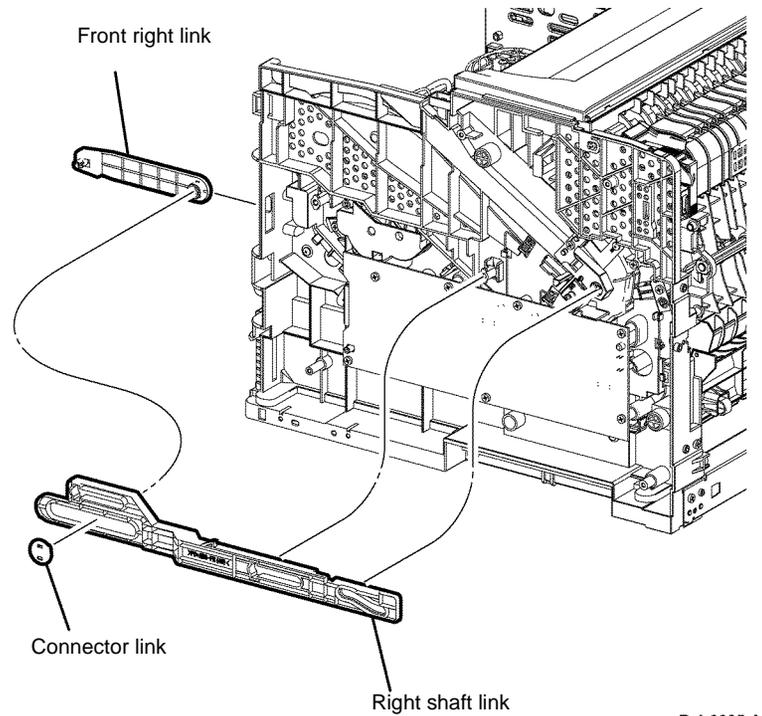
9. From the right shaft link, release the hook on the link connector, that fixes the right front link, then remove the link cover, [Figure 2](#).
10. Release the right shaft link from the hook on the printer, then remove the right shaft link, [Figure 2](#).

**Figure 2 Right shaft link removal**

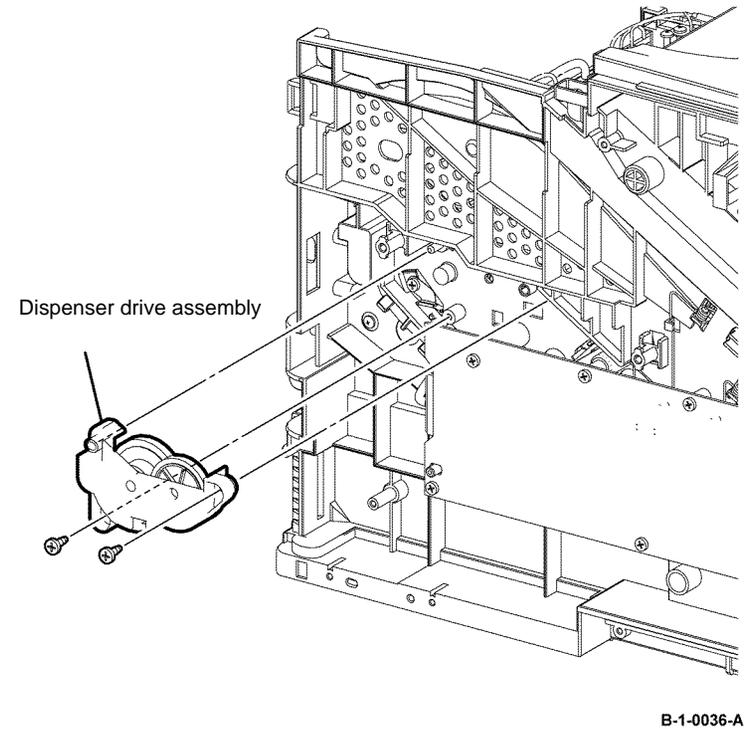
11. Remove two screws (silver, tapping, 10mm), that fix the dispenser drive assembly, release one boss, then remove the dispenser drive assembly, [Figure 3](#).

**Figure 3 Dispenser drive assembly removal**

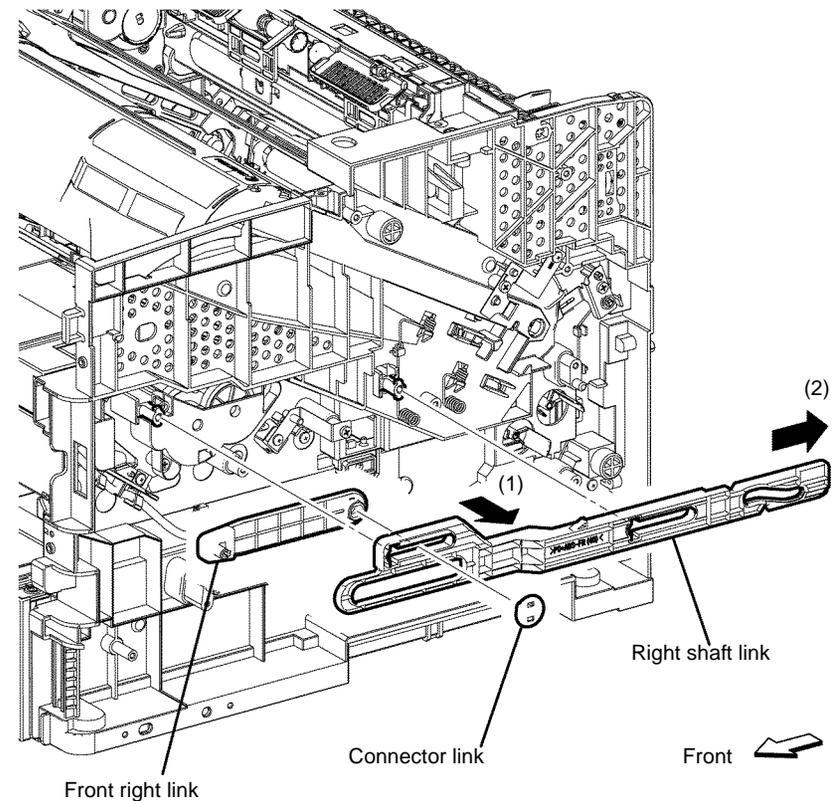
B-1-0112-A

8. Release the hook on the front right link, then remove the connector link, and the front right link from the right shaft link, [Figure 1](#).
9. Remove the right shaft link by bending it out from inside the printer, [Figure 1](#).

Figure 1 Right link shaft removal

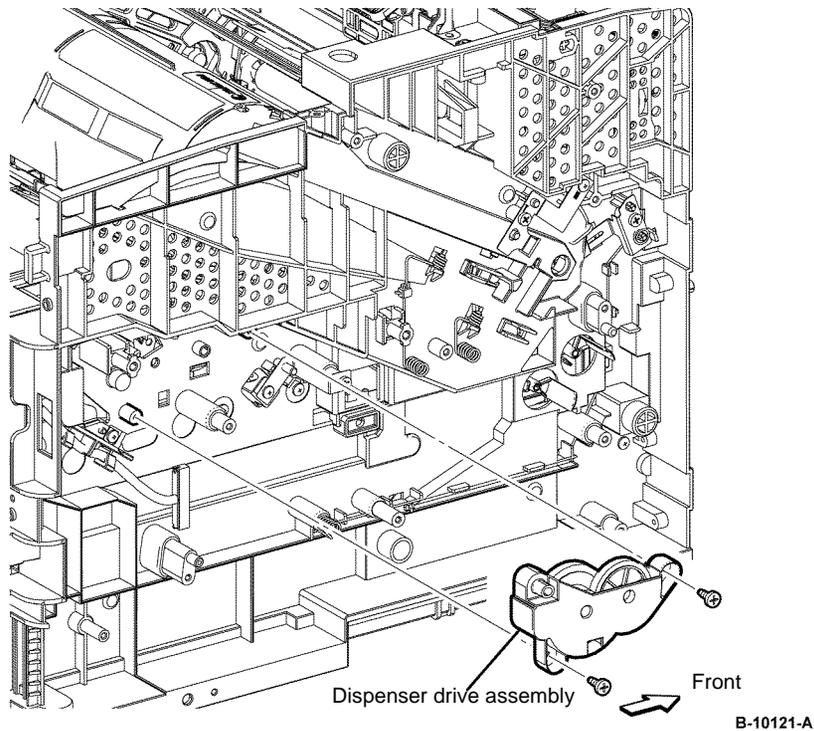
10. Remove two screws (silver, tapping, 10mm), that fix the dispenser drive assembly, then remove the dispenser drive assembly, [Figure 2](#).

**Figure 2 Dispenser drive assembly removal**

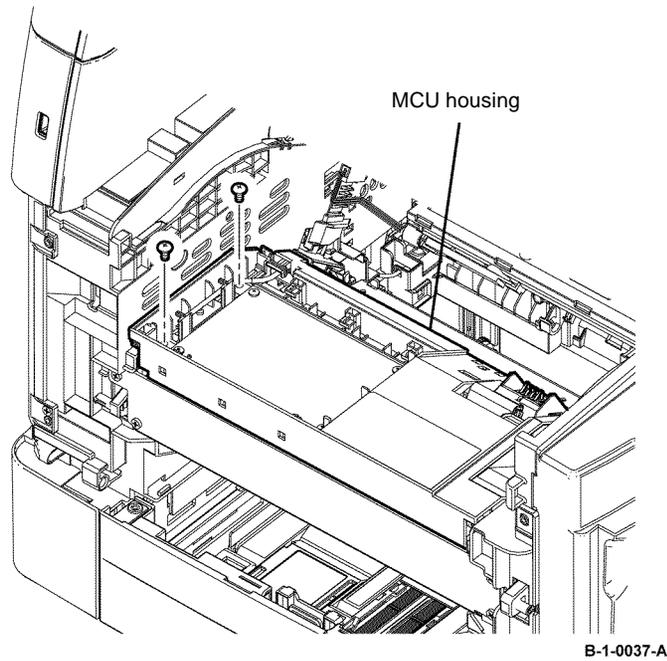
10. Remove two screws (silver, M3, 6mm) that fix the MCU housing, release the hook, then remove the MCU housing from the printer, [Figure 1](#).

Figure 1 MCU housing removal

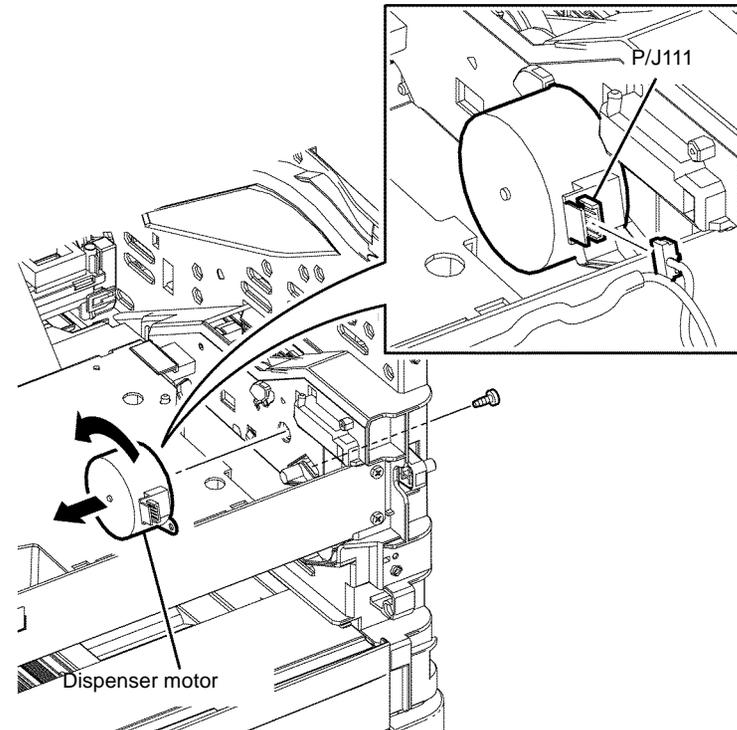
11. Disengage P/J111 of the harness connected to the dispenser motor, [Figure 2](#).
12. Remove one screw (silver, tapping, 8mm) that fixes the dispenser motor, rotate the dispenser motor anti-clockwise and remove, [Figure 2](#).

Figure 2 Dispenser motor removal

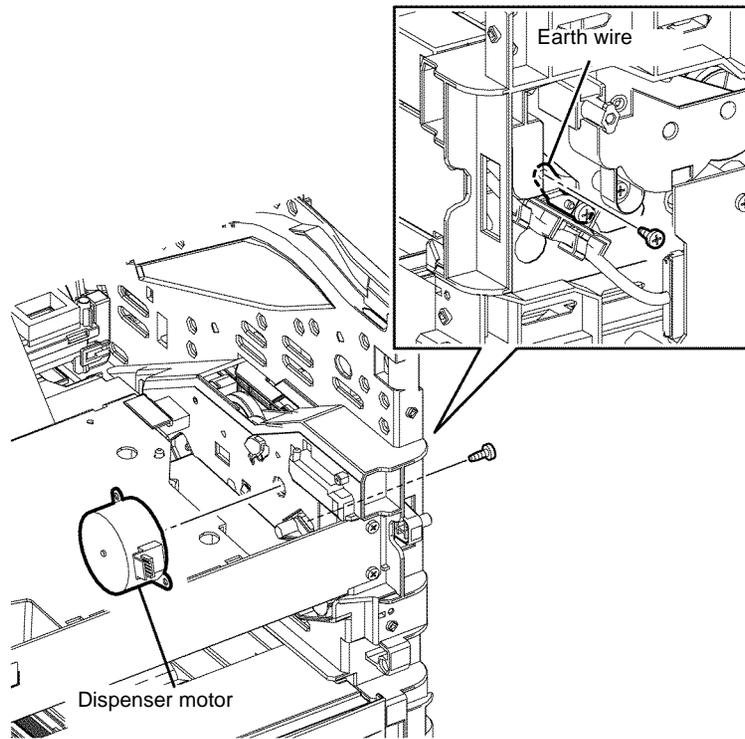
B-1-0039-A

- When installing the dispenser motor, secure the dispenser motor and earth wire together with the screw, [Figure 3](#).

**Figure 3 Dispenser motor installation**

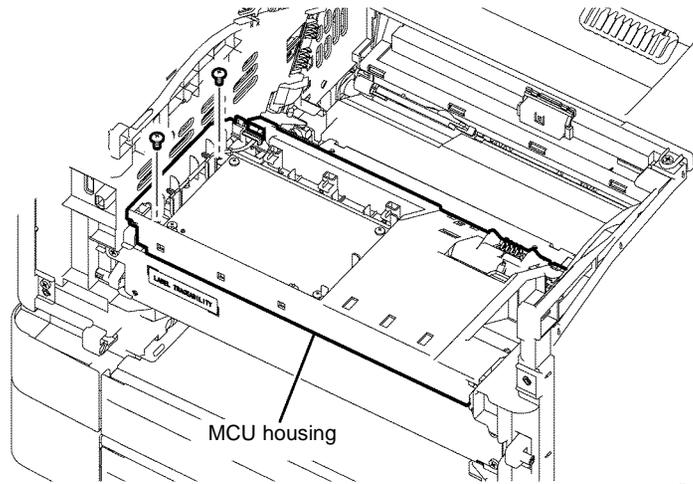
B-1-0122-A

12. Remove two screws (silver, M3, 6mm) that fix the MCU housing, [Figure 2](#).

**Figure 2 MCU housing screw removal**

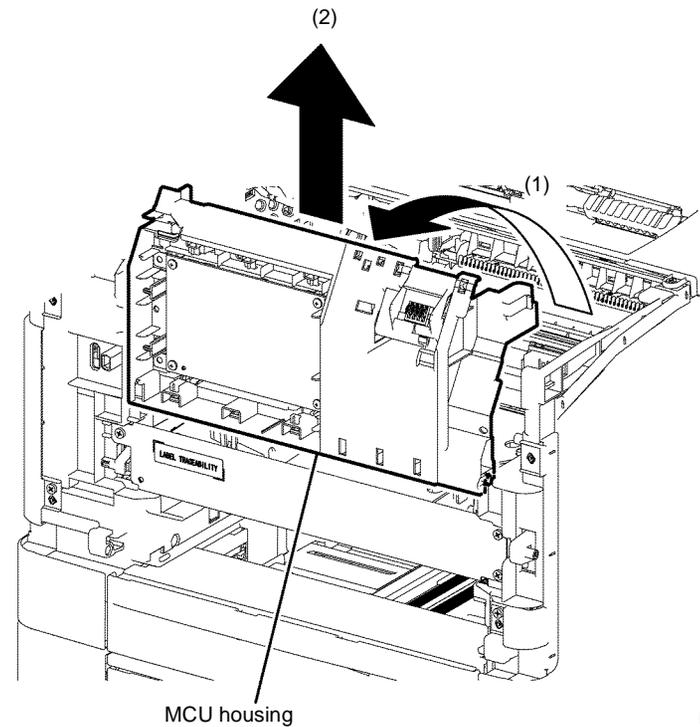
13. Rotate the MCU housing in the arrowed direction, release the hook, then MCU housing from the printer, [Figure 3](#).

**Figure 3 MCU housing removal**

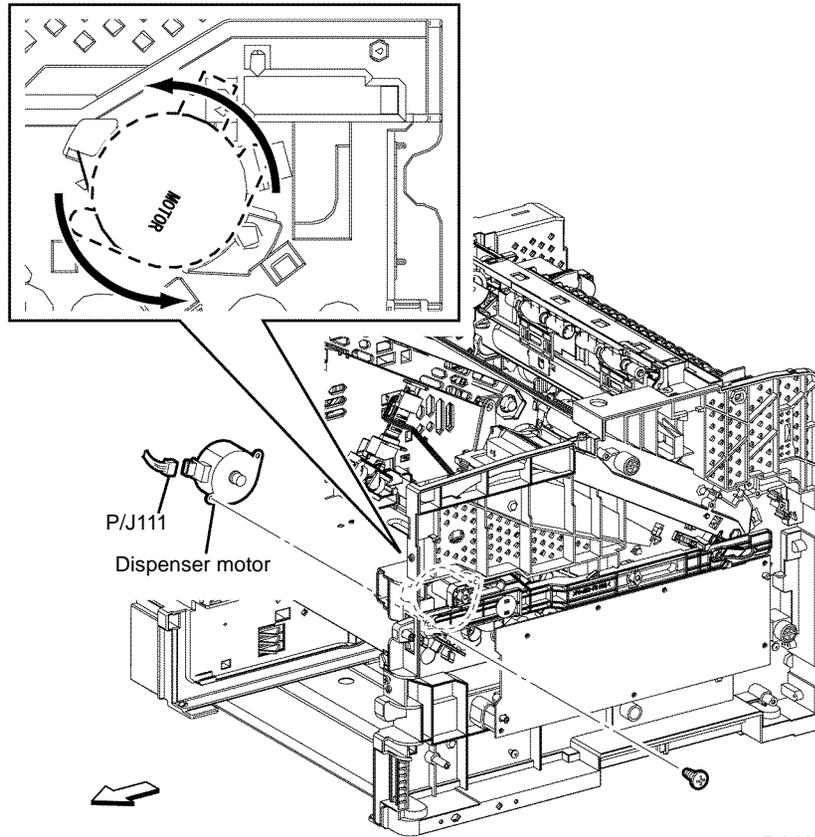
15. Remove one screw (silver, tapping, 8mm) that fixes the dispenser motor, rotate the dispenser motor anti-clockwise and remove, [Figure 4](#).

Figure 4 Dispenser motor removal

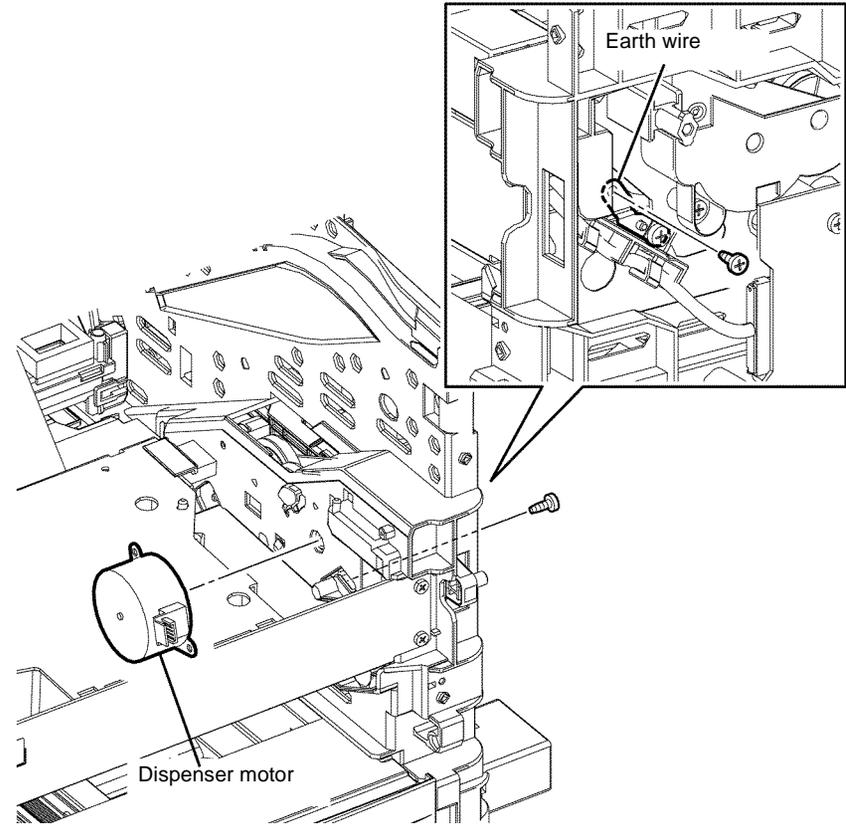
2. When installing the dispenser motor, secure the dispenser motor and earth wire together with the screw, [Figure 5](#).

Figure 5 Dispenser motor installation

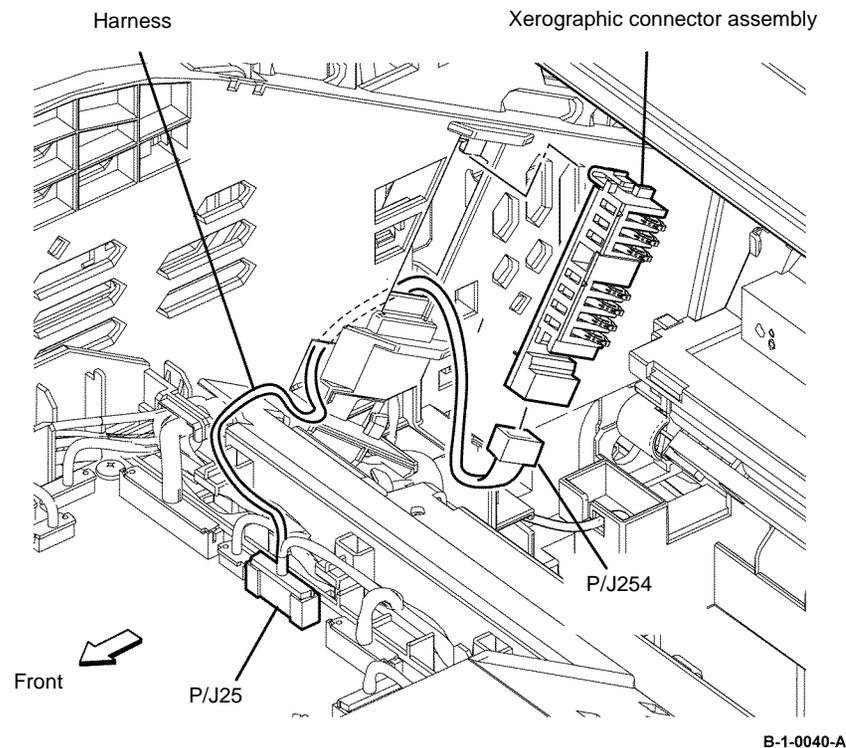
6. Release the hook that fixes the xerographic connector assembly, and then remove the xerographic connector assembly, Figure 2.
7. Pull the yellow harness to create slack and disengage P/J254 from the Xerographic connector assembly, Figure 2.

Figure 2 Xerographic connector assembly removal

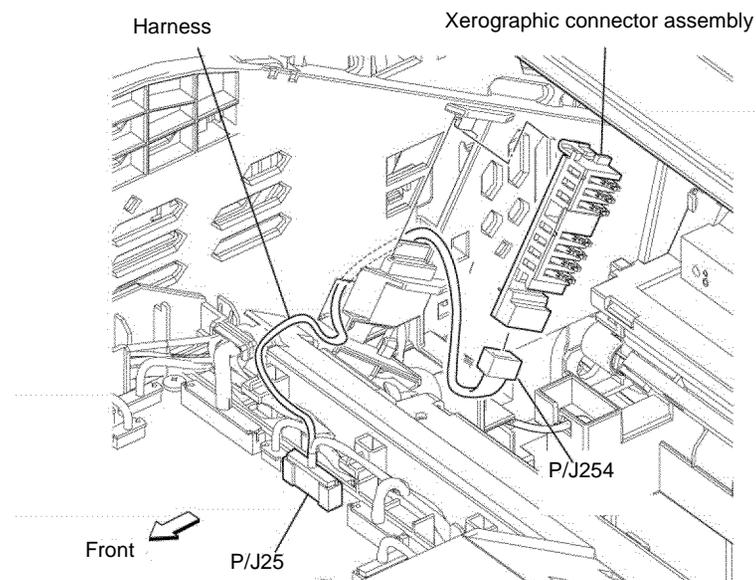
B-1-0126-A

6. Release the hook that fixes the xerographic connector assembly, and then remove the xerographic connector assembly, Figure 2.
7. Pull the yellow harness to create slack and disengage P/J254 from the xerographic connector assembly, Figure 2.

Figure 2 Xerographic connector assembly removal

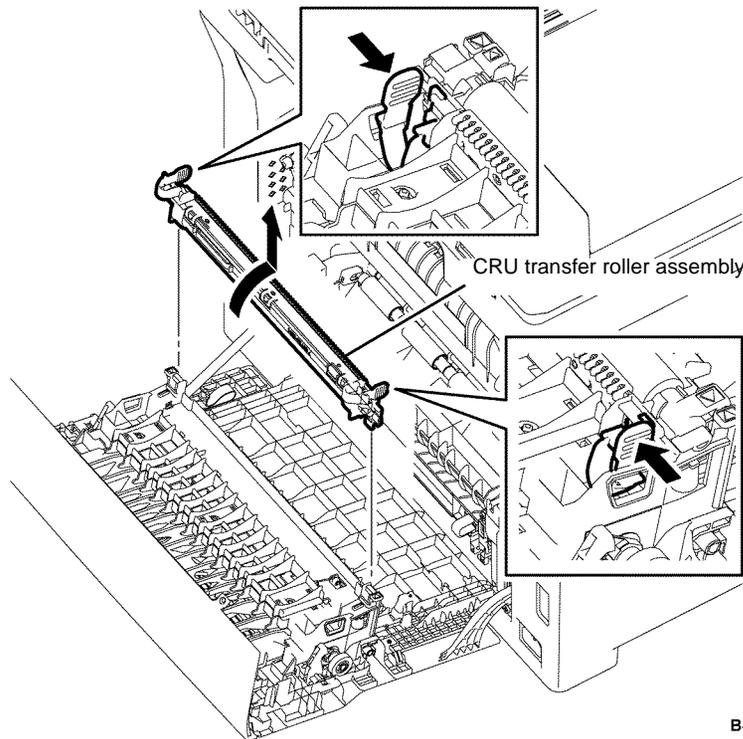
B-1-0041-A

1. Open the rear cover assembly, [PL 19.2B Item 99](#).
2. Release two hooks that fix the CRU transfer roller assembly, then remove the CRU transfer roller assembly by rotating it in the arrowed direction, [Figure 1](#).

Figure 1 CRU transfer roll assembly removal

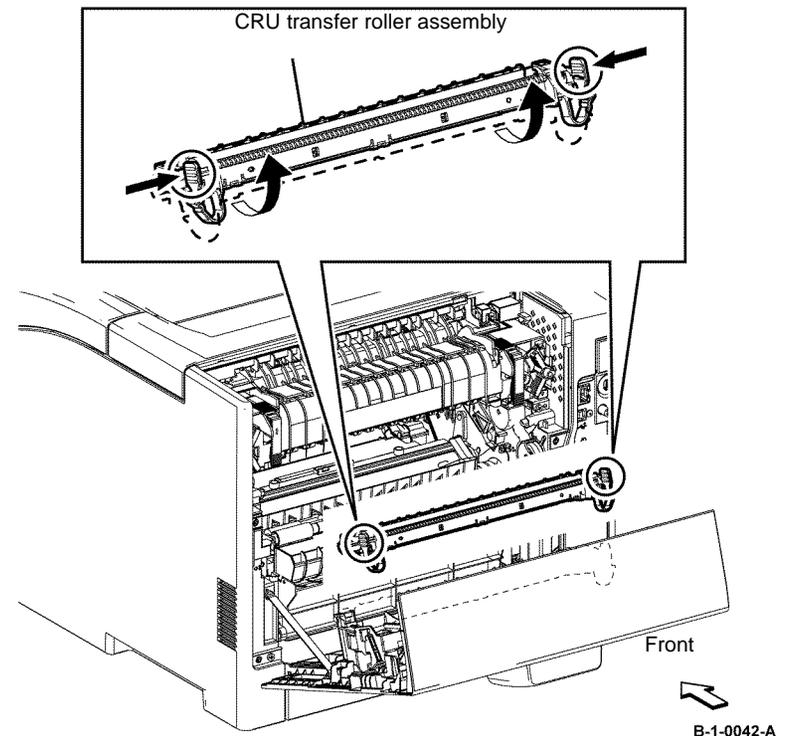
B-1-0042-A

1. Open the rear cover assembly, [PL 19.2A Item 99](#).
2. Press the two hooks on the left and right sides of the CRU transfer roller assembly to unlock the CRU transfer roller assembly, then remove the CRU transfer roller assembly by rotating it along the axis between the bosses, [Figure 1](#).

Figure 1 CRU transfer roll assembly removal

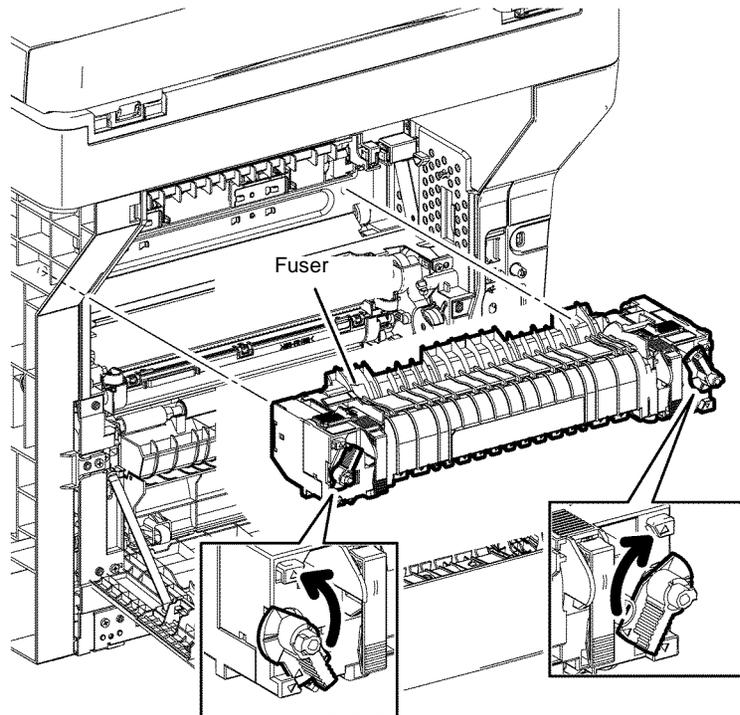
B-1-0043-A

1. Open the rear cover assembly, [PL 19.2B Item 99](#).
2. Rotate the two levers that lock the fuser in the arrowed direction to unlock and remove the fuser, [Figure 1](#).

Figure 1 Fuser removal

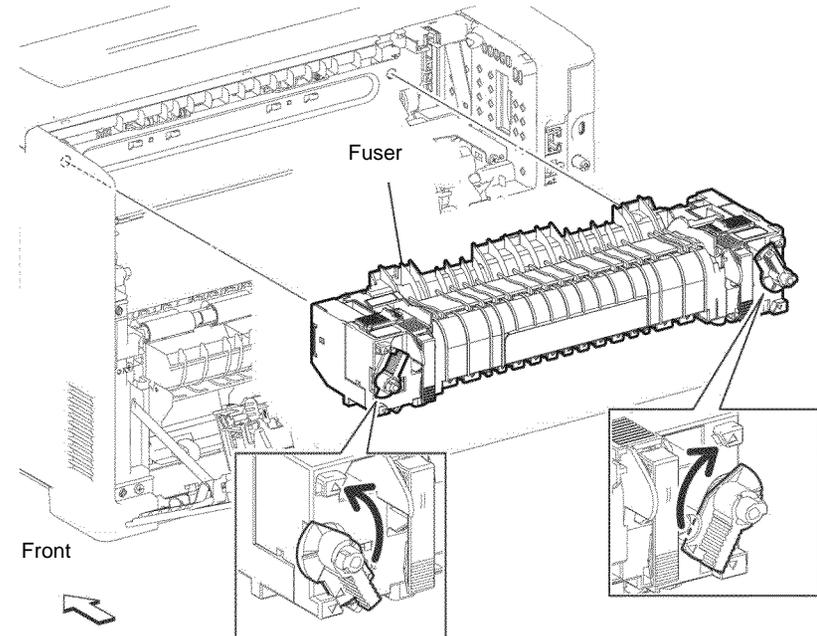
B-1-0044-A

1. Open the rear cover assembly, [PL 19.2A Item 99](#).
2. Rotate the two levers that lock the fuser in the arrowed direction to unlock and remove the fuser, [Figure 1](#).

Figure 1 Fuser removal

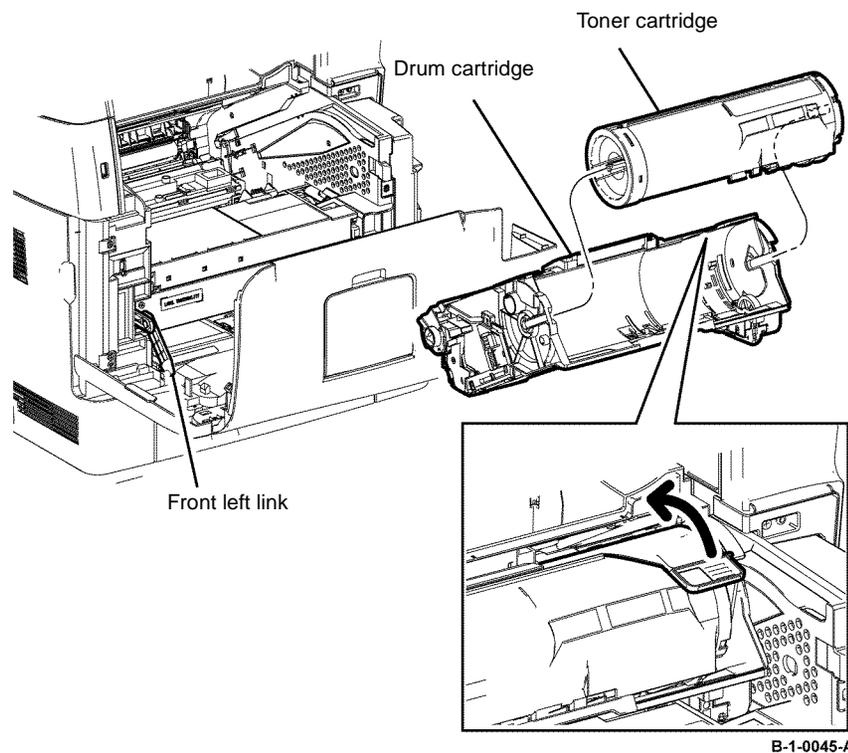
1. Open the front cover assembly, [PL 19.1B Item 98](#).
2. Unlock and remove the toner cartridge, [PL 8.1 Item 2](#).
3. Remove the drum cartridge, [Figure 1](#).

**NOTE:** Note that the drum cartridge is locked while the right front link, [PL 4.1B Item 3](#), and left front link, [PL 4.1B Item 4](#), are pressed.

Figure 1 Drum cartridge removal

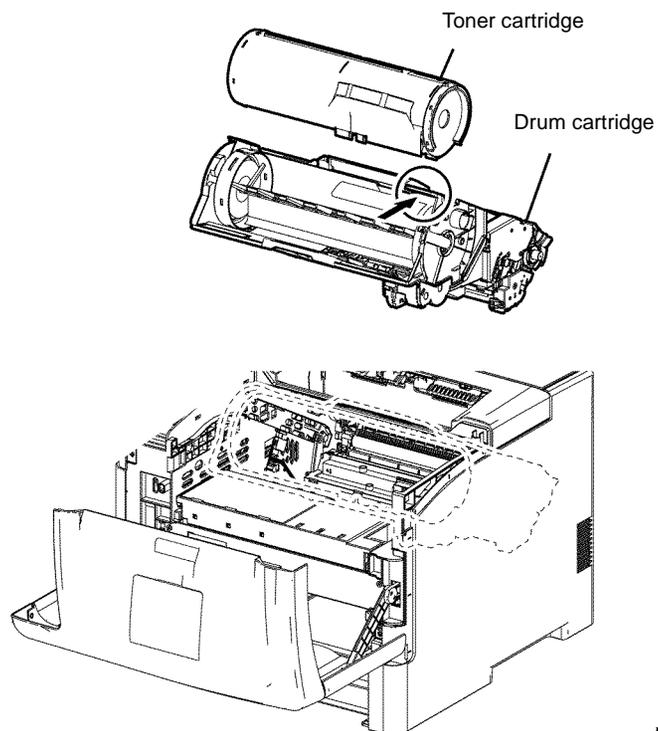
B-1-0046-A

1. Open the front cover assembly, [PL 19.1A Item 98](#).
2. Unlock and remove the toner cartridge, [PL 8.1 Item 2](#).
3. Remove the drum cartridge, [Figure 1](#).

**NOTE:** Note that the drum cartridge is locked while the front right link, [PL 4.1A Item 3](#), and front left link, [PL 4.1A Item 4](#), are pressed.

Figure 1 Drum cartridge removal

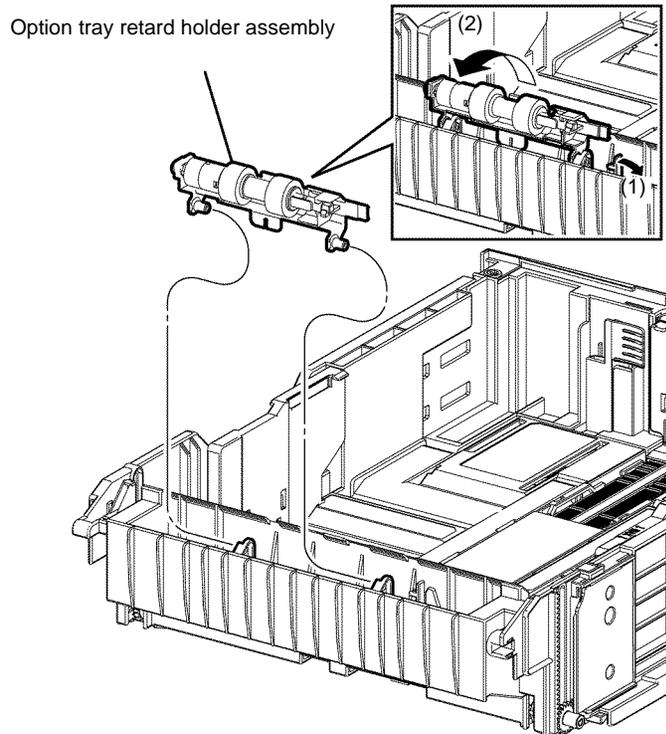
1. Remove the option tray assembly, [PL 9.2 Item 1](#).
2. Release the hook that fixes the option tray retard holder assembly, then rotate the option tray retard holder assembly in the arrowed direction, [Figure 1](#).
3. Release the two bosses on the retard holder assembly, and then remove the retard roll holder assembly, [Figure 1](#).

Figure 1 Retard roll holder assembly removal
