# Xerox® VersaLink® B400 & B405 Family Multifunction Printer Service Manual

VersaLink B400 and B405 Family Multifunction Printer Service Manual

708P91373

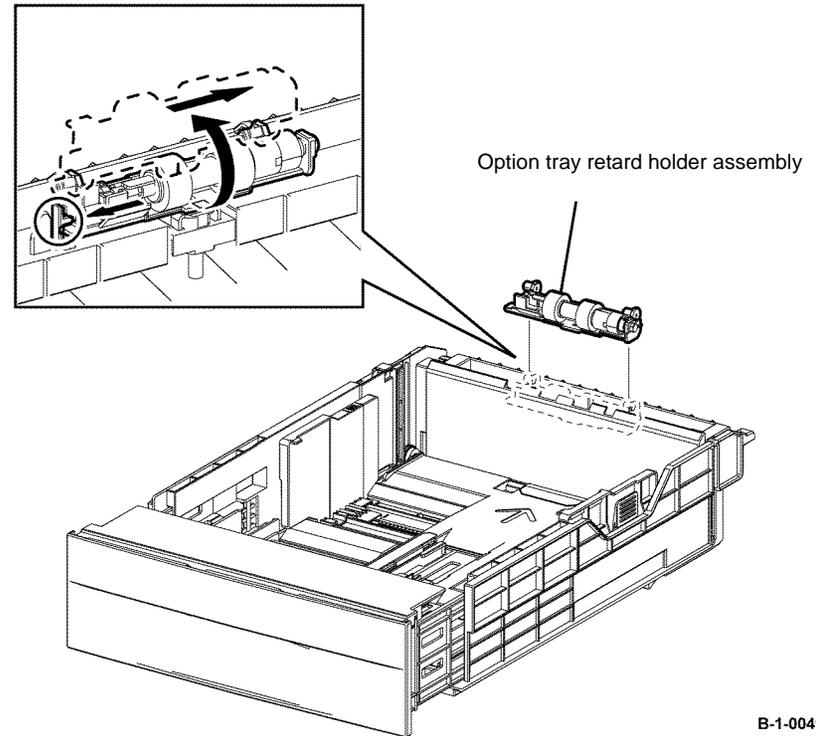
1. Remove the option tray assembly, [PL 9.2 Item 1](#).
2. Release the hook that fixes the option tray retard holder assembly to the 550 tray assembly, rotate the option tray retard holder assembly, along the axis, then remove the retard holder assembly by moving it in the arrowed direction, [Figure 1](#).

Figure 1 Retard roll holder assembly removal

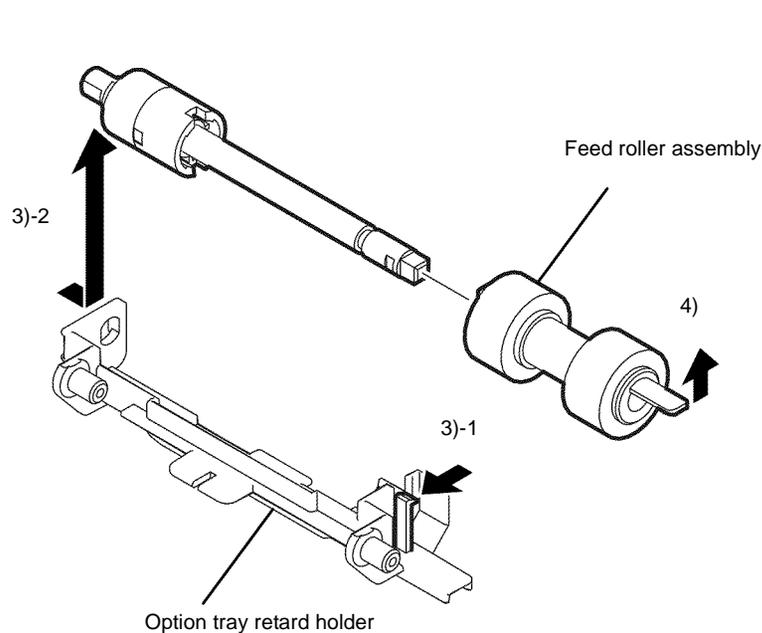
B-1-0048-A

4. Pull out the feed roll assembly while releasing the hook fixing it, [Figure 1](#).

Figure 1 Feed roll assembly removal

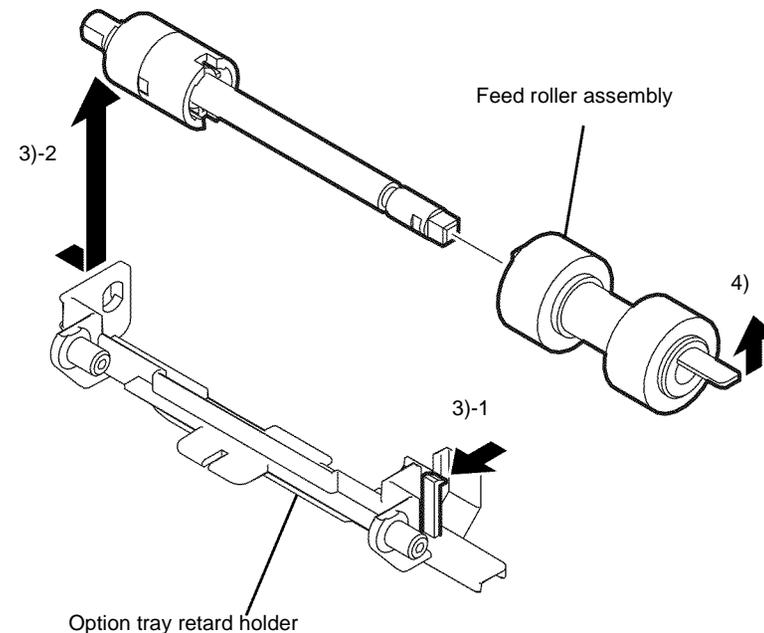
B-1-0127-A

4. Pull out the feed roll assembly while releasing the hook fixing it, [Figure 1](#).

Figure 1 Feed roll assembly removal

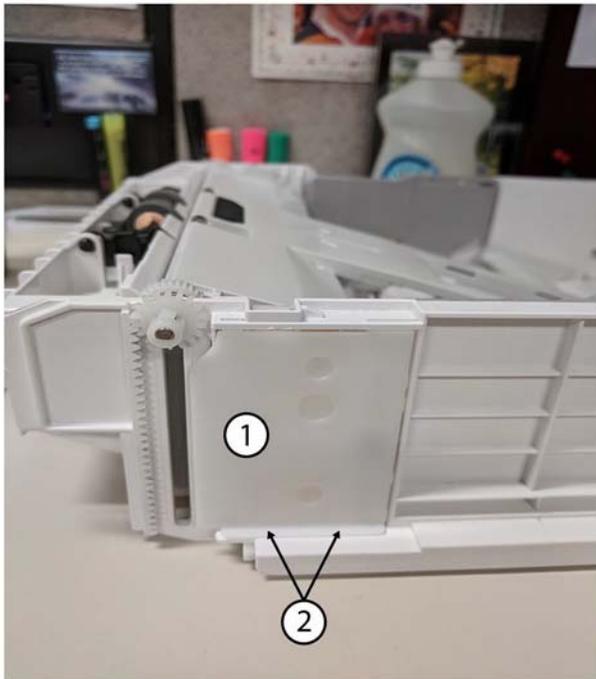
B-1-0277-A

1. Remove tray 1 from the machine, [PL 9.2 Item 1](#).
2. Remove the bottom lock cover, [Figure 1](#):
  - a. Stand the option feeder tray on its side with the bottom lock cover face up (1).
  - b. Carefully pry the bottom lock cover at two points (2) releasing two tabs in the option feeder tray, then remove the bottom lock cover (1).

Figure 1 Bottom lock cover removal

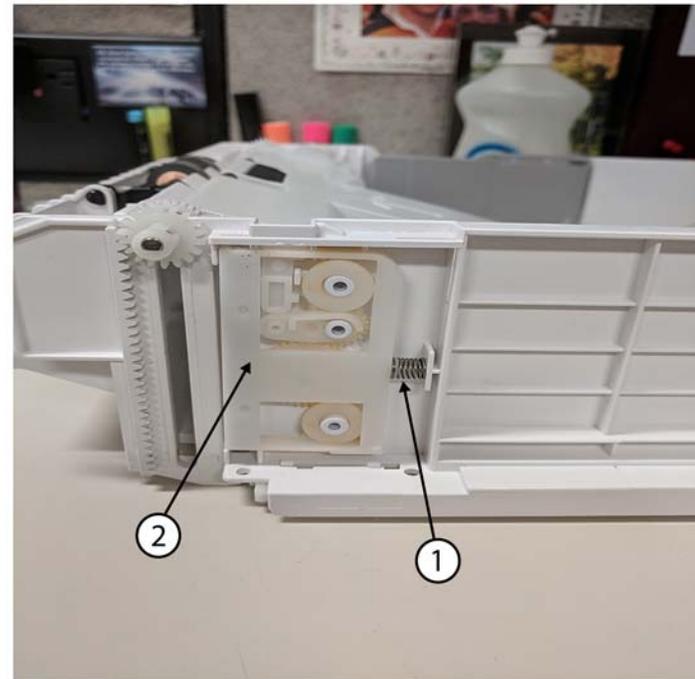
B-1-0278-A

3. Remove the lock spring (1), [Figure 2](#).

**NOTE:** To ensure the gears do not fall out of the lift assembly (2), hold the lift assembly in-place while removing the lock spring.

Figure 2 Lock spring removal

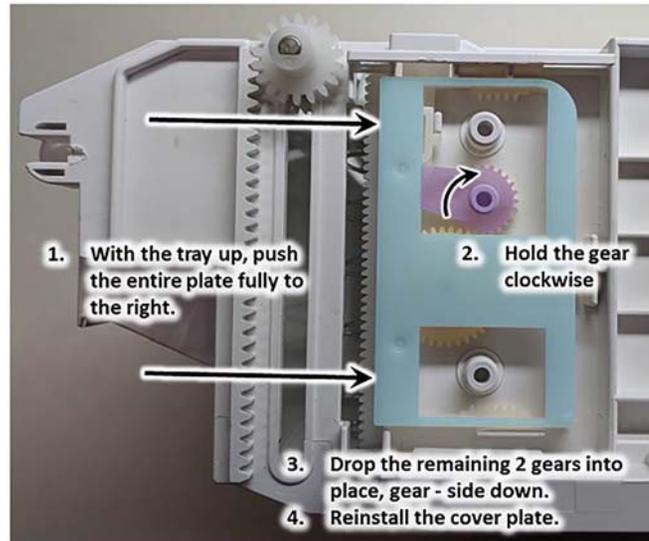
B-1-0280-A

If the assembly comes apart during removal, re-assemble the assembly as shown below to ensure the lift dampening of the assembly function's properly, [Figure 3](#).

Figure 3 Option feeder tray lift reassembly

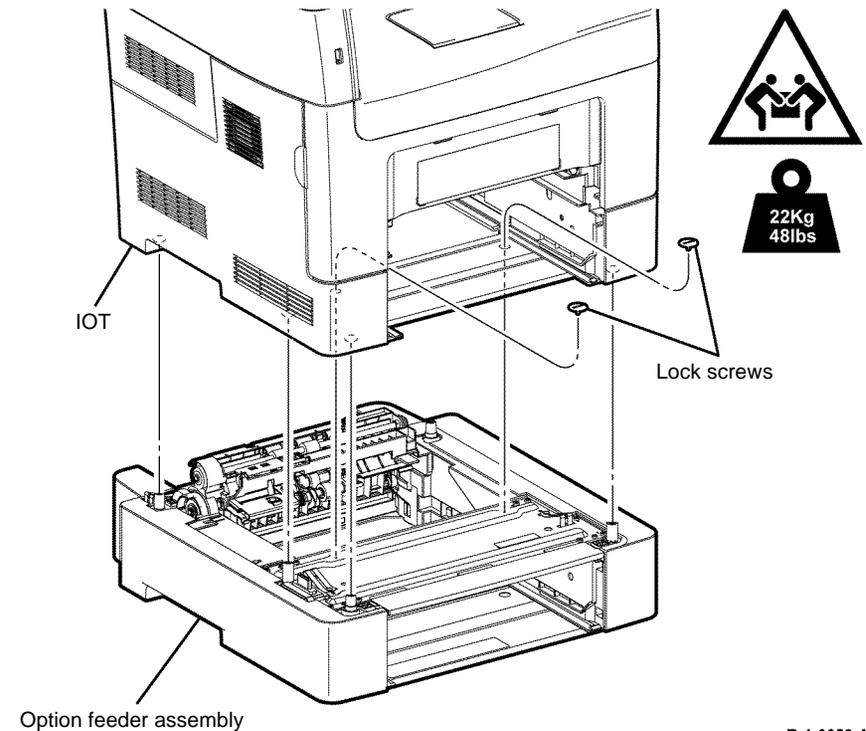
5. Release the five bosses on the option feeder assembly from the holes on the IOT, then lift the IOT upward from the option feeder assembly, [Figure 1](#).

Figure 1 Option feeder assembly removal

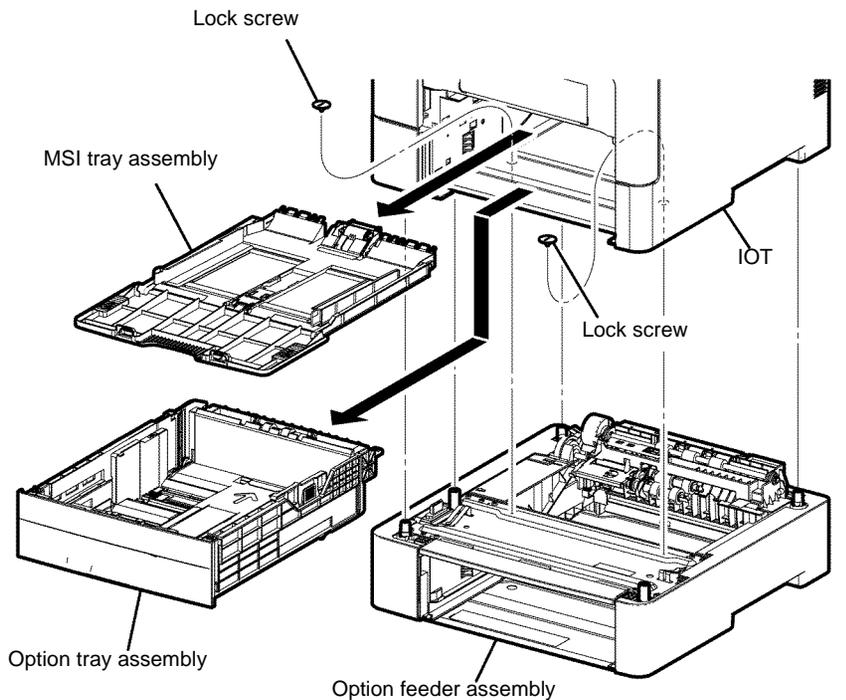
B-1-0051-A

1. Open the MSI cover, [PL 13.2 Item 99](#).
2. Pull out the MSI tray assembly, [PL 13.2 Item 9](#).
3. Remove the option tray assembly, [PL 9.2 Item 1](#).
4. Release the two lock screws fixing the option feeder assembly, [Figure 1](#).
5. Release the five bosses on the option feeder assembly from the holes on the IOT, then lift the IOT upward from the option feeder assembly, [Figure 1](#).

Figure 1 Option feeder assembly removal

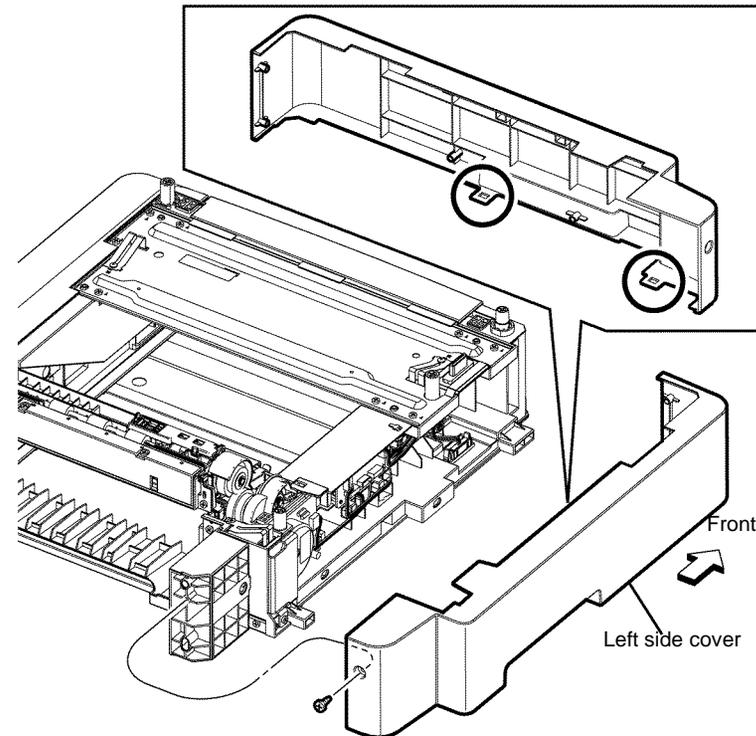
B-1-0052-A

1. Remove the option tray assembly, [PL 9.2 Item 1](#) from the printer.
2. Remove the option feeder assembly, [REP 11.1](#).
3. Remove the one screw (silver, tapping, 8mm) that fixes the option feeder left cover, release the two hooks from the bosses, release the six bosses from the holes, then remove the option feeder left cover, [Figure 1](#).

Figure 1 Option feeder left cover removal

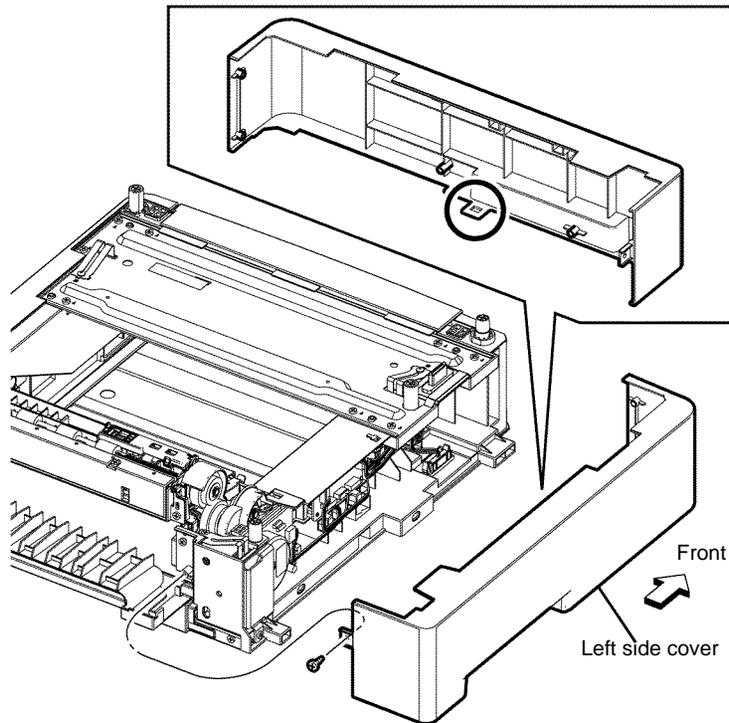
1. Remove the option tray assembly, [PL 9.2 Item 1](#).
2. Remove the option feeder assembly, [REP 11.2](#).
3. Remove the one screw (silver, tapping, 8mm) that fixes the option feeder left cover, release the one hook from the boss, release the six bosses from the holes, then remove the option feeder left cover, [Figure 1](#).

Figure 1 Option feeder left cover removal

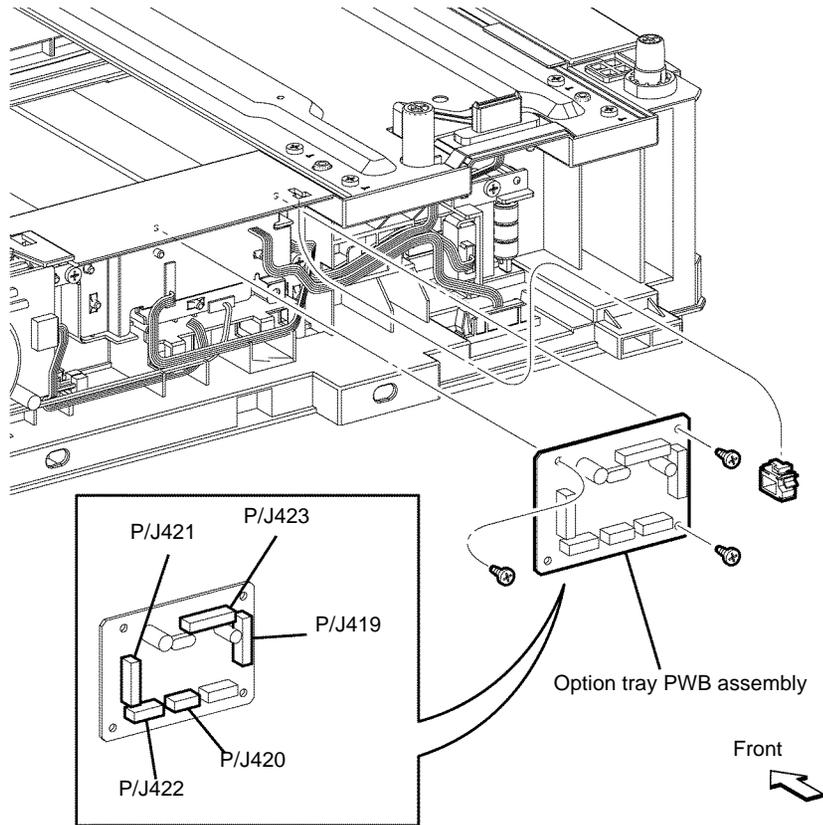
B-1-0054-A

1. Remove the option tray assembly, [PL 9.2 Item 1](#).
2. Remove the option feeder assembly, [REP 11.2](#).
3. Remove the option feeder left cover, [REP 11.4](#).
4. Release the harness from the clamp, then remove the clamp from the frame.

Figure 2 Option feeder PWB assembly removal

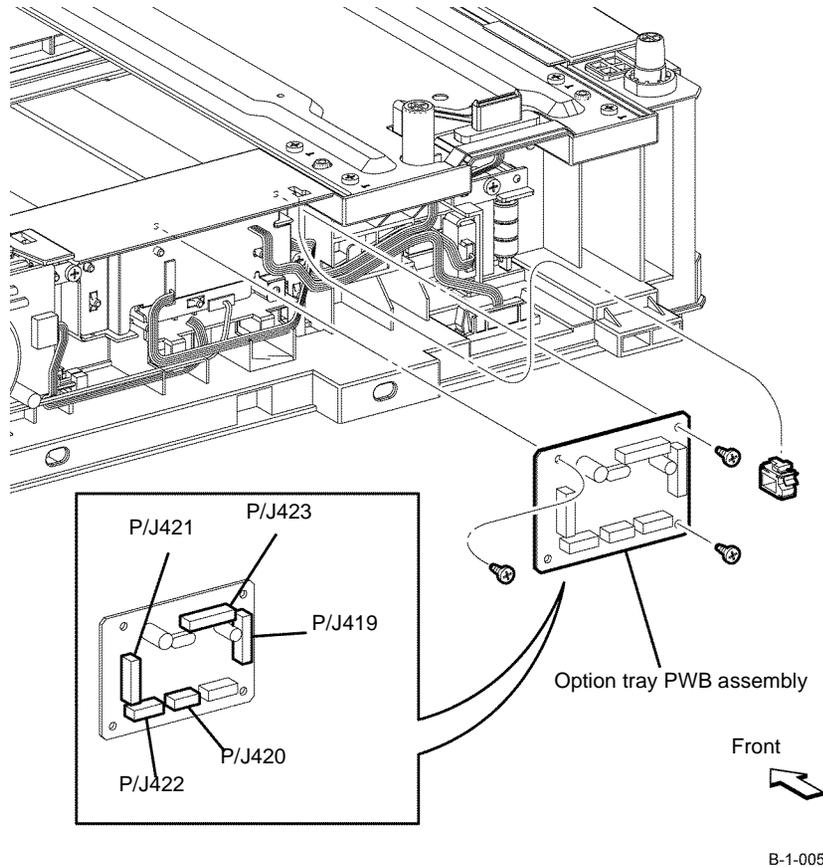
5. Disengage all connectors from the option tray PWB assembly, [Figure 2](#).
6. Remove three screws (silver, tapping, 8mm) that fix the option tray PWB assembly, then remove the option feeder PWB assembly, [Figure 2](#).

Figure 2 Option feeder PWB assembly removal

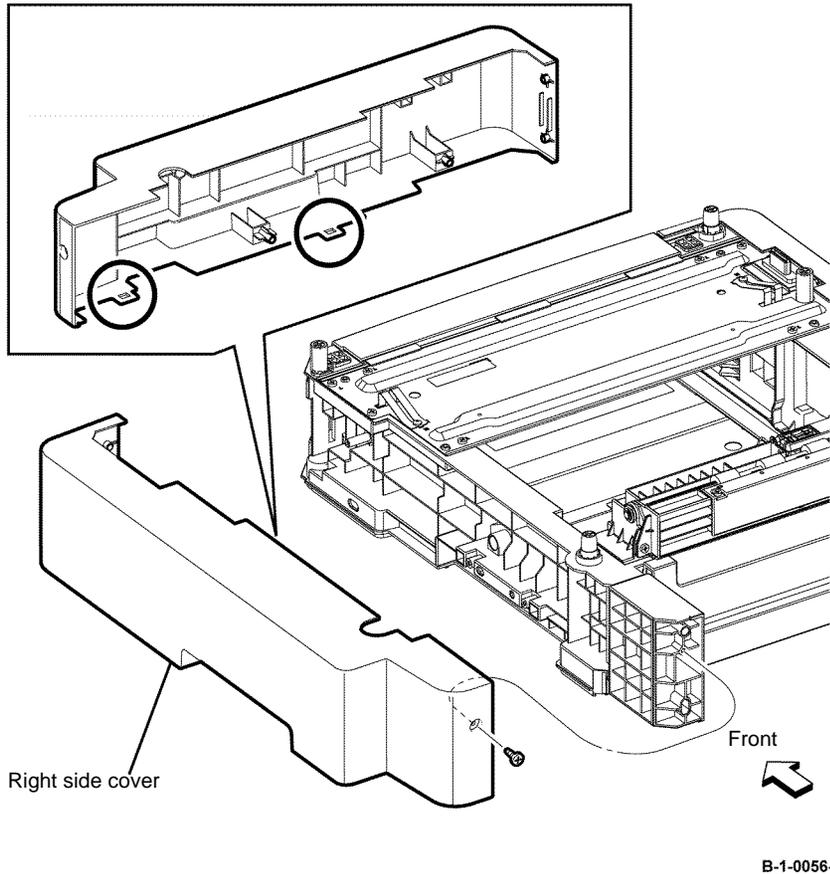
1. Remove the option tray assembly, [PL 9.2 Item 1](#).
2. Remove the option feeder assembly, [REP 11.2](#).
3. Remove one screw (silver, tapping, 8mm) that fixes the option feeder right cover, release the two hooks from the bosses, release the six bosses from the holes, then remove the option feeder right cover, [Figure 1](#).

Figure 2 Option feeder right cover removal

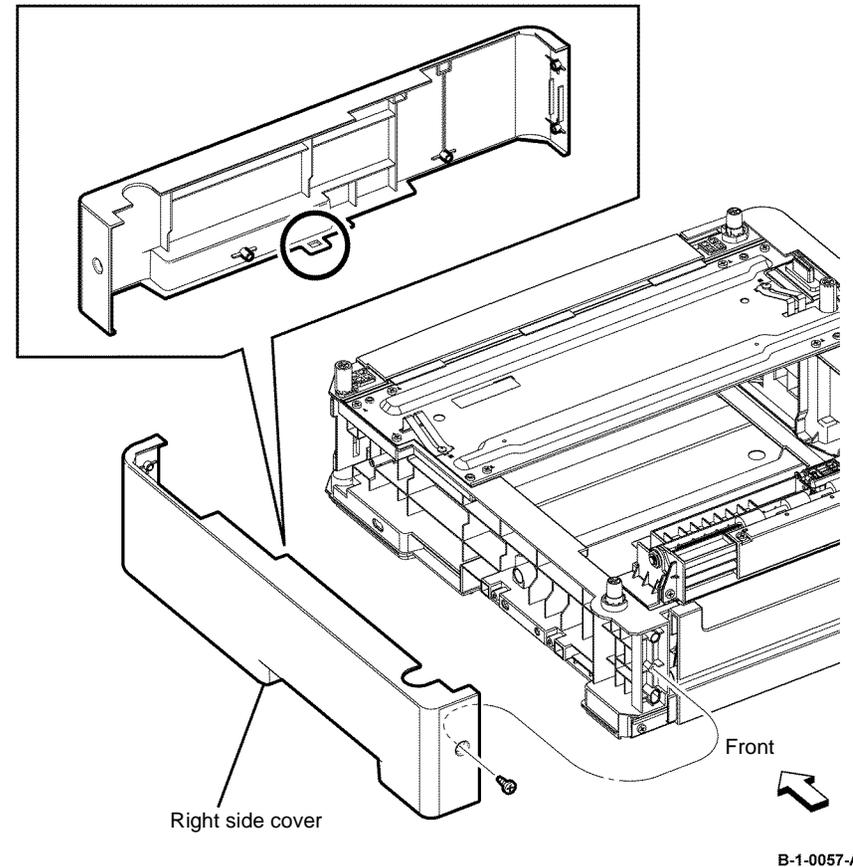
Figure 1 Option feeder right cover removal

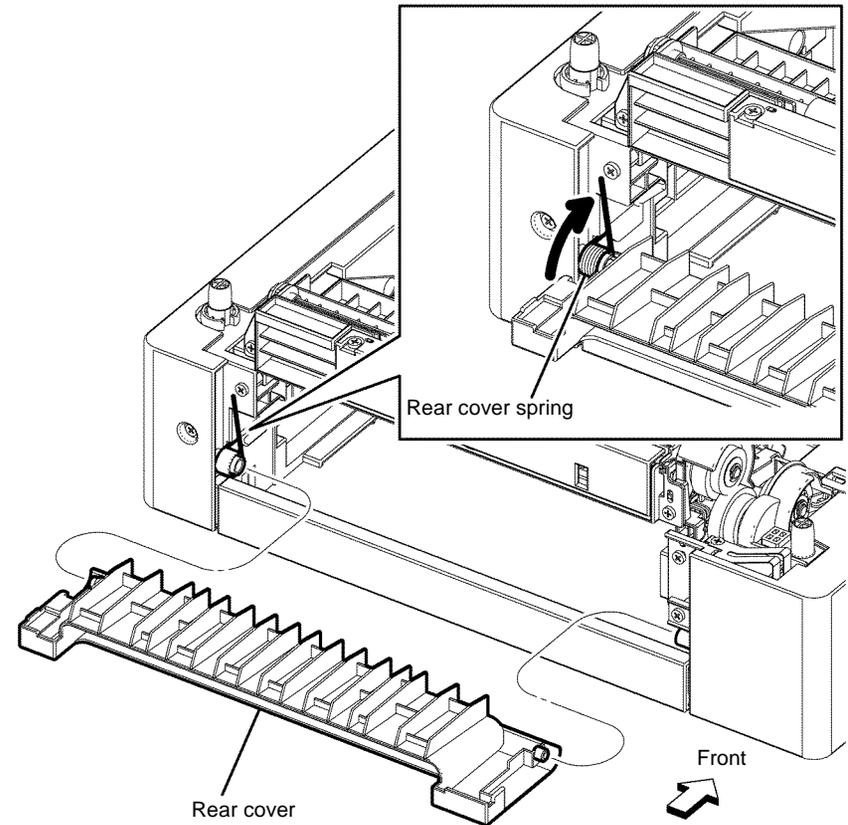
B-1-0058-A

1. Remove the tray assembly, [PL 9.2 Item 1](#).
2. Remove the option feeder assembly, [REP 11.1](#).
3. Remove one side of the rear cover spring from the option feeder rear cover, [Figure 1](#).
4. Remove the left boss from the hole, then remove the option feeder rear cover, [Figure 1](#).

Figure 1 Option feeder 550 rear cover removal

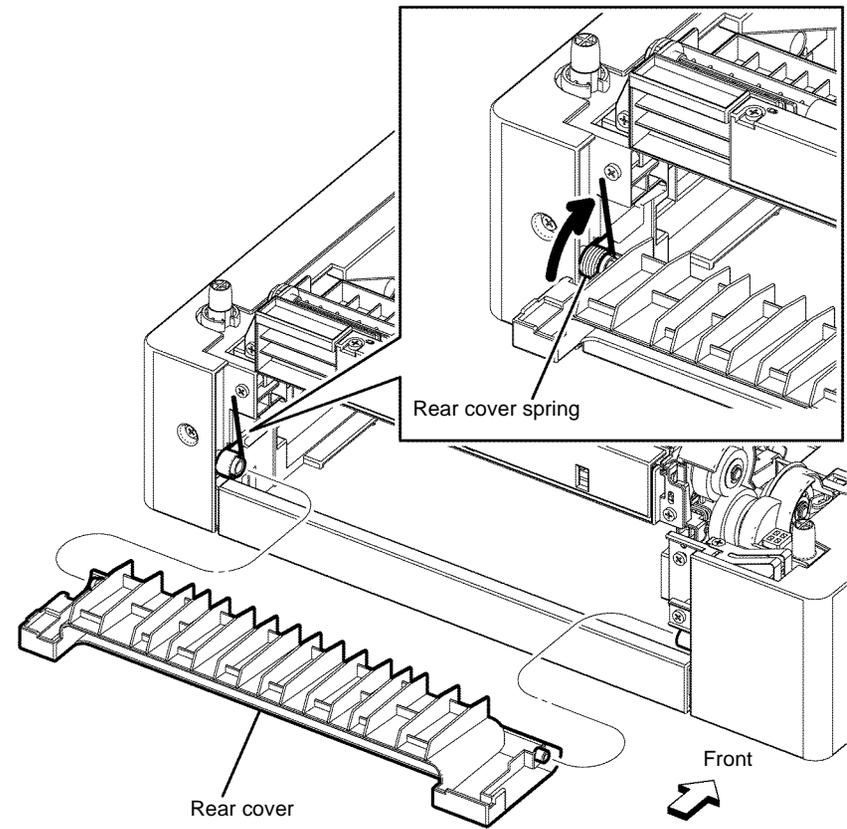
B-1-0059-A

1. Remove the option tray assembly, [PL 9.2 Item 1](#).
2. Remove the option feeder assembly, [REP 11.2](#).
3. Remove one side of the rear cover spring from the option feeder rear cover, [Figure 1](#).
4. Remove the left boss from the hole, then remove the option feeder rear cover, [Figure 1](#).

Figure 1 Option feeder rear cover removal

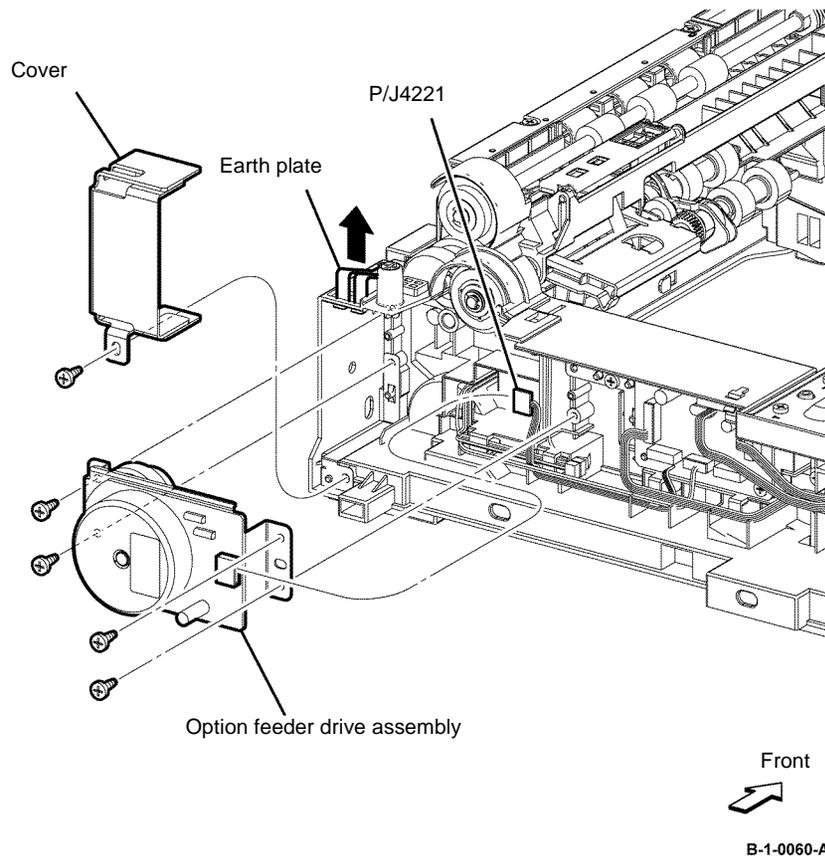
1. Remove the option tray assembly, [PL 9.2 Item 1](#).
2. Remove the option feeder assembly, [REP 11.1](#).
3. Remove the option feeder left cover, [REP 11.3](#).
4. Remove one screw (silver, tapping, 8mm), then remove the cover by lifting the earth plate, [Figure 1](#).
5. Disconnect PJ4221 from the option feeder motor assembly, [Figure 1](#).
6. Remove four screws (silver, tapping, 8mm) that fix the option feeder drive assembly, then remove the option feeder drive assembly, [Figure 1](#).

Figure 1 Option feeder drive assembly removal

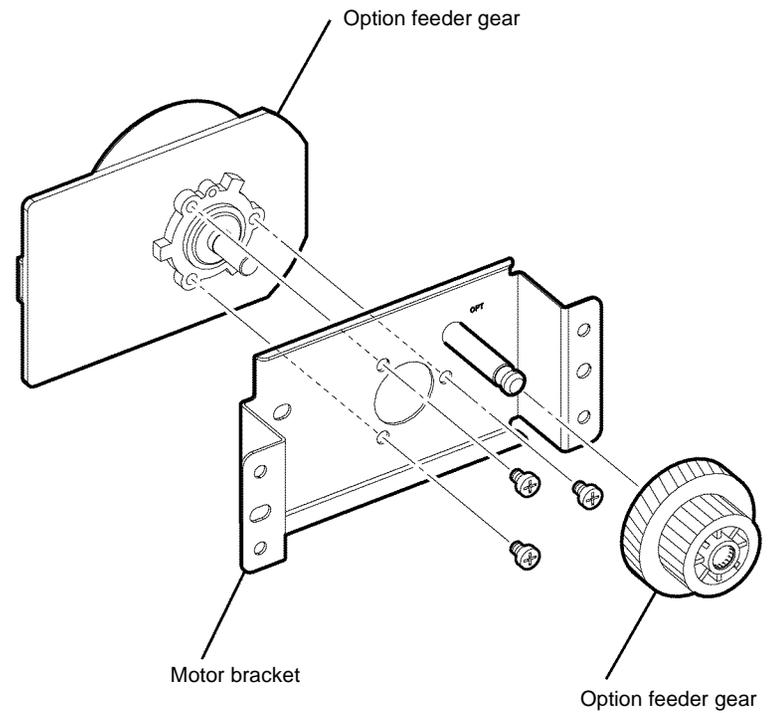
B-1-0061-A

- Remove the option feeder gear and three screws (silver, M3, 4mm) that fix the option feeder motor assembly, then remove the option feeder motor assembly from the motor bracket, [Figure 2](#).

Figure 2 Option feeder motor assembly removal

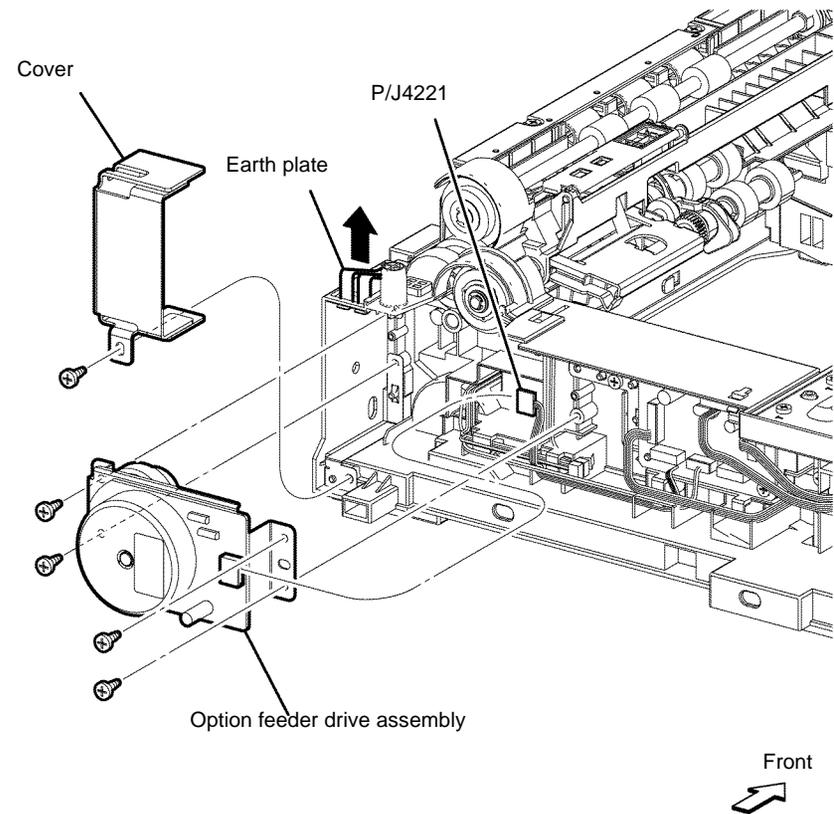
B-1-0062-A

1. Remove the option tray assembly, [PL 9.2 Item 1](#).
2. Remove the option feeder assembly, [REP 11.2](#).
3. Remove the option feeder left cover, [REP 11.4](#).
4. Remove one screw (silver, tapping, 8mm), then remove the cover by lifting the earth plate, [Figure 1](#).
5. Disconnect PJ4221 from the option feeder motor assembly, [Figure 1](#).
6. Remove four screws (silver, tapping, 8mm) that fix the option feeder drive assembly, then remove the option feeder drive assembly, [Figure 1](#).

Figure 1 Option feeder drive assembly removal

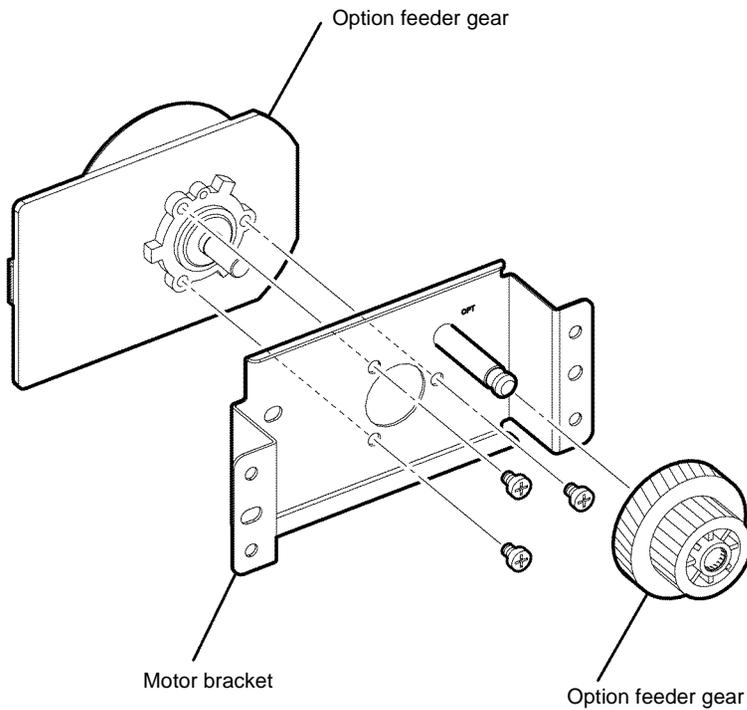
B-1-0063-A

Figure 2 Option feeder motor assembly removal

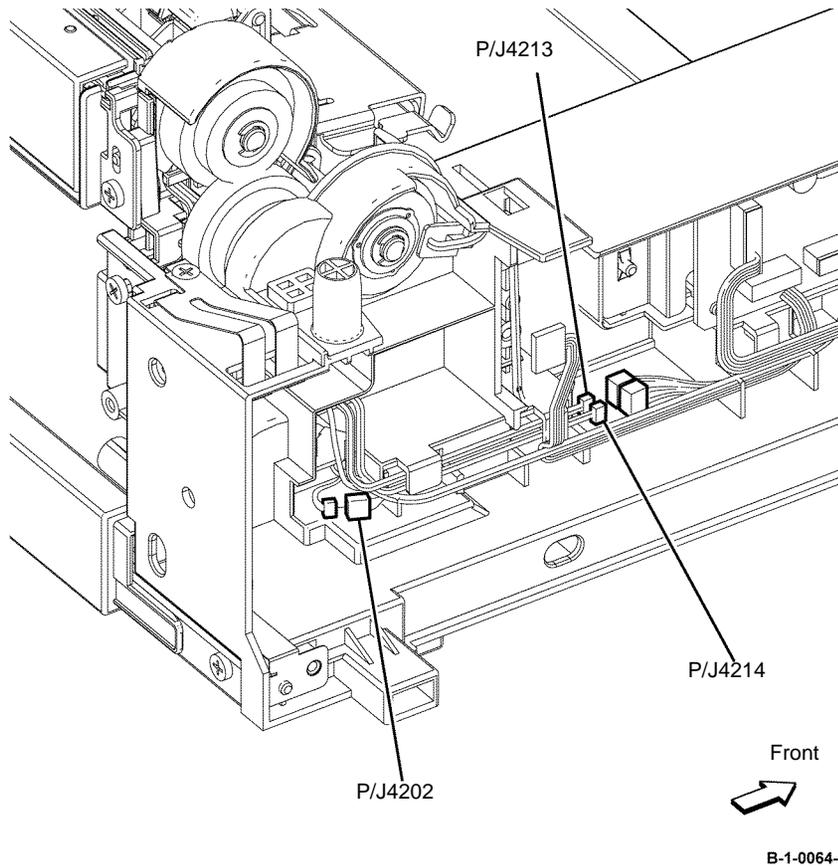
1. Remove the option tray assembly, [PL 9.2 Item 1](#).
2. Remove the option feeder assembly, [REP 11.1](#).
3. Remove the option feeder left cover, [REP 11.3](#).
4. Remove the option feeder clutch assembly, [REP 11.15](#).
5. Disconnect PJ4202, PJ4213 and PJ4214 from the option feeder, [Figure 1](#).

Figure 1 Option feeder relay disconnect

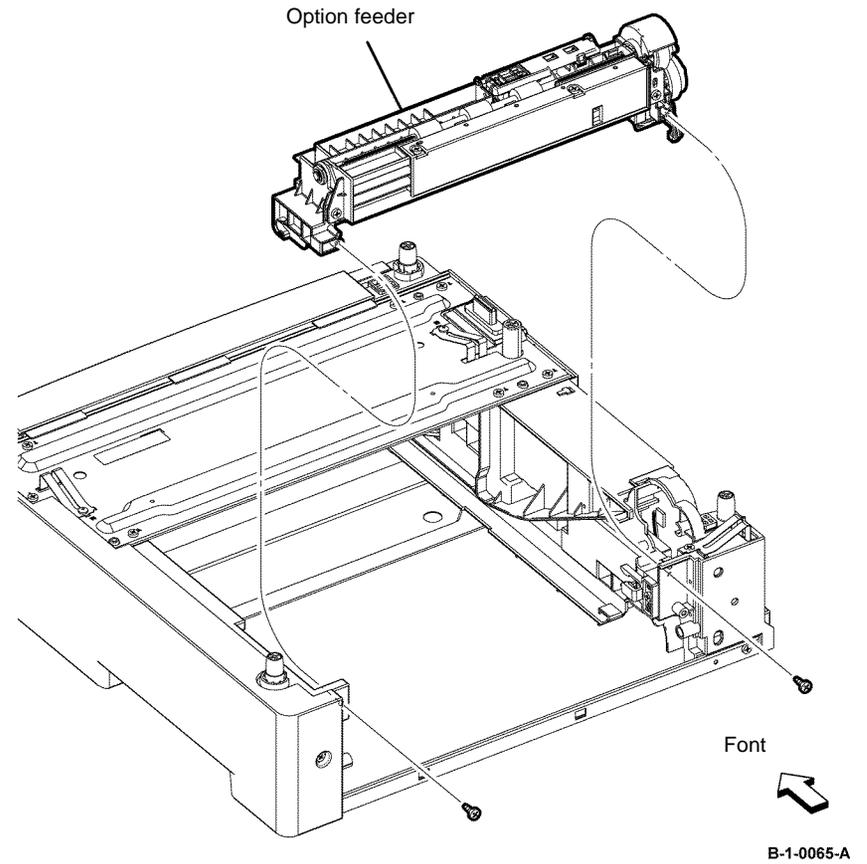
6. Release the harness from the harness guide on the frame.
7. Remove two screws (silver, tapping, 8mm) that fix the option feeder, release the four holes from the bosses on the frame, then remove the option feeder, [Figure 2](#).

Figure 2 Option feeder removal

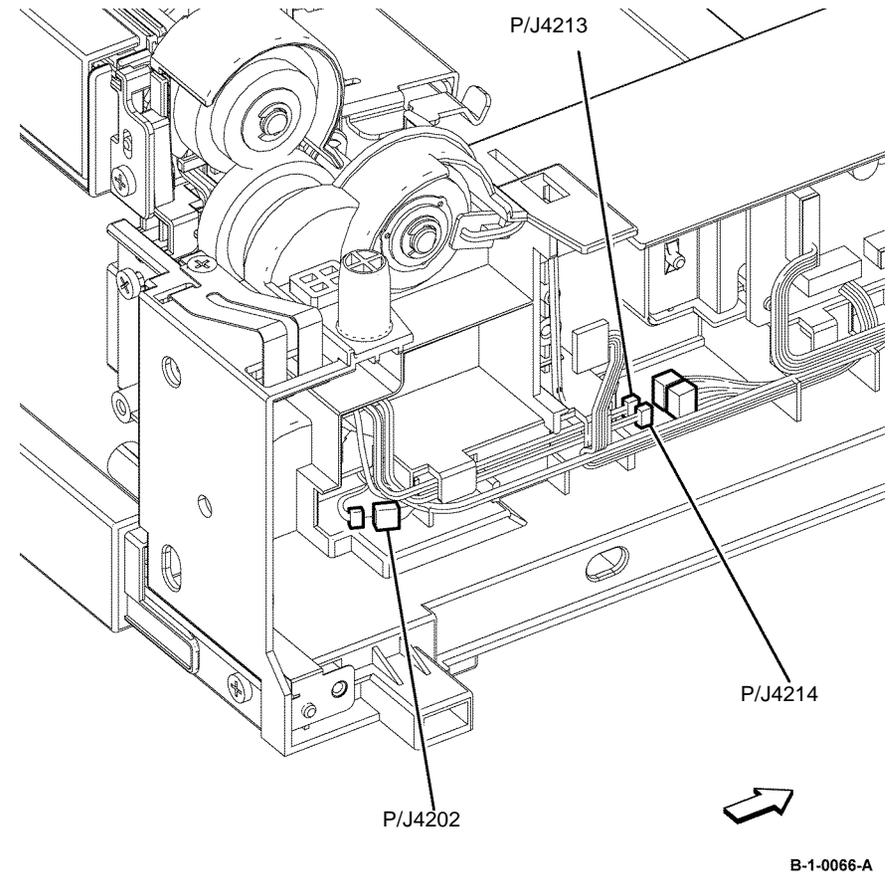
1. Remove the option tray assembly, [PL 9.2 Item 1](#).
2. Remove the option feeder assembly, [REP 11.2](#).
3. Remove the option feeder left cover, [REP 11.4](#).
4. Remove the option feeder clutch assembly, [REP 11.16](#).
5. Disconnect PJ4202, PJ4213 and PJ4214 from the option feeder, [Figure 1](#).

Figure 1 Option feeder relay disconnect

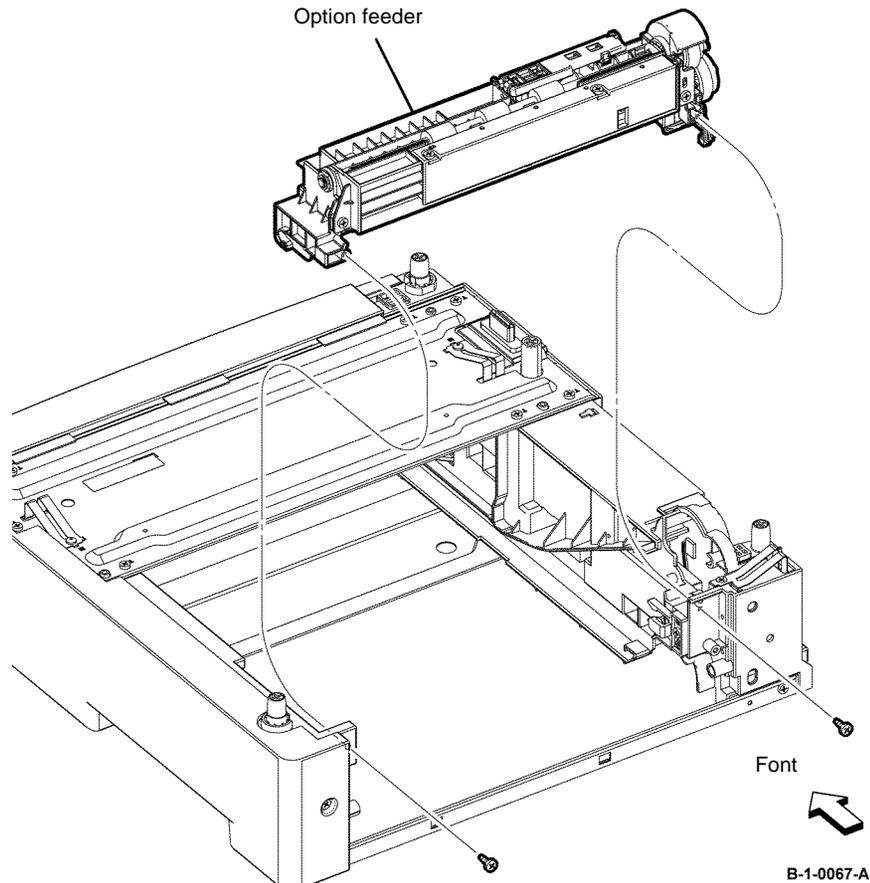
6. Release the harness from the harness guide on the frame.
7. Remove two screws (silver, tapping, 8mm) that fix the option feeder, release the four holes from the bosses on the frame, then remove the option feeder, [Figure 2](#).

Figure 2 Option feeder removal

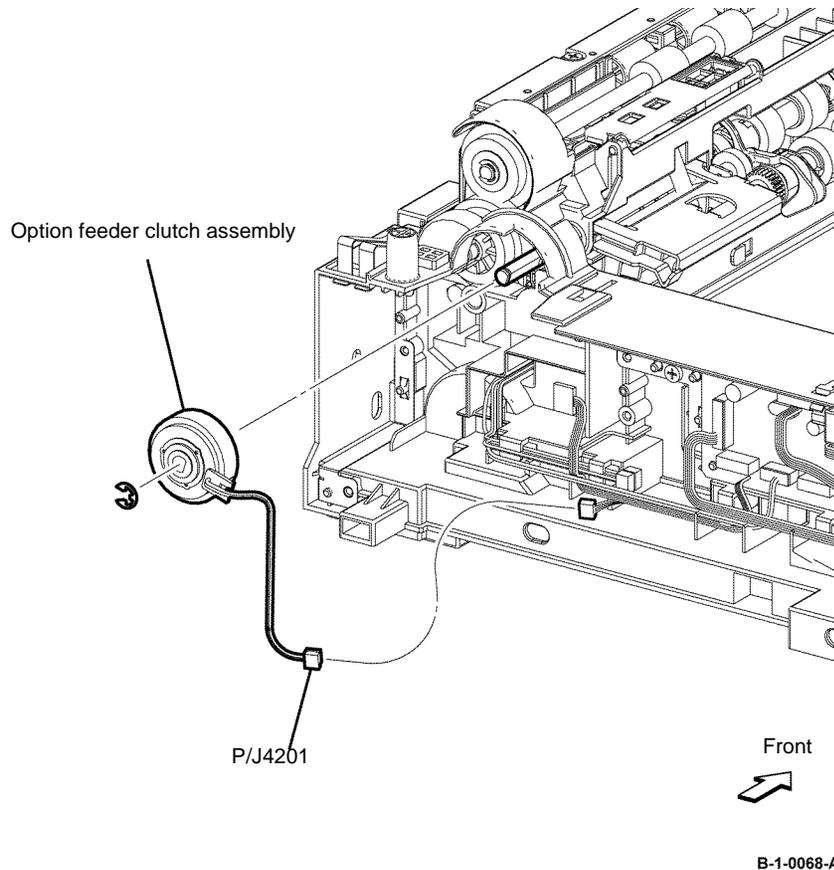
5. Disconnect PJ4201 from the option feeder clutch assembly, then release the harness from the harness guide on the frame, [Figure 1](#).
6. Remove the E-ring that fixes the option feeder clutch assembly, then remove the option feeder clutch assembly, [Figure 1](#).

Figure 1 Option feeder clutch assembly removal

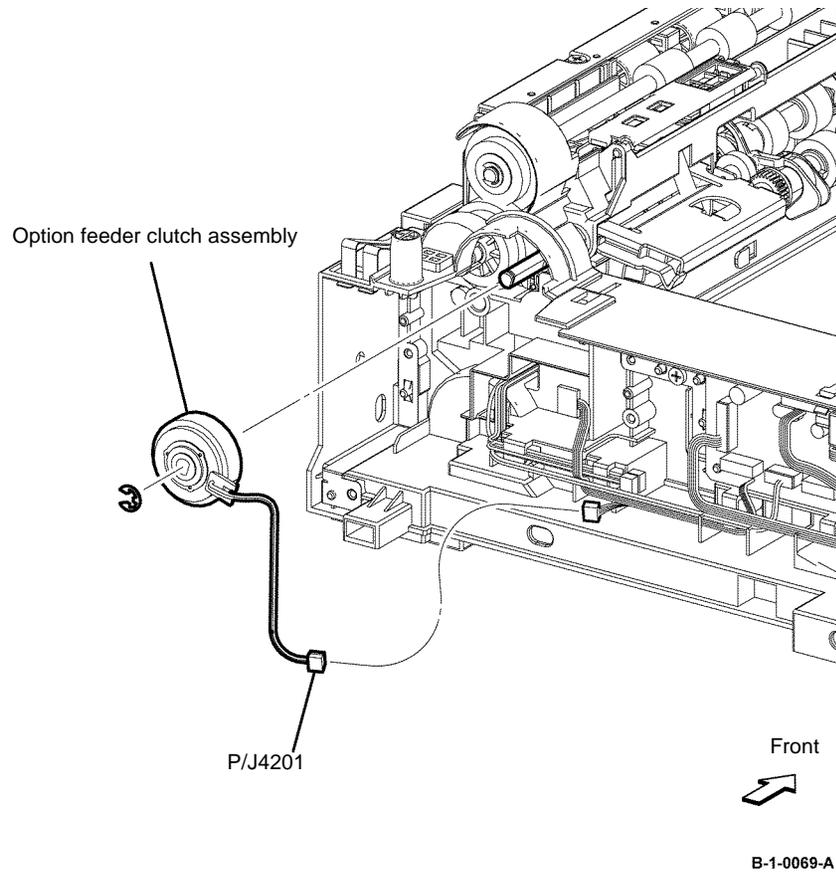
5. Disconnect PJ4201 from the option feeder clutch assembly, then release the harness from the harness guide on the frame, [Figure 1](#).
6. Remove the E-ring that fixes the option feeder clutch assembly, then remove the option feeder clutch assembly, [Figure 1](#).

Figure 1 Option feeder clutch assembly removal

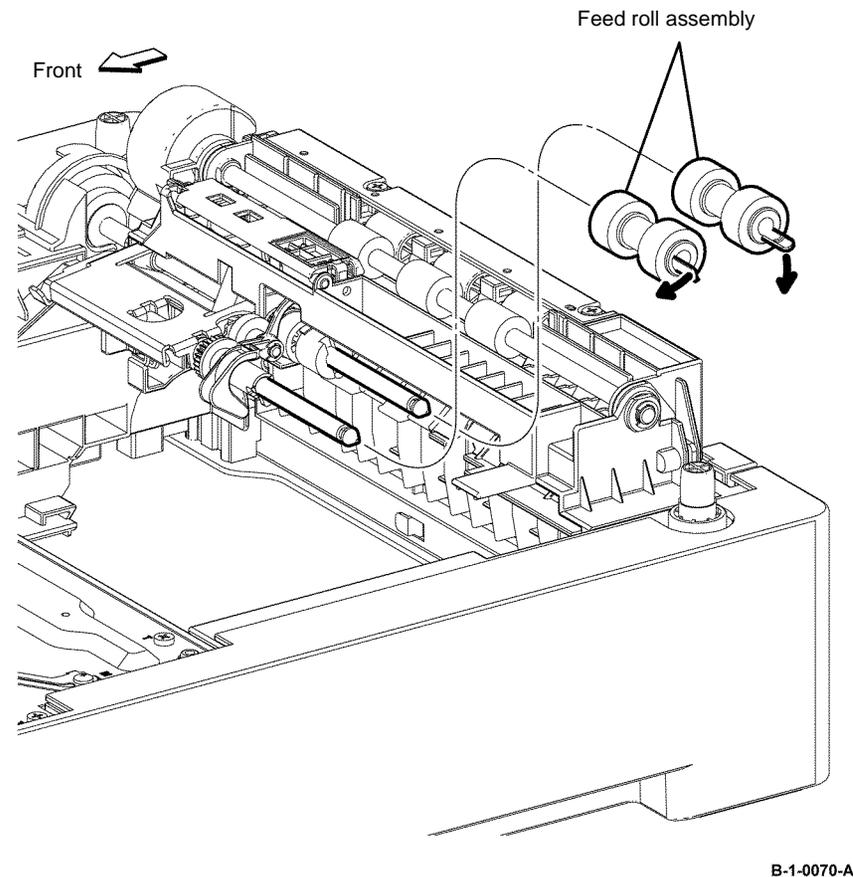
1. Remove the option tray assembly, [PL 9.2 Item 1](#).
2. Remove the option feeder assembly, [REP 11.1](#).
3. Remove the hook that fixes the option feeder feed roll assembly, then remove the option feeder feed roll assembly, [Figure 1](#).

Figure 1 Option feeder feed roll assembly removal

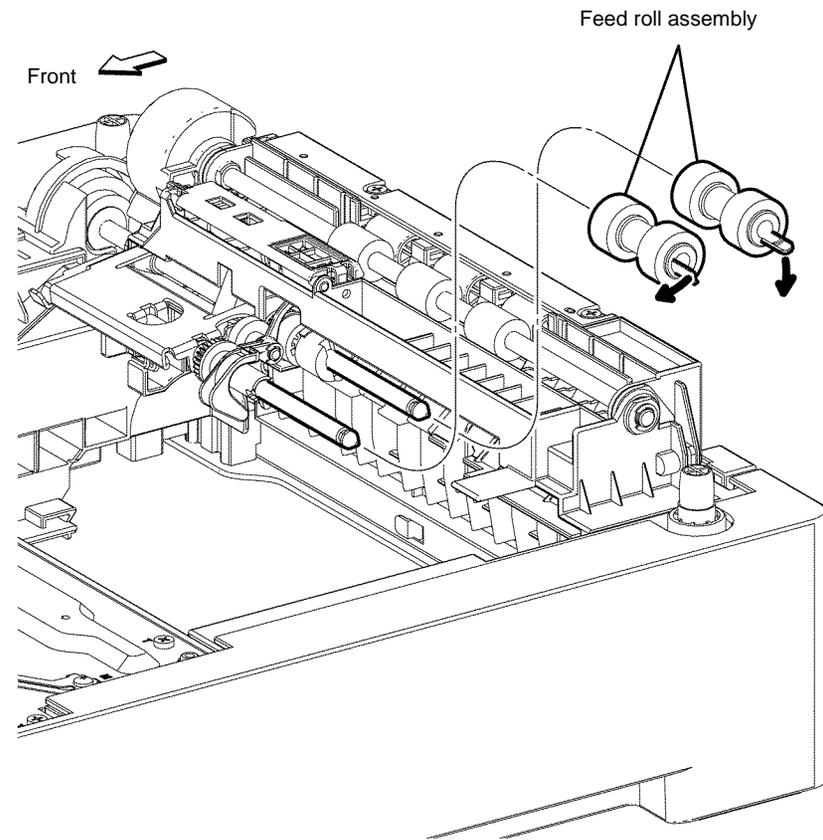
B-1-0071-A

1. Remove the option tray assembly, [PL 9.2 Item 1](#).
2. Remove the option feeder assembly, [REP 11.2](#).
3. Remove the hook that fixes the option feeder feed roll assembly, then remove the option feeder feed roll assembly, [Figure 1](#).

Figure 1 Option feeder feed roll assembly removal

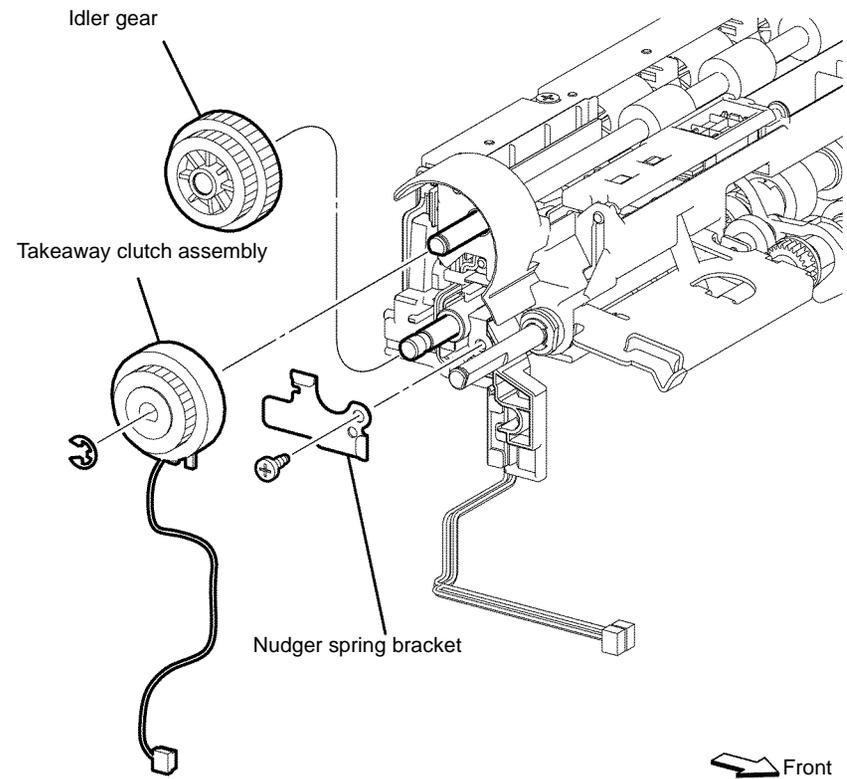
B-1-0072-A

1. Remove the option tray assembly, [PL 9.2 Item 1](#).
2. Remove the option feeder assembly, [REP 11.1](#).
3. Remove the option feeder assembly, [REP 11.13](#).
4. Remove the idler gear and remove one screw (silver, tapping, 8mm) that fixes the nudger spring bracket, then remove the nudger spring bracket, [Figure 1](#).
5. Remove the E-ring, then remove the takeaway clutch assembly, [Figure 1](#).

Figure 1 Option feeder takeaway clutch assembly removal

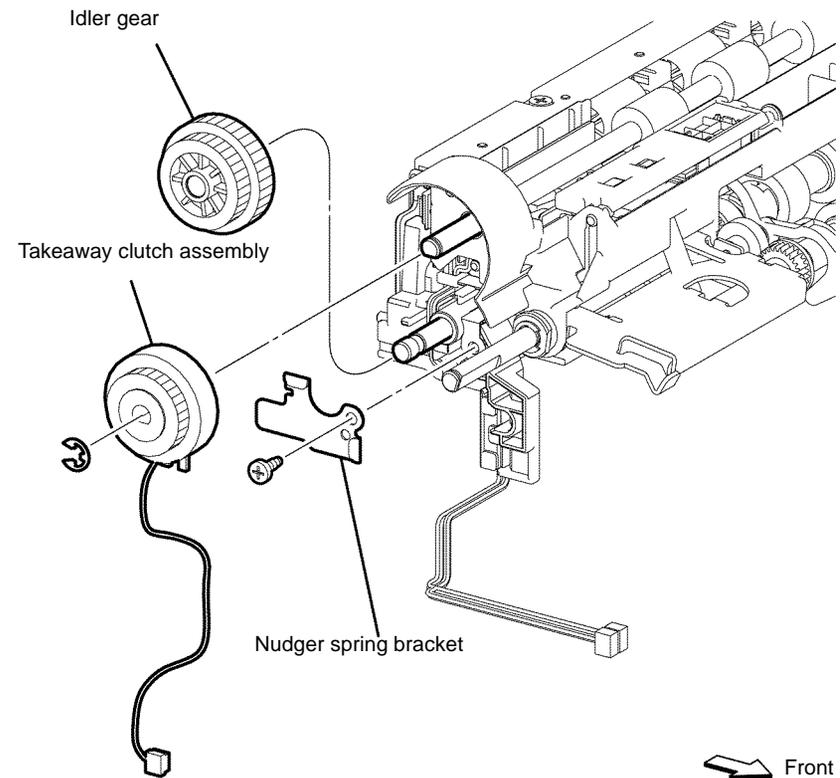
B-1-0072-A

1. Remove the option tray assembly, [PL 9.2 Item 1](#).
2. Remove the option feeder assembly, [REP 11.2](#).
3. Remove the option feeder assembly, [REP 11.14](#).
4. Remove the idler gear and remove one screw (silver, tapping, 8mm) that fixes the nudger spring bracket, then remove the nudger spring bracket, [Figure 1](#).
5. Remove the E-ring, then remove the takeaway clutch assembly, [Figure 1](#).

Figure 1 Option Feeder takeaway clutch assembly removal

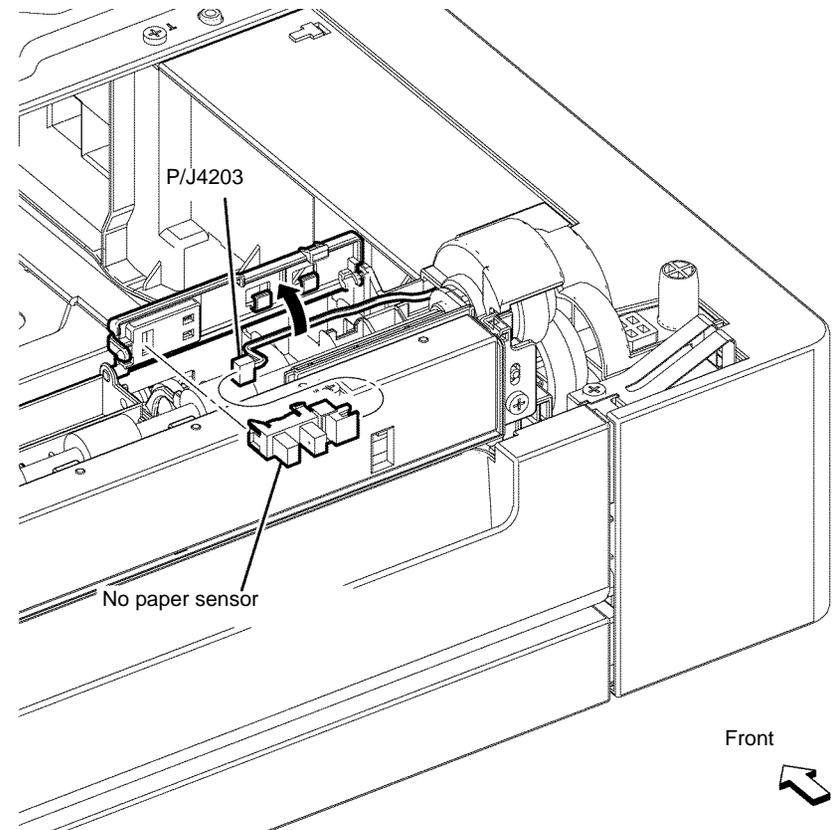
B-1-0074-A

1. Remove the option feeder assembly, [REP 11.1](#).
2. Remove the harness from the clamp, [Figure 1](#).
3. Disconnect P/J4203, then remove the option feeder no paper sensor, [Figure 1](#).

Figure 1 Option feeder no paper sensor removal

1. The replacement is the reverse of the removal procedure.
2. Connect the harness to the option feeder no paper sensor, then route the harness.
