# Xerox® VersaLink® B400 & B405 Family Multifunction Printer Service Manual

VersaLink B400 and B405 Family Multifunction Printer Service Manual

708P91373

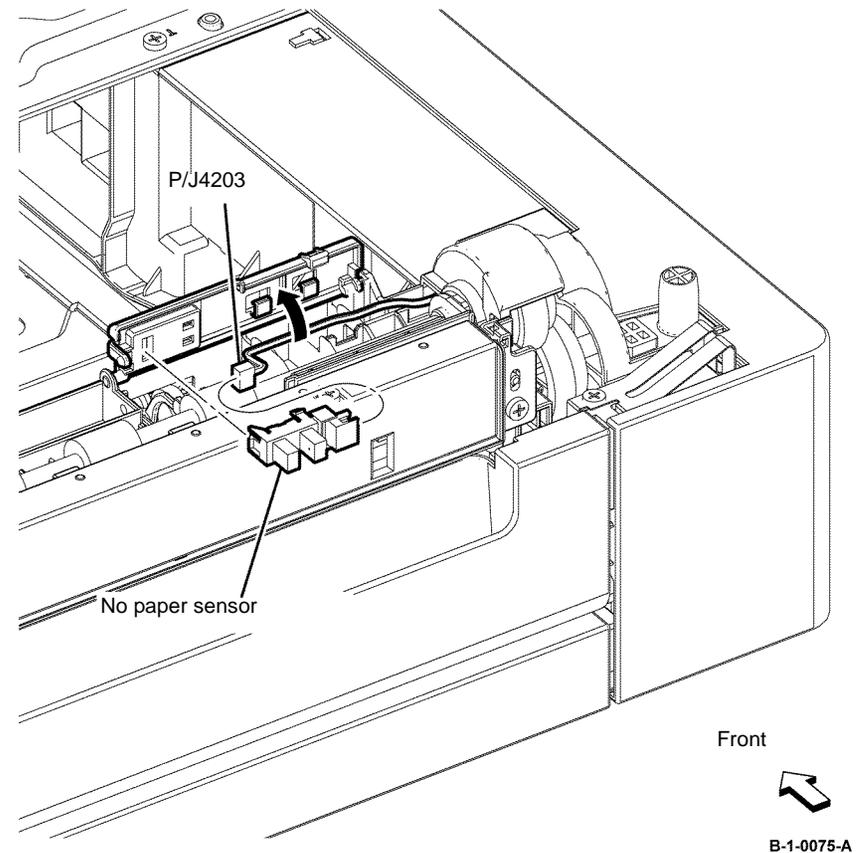
1. Remove the option feeder assembly, [REP 11.2](#).
2. Remove the harness from the clamp, [Figure 1](#).
3. Disconnect P/J4203, then remove the option feeder no paper sensor, [Figure 1](#).

Figure 1 Option feeder no paper sensor removal

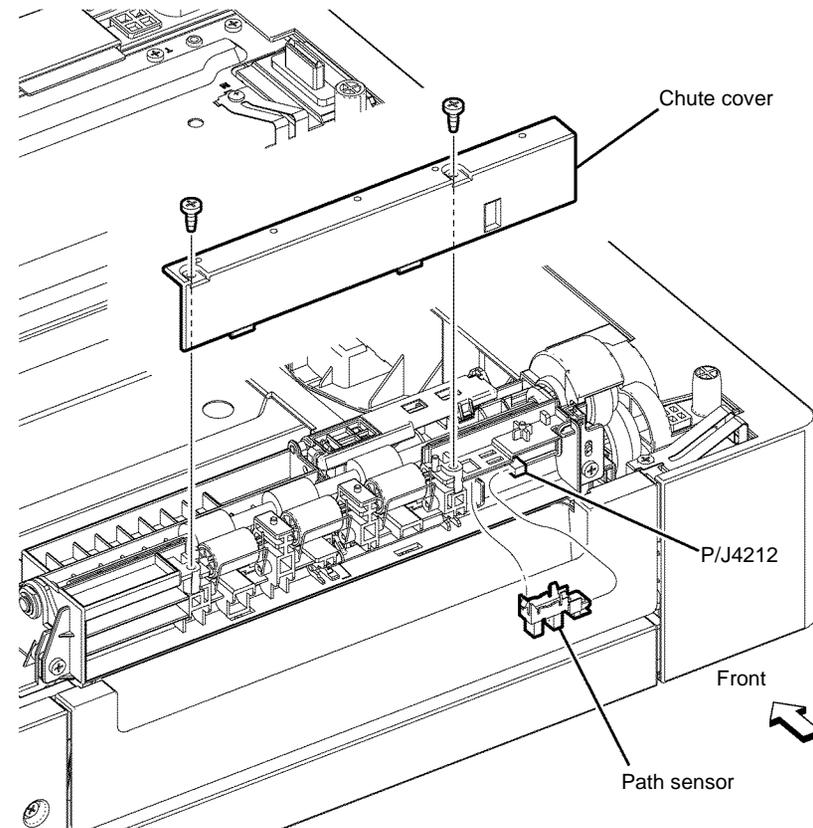
B-1-0076-A

1. Remove the option feeder assembly, [REP 11.1](#).
2. Remove two screws (silver, tapping, 8mm), then remove the chute cover, [Figure 1](#).
3. Disconnect PJ4212, then remove the option feeder path sensor, [Figure 1](#).

Figure 1 Option feeder path sensor removal

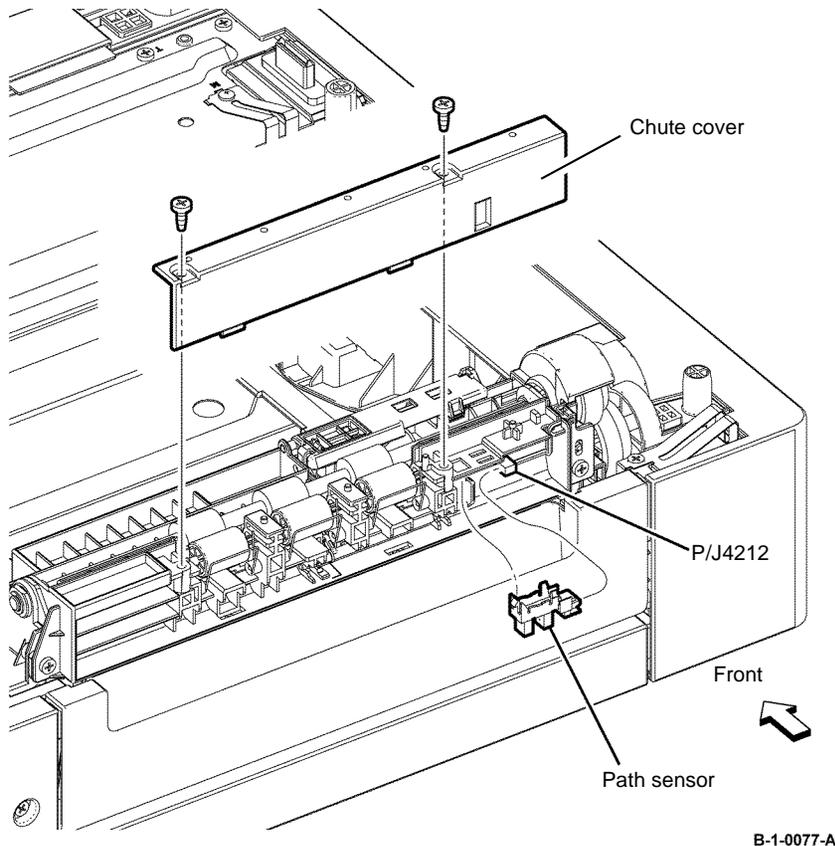
1. Remove the option feeder assembly, [REP 11.2](#).
2. Remove two screws (silver, tapping, 8mm), then remove the chute cover, [Figure 1](#).
3. Disconnect P/J4212, then remove the option feeder path sensor, [Figure 1](#).

Figure 1 Option feeder path sensor removal

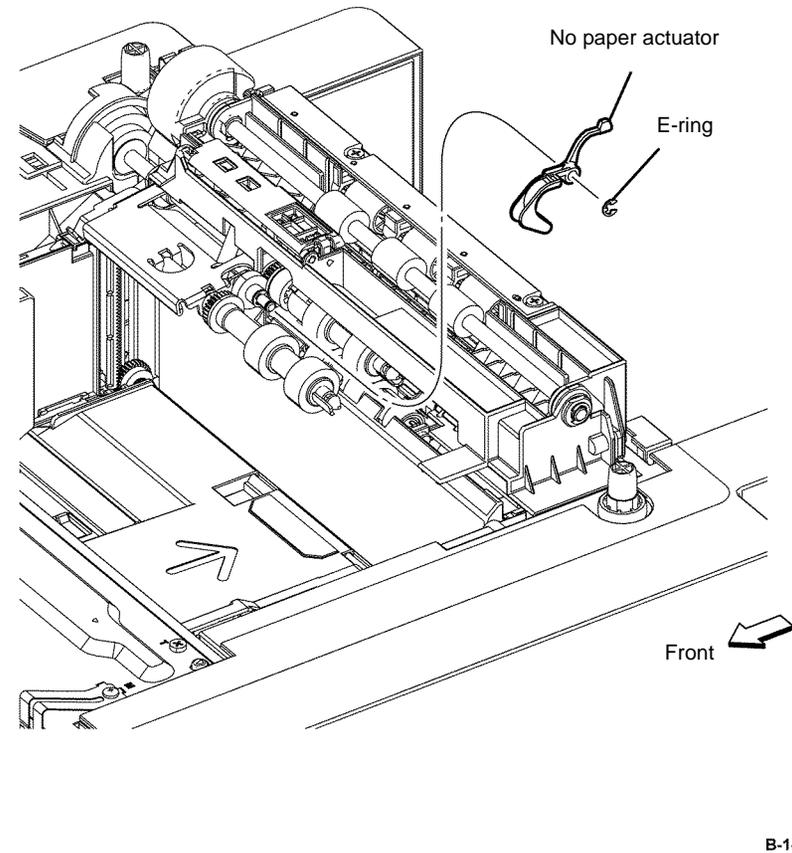
1. Remove the tray assembly, [PL 9.2 Item 1](#).
2. Remove the option feeder assembly, [REP 11.1](#).
3. Remove the E-ring, then remove the option feeder no paper actuator, [Figure 1](#).

Figure 1 Option feeder no paper actuator removal

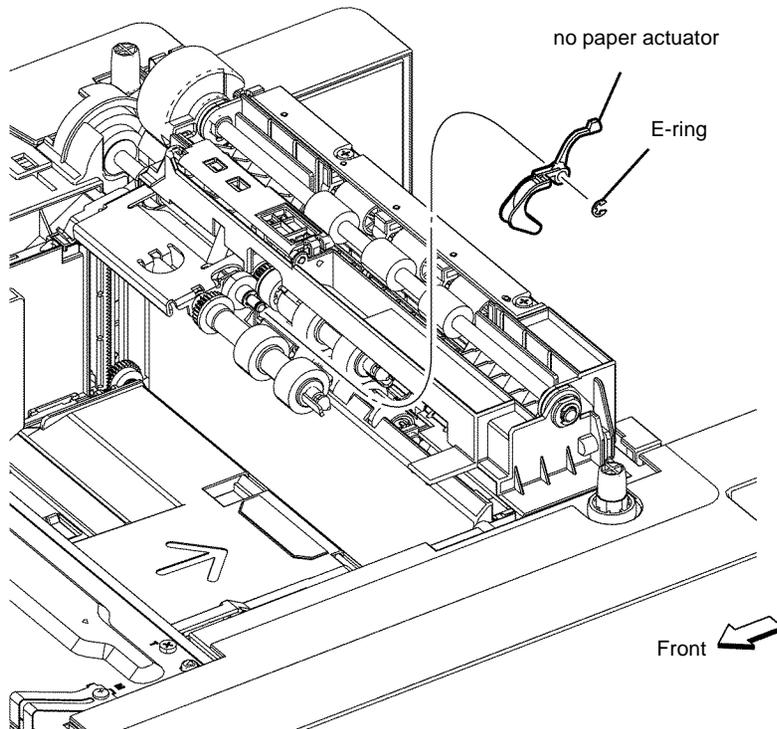
B-1-0079--A

1. Remove the tray assembly, [PL 9.2 Item 1](#).
2. Remove the option feeder assembly, [REP 11.2](#).
3. Remove the E-ring, then remove the option feeder no paper actuator, [Figure 1](#).

Figure 1 Option feeder no paper actuator removal

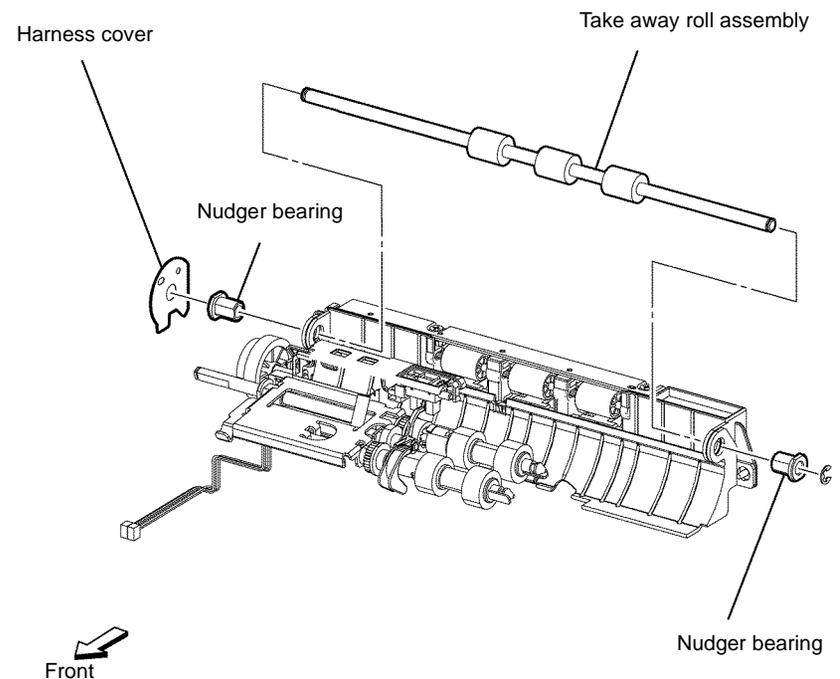
B-1-0080-A

1. Remove the option tray assembly, [PL 9.2 Item 1](#).
2. Remove the option feeder assembly, [REP 11.1](#).
3. Remove the option feeder assembly, [REP 11.13](#).
4. Remove the option feeder takeaway clutch assembly, [REP 11.19](#).
5. Remove the E-ring and nudger bearing, then remove the option feeder take away roll assembly by shifting it to the left, [Figure 1](#).

Figure 1 Option feeder take away roll assembly removal

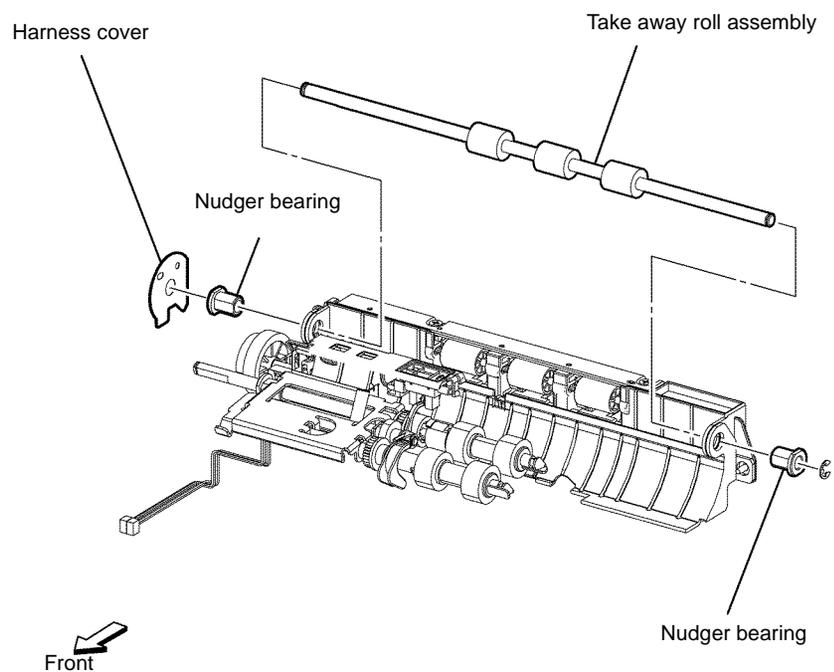
B-1-0081-A

1. Remove the option tray assembly, [PL 9.2 Item 1](#).
2. Remove the option feeder assembly, [REP 11.2](#).
3. Remove the option feeder assembly, [REP 11.14](#).
4. Remove the option feeder takeaway clutch assembly, [REP 11.20](#).
5. Remove the E-ring and nudger bearing, then remove the option feeder take away roll assembly by shifting it to the left, [Figure 1](#).

Figure 1 Option feeder take away roll assembly removal

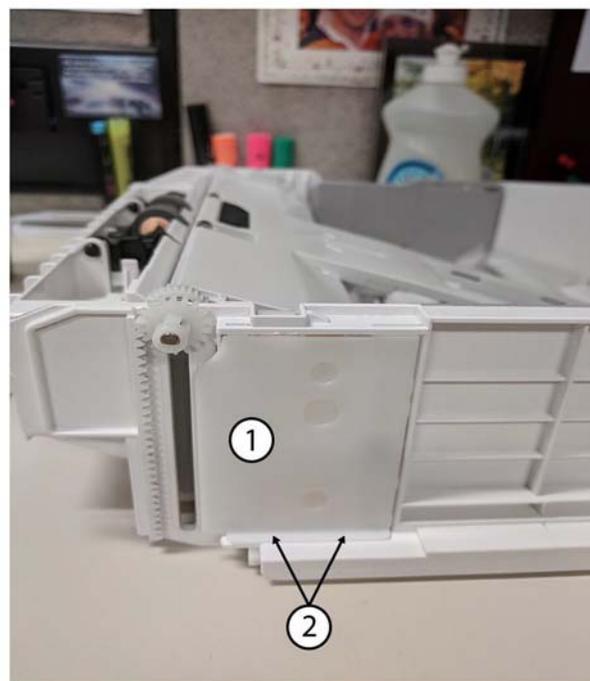
B-1-0277-A

1. Remove the option feeder tray assembly, [PL 11.3 Item 1](#).
2. Remove the bottom lock cover, [Figure 1](#):
  - a. Stand the option feeder tray on its side with the bottom lock cover face up (1).
  - b. Carefully pry the bottom lock cover at two points (2) releasing two tabs in the option feeder tray, then remove the bottom lock cover (1).

Figure 1 Bottom lock cover removal

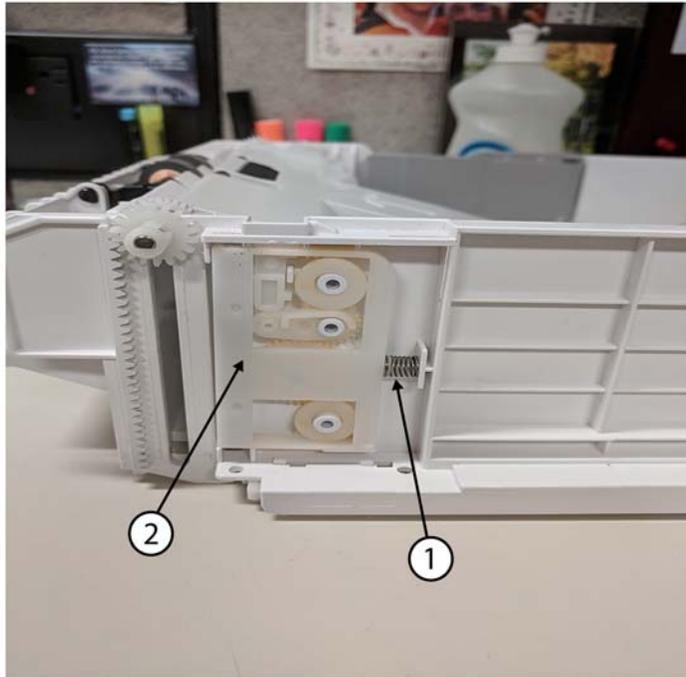
B-1-0278-A

3. Remove the lock spring (1), [Figure 2](#).

**NOTE:** To ensure the gears do not fall out of the lift assembly (2), hold the lift assembly in-place while removing the lock spring.

Figure 2 Lift assembly removal

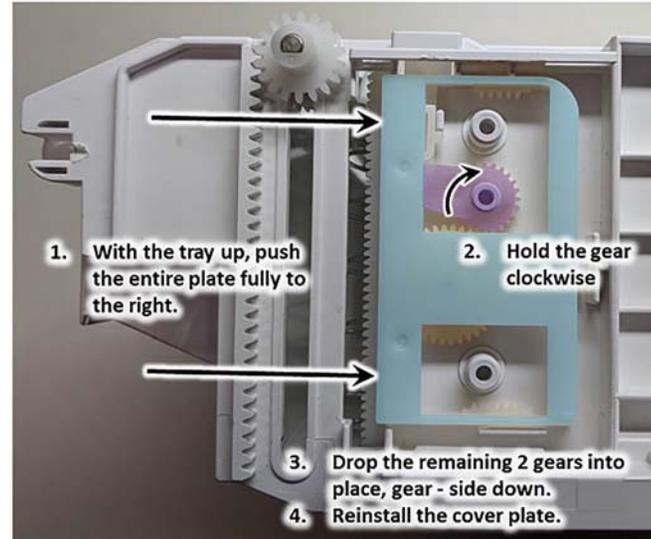
B-1-0280-A

If the assembly comes apart during removal, re-assemble the assembly as shown below to ensure the lift dampening of the assembly function's properly, [Figure 3](#).

Figure 3 Option feeder tray lift reassembly

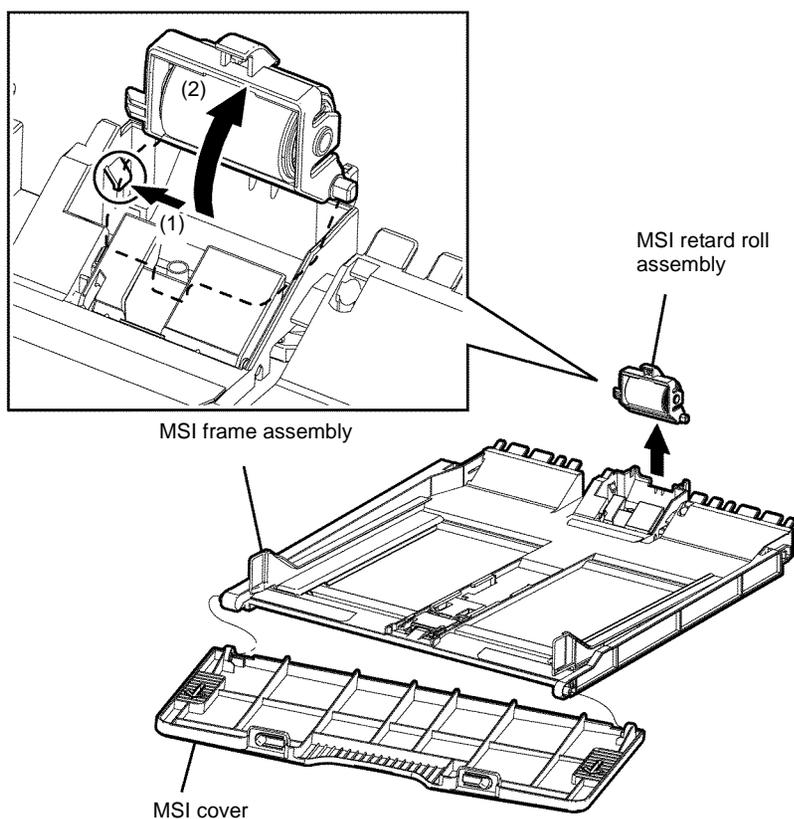
B-1-0128-A

1. Open the MSI cover, [PL 13.2 Item 99](#).
2. Pull out the MSI tray assembly, [PL 13.2 Item 9](#).
3. Release the hook that fixes the MSI retard roll assembly to the MSI frame assembly. Remove the MSI retard roll assembly by rotating it in the arrowed direction, [Figure 1](#).
4. Release the hole on the MSI cover from the boss on the MSI frame assembly, then remove the MSI cover, [Figure 1](#).

Figure 1 MSI cover and retard roll assembly removal

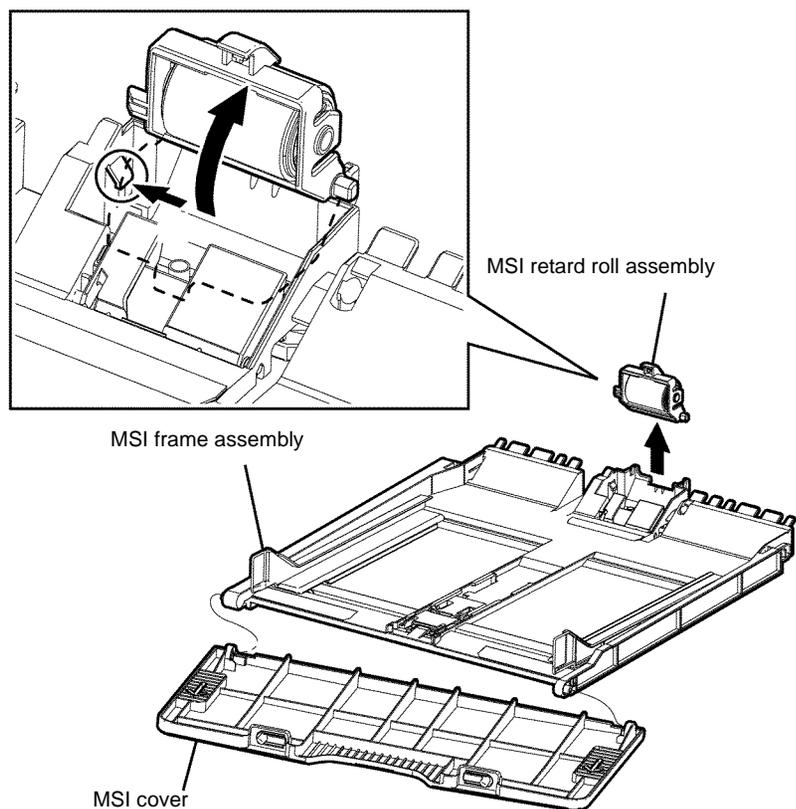
B-1-0129-A

1. Open the MSI cover, [PL 13.2 Item 99](#).
2. Pull out the MSI tray assembly, [PL 13.2 Item 9](#).
3. Release the hook that fixes the MSI retard roll assembly to the MSI frame assembly, then remove the MSI retard roll assembly by rotating it in the arrowed direction. [Figure 1](#).
4. Release the hole on the MSI cover from the boss on the MSI frame assembly, then remove the MSI cover, [Figure 1](#).

Figure 1 MSI cover and retard roll assembly removal

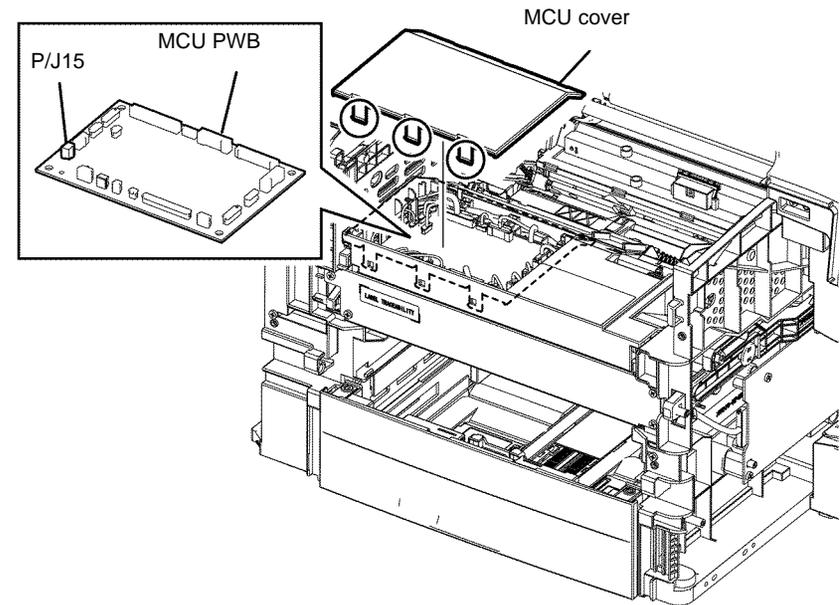
B-1-0130-A

1. Open the MSI cover, [PL 13.2 Item 99](#).
2. Pull out the MSI tray assembly, [PL 13.2 Item 9](#).
3. Remove the option tray assembly, [PL 9.2 Item 1](#).
4. Remove the front cover assembly, [REP 19.1](#).
5. Remove the drum Cartridge, [REP 8.1](#).
6. Remove the rear cover assembly, [REP 19.13](#).
7. Remove the ESS window cover assembly, [REP 19.3](#).
8. Remove the WIFI cap cover, [REP 19.19](#).
9. Remove the left cover, [REP 19.11](#).
10. Remove the ESS PWB, [REP 18.1](#).
11. Remove the main drive assembly, [REP 3.1](#).
12. Remove the MCU cover by releasing the hook. Disconnect PJ15 from the MCU PWB, then release the harness of the MSI feed solenoid from the harness guide, [Figure 1](#).

Figure 1 MSI feed solenoid disconnect

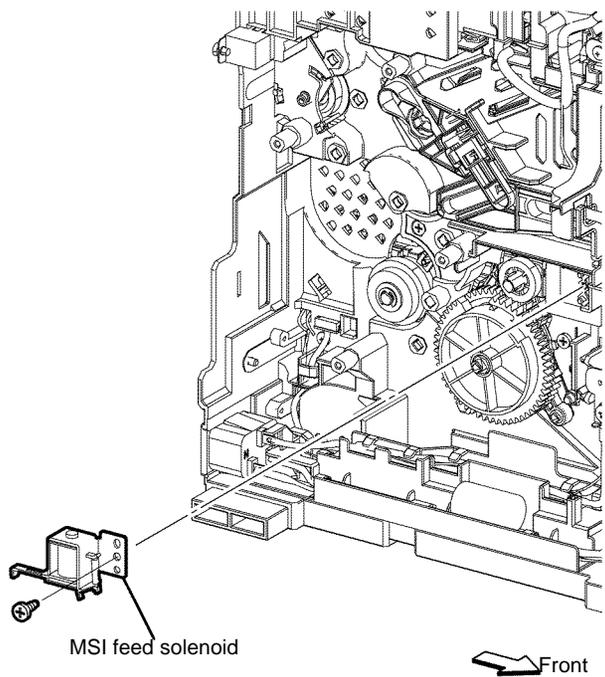
B-1-0131-A

13. Remove one screw (silver, tapping, 8mm), then remove the MSI feed solenoid, [Figure 2](#).

Figure 2 MSI feed solenoid removal

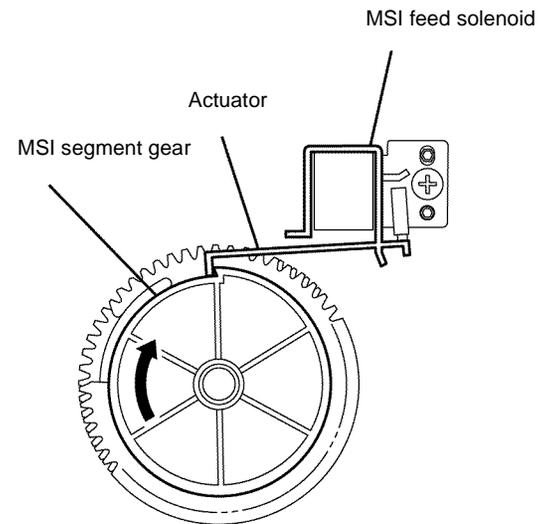
B-1-0132-A

Figure 3 MSI feed solenoid installation

1. The replacement is the reverse of the removal procedure.
2. When installing the MSI feed solenoid, ensure that the actuator is latched to the MSI segment gear 1, [Figure 3](#).

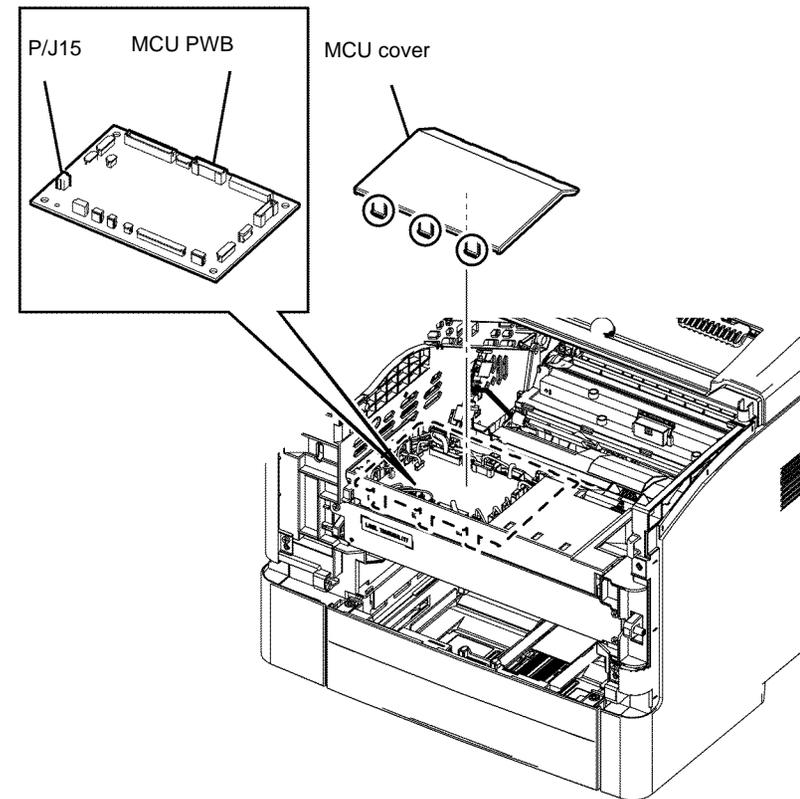
B-1-0133-A

1. Open the MSI cover, [PL 13.2 Item 99](#).
2. Pull out the MSI tray assembly, [PL 13.2 Item 9](#).
3. Remove the option tray assembly, [PL 9.2 Item 1](#).
4. Remove the front cover assembly, [REP 19.2](#).
5. Remove the Drum cartridge. [REP 8.2](#).
6. Remove the rear cover assembly, [REP 19.14](#).
7. Remove the UI console assembly, [REP 1.3](#).
8. Remove the exit top cover assembly, [REP 19.10](#).
9. Remove the WIFI cap cover, [REP 19.20](#).
10. Remove the ESS window cover assembly, [REP 19.4](#).
11. Remove the front/left UI cover assembly, [REP 1.4](#).
12. Remove the left cover, [REP 19.12](#).
13. Remove the ESS PWB, [REP 18.2](#).
14. Remove the main drive assembly, [REP 3.2](#).
15. Remove the MCU cover by releasing the hook. Disconnect PJ15 from the MCU PWB, then release the harness of the MSI feed solenoid from the harness guide, [Figure 1](#).

Figure 1 MSI feed solenoid disconnect

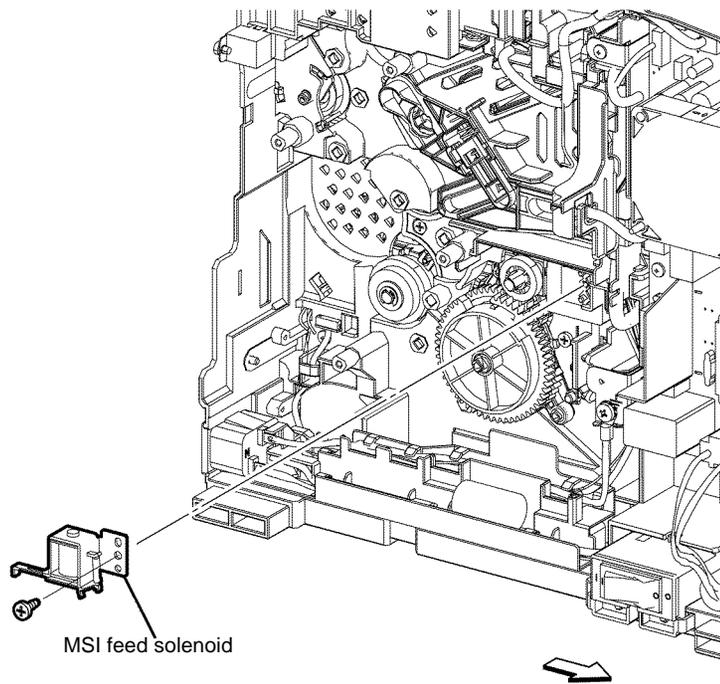
B-1-0134-A

16. Remove one screw (silver, tapping, 8mm), then remove the MSI feed solenoid, [Figure 2](#).

MSI feed solenoid

Figure 2 MSI feed solenoid removal

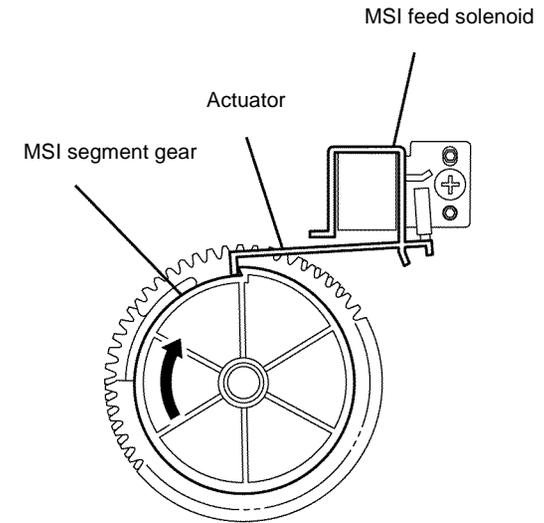
B-1-0135-A

Figure 3 MSI feed solenoid installation

1. The replacement is the reverse of the removal procedure.
2. When installing the MSI feed solenoid, ensure that the actuator is latched to the MSI segment gear 1, [Figure 3](#).

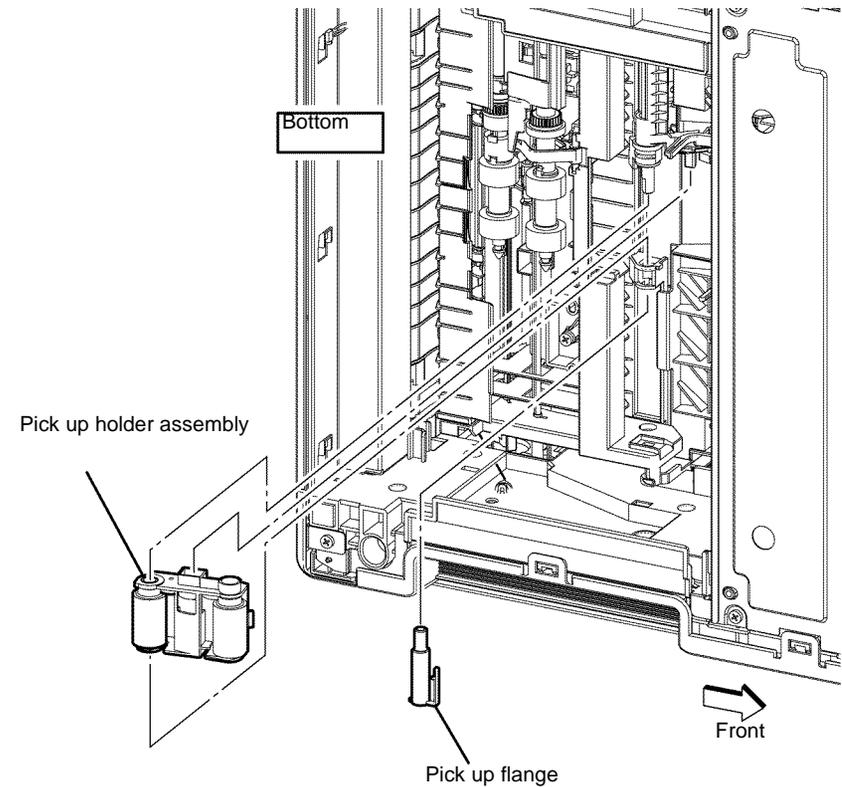
B-1-0136-A

6. Remove the pick up flange by releasing the hook, then remove the pick up holder assembly, [Figure 1](#).

Figure 1 Pick up holder removal

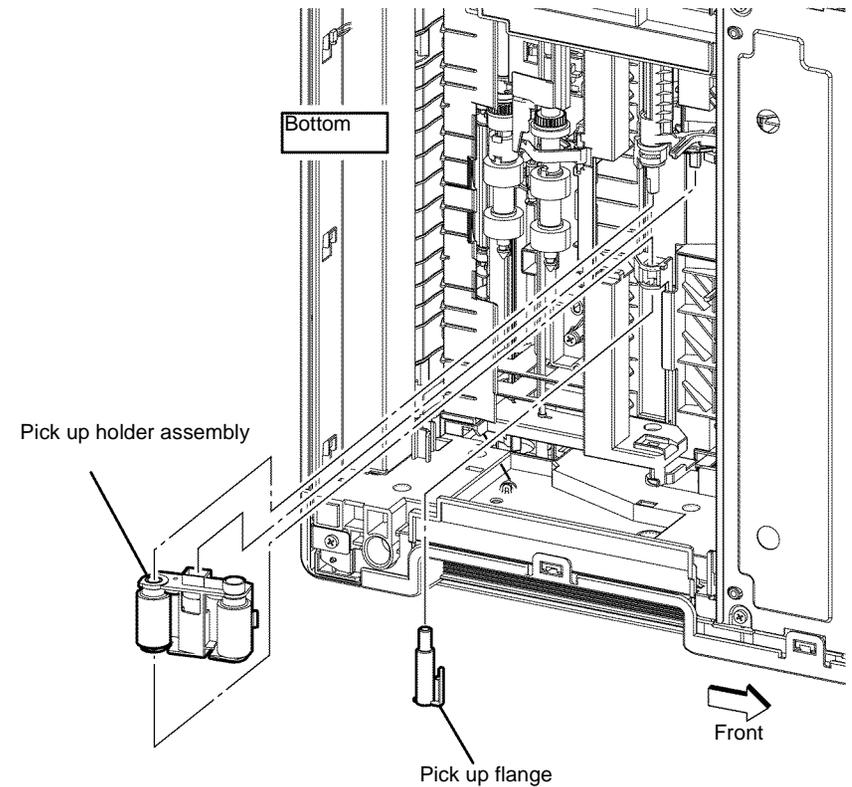
B-1-0137-A

6. Remove the pick up flange by releasing the hook, then remove the pick up holder assembly, [Figure 1](#).

Figure 1 Pick up holder removal

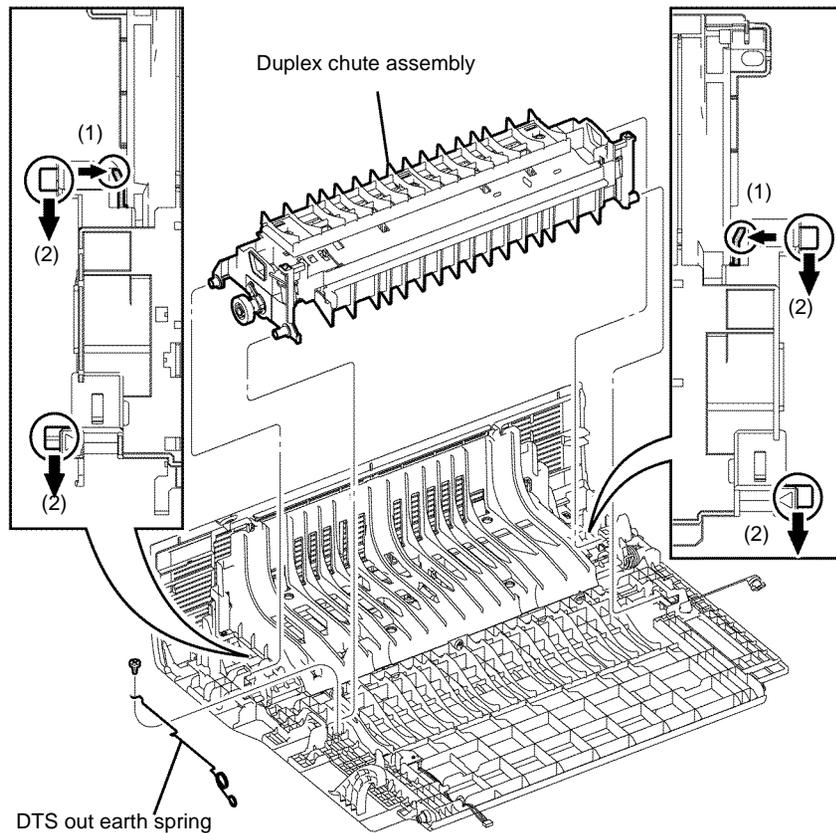
B-1-0138-A

1. Remove the rear cover assembly, [REP 19.13](#).
2. Remove the CRU transfer roller assembly, [REP 6.1](#).
3. Remove one screw (silver, tapping, 4mm), then remove the DTS out earth spring from the rear cover assembly, [Figure 1](#).
4. Release the two hooks, then remove the duplex chute assembly by sliding it to the left until the four bosses are released, [Figure 1](#).

Figure 1 Duplex chute assembly removal

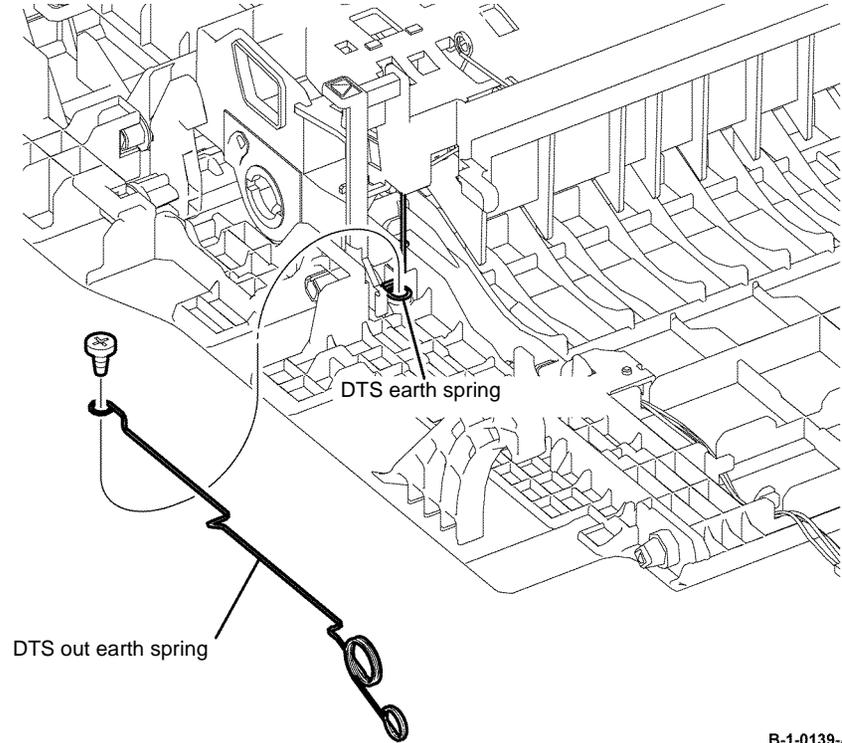
B-1-0139-A

1. The replacement is the reverse of the removal procedure.
2. When installing the DTS out earth spring, ensure it is positioned above the DTS earth spring, on the duplex chute assembly, [Figure 2](#).

Figure 2 DTS out earth spring installation

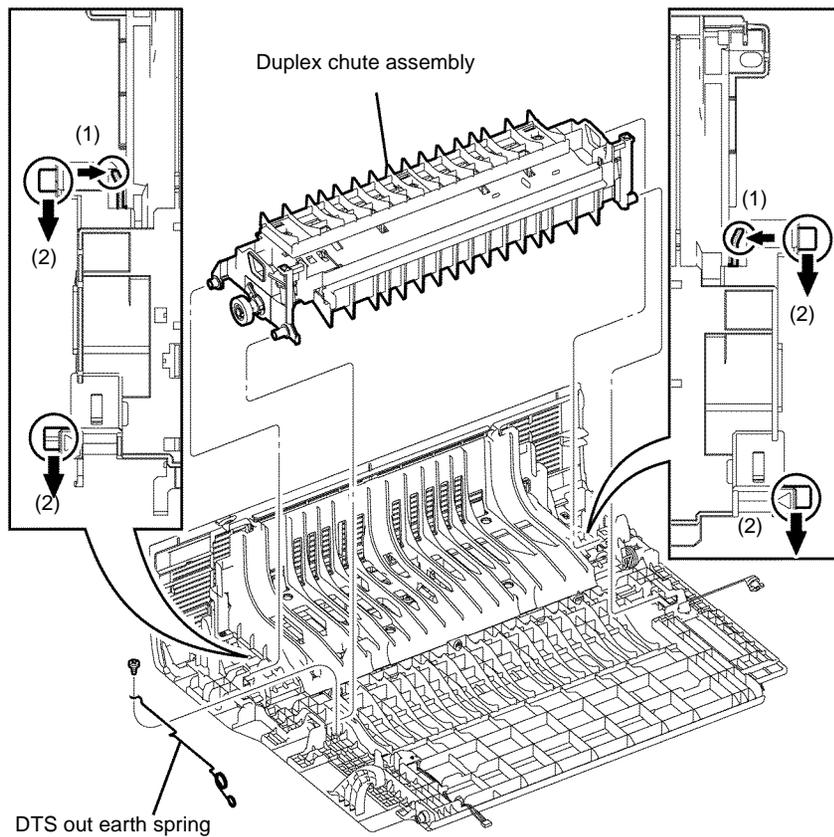
B-1-0140-A

1. Remove the rear cover assembly, [REP 19.14](#).
2. Remove the CRU transfer roller assembly, [REP 6.2](#).
3. Remove one screw (silver, tapping, 4mm), then remove the DTS out earth spring from the rear cover assembly, [Figure 1](#).
4. Release the two hooks, then remove the duplex chute assembly by sliding it to the left until the four bosses are released, [Figure 1](#).

Figure 1 Duplex chute assembly removal

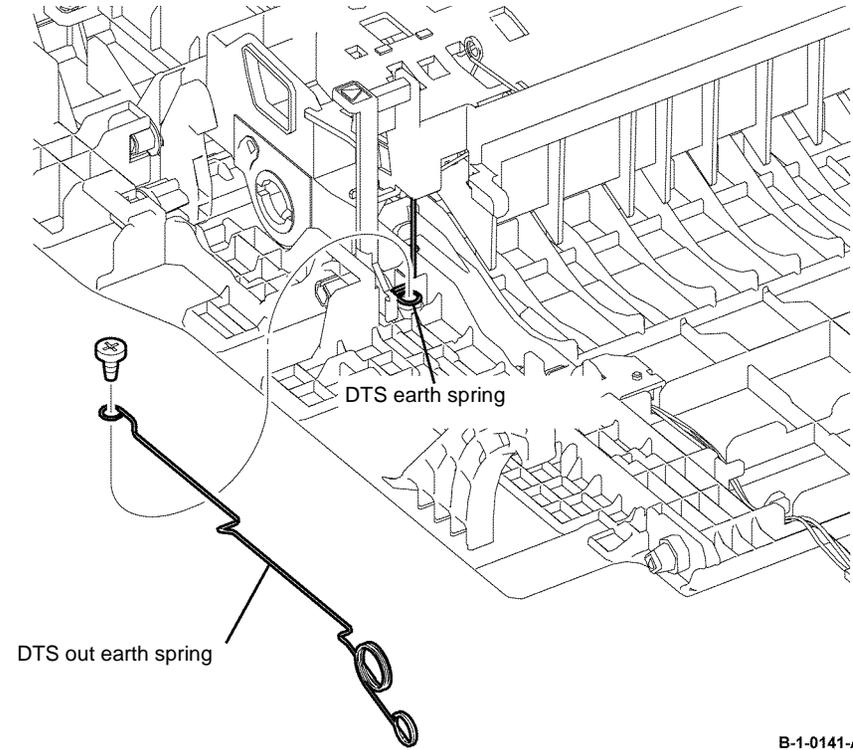
B-1-0141-A

1. The replacement is the reverse of the removal procedure.
2. When installing the DTS out earth spring, ensure it is positioned above the DTS earth spring, on the duplex chute assembly, [Figure 2](#).

Figure 2 DTS out earth spring installation

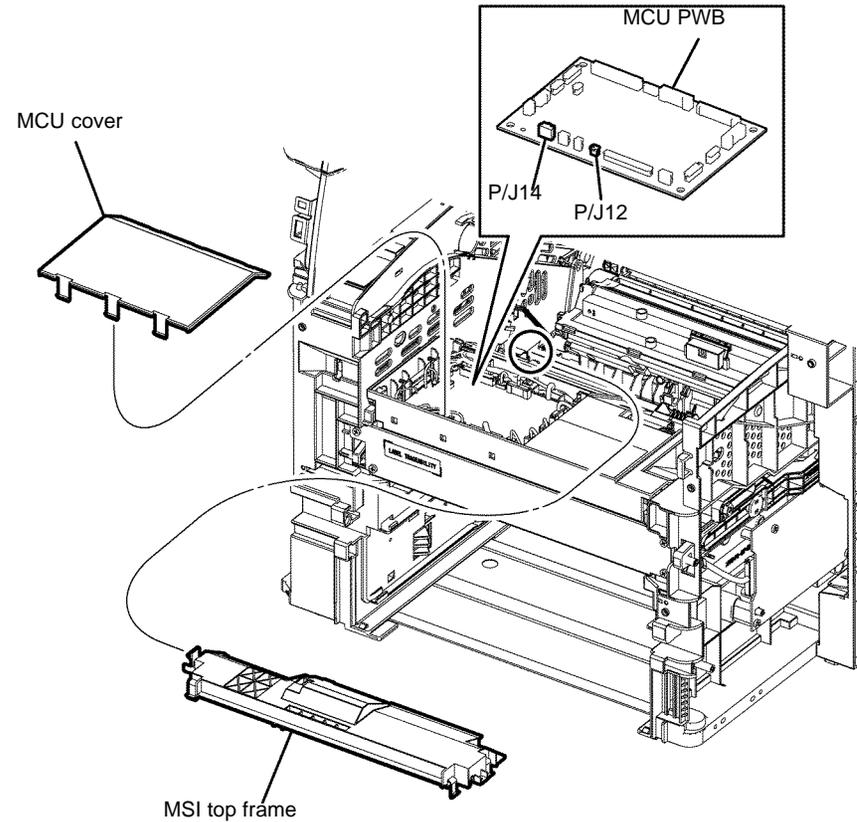
B-1-0142-A

16. Release four hooks, then remove the MSI top frame, [Figure 1](#).
17. Remove the MCU cover by releasing the hook. Disconnect P/J12 and P/J14 from the MCU PWB, then release the registration transport assembly harness from the harness guide, [Figure 1](#).

Figure 1 Registration transport assembly harness release

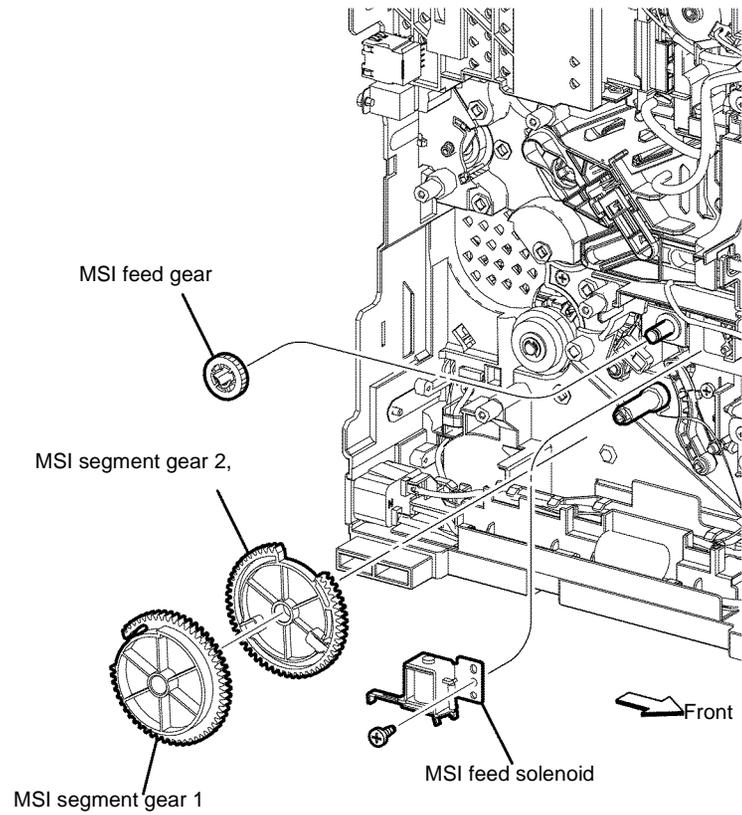
B-1-0143-A

18. Remove one screw (silver, tapping, 8mm), then remove the MSI feed solenoid, [Figure 2](#).
19. Remove the MSI segment gear 1, MSI segment gear 2, and MSI feed gear, [Figure 2](#).

**Figure 2 MSI feed solenoid, segment and MSI feed gears removal**

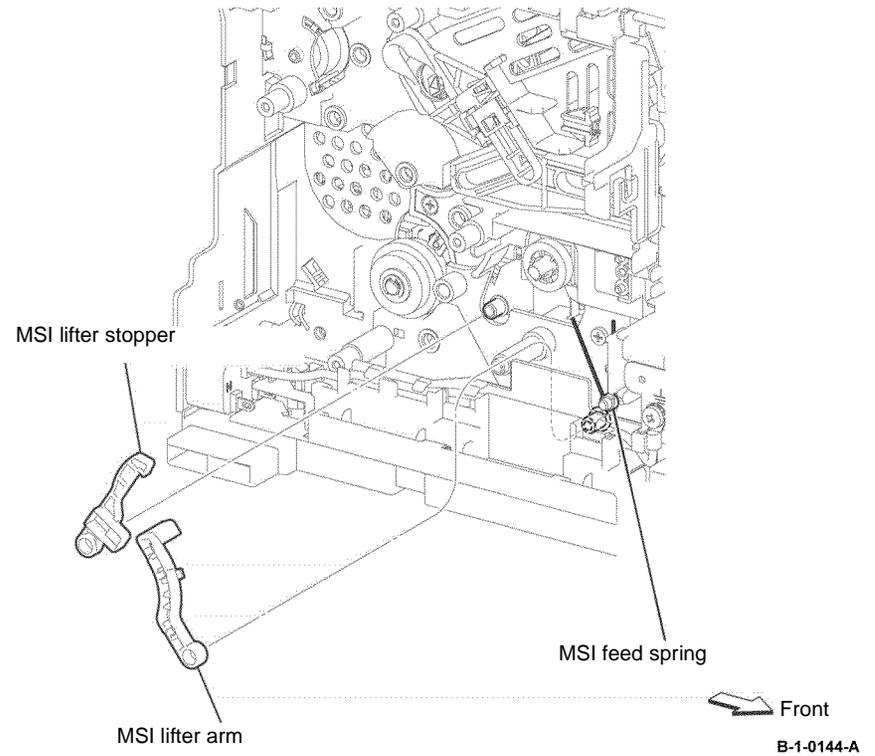
B-1-0144-A

20. Release the MSI feed spring from the MSI lifter arm, then remove the MSI lifter arm and MSI lifter stopper, [Figure 3](#).

**Figure 3 MSI lifter arm and lifter stopper removal**

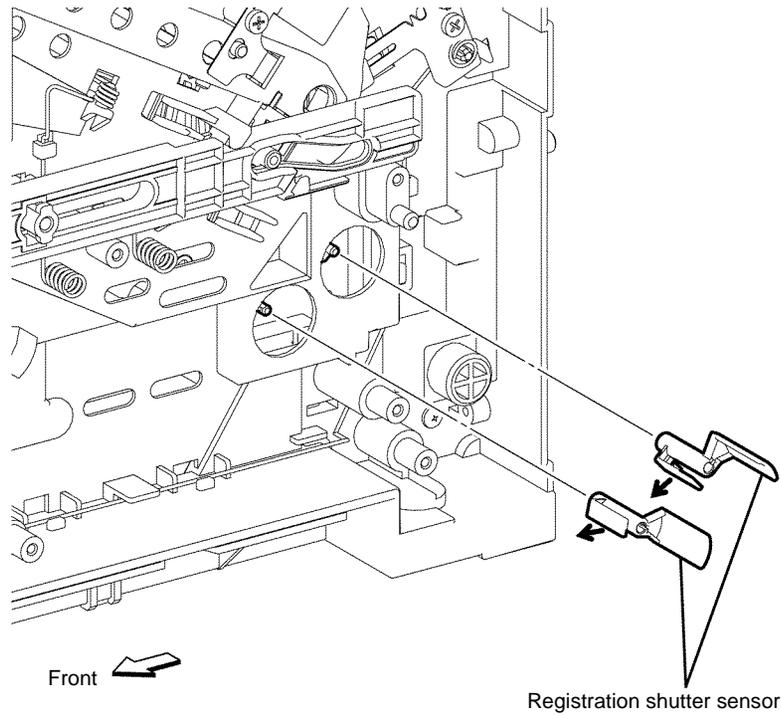
B-1-0145-A

21. Release the hook, then remove the registration shutter sensor, [Figure 4](#).

Registration shutter sensor

**Figure 4 Registration shutter sensor removal**

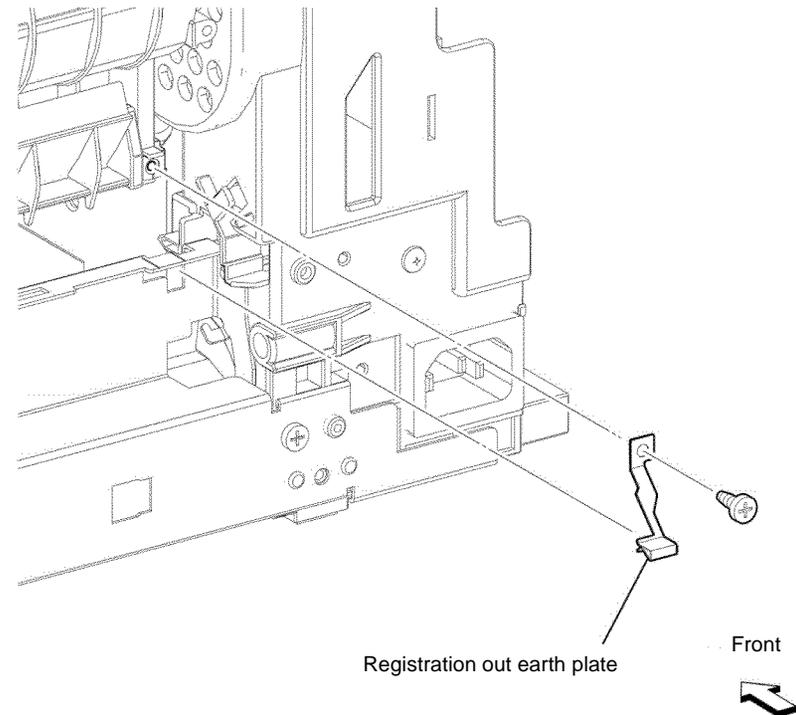
Registration out earth plate

22. Release one screw (silver, tapping, 8mm), then remove the registration out earth plate, [Figure 5](#).

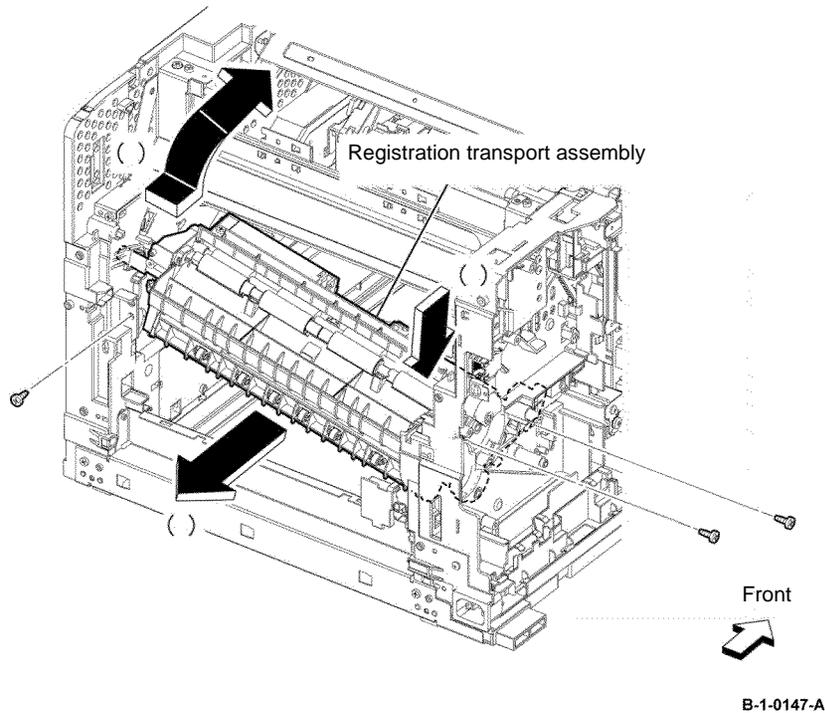
B-1-0147-A

23. Remove three screws (silver, tapping, 8mm), then remove the registration transport assembly from the printer, [Figure 6](#).

Figure 6 Registration transport assembly removal

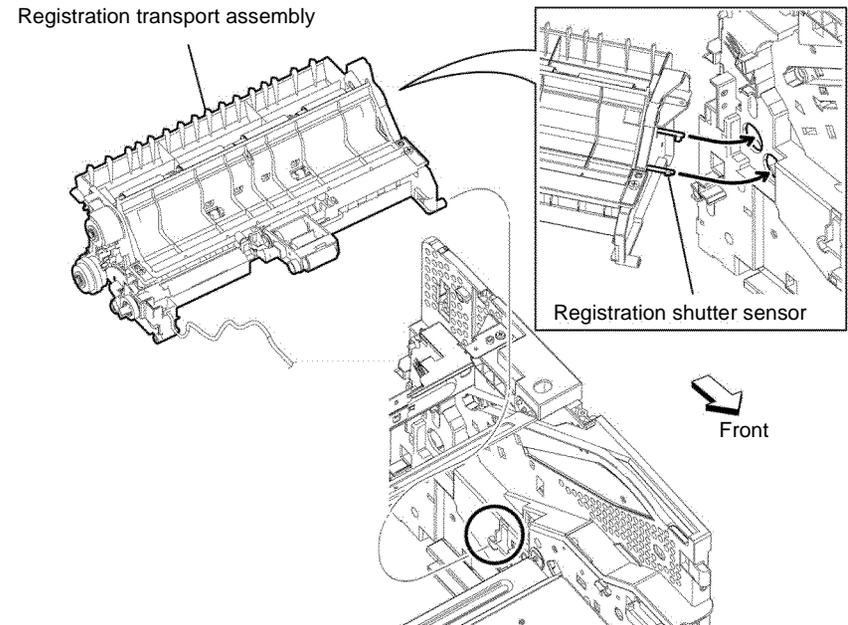
B-1-0148-A

Figure 7 Registration transport assembly installation

1. The replacement is the reverse of the removal procedure.
2. When installing the registration transport assembly, ensure the position of the boss and the registration shutter sensor is correct, [Figure 7](#).

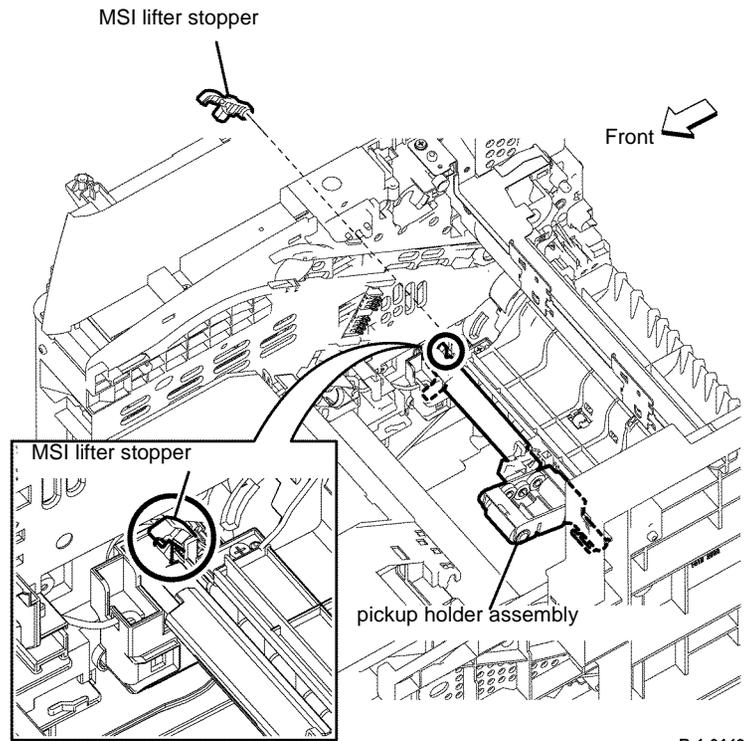
B-1-0149-A

3. When installing the MSI lifter stopper, ensure the pickup holder assembly, is in the position shown, [Figure 8](#).

**Figure 8 MSI lifter stopper installation**

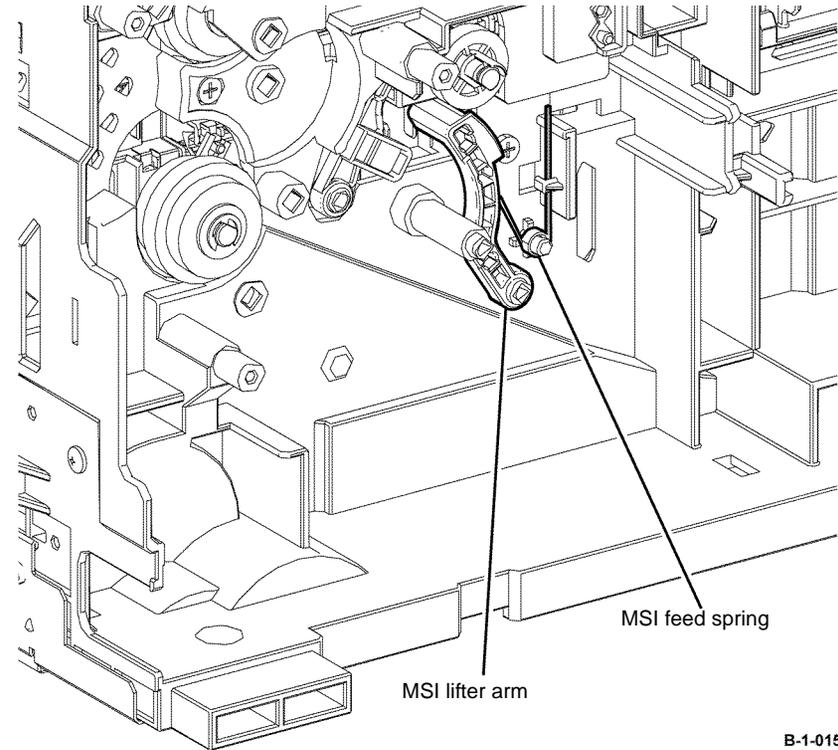
B-1-0150-A

**Figure 9 MSI lifter arm installation**

4. When installing the MSI lifter arm, ensure the MSI feed spring, is correctly positioned, [Figure 9](#).
5. When installing the MSI segment gear 1 and MSI segment gear 2, fit the bosses on the MSI segment gear 1 into the holes on the MSI segment gear 2, [Figure 10](#).

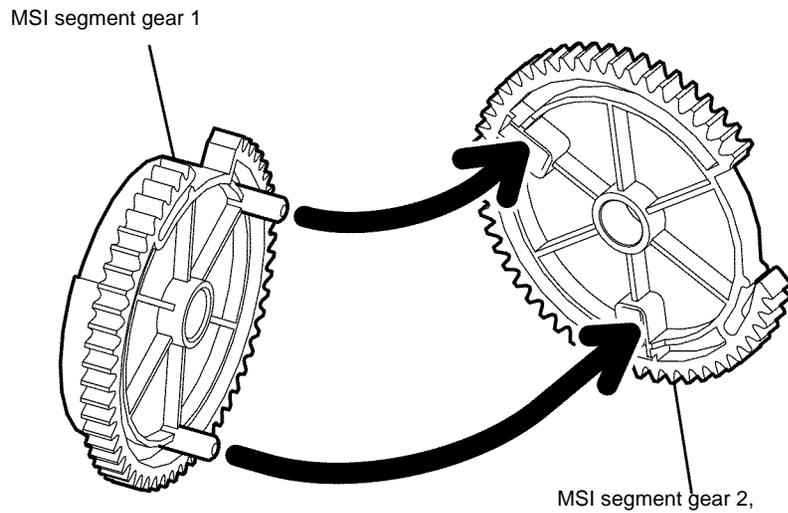
B-1-0151-A

**Figure 10 MSI segment gear 1 and 2 installation**

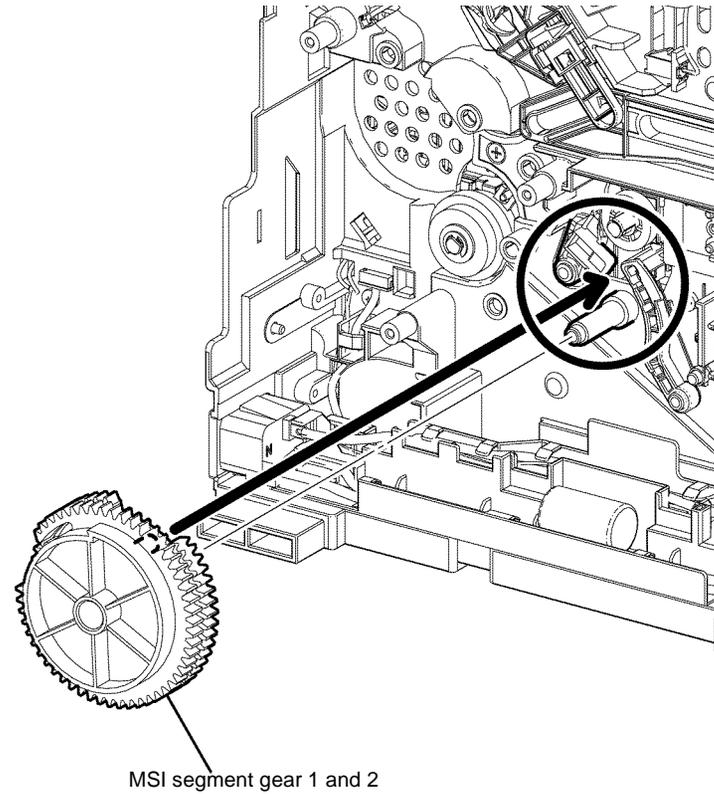
B-1-0152-A

- When installing the MSI segment gear 1 and MSI segment gear 2, ensure that the actuator is the position shown, [Figure 11](#).

**Figure 11 MSI segment gear 1 and 2 actuator position**
