# Xerox® VersaLink® B400 & B405 Family Multifunction Printer Service Manual

VersaLink B400 and B405 Family Multifunction Printer Service Manual

708P91373

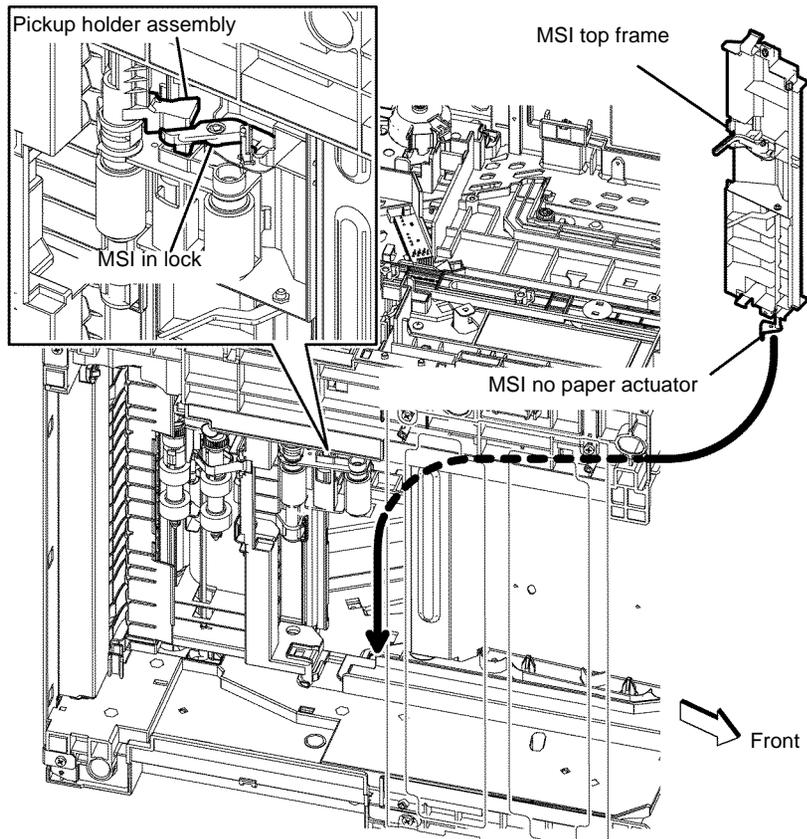
B-1-0153-A

- When installing the MSI top frame, ensure the MSI no paper actuator, coupled with the MSI top frame, fits into the hole on the printer, [Figure 12](#).

Figure 12 MSI top frame installation

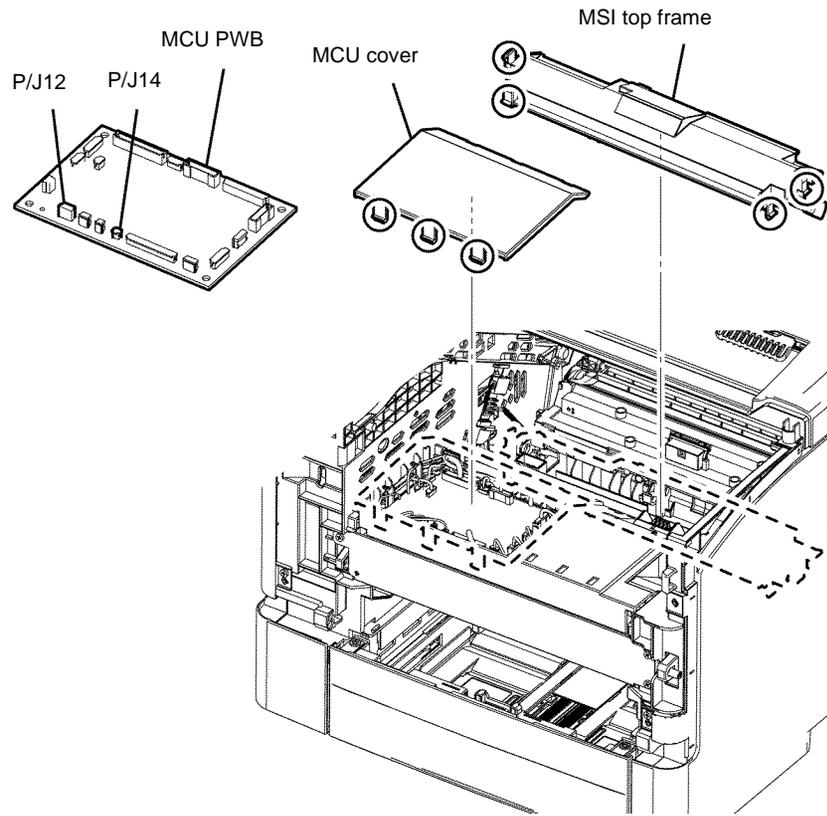
B-1-0154-A

19. Release four hooks, then remove the MSI top frame, from the printer, [Figure 1](#).
20. Remove the MCU cover, by releasing the hook, disconnect PJ12 and PJ14 from the MCU PWB, then release the registration transport assembly harness from the harness guide, [Figure 1](#).

**Figure 1 Registration transport assembly harness release**

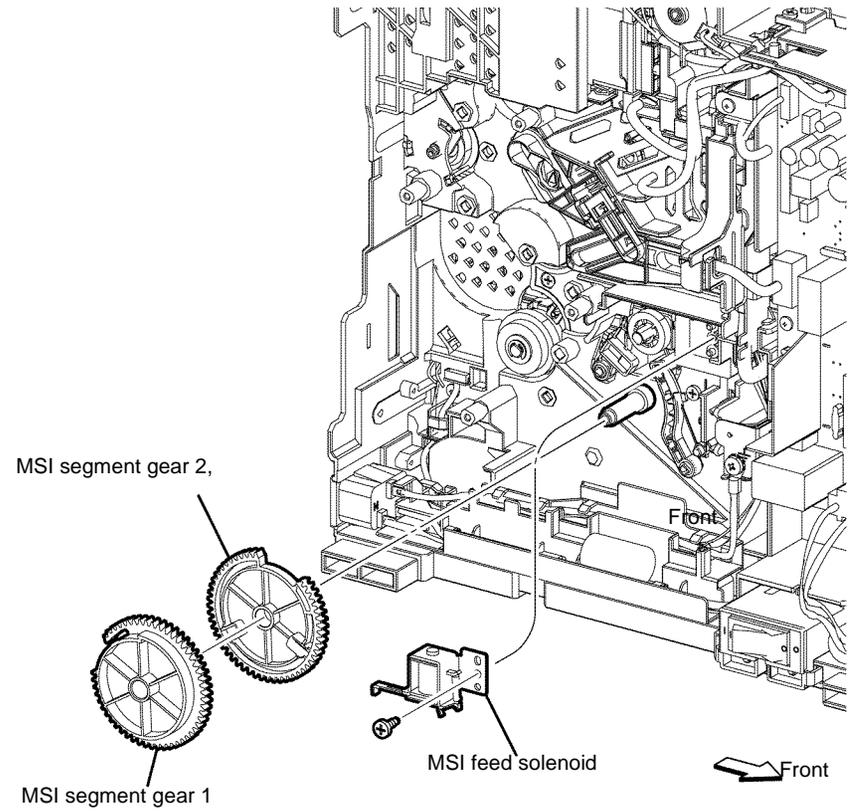
B-1-0155-A

21. Remove one screw (silver, tapping, 8mm), then remove the MSI feed solenoid, [Figure 2](#).
22. Remove the MSI segment gear 1, MSI segment gear 2 and MSI feed gear, [Figure 2](#).

**Figure 2 MSI feed solenoid, segment and MSI feed gears removal**

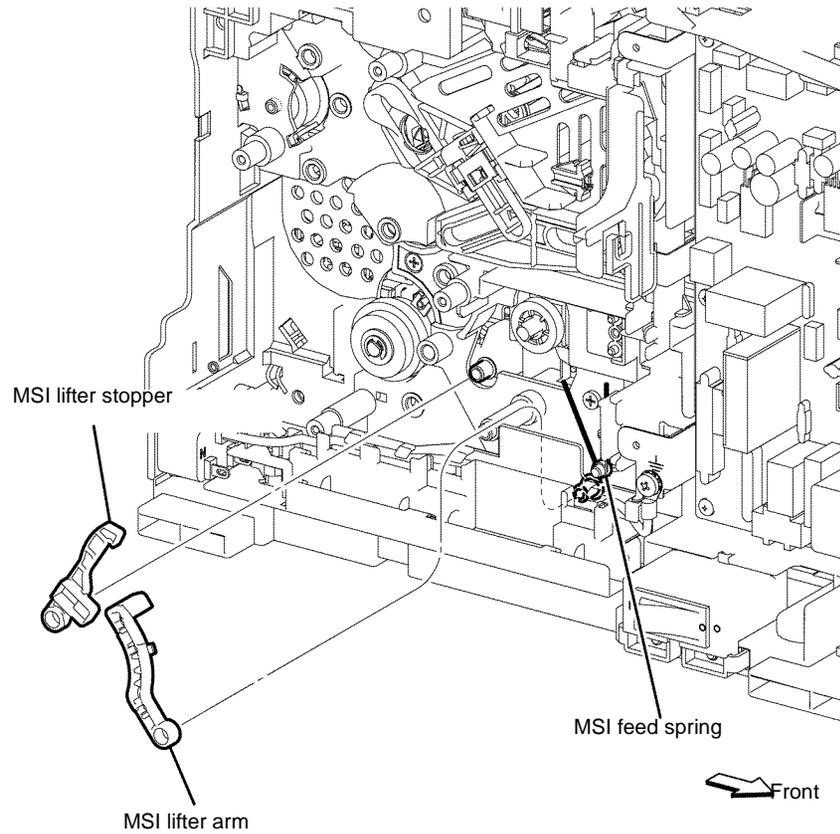
B-1-0156-A

23. Release the MSI feed spring from the MSI lifter arm, then remove the MSI lifter arm and MSI lifter stopper, [Figure 3](#).

**Figure 3 MSI lifter arm and lifter stopper removal**

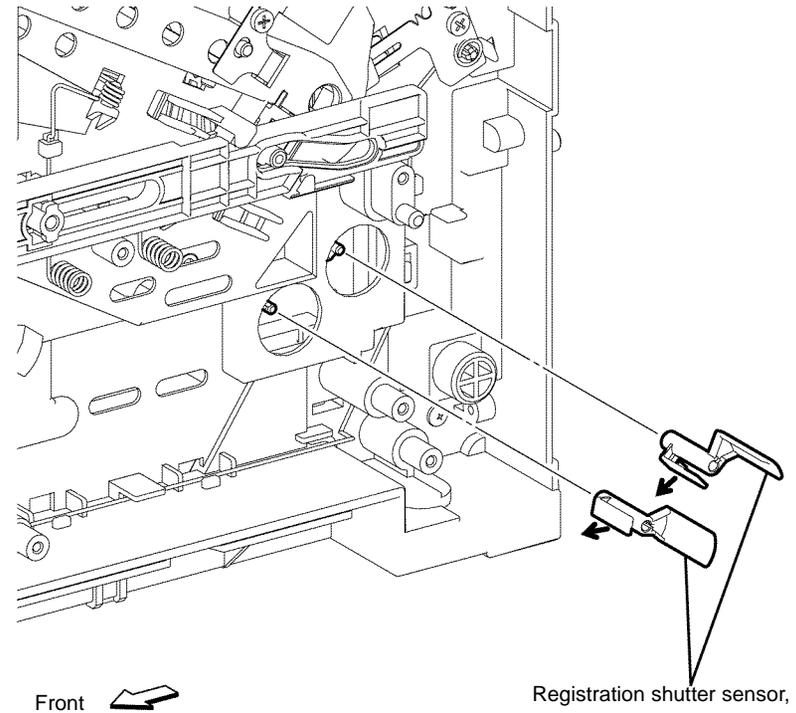
B-1-0157-A

24. Release the hook, then remove the registration shutter sensor, [Figure 4](#).

**Figure 4 Registration shutter sensor removal**

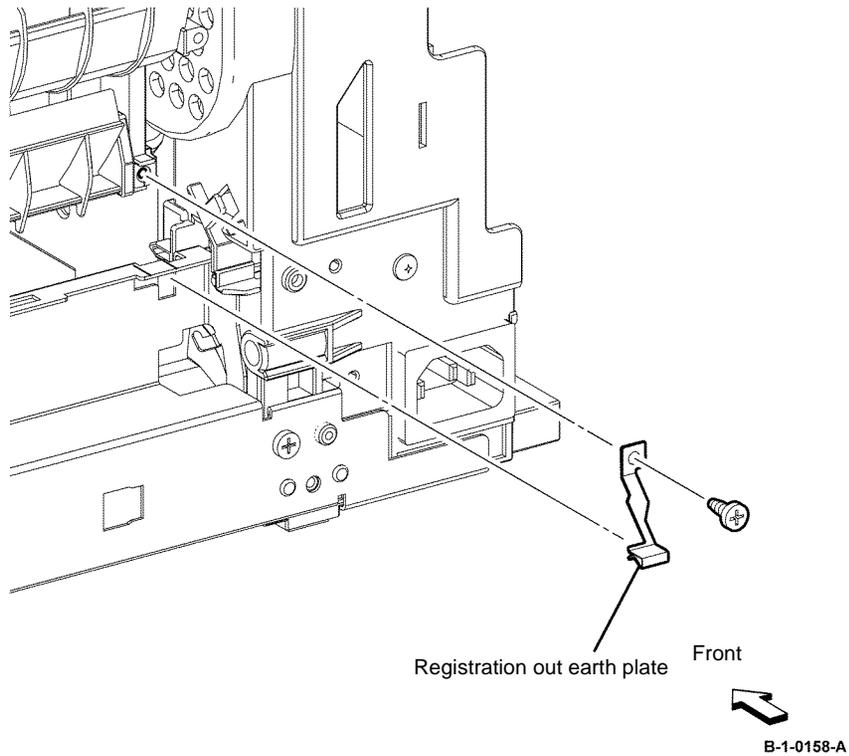
25. Release one screw (silver, tapping, 8mm), then remove the registration out earth plate, [Figure 5](#).

**Figure 5 Registration out earth plate removal**

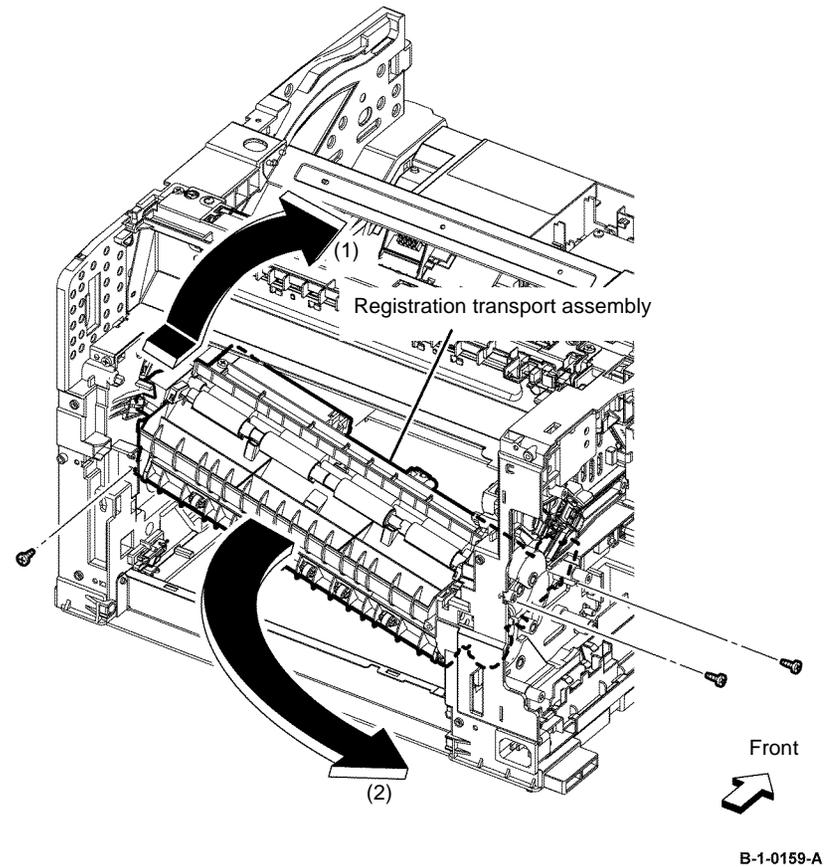
26. Remove three screws (silver, tapping, 8mm), then remove the registration transport assembly from the printer, [Figure 6](#).

**Figure 6 Registration transport assembly removal**

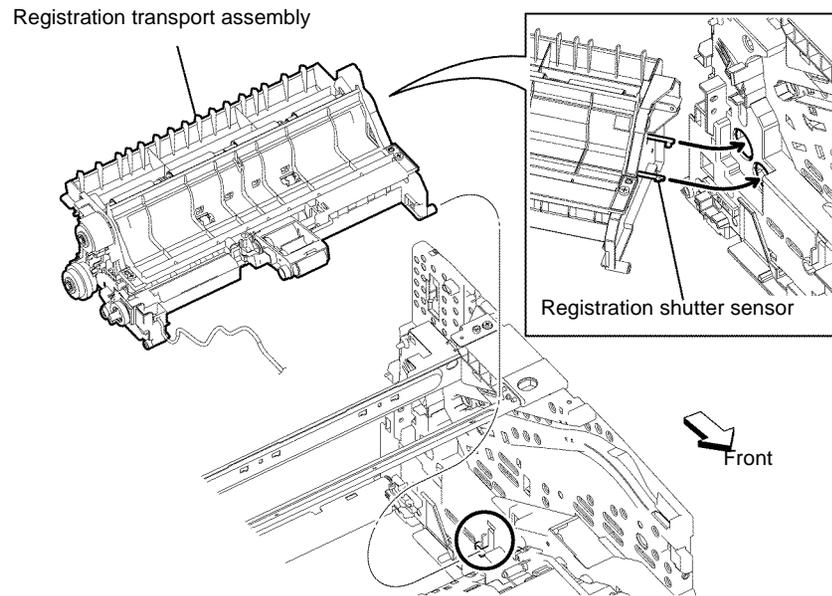
B-1-0160-A

1. The replacement is the reverse of the removal procedure.
2. When installing the registration transport assembly, ensure the position of the boss and the registration shutter sensor is correct, [Figure 7](#).

**Figure 7 Registration transport assembly installation**

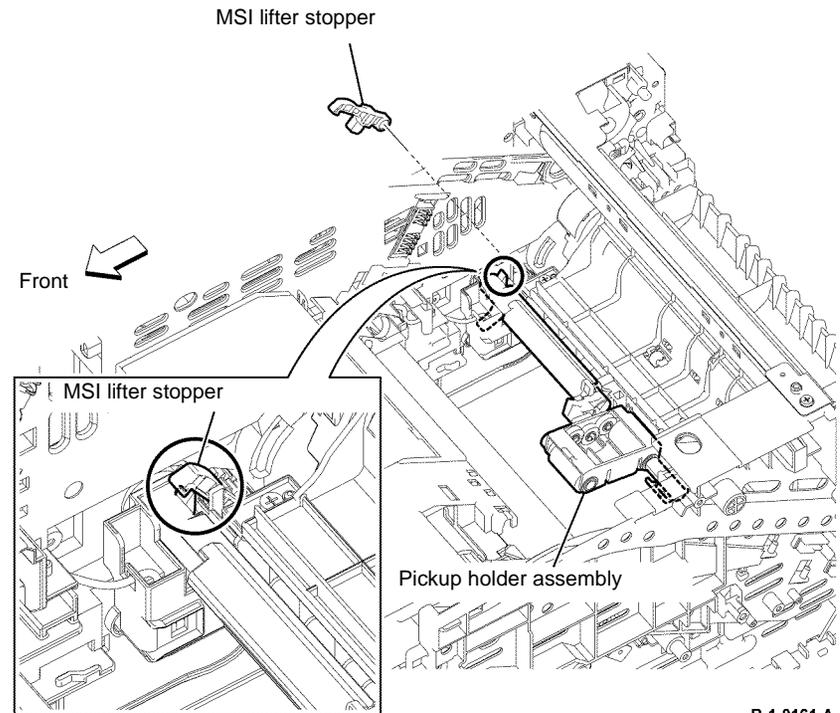
B-1-0161-A

**Figure 8 MSI lifter stopper installation**

3. When installing the MSI lifter stopper, ensure the pickup holder assembly, is in the position shown, [Figure 8](#).
4. When installing the MSI lifter arm., ensure the MSI feed spring is correctly positioned, [Figure 9](#).

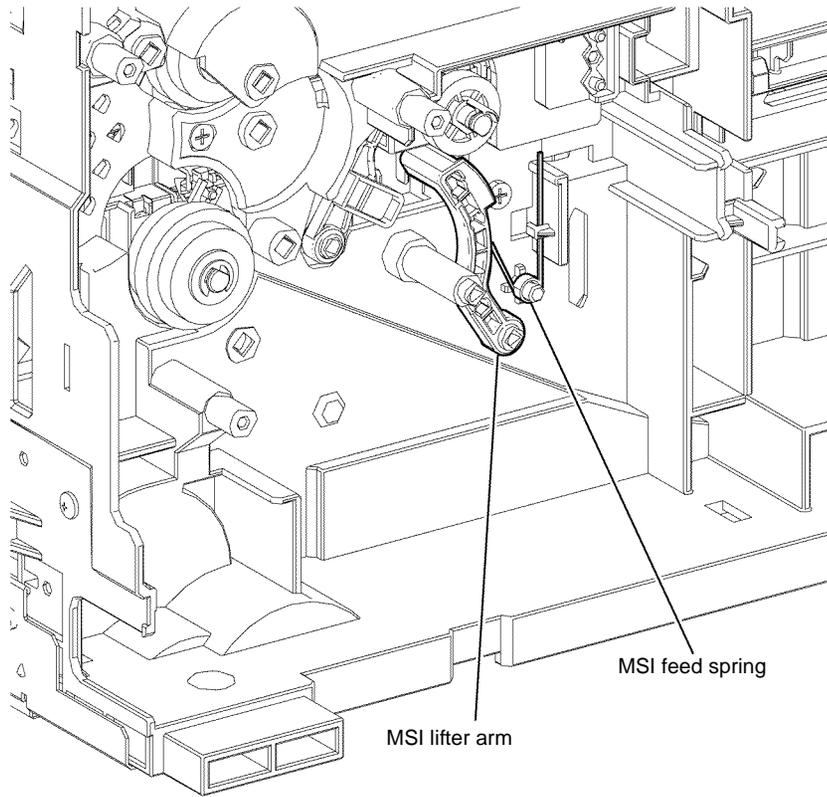
B-1-0162-A

**Figure 9 MSI lifter arm installation**

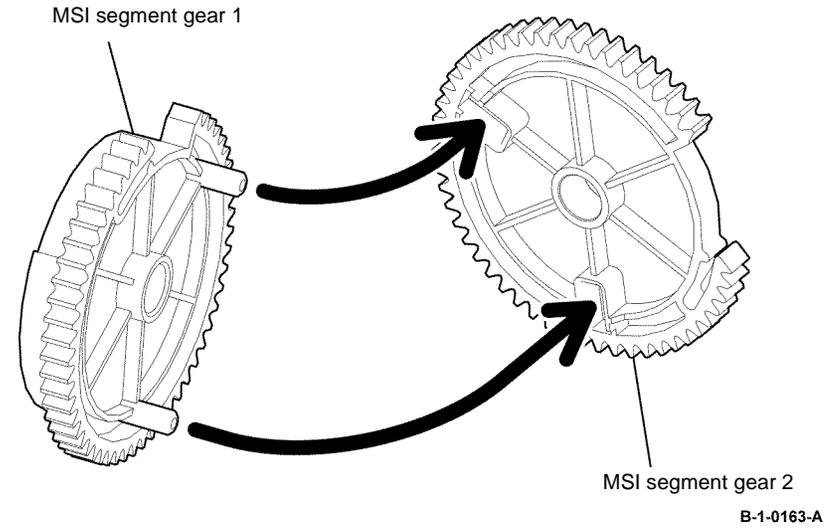
- When installing the MSI segment gear 1 and MSI segment gear 2, fit the bosses on the MSI segment gear 1 into the holes on the MSI segment gear 2, [Figure 10](#).

**Figure 10 MSI segment gear 1 and 2 installation**

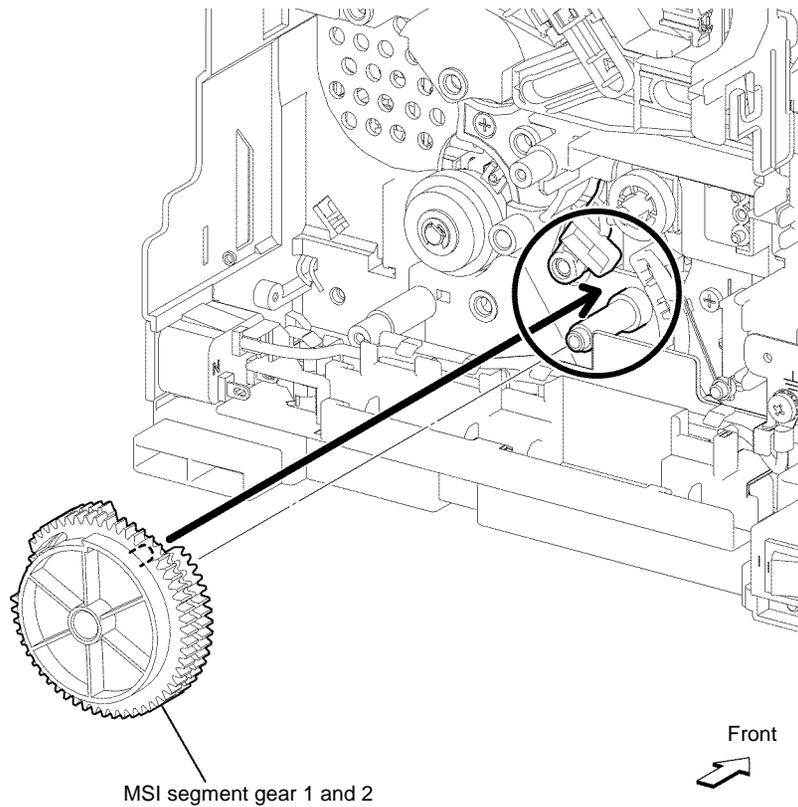
B-1-0164-A

- When installing the MSI segment gear 1 and MSI segment gear 2, ensure that the actuator is the position shown, [Figure 11](#).

MSI segment gear 1 and 2

Figure 11 MSI segment gear 1 and 2 actuator position

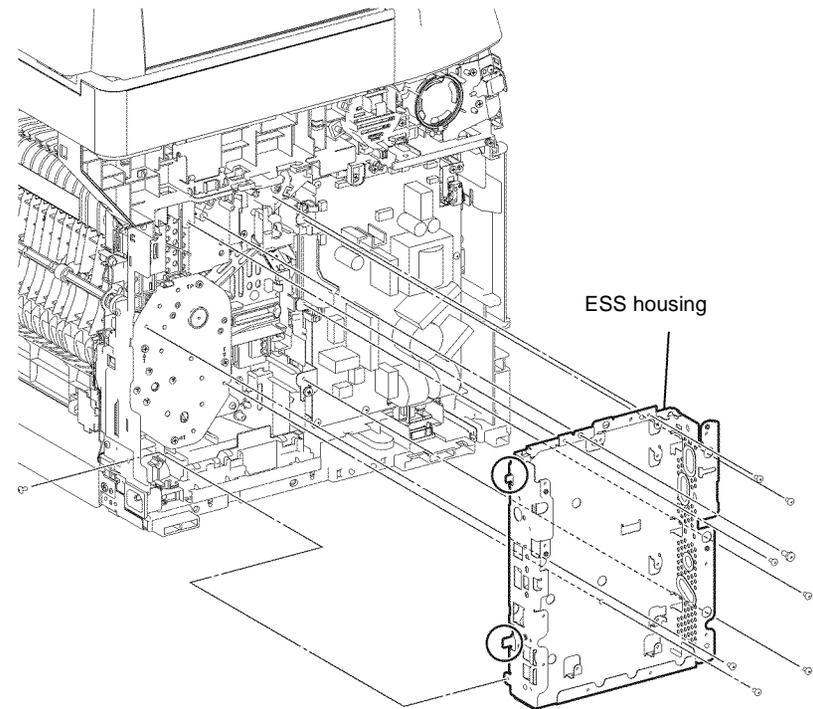
B-1-0166-A

1. Open the MSI cover, [PL 13.2 Item 99](#).
2. Pull out the MSI tray assembly, [PL 13.2 Item 9](#).
3. Remove the front cover assembly, [REP 19.1](#).
4. Remove the rear cover assembly, [REP 19.13](#).
5. Remove the ESS window cover assembly, [REP 19.3](#).
6. Remove the WIFI cap cover, [REP 19.19](#).
7. Remove the left cover, [REP 19.11](#).
8. Remove the ESS PWB, [REP 18.1](#).
9. Release six screws (silver, M3, 6mm), then remove the ESS housing, [Figure 1](#).

Figure 1 ESS housing removal

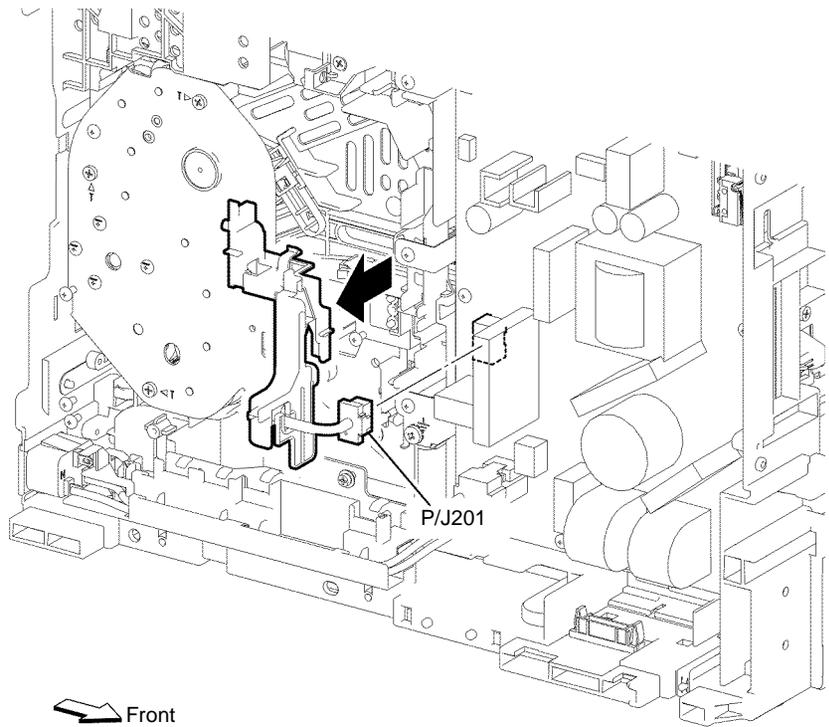
B-1-0167-A

10. Disconnect P/J201 from the LVPS PWB, then move the harness guide, [Figure 2](#).

**Figure 2 P/J201 disconnection**

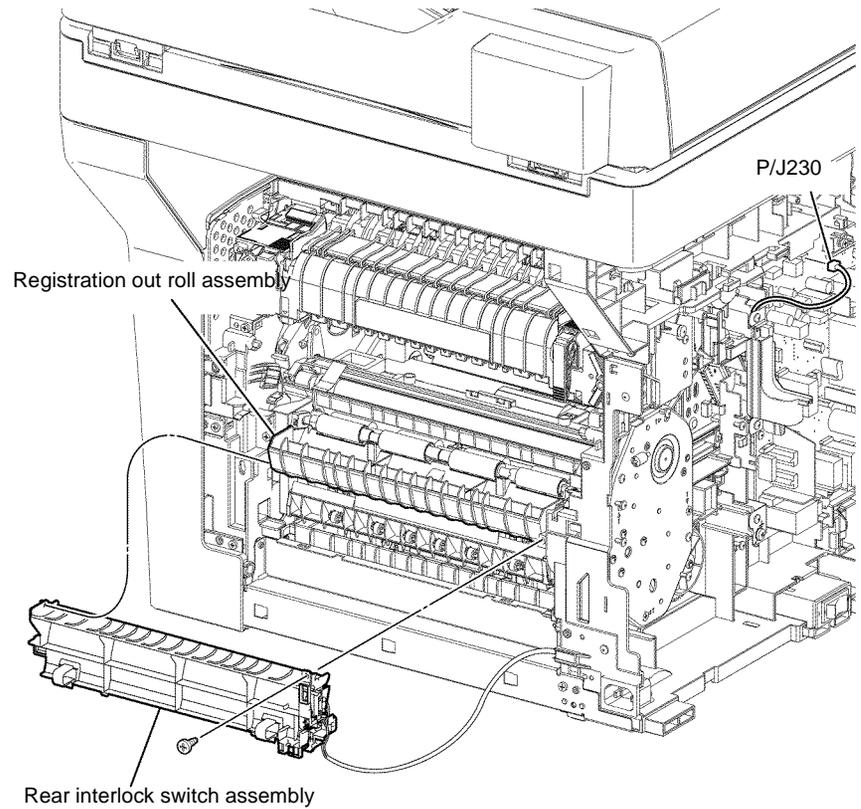
B-1-0168-A

11. Disconnect P/J230 from the LVPS PWB, release the harness from the harness guide fixed on the printer, then pull the harness out of the hole on the printer.
12. Remove one screw (silver, tapping, 8mm) that fixes the rear interlock switch assembly. Release the two hooks, then remove the rear interlock switch assembly by releasing the boss on the registration out roll assembly from the hole, [Figure 3](#).

**Figure 3 Rear interlock switch assembly removal**

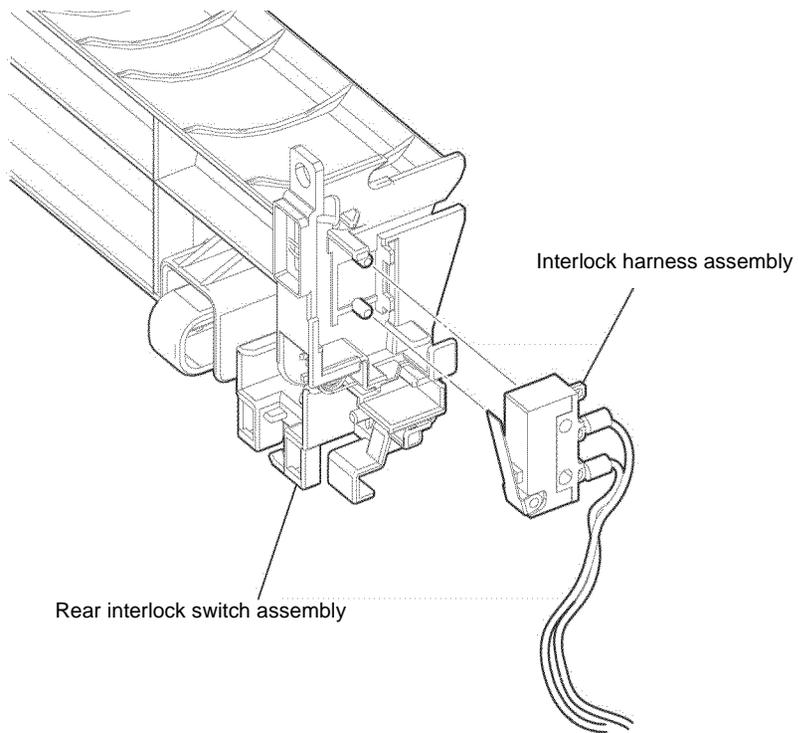
B-1-0169-A

13. Remove the interlock harness assembly from the rear interlock switch assembly, [Figure 4](#).

**Figure 4 Interlock harness assembly removal**

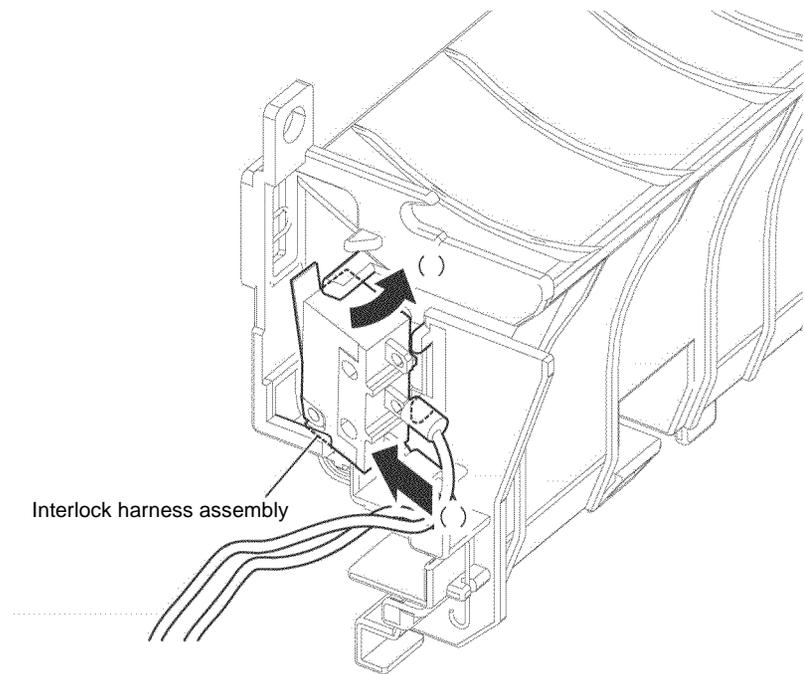
**Figure 5 Interlock harness assembly installation**

1. The replacement is the reverse of the removal procedure.
2. Install the interlock harness assembly to the rear interlock switch assembly as shown in [Figure 5](#).

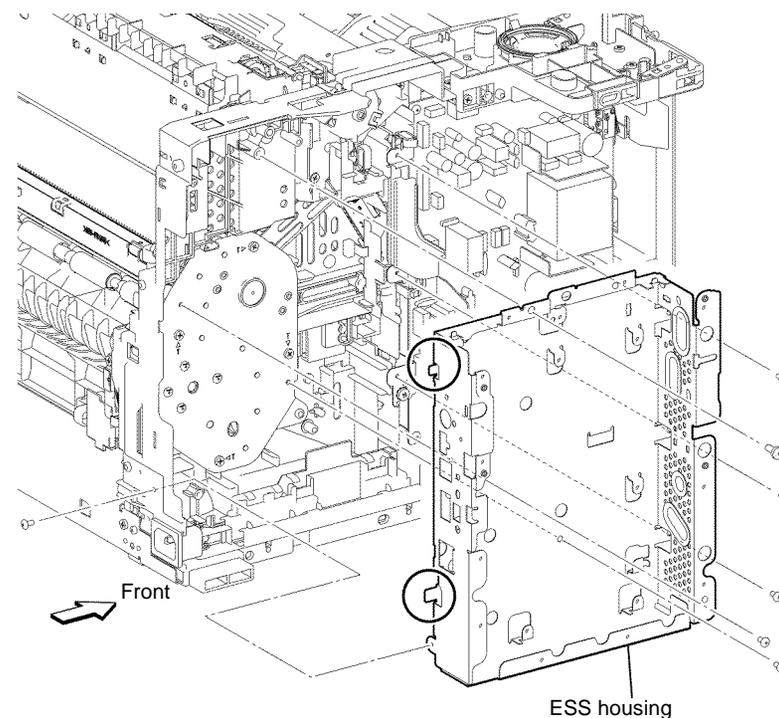
Figure 1 ESS housing removal

1. Open the MSI cover, [PL 13.2 Item 99](#).
2. Pull out the MSI tray assembly, [PL 13.2 Item 9](#).
3. Remove the option tray assembly, [PL 9.2 Item 1](#).
4. Remove the front cover assembly, [REP 19.2](#).
5. Remove the drum Cartridge. [REP 8.2](#).
6. Remove the rear cover assembly, [REP 19.14](#).
7. Remove the UI console assembly, [REP 1.3](#).
8. Remove the exit top cover assembly, [REP 19.10](#).
9. Remove the WIFI cap cover, [REP 19.20](#).
10. Remove the ESS window cover assembly, [REP 19.4](#).
11. Remove the front/left UI cover assembly, [REP 1.4](#).
12. Remove the left cover, [REP 19.12](#).
13. Remove the ESS PWB, [REP 18.2](#).
14. Remove six screws (silver, M3, 6mm) and one screw (silver, tapping, M4, 10mm). Release the two tabs from the frame, then remove the ESS housing, [Figure 1](#).

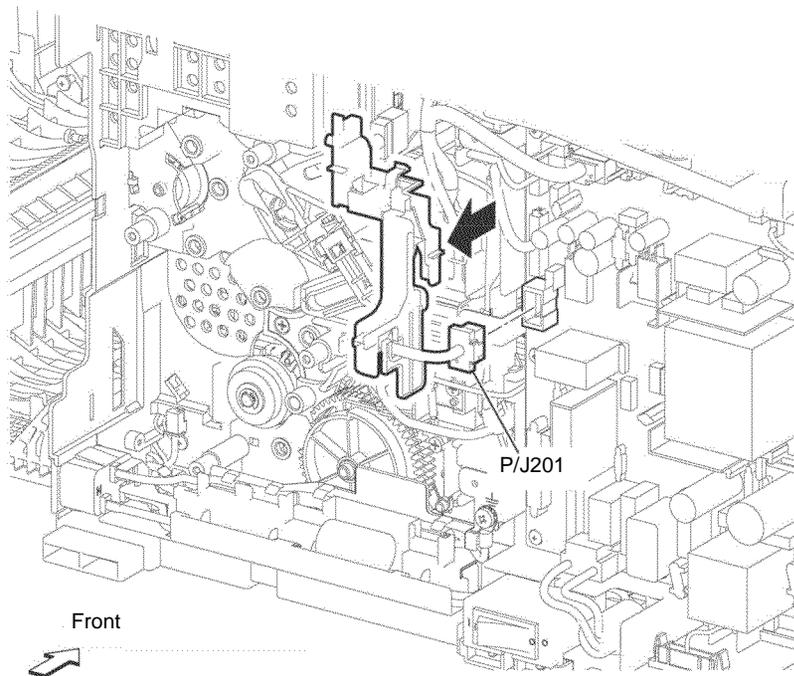
B-1-0172-A

15. Disconnect PJ201 from the LVPS PWB, then move the harness guide, [Figure 2](#).

**Figure 2 P/J201 disconnection**

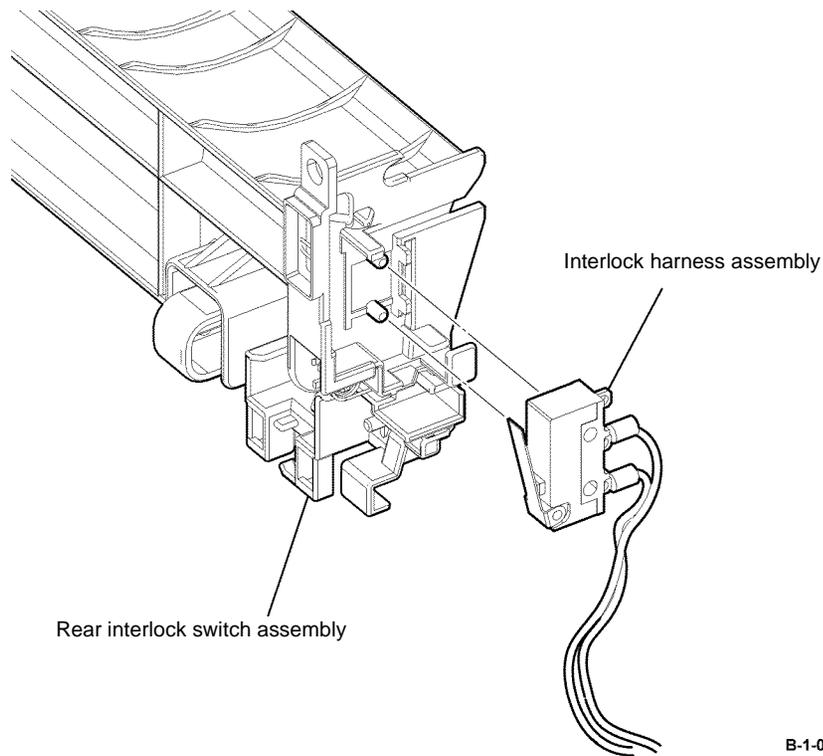
B-1-0174-A

18. Remove the interlock harness assembly from the rear interlock switch assembly, [Figure 4](#).

Figure 4 Interlock harness assembly removal

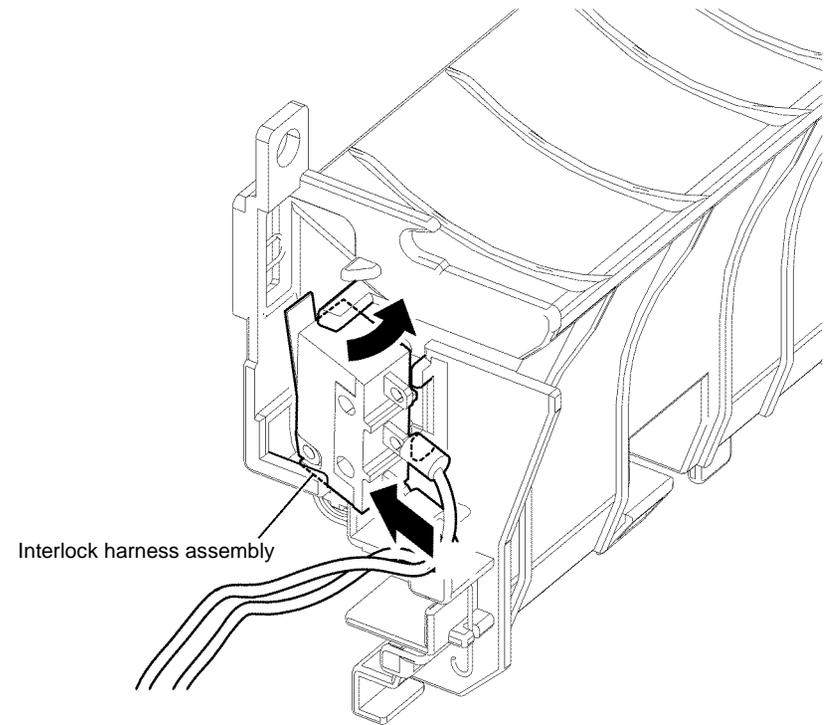
B-1-0175-A

Figure 5 Interlock harness assembly installation

1. The replacement is the reverse of the removal procedure.
2. Install the interlock harness assembly to the rear interlock switch assembly as shown in [Figure 5](#).

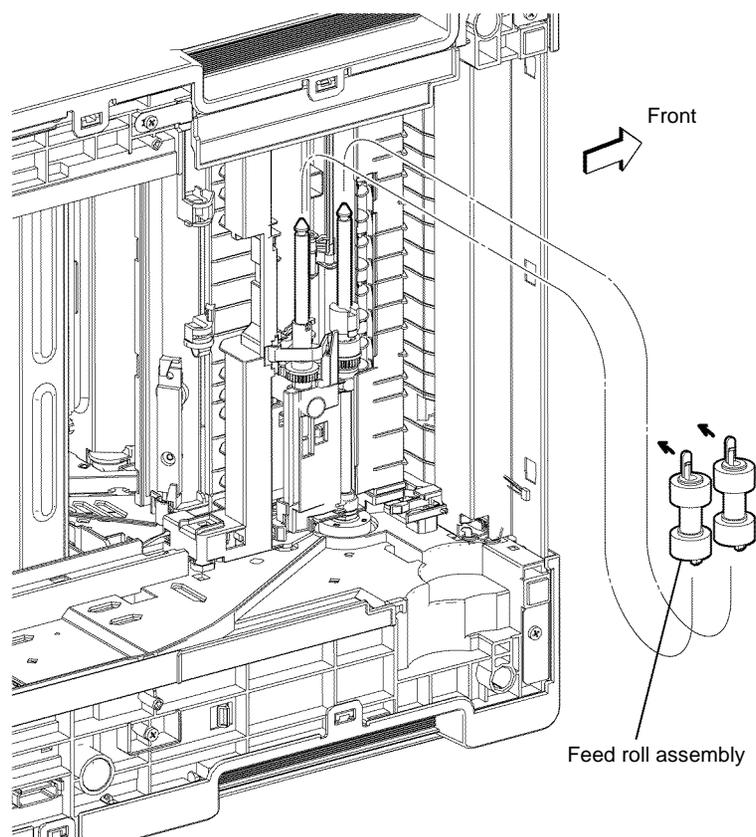
B-1-0176-A

1. Open the MSI cover, [PL 13.2 Item 99](#).
2. Pull out the MSI tray assembly, [PL 13.2 Item 9](#).
3. Remove the drum cartridge, [REP 8.1](#).
4. Place the printer right side up.
5. Remove the feed roll assembly from the bottom of the printer by releasing the hook, [Figure 1](#).

Figure 1 Feed roll assembly removal

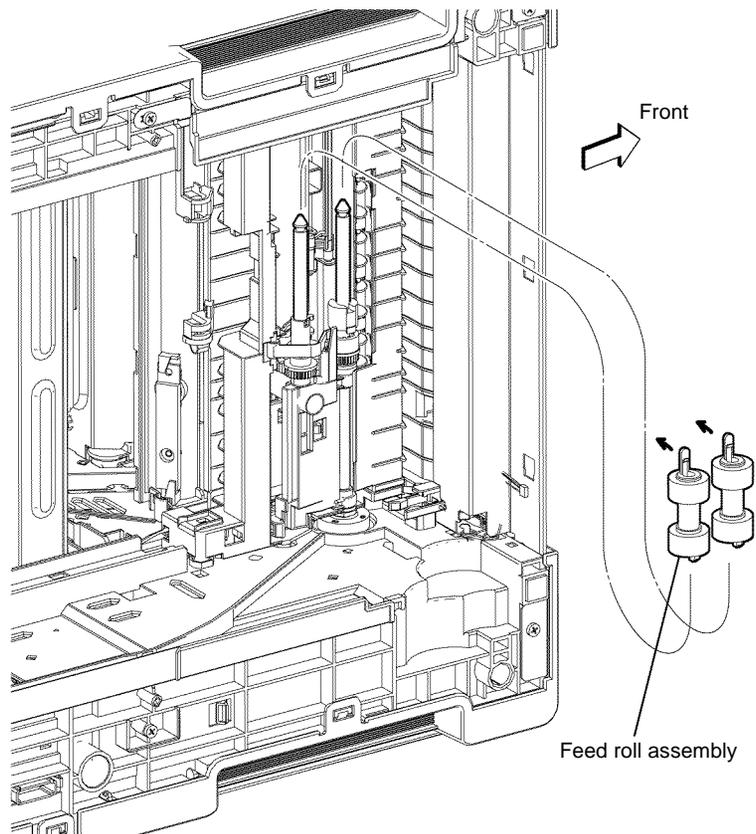
B-1-0177-A

1. Open the MSI cover, [PL 13.2 Item 99](#).
2. Pull out the MSI tray assembly, [PL 13.2 Item 9](#).
3. Remove the drum cartridge, [REP 8.2](#).
4. Place the printer right side up.
5. Remove the feed roll assembly from the bottom of the printer by releasing the hook, [Figure 1](#).

Figure 1 Feed roll assembly removal

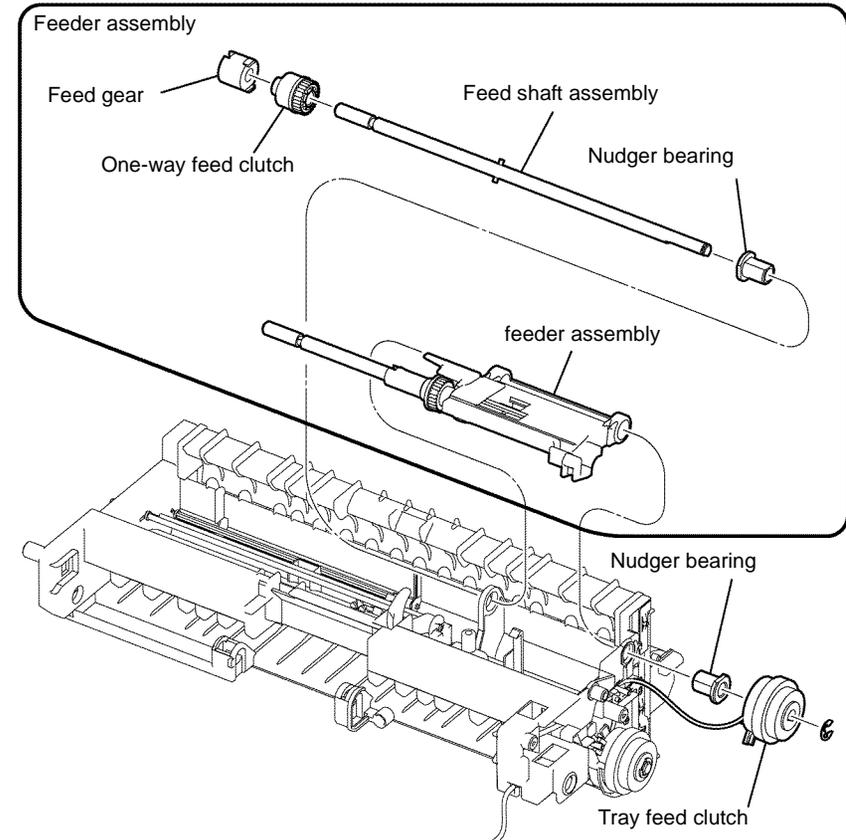
B-1-0178-A

17. Turn the registration transport assembly upside down, remove the E-ring that fixes the tray feed clutch, then remove the tray feed clutch and nudger bearing, Figure 1.

18. Remove the feed gear, one-way feed clutch, feed shaft assembly and nudger bearing, Figure 1.
19. Remove the feeder assembly, Figure 1.

Figure 1 Feeder assembly removal

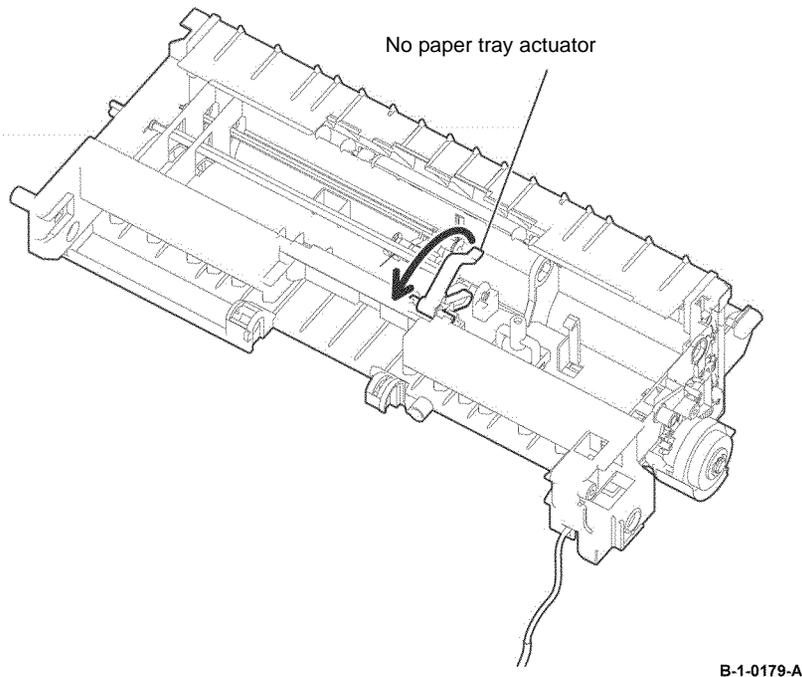
B-1-0179-A

Figure 2 Feeder assembly installation

1. The replacement is the reverse of the removal procedure.
2. When installing the feeder assembly, ensure that the no paper tray actuator, is positioned as shown in Figure 2.

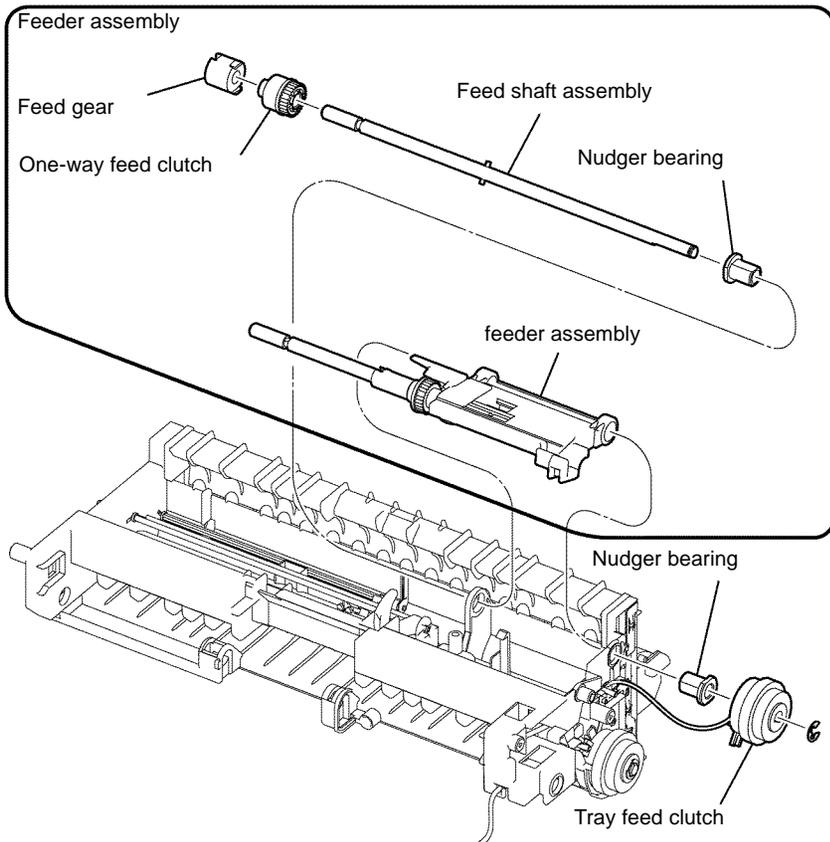
B-1-0180-A

19. Turn the registration transport assembly upside down, remove the E-ring that fixes the tray feed clutch. Remove the tray feed clutch and nudger bearing, [Figure 1](#)

20. Remove the feed gear, one-way feed clutch, feed shaft assembly, and nudger bearing, [Figure 1](#).
21. Remove the feeder assembly, [Figure 1](#).

Figure 1 Feeder assembly removal

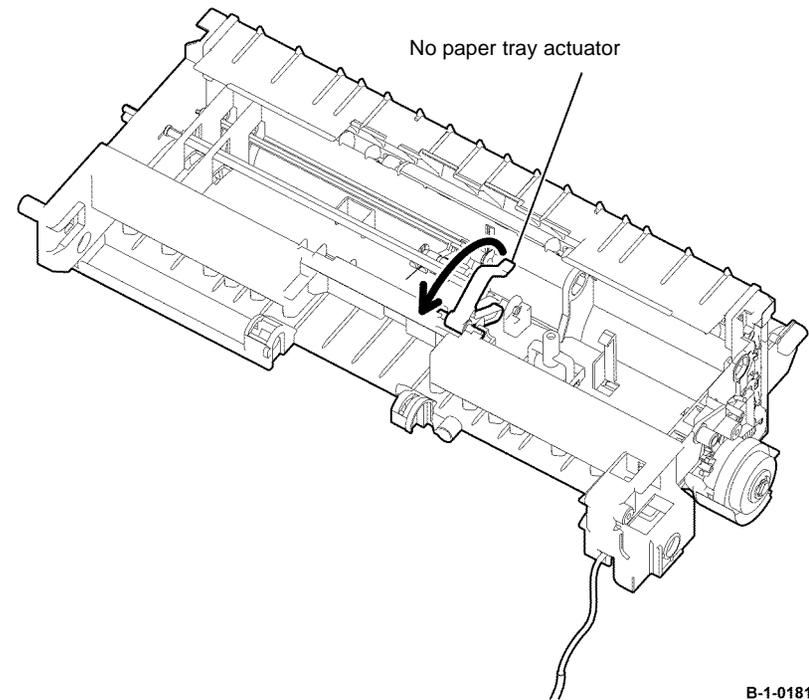
B-1-0181-A

1. The replacement is the reverse of the removal procedure.
2. When installing the feeder assembly, ensure that the no paper tray actuator, is positioned as shown in [Figure 2](#).

Figure 2 Feeder assembly installation

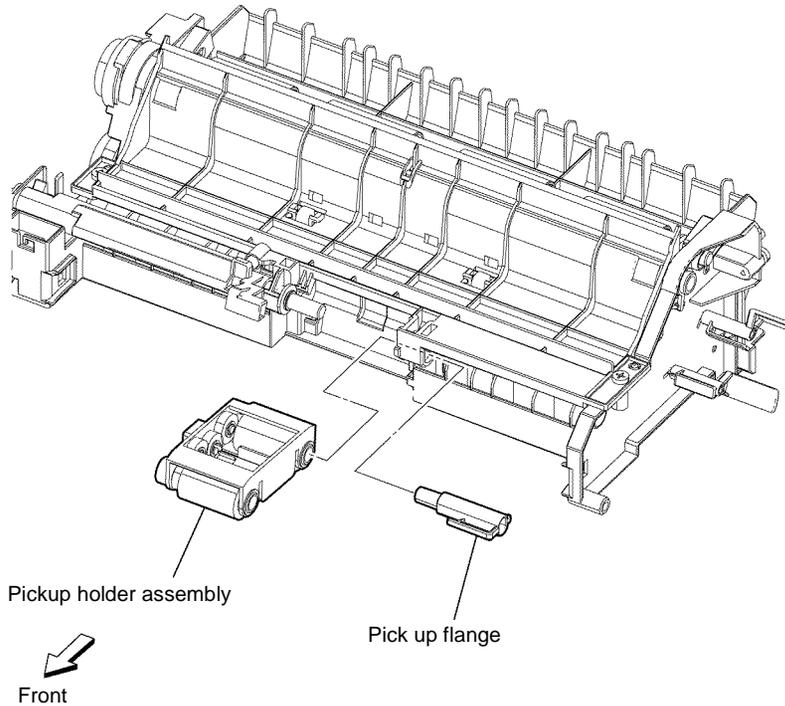
B-1-0182-A

1. Remove the registration transport assembly, REP 15.1.
2. Remove the pick up flange, then remove the pickup holder assembly, Figure 1.

Figure 1 Pickup holder assembly removal

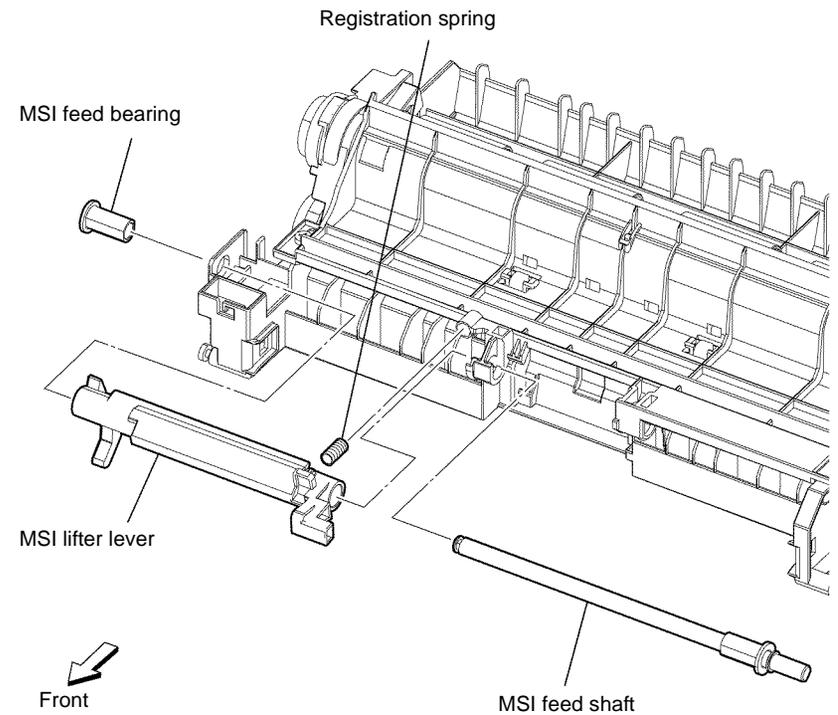
B-1-0183-A

3. Remove the registration spring and MSI feed bearing. Remove the MSI feed shaft and MSI lifter lever, Figure 2.

Figure 2 MSI spring, feed bearing, lifter lever and feed shaft removal

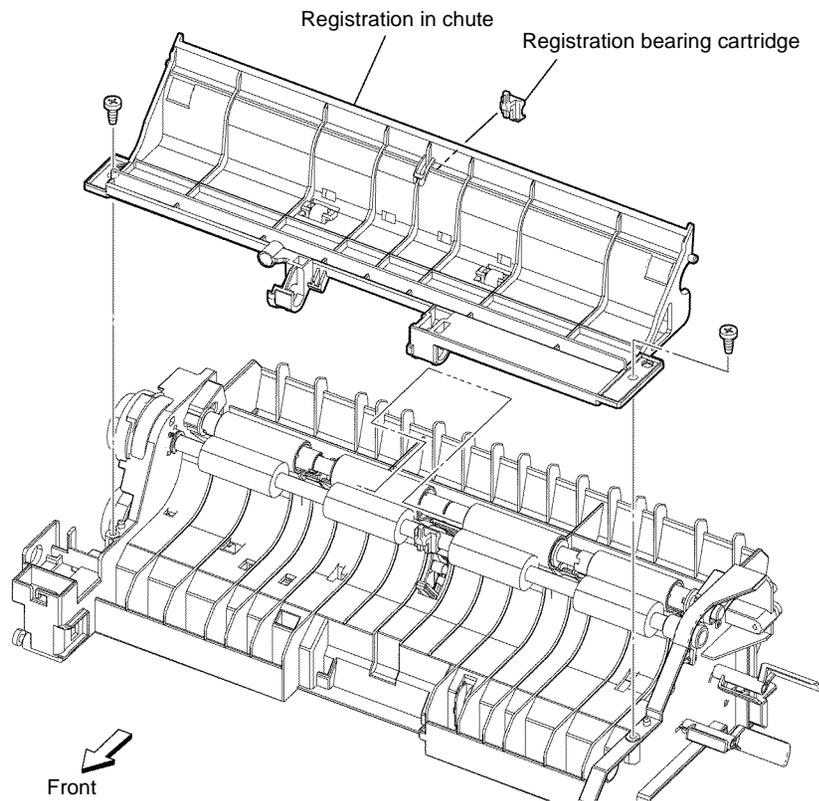
B-1-0184-A

4. Remove two screws (silver, tapping, 8mm), then remove the registration in chute by opening the both side frames, Figure 3.

**NOTE:** Retain the registration bearing cartridge.

**Figure 3 Registration in chute removal**

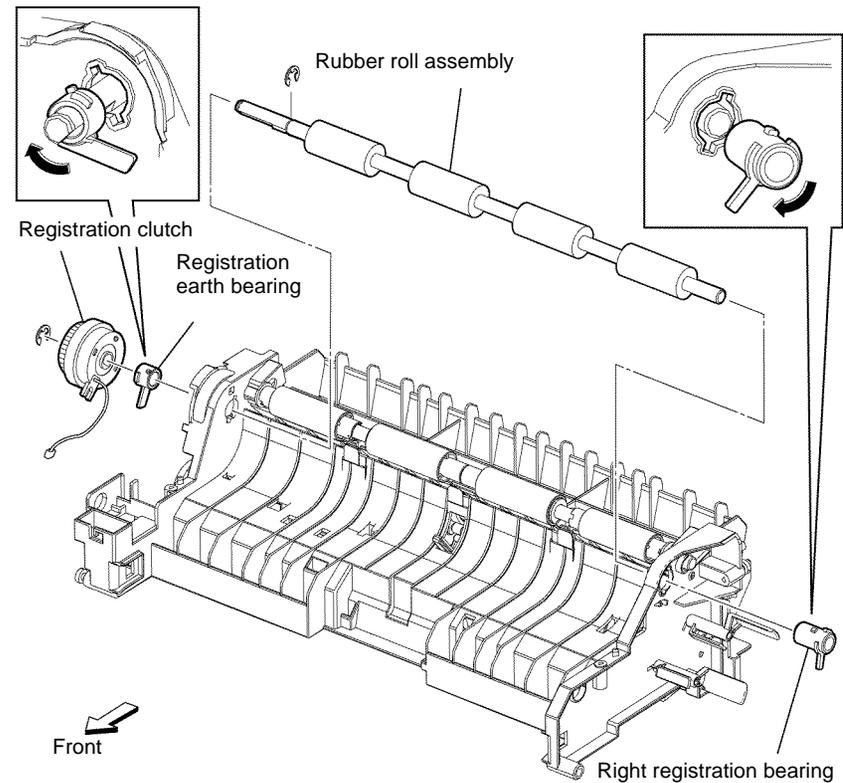
B-1-0185-A

5. Remove the E-ring, then remove the registration clutch, [Figure 4](#).
6. Remove the right registration bearing and the registration earth bearing, by rotating clockwise, [Figure 4](#).
7. Remove the E-ring, then remove the rubber roll assembly, [Figure 4](#).

**Figure 4 Registration clutch and rubber roll assembly removal**

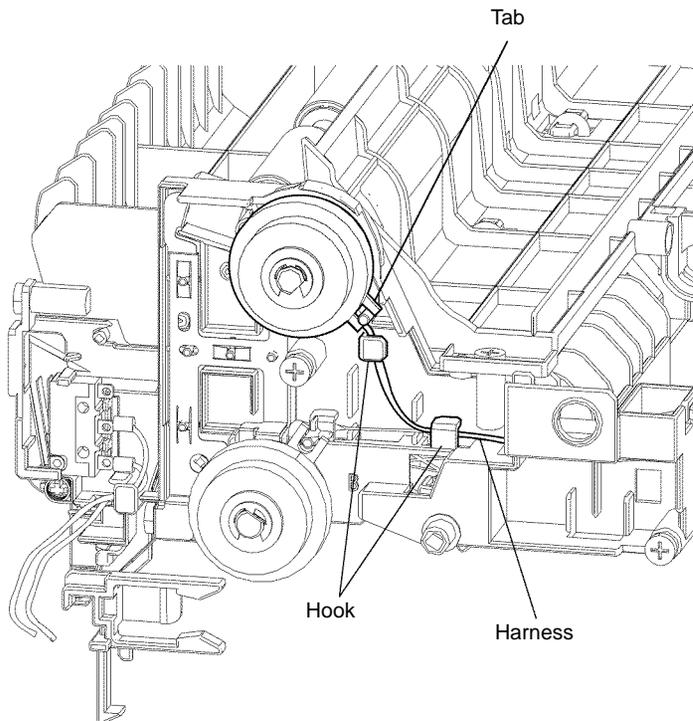
B-1-0186-A

Figure 5 Registration clutch installation

1. The replacement is the reverse of the removal procedure.
2. When installing the registration clutch, fit the tab with the stopper of the registration transport assembly, then route the harness of the registration clutch into the hooks, [Figure 5](#).

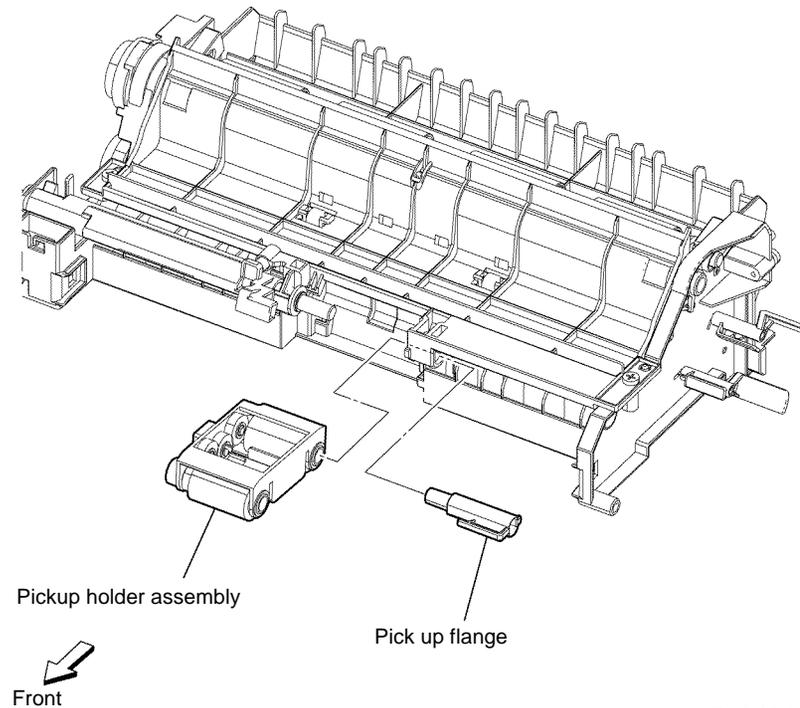
B-1-0187-A

1. Remove the registration transport assembly, [REP 15.2](#).
2. Remove the pick up flange, then remove the pickup holder assembly, [Figure 1](#).

Figure 1 Pickup holder assembly removal
