# Xerox® VersaLink® B400 & B405 Family Multifunction Printer Service Manual

VersaLink B400 and B405 Family Multifunction Printer Service Manual

708P91373

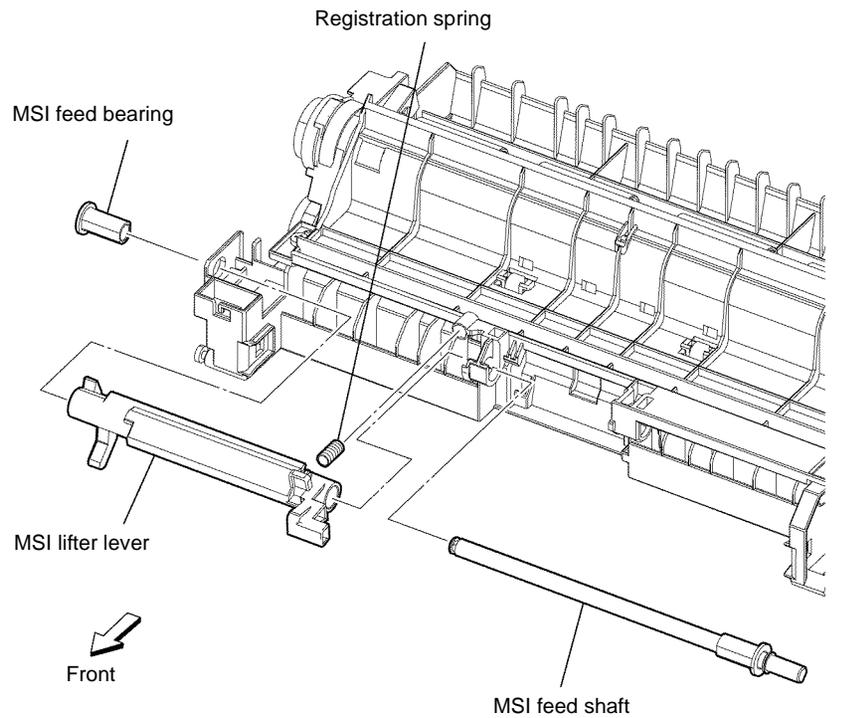
B-1-0188-A

3. Remove the registration spring and MSI feed bearing. Remove the MSI feed shaft and MSI lifter lever, [Figure 2](#).

**Figure 2 MSI spring, feed bearing, lifter lever and feed shaft removal**

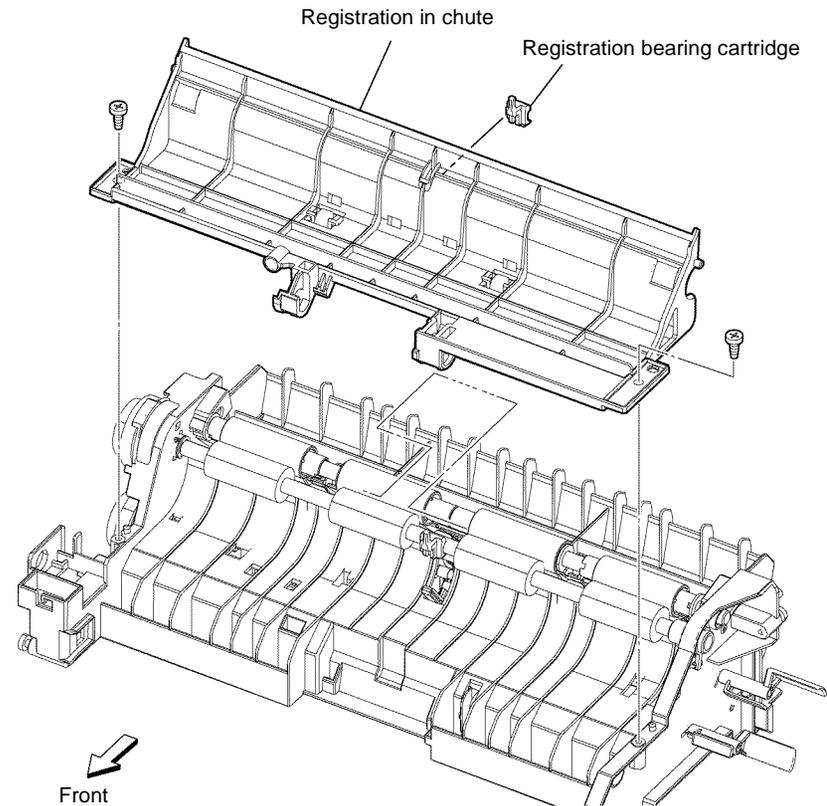
B-1-0189-A

4. Remove two screws (silver, tapping, 8mm), then remove the registration in chute, by opening the both side frames, [Figure 3](#).

**NOTE:** Retain the registration bearing cartridge.

**Figure 3 Registration in chute removal**

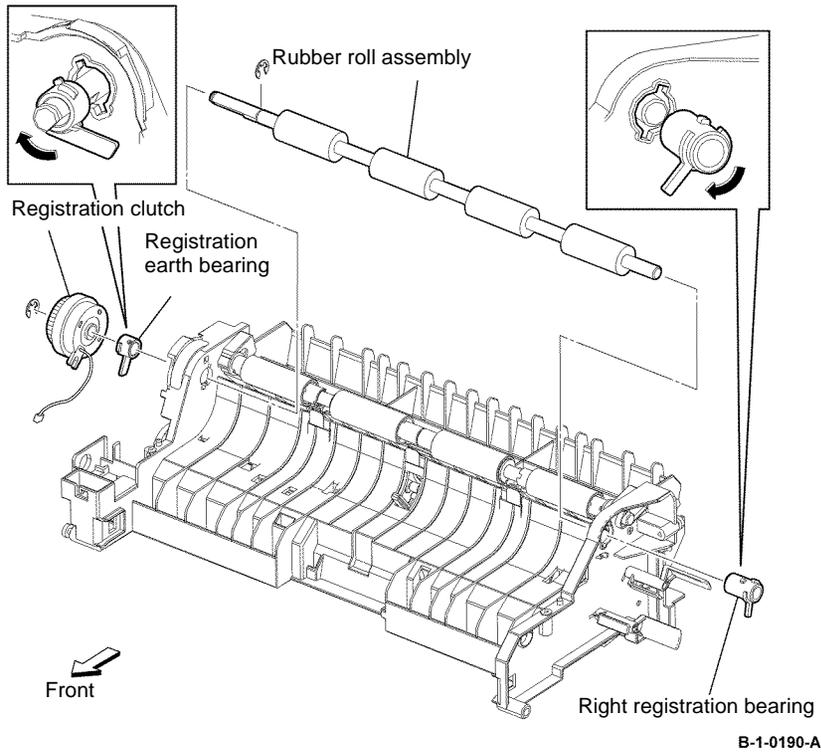
5. Remove the E-ring, then remove the registration clutch, [Figure 4](#).
6. Remove the right registration bearing and the registration earth bearing, by rotating clockwise, [Figure 4](#).
7. Remove the E-ring, then remove the rubber roll assembly, [Figure 4](#).

Figure 4 Registration clutch and rubber roll assembly removal

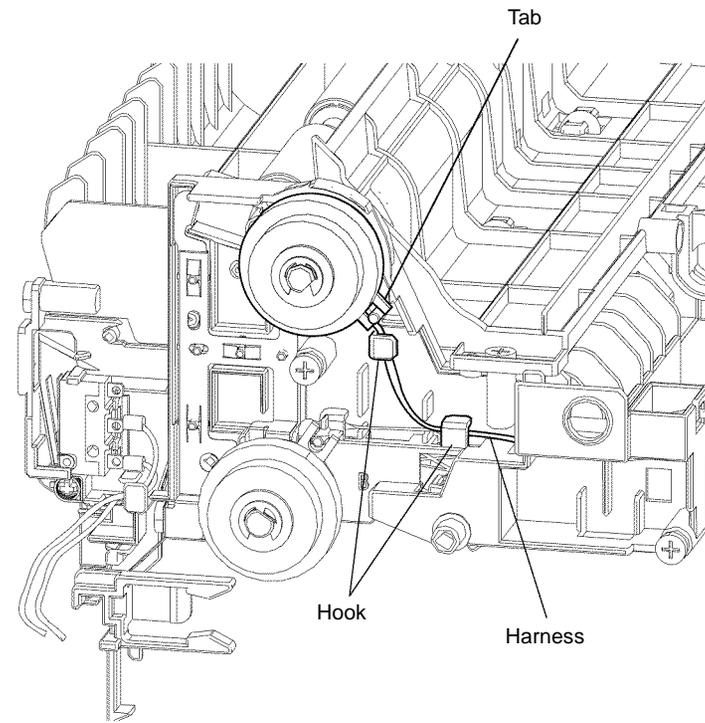
Figure 5 Registration clutch installation

1. The replacement is the reverse of the removal procedure.
2. When installing the registration clutch, fit the tab with the stopper of the registration transport assembly, then route the harness of the registration clutch into the hooks, [Figure 5](#).

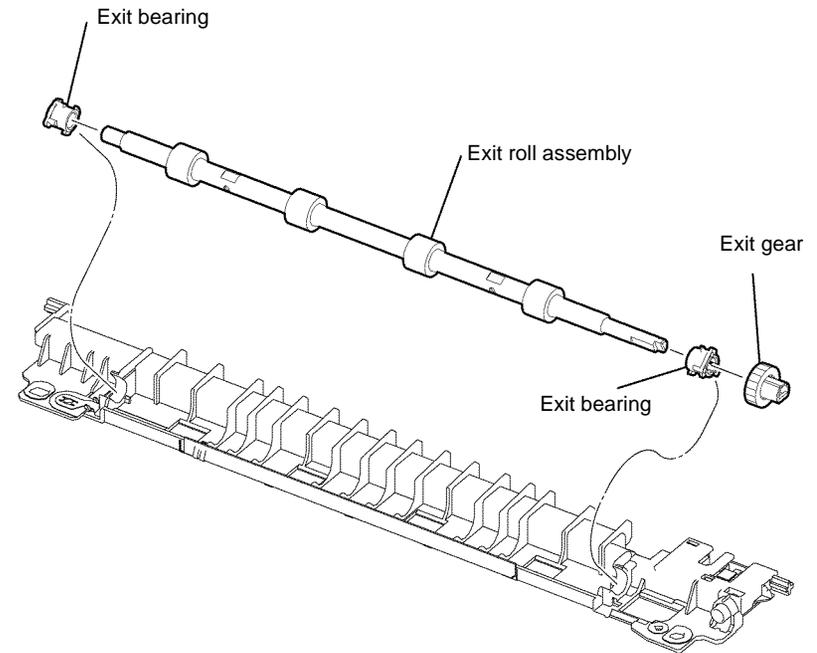
B-1-0192-A

8. Turn the exit chute assembly upside down, release the hook, then remove the exit gear, **Figure 1**.
9. Release the hook that fixes the exit bearing, then remove the exit roll assembly, **Figure 1**.

Figure 1 Exit roll assembly removal

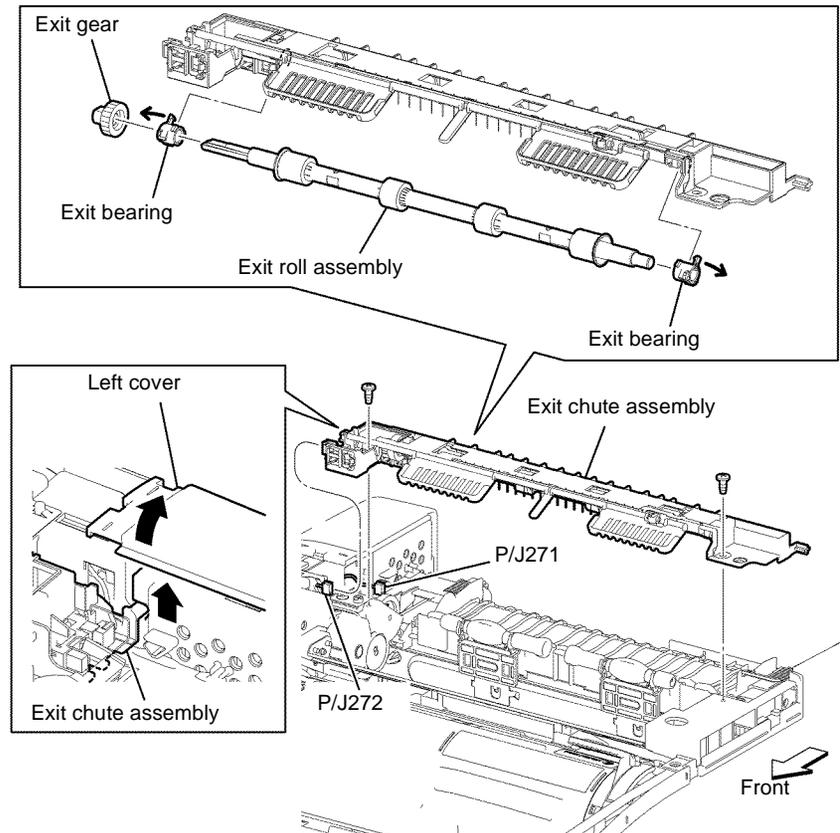
B-1-0193-A

8. Remove two screws (silver, M3, 6mm) that fix the exit chute assembly to the printer. Lift the exit chute assembly in the arrowed direction, then disconnect P/J272 from the photo sensor, Figure 1.
9. Bend the left cover release the two bosses of the exit chute assembly from the printer, then lift the exit chute assembly in the arrowed direction, Figure 1.
10. Disconnect PJ271 from the exit sensor, then remove the exit chute assembly, Figure 1.
11. Remove the exit gear. Release the hook that fixes the exit bearing, then remove the exit bearing and the exit roll assembly, Figure 1.

Figure 1 Exit chute assembly and exit roll assembly removal

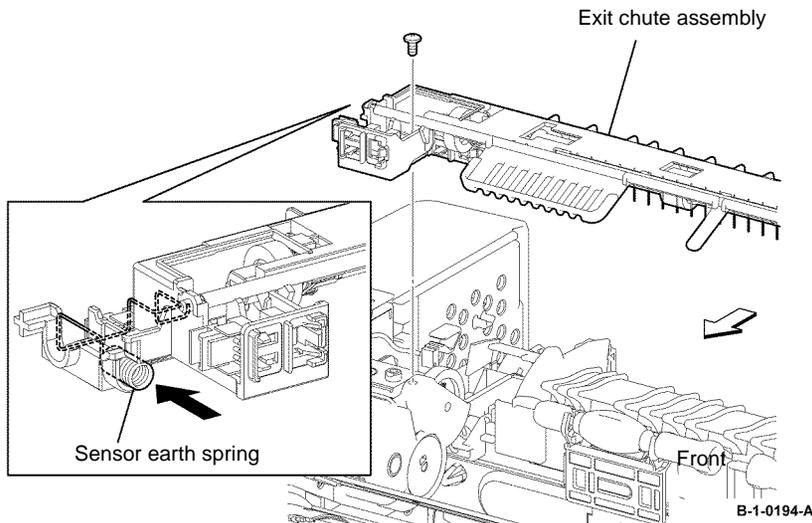
1. The replacement is the reverse of the removal procedure.
2. When installing the exit chute assembly, ensure the end of the sensor earth spring is in contact with the plate on the frame, [Figure 2](#).

**Figure 2** Exit chute assembly installation

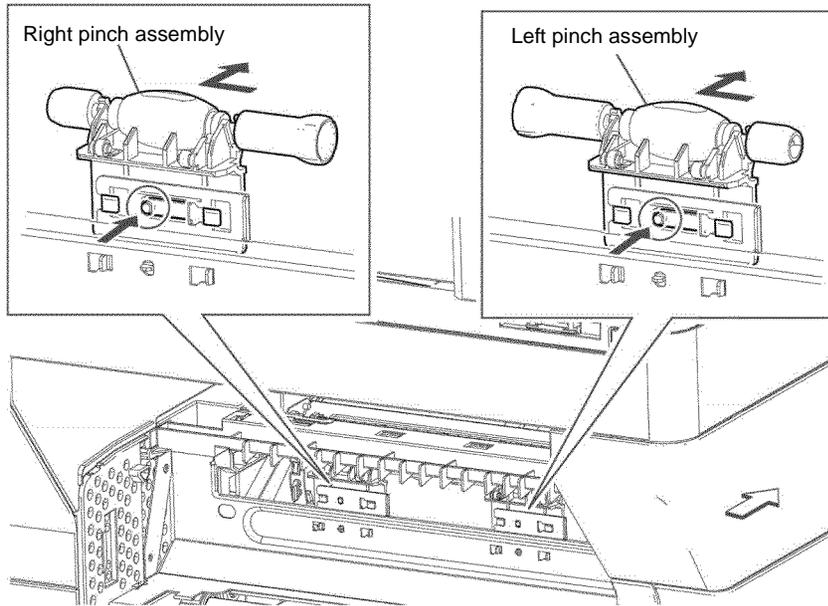
B-1-0195-A

8. Release the hooks, then remove the left and right pinch assemblies, [Figure 1](#).

Figure 1 Left and right pinch assembly removal

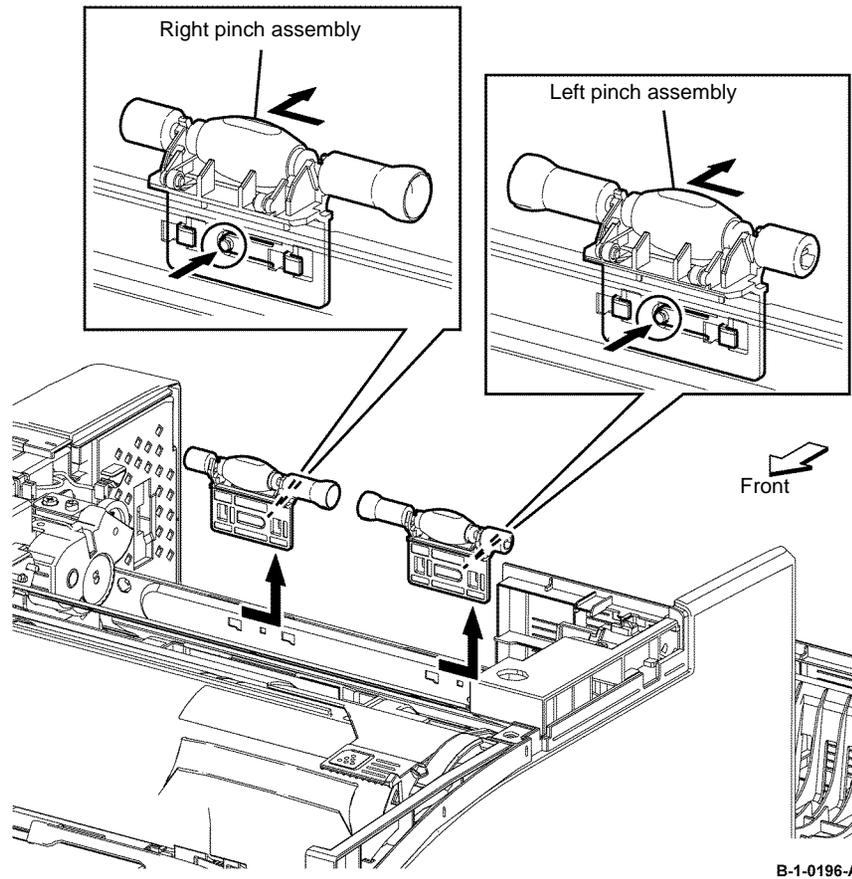
Figure 1 Left and right pinch assembly removal

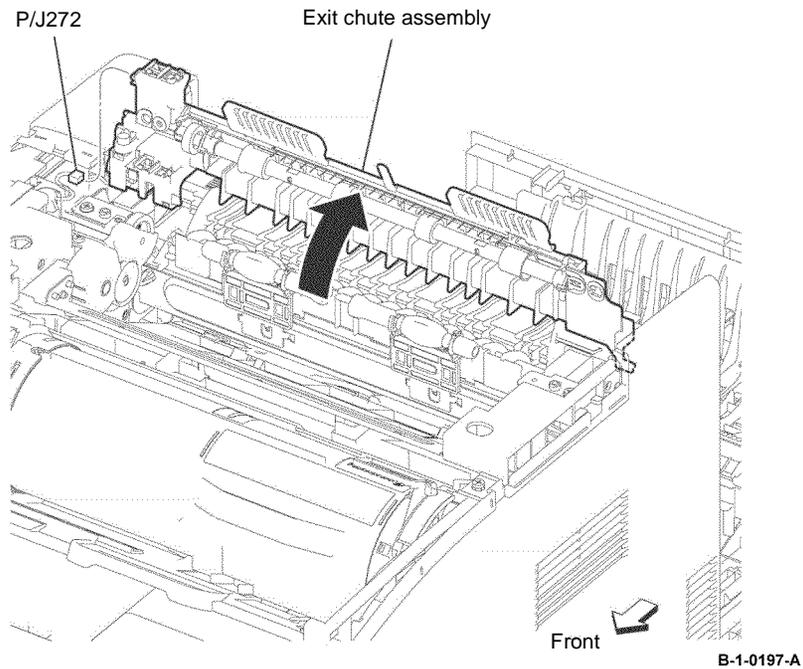
- Remove two screws (silver, M3, 6mm) that fix the exit chute assembly to the printer. Lift the exit chute assembly in the arrowed direction, then disconnect P/J272 from the full stack sensor, [Figure 1](#).

**Figure 1 Full stack sensor disconnect**

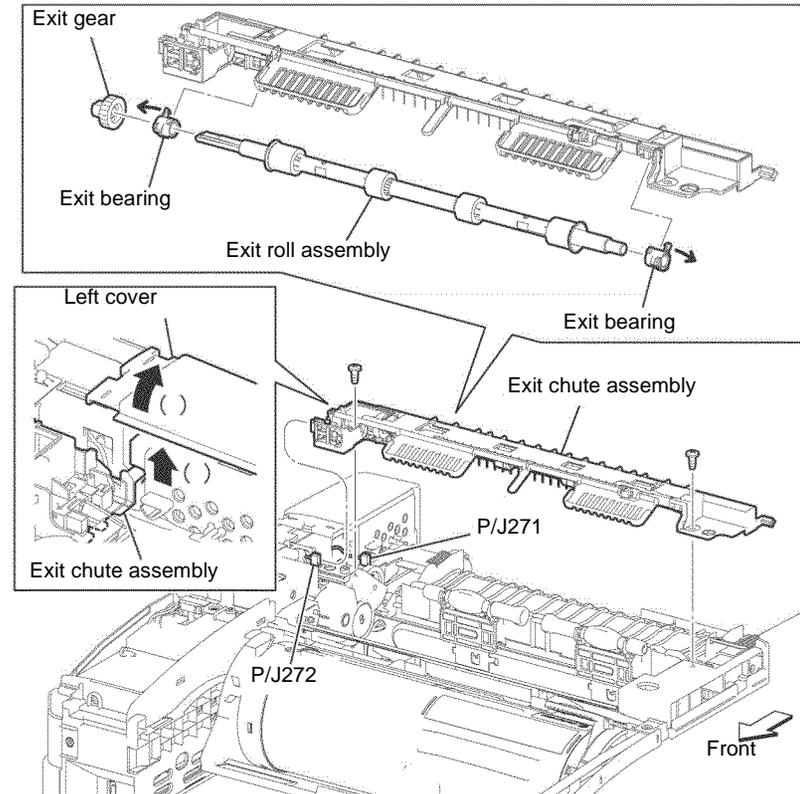
- Bend the left cover, release the two bosses of the exit chute assembly from the printer, then lift the exit chute assembly in the arrowed direction, [Figure 2](#).
- Disconnect P/J271 from the exit sensor, then remove the exit chute assembly, [Figure 2](#).
- Remove the exit gear. Release the hook that fixes the exit bearing, then remove the exit bearing and the exit roll assembly, [Figure 2](#).

**Figure 2 Exit chute assembly removal**

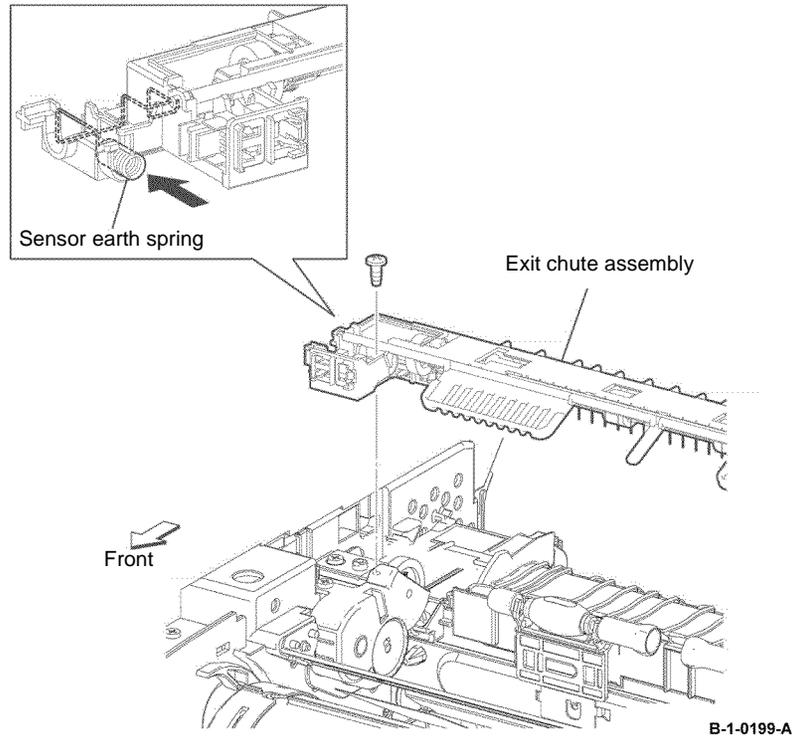
1. The replacement is the reverse of the removal procedure.
2. When installing the exit chute assembly, ensure the end of the sensor earth spring is in contact with the plate on the frame, [Figure 3](#).

**Figure 3 Exit chute assembly installation**

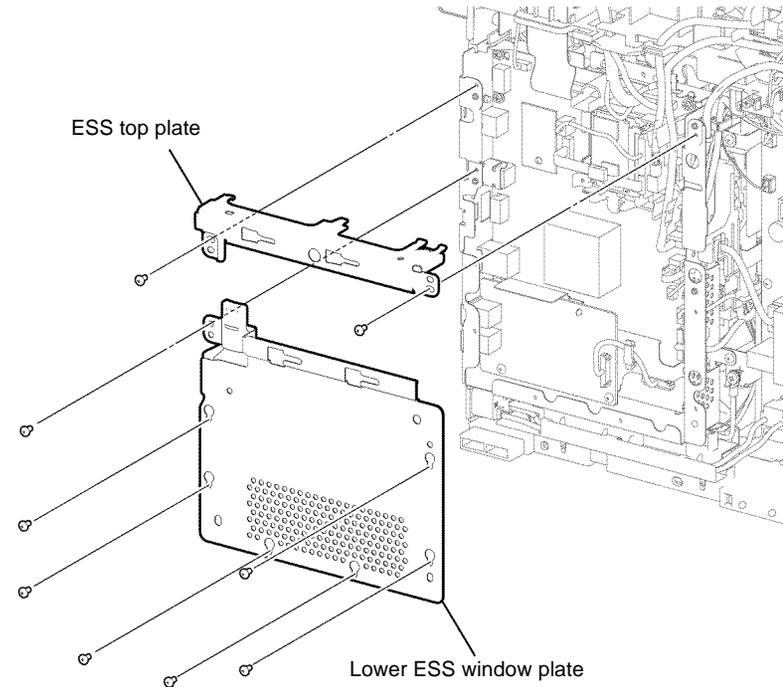
B-1-0200-A

1. Open the MSI cover, [PL 13.2 Item 99](#).
2. Pull out the MSI tray assembly, [PL 13.2 Item 9](#).
3. Remove the front cover assembly, [REP 19.1](#).
4. Remove the rear cover assembly, [REP 19.13](#).
5. Remove the ESS window cover assembly, [REP 19.3](#).
6. Remove the WIFI cap cover, [REP 19.19](#).
7. Remove the left cover, [REP 19.11](#).
8. Remove seven screws (silver, M3, 6mm), then remove the lower ESS window plate with WIFI release lever, [Figure 2](#).
9. Remove two screws (silver, M3, 6mm), then remove the ESS top plate, [Figure 2](#).

Figure 2 ESS top and lower plate removal

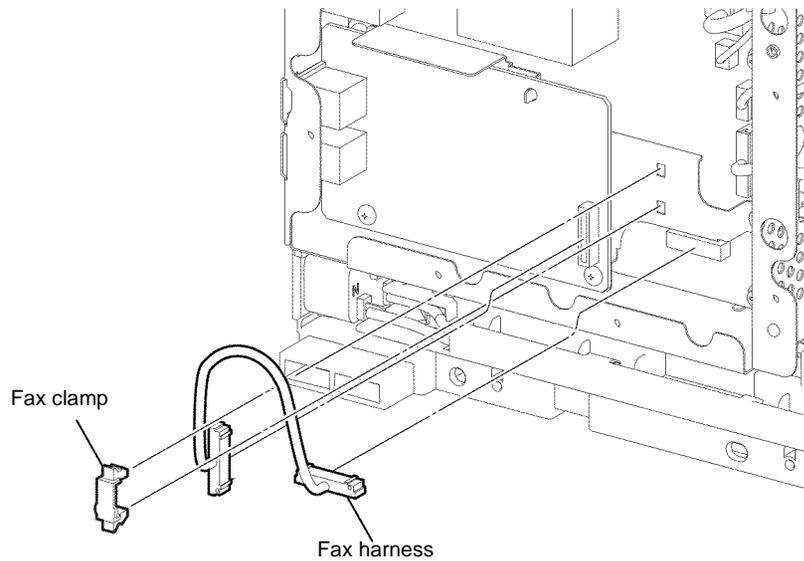
B-1-0201-A

10. Remove the fax clamp fixing the fax harness assembly, [Figure 3](#).
11. Disconnect P/J432 from the ESS PWB and P/J1350 from the Fax PWB, then remove the fax harness, [Figure 3](#).

**Figure 3 Fax harness removal**

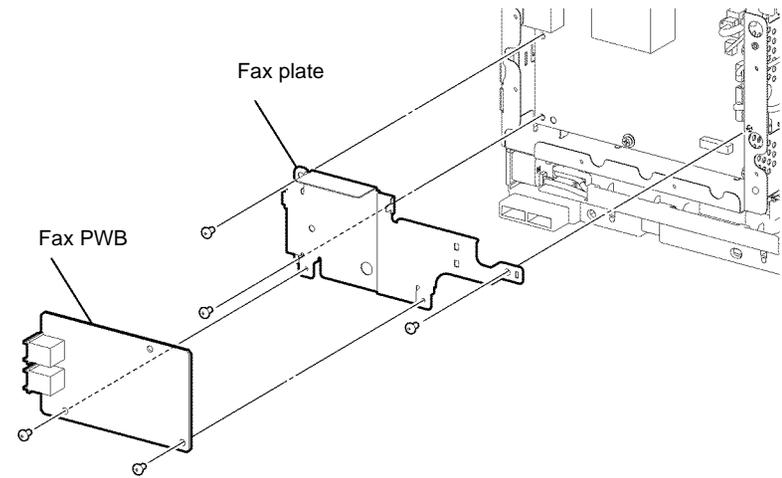
B-1-0202-A

12. Remove two screws (silver, M3, 6mm), then remove the fax PWB, [Figure 4](#).
13. Remove three screws (silver, M3, 6mm), then remove the fax plate, [Figure 4](#).

**Figure 4 Fax PWB and plate removal**

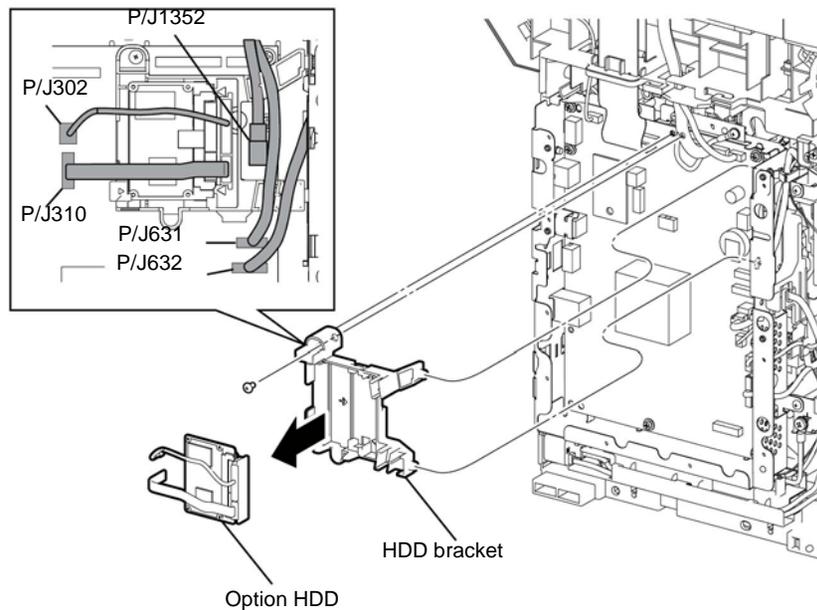
B-1-0203-A

14. Disconnect, P/J1352, P/J631 and P/J632, then remove the harnesses from the HDD bracket, [Figure 5](#).
15. Disconnect P/J302 and P/J310, then remove the option HDD, [Figure 5](#).
16. Remove one screw (silver, M3, 6mm), then release the two bosses to remove the HDD bracket, [Figure 5](#).

Figure 5 HDD and HDD bracket removal

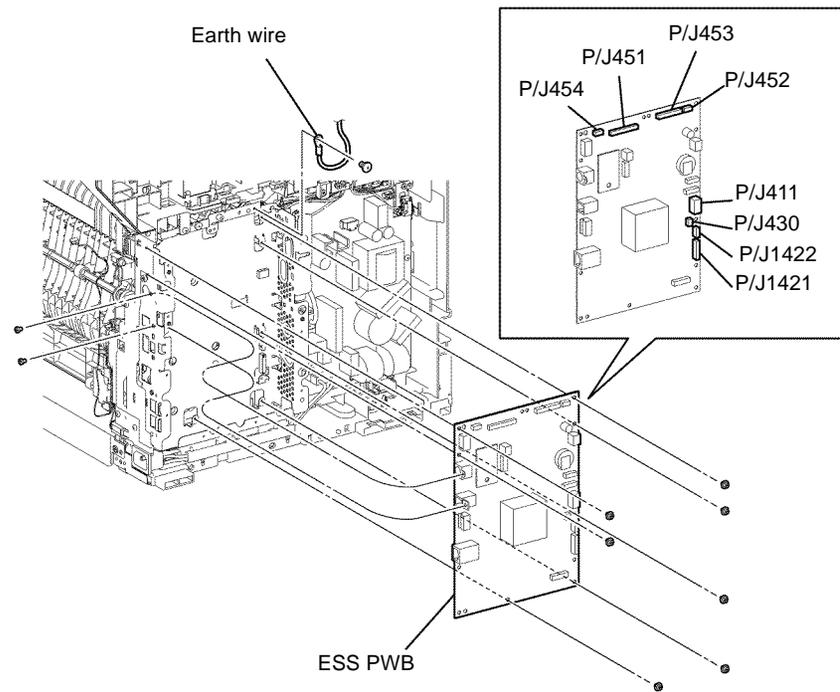
B-1-0204-A

Figure 6 ESS PWB removal

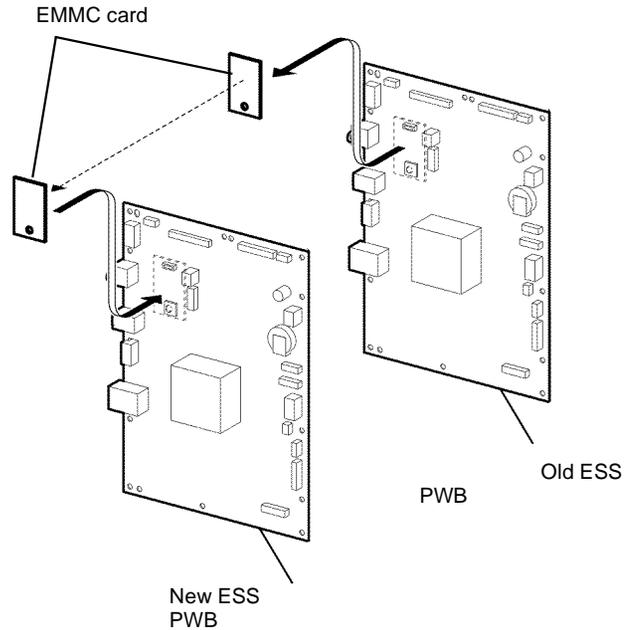
B-1-0205-A

Figure 7 EMMC card

1. The replacement is the reverse of the removal procedure.
2. If a new ESS PWB is to be installed, remove the EMMC card from the old ESS PWB, then install it onto the new ESS PWB, Figure 7.

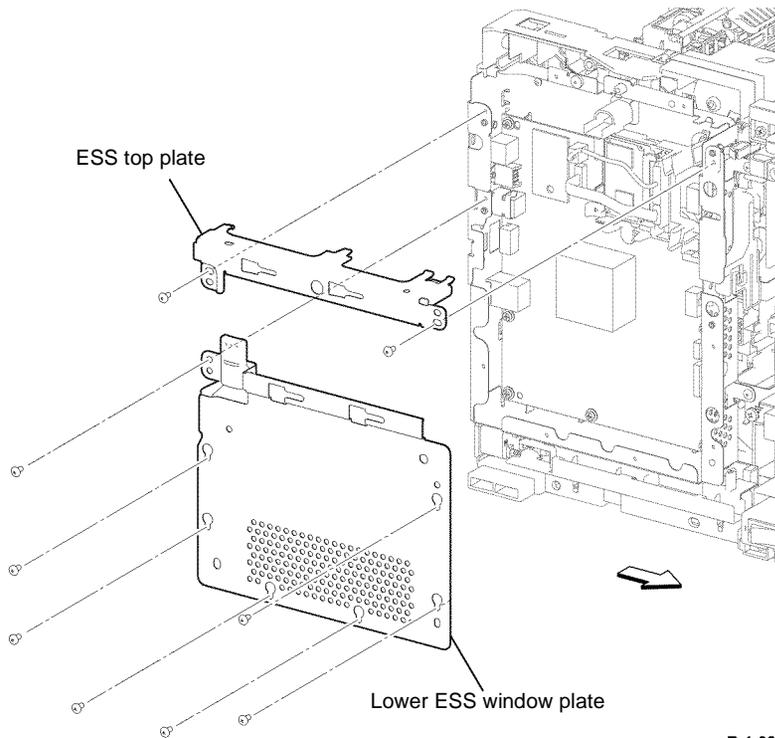
B-1-0206-A

1. Open the MSI cover, [PL 13.2 Item 99](#).
2. Pull out the MSI tray assembly, [PL 13.2 Item 9](#).
3. Remove the front cover assembly, [REP 19.2](#).
4. Remove the rear cover assembly, [REP 19.14](#).
5. Remove the UI console assembly, [REP 1.3](#).
6. Remove the exit top cover assembly, [REP 19.10](#).
7. Remove the WIFI cap cover, [REP 19.20](#).
8. Remove the ESS window cover assembly, [REP 19.4](#).
9. Remove the front/left UI cover assembly, [REP 1.4](#).
10. Remove the left cover, [REP 19.12](#).
11. Remove seven screws (silver, M3, 6mm), then remove the lower ESS window plate with WIFI release lever, [Figure 2](#).
12. Remove two screws (silver, M3, 6mm), then remove the ESS top plate, [Figure 2](#).

**Figure 2 ESS top and lower plate removal**

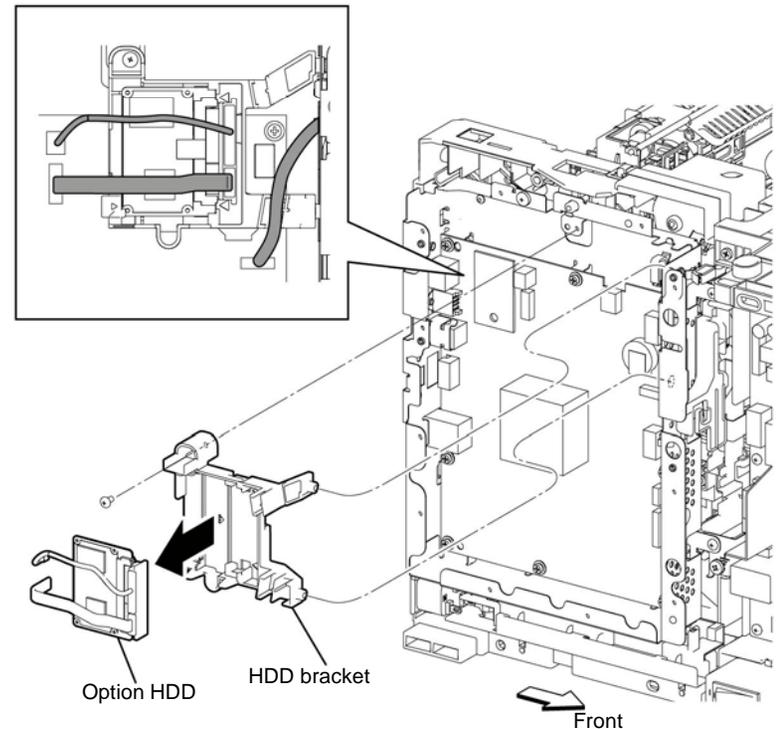
B-1-0207-A

13. Disconnect P/J631, then remove the harness from the HDD bracket, [Figure 3](#).
14. Disconnect P/J302 and P/J310, then remove the option HDD, [Figure 3](#).
15. Remove one screw (silver, M3, 6mm), then release the two bosses to remove the HDD bracket, [Figure 3](#).

**Figure 3 HDD and HDD bracket removal**

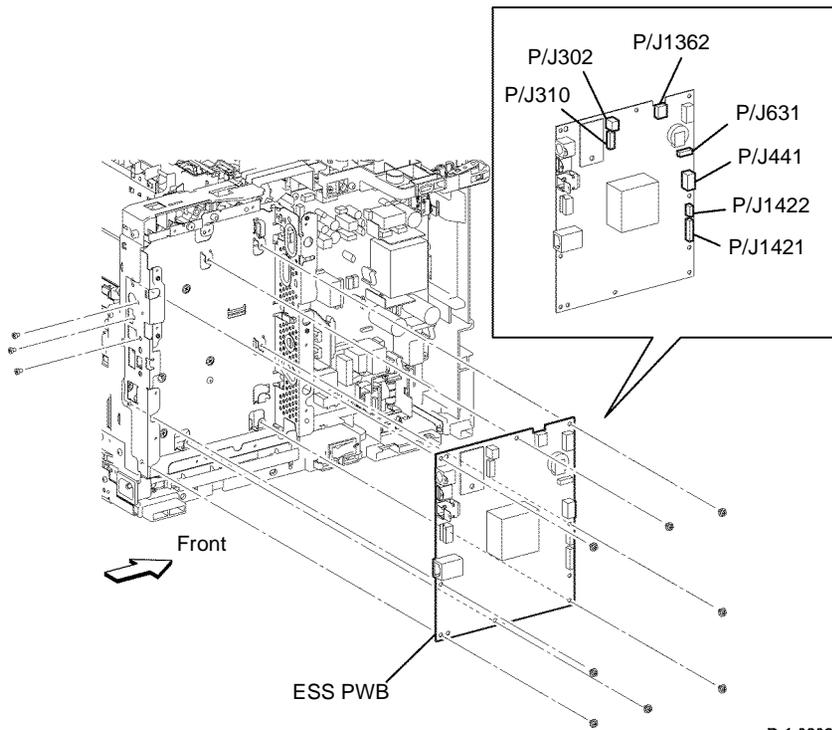
B-1-0208-A

*When handling the ESS PWB, ensure that only the marked areas at the top and bottom of the PWB are touched.*
17. Remove eight screws (silver with spring washer and plain washer, M3, 6mm) and three screws (silver, M3, 4mm), then remove the ESS PWB, [Figure 4](#).

Figure 4 ESS PWB removal

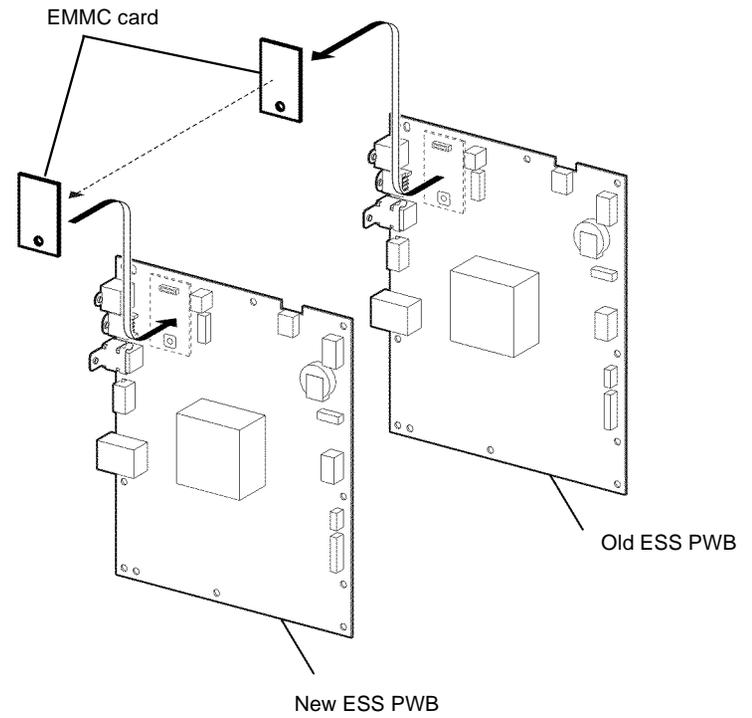
B-1-0209-A

Figure 5 EMMC card

1. The replacement is the reverse of the removal procedure.
2. If a new ESS PWB is to be installed, remove the EMMC card from the old ESS PWB, then install it onto the new ESS PWB, [Figure 5](#).
3. When installing the ESS PWB, ensure the harness is connected properly to the power connector P/J441 before powering on the printer.

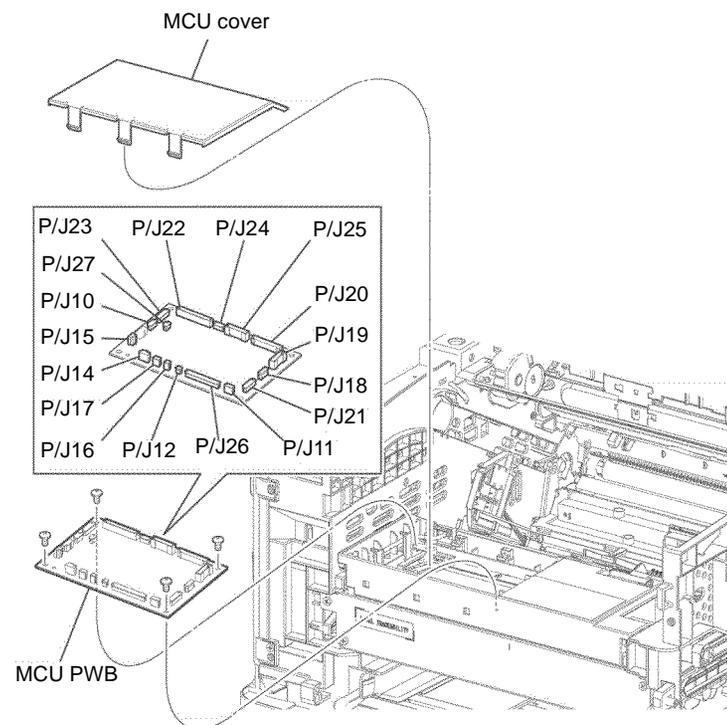
B-1-0210-A

1. Open the MSI cover, [PL 13.2 Item 99](#).
2. Pull out the MSI tray assembly, [PL 13.2 Item 9](#).
3. Remove the front cover assembly, [REP 19.1](#).
4. Remove the drum cartridge, [REP 8.1](#).
5. Remove the MCU cover, by releasing the hooks, [Figure 2](#).
6. Disconnect all connectors from the MCU PWB, [Figure 2](#).
7. Remove four screws (silver, M3, 6mm), then remove the MCU PWB, [Figure 2](#).

Figure 2 MCU PWB removal

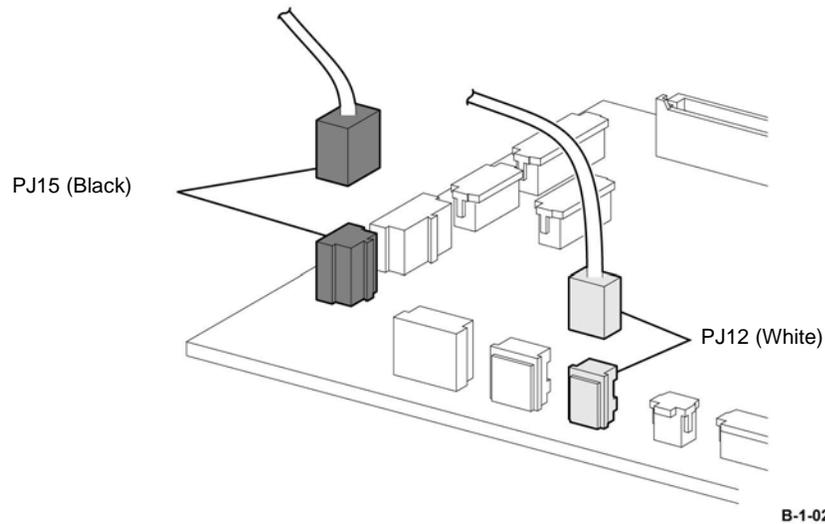
Figure 3 MCU PWB installation

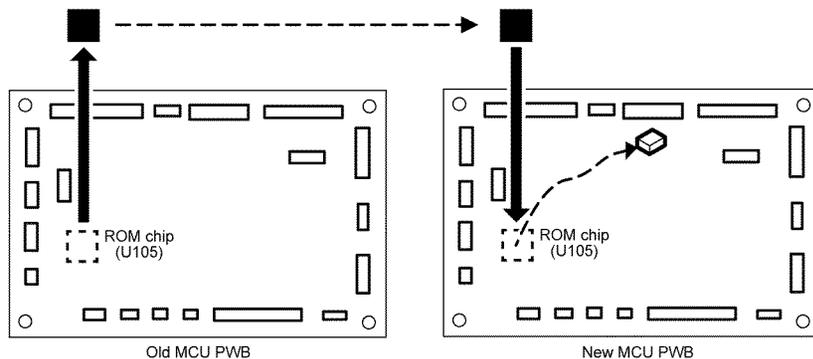
2. If a new MCU PWB is to be installed, remove the U105 ROM chip from the old MCU PWB, then install it onto the new MCU PWB, [Figure 4](#).

Figure 4 U105 ROM chip installation

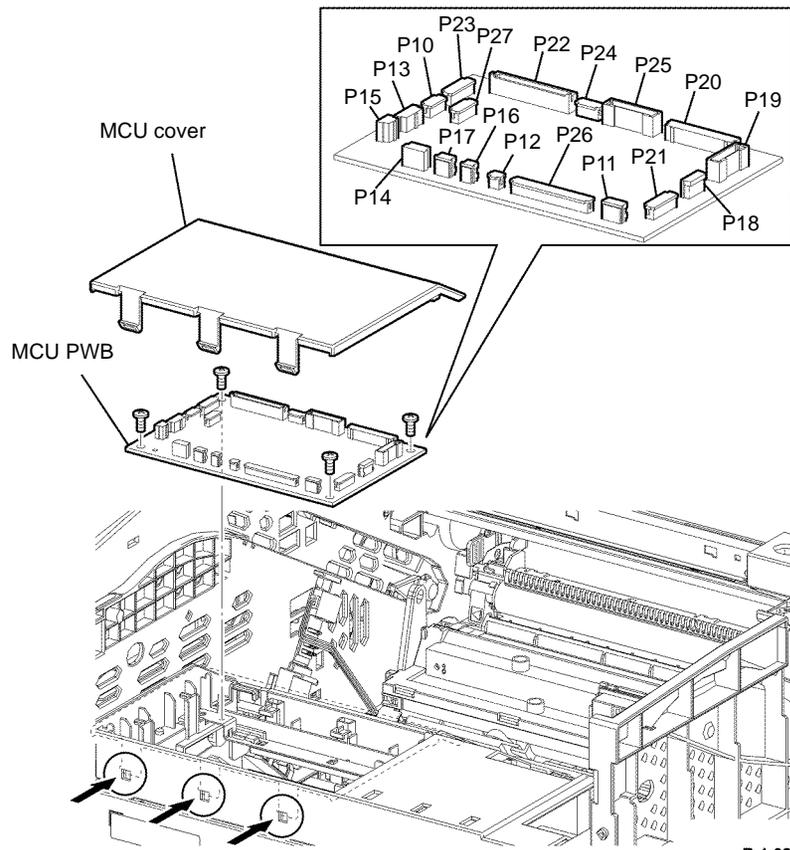
B-1-0212-A

1. Open the MSI cover, [PL 13.2 Item 99](#).
2. Pull out the MSI tray assembly, [PL 13.2 Item 9](#).
3. Remove the front cover assembly, [REP 19.2](#).
4. Remove the drum cartridge, [REP 8.2](#).
5. Remove the MCU cover, by releasing the hooks, [Figure 2](#).
6. Disconnect all connectors from the MCU PWB, [Figure 2](#).
7. Remove four screws (silver, M3, 6mm), then remove the MCU PWB, [Figure 2](#).

Figure 2 MCU PWB removal

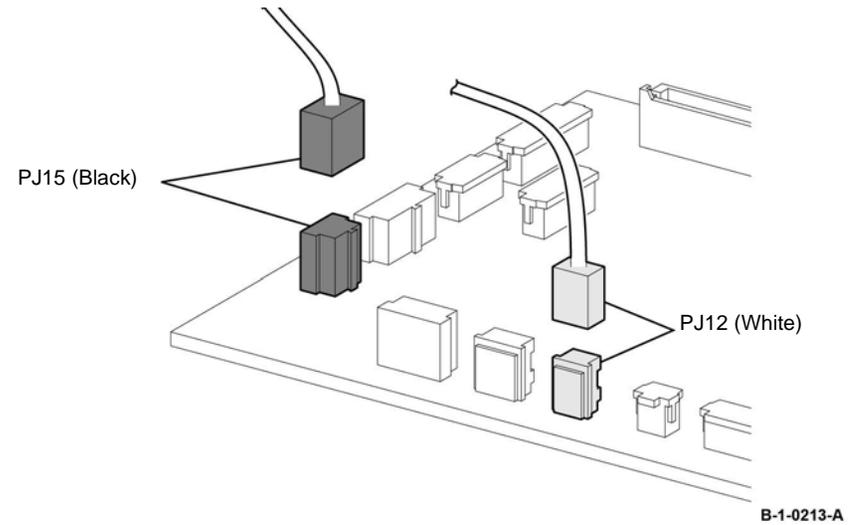
B-1-0213-A

Do not confuse connectors with same number of pins. The PJ15 connectors are white. The PJ15 connectors are black, Figure 3.

Figure 3 MCU PWB Installation

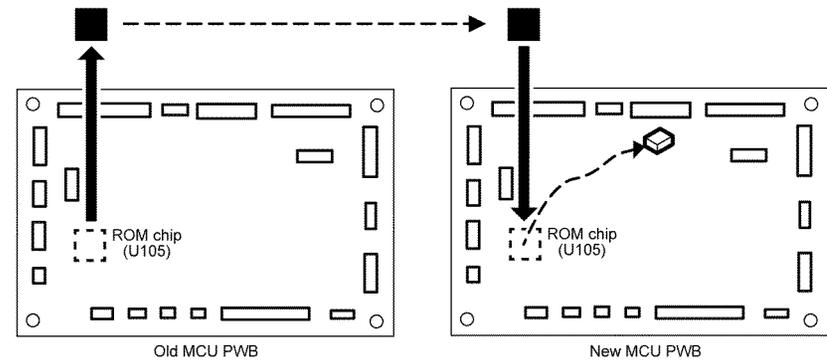
B-1-0345-A

2. If a new MCU PWB is to be installed, remove the U105 ROM chip from the old MCU PWB, then install it onto the new MCU PWB, Figure 4.

Figure 4 U105 ROM chip installation

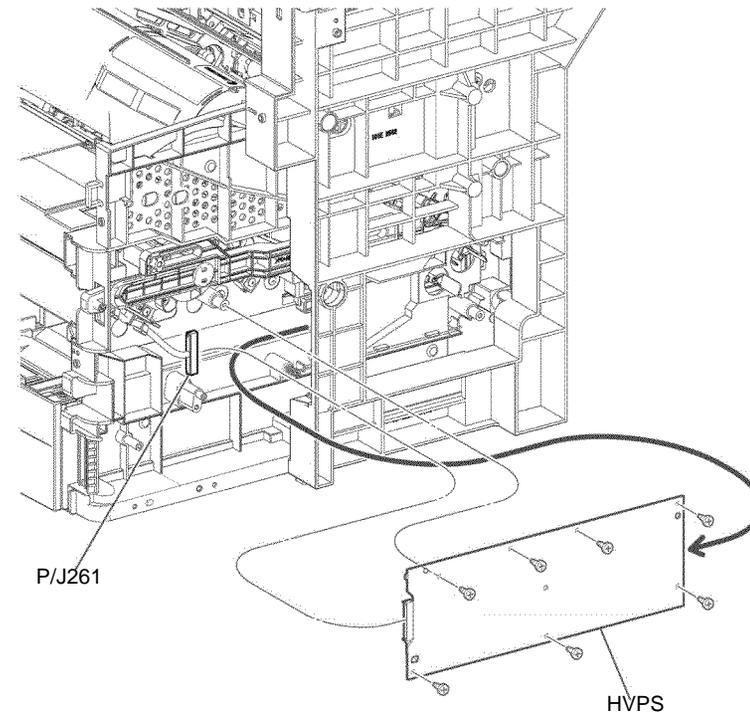
B-1-0214-A

1. Open the MSI cover, [PL 13.2 Item 99](#).
2. Pull out the MSI tray assembly, [PL 13.2 Item 9](#).
3. Remove the front cover assembly, [REP 19.1](#).
4. Remove the rear cover assembly, [REP 19.13](#).
5. Remove the right cover, [REP 19.7](#).
6. Disconnect P/J261 from the HVPS. Remove seven screws (silver, tapping, 8mm) that fix the HVPS. Release two bosses on the frame from the holes on the HVPS, then remove the HVPS, [Figure 2](#).

Figure 2 HVPS removal

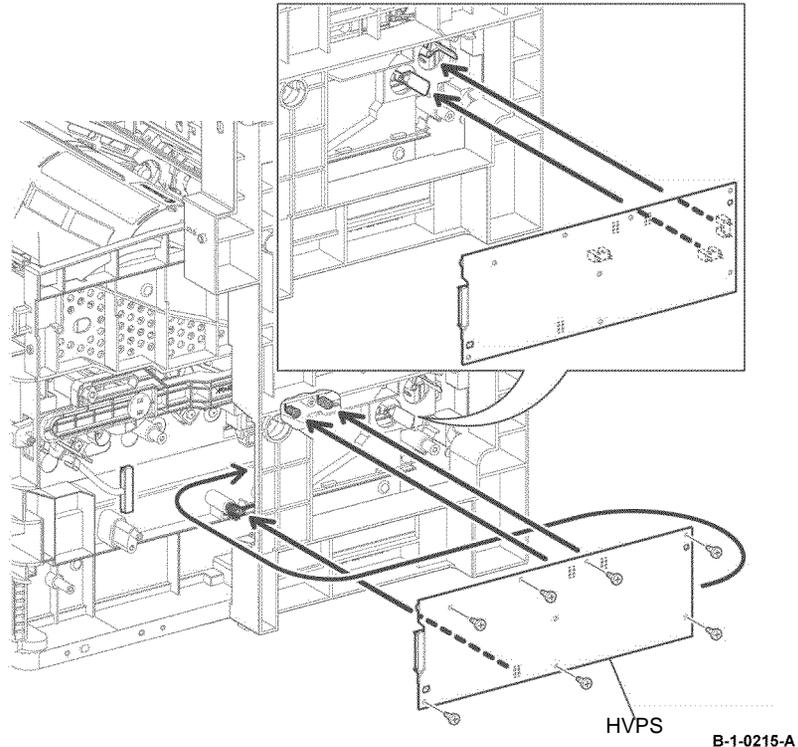
1. The replacement is the reverse of the removal procedure.
2. When installing the HVPS, ensure that the ends of the three conductive springs provided on the frame are in contact with the terminals on the board, and that the two sensors on the HVPS are correctly aligned with the registration shutter sensor, [Figure 3](#).

Figure 3 HVPS installation

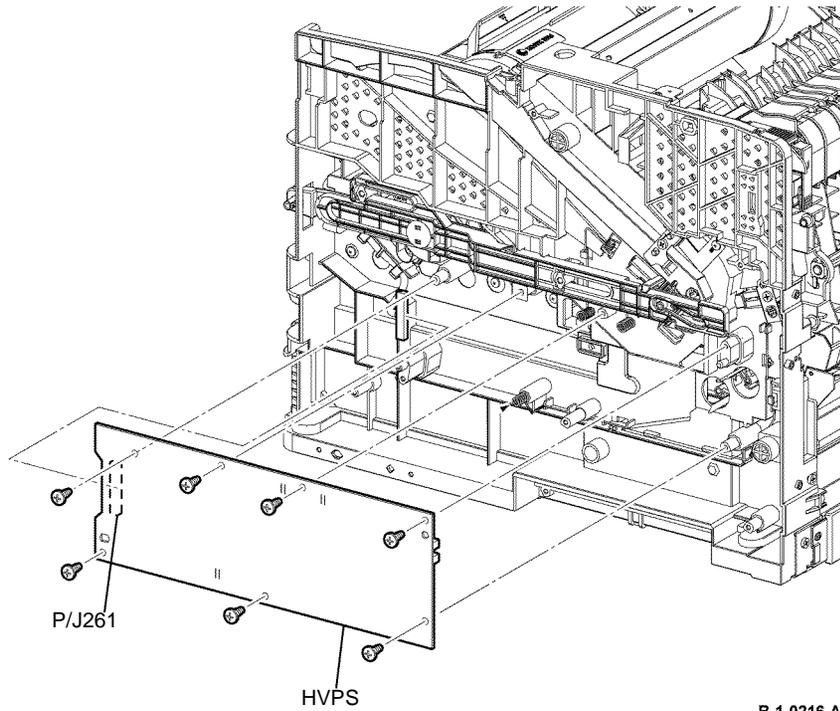
B-1-0216-A

1. Open the MSI cover, [PL 13.2 Item 99](#).
2. Pull out the MSI tray assembly, [PL 13.2 Item 9](#).
3. Remove the front cover assembly, [REP 19.2](#).
4. Remove the rear cover assembly, [REP 19.14](#).
5. Remove the UI console assembly, [REP 1.3](#).
6. Remove the exit top cover assembly, [REP 19.10](#).
7. Remove the right cover, [REP 19.8](#).
8. Disconnect P/J261 from the HVPS. Remove seven screws (silver, tapping, 8mm) that fix the HVPS. Release two bosses on the frame from the holes on the HVPS, then remove the HVPS, [Figure 2](#).

Figure 2 HVPS removal

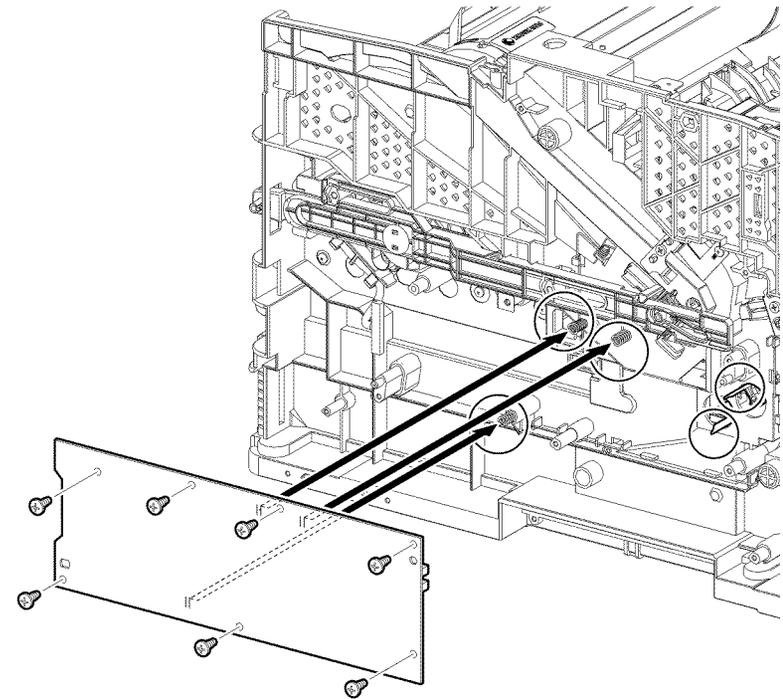
B-1-0217-A

Figure 3 HVPS installation

1. The replacement is the reverse of the removal procedure.
2. When installing the HVPS, ensure that the ends of the three conductive springs provided on the frame are in contact with the terminals on the board, and that the two sensor on the HVPS is correctly aligned with the registration shutter sensor, [Figure 3](#).

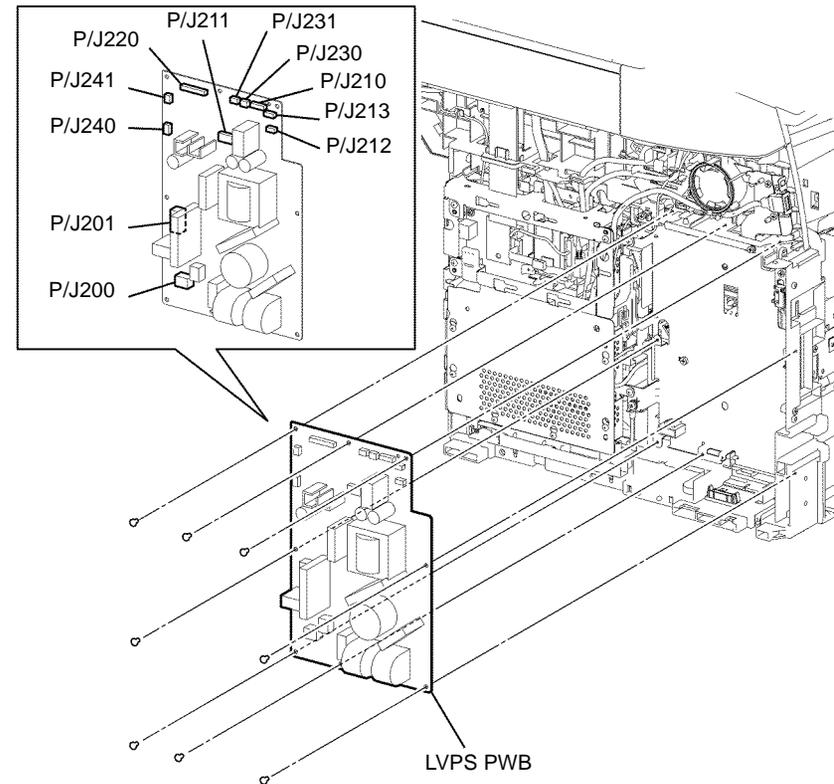
B-1-0218-A

1. Open the MSI cover, [PL 13.2 Item 99](#).
2. Pull out the MSI tray assembly, [PL 13.2 Item 9](#).
3. Remove the front cover assembly, [REP 19.1](#).
4. Remove the rear cover assembly, [REP 19.13](#).
5. Remove the ESS window cover assembly, [REP 19.3](#).
6. Remove the WIFI cap cover, [REP 19.19](#).
7. Remove the left cover, [REP 19.11](#).
8. Disconnect all connectors from the LVPS PWB, [Figure 2](#).
9. Remove eight screws (silver, M3, 6mm) that fix the LVPS PWB, then remove the LVPS PWB, [Figure 2](#).

Figure 2 LVPS PWB removal

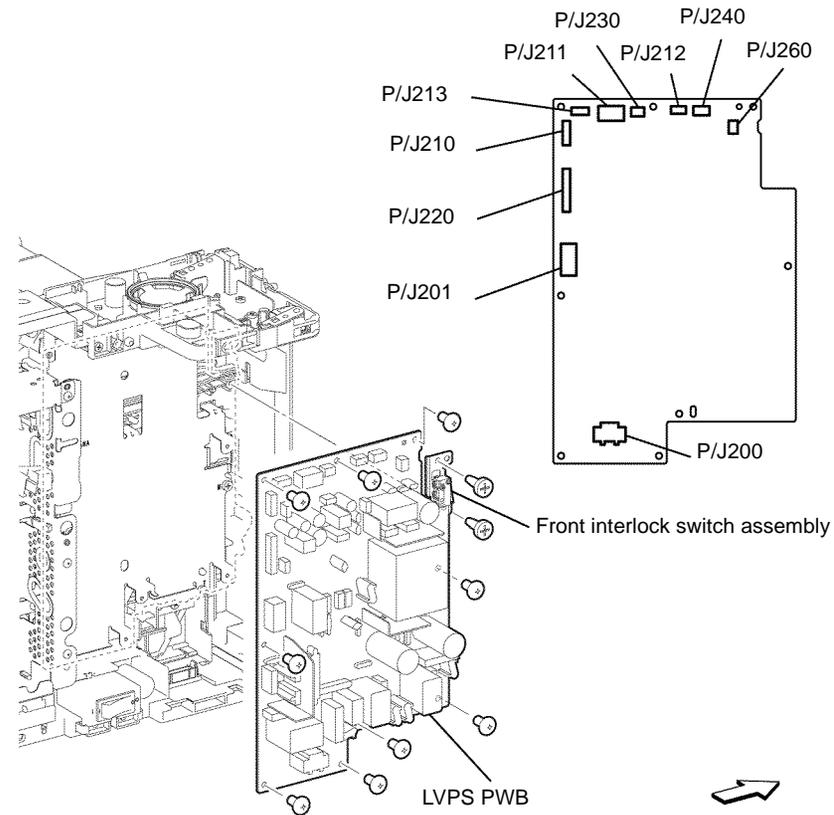
B-1-0219-A

1. Open the MSI cover, [PL 13.2 Item 99](#).
2. Pull out the MSI tray assembly, [PL 13.2 Item 9](#).
3. Remove the front cover assembly, [REP 19.2](#).
4. Remove the rear cover assembly, [REP 19.14](#).
5. Remove the UI console assembly, [REP 1.3](#).
6. Remove the exit top cover assembly, [REP 19.10](#).
7. Remove the WIFI cap cover, [REP 19.20](#).
8. Remove the ESS window cover assembly, [REP 19.4](#).
9. Remove the front/left UI cover assembly, [REP 1.4](#).
10. Remove the left cover, [REP 19.12](#).
11. Disconnect all connectors from the LVPS PWB, [Figure 2](#).
12. Remove nine screws (silver, M3, 6mm) that fix the LVPS PWB and two screws (silver, tapping, 8mm) that fix the front interlock switch assembly. Remove the LVPS PWB, [Figure 2](#).

Figure 2 LVPS PWB removal

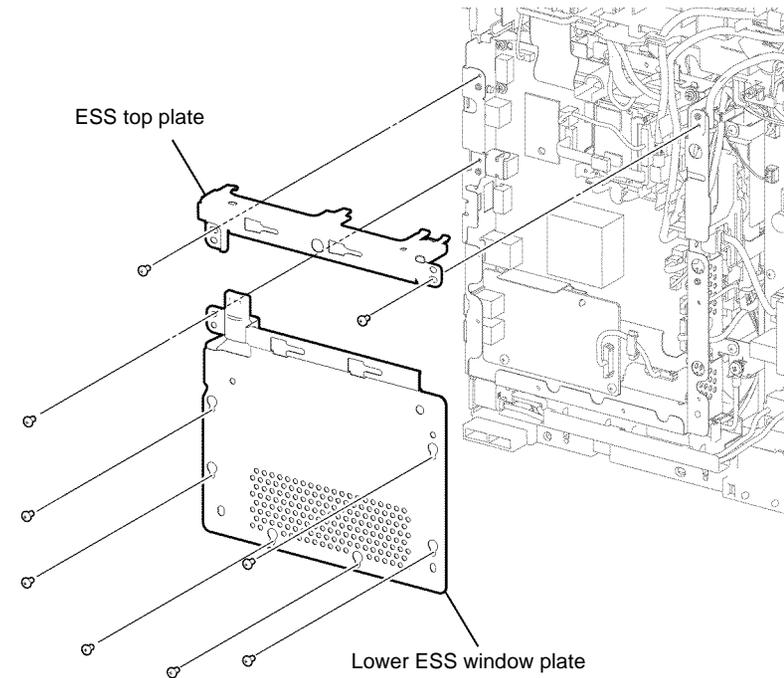
B-1-0220-A

1. Open the MSI cover, [PL 13.2 Item 99](#).
2. Pull out the MSI tray assembly, [PL 13.2 Item 9](#).
3. Remove the front cover assembly, [REP 19.1](#).
4. Remove the rear cover assembly, [REP 19.13](#).
5. Remove the ESS window cover assembly, [REP 19.3](#).
6. Remove the WIFI cap cover, [REP 19.19](#).
7. Remove the left cover, [REP 19.11](#).
8. Remove seven screws (silver, M3, 6mm), then remove the lower ESS window plate with WIFI release lever, [Figure 1](#).
9. Remove two screws (silver, M3, 6mm), then remove the ESS top plate, [Figure 1](#).

Figure 1 ESS top and lower plate removal

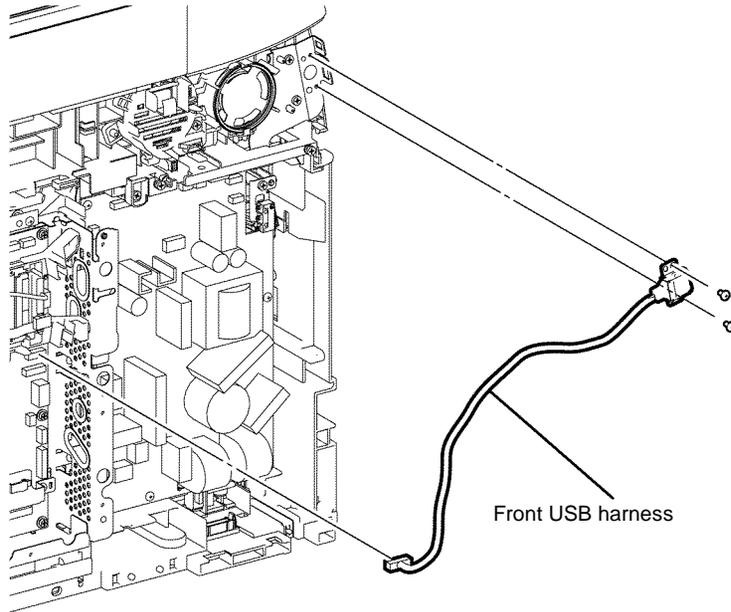
B-1-01221-A

Figure 2 Front USB harness removal
