# Xerox® VersaLink® B400 & B405 Family Multifunction Printer Service Manual

VersaLink B400 and B405 Family Multifunction Printer Service Manual

708P91373

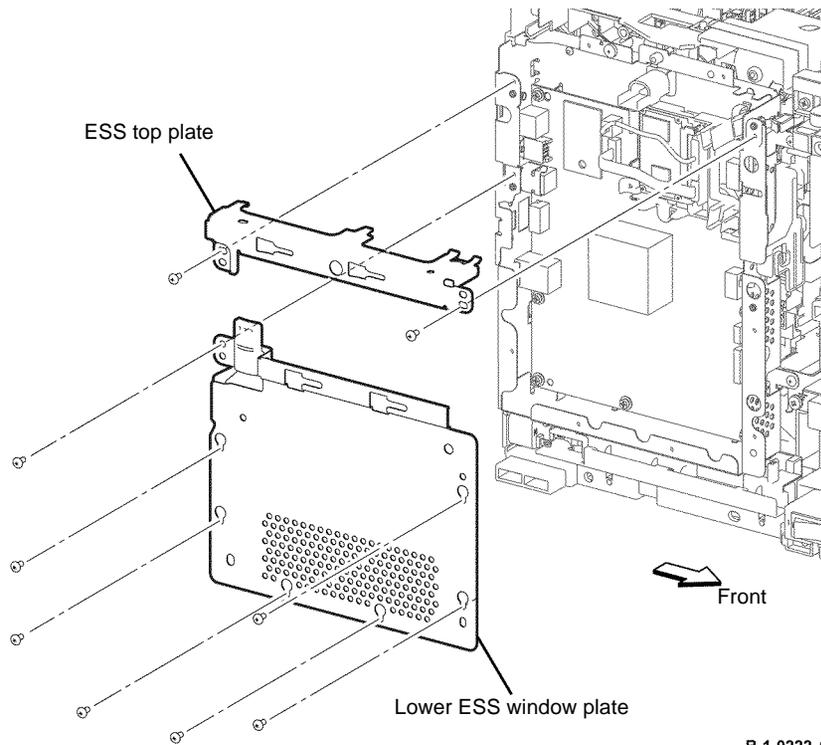
B-1-0222-A

1. Open the MSI cover, [PL 13.2 Item 99](#).
2. Pull out the MSI tray assembly, [PL 13.2 Item 9](#).
3. Remove the front cover assembly, [REP 19.2](#).
4. Remove the rear cover assembly, [REP 19.14](#).
5. Remove the UI console assembly, [REP 1.3](#).
6. Remove the exit top cover assembly, [REP 19.10](#).
7. Remove the WIFI cap cover, [REP 19.20](#).
8. Remove the ESS window cover assembly, [REP 19.4](#).
9. Remove the front/left UI cover assembly, [REP 1.4](#).
10. Remove the left cover, [REP 19.12](#).
11. Remove seven screws (silver, M3, 6mm), then remove the lower ESS window plate with WIFI release lever, [Figure 1](#).
12. Remove two screws (silver, M3, 6mm), then remove the ESS top plate, [Figure 1](#).

**Figure 1 ESS top and lower plate removal**

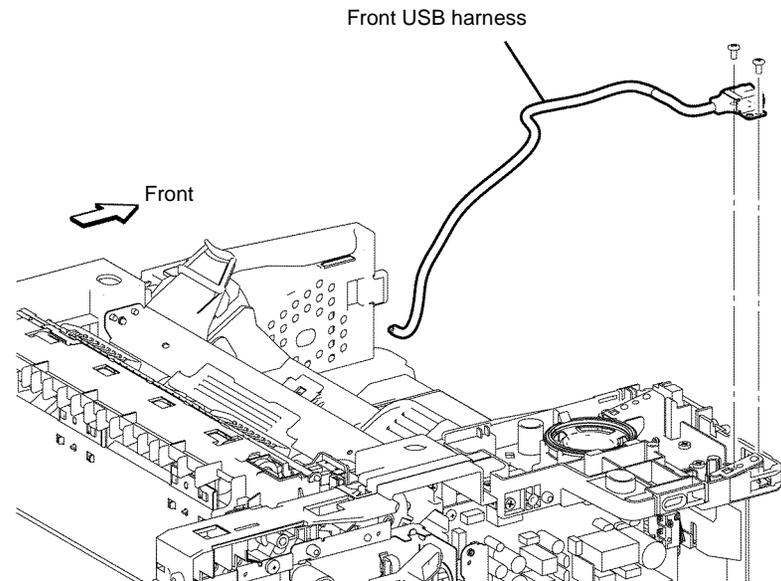
B-1-0223-A

13. Disconnect P/J631 from the ESS PWB, [Figure 2](#).
14. Remove two screws (silver, M3, 6mm), then remove the front USB harness, [Figure 2](#).

**Figure 2 Front USB harness removal**

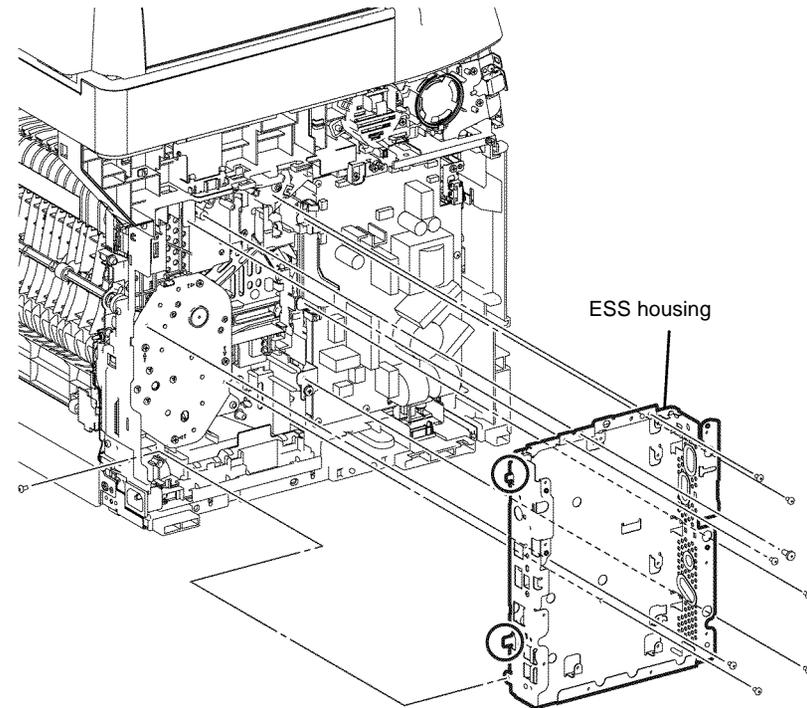
B-1-0224-A

1. Open the MSI cover, [PL 13.2 Item 99](#).
2. Pull out the MSI tray assembly, [PL 13.2 Item 9](#).
3. Remove the front cover assembly, [REP 19.1](#).
4. Remove the rear cover assembly, [REP 19.13](#).
5. Remove the ESS window cover assembly, [REP 19.3](#).
6. Remove the WIFI cap cover, [REP 19.19](#).
7. Remove the left cover, [REP 19.11](#).
8. Remove the ESS PWB, [REP 18.1](#).
9. Remove six screws (silver, M3, 6mm), one screw (silver, tapping, M4, 10mm), one screw (silver, M4, 8mm) and one screw (silver, tapping, 10mm), that fix the ESS housing. Release the two tabs from the frame, then remove the ESS housing from the printer, [Figure 1](#).

Figure 1 ESS housing removal

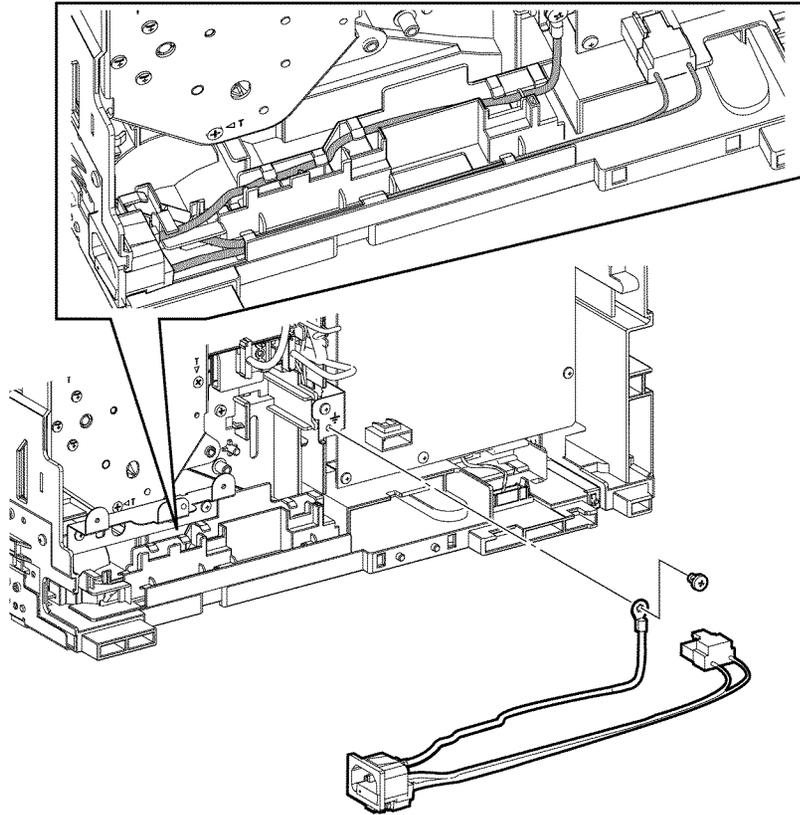
B-1-0225-A

Figure 2 Inlet harness assembly removal

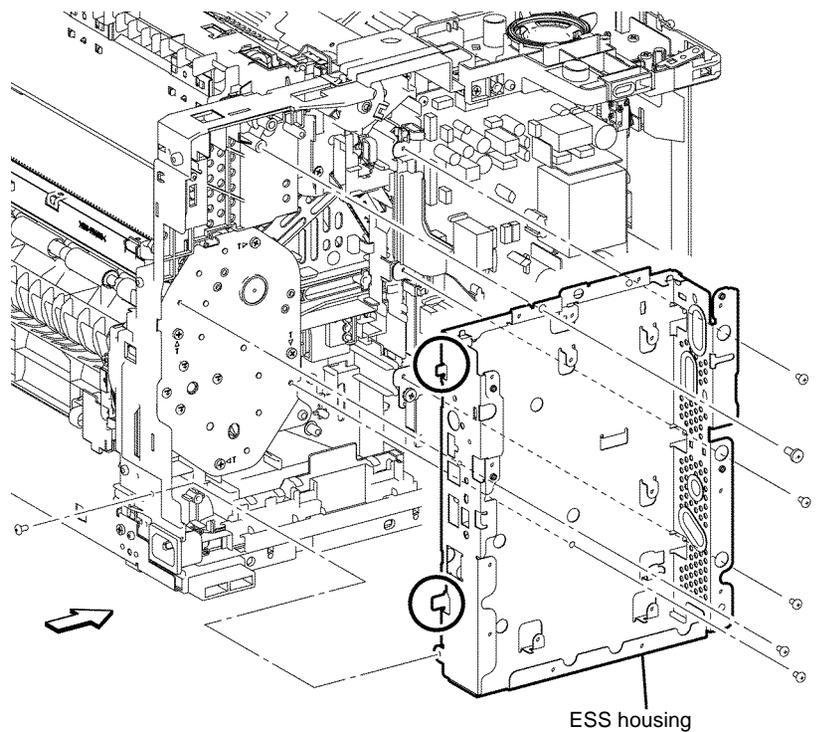
B-1-0226-A

1. Open the MSI cover, [PL 13.2 Item 99](#).
2. Pull out the MSI tray assembly, [PL 13.2 Item 9](#).
3. Remove the front cover assembly, [REP 19.2](#).
4. Remove the rear cover assembly, [REP 19.14](#).
5. Remove the UI console assembly, [REP 1.3](#).
6. Remove the exit top cover assembly, [REP 19.10](#).
7. Remove the WIFI cap cover, [REP 19.20](#).
8. Remove the ESS window cover assembly, [REP 19.4](#).
9. Remove the front/left UI cover assembly, [REP 1.4](#).
10. Remove the left cover, [REP 19.12](#).
11. Remove the ESS PWB, [REP 18.2](#).
12. Remove six screws (silver, M3, 6mm), one screw (silver, tapping, M4, 10mm), that fix the ESS housing. Release the two tabs from the frame, then remove the ESS housing from the printer, [Figure 1](#).

Figure 1 ESS housing removal

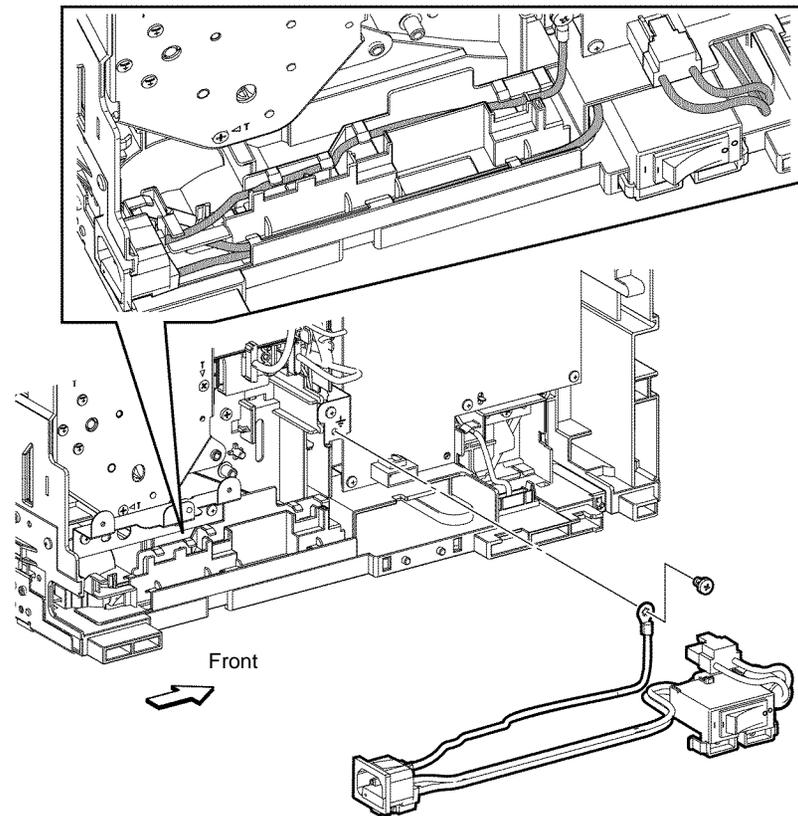
B-1-0227-A

13. Remove one screw (silver, M4, 5mm) that fixes the earth wire. Disconnect PJ200 from the LVPS PWB. Release both sides of the hook of the power switch, then remove the inlet harness assembly, [Figure 2](#).

Figure 2 Inlet harness assembly removal

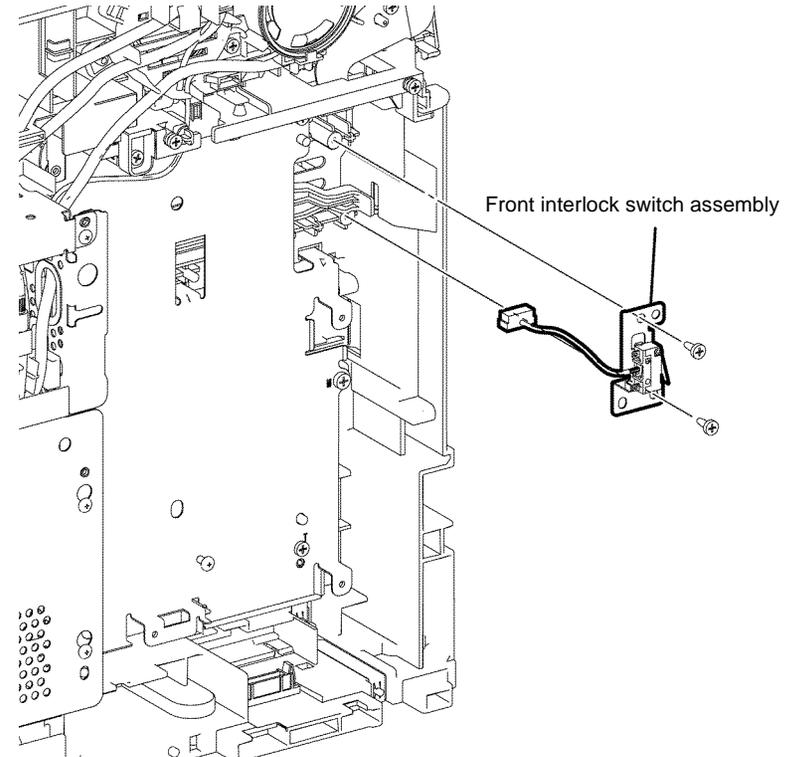
B-1-0228-A

1. Open the MSI cover, [PL 13.2 Item 99](#).
2. Pull out the MSI tray assembly, [PL 13.2 Item 9](#).
3. Remove the front cover assembly, [REP 19.1](#).
4. Remove the rear cover assembly, [REP 19.13](#).
5. Remove the ESS window cover assembly, [REP 19.3](#).
6. Remove the WIFI cap cover, [REP 19.19](#).
7. Remove the left cover, [REP 19.11](#).
8. Remove the LVPS PWB, [REP 18.7](#).
9. Remove two screws (silver, tapping, 8mm), then remove the front interlock switch assembly, [Figure 1](#).

Figure 1 Front interlock switch assembly removal

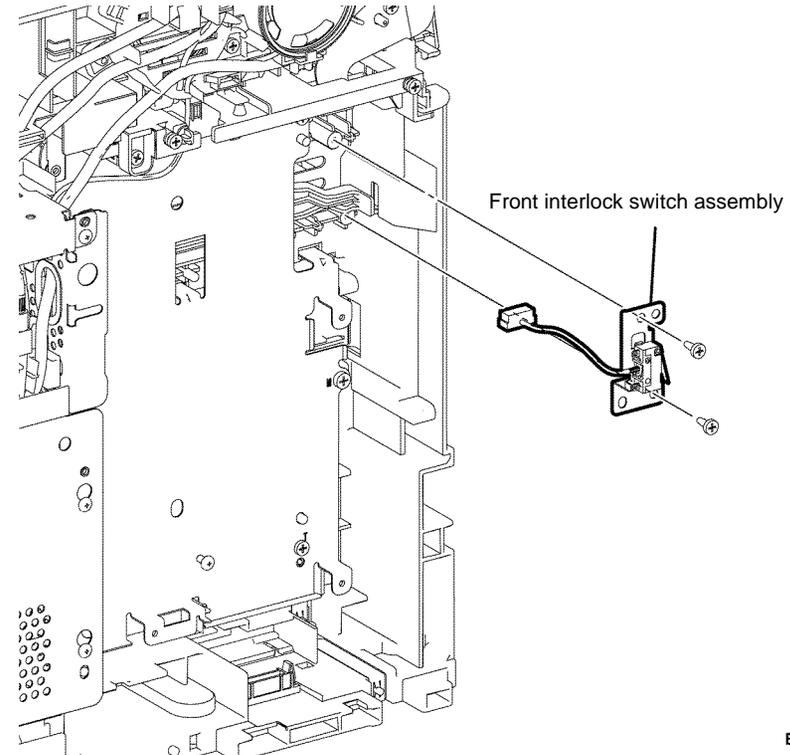
B-1-0229-A

1. Open the MSI cover, [PL 13.2 Item 99](#).
2. Pull out the MSI tray assembly, [PL 13.2 Item 9](#).
3. Remove the front cover assembly, [REP 19.2](#).
4. Remove the rear cover assembly, [REP 19.14](#).
5. Remove the UI console assembly, [REP 1.3](#).
6. Remove the exit top cover assembly, [REP 19.10](#).
7. Remove the WIFI cap cover, [REP 19.20](#).
8. Remove the ESS window cover assembly, [REP 19.4](#).
9. Remove the front/left UI cover assembly, [REP 1.4](#).
10. Remove the left cover, [REP 19.12](#).
11. Remove the LVPS PWB, [REP 18.8](#).
12. Remove two screws (silver, tapping, 8mm), then remove the front interlock switch assembly, [Figure 1](#).

Figure 1 Front interlock switch assembly removal

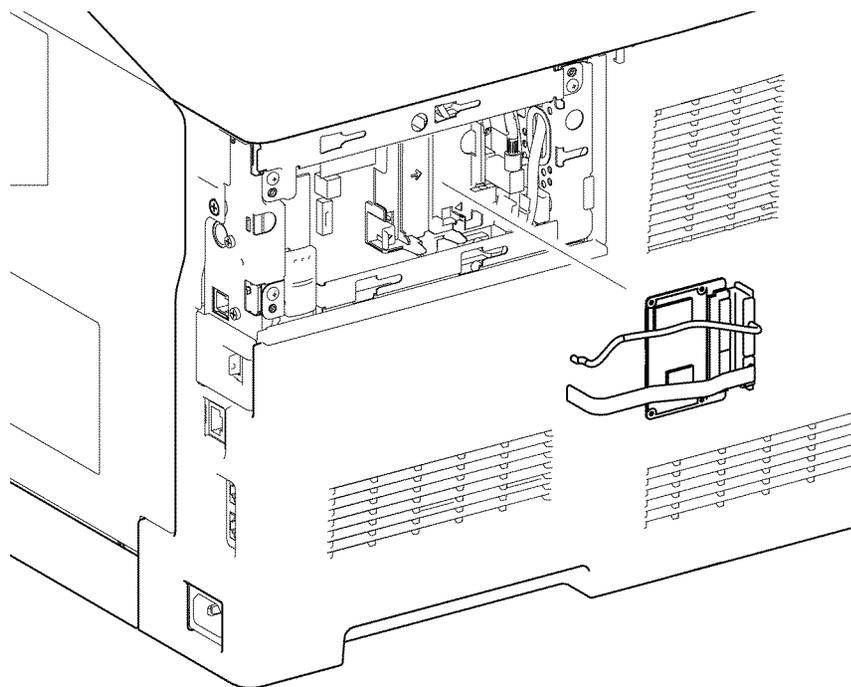
B-1-0366-A

1. Remove the ESS window cover assembly, [REP 19.4](#) (B400) or [REP 19.3](#) (B405).
2. Disconnect P/J302 and P/J310, then remove the option HDD, [Figure 1](#).

Figure 1 HDD removal

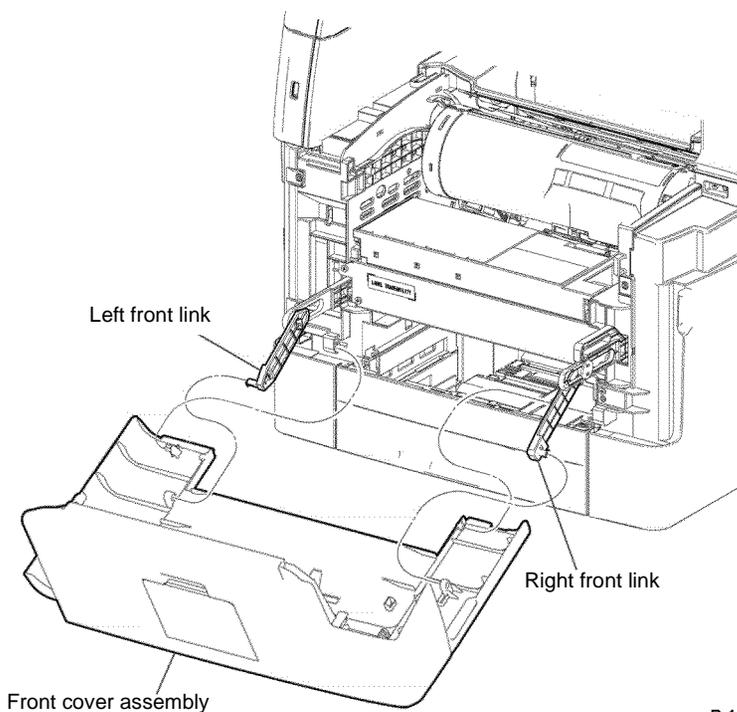
B-1-0230-A

1. Open the MSI cover, [PL 13.2 Item 99](#).
2. Pull out the MSI tray assembly, [PL 13.2 Item 9](#).
3. Open the front cover assembly. Release the hooks on the right and left front links, [Figure 1](#).
4. Remove the front cover assembly by flexing it to release one of the bosses from the hole, [Figure 1](#).

Figure 1 Front cover assembly removal

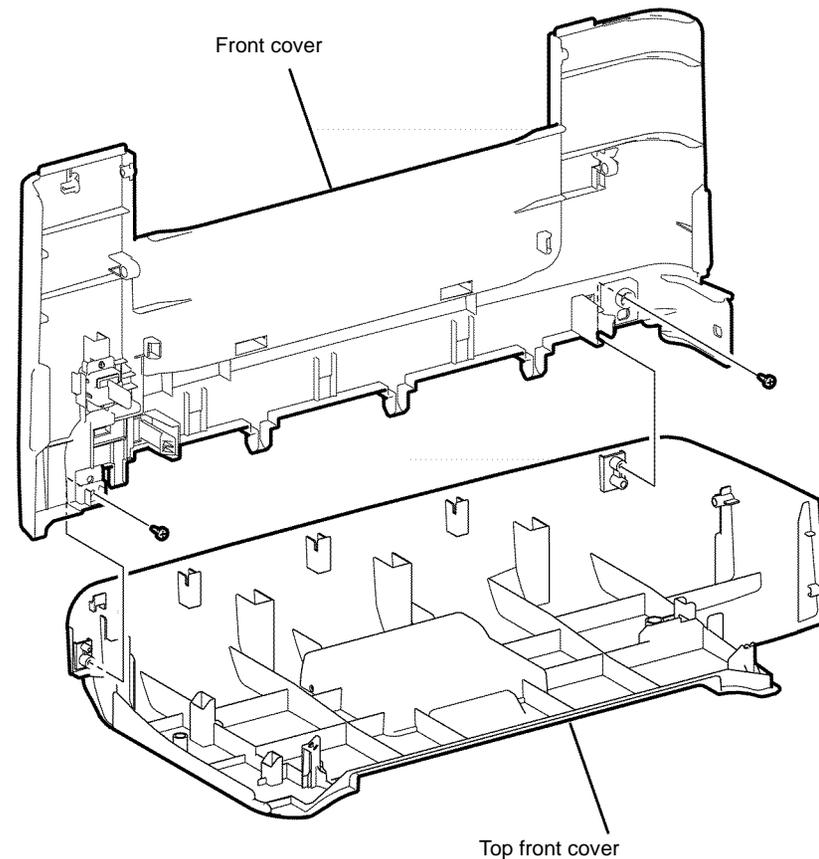
B-1-0231-A

Figure 2 Front cover removal

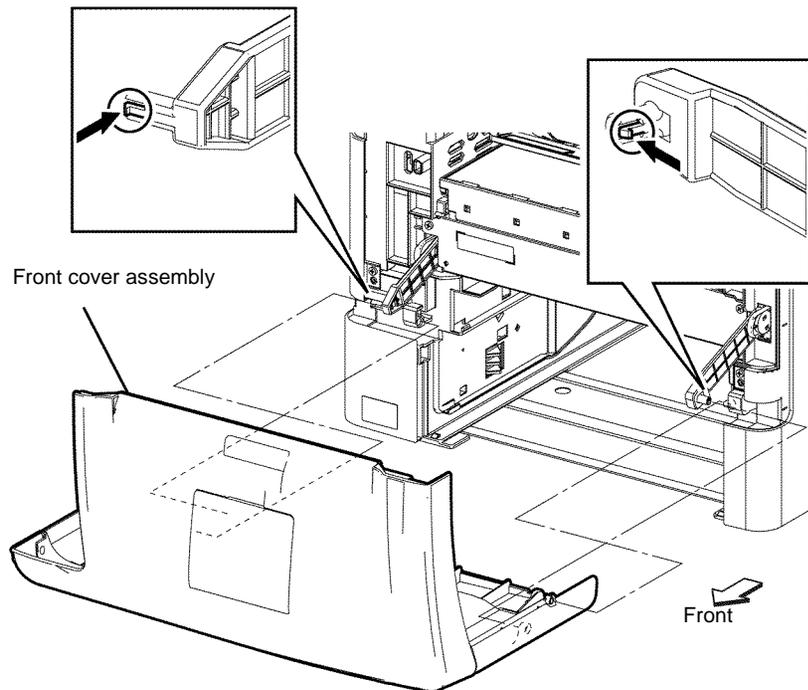
B-1-0232-A

1. Open the MSI cover, [PL 13.2 Item 99](#).
2. Pull out the MSI tray assembly, [PL 13.2 Item 9](#).
3. Open the front cover assembly. Release the hooks on the right and left front links, [Figure 1](#).
4. Remove the front cover assembly by flexing it to release one of the bosses from the hole, [Figure 1](#).

Figure 1 Front cover assembly removal

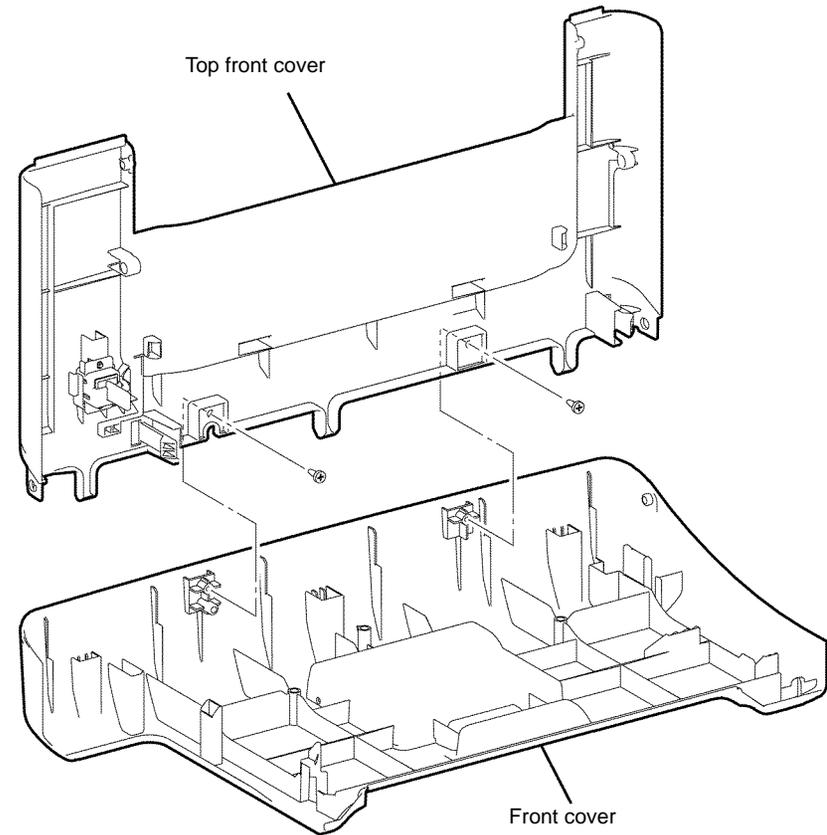
B-1-0233-A

Figure 2 Front cover removal

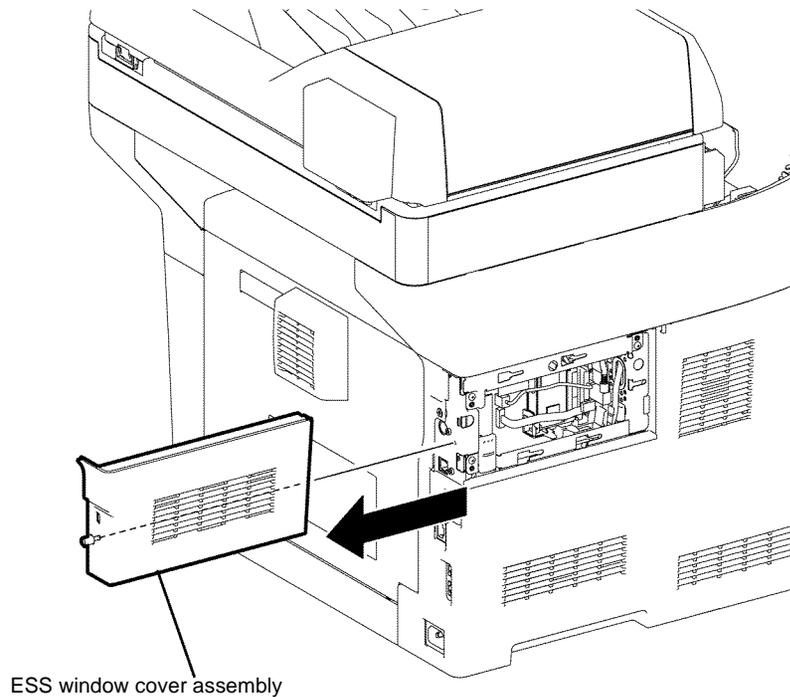
B-1-0234-A

1. Loosen the thumb screw that fixes the ESS window cover assembly, then remove the ESS window cover assembly from the printer, [Figure 1](#).

Figure 1 ESS window cover assembly removal

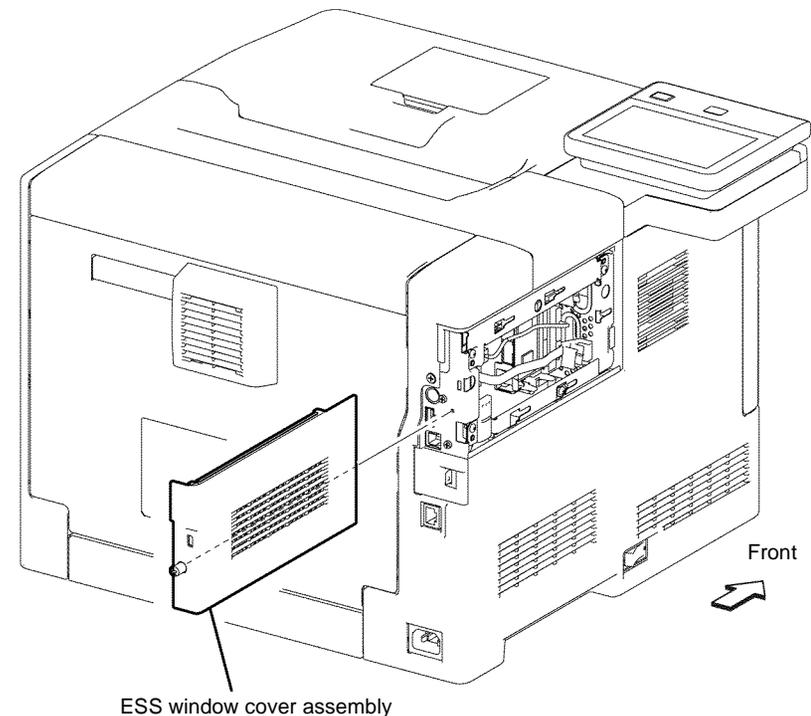
B-1-0235-A

1. Loosen the thumb screw that fixes the ESS window cover assembly, then remove the ESS window cover assembly from the printer, [Figure 1](#).

Figure 1 ESS window cover assembly removal

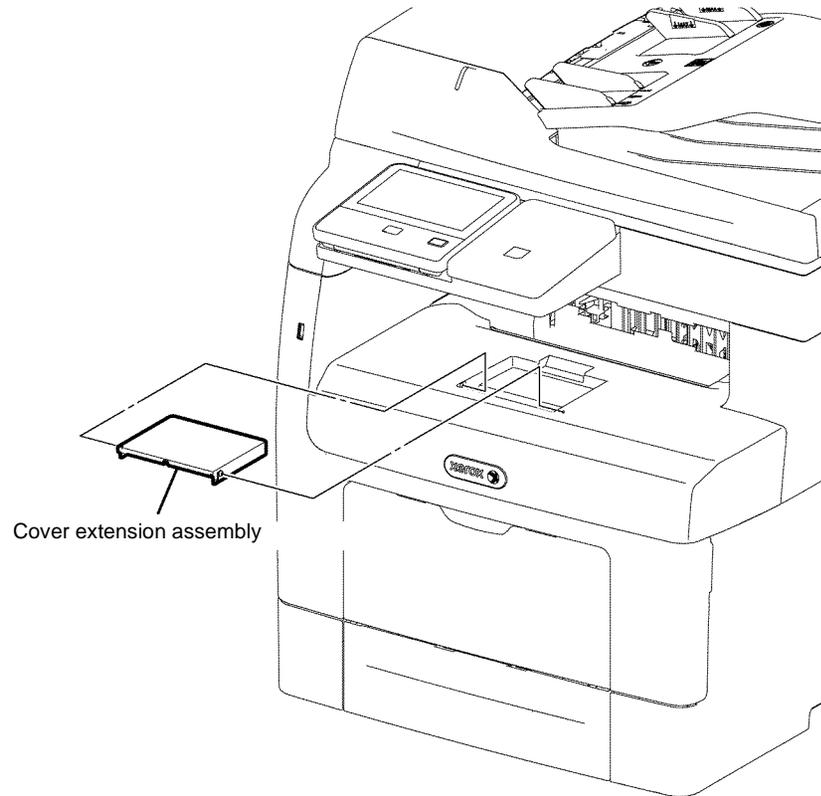
B-1-0236-A

1. Remove the cover extension assembly by flexing it to release one of the bosses from the hole, [Figure 1](#).

Figure 1 Cover extension assembly removal

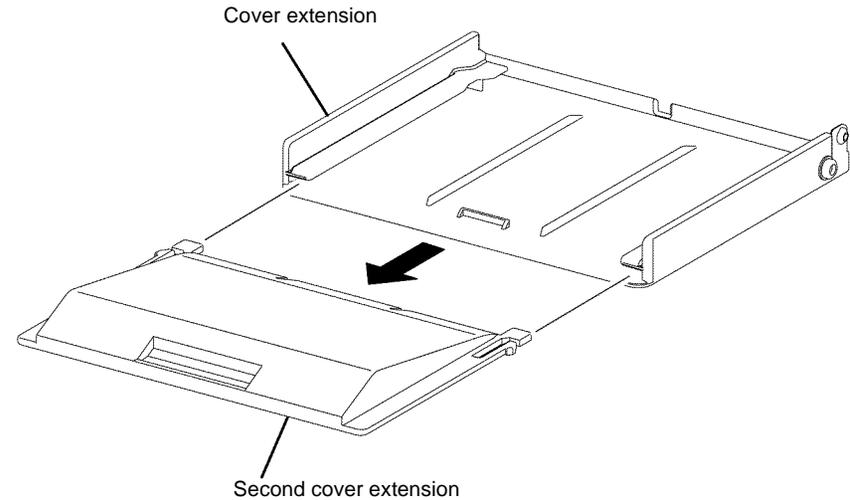
B-1-0237-A

2. Remove the second cover extension from the cover extension by flexing the second cover extension to release one of the bosses from the hole, [Figure 2](#).

Figure 2 Second cover extension removal

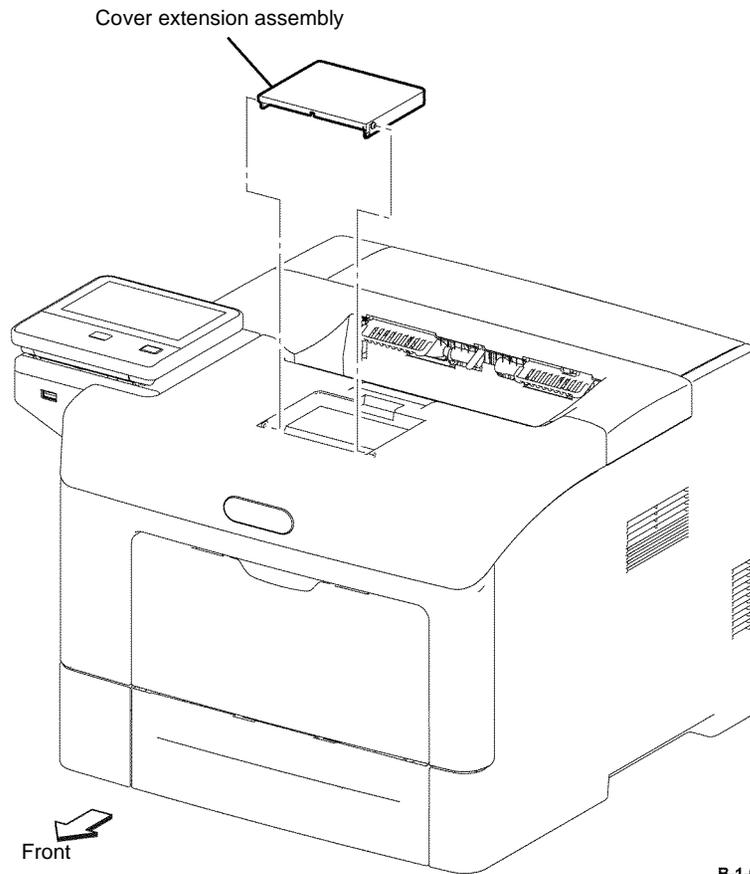
1. Remove the cover extension assembly by flexing it to release one of the bosses from the hole, [Figure 1](#).

Figure 1 Cover extension assembly removal

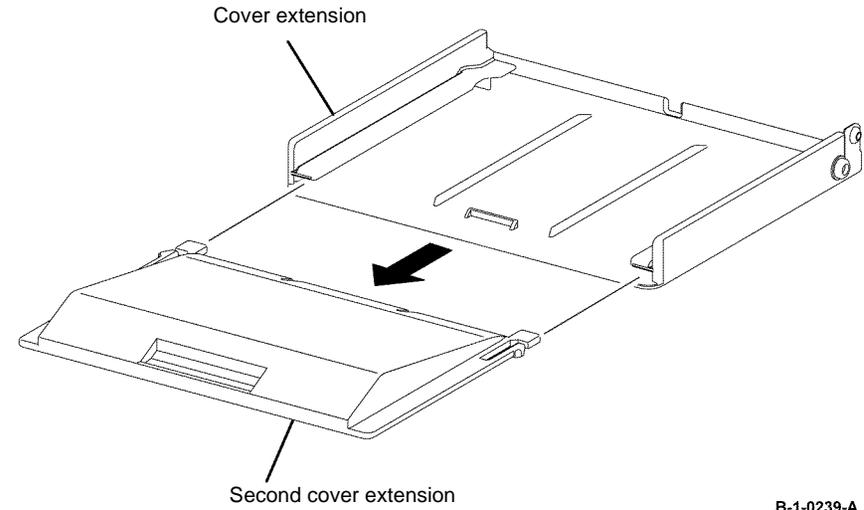
2. Remove the second cover extension from the from the cover extension by flexing the second cover extension to release one of the bosses from the hole, [Figure 2](#).

Figure 2 Second cover extension removal

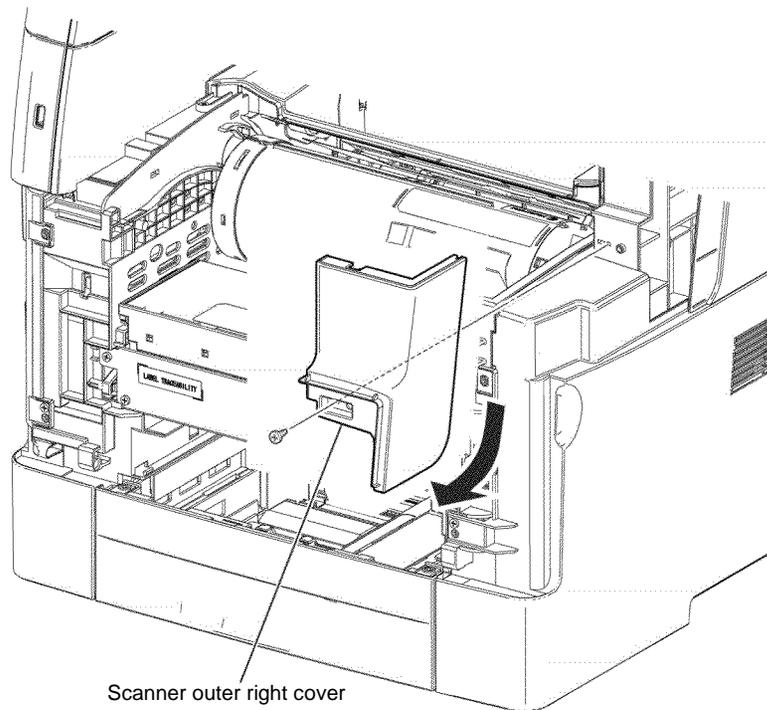
1. Open the MSI cover, [PL 13.2 Item 99](#).
2. Pull out the MSI tray assembly, [PL 13.2 Item 9](#).
3. Remove the front cover assembly, [REP 19.1](#).
4. Remove the rear-cover assembly, [REP 19.13](#).
5. Remove one screw (silver, tapping, 8mm) that fixes the scanner outer right cover. Release one hook, then remove the scanner outer right cover, [Figure 1](#).

Figure 1 Scanner outer right cover removal

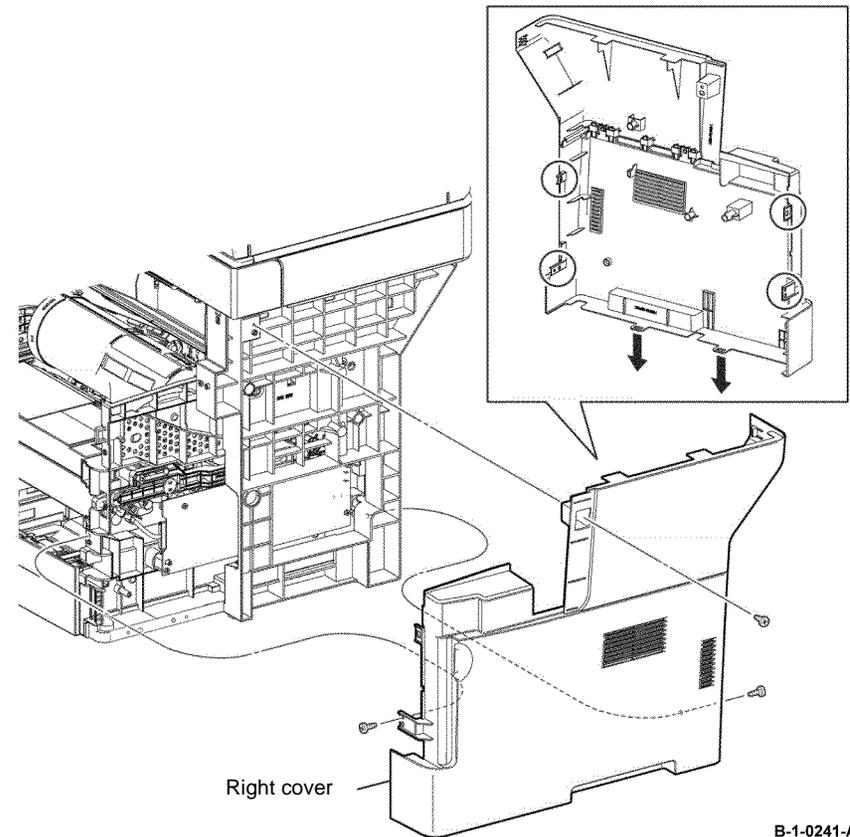
6. Remove three screws (silver, tapping, 8mm) that fix the right cover. Release four holes from the bosses on the frame. Release two hooks, then remove the right cover, [Figure 2](#).

Figure 2 Right cover assembly removal

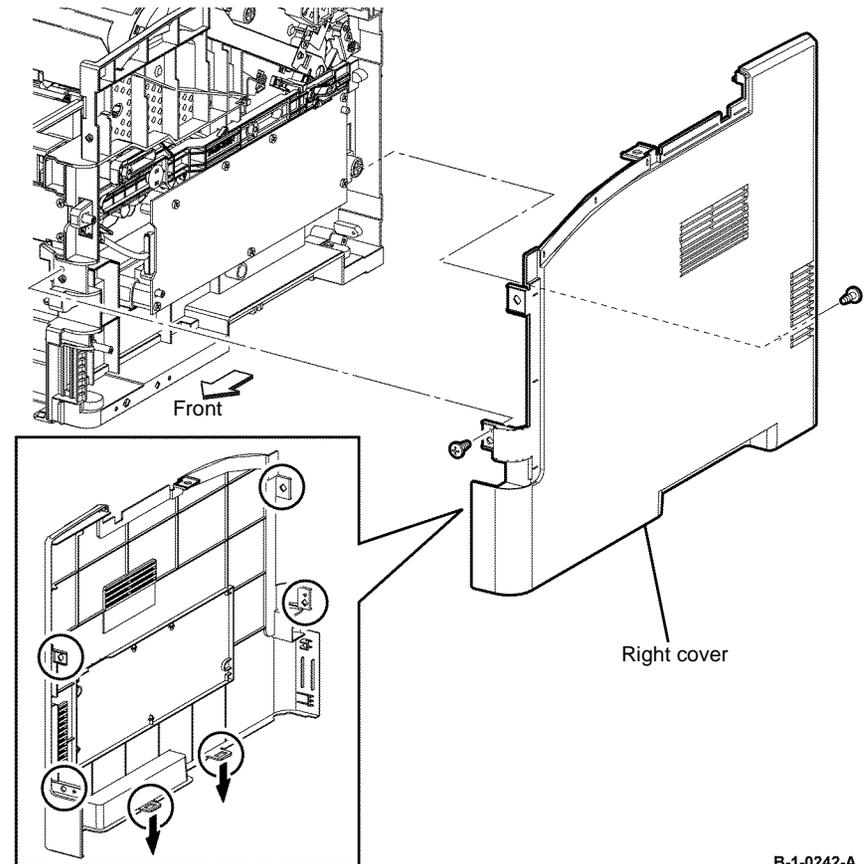
1. Open the MSI cover, [PL 13.2 Item 99](#).
2. Pull out the MSI tray assembly, [PL 13.2 Item 9](#).
3. Remove the front cover assembly, [REP 19.2](#).
4. Remove the rear-cover assembly, [REP 19.14](#).
5. Remove the UI console assembly, [REP 1.3](#).
6. Remove the exit top cover assembly, [REP 19.10](#).
7. Remove two screws (silver, tapping, 8mm) that fixes the right cover, [Figure 1](#).
8. Release four holes on the right cover from the bosses on the printer. Release two hooks, then remove the right cover, [Figure 1](#).

Figure 1 Right cover removal

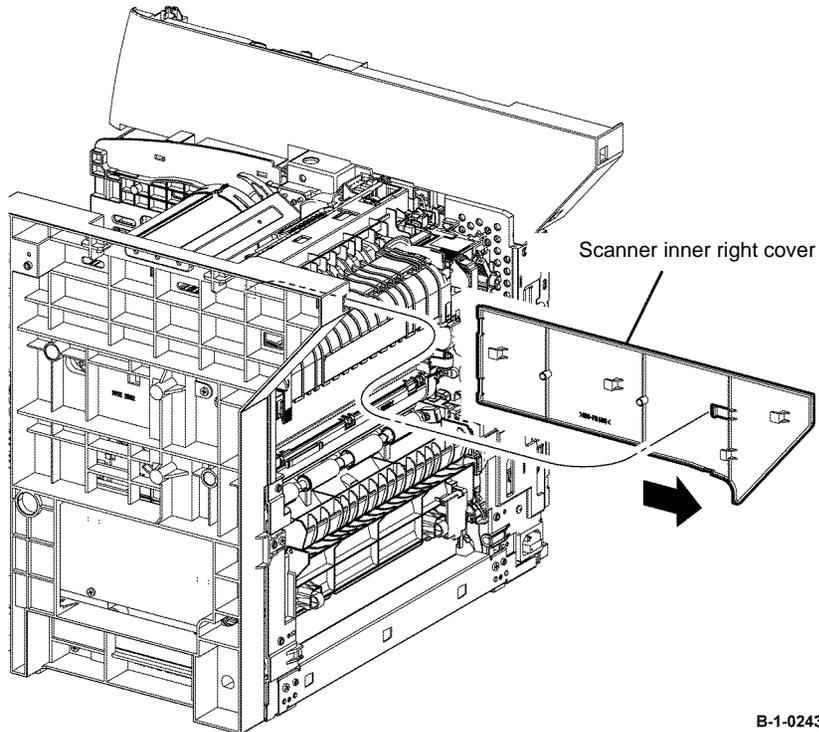
1. Open the MSI cover, [PL 13.2 Item 99](#).
2. Pull out the MSI tray assembly, [PL 13.2 Item 9](#).
3. Remove the front cover assembly, [REP 19.1](#).
4. Remove the rear-cover assembly, [REP 19.13](#).
5. Remove the right cover assembly, [REP 19.7](#).
6. Release the hooks that fix the scanner inner right cover, then slide it out of the printer, [Figure 1](#).

Figure 1 Scanner inner right cover removal

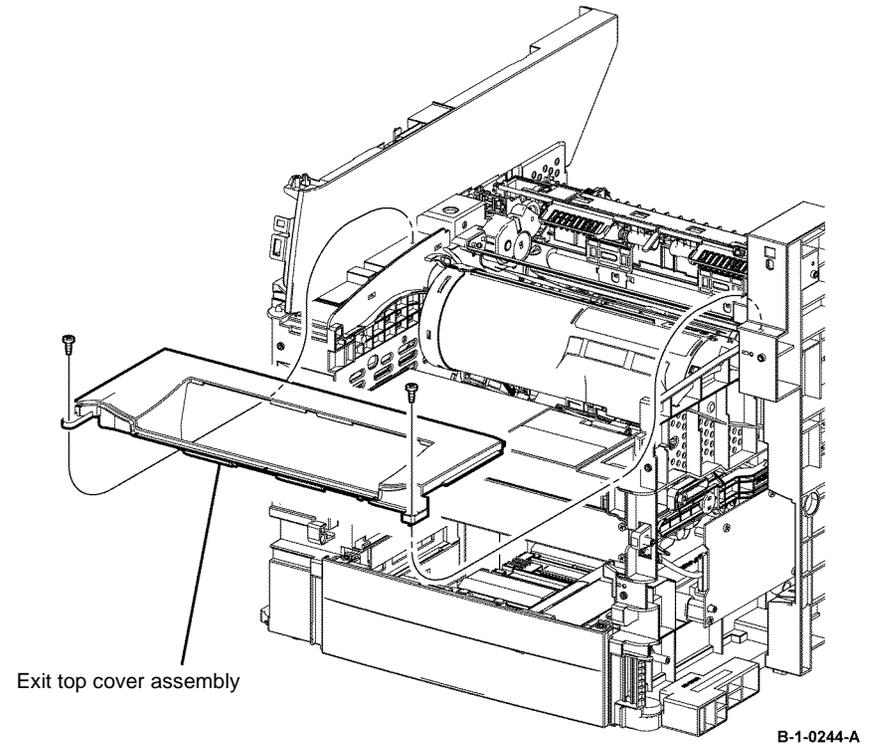
Figure 2 Exit top cover assembly removal

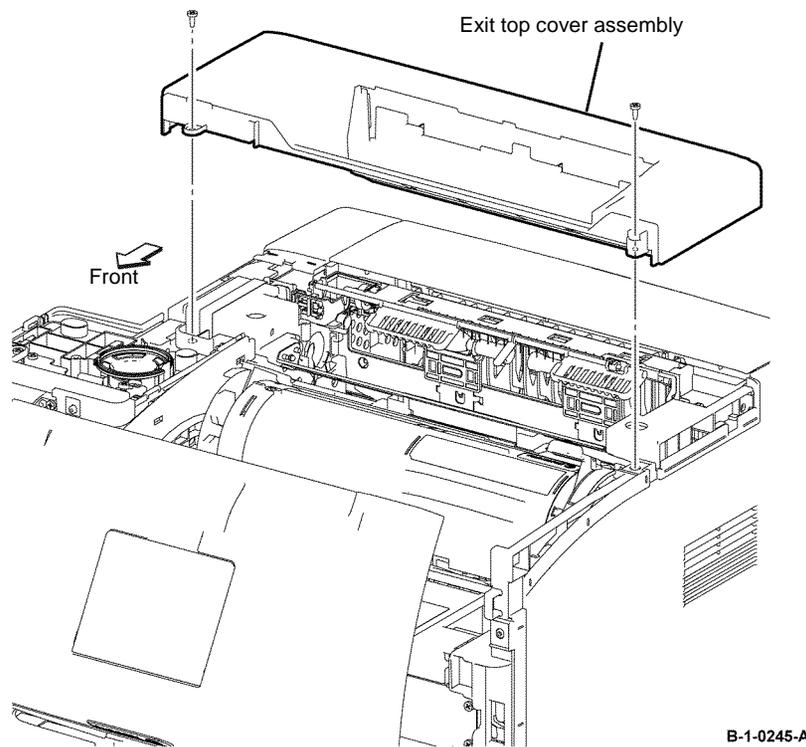
1. Open the MSI cover, [PL 13.2 Item 99](#).
2. Pull out the MSI tray assembly, [PL 13.2 Item 9](#).
3. Remove the front cover assembly, [REP 19.2](#).
4. Remove the rear-cover assembly, [REP 19.14](#).
5. Remove the right cover assembly, [REP 19.8](#).
6. Remove the UI console assembly, [REP 1.3](#).
7. Remove two screws (silver, tapping, 8mm), then remove the exit top cover assembly, [Figure 1](#).

Figure 1 Exit top cover assembly removal

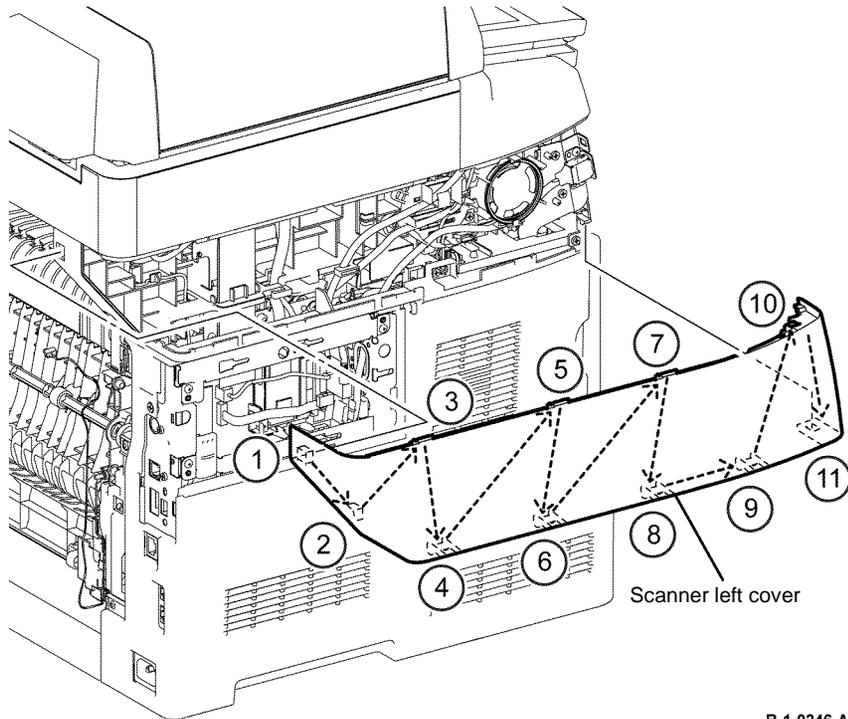
1. Open the MSI cover, PL 13.2 Item 99.
2. Pull out the MSI tray assembly, PL 13.2 Item 9.
3. Remove the front cover assembly, REP 19.1.
4. Remove the rear-cover assembly, REP 19.13.
5. Remove the ESS window cover assembly, REP 19.3.
6. Remove the WIFI cap cover, REP 19.19.
7. Release eleven hooks, then remove the scanner left cover, Figure 1.

Figure 1 Scanner left cover removal

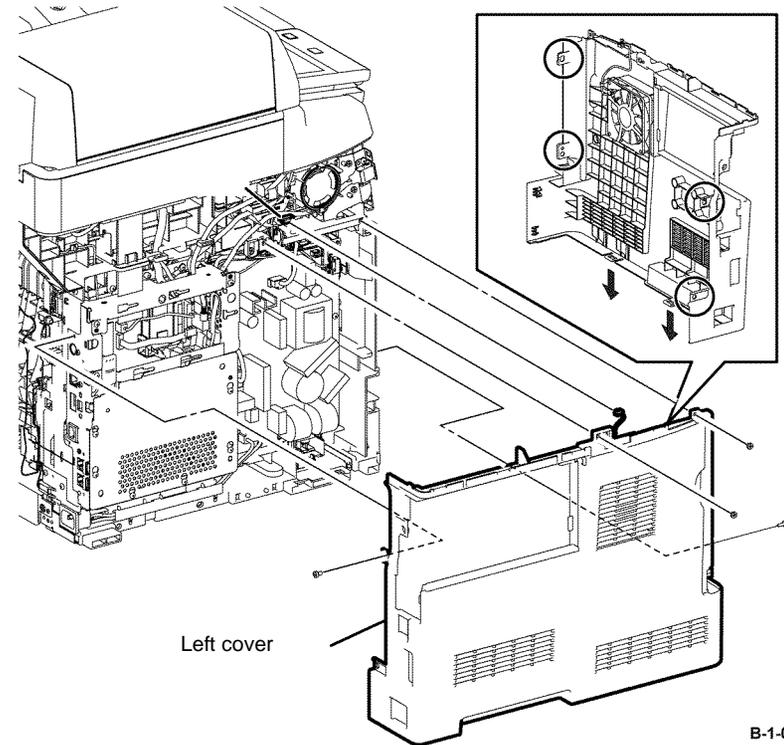
8. Remove five screws (silver, tapping, 8mm), (silver, M4, 6mm) that fix the left cover, Figure 2.

9. Disconnect PJ241 from the LVPS PWB, then release the harness clamp from the printer, Figure 2.

Figure 2 Left cover removal

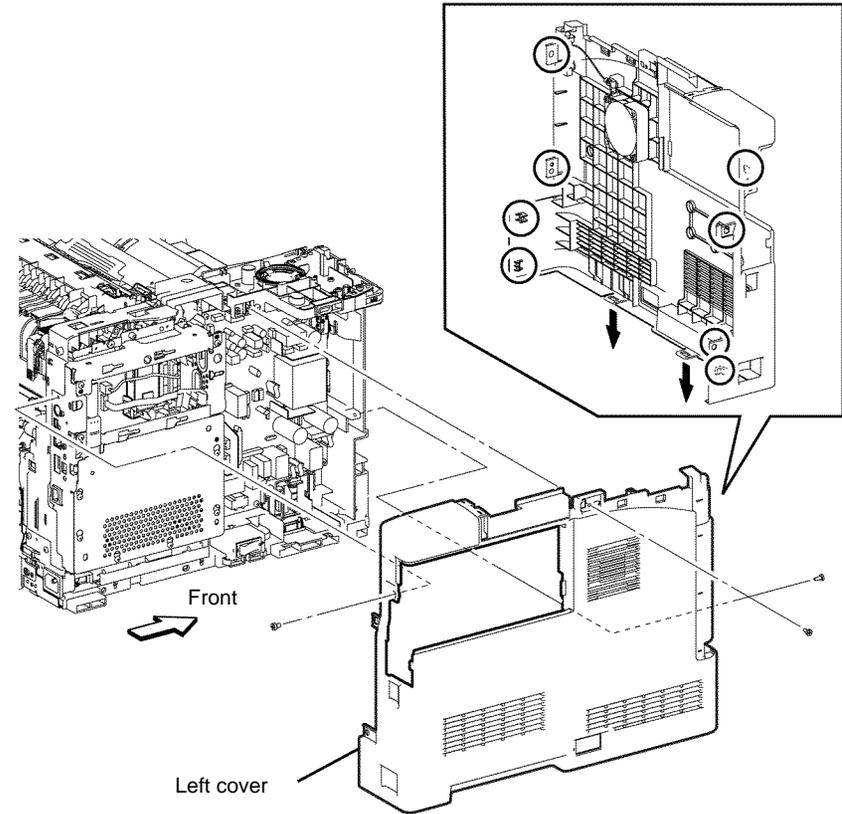
B-1-0248-A

1. Open the MSI cover, [PL 13.2 Item 99](#).
2. Pull out the MSI tray assembly, [PL 13.2 Item 9](#).
3. Remove the front cover assembly, [REP 19.2](#).
4. Remove the rear-cover assembly, [REP 19.14](#).
5. Remove the UI console assembly, [REP 1.3](#).
6. Remove the exit top cover assembly, [REP 19.10](#).
7. Remove the WIFI cap cover, [REP 19.20](#).
8. Remove the ESS window cover assembly, [REP 19.4](#).
9. Remove the front/left UI cover assembly, [REP 1.4](#).
10. Remove two screws (silver, tapping, 8mm) and one screw (silver, M4, 6mm) that fix the left cover. Release four holes from the bosses on the frame. Release two hooks, then remove the left cover, [Figure 1](#).
11. Disconnect PJ241 from the LVPS PWB, then release the harness clamp from the printer, [Figure 1](#).

Figure 1 Left cover removal

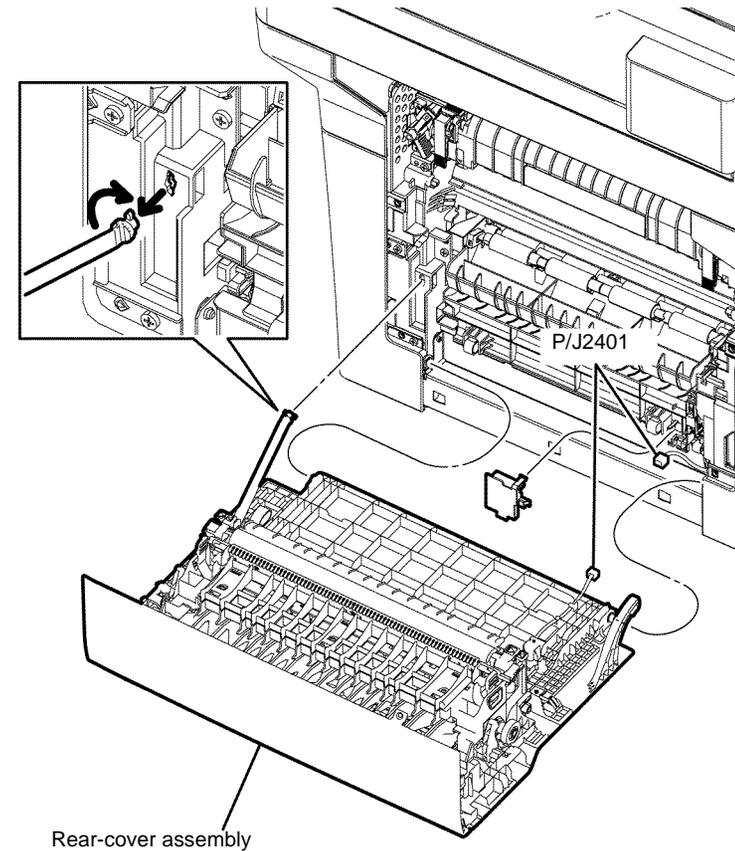
B-1-0249-A

1. Open the rear-cover, [PL 19.2B Item 10](#).
2. Release the one hook on the top-right corner that holds the connector cover, then remove the connector cover, [Figure 1](#).
3. Disconnect P/J2401 from the rear-cover assembly, [Figure 1](#).
4. Remove the stopper that fixes the rear-cover assembly, by rotating the stopper in the direction of the arrow, [Figure 1](#).
5. Release the hook on the rear-cover assembly. Release one of the bosses from the hole on the printer, remove the DTS out earth spring, then remove the rear-cover assembly, [Figure 1](#).

Figure 1 Rear-Cover Assembly Removal

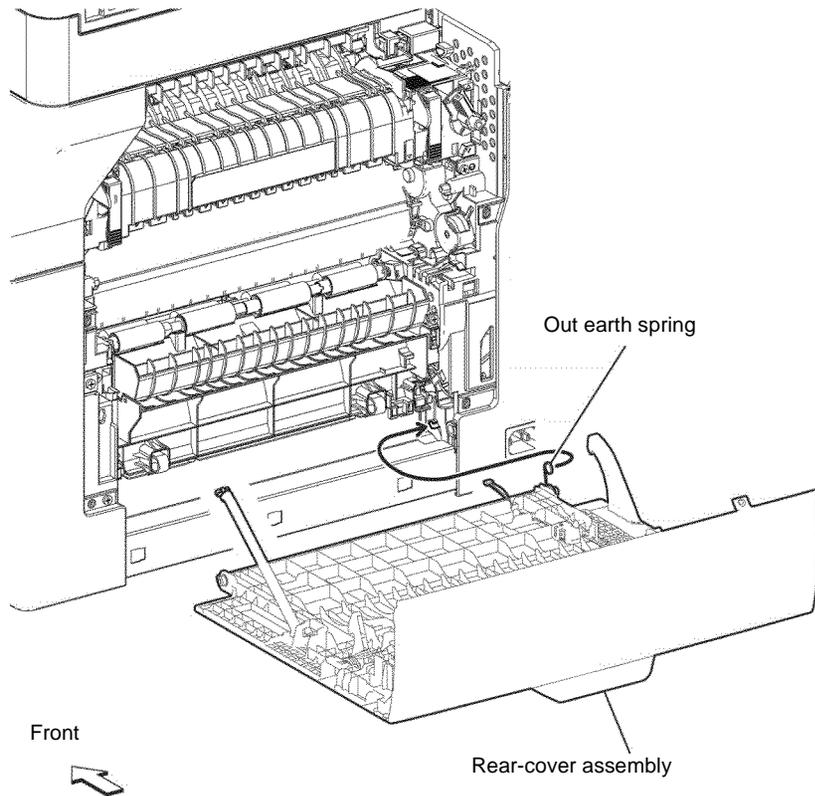
B-1-0250-A

Figure 2 Rear-Cover Assembly Installation

1. The replacement is the reverse of the removal procedure.
2. When installing the rear-cover assembly, ensure that DTS out earth spring is set in the hook of the printer, [Figure 2](#).

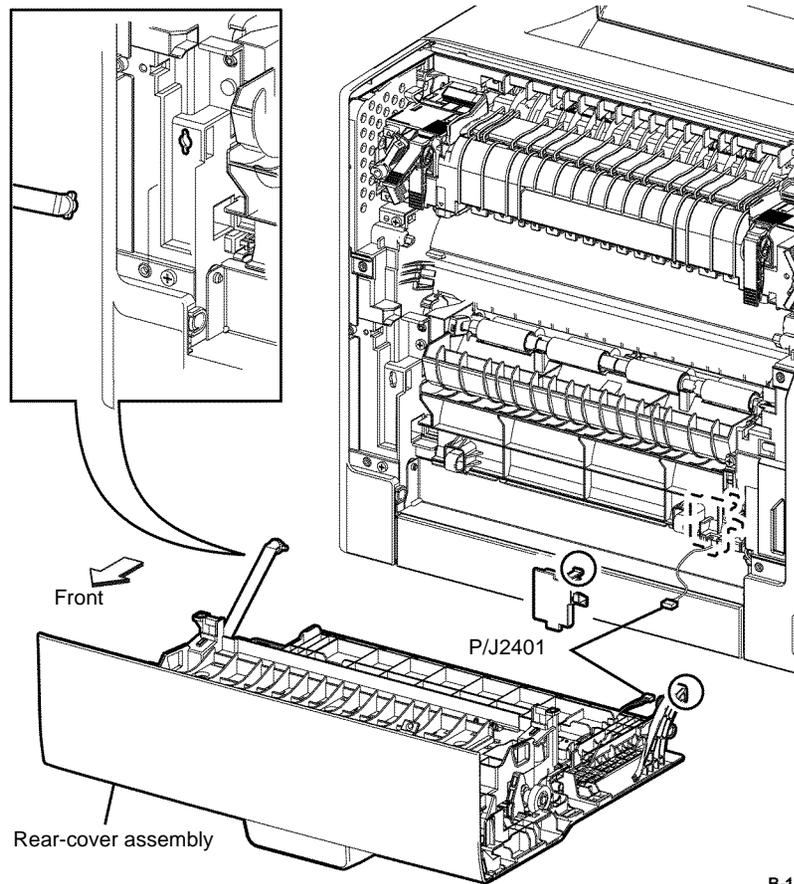
B-1-0251-A

1. Open the rear-cover, [PL 19.2A Item 10](#).
2. Release the one hook on the top-right holds the connector cover, then remove the connector cover, [Figure 1](#).
3. Disconnect P/J2401 from the rear-cover assembly, [Figure 1](#).
4. Remove the stopper that fixes the rear-cover assembly, by rotating the stopper in the direction of the arrow, [Figure 1](#).
5. Release the hook on the rear-cover assembly by releasing one of the bosses from the hole on the printer. Remove the DTS out earth spring, while removing the rear-cover assembly, [Figure 1](#).

Figure 1 Rear-Cover Assembly Removal

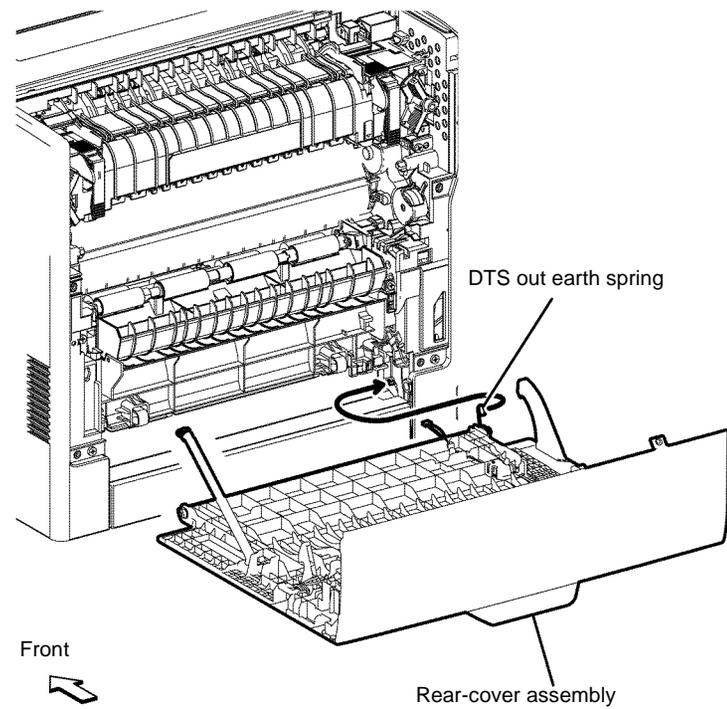
B-1-0252-A

1. The replacement is the reverse of the removal procedure.
2. When installing the rear-cover assembly, ensure that DTS out earth spring is set in the hook of the printer, [Figure 2](#).

Figure 2 Rear-Cover Assembly Installation
