# Xerox® VersaLink® B400 & B405 Family Multifunction Printer Service Manual

VersaLink B400 and B405 Family Multifunction Printer Service Manual

708P91373

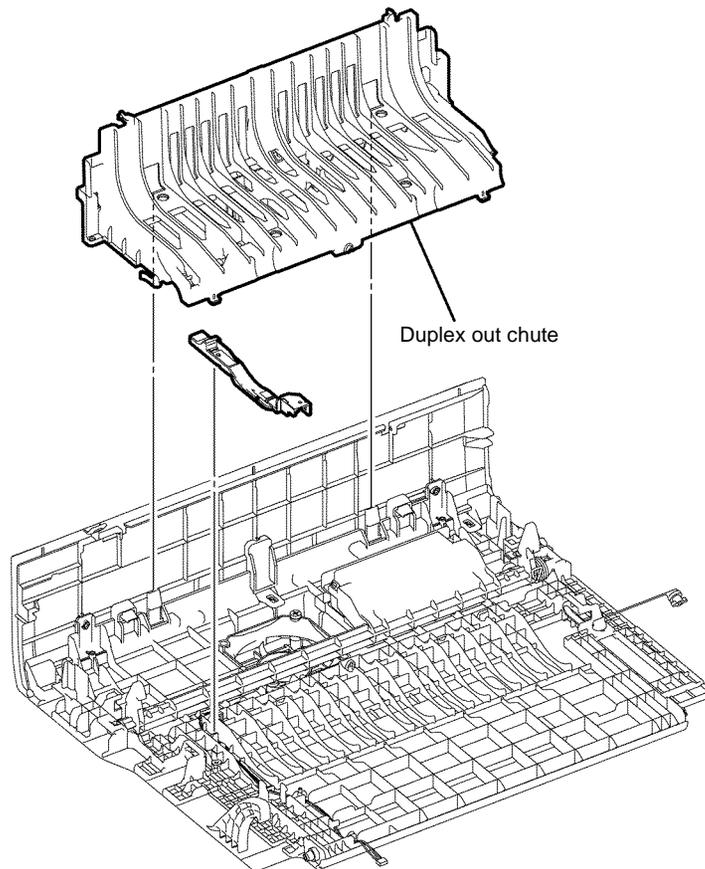
B-1-0253-A

1. Remove the rear-cover assembly, [REP 19.13](#).
2. Remove the transfer roll assembly, [REP 6.1](#).
3. Remove the duplex chute assembly, [REP 14.1](#).
4. Release two hooks, then remove the harness guide, [Figure 1](#).
5. Release the two hooks that fix the duplex out chute. Release the four bosses from the holes, then remove the duplex out chute, [Figure 1](#).

Figure 1 Duplex out chute removal

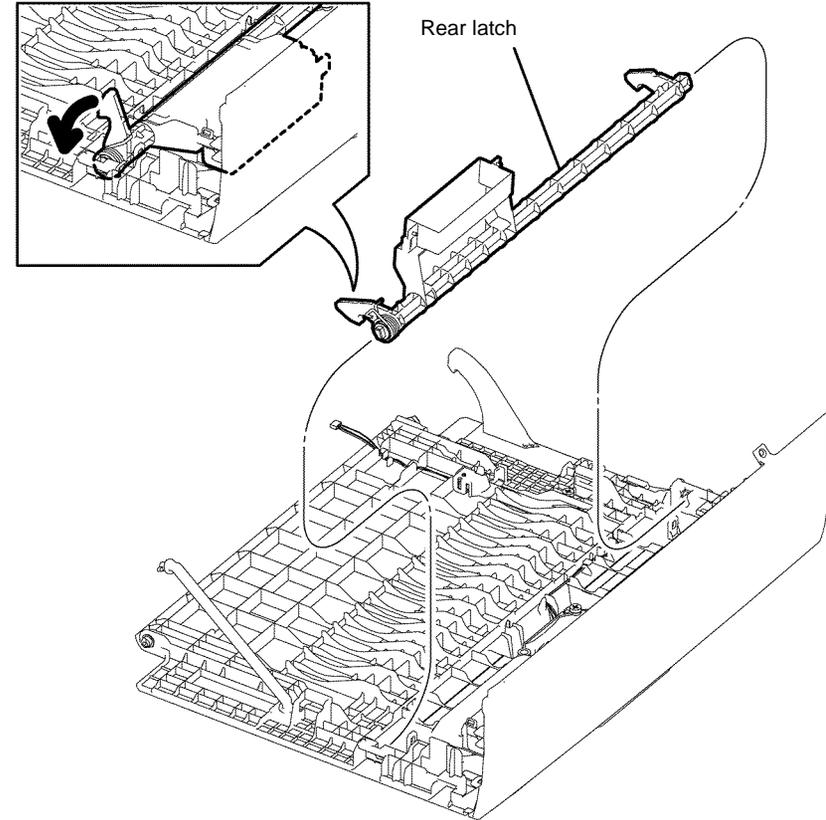
B-1-0254-A

6. Release the rear latch in the arrowed direction to release the two hooks, then remove the rear latch, [Figure 2](#).

Figure 2 Rear latch removal

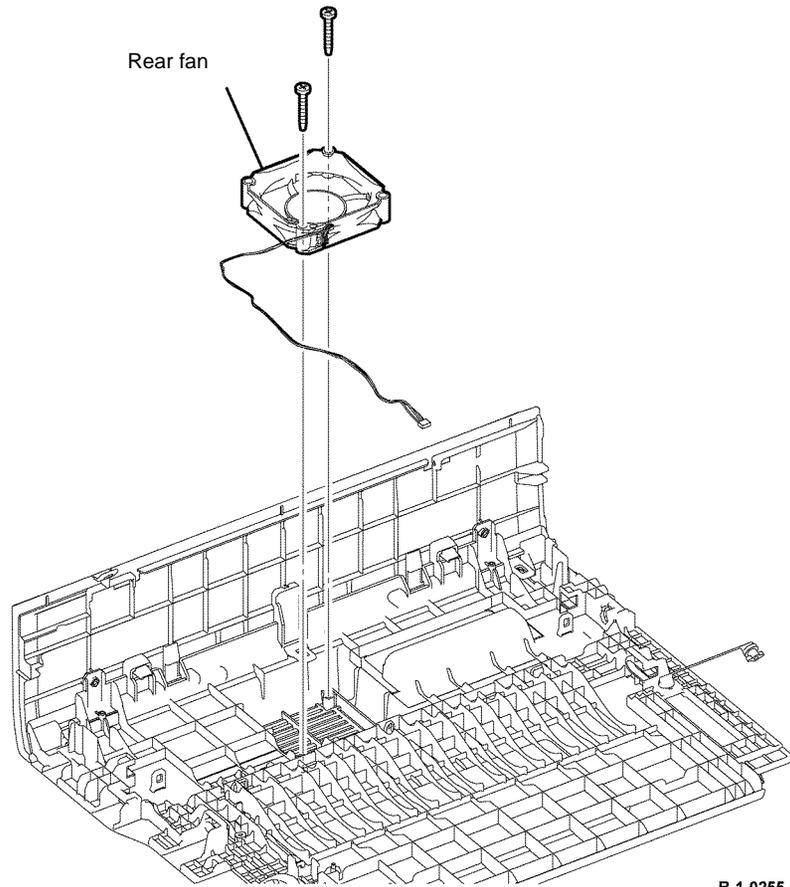
Figure 3 Rear fan removal

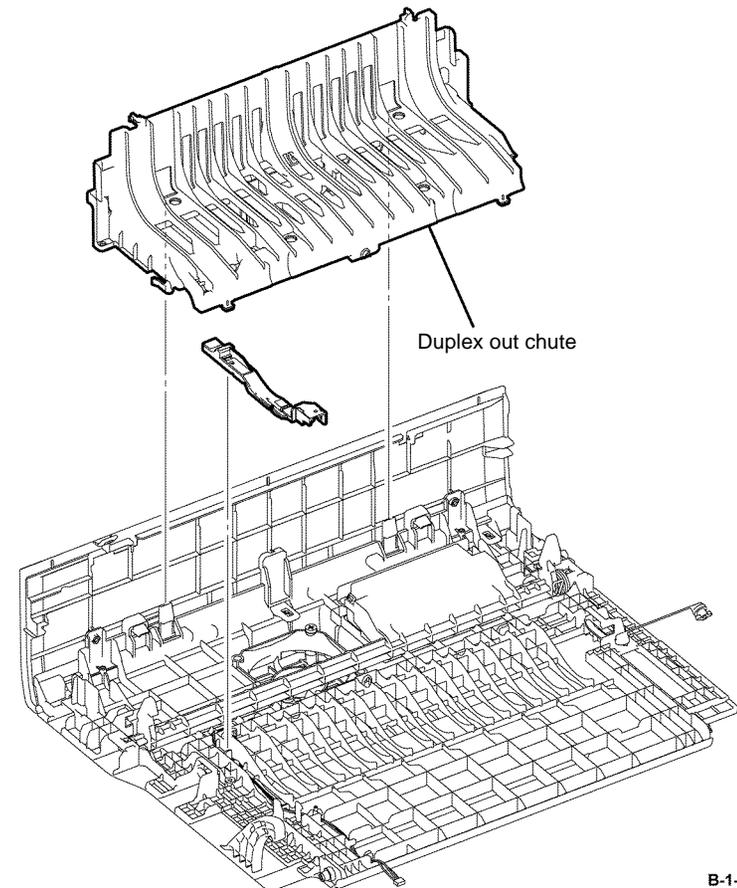
1. Remove the rear-cover assembly, [REP 19.14](#).
2. Remove the transfer roll assembly, [REP 6.2](#).
3. Remove the duplex chute assembly, [REP 14.2](#).
4. Release two hooks, then remove the harness guide, [Figure 1](#).
5. Release the two hooks that fix the duplex out chute. Release the four bosses from the holes, then remove the duplex out chute, [Figure 1](#).

Figure 1 Duplex out chute removal

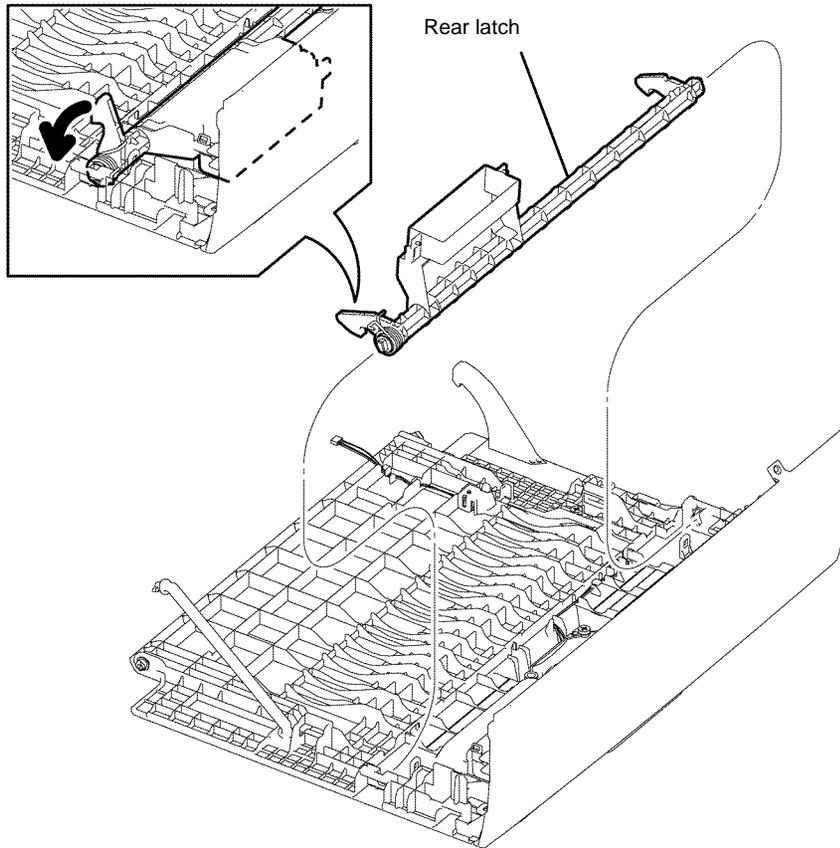
B-1-0257-A

6. Release the rear latch in the arrowed direction to release the two hooks, then remove the rear latch, [Figure 2](#).

**Figure 2** Rear latch removal

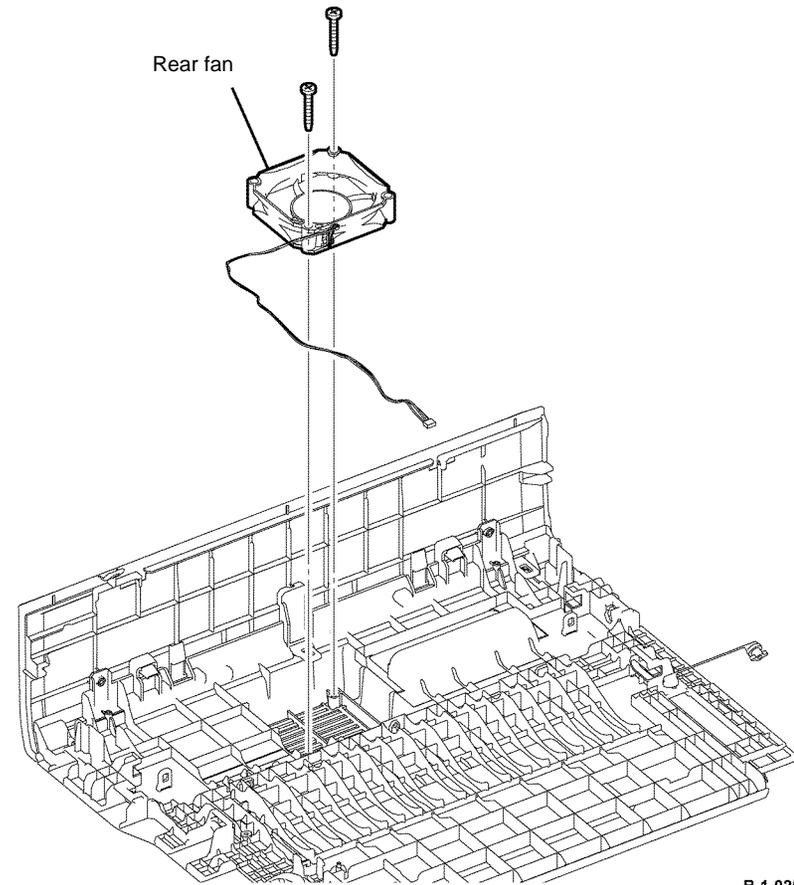
B-1-0258-A

7. Remove two screws (silver, tapping, 22mm) that fix the rear fan. Release the harness from the harness guide, then remove the rear fan, [Figure 3](#).

**Figure 3** Rear fan removal

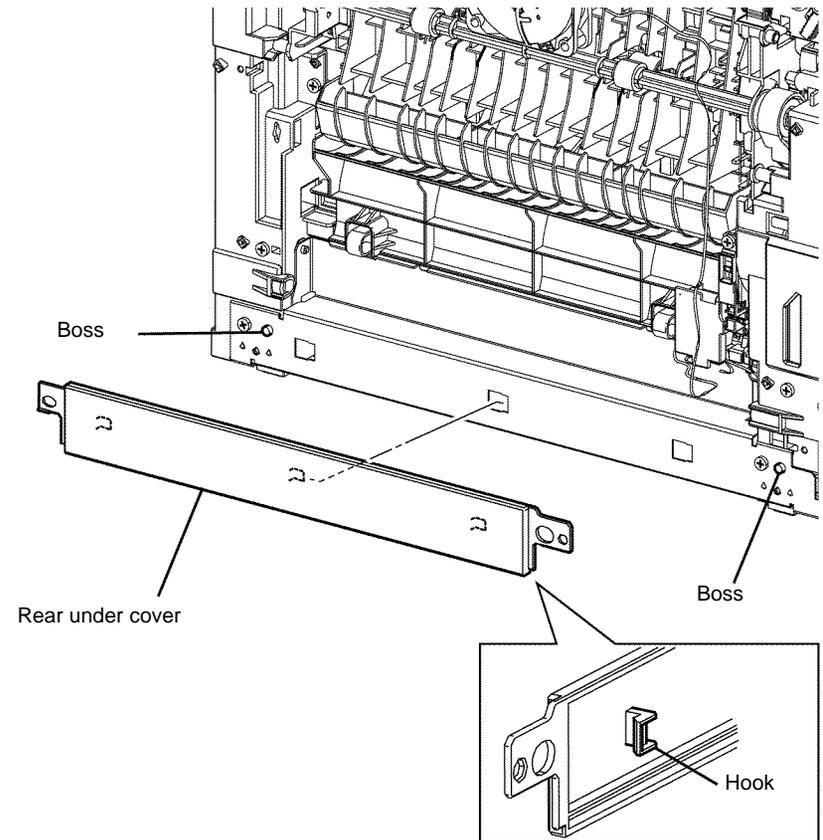
B-1-0259-A

1. Open the MSI cover, [PL 13.2 Item 99](#).
2. Pull out the MSI tray assembly, [PL 13.2 Item 9](#).
3. Remove the front cover assembly, [REP 19.1](#).
4. Remove the rear-cover assembly, [REP 19.13](#).
5. Remove the ESS window cover assembly, [REP 19.3](#).
6. Remove the WIFI cap cover, [REP 19.19](#).
7. Remove the left cover, [REP 19.11](#).
8. Release two holes on the rear under cover from the bosses on the printer, [Figure 1](#).
9. Remove the rear under cover by sliding it to the left to disengage three hooks, [Figure 1](#).

Figure 1 Rear under cover removal

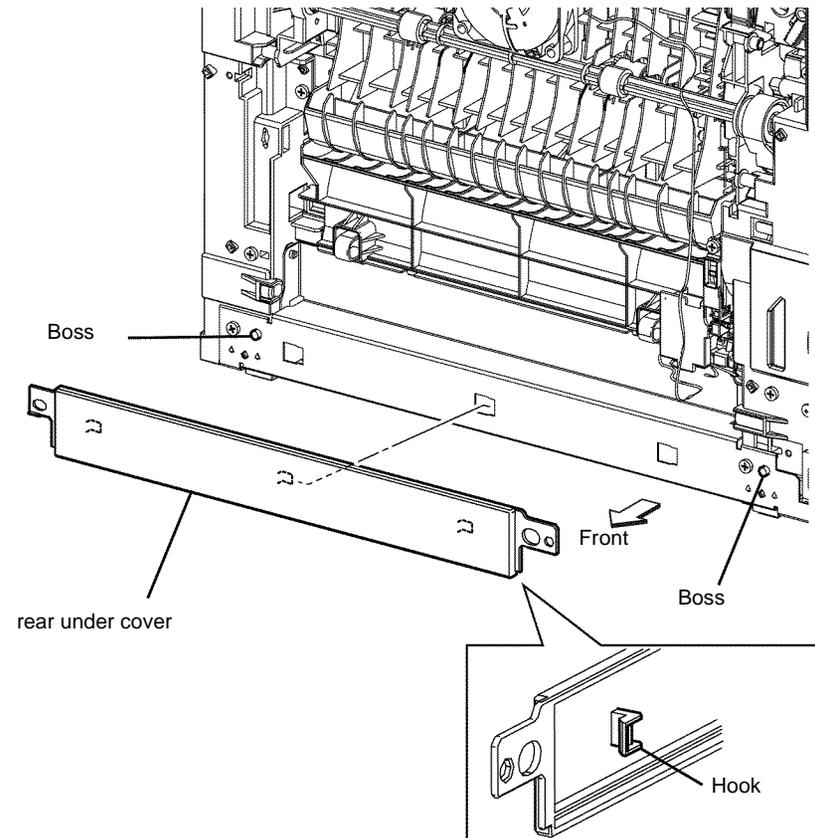
B-1-0260-A

1. Open the MSI cover, [PL 13.2 Item 99](#).
2. Pull out the MSI tray assembly, [PL 13.2 Item 9](#).
3. Remove the front cover assembly, [REP 19.2](#).
4. Remove the rear-cover assembly, [REP 19.14](#).
5. Remove the UI console assembly, [REP 1.3](#).
6. Remove the exit top cover assembly, [REP 19.10](#).
7. Remove the Right Cover, [REP 19.8](#).
8. Remove the WIFI cap cover, [REP 19.20](#).
9. Remove the ESS window cover assembly, [REP 19.4](#).
10. Remove the front/left UI cover assembly, [REP 1.4](#).
11. Remove the left cover, [REP 19.12](#).
12. Release two holes on the rear under cover from the bosses on the printer, [Figure 1](#).
13. Remove the rear under cover by sliding it to the left to disengage three hooks, [Figure 1](#).

Figure 1 Rear under cover removal

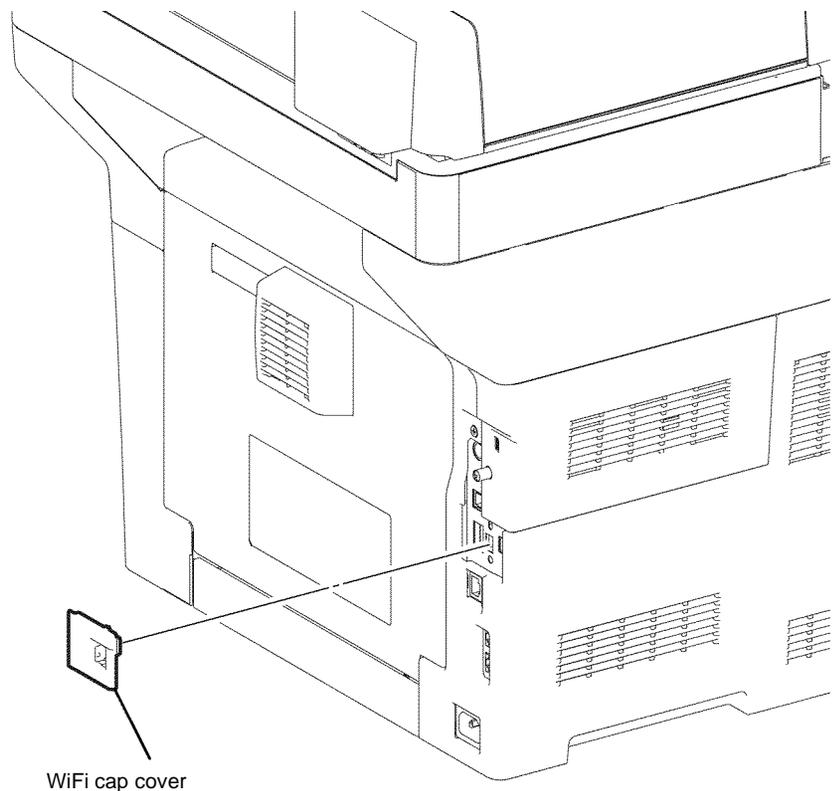
1. Push the lever and remove the WiFi cap cover, [Figure 1](#).

WiFi cap cover

Figure 1 WiFi cap cover removal

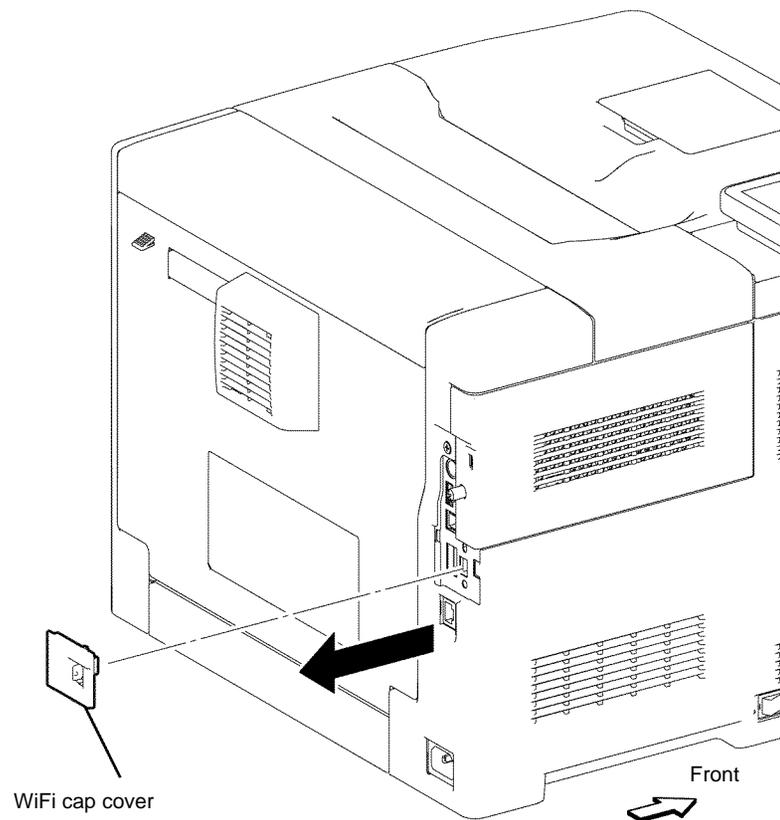
1. Push the lever and remove the WiFi cap cover, [Figure 1](#).

WiFi cap cover

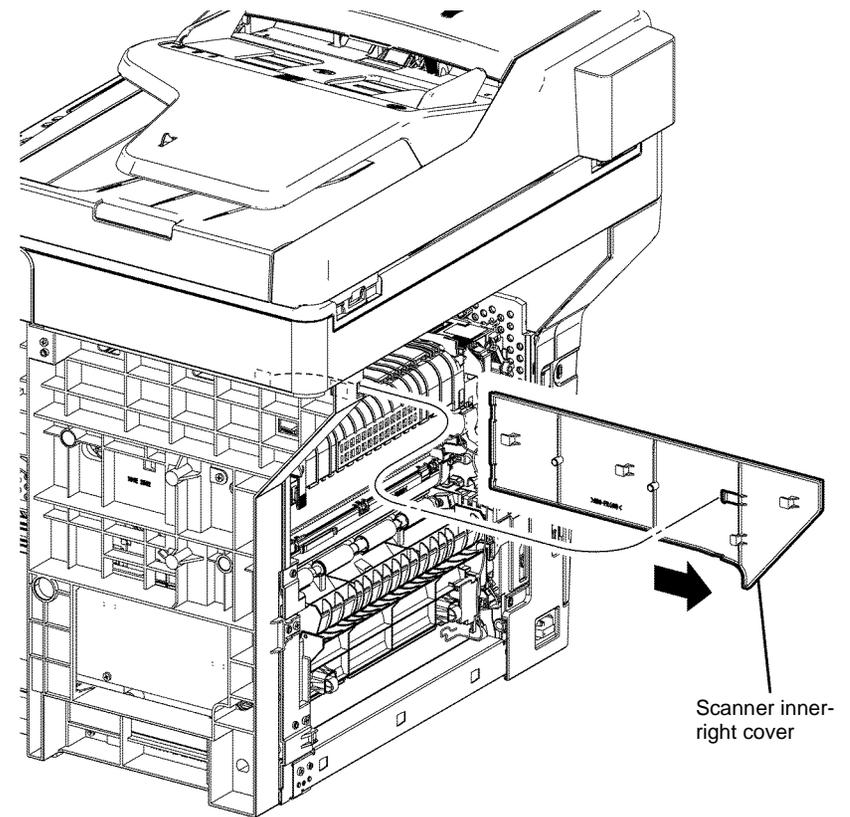
B-1-0263-A

1. Open the MSI cover, [PL 13.2 Item 99](#).
2. Pull out the MSI tray assembly, [PL 13.2 Item 9](#).
3. Remove the rear-cover assembly, [REP 19.13](#).
4. Remove the ESS window-cover assembly, [REP 19.3](#).
5. Remove the WIFI cap cover, [REP 19.19](#).
6. Remove the left cover, [REP 19.11](#).
7. Remove the right cover, [REP 19.7](#).
8. Remove the UI access door, UI console assembly, ICCR cover, UI top cover, IIT front top cover, and IIT left cover, [REP 1.1](#).
9. Remove the UI harness assembly, UI speaker, and UI bottom, [REP 1.2](#).
10. Release the hooks that holds the scanner inner-right cover, then slide it out of the printer, [Figure 1](#).

Figure 1 IIT in Right Cover Removal

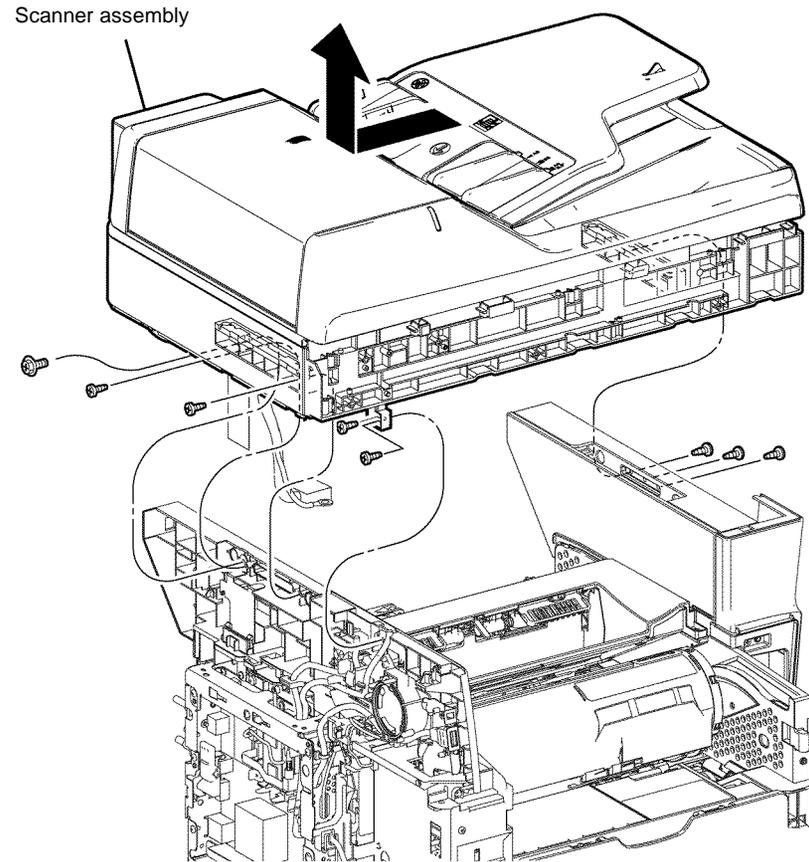
14. Remove the screw (silver, hexagon head with flange, M4, 8 mm), two screws (silver, tapping, 10 mm), two screws (silver, tapping, 8 mm) on the left, and the three screws (silver, tapping, 10 mm) on the right that fix the scanner assembly. Release four bosses on the scanner assembly from the holes, then remove the scanner assembly, [Figure 3](#).

Figure 3 Scanner assembly removal

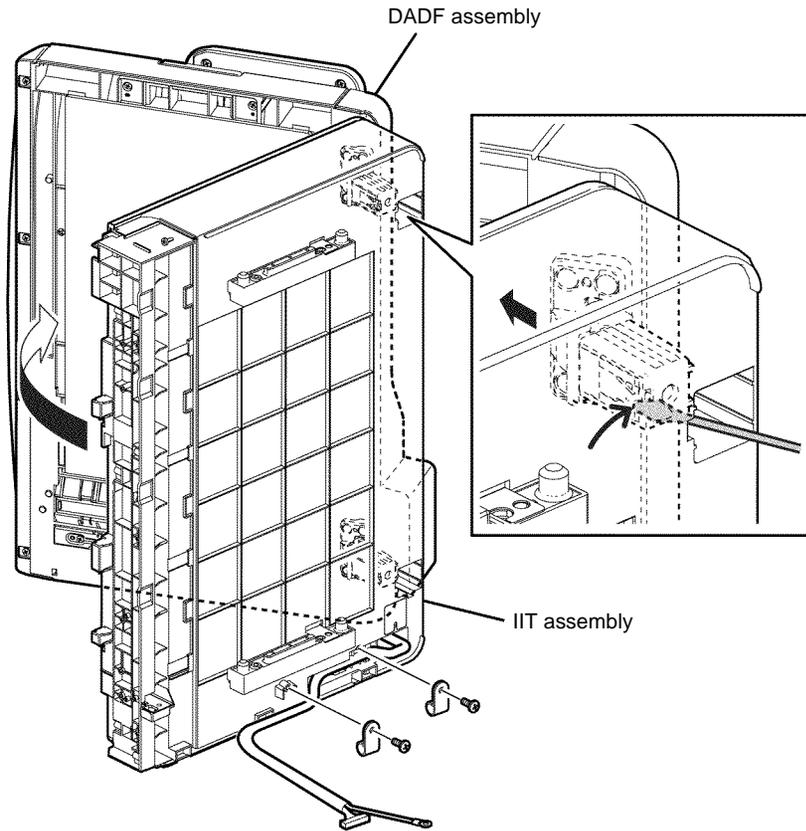
B-1-0266-A

Figure 4 DADF, IIT assembly separation

15. Remove one screw (silver, tapping, 8 mm) from the harness clamps, then pull the harness out of the hole in the scanner assembly, [Figure 4](#).
16. Release the latch of the right hinge assembly, then separate the DADF assembly from the IIT assembly, [Figure 4](#).

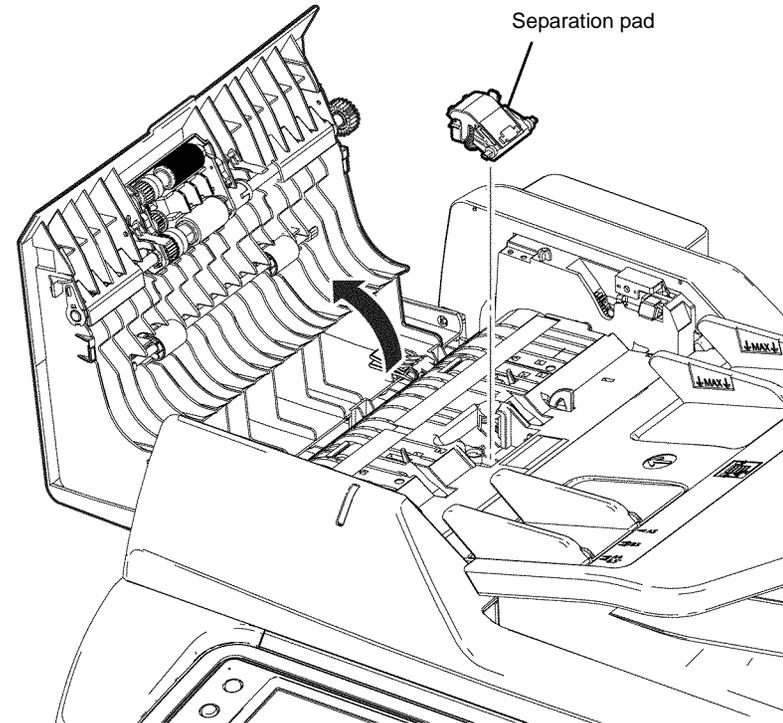
Figure 1 Separation pad removal

1. Open the DADF top cover, [PL 21.1 Item 2](#).
2. Release two hooks, then remove the separation pad, [Figure 1](#).

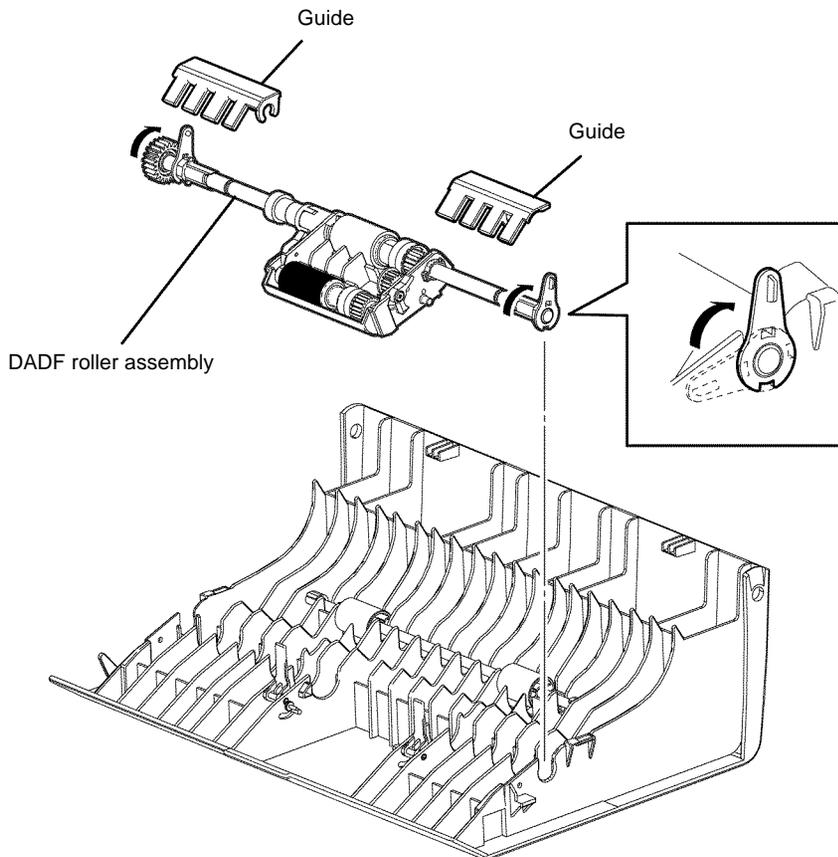
Figure 1 DADF feed roller assembly removal

1. Open the DADF top cover, [PL 21.1 Item 2](#).
2. Release two lock levers, then remove the DADF roller assembly, [Figure 1](#).

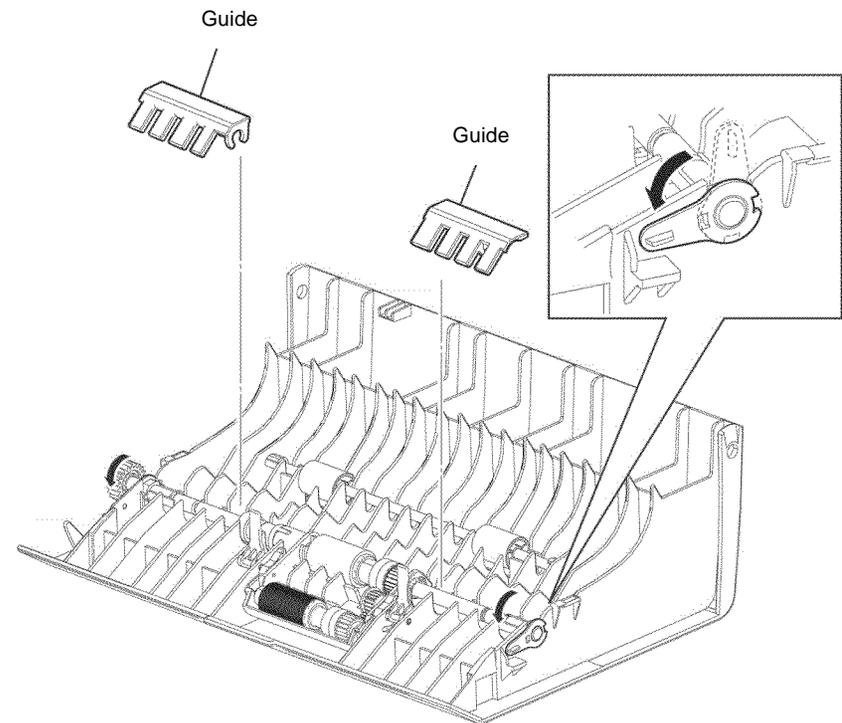
Figure 2 DADF feed roller assembly installation

1. The replacement is the reverse of the removal procedure.
2. Set the boss of the DADF roller assembly into the hole of the DADF top cover, [Figure 2](#).

3. Position the two guides on the DADF roller assembly, [Figure 2](#).

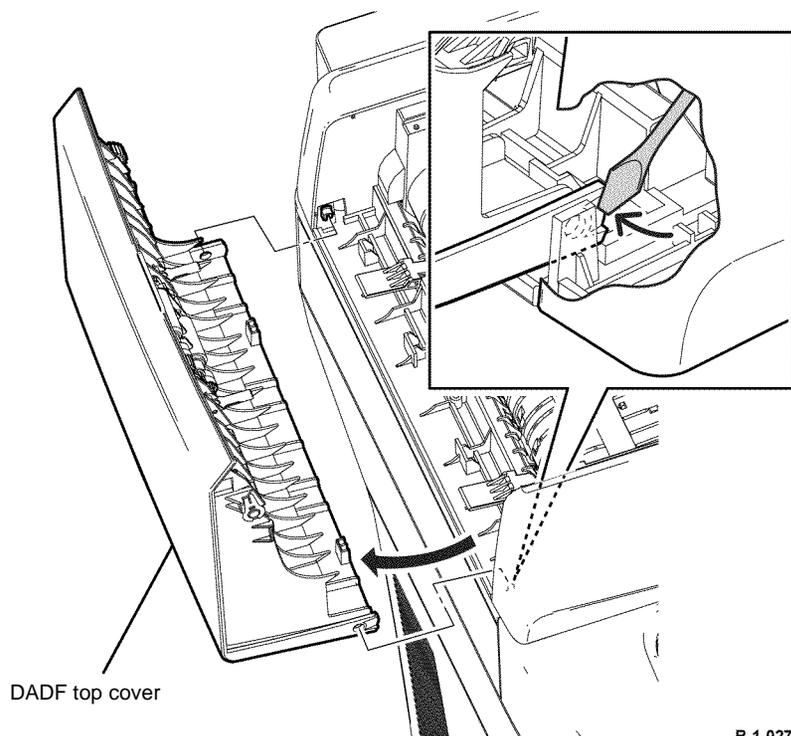
Figure 1 DADF top cover removal

1. Open the DADF top cover, [PL 21.1 Item 2](#).
2. Release the cover from the front stud, then remove the DADF top cover, [Figure 1](#).

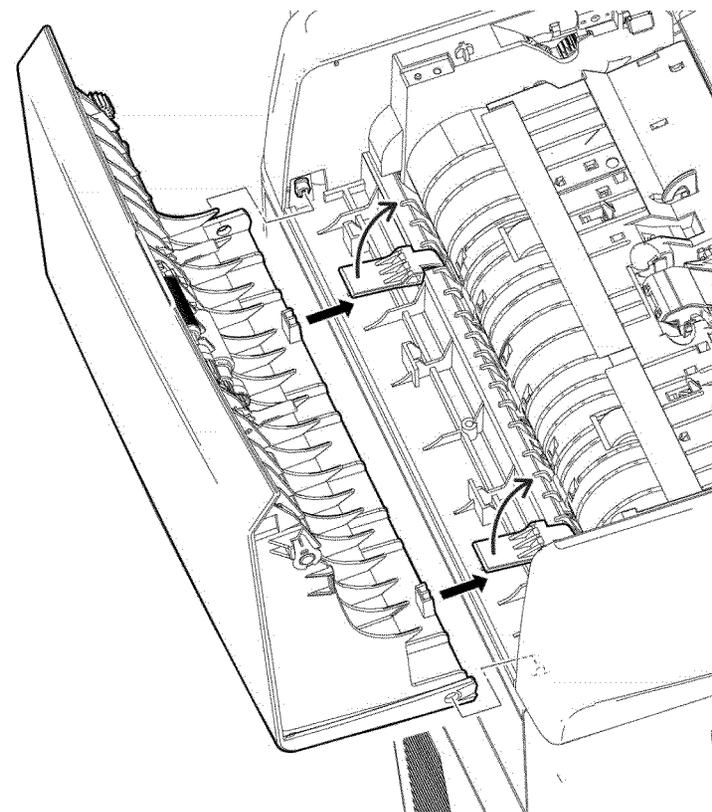
Figure 2 DADF top cover installation

1. The replacement is the reverse of the removal procedure.
2. When installing the DADF top cover, ensure the DADF top cover is positioned under the two black tabs, [Figure 2](#).

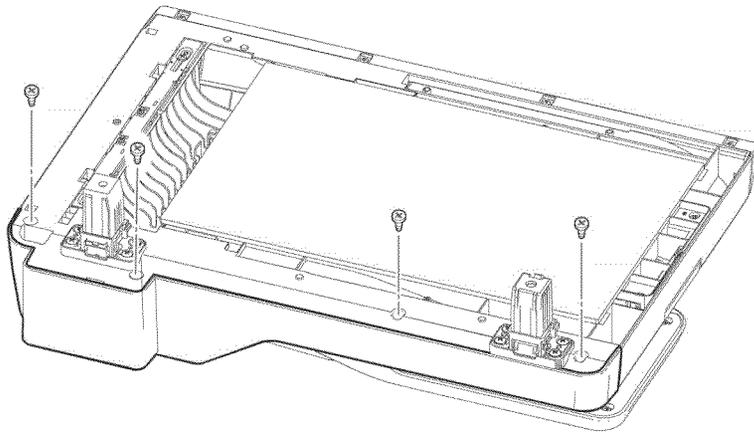
Figure 1 DADF rear-cover screw removal

1. Remove the scanner assembly, [REP 21.1](#).
2. Remove four screws (silver, tapping, 8mm), from the DADF assembly, [Figure 1](#).

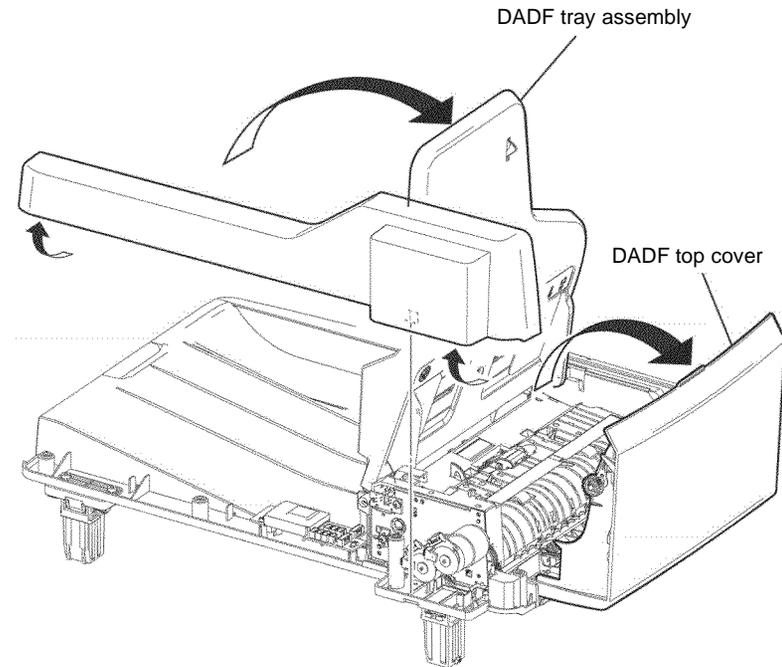
Figure 2 DADF rear-cover removal

3. Open the DADF top cover and DADF tray assembly, then remove the DADF rear-cover, [Figure 2](#).

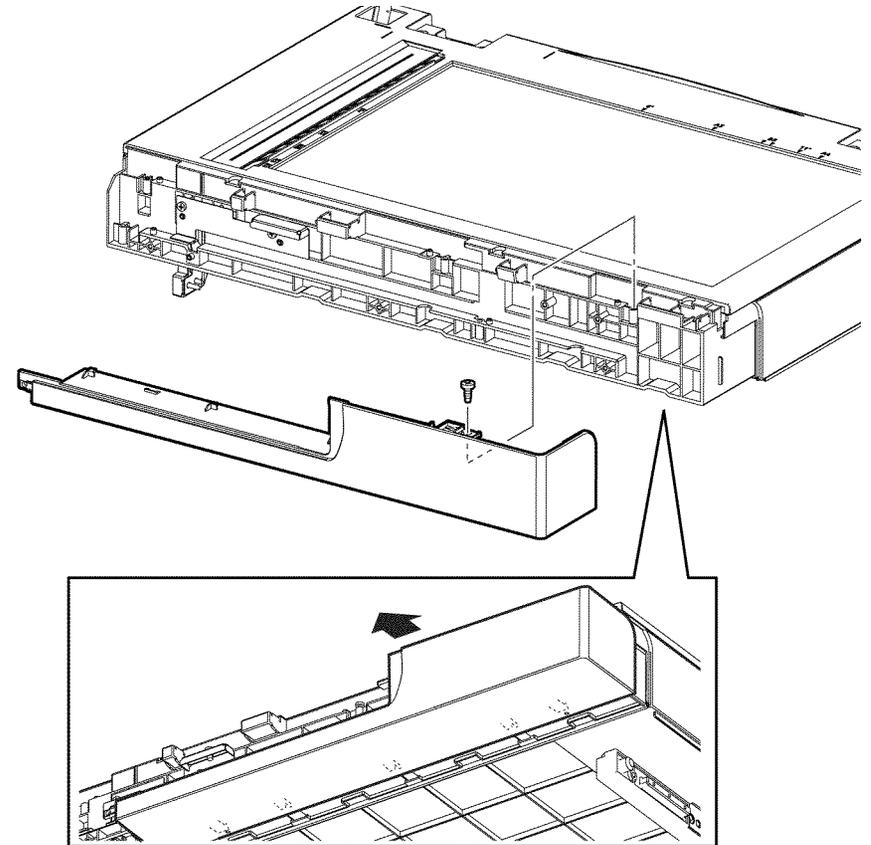
Figure 1 Scanner front bottom cover removal

1. Remove the scanner assembly, [REP 21.1](#).
2. Remove one screw (silver, tapping, 8mm), then remove the scanner front bottom cover, [Figure 1](#).

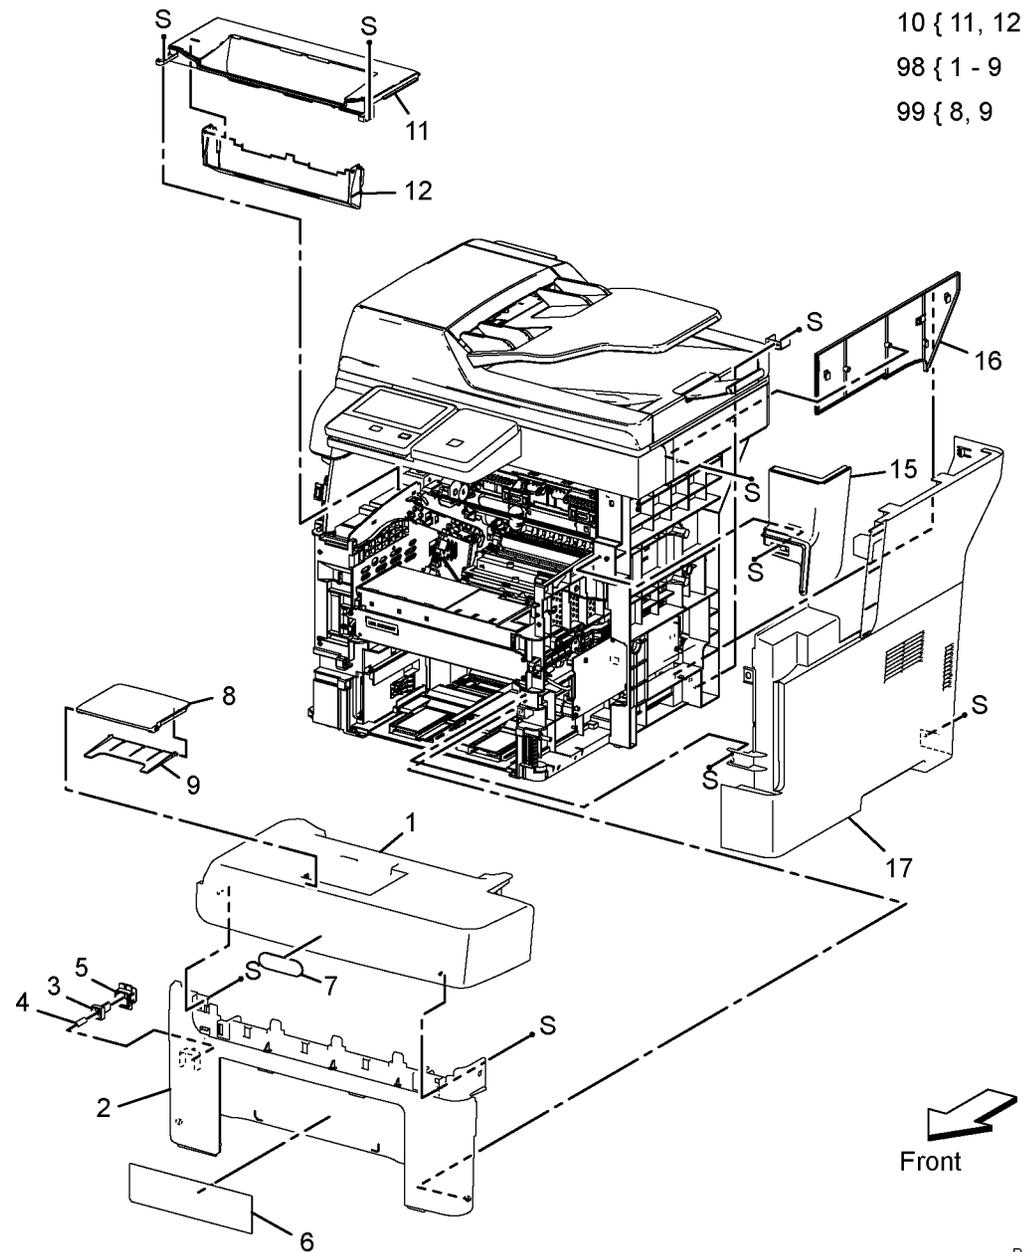
B-8-0029-A

## PL 19.1B Cover (1 of 3) - B405

10 { 11, 12  
 98 { 1 - 9  
 99 { 8, 9

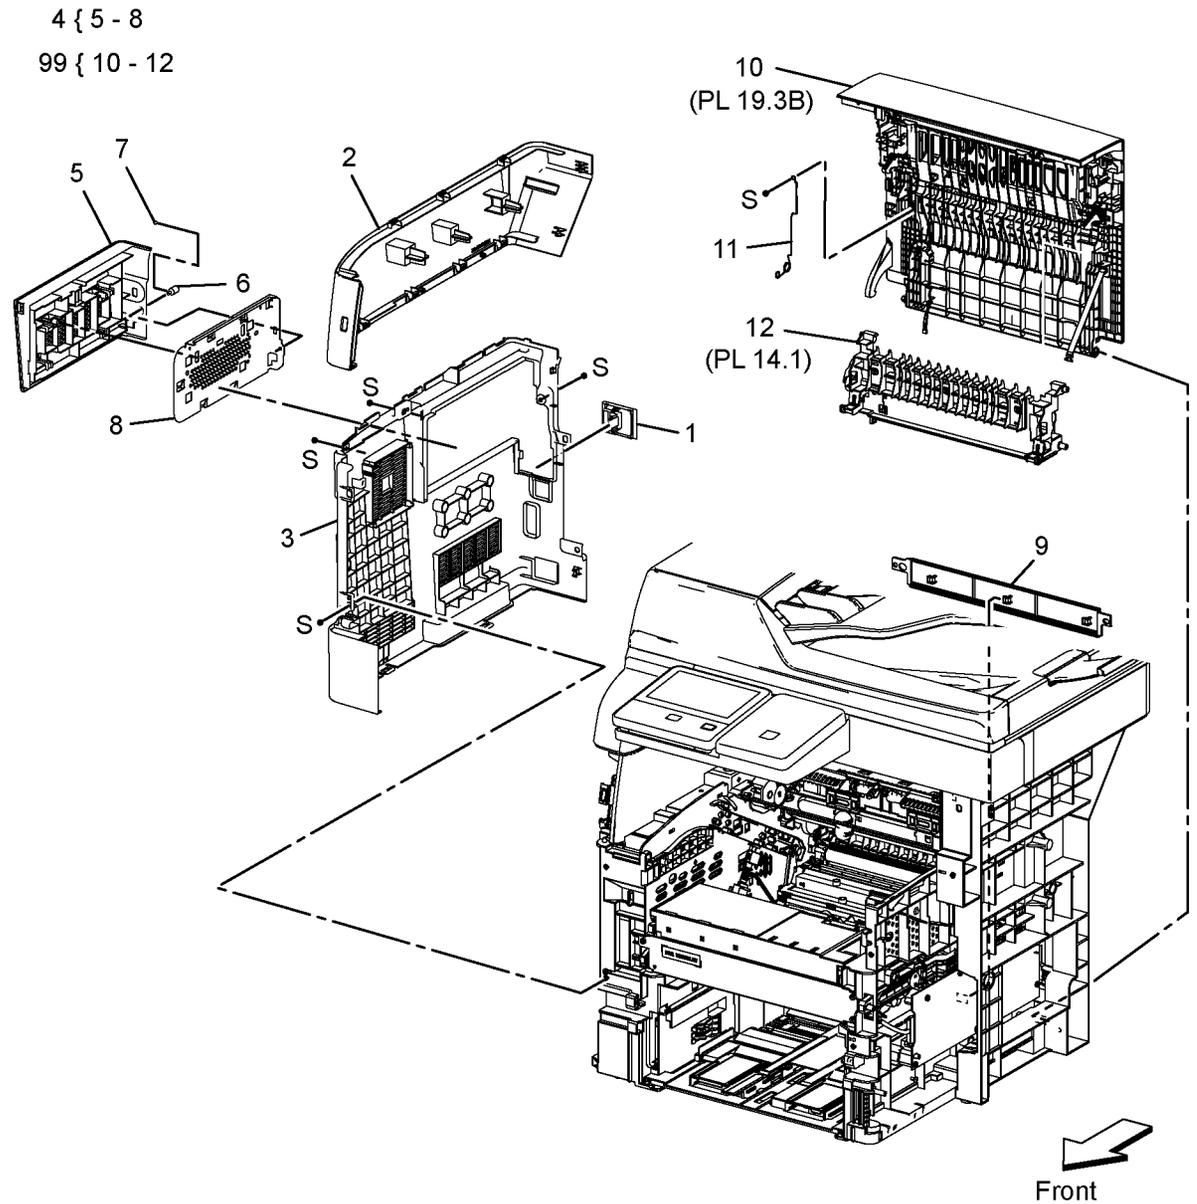
B-8-0036-A

# PL 19.2B Cover (2 of 3) - B405

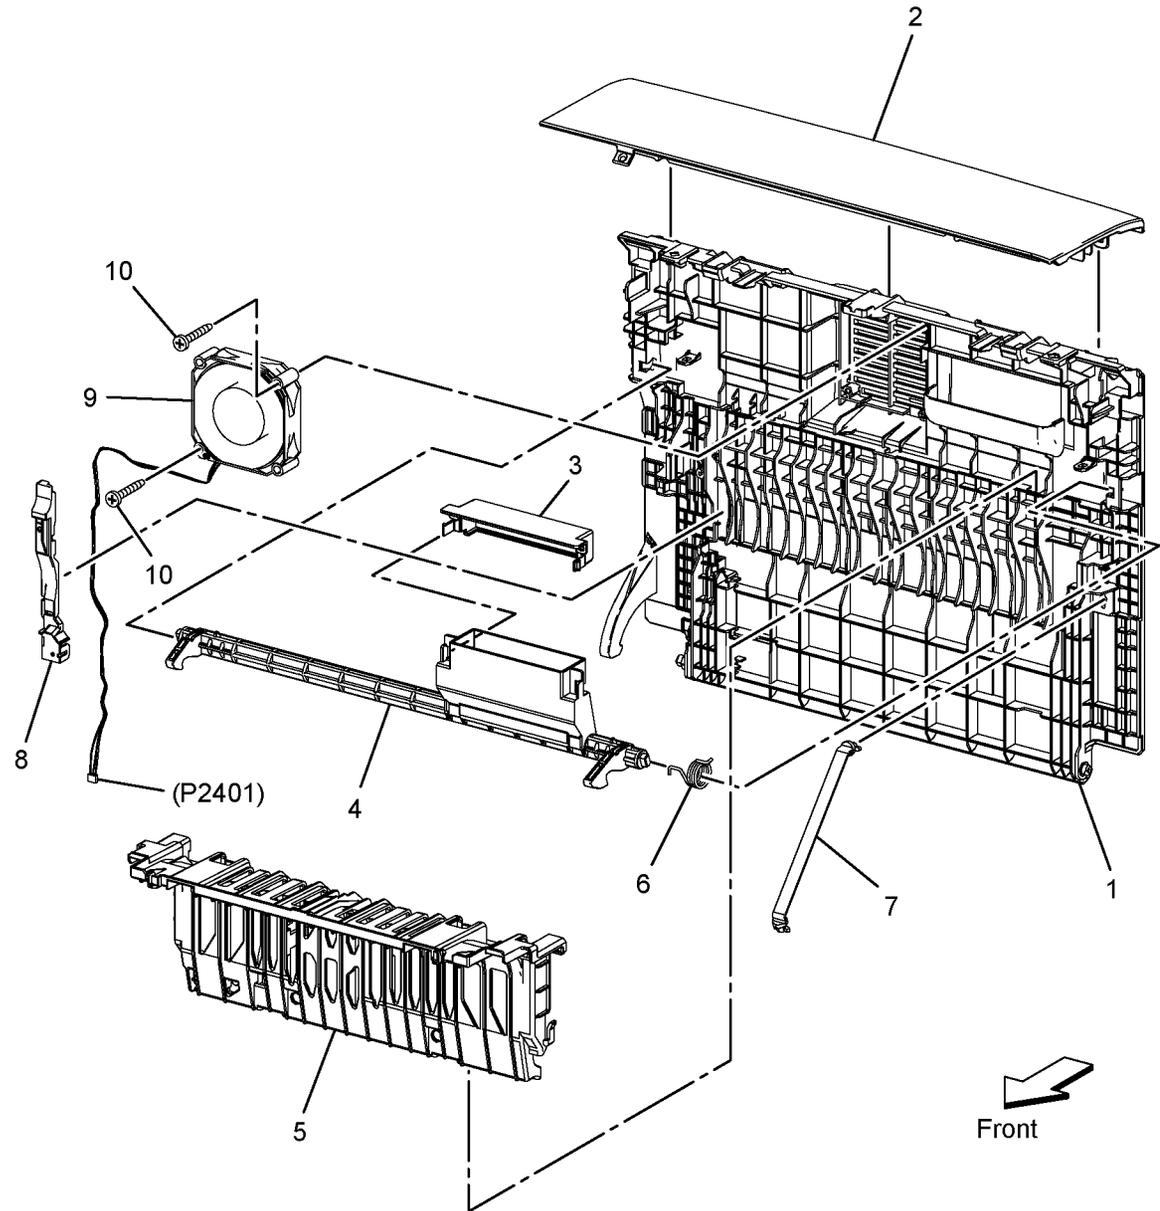
B-8-0037-A

## PL 19.3B Cover (3 of 3) - B405

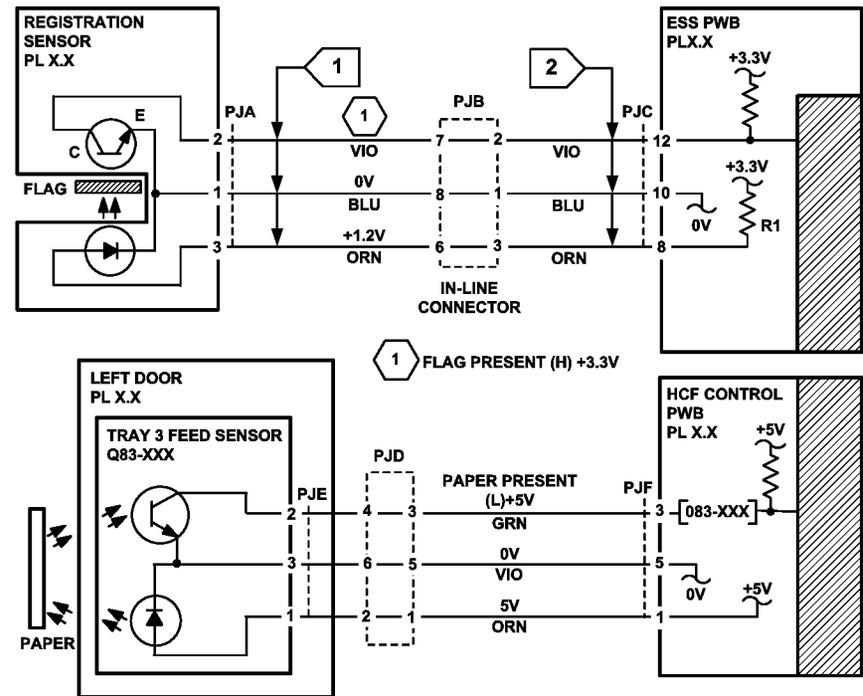
TB-1-0361-A

For the upper sensor in [Figure 1](#):

- Disconnect PJA ([Flag 1](#)). Check for +3.3V and 0V at PJA on the harness.
- Disconnect PJC ([Flag 2](#)). Check the wiring and the connectors for the sensor circuit.
- Check for +3.3V and 0V at PJC ([Flag 2](#)) on the ESS PWB.
- If necessary, install new components or repair the wiring.

Figure 1 Wiring diagram

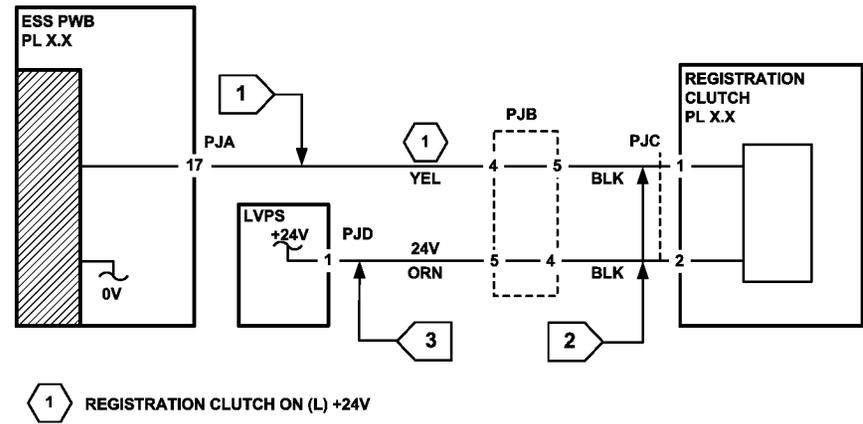
TB-1-0362-A

- Check that the signal changes on the ESS PWB (Flag 1) when the component control code for the clutch or solenoid is entered.
- Disconnect PJC (Flag 2). Check that +24V is measured when the component control code for the clutch or solenoid is entered.
- Disconnect PJD (Flag 3). Check for +24V on the LVPS.
- Check the wiring and the connectors for the clutch or solenoid circuit.

Figure 1 Wiring diagram

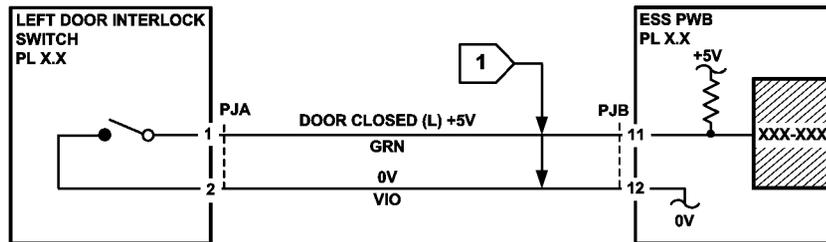
TB-1-0363-A

- Disconnect PJA ([Flag 1](#)). Check the electrical operation of the switch.
- Disconnect PJB ([Flag 1](#)). Check for +5V and 0V on the IOT PWB.
- Check the wiring and the connectors for the switch circuit.

Figure 1 Wiring diagram

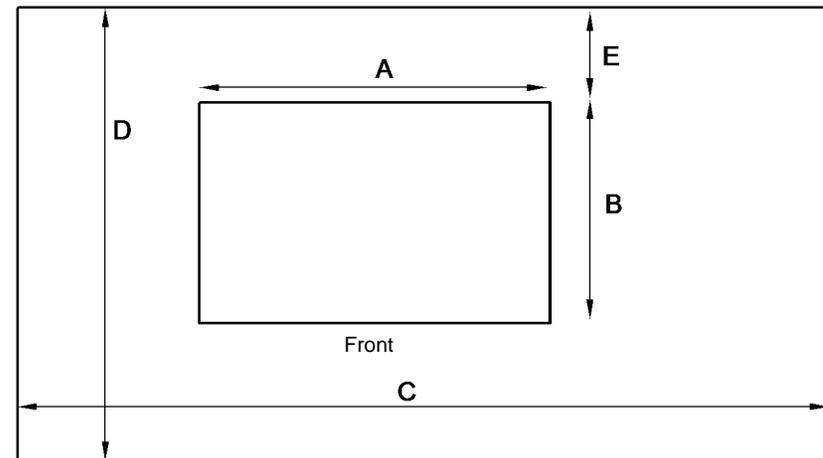
B-1-0302-A

Figure 1 Installation plan

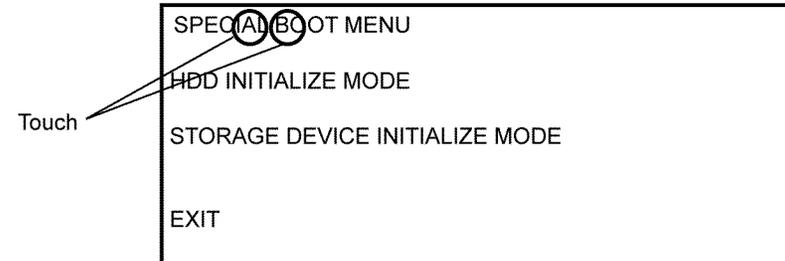
TB-1-0326-A

- Switch off the machine, [GP 10](#).
- Simultaneously press then hold down the **Home** and **Power** buttons until the device powers on and SPECIAL BOOT MENU appears, [Figure 1](#).
- Simultaneously touch the letters **A** in **SPECIAL**, **B** in **BOOT** and the **Home** button. Do not hold any of the three locations, just touch and then release simultaneously, [Figure 1](#).

Figure 1 Accessing special boot mode

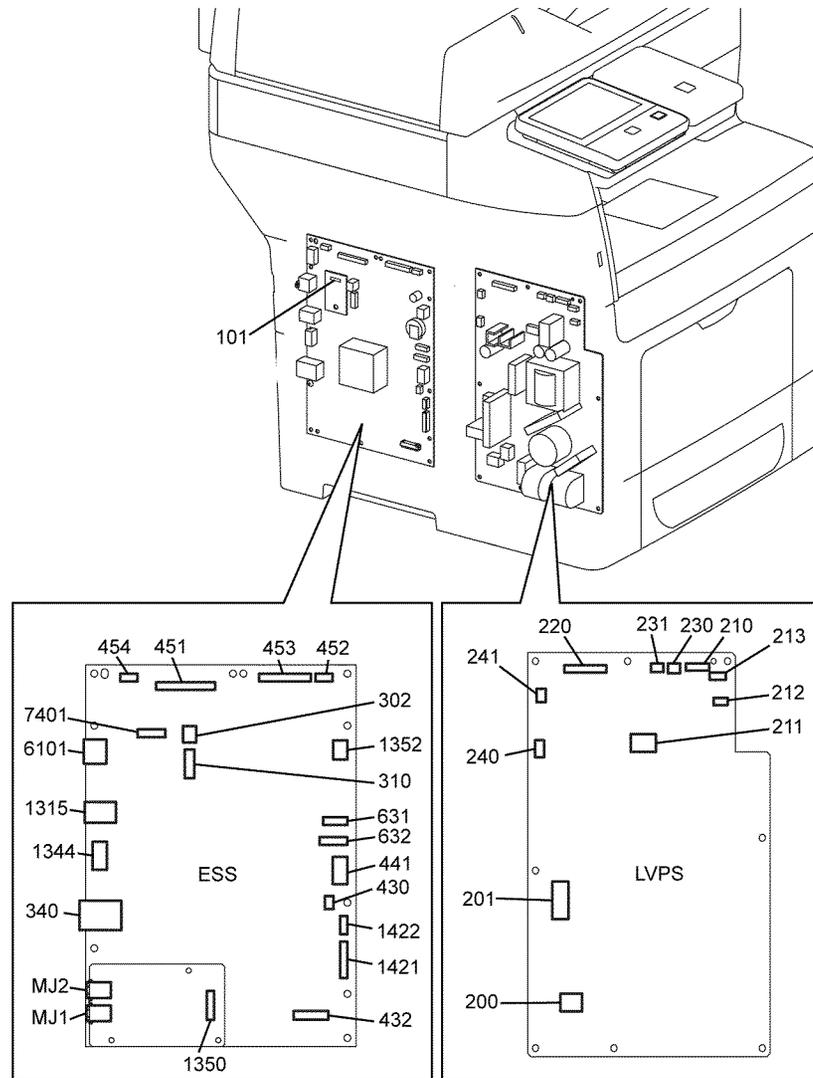
TB-1-0290-A

Figure 1 ESS and LVPS
