# Xerox® VersaLink® B400 & B405 Family Multifunction Printer Service Manual

VersaLink B400 and B405 Family Multifunction Printer Service Manual

708P91373

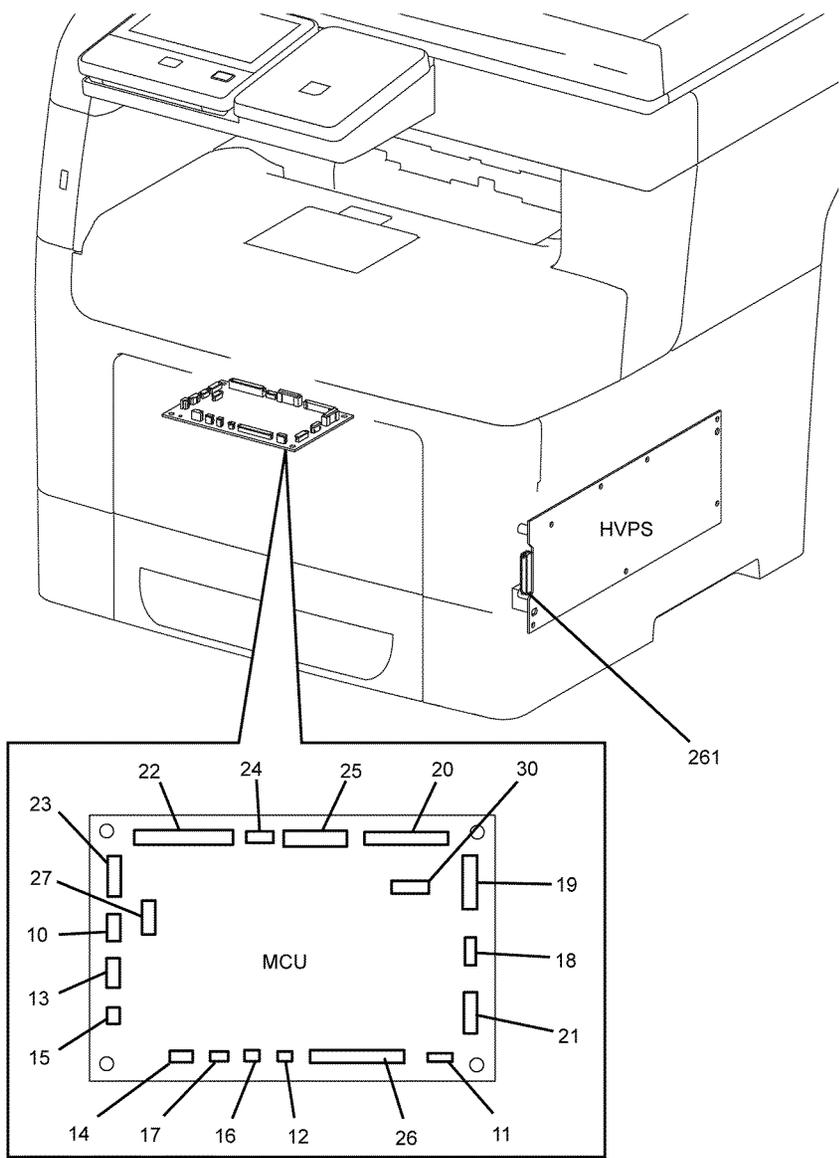
TB-1-0291-A

Figure 2 MCU

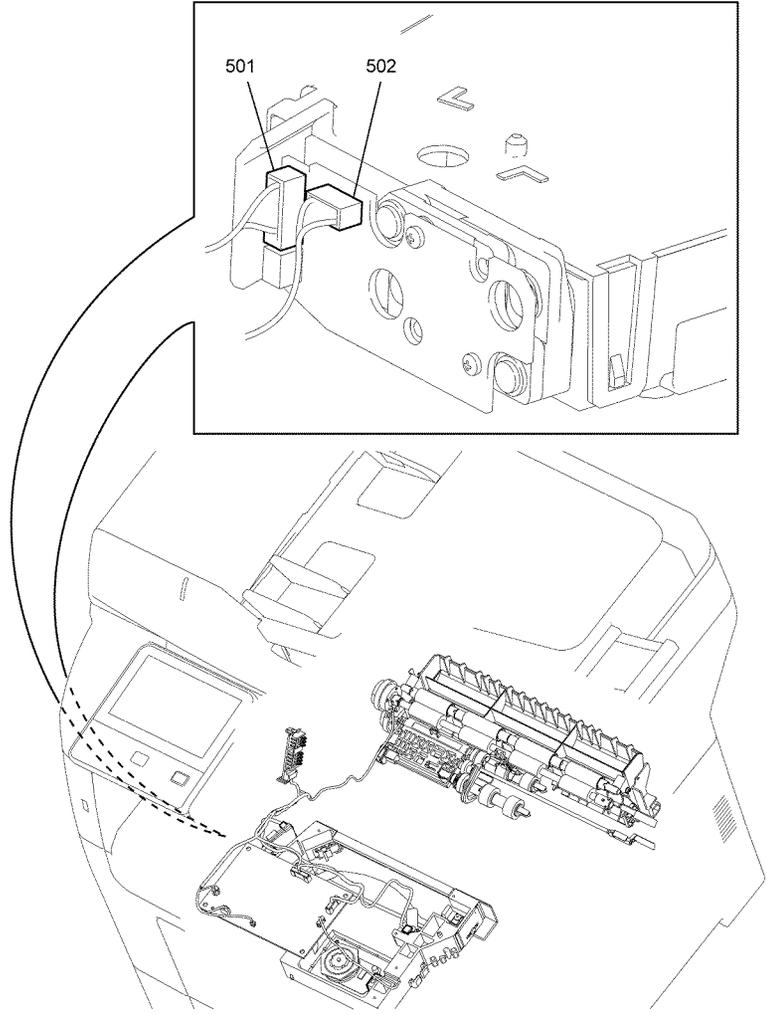
TB-1-0292-A

Figure 3 ROS

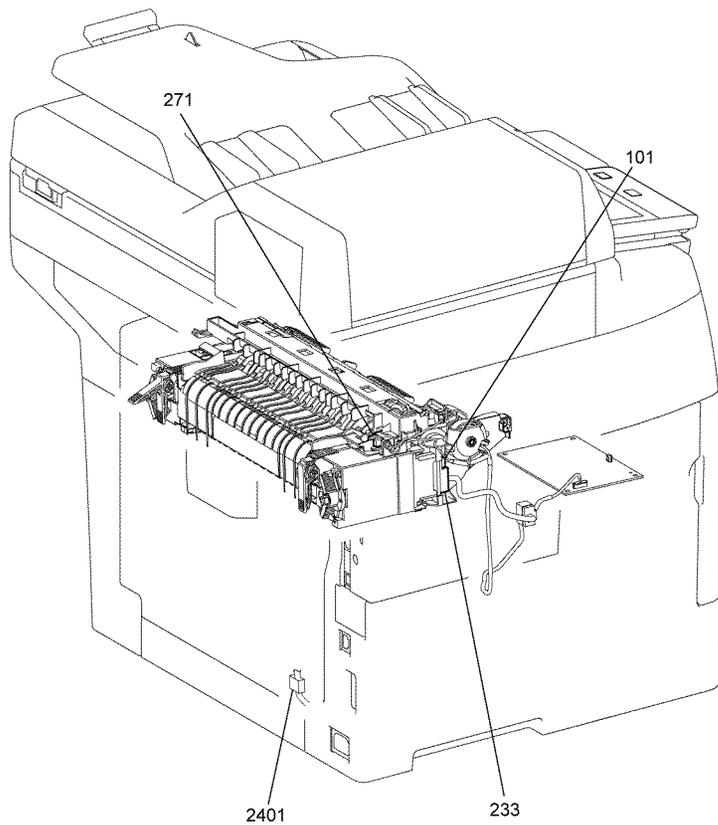
TB-1-0293-A

Figure 4 Fuser, Drive

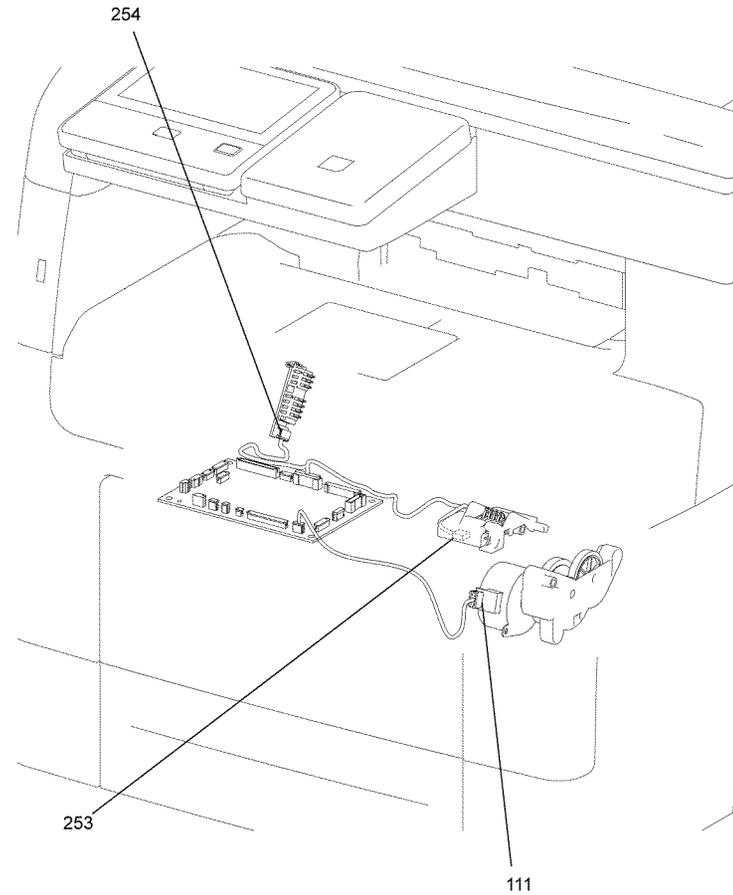
TB-1-0294-A

Figure 5 Xerographics

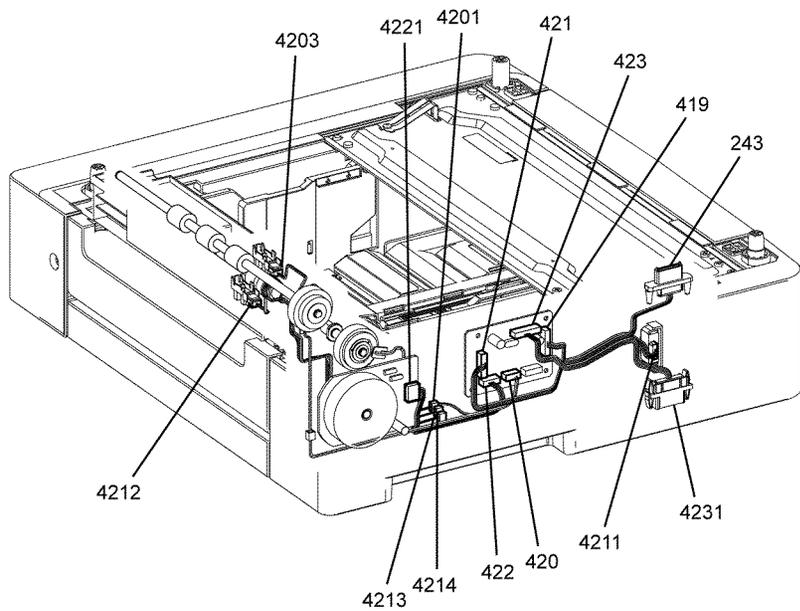
TB-1-0295-A

Figure 6 Option Feeder

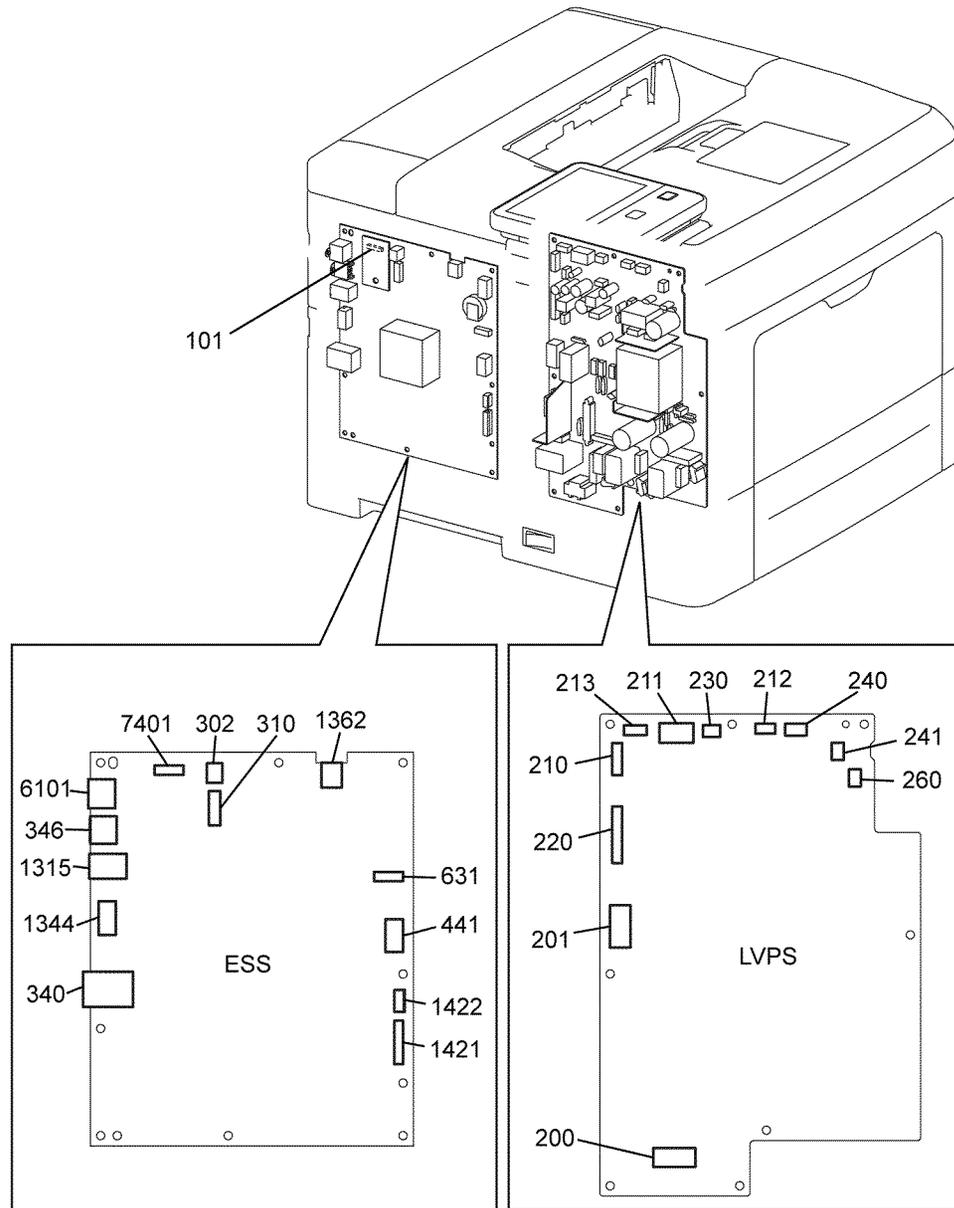
TB-1-0296-A

Figure 7 ESS and LVPS

| P/Js | Coordinates | Description |
|---|---|---|
| 7401 | Figure 7 | Connects ESS PWB, PL 18.1A Item 5 and EMMC card, PL 18.1A Item 6 |

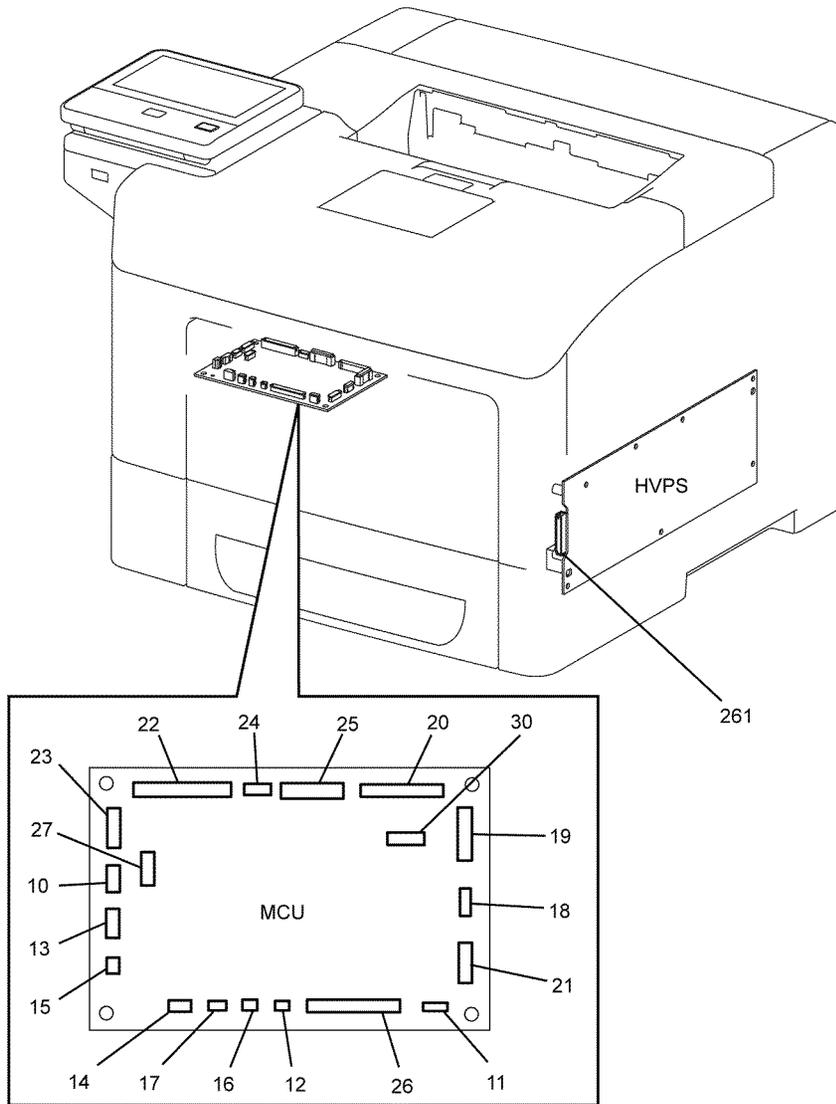
TB-1-0297-A

Figure 8 MCU

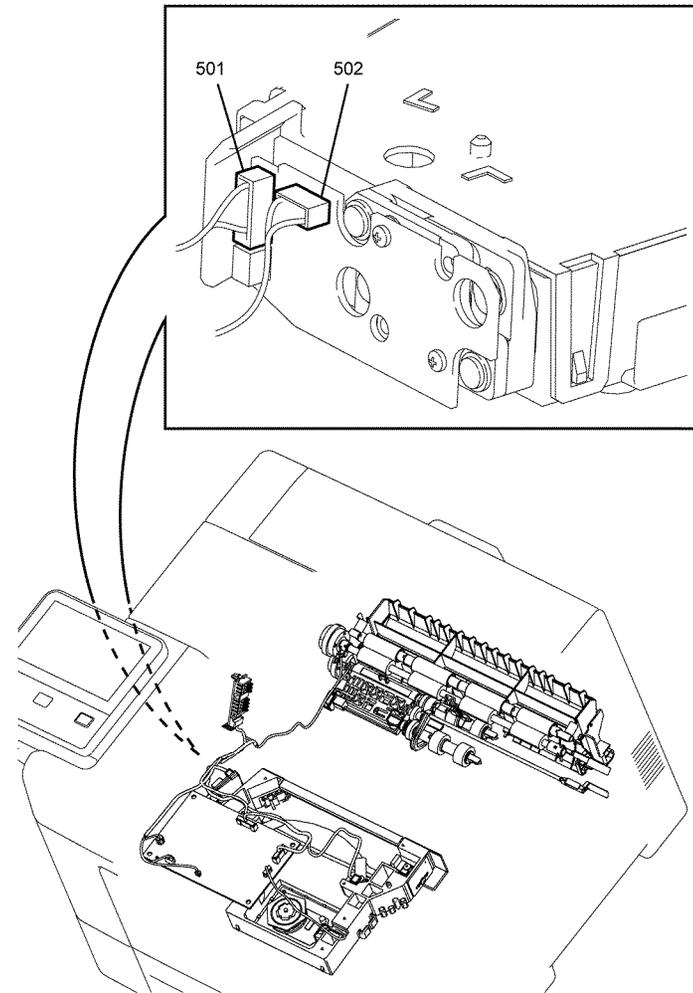
TB-1-0298-A

Figure 9 ROS

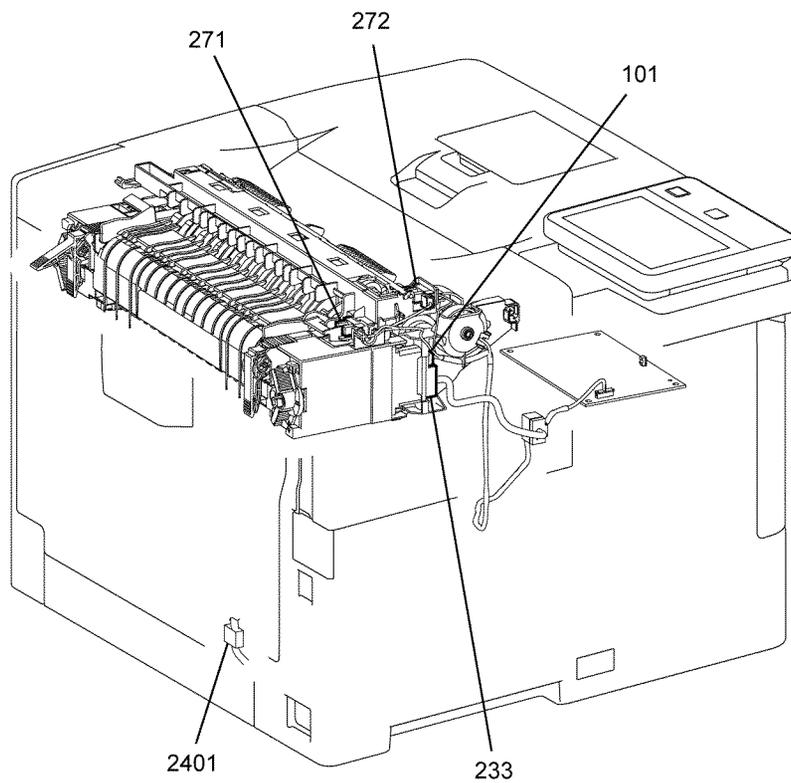
TB-1-0299-A

Figure 10 Fuser, Drive

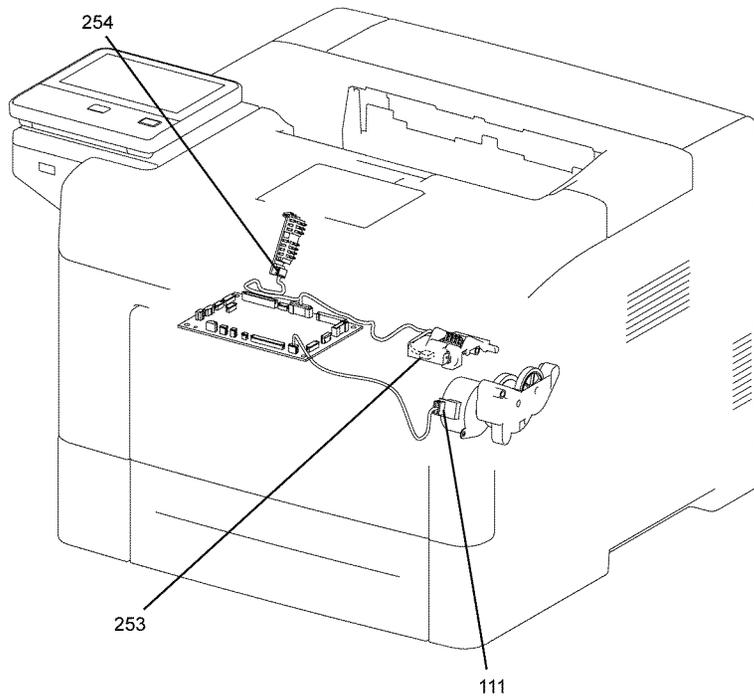
TB-1-0300-A

Figure 11 Xerographics

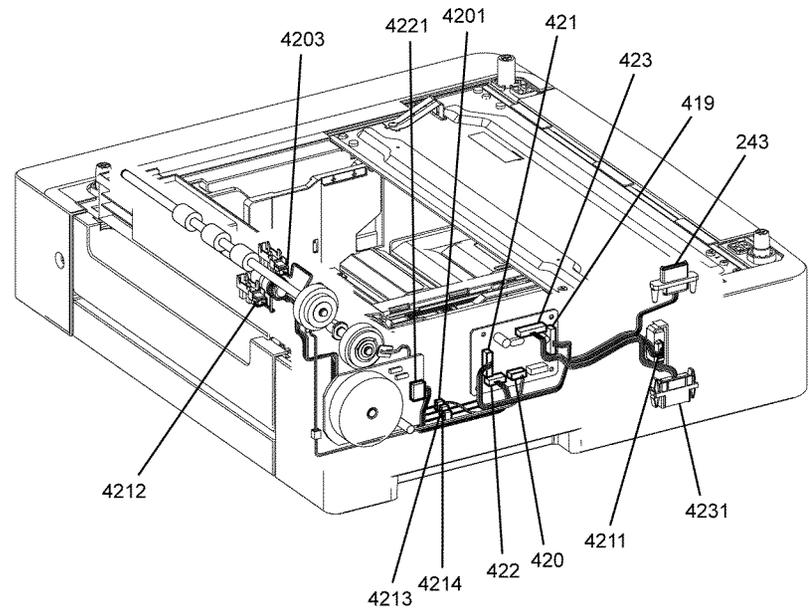
TB-1-0301-A

Figure 12 Option Feeder

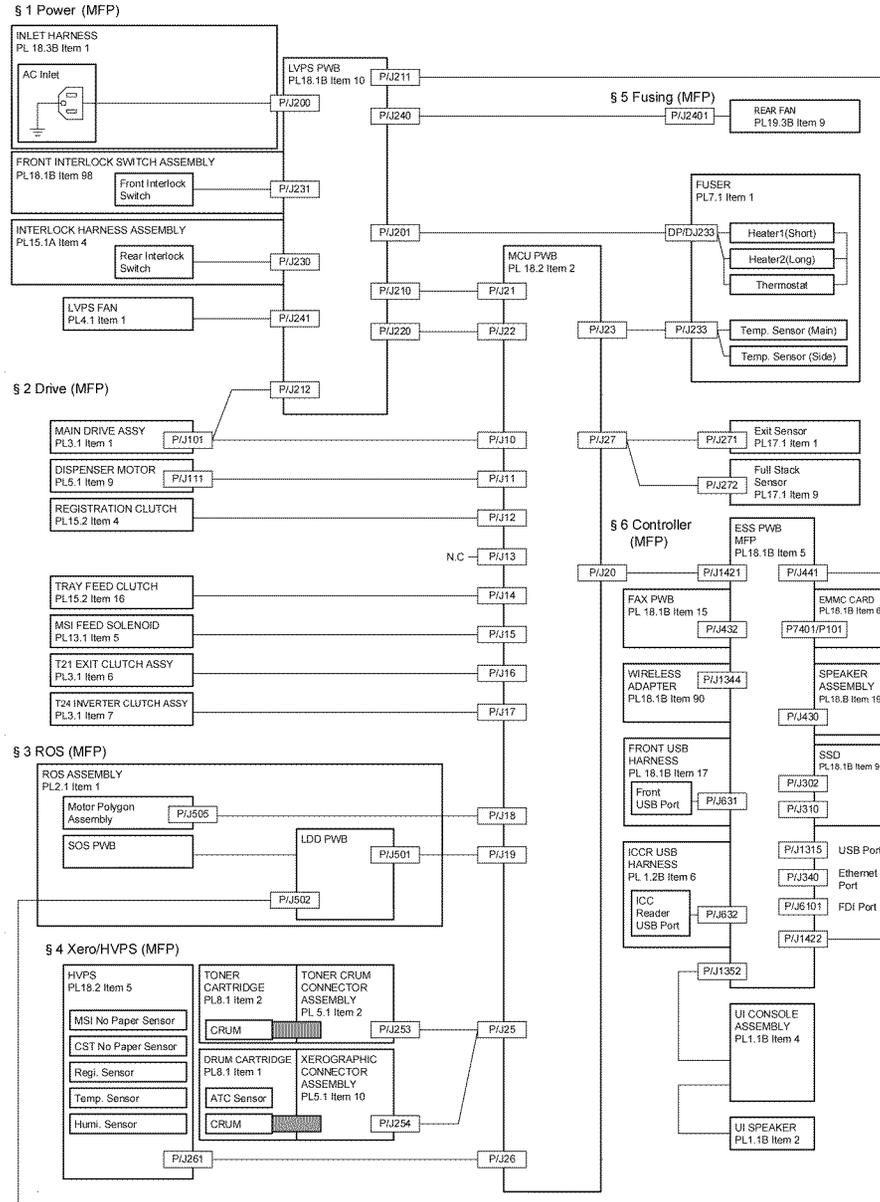
TB-1-0287-B

# Wiring Diagram 1 Component Interconnection (B405)

Figure 1 Wiring Diagram 1

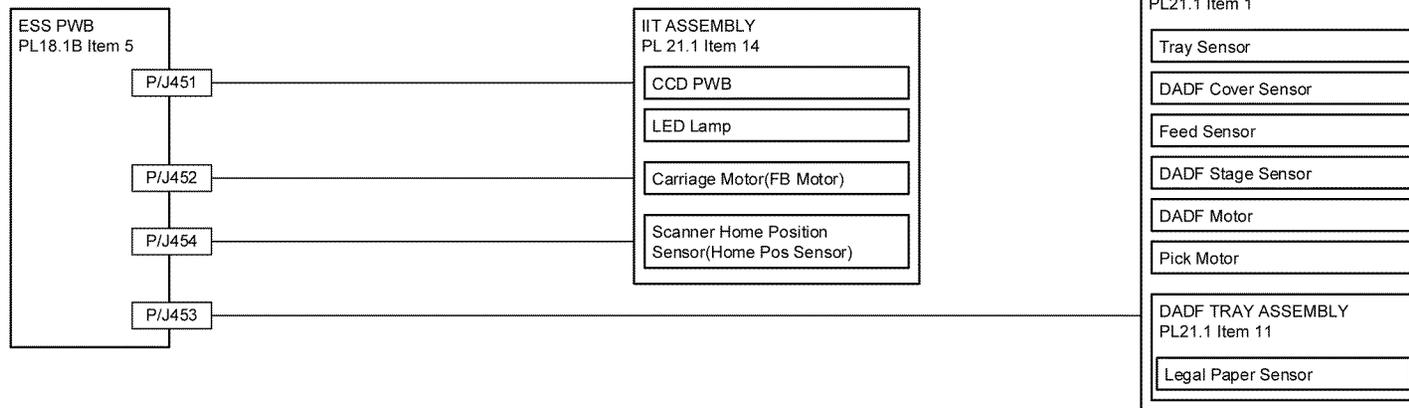
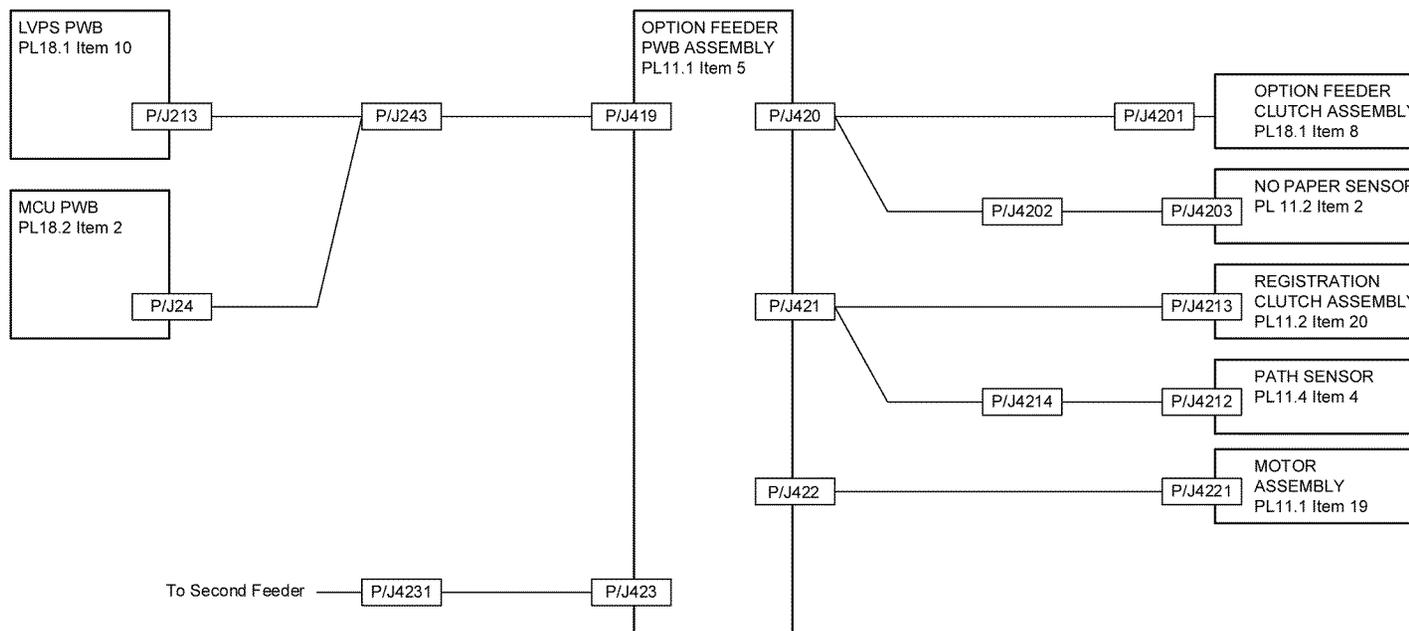
TB-1-0289-A

# Wiring Diagram 3 Scanner (B405 only), Option Feeder, Interconnection

## §7 Scanner

## §8 Optional 550 Sheet Feeder

Figure 3 Wiring Diagram 3

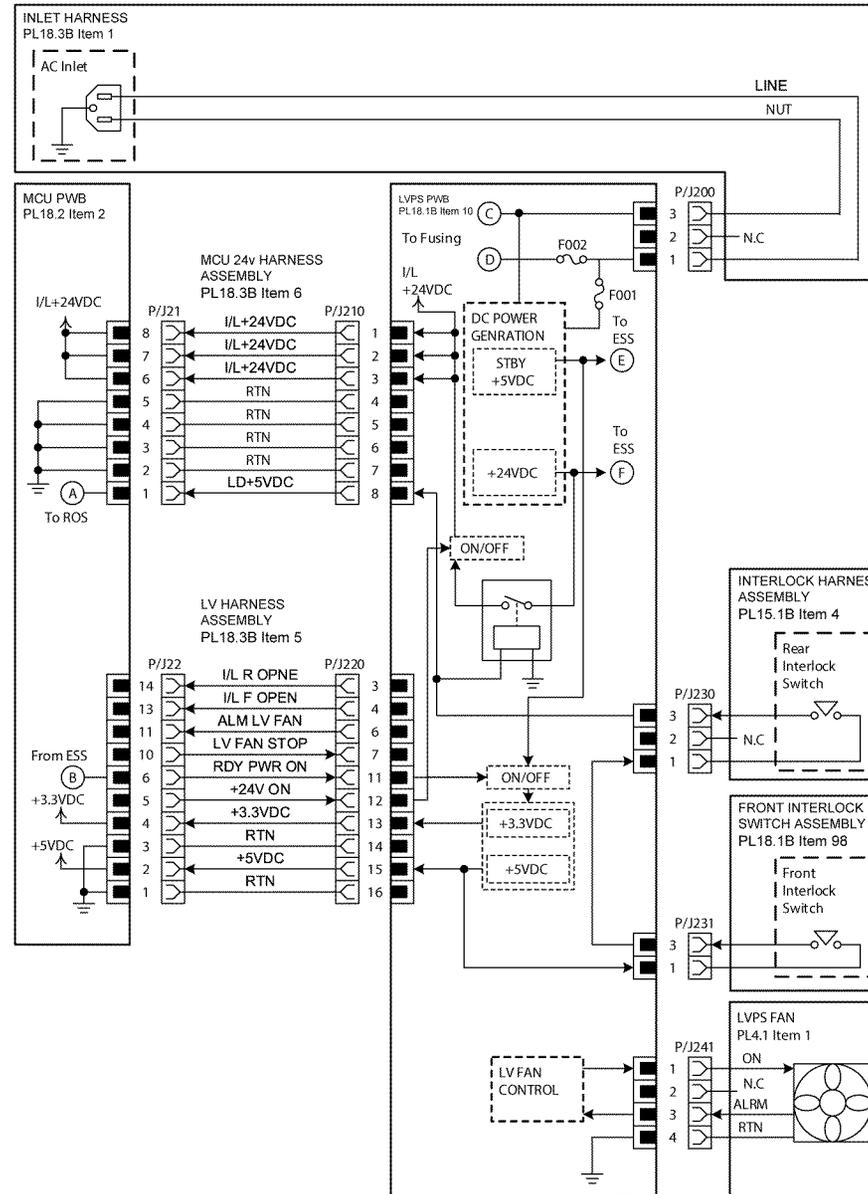
TB-1-0277

# Wiring Diagram 4 Power Regulation and Distribution (B405)

Figure 4 Wiring Diagram 4

- B405 Power Regulation and Distribution, [Wiring Diagram 4](#).
- B400 Power Regulation and Distribution, [Wiring Diagram 5](#).
- Drive, [Wiring Diagram 6](#).
- ROS, [Wiring Diagram 7](#).
- Xerographics/HVPS, [Wiring Diagram 8](#).
- Fuser/Exit, [Wiring Diagram 9](#).
- B405 Controller, [Wiring Diagram 10](#).
- B400 Controller, [Wiring Diagram 11](#).
- B405 only Scanner, [Wiring Diagram 12](#).
- Option Feeder, [Wiring Diagram 13](#).

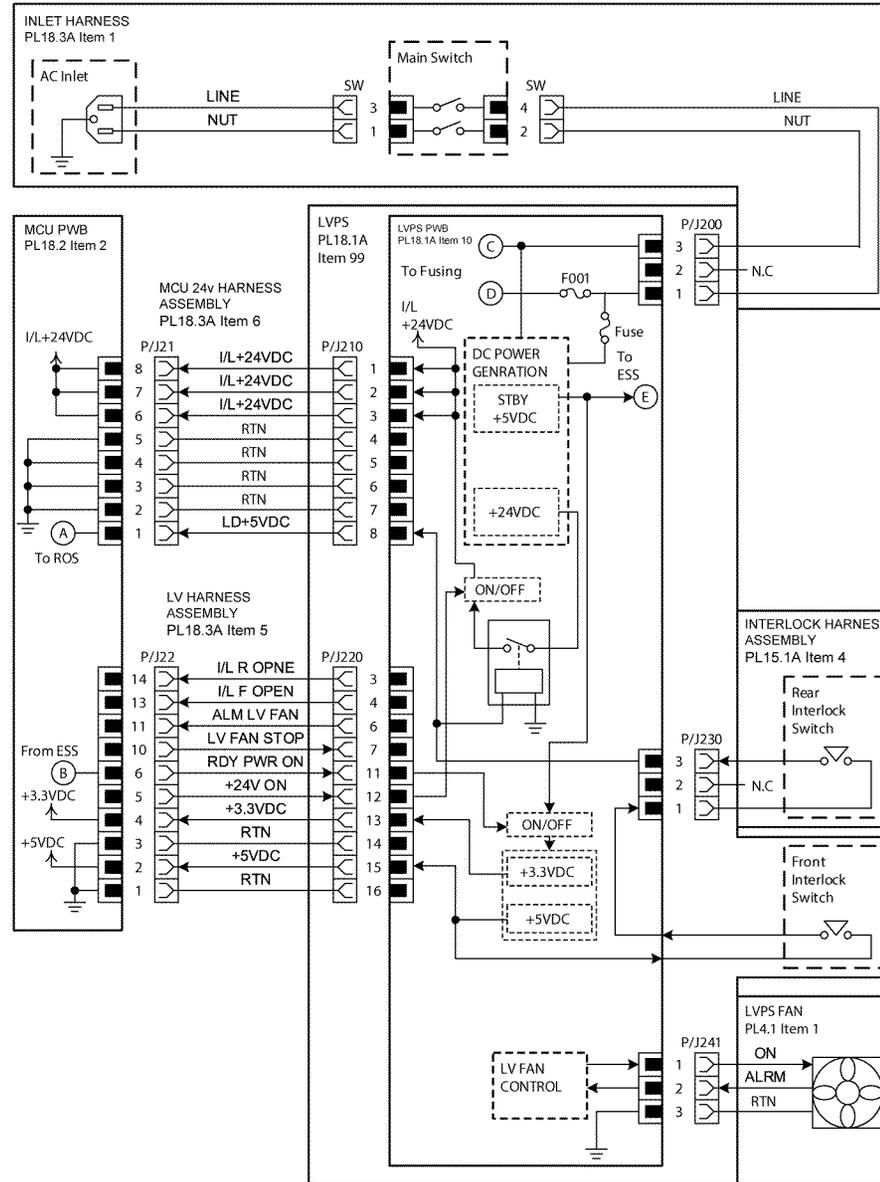
TB-1-0278-A

# Wiring Diagram 5 Power Regulation and Distribution (B400)

Figure 5 Wiring Diagram 5

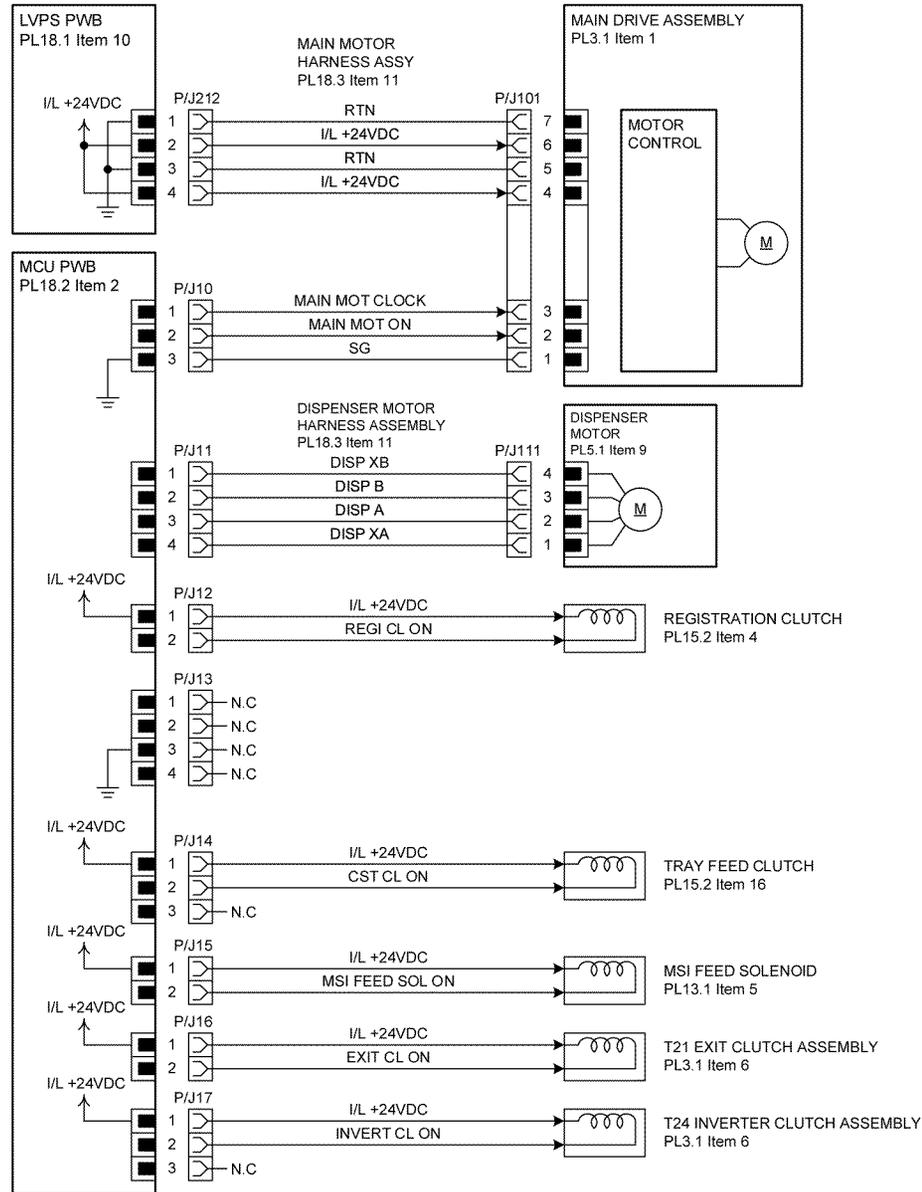
TB-1-0279-A

# Wiring Diagram 6 Drive

Figure 6 Wiring Diagram 6

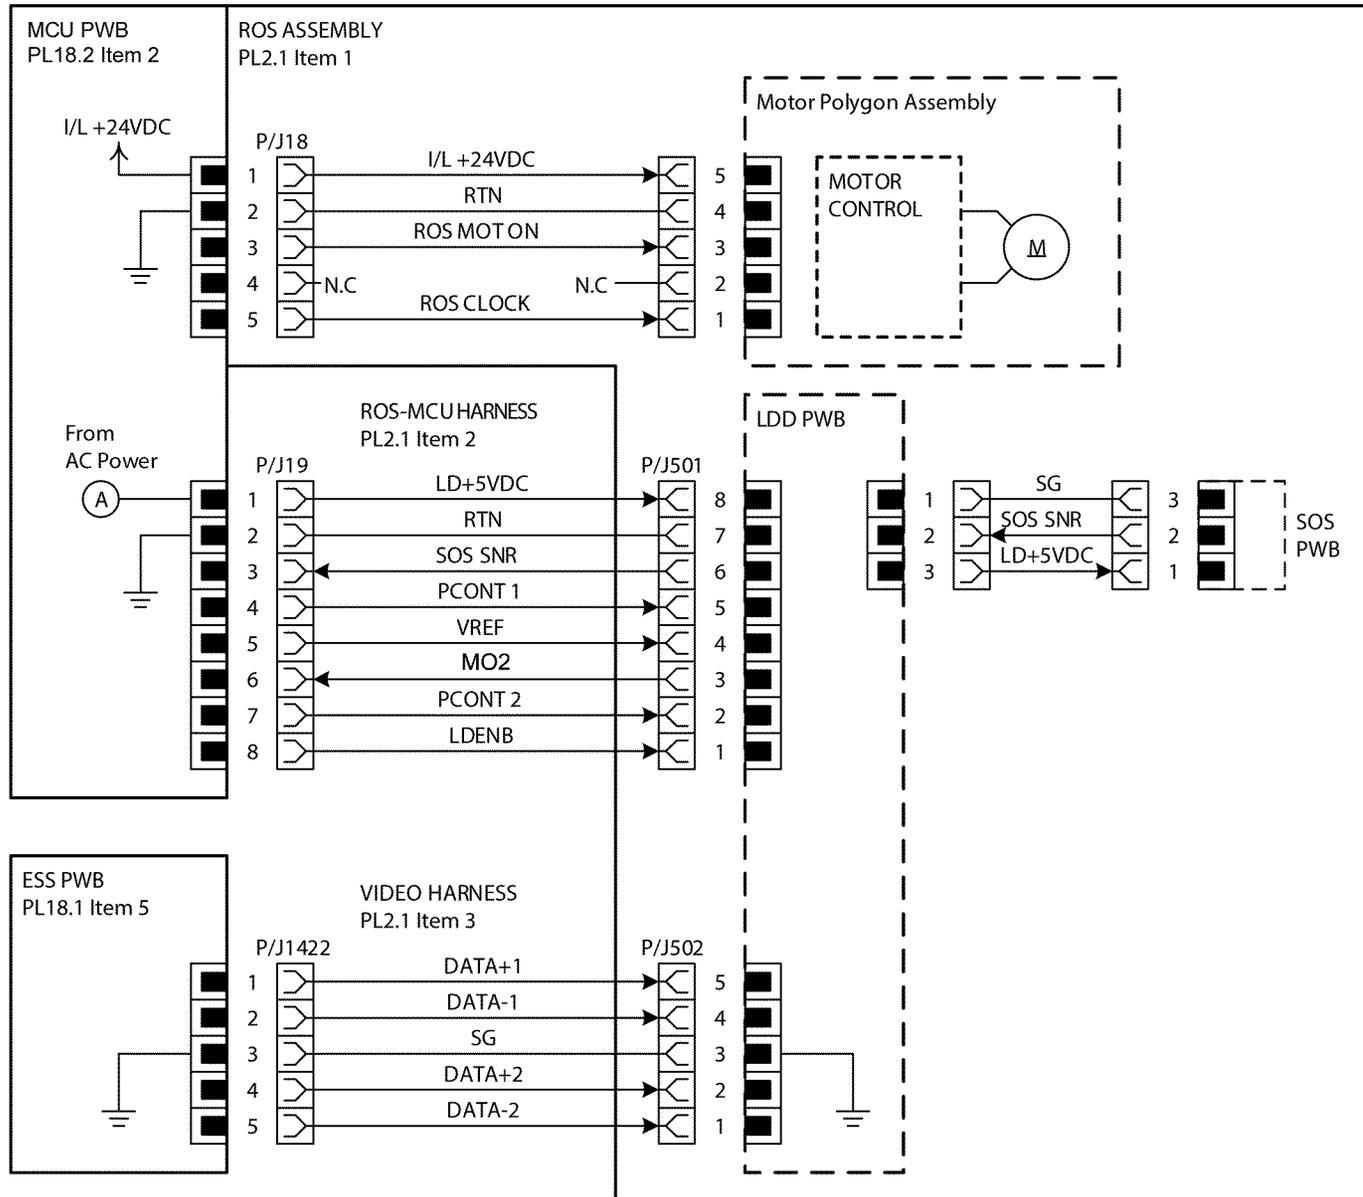
TB-1-0280-A

# Wiring Diagram 7 ROS

Figure 7 Wiring Diagram 7

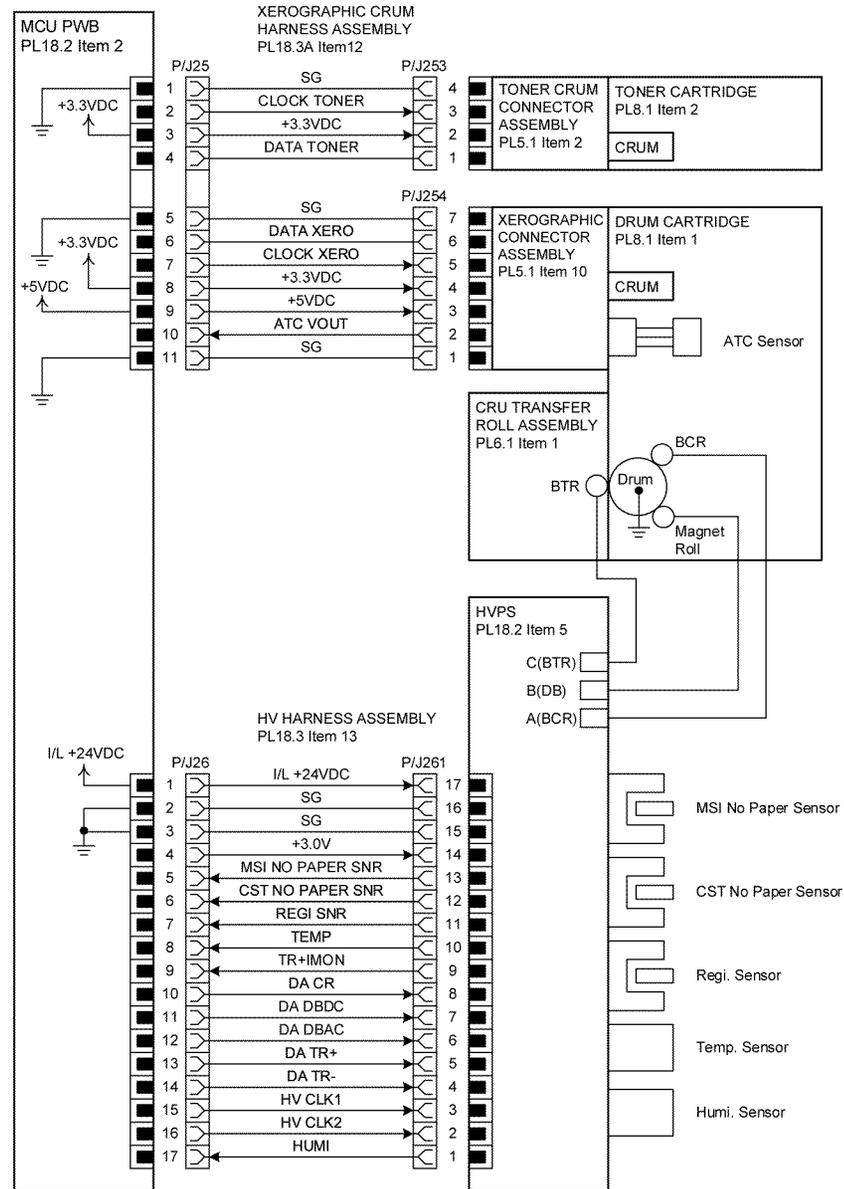
TB-1-0281-B

# Wiring Diagram 8 Xerographics/HVPS

Figure 8 Wiring Diagram 8

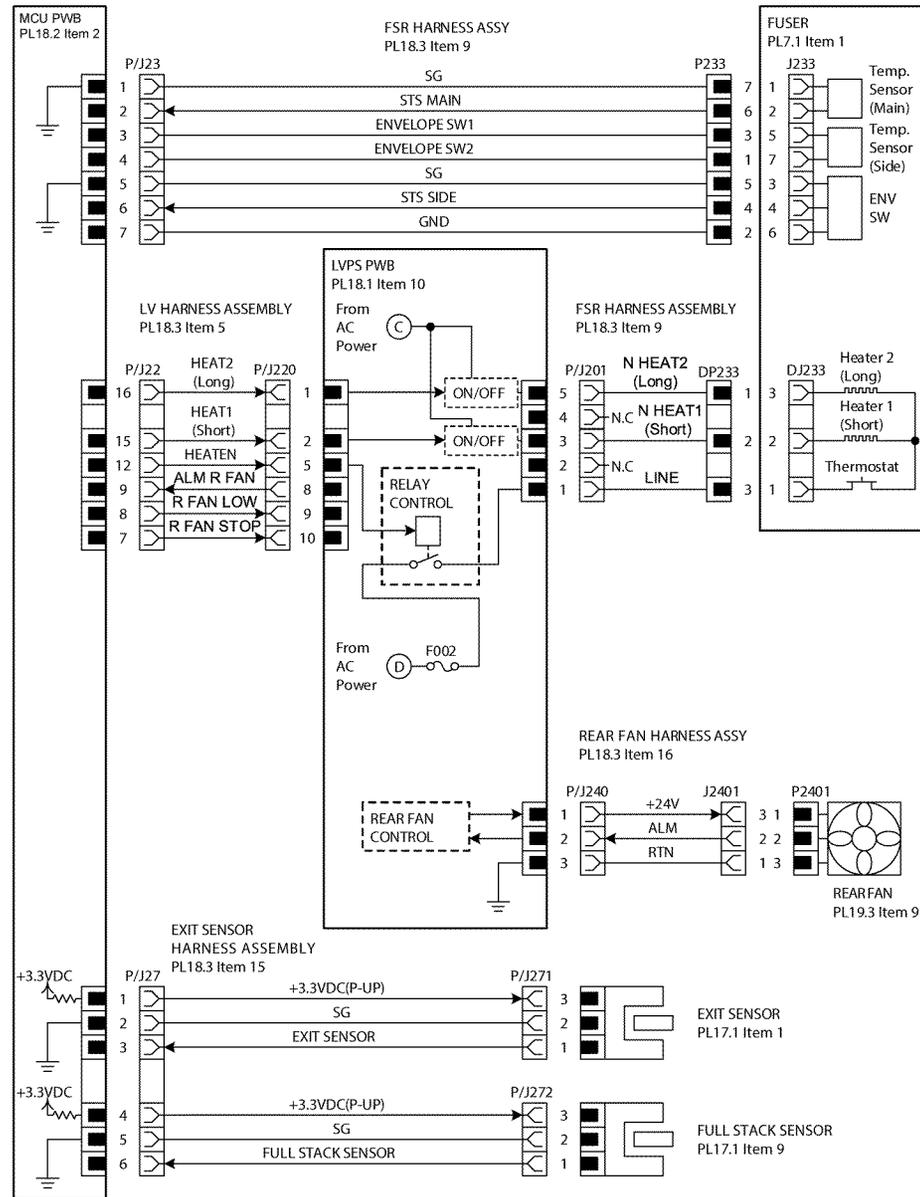
TB-1-0282-A

# Wiring Diagram 9 Fuser/Exit

Figure 9 Wiring Diagram 9

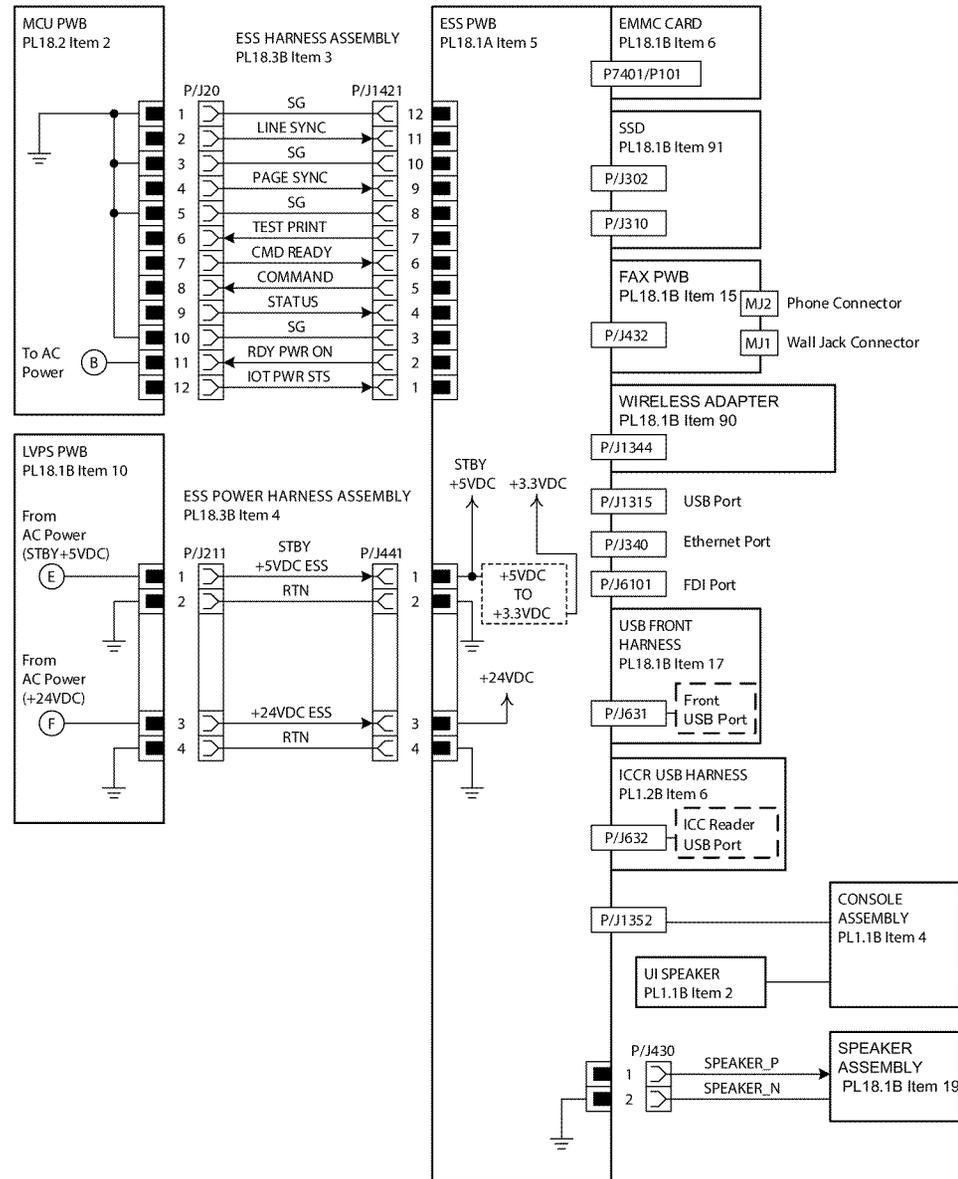
# Wiring Diagram 10 Controller (B405)

Figure 10 Wiring Diagram 10

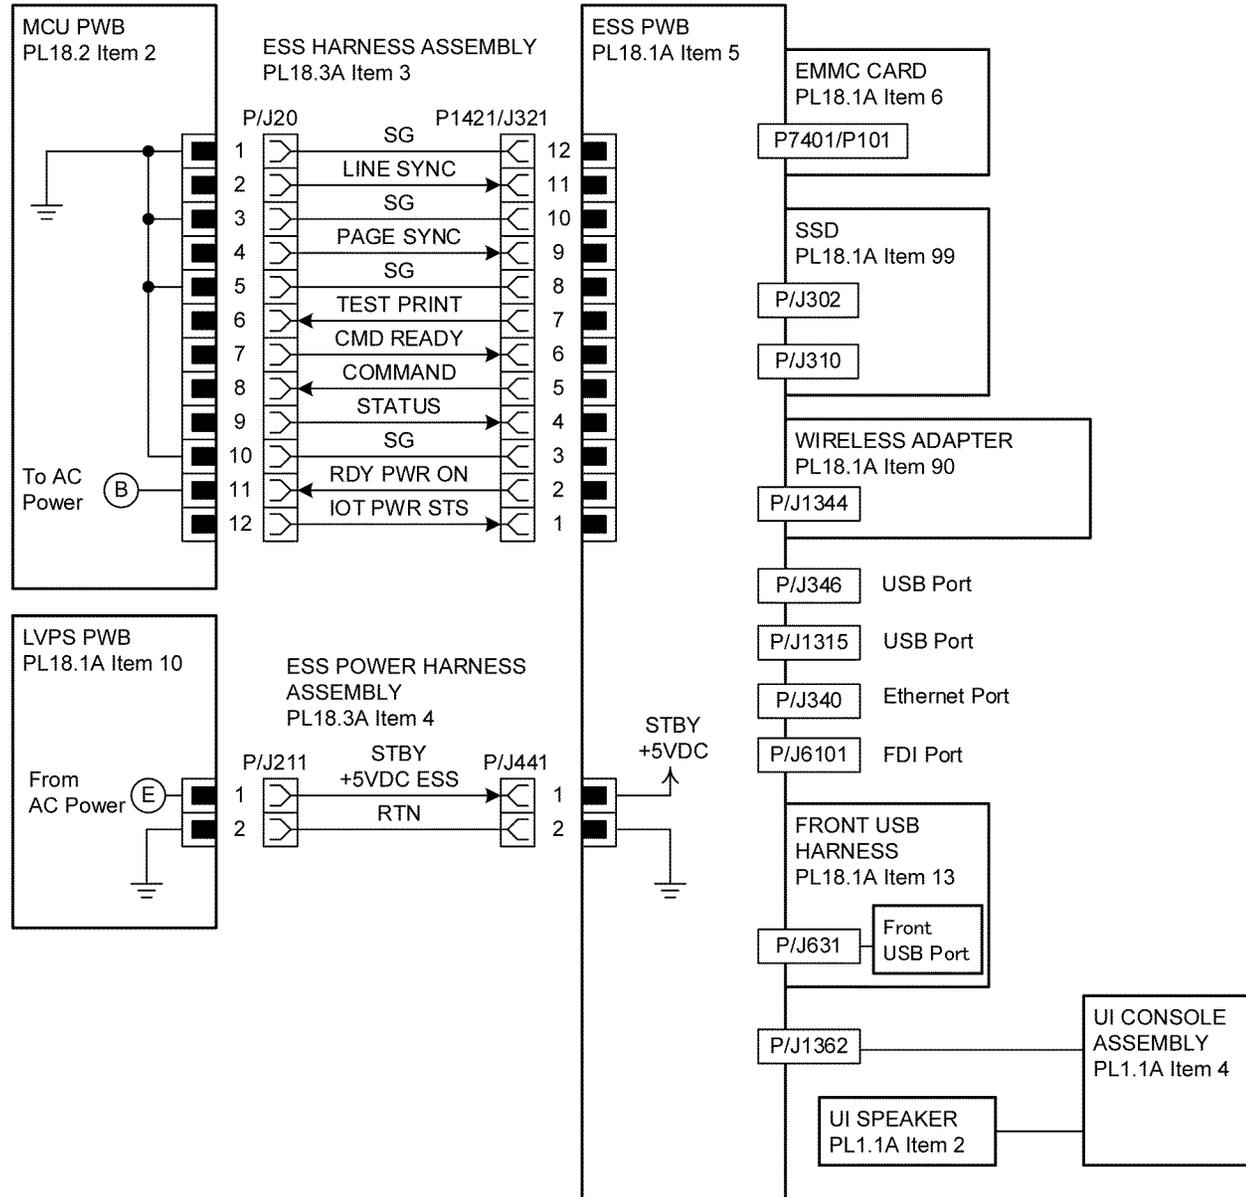
Figure 11 Wiring Diagram 11

# Wiring Diagram 11 Controller (B400)

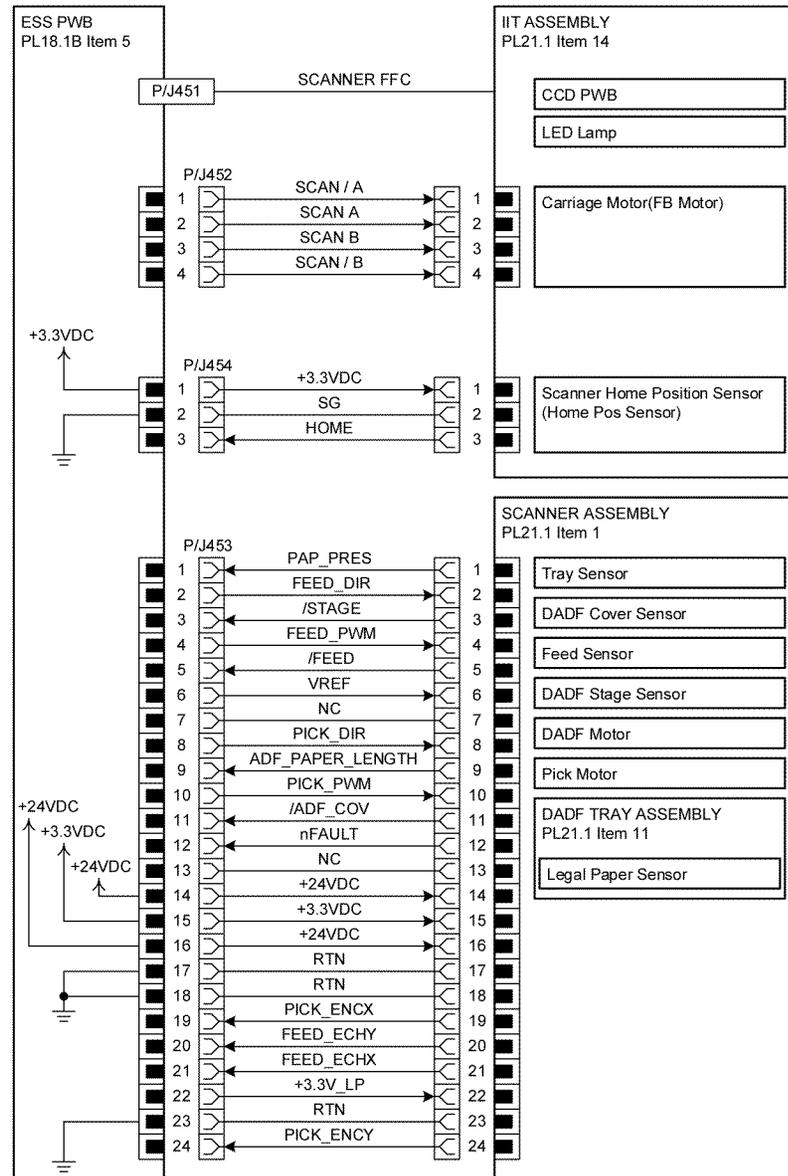
Figure 12 Wiring Diagram 12

# Wiring Diagram 12 Scanner

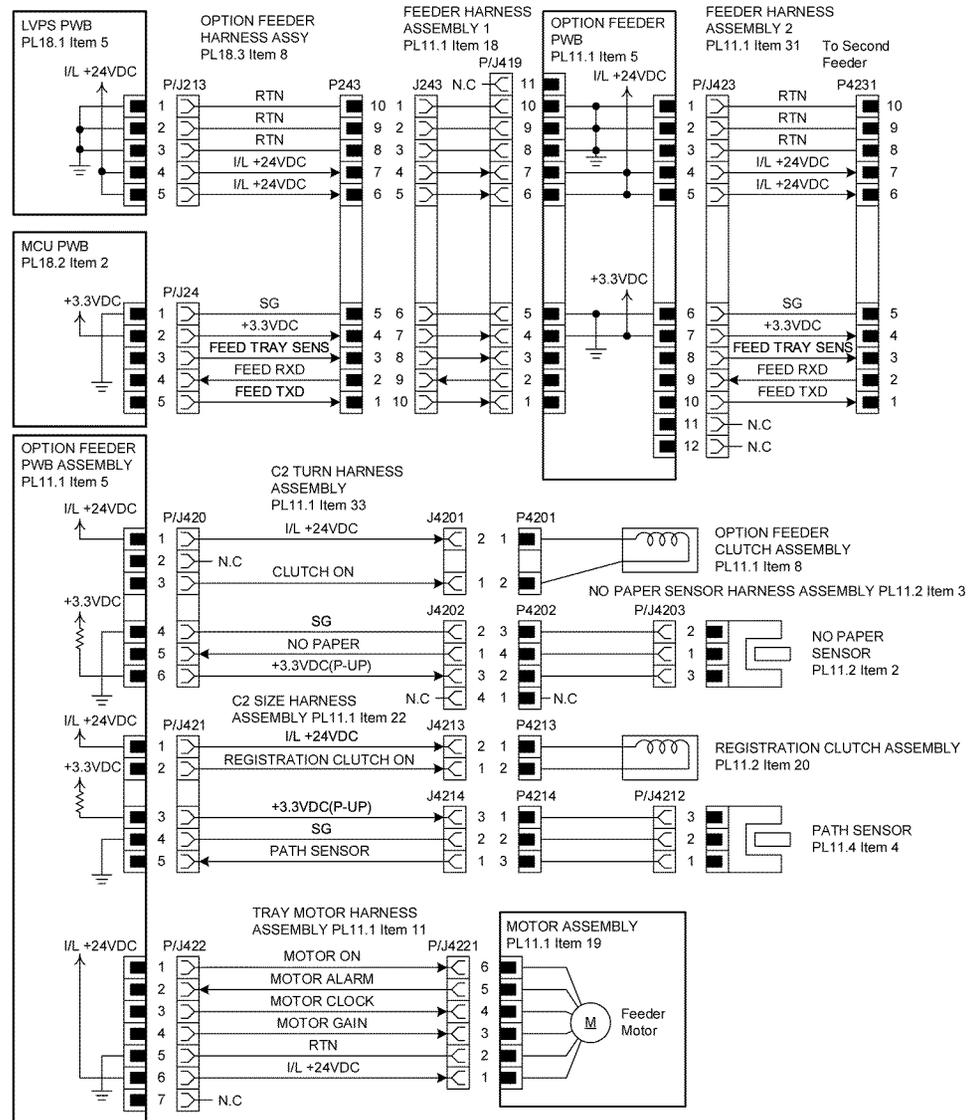
Figure 13 Wiring Diagram 13

# Wiring Diagram 13 Option Feeder

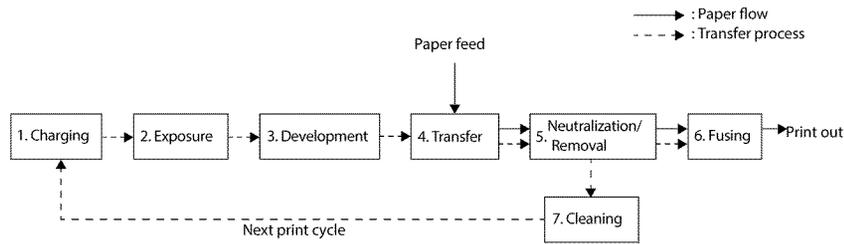
Figure 1 Xerographic process

This printer is a xerography-based, black and white laser printer. The xerographic system consists of the following basic seven steps in which a toner image is formed on the drum, and then transferred and fused onto the paper. Refer to [Figure 1](#).

1. Charging. The drum surface is charged with electricity.
2. Exposure. An image is formed by exposing the drum surface to laser light.
3. Development. The image on the drum surface is developed with toner.
4. Transfer. The toner image on the drum is transferred onto the paper.
5. Neutralization/Removal. The paper is removed from the drum surface.
6. Fusing. The toner on the paper is fixed by heat and pressure.
7. Cleaning. The drum is cleaned.

As the rotating drum surface goes through the steps of charging, exposure, development, transfer, removal, and cleaning, a toner image is formed on the drum surface and is transferred onto the paper. As the paper is fed by the feeding mechanism through the steps of transfer, removal, and fusing, the toner image is transferred from the drum surface onto the paper, and then is fused.
