# Xerox® VersaLink® B400 & B405 Family Multifunction Printer Service Manual

VersaLink B400 and B405 Family Multifunction Printer Service Manual

708P91373

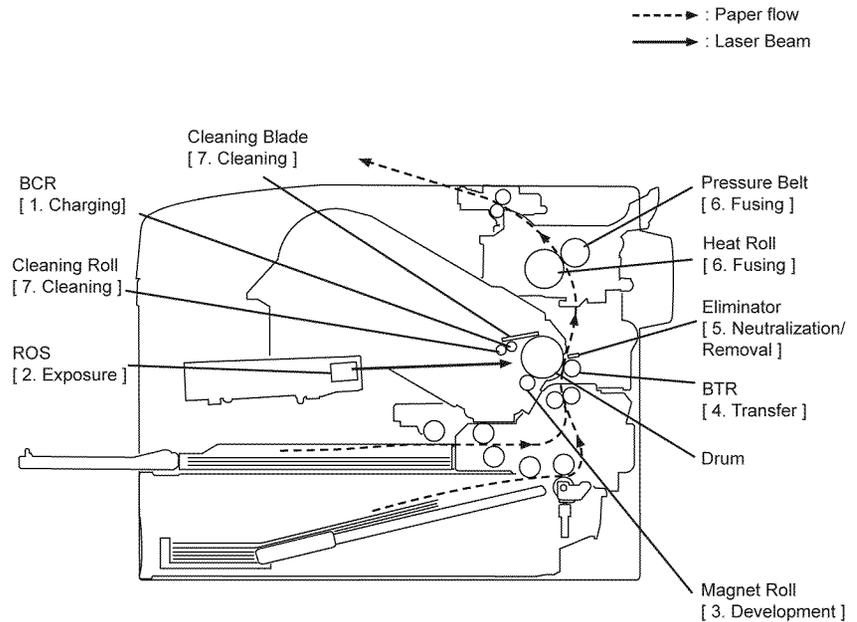
Figure 2 Printing process

The outline of the printing process is shown in [Figure 2](#).

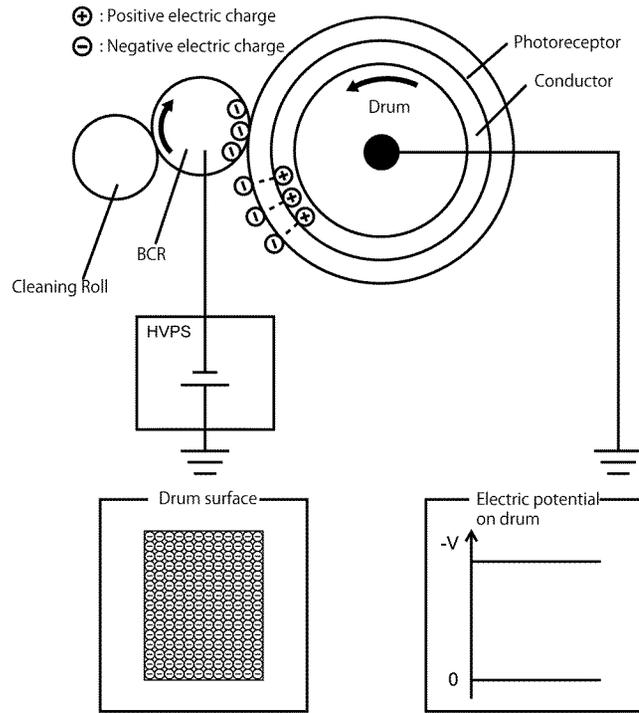
Figure 3 Charging

During the charging process, the surface of the drum rotating at a constant speed is uniformly charged with negative polarity by the discharge from the bias charge roll (BCR). Refer to [Figure 3](#).

- The BCR is kept in contact with the drum and rotates following the rotations of the drum. The BCR is a conductive roll that uniformly and negatively charges the drum surface with the negative voltage applied by the HVPS.
- The drum surface is uniformly and negatively charged with DC bias voltage. The drum surface consists of a photoreceptor (which is an insulator in the dark and a conductor in the light) backed with a conductor.
- The cleaning roll contacts with the BCR to remove the toner from its surface.

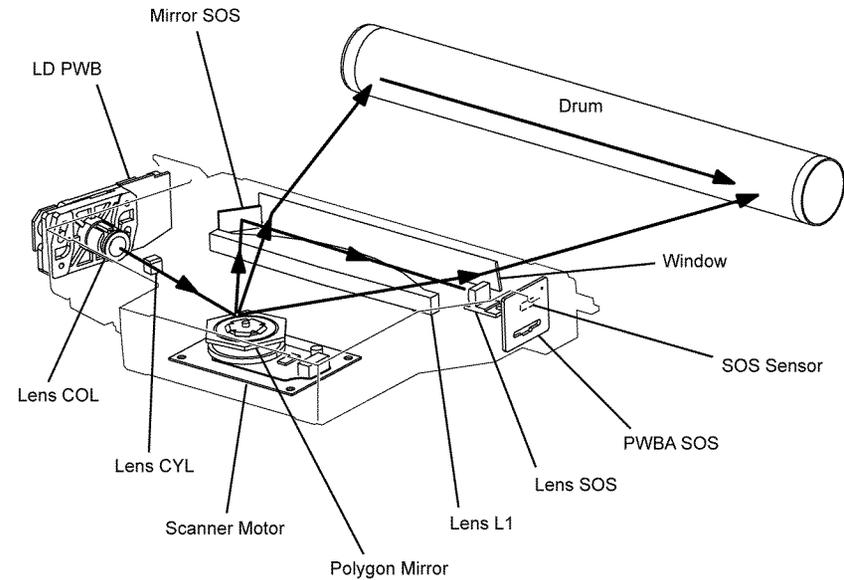
Figure 4 Exposure

The exposure process forms an invisible electrostatic latent image on the negatively charged drum surface by scanning it with laser light. Refer to [Figure 4](#)

- The laser light is emitted from the laser diode (LD) to the polygon mirror via the two lenses. The laser light reflected from the polygon mirror goes through the drum through the lens L1 and the window.
- The polygon mirror has six reflecting mirror faces and rotates driven by the scanner motor. The changing angle of the reflecting mirror surfaces allows the incoming laser light to scan the drum from end to end. One reflecting mirror is used to scan one line.
- When one line of scanning ends, the laser light reflected from the polygon mirror enters the SOS mirror and is reflected to the SOS sensor. The SOS sensor generates a scan reference signal in response to the detection of laser light. This signal is used to time the start of laser scanning to the start of image writing.

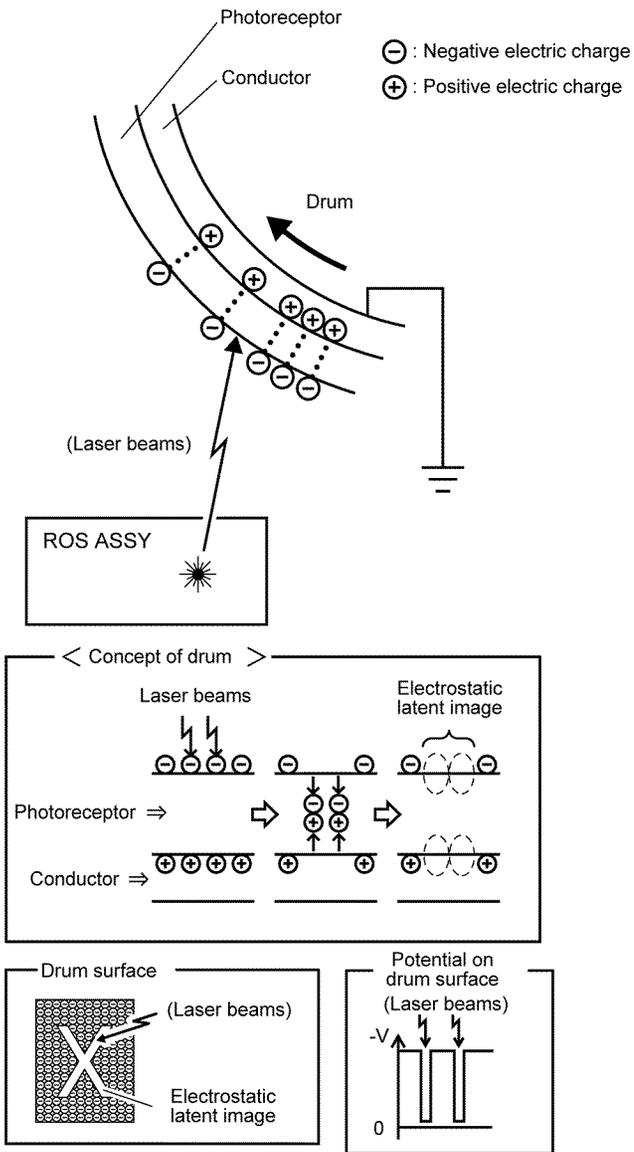
Figure 5 Latent image

- The laser light is illuminated according to the printing data (image data) output from the printer controller. Only the points on the drum surface corresponding to the pixels (minute points composing characters of pictures) of the printing data are illuminated by laser light (the laser diode turns on at the area to be illuminated with toner, and turns off at the area not to be developed). The areas on the drum illuminated with the laser light become conductive. This allows the negative charge on the drum surface to flow to the positive side and to cancel out the positive charge, lowering the potential on the drum surface. This low-potential area becomes the electrostatic latent image. Refer to [Figure 5](#).

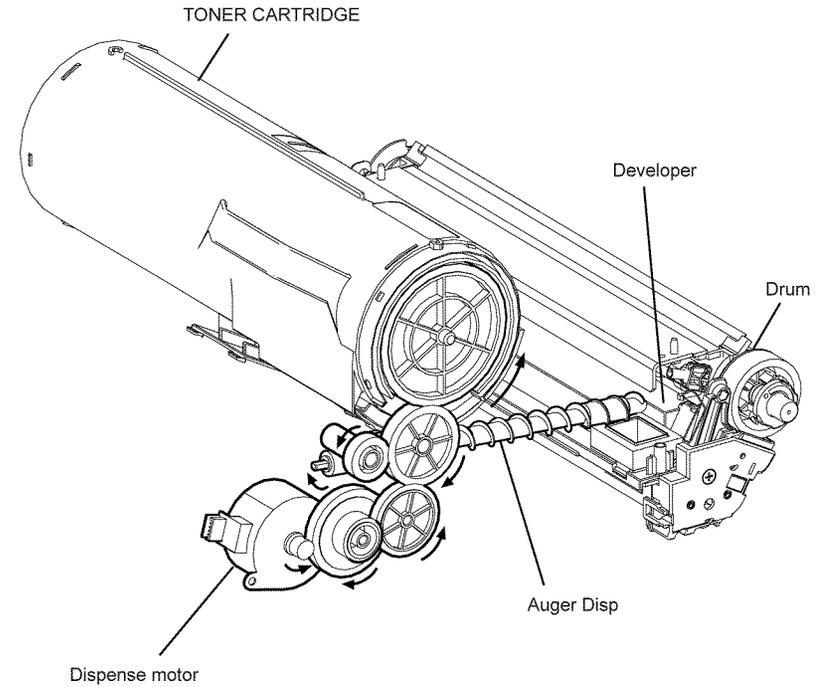
Figure 6 Toner feeding

- The toner in the toner cartridge is fed into the developer unit by the auger driven by the dispense motor. Refer to Figure 6.

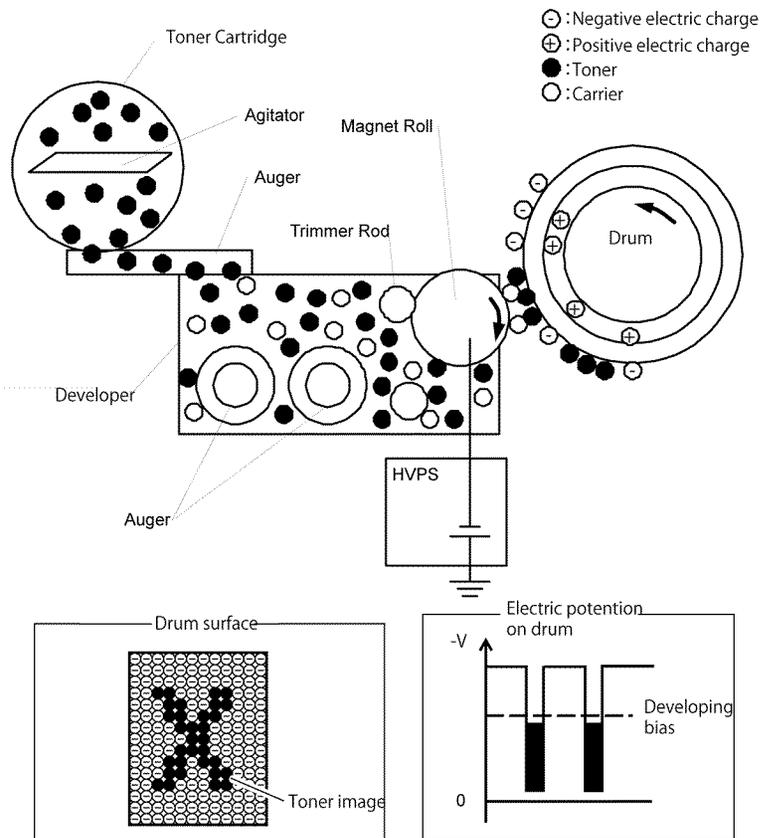
Figure 7 Development

- In the developer section, the incoming toner is mixed with the existing developer (toner/carrier mixture) by the auger, and then supplied to the magnet roll located near the drum surface. The toner and carrier are charged by friction due to agitation (toner in negative, carrier in positive), and they attract each other electrically. The carrier, due to its magnetic properties, is attracted to the magnetized magnet roll, and then uniformly leveled by the trimmer rod.

- The entire surface of the magnet roll is covered by a thin conductive sleeve. The developing bias (DB) voltage is supplied to this conductive sleeve from the high voltage power supply (HVPS). The DB voltage is a DC voltage. The DC voltage keeps the magnet roll at a constant negative voltage against the photoreceptor layer of the drum. Therefore, at the area where the negative electric charge on the drum surface does not decrease, the potential is lower than that of the magnet roll, while the potential is higher than that of the magnet roll at the area where the negative charge on the drum surface decreases. Thus, the negatively charged toner is attracted only to the portions of the drum surface where the negative charge has decreased below that of the magnet roll (electrostatic latent image), forming an image on the drum. Once the toner is deposited on the drum, the toner-attracting force of the corresponding portion decreases because the increase of negative charge lowers the potential at that portion. Refer to [Figure 7](#).

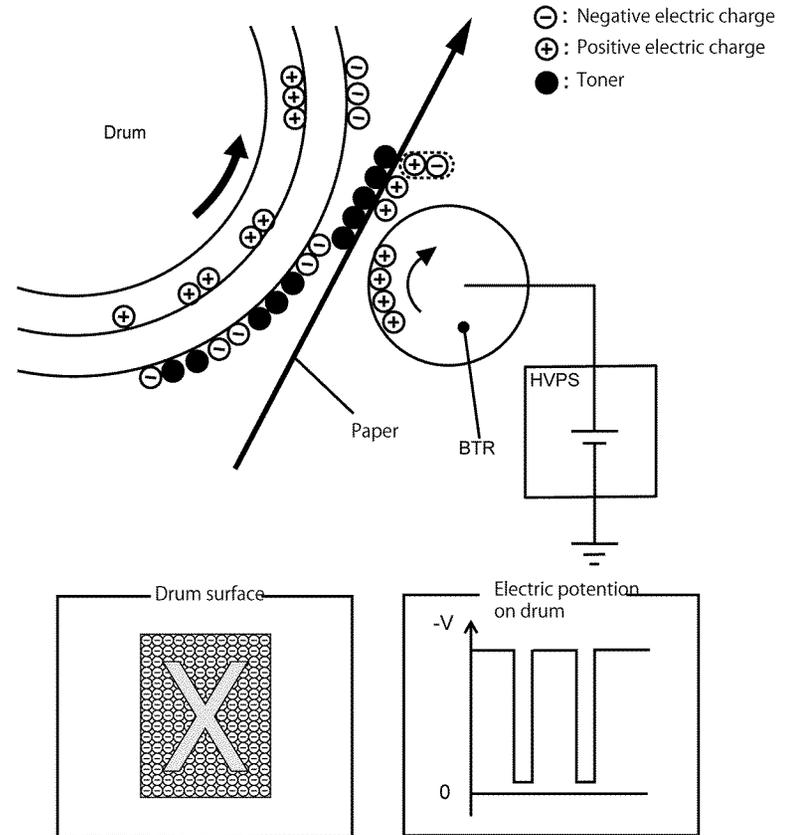
Figure 8 Transfer

During the transfer process, the toner image formed on the drum surface is transferred to the paper via the bias transfer roll (BTR).

- The BTR is a conductive roll, which is located in contact with the drum and is supplied with high voltage from the HVPS. When the paper moves from the BTR to the drum, the BTR applies positive charge to the backside of the paper. The toner image on the drum surface is transferred from the drum to the paper, attracted by the positive charge of the paper backside. The paper is attracted to the drum surface because the negative charge induced in the conductive layer of the drum attracts the positive charge on the paper backside. Refer to [Figure 8](#).

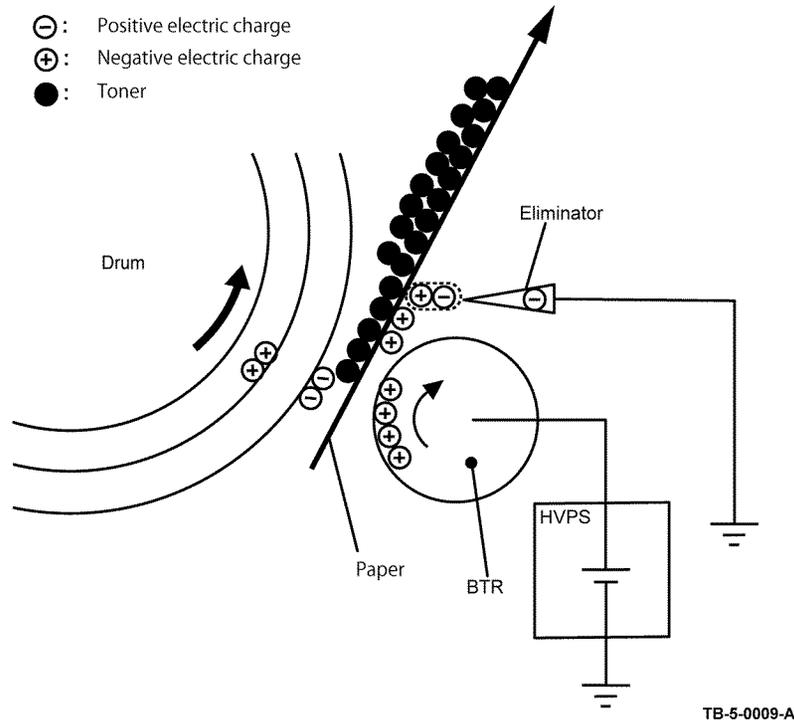
**Figure 9 Neutralization/removal**

This also eliminates the force that attracts the paper to the drum surface, allowing the paper to peel off from the drum due to the elasticity of its own.

- The eliminator neutralizes the charge to prevent the toner on the paper from spreading over the surrounding metal surfaces. The eliminator is a metal sheet that is held at the ground level. It neutralizes the positive charge applied during the transfer process by applying negative charge to the backside of the paper. Refer to [Figure 9](#).

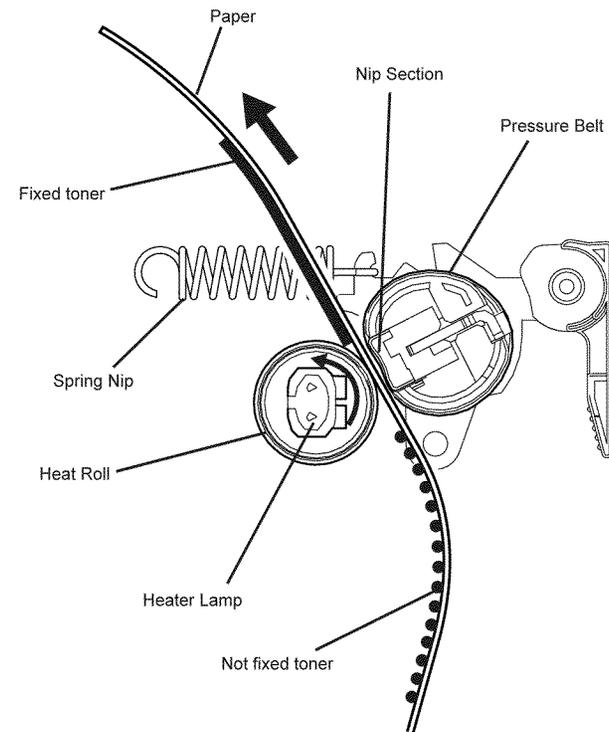
**Figure 10 Fusing**

During the fusing process, toner is fixed onto the paper by heat and pressure.

- The toner particles are melted by the heat roll heated by the heater lamp, and fused onto the print medium by the pressure between the heat roll and the pressure belt.
- The pressure belt friction-driven by the heat roll nips the paper against the heat roll using the pressurizing mechanism contained in the pressure belt. Refer to [Figure 10](#).

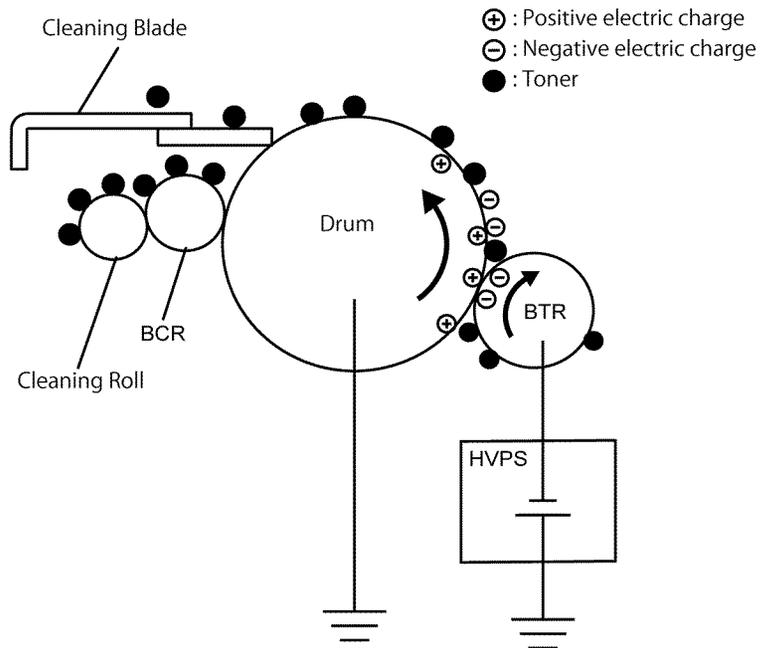
Figure 11 Cleaning

- Drum cleaning. The toner that was not transferred to the drum surface during the transfer process remains on the drum surface. To prevent the remaining toner on the drum surface from causing image quality defects during the subsequent process, the cleaning blade in contact with the drum scrapes off the remaining toner, and transports it to the waste toner collecting area.

- BCR cleaning. The cleaning roll, made of spongy material, contacts the BCR surface and scrapes off the remaining toner, and transports it to the waste toner collecting area.

- BTR cleaning. The excess toner deposited on the BTR during the transfer process contaminates the backside of the subsequent sheets. To prevent this, the HVPS sends negative high voltage (contrary to the transfer process) to the BTR to reverse-transfer the toner from the BTR to the drum. The cleaning blade in contact with the drum scrapes off the reverse-transferred toner from the drum, and transports it to the waste toner collecting area. Refer to [Figure 11](#).

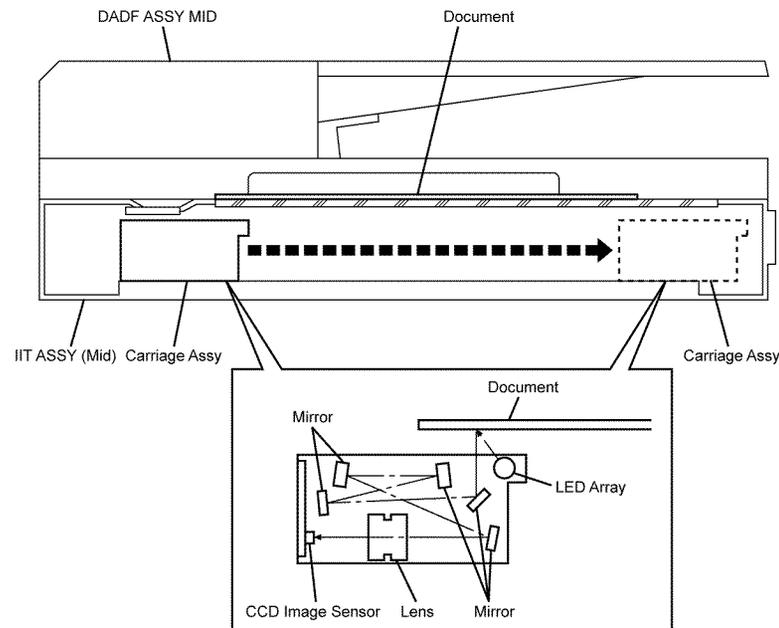
Figure 1 Platen scanning

The carriage assembly consists of the LED array for illuminating a document, the CCD image sensor for photo electronic converting image data, the mirrors and the lens.

By the drive from the carriage motor, the carriage assembly in the IIT moves at the shifting speed corresponding to the set magnification and irradiates the document by the LED array. The optical image of the document irradiated by the LED array is reflected by the multiple mirrors, passed through the lens, and then scanned by the CCD image sensor. Refer to Figure 1.

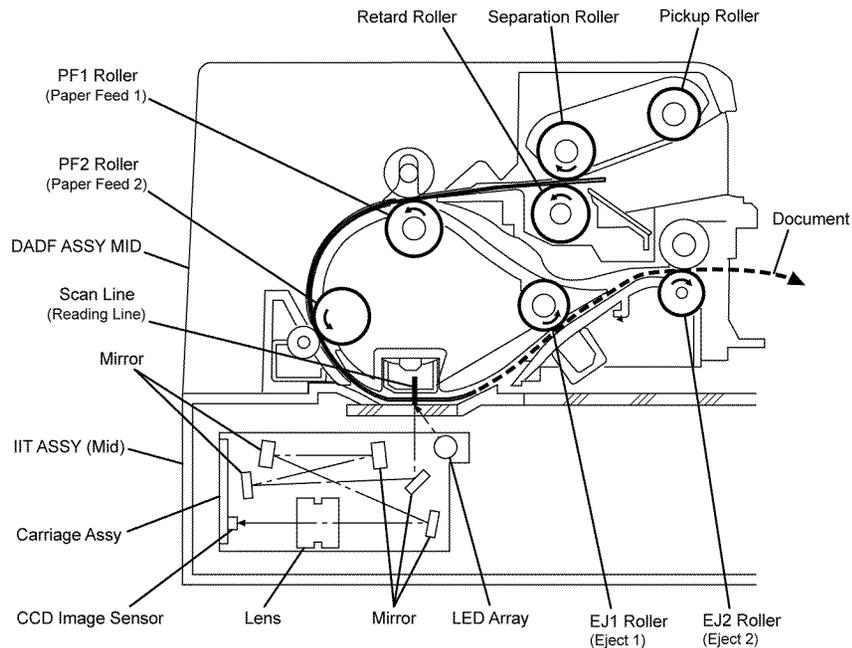
Figure 2 DADF scanning

When the document being fed by the torque from the pick motor and DADF motor at the speed corresponding to the set magnification passes the scanner home position (constant velocity transport (CVT)) of the carriage assembly in the IIT, allowing the reflected image to be read by the CCD image sensor through the rod scope. Refer to [Figure 2](#).

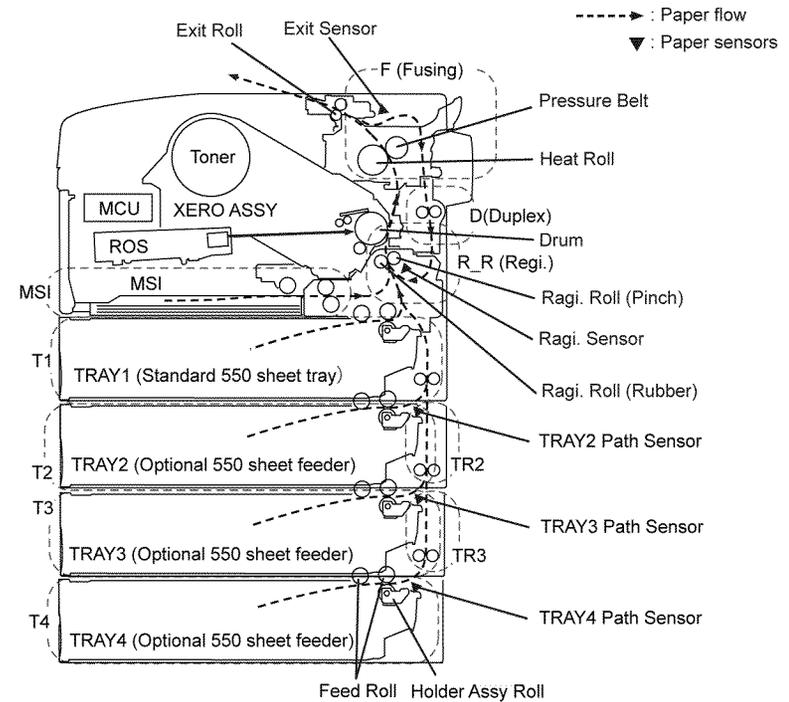
Figure 1 Paper path

Figure 1 shows the paper path layout and the paper path-related components of the configuration with the optional 550 sheet feeder.

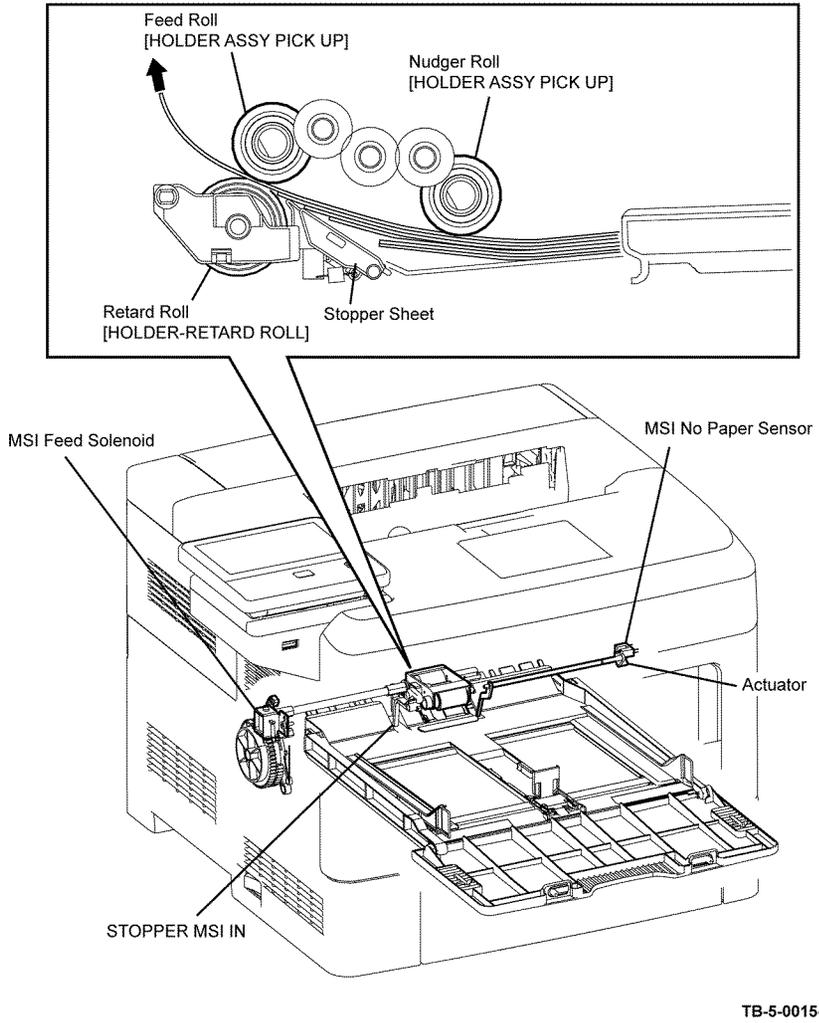
Figure 2 MSI feed

The feed roll and the nudger roll rotate driven by the main drive assembly, to feed the sheet to the position where it is nipped between the feed roll and the retard roll.

If multiple sheets are fed together, the friction with the stopper sheet and the retard roll prevents the bottom sheets from going any further, allowing only the top sheet to pass. Refer to [Figure 2](#).

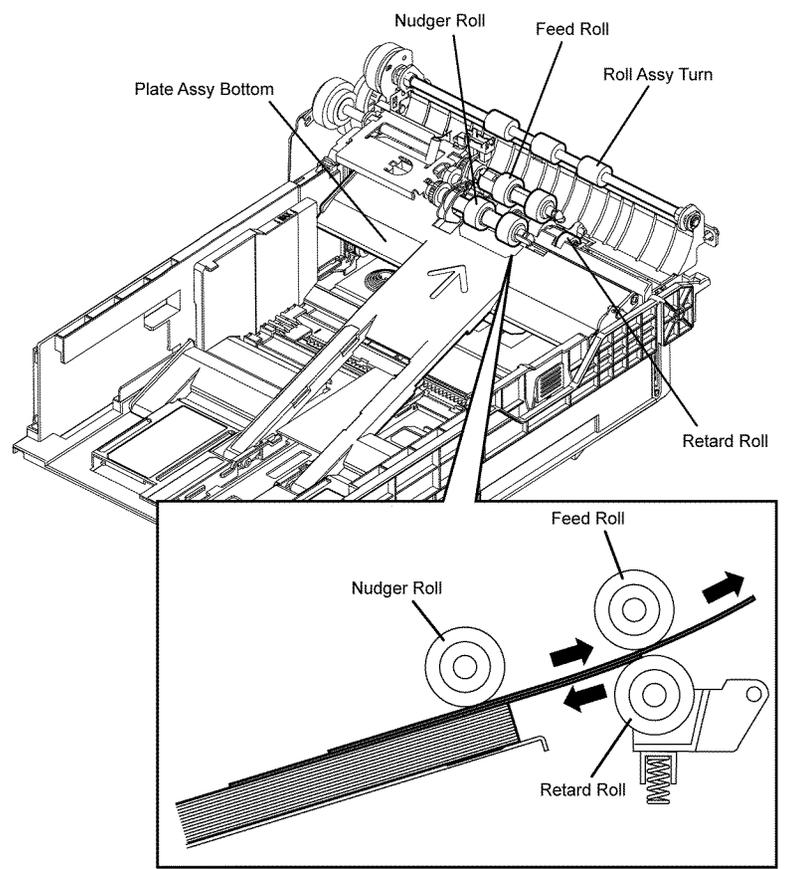
Figure 3 Tray feed

Sheets loaded in the tray are fed by the nudger roll to the position where it is nipped between the feed roll and the retard roll. The retard roll separates the sheets by the rotational friction obtained by being pressurized to the feed roll by the spring from below. If multiple sheets are fed together, the retard roll is braked to stop by the built-in torque limiter, and prevents, by friction, the bottom sheets from going any further, allowing only the top sheet to pass. The plate assembly bottom rises by the spring pressure as the sheet stack becomes thinner. Refer to Figure 3.

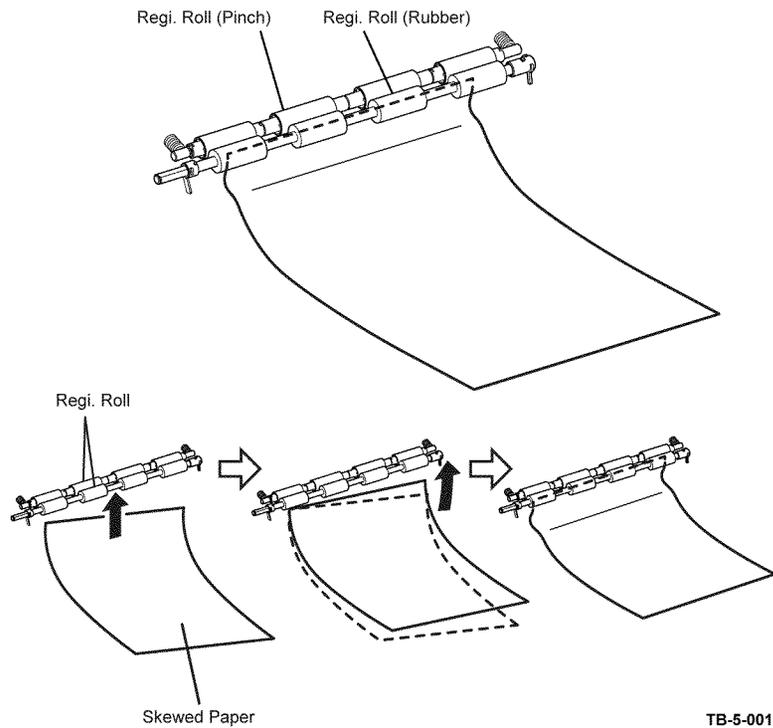
**Figure 4 Registration**

To avoid this, the lead edge position needs to be adjusted at the registration section before the sheet is fed to the toner transfer section.

By thrusting the edge of the sheet coming out of the tray or MSI against the registration roll, the lead edge of the sheet is correctly adjusted. Refer to [Figure 4](#).

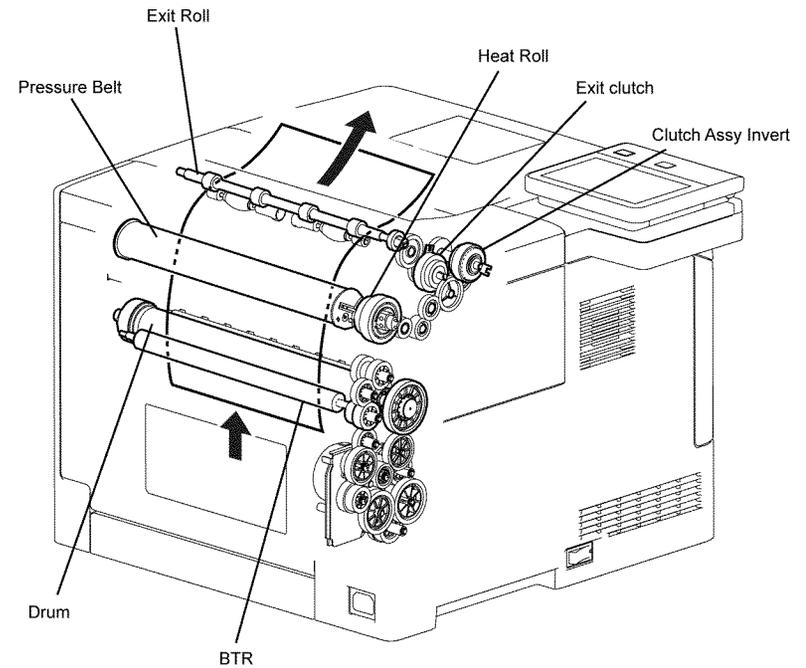
**Figure 5 Exit**

As the sheet is forwarded to the exit section, the toner image is fused onto the sheet surface by the heat roll that rotates driven by the main drive assembly.

At the exit, the torque from the main drive assembly is conveyed to the exit roll by energizing the exit clutch to forward the sheet to the exit direction. Refer to [Figure 5](#).

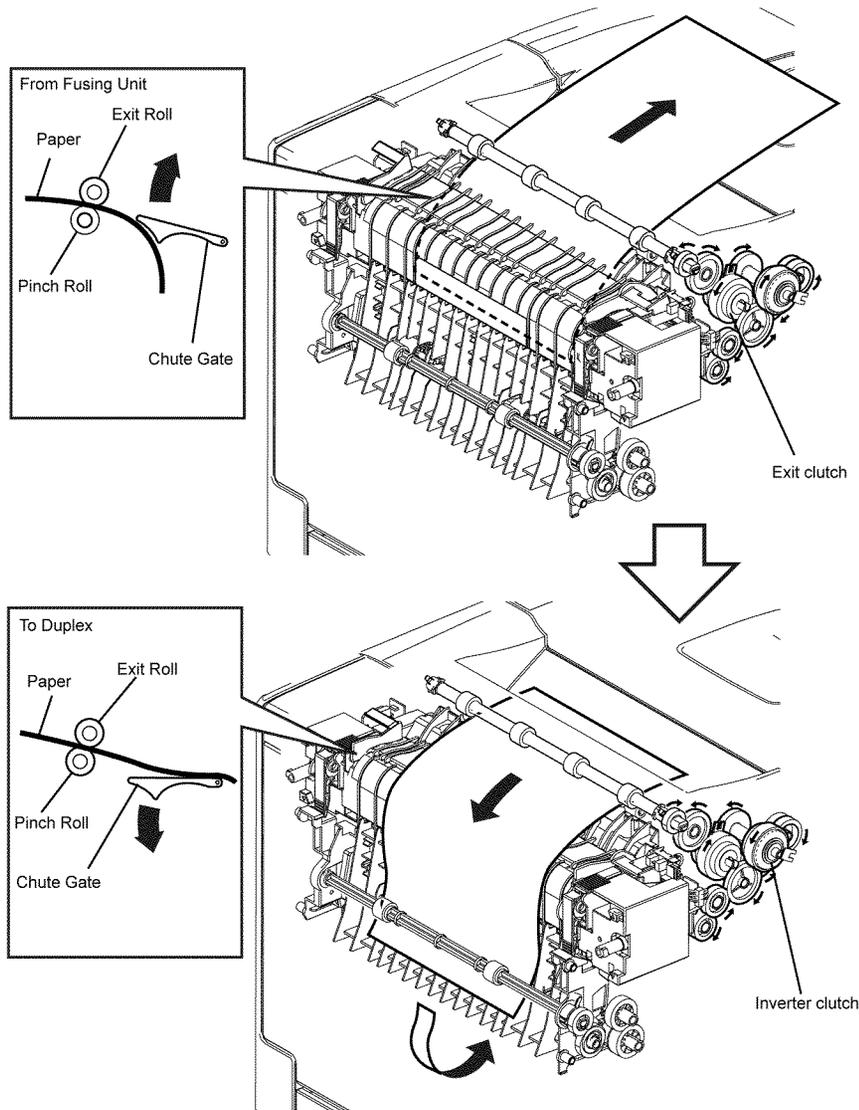
Figure 6 Duplex

After the printing of the side 1 is completed and the lead edge of the sheet passes the chute gate, the inverter clutch is energized and the exit roll rotates toward the duplex path. The chute gate lowers under its own weight, and the sheet is fed toward the duplex path.

The duplex roll rotates driven by the main drive assembly to feed the sheet to the registration position. Refer to [Figure 6](#).

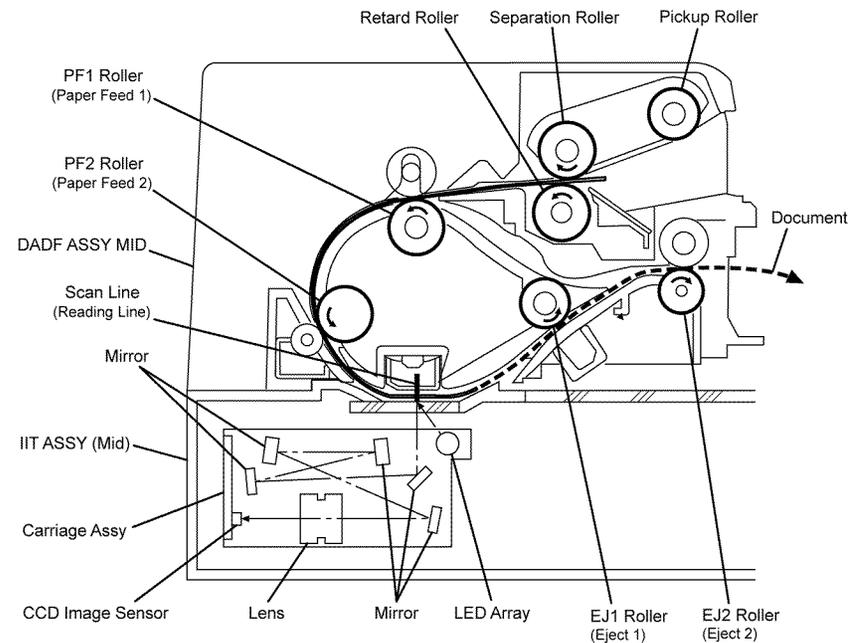
Figure 7 DADF simplex document path

Inside the DADF, the sheet is fed by the paper feed 1 roller and paper feed 2 roller that rotates by the torque from the DADF motor to the scanner home (CVT) position in the carriage assembly, and is scanned.

After being scanned, the sheet is ejected to the document output tray of the DADF by the eject 1 roller and eject 2 roller that rotates by the torque from the DADF motor. Refer to [Figure 7](#).

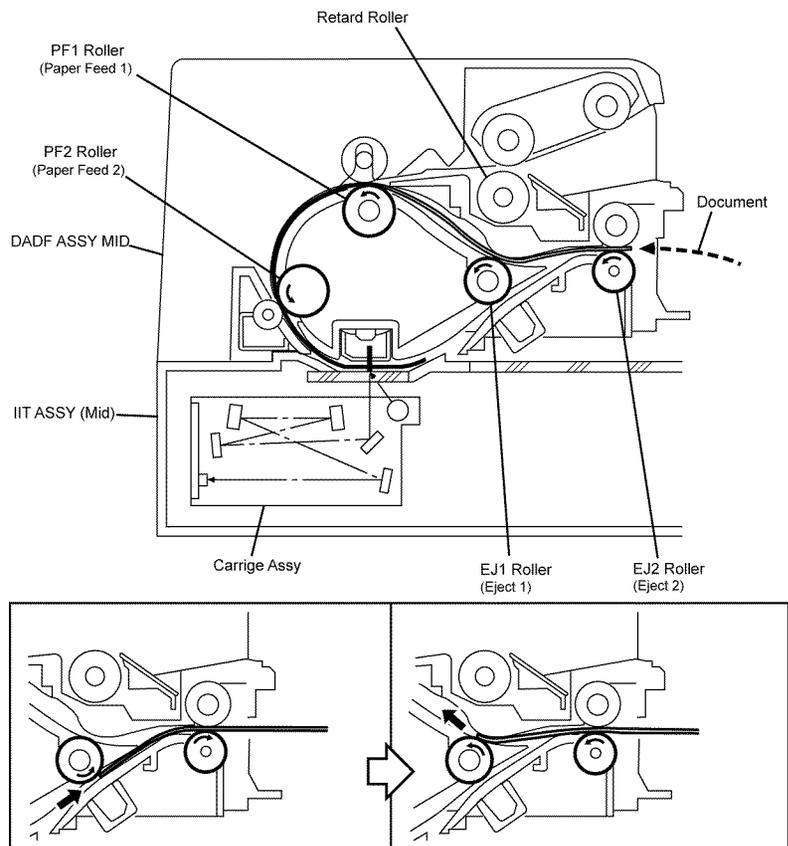
Figure 8 DADF duplex document path

After scanning a document is completed and the rear edge of the document is passed through the flapper gate, the eject 2 roller is reversed by the reverse drive of the DADF motor, and the document is nipped into the DADF. The document is reversed at this time.

When the document is fed near side of the paper feed 1 roller, the DADF motor returns to the positive rotation drive, and the document is fed to the scanner home position (CVT) by the torque from the paper feed 1 roller and paper feed 2 roller. The document scanned at the CVT position is fed to the document output tray of the DADF by the eject 1 roller and eject 2 roller. Refer to [Figure 8](#).

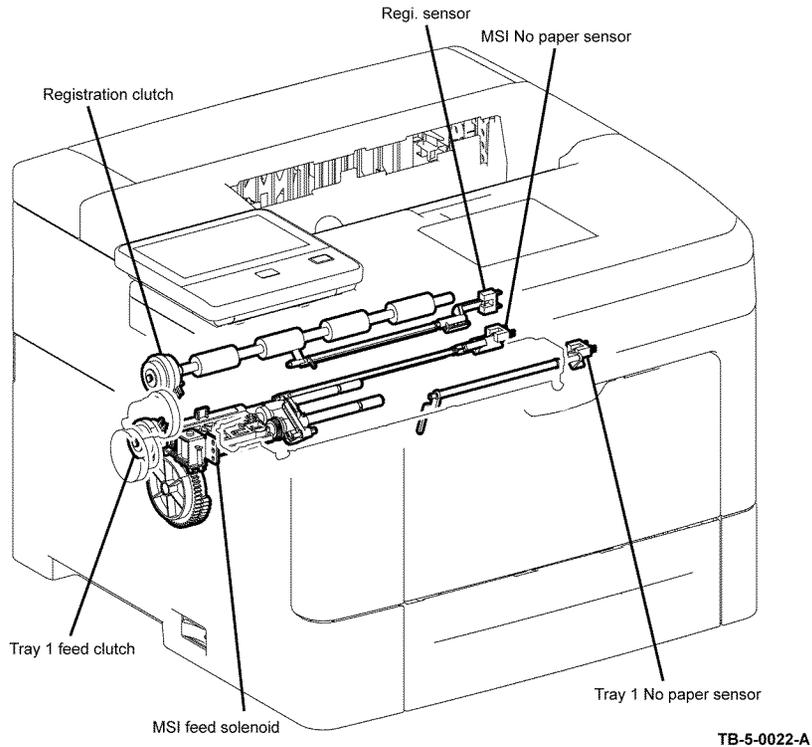
**Figure 1 Paper feeder**

Refer to [Figure 1](#). The major components are listed below:

- Registration clutch. Transmits the torque of the main drive assembly to the registration roll.
- Tray feed clutch. Transmits the torque of the main drive assembly to the feed roll and the nudger roll of tray 1.
- MSI solenoid feed. Releases the stopper of the MSI to allow the nudger roll to contact the top sheet of the stack loaded in the MSI.
- Registration sensor (mounted on the HVPS). Detects that the lead edge of the paper has reached the registration section based on the change of the actuator position.
- Tray 1 no paper sensor (mounted on the HVPS). Detects the presence/absence of sheets in tray 1 based on the change of the actuator position.
- MSI no paper sensor (mounted on the HVPS). Detects the presence/absence of sheets in the MSI based on the change of the actuator position.

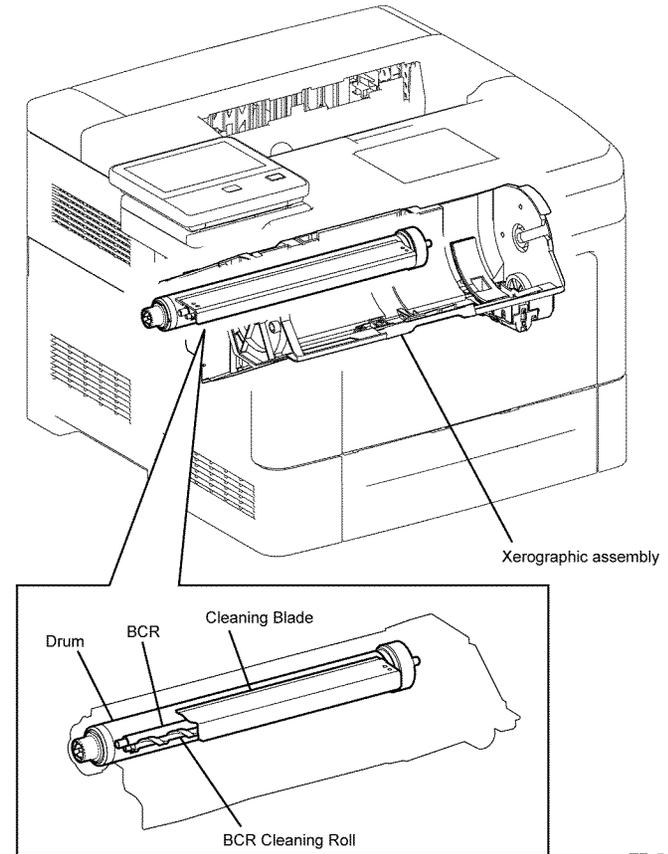
**Figure 2 Charging/cleaning**

Refer to [Figure 2](#). The major components are listed below:

- The drum forms an electrostatic latent image and a toner image.
- The BCR charges the drum electrically.
- The cleaning blade removes the toner remaining on the drum after the toner image is transferred to the paper.
- The BCR cleaning roll removes the toner remaining on the BCR.

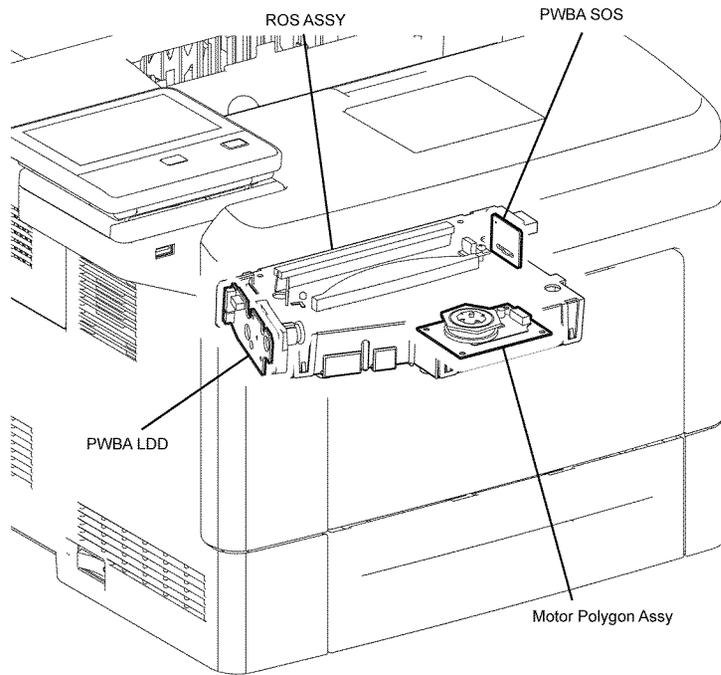
Figure 3 ROS

The ROS assembly is an exposure device that emits laser light to form an electrostatic latent image on the Drum surface. Refer to [Figure 3](#). The major components are listed below:

- PWB LDD. Converts the image data coming in from the PWB ESS SFP to the ROS assembly into laser light, and illuminate the built-in laser diode.
- Motor Polygon assembly. Consists of the scanner motor that rotates at a constant speed and of the polygon mirror installed on the motor shaft.
- PWB SOS. A PWB equipped with the SOS sensor. The SOS sensor converts the incoming laser light into an electrical signal as the reference point for scanning start, and sends it to the PWB MCU.

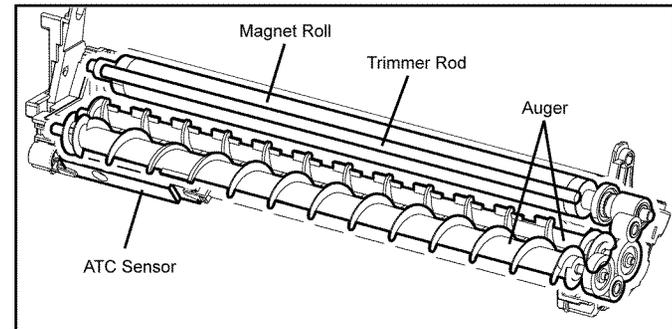
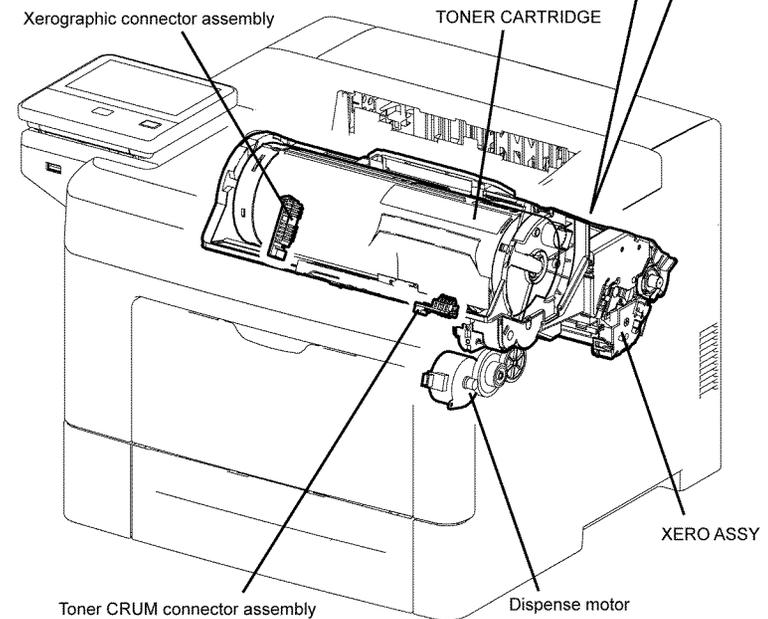
Figure 4 Development

- Toner cartridge. Contains toner and is installed with the customer replaceable unit memory (CRUM) that stores cartridge-specific information.
- Toner CRUM connector assembly. Contacts the CRUM installed on the toner cartridge to relay the cartridge-specific data stored in the CRUM to the PWB MCU.

- Xerographic connector assembly. Contacts the CRUM installed on the drum cartridge to relay the component-specific data stored in the CRUM to the PWB MCU.

- The drum cartridge is installed with the CRUM that stores component-specific information.
