VersaLink[®] C500/C600 Printer and C505/C605 Multifunction Printer Service Manual

Xerox VersaLink C605F Family Printer Service Manual

705P01395

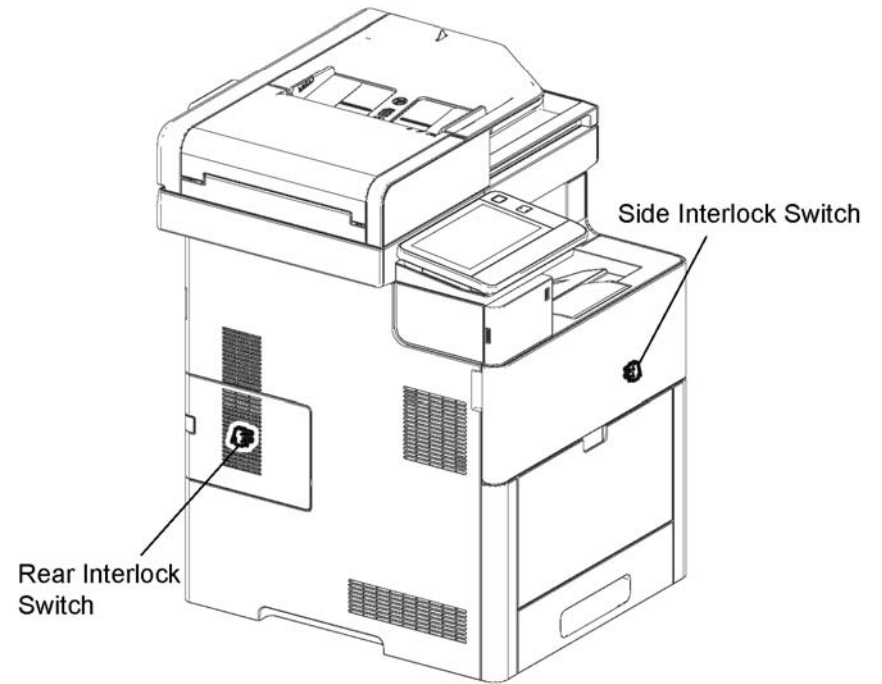
D-8-0001-A

Figure 1 Safety interlock switches

Use caution so that the safety devices for preventing accidents (interlocks switches, fuses, thermostats, etc.) and the protective parts for users (covers, control panel, etc.) can function as intended. Make sure all covers are in place and all interlock switches are functioning correctly after you have completed a service call. If you bypass an interlock switch, use extreme caution when working on or around the printer. [Figure 1](#) and [Figure 2](#) show the interlock switch locations and circuitry.

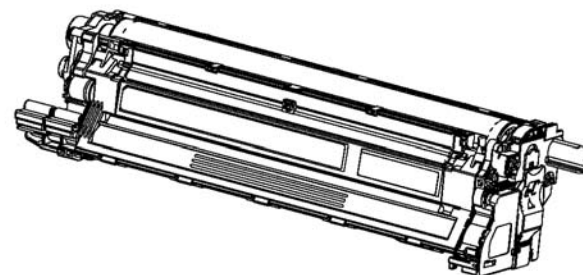
D-8-0004-A

Figure 2 Drum cartridge

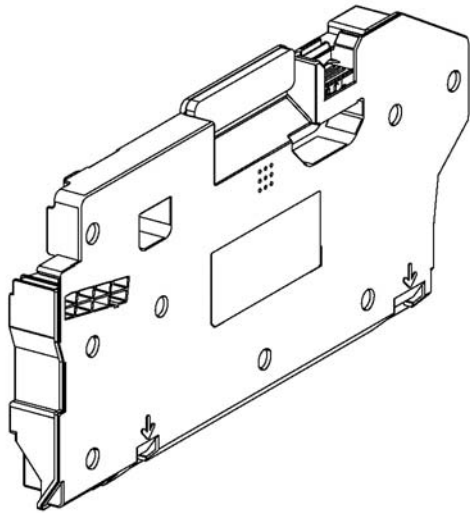
D-8-0005-A

Figure 3 Waste Cartridge

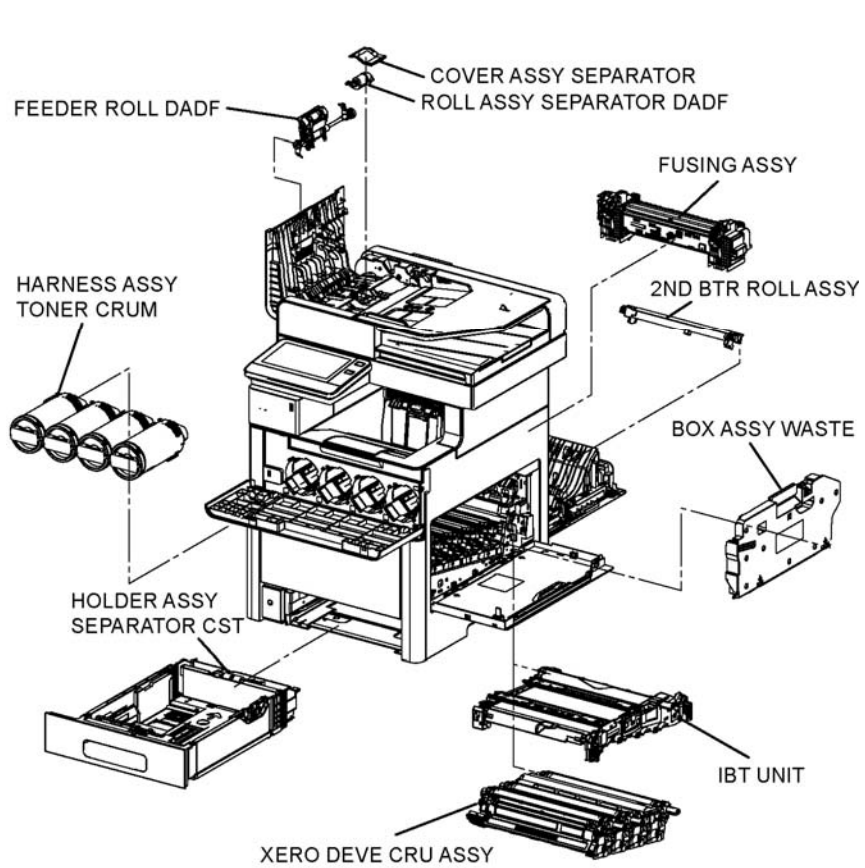
D-8-0006-A

Figure 4 MFP routine maintenance items

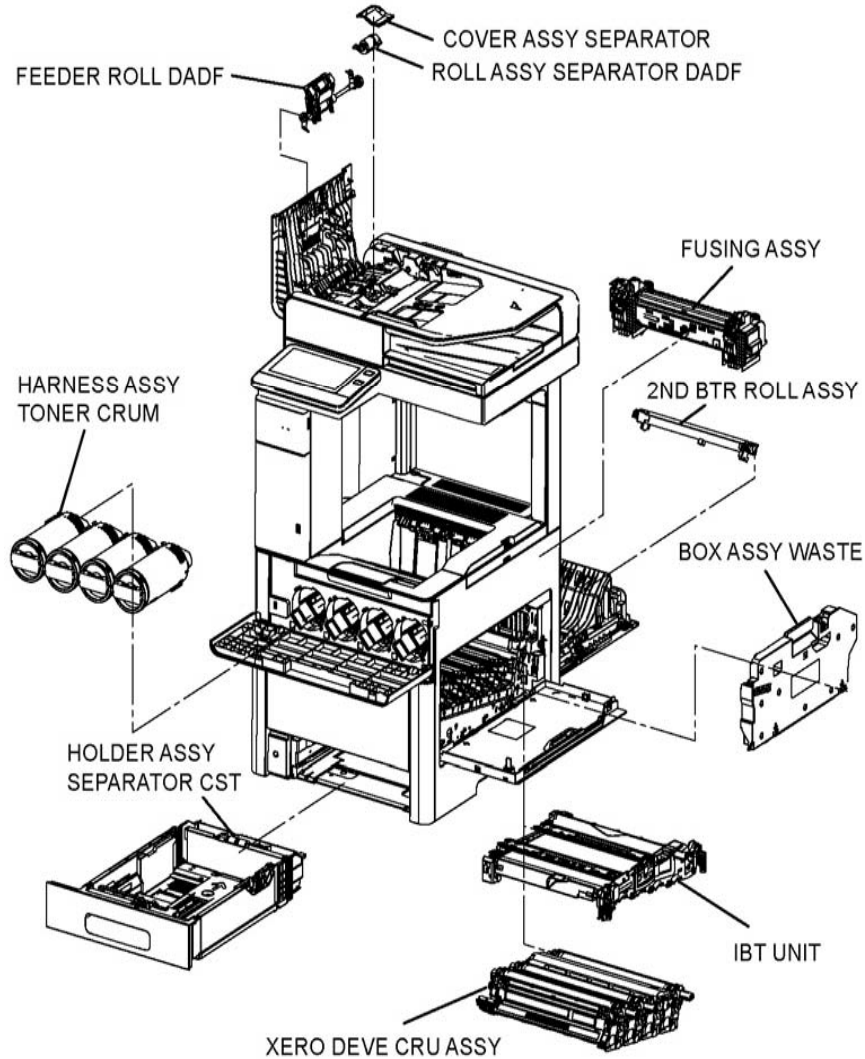
D-8-0007-A

Figure 5 MFP_Tall routine maintenance items

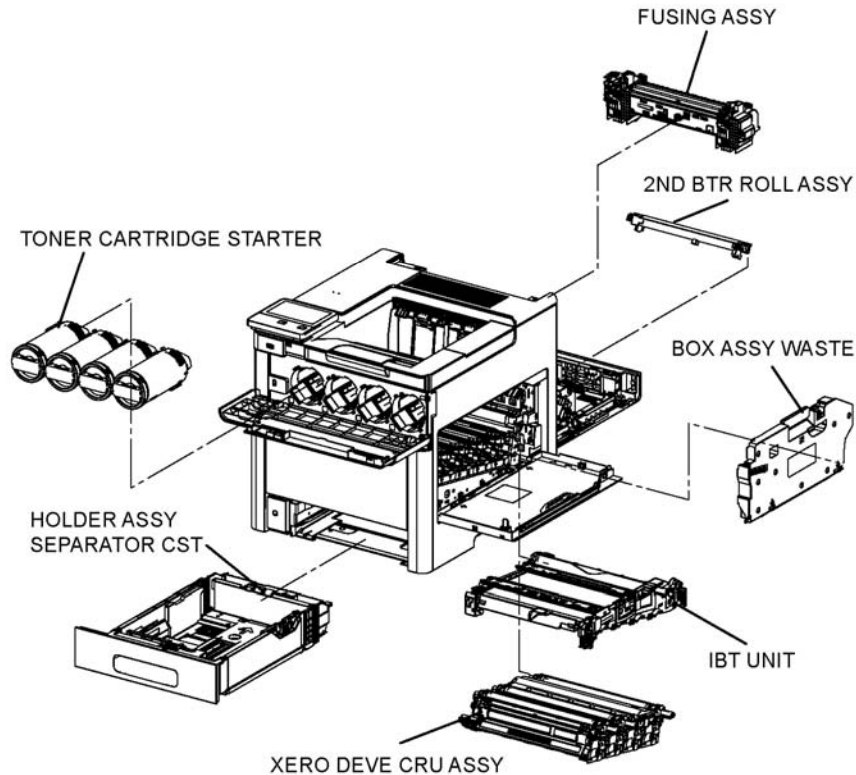
D-8-0008-A

Figure 6 SFP routine maintenance items

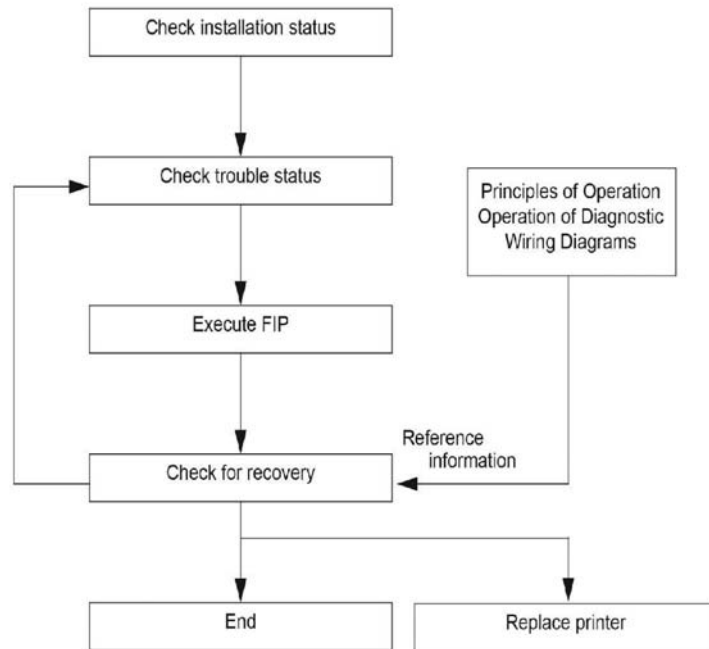
Figure 1 Troubleshooting Flow Diagram

Flow of the troubleshooting is as follows:

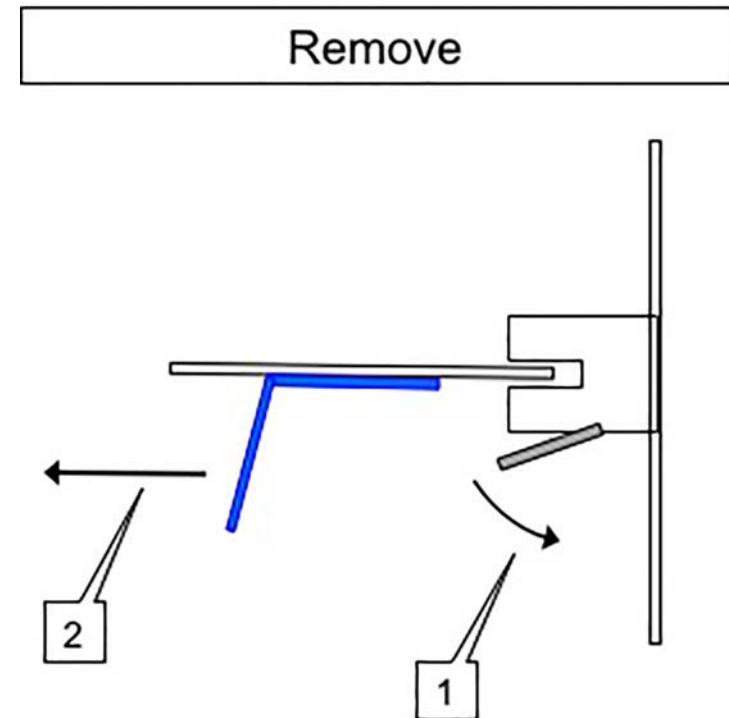
010-331: Fusing Assembly HR STS Over Temperature Fail

NOTE: When engaging the release lever on the FFC connector, slightly open the release lever no more than 15 degrees. Hold the lever while gently removing the FFC from the connector as shown in Figure 1.

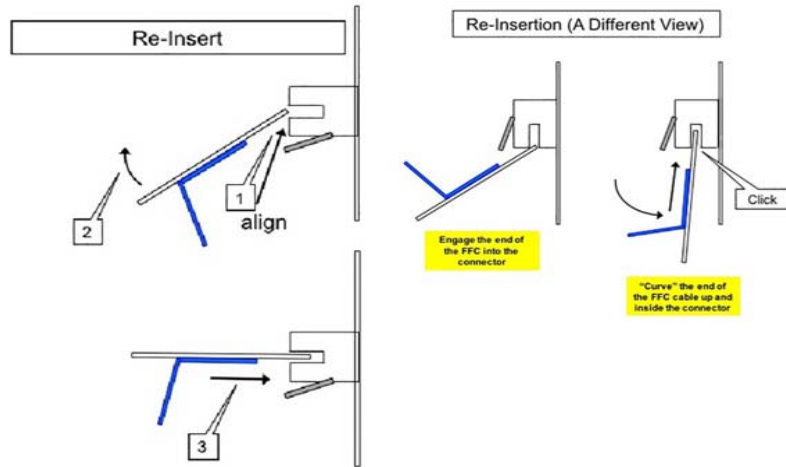
1. Slip the core down the FFC cable.
2. To ease installation and ensure proper alignment of the FFC cable, bend the blue “grip tab” 90 degrees perpendicular to the FFC.
3. Refer to Figure 2, grasp the grip tab of the FFC cable placing the back, or non-conductive side, of the FFC cable against the edge of the connector and centered to the connector.

Figure 2 Proper FFC Cable Insertion.

4. Using the grip tab bent at 90 degrees, firmly push the FFC cable into the connector until fully seated. The latch of the connector will “click” when fully seated, locking the FFC in place.

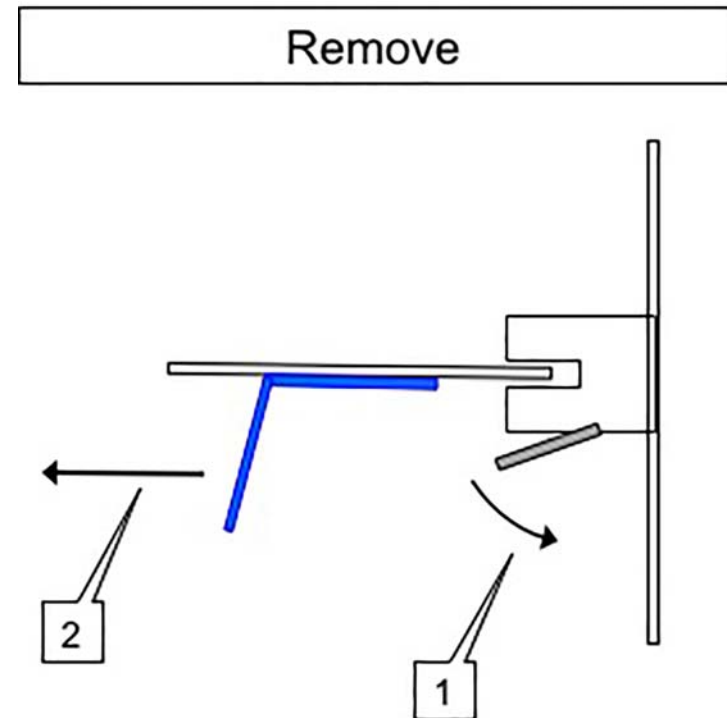
NOTE: When engaging the release lever on the FFC connector, slightly open the release lever no more than 15 degrees. Hold the lever while gently removing the FFC from the connector as shown in Figure 1.

Figure 1 Proper FFC Cable Removal

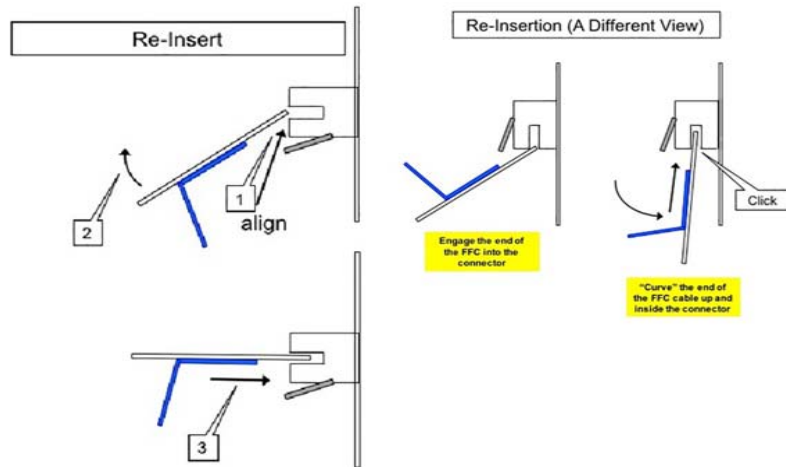
- Refer to Figure 2, grasp the grip tab of the FFC cable placing the back, or non-conductive side, of the FFC cable against the edge of the connector and centered to the connector.

Figure 2 Proper FFC Cable Insertion.

- Using the grip tab bent at 90 degrees, firmly push the FFC cable into the connector until fully seated. The latch of the connector will “click” when fully seated, locking the FFC in-place.

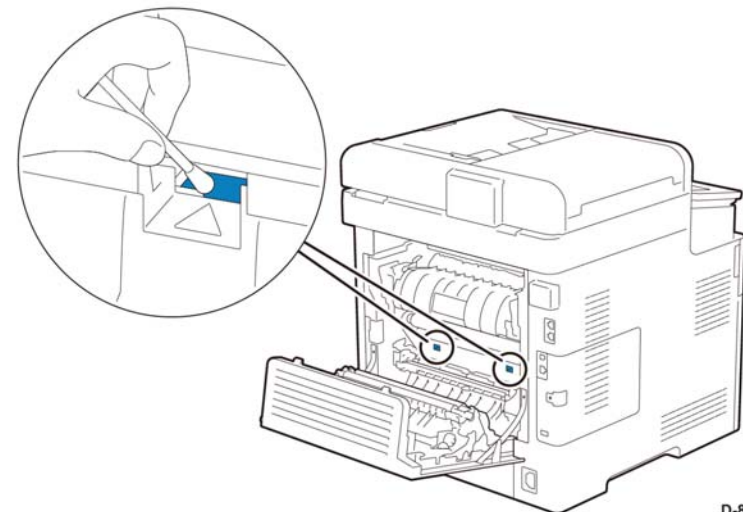
D-8-0461-A

1. Turn the printer off, GP 4
2. Pull up the handle lever of the rear cover, and open the rear cover.
3. Clean the CTD sensor with a clean and dry cotton swab.

Figure 1 Cleaning the CTD sensor

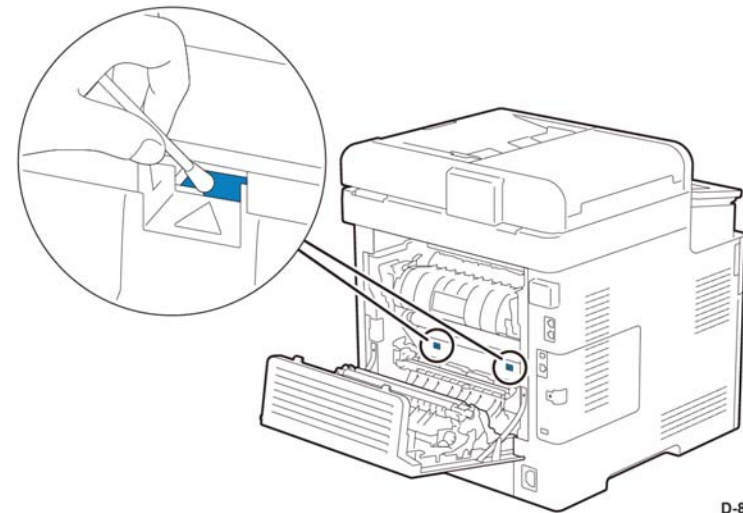
D-8-0461-A

1. Turn the printer off, [GP 4](#)
2. Pull up the handle lever of the rear cover, and open the rear cover.
3. Clean the CTD sensor with a clean and dry cotton swab.

Figure 1 Cleaning the CTD sensor

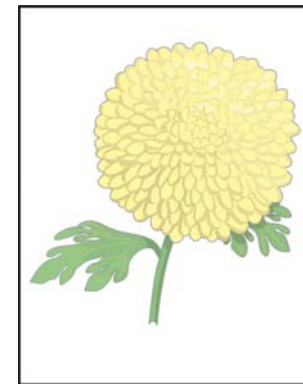
Light or Undertone Print

Figure 1 Light or undertoned print example

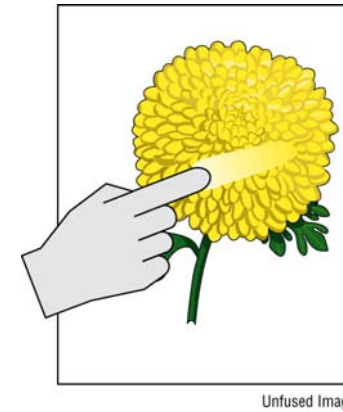
Figure 1 Unfused image example

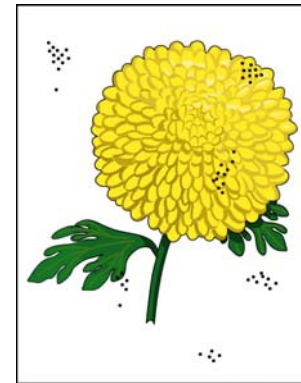
Random Spots

Figure 1 Random spots example

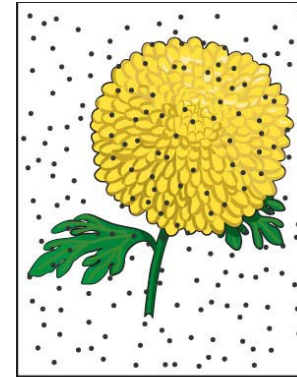
Bead Carryout

Figure 1 Bead carry-out example

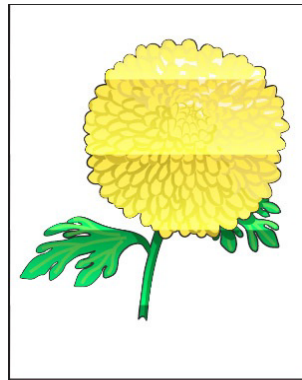
Light Induced Fatigue

Figure 1 Light-induced fatigue example

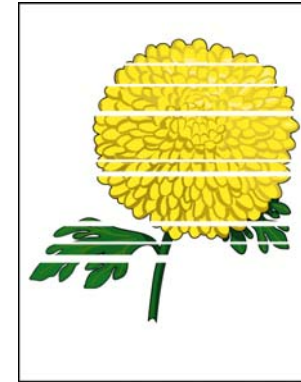
Horizontal Band, Void, or Streaks

Figure 2 Horizontal bands, voids, or streaks example

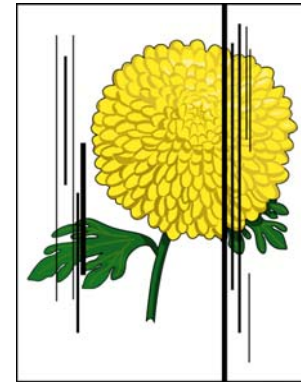
Vertical Stripes

Figure 1 Vertical streaks example

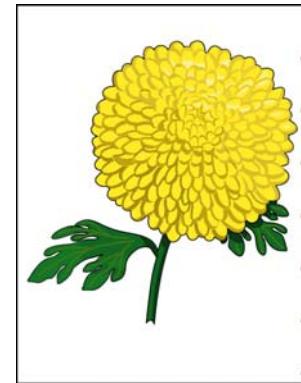
Repeating Defect, Developer Roller

Figure 1 Cyclic dot/ line example

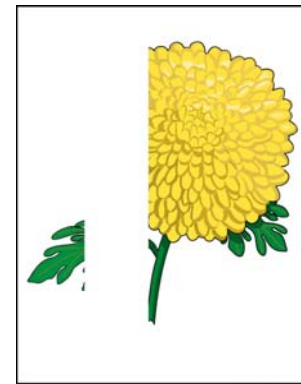
Vertical White Band

Figure 1 Vertical blank deletions (line or streak) example

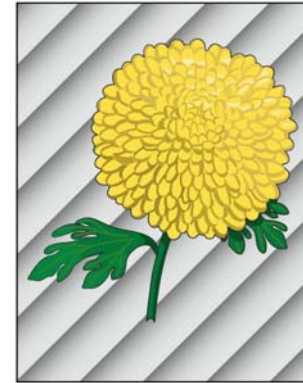
TS Augermark

Figure 1 Diagonal banding (auger marks) example

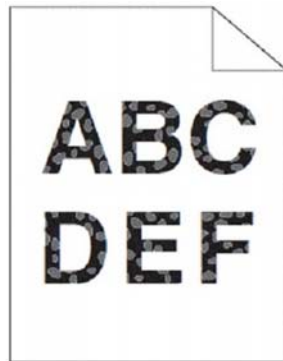
Figure 1 Uneven density example

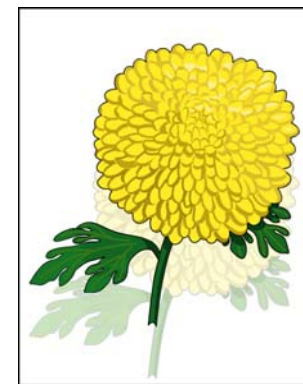
Residual Image/Ghosting

Figure 1 Ghosting example

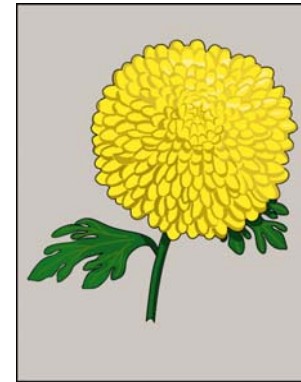
Background Contamination

Figure 1 High background contamination example

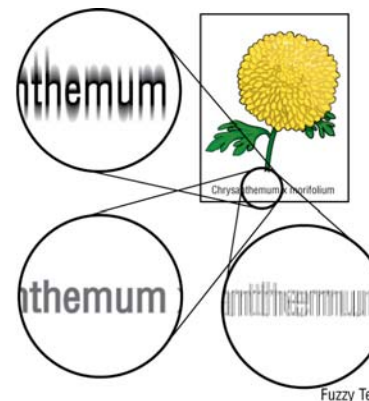
Figure 1 Fuzzy/ blurry text and image example

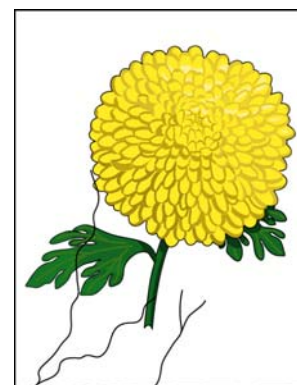
Wrinkling

Figure 1 Wrinkled or creased example

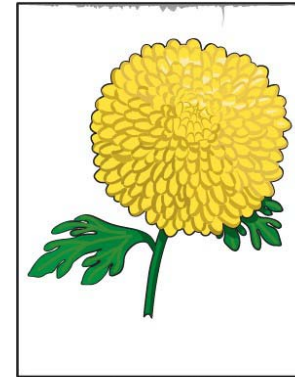
Leading Edge Damage

Figure 1 Leading edge paper damage example

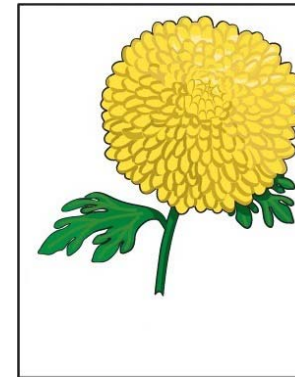
Image Not Centered

Figure 1 Incorrect position or margins example

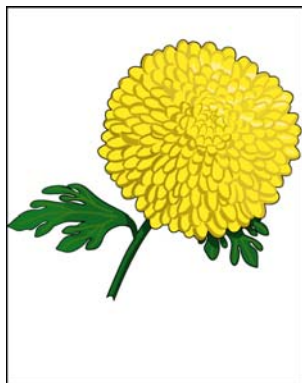
Skew 2

Figure 1 Skewed image example

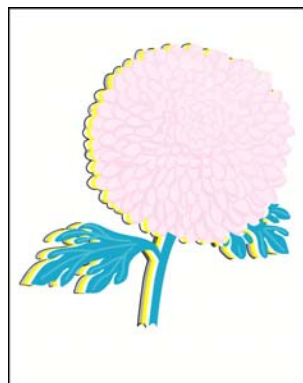
Color Registration

Figure 1 Color registration misalignment example

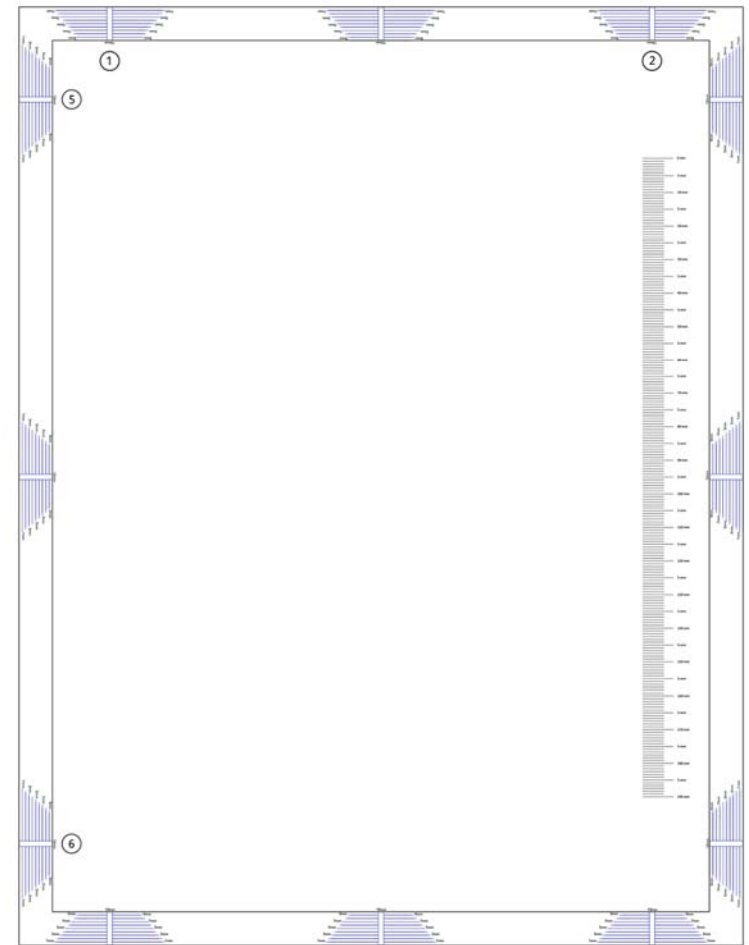
B-1-0360-A

Tray	Flatbed Copy (From Platen)	DADF Copy	IIT Scan from platen to file	IIT + DADF (Scan) Scan to file	IOT (Internal Print)
Side Edge (280mm edge)	Paper Tray	±1.3mm	±2.3mm	±0.6mm	±2.0mm	±1.1mm
	Bypass Tray	±1.3mm	±2.3mm	±0.6mm	±2.0mm	±1.1mm

Figure 1 Skew Check

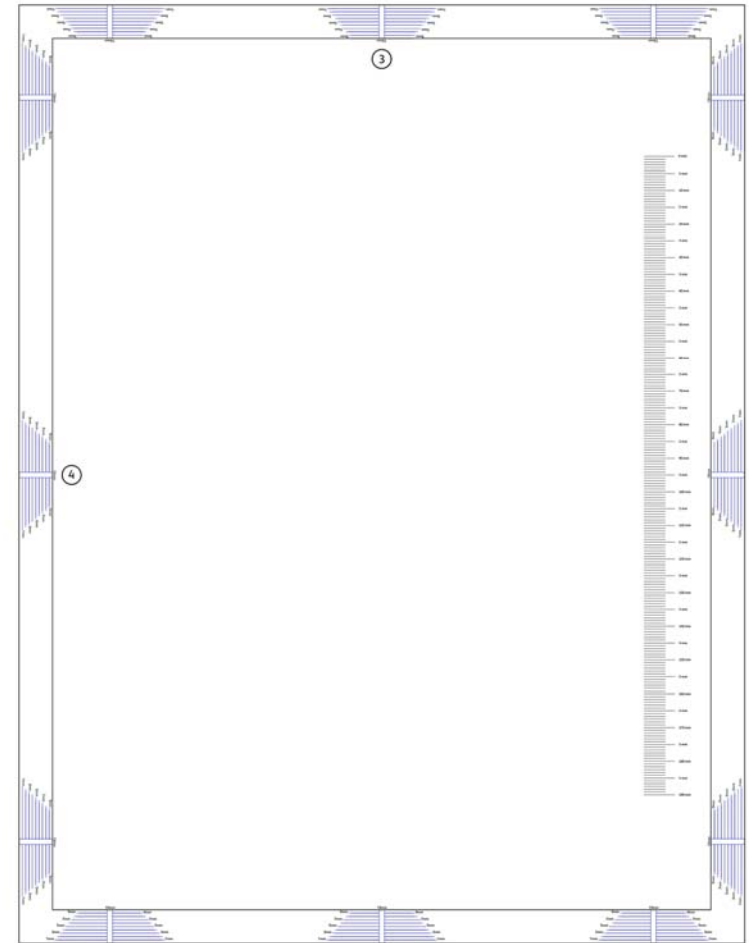
B-1-0361-A

Tray	Flatbed Copy (From Platen)	DADF Copy	IIT Scan from platen to file	IIT + DADF (Scan) Scan to file	IOT (Internal Print)
Lead Edge (180mm edge) Registration	Paper Tray	±2.3mm	±2.9mm	±1.0mm	±2.0mm	±2.0mm
	Bypass Tray	±2.3mm	±2.9mm	±1.0mm	±2.0mm	±2.0mm
Side Edge (280mm edge) Registration	Paper Tray	±2.7mm	±3.0mm	±1.0mm	±1.5mm	±2.5mm
	Bypass Tray	±2.7mm	±3.0mm	±1.0mm	±1.5mm	±2.5mm

Figure 1 Registration Check

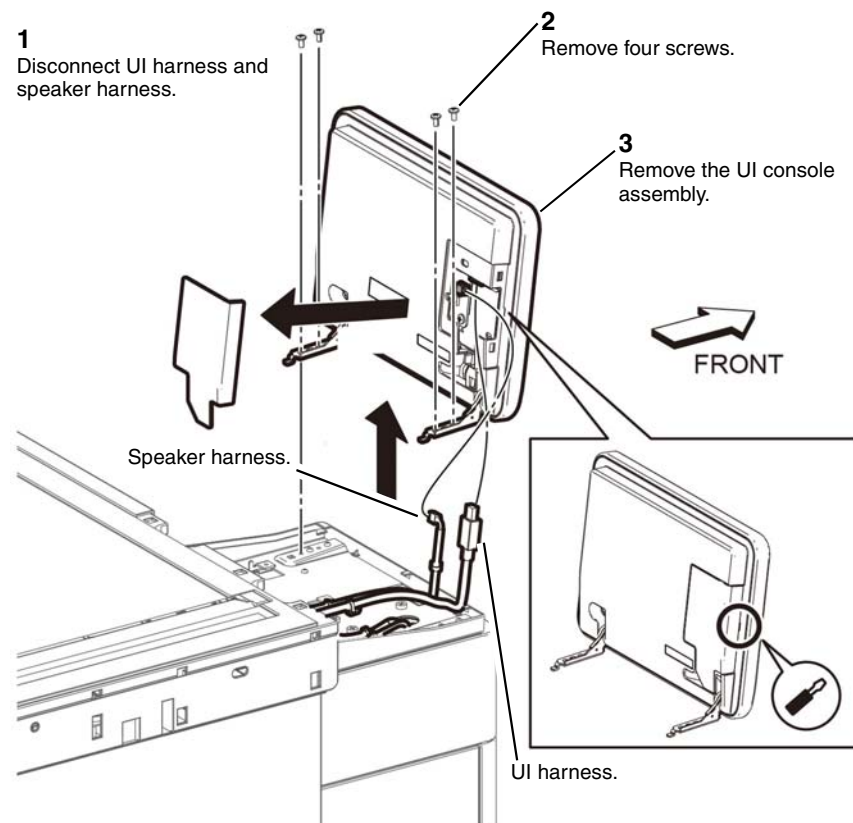
D-8-0018-A

1. Before starting removal of the UI console assembly, print a configuration report. Use the Web UI if necessary.
2. Remove the UI access door from the console, [REP 1.2](#).
3. Remove the UI console assembly from the UI frame assembly, [Figure 1](#).

Figure 1 UI console assembly

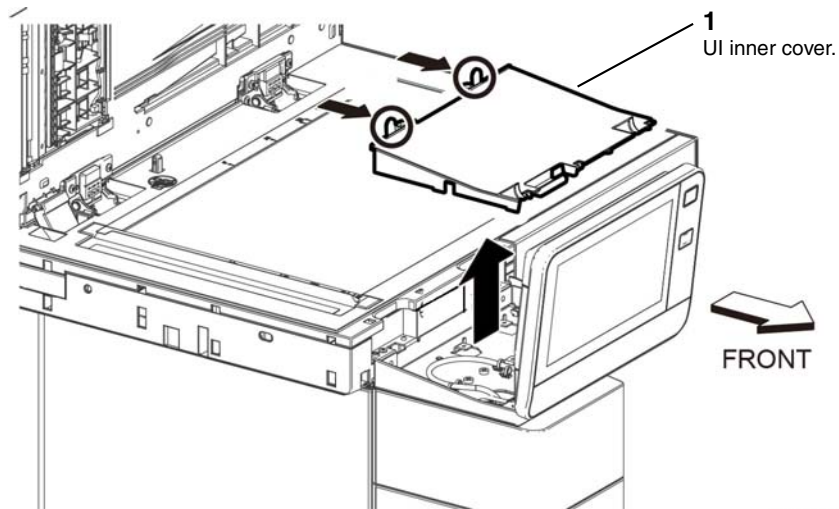
D-8-0017-A

1. Remove the left side IIT cover, [REP 50.5](#).
2. Release two hooks, then remove the UI inner cover, [Figure 1](#).

Figure 1 UI inner cover

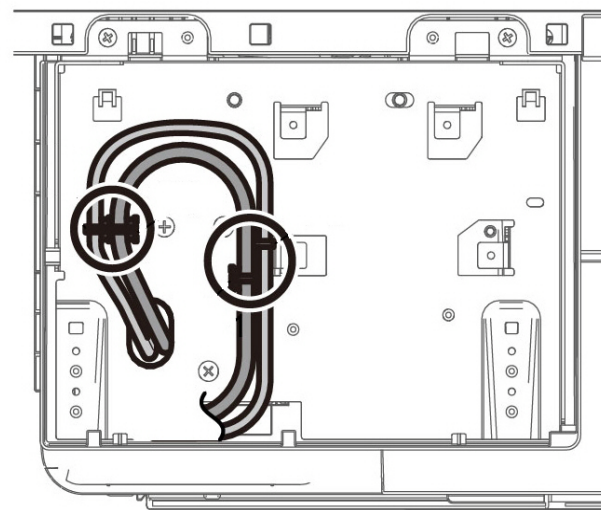
1. Remove the IU inner cover, [REP 1.2](#).
2. Remove the UI console assembly, [REP 1.1](#).
3. Release four push ties, then release the harnesses, [Figure 1](#).

Figure 1 Release push ties

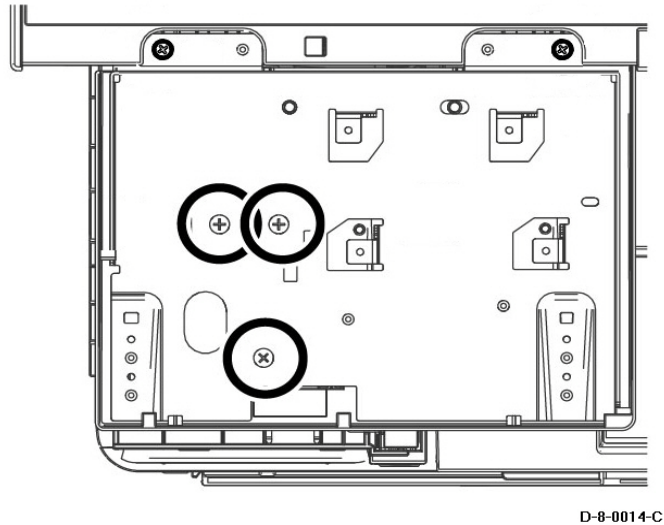
- Remove three screws, then remove the UI frame inner cover, [PL 1.1 Item 3, Figure 2](#).

Figure 2 UI frame inner cover screws

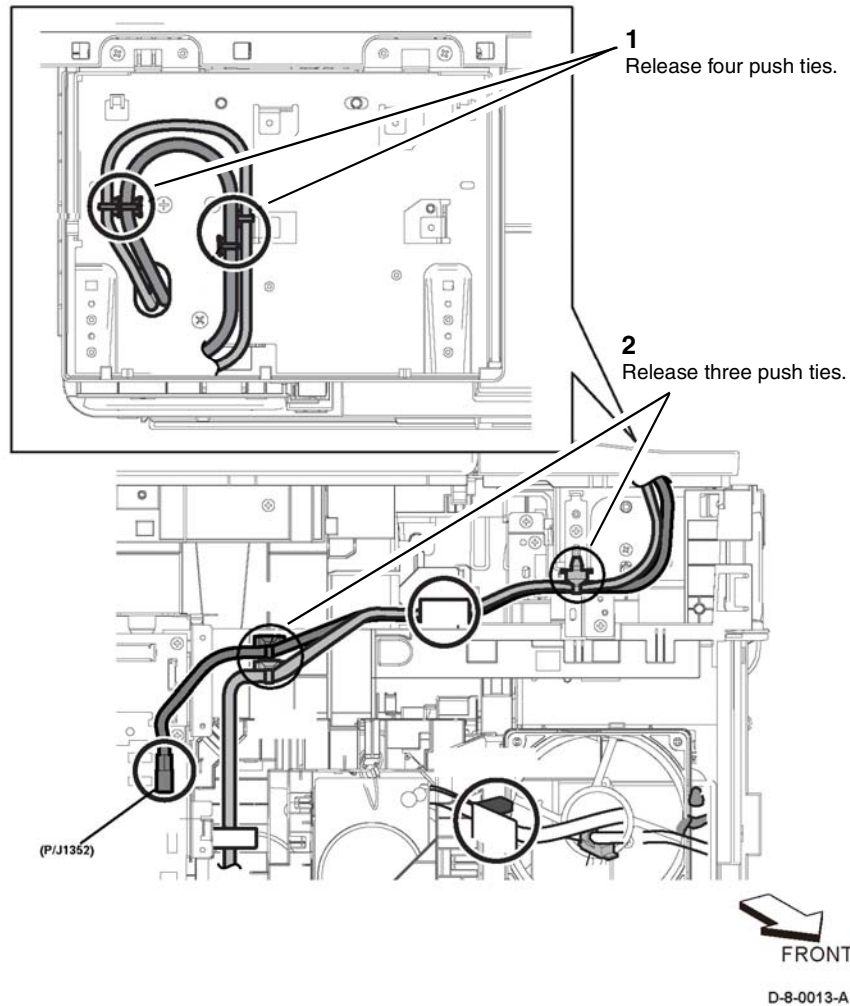
- Remove the UI frame cover, [REP 1.3](#).
- Disconnect the UI harness from the ESS PWB, [P/J1352, Figure 1](#).
- Release four push ties (1) attaching the harnesses to the top cover, [Figure 1](#).

4. Release three push ties (2) holding the speaker harness, then release the harness, **Figure 1**.

Figure 1 UI harness

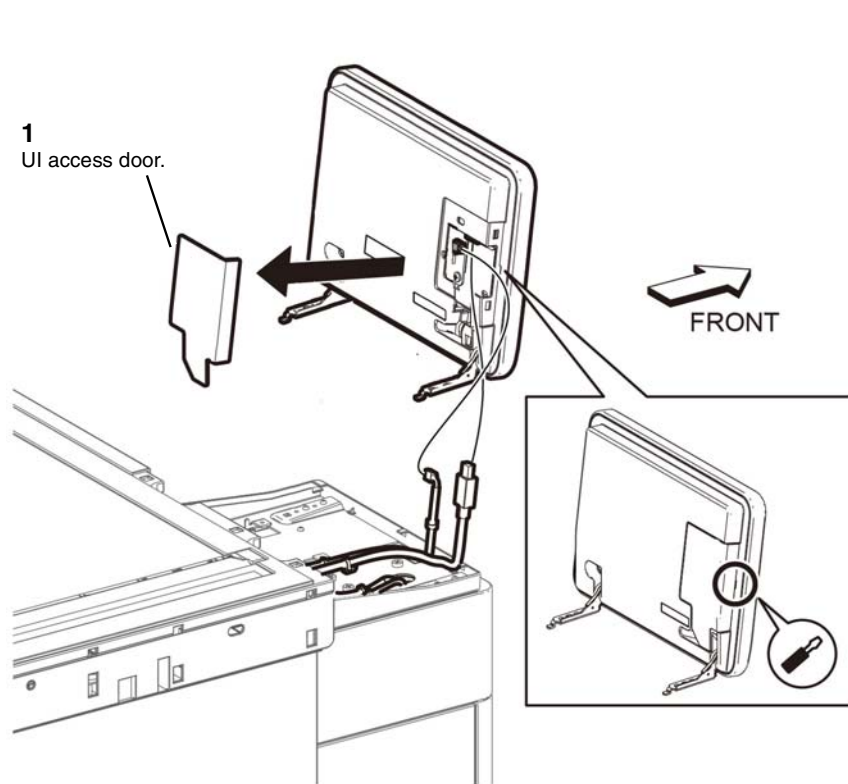
D-8-0018-B

1. Insert a flat blade screwdriver at the side of the UI access door (1), then remove the UI access door, [Figure 1](#).

Figure 1 UI Access Door

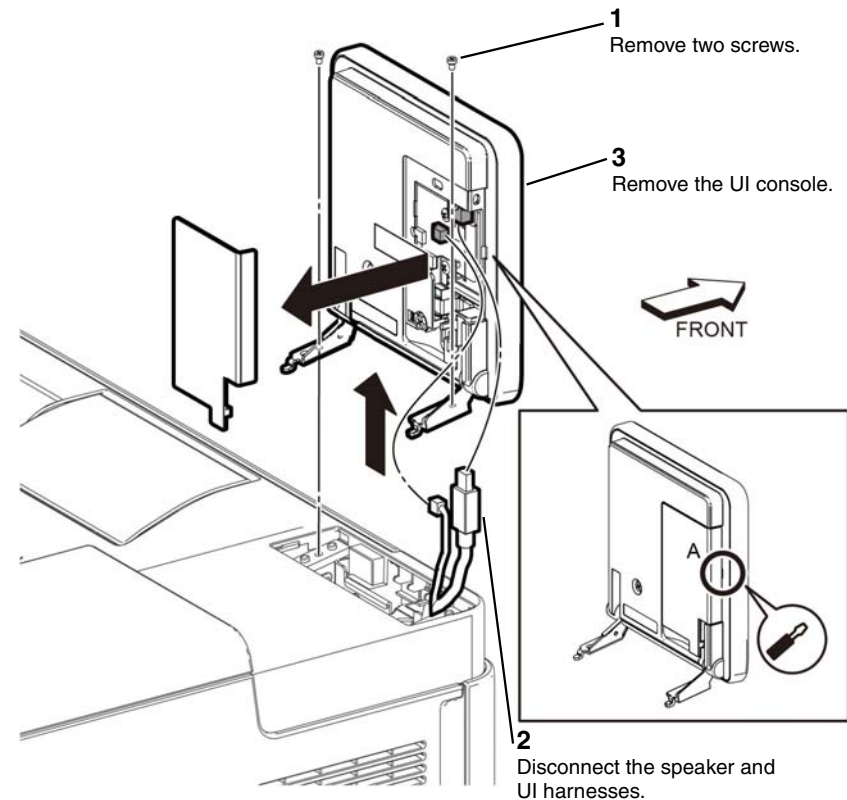
D-8-0022-B

1. Remove the UI inner cover, [REP 1.2](#).
2. Remove the UI access door, [REP 1.5](#).
3. Remove the UI console assembly, [Figure 1](#).

Figure 1 Remove the UI Console Assembly (C500/C505)

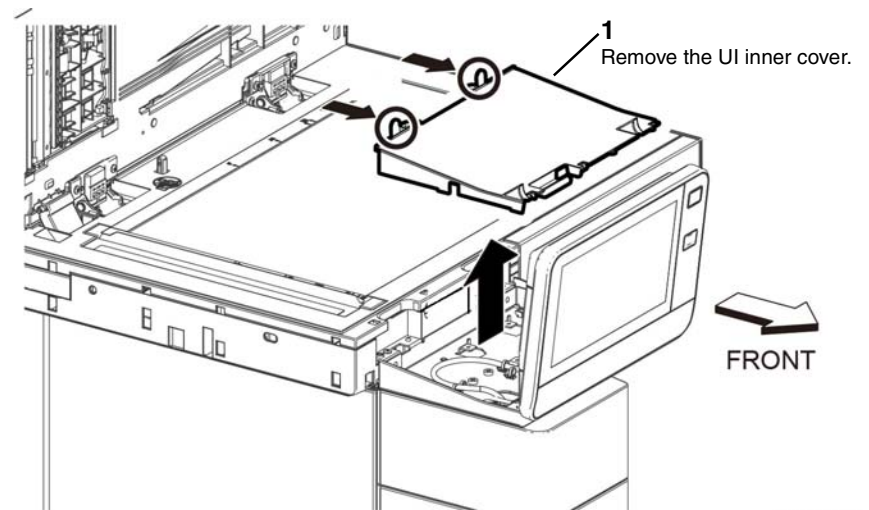
1. Remove the Left IIT Cover, [REP 50.6](#).
2. Remove the UI inner cover, [Figure 1](#).

Figure 1 Remove the UI Inner Cover

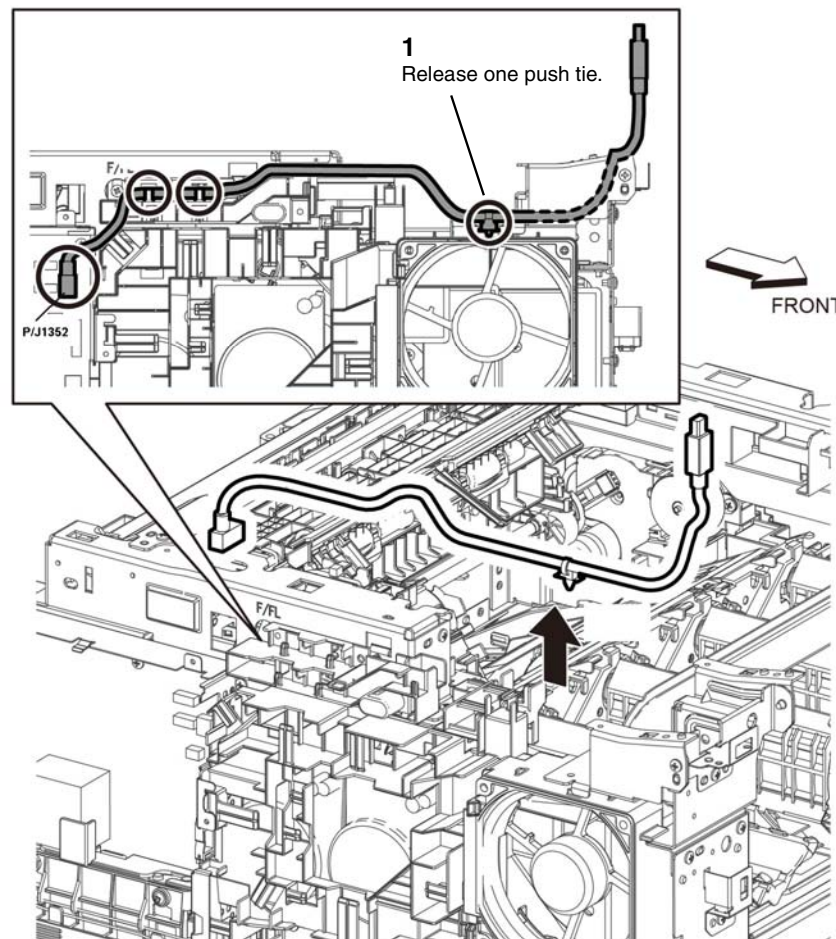
D-8-0023-B

1. Remove the ESS top plate, [PL 18.1 Item 18](#).
2. Release one push tie (1) holding the harness to the front USB harness guide, [PL 18.11 Item 21](#).
3. Disconnect the UI harness from the ESS PWB at [P/J1352](#), then remove the UI harness, [Figure 1](#).

Figure 1 Remove the UI Harness Assembly (C500/C505)

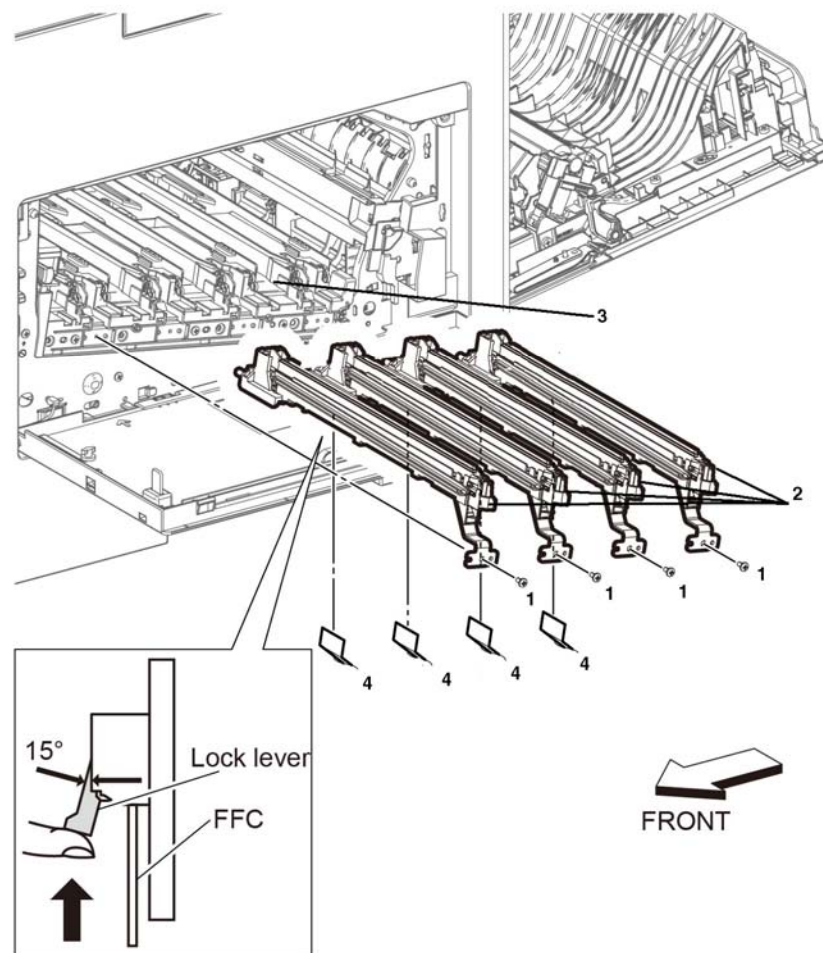
D-8-0024-A

4. Remove the LPG color head assembly, Figure 1:
 - a. Remove four screws (1) from the LPH color head assembly (2).
 - b. Pull the LPH color head assembly (2) out of the guide ZERO CRU (3), then disconnect the four FFC LPH color assembly cables (4).
 - c. Remove the LPH color head assembly (2).

Figure 1 Remove the LPH color head assembly

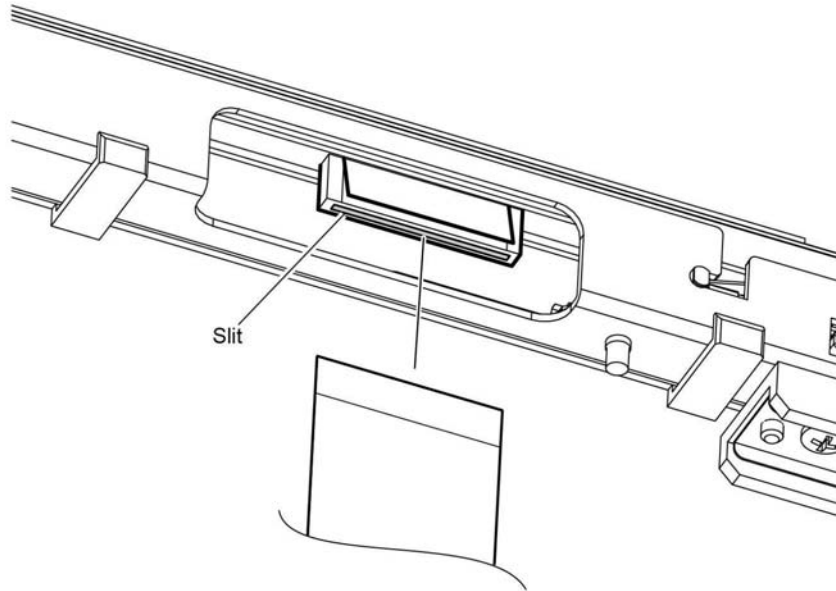
D-8-0025-A

Figure 2 Reconnect the LPH color head FFC

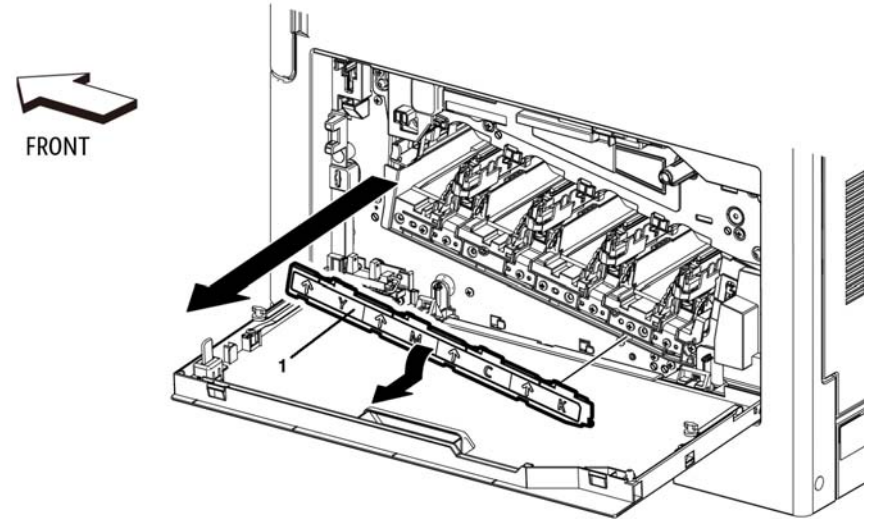
D-8-1104-A

1. Remove the Right Side Cover, [REP 19.2](#).
2. Remove the guide cover assembly (1) by gently prying the top of the cover down to release the hooks along the bottom, [Figure 1](#).

Figure 1 Guide cover assembly removal

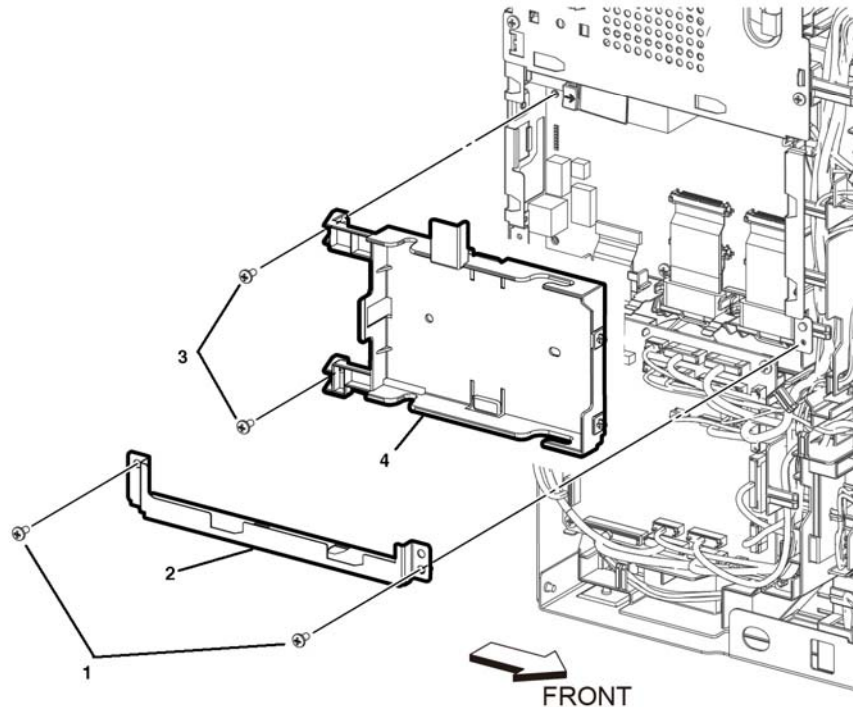
D-8-0157-A

1. Remove the LPH color head assembly, [REP 2.1](#).
2. Remove the HDD, [PL 18.1 Item 27](#).
3. Remove the ESS lower plate and HDD bracket, [Figure 1](#):
 - a. Remove two screws (1), then the ESS lower plate (2).
 - b. Remove the two screws (3), then the HDD bracket (4).

Figure 1 ESS lower plate and HDD bracket removal

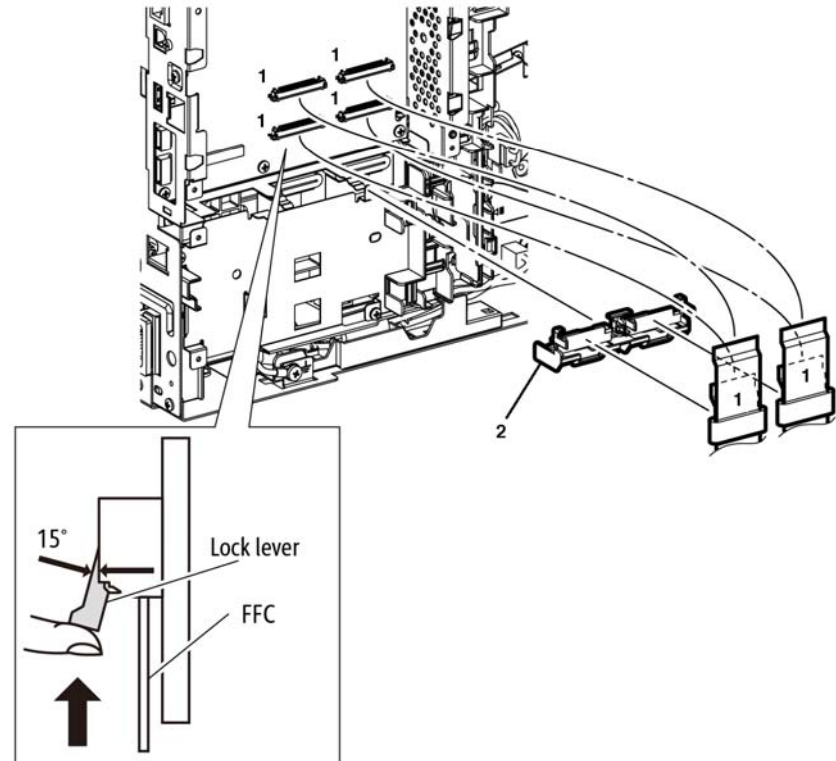
D-8-1105-A

6. Remove the FFC color LPH guide.
 - a. Release the four FFC cables (1) at ([P/J1360](#), [P/J1361](#), [P/J1362](#), [P/J1363](#)) from the ESS PWB.
 - b. Release the FFC color LPH cables (1) from FFC color LPH guide, then remove the FFC color LPH guide (2).

Figure 2 LPH color FFC guide removal

NOTE: In the following step, when releasing the FFC lock lever on the connector, slightly open the lock lever to 15 degrees until the lock lever contacts the FFC connector as shown in [Figure 2](#). After releasing the lock lever, hold the lever while gently pulling the FFC from the connector.

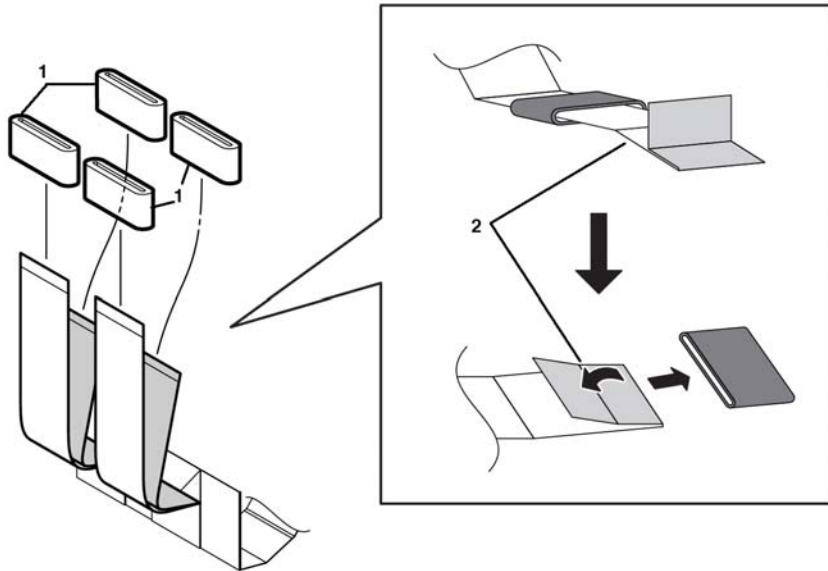
D-8-1106-A

7. Remove four LPH ferrite cores (1) by pressing the reinforcing tabs (2) flat against the FFC, [Figure 3](#).

Figure 3 LPH ferrite core removal

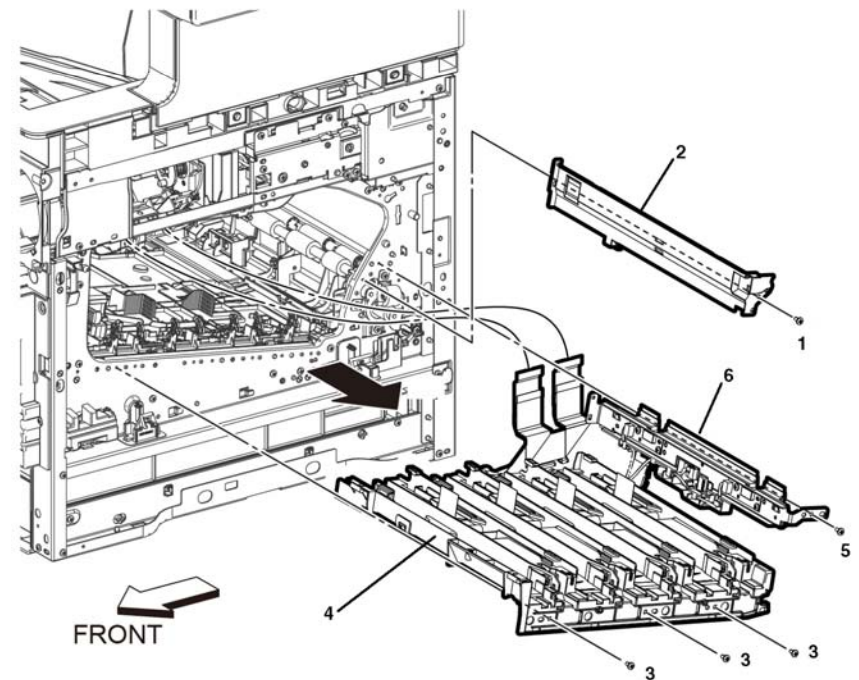
D-8-0089-A

8. Remove the CTD sensor assembly and the xerographic CRU guide, [Figure 4](#):
- Remove the screw (1) attaching the CTD sensor cover (2), [PL 6.1 Item 4](#), then remove the CTD sensor cover.
 - Remove three screws (3) attaching the xerographic CRU guide (4).
 - Remove the screw (5) attaching the CDT sensor assembly (6).
 - Remove the xerographic CRU guide (4) and the CTD sensor assembly (6).

Figure 4 Remove the LPH FFC xerographic CRUM

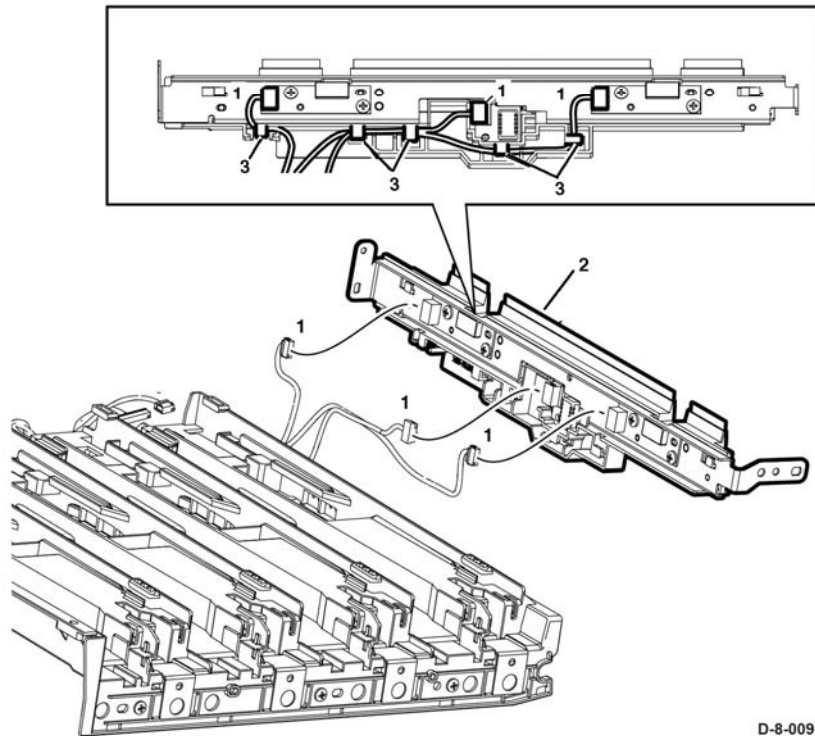
D-8-0090-A

9. Remove the CDT sensor, [Figure 1](#):
 - a. Disconnect three connectors (1) ([P/J142](#), [P/J143](#), [P/J145](#)) from the CDT sensor assembly (2).
 - b. Release the cables from five hooks (3) and remove the CTD sensor from the CDT sensor assembly.

Figure 5 Disconnect the CTD sensor connectors

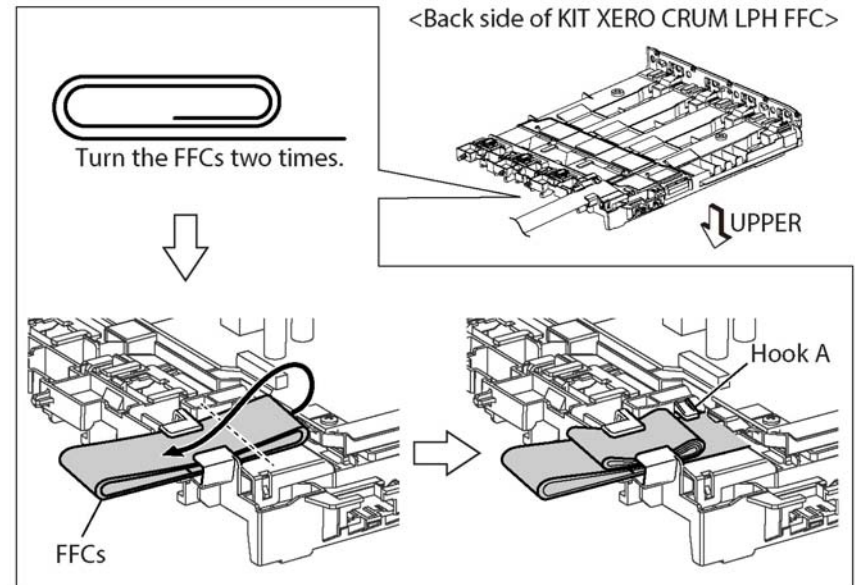
1. Fold the FFCs as shown in [Figure 6](#).

Figure 6 Install the LPH xerographic CRUM
