VersaLink[®] C500/C600 Printer and C505/C605 Multifunction Printer Service Manual

Xerox VersaLink C605F Family Printer Service Manual

705P01395

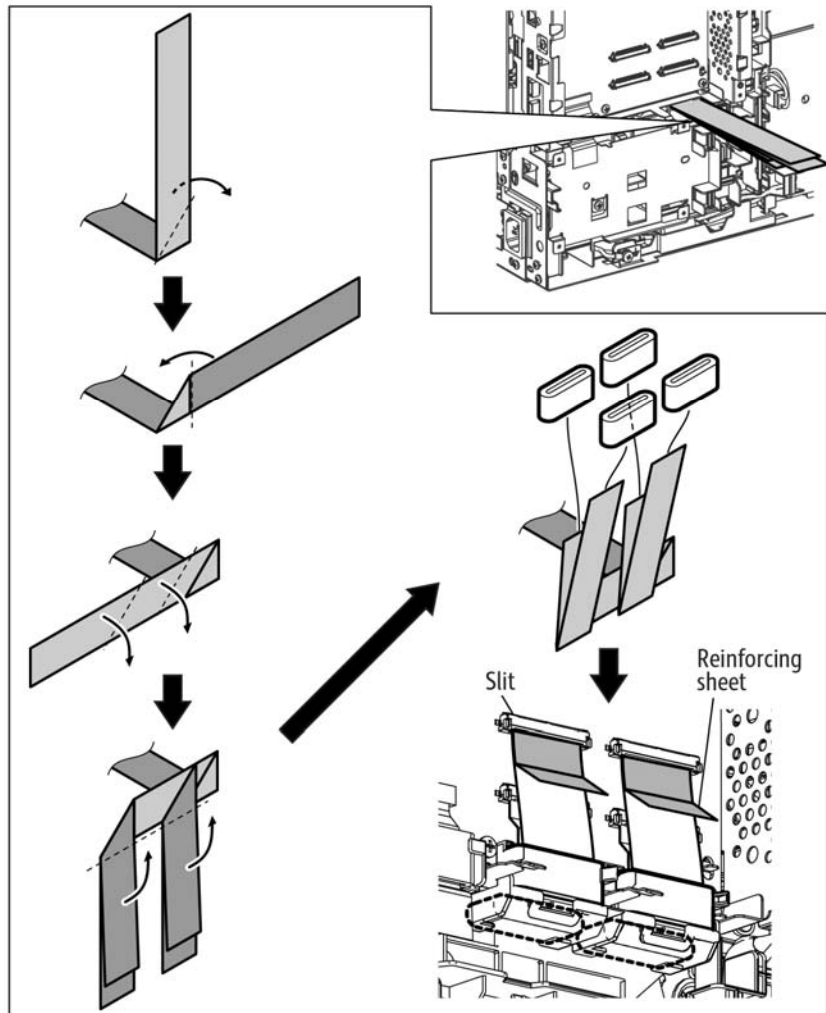
D-8-1107-A

2. Before inserting the FFC into the connector, bend the reinforcing tab to 90 degrees, then hold the tab to insert the FFC into the slit until hearing a click, [Figure 7](#).

Figure 7 Fold and connect the FFCs

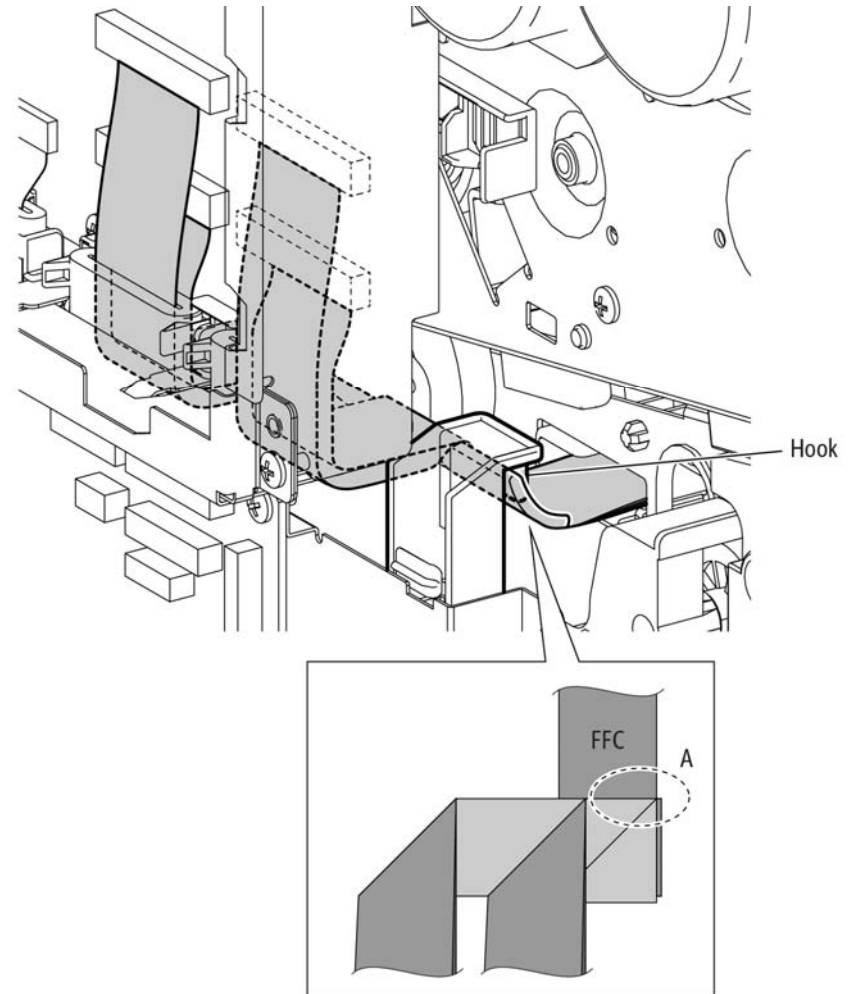
D-8-1108-A

3. Check the bend of the cable at location (A) in the inset and at the hook, [Figure 8](#).

Figure 8 Position FFC to avoid damage

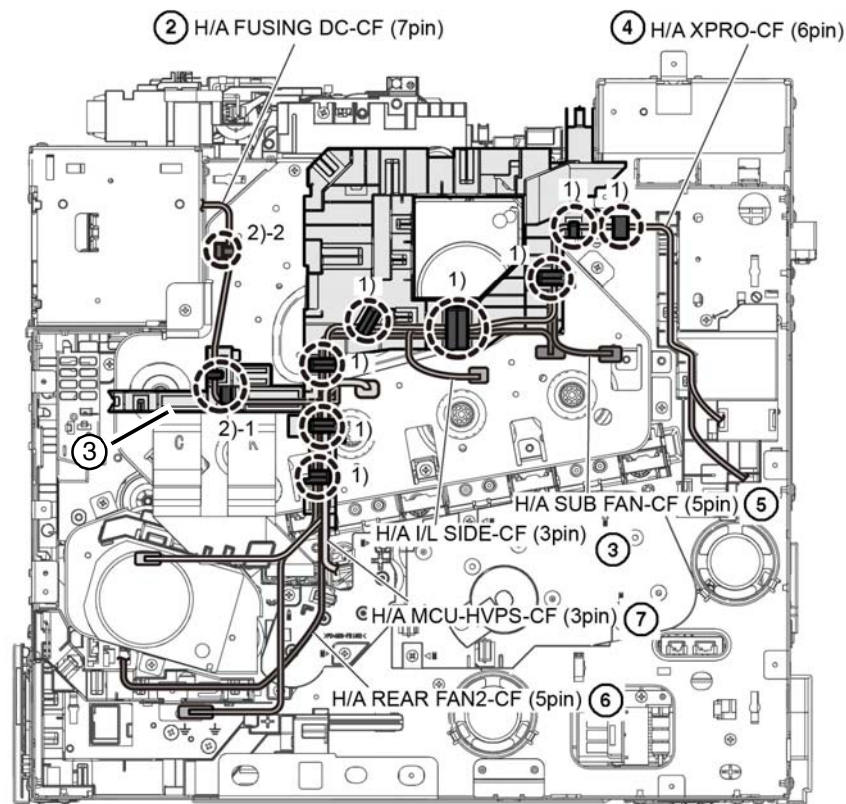
D-8-0026-A

- Disconnect the SUB FAN-CF harness assembly (5), (PL 18.4 Item 8 / PL 18.8 Item 8 / PL 18.12 Item 8).
- Disconnect the REAR FAN2-CF harness assembly (6), (PL 18.4 Item 9 / PL 18.8 Item 9 / PL 18.12 Item 9).
- Release the MCU-HVPS-CGF harness assembly (7), (PL 18.2 Item 9 / PL 18.6 Item 9).
- Release the DC-CF fusing harness assembly (1) from the rear I/L harness guide (2-1), (PL 18.3 Item 11 / PL 18.7 Item 11 / PL 18.11 Item 11), then release the push tie (2-2) from the main H drive assembly (3) (PL 3.1 Item 1).

Figure 1 DC harness guide harnesses

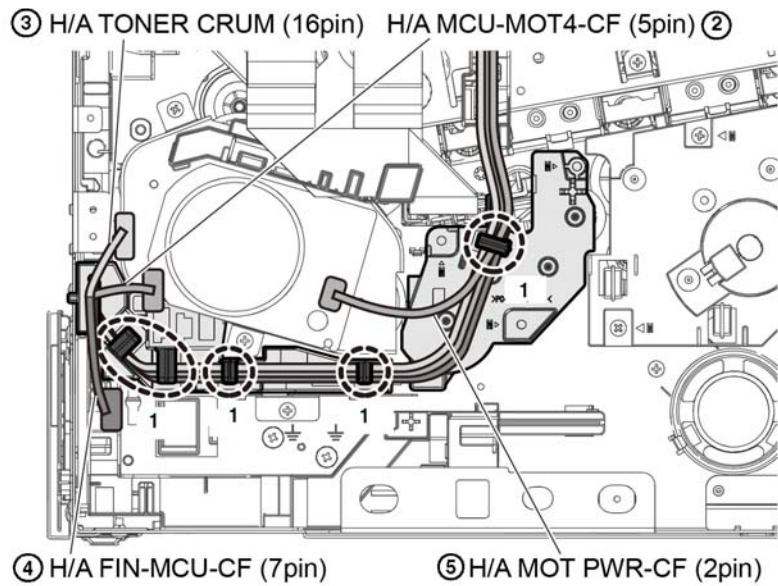
D-8-0027-A

29. Release the harnesses from the AC harness guide (1), **Figure 2**:
 - Disconnect the MCU-MOT4-CF harness assembly (2), (PL 3.1 Item 11).
 - Disconnect the toner CRUM harness assembly (3), (PL 5.1 Item 10).
 - Disconnect the FIN-MCU-CF harness assembly (4), (PL 18.8 Item 10 / PL 18.12 Item 10).
 - Disconnect the MOT PWR-CF harness assembly (5), (PL 3.1 Item 8 / PL 3.2 Item 8).

Figure 2 AC harness guide harnesses

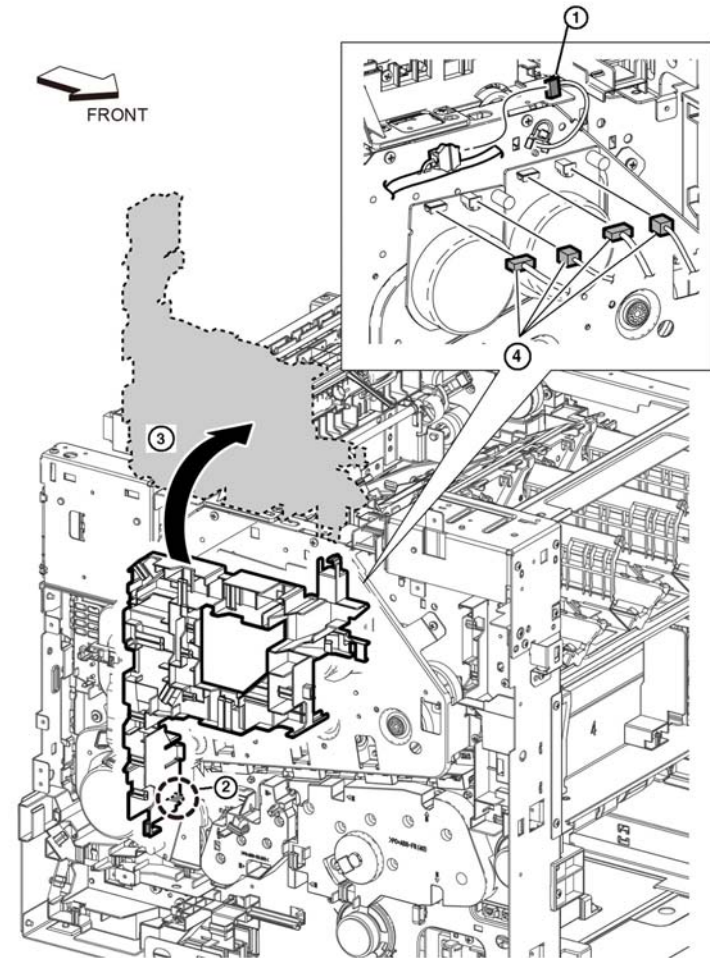
D-8-0029-A

30. Remove the DC harness guide, **Figure 3**:
 - a. Disengage the connector P/J468 (1).
 - b. Release three hooks (2) of the DC harness guide, then remove the DC harness guide.
 - c. Avoid the DC harness guide with cables in the direction of the arrow.
 - d. Disengage the connectors (P/J571, P/J572, P/J573, P/J574).

Figure 3 DC harness guide removal

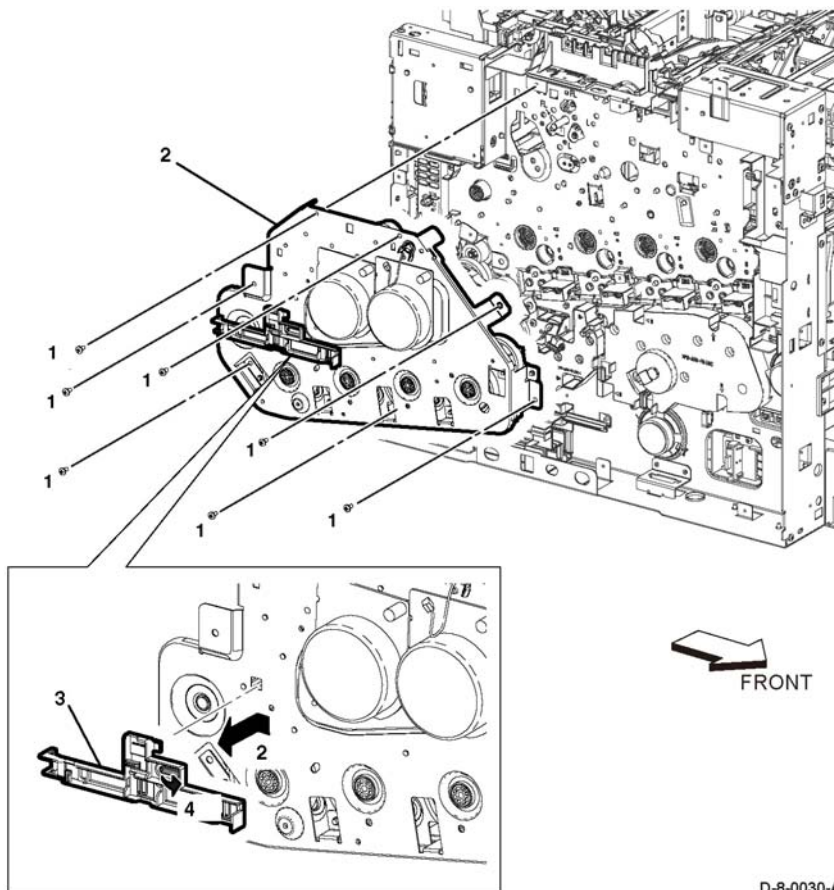
D-8-0030-A

31. Remove the main H drive assembly, [Figure 4](#):
 - a. Remove seven screws (1), then remove the main H drive assembly (2) with the rear interlock harness guide attached (3).
 - b. Release the hook (4) to remove the rear interlock harness guide (3) from the main H drive assembly (2).

Figure 4 Main H drive assembly removal

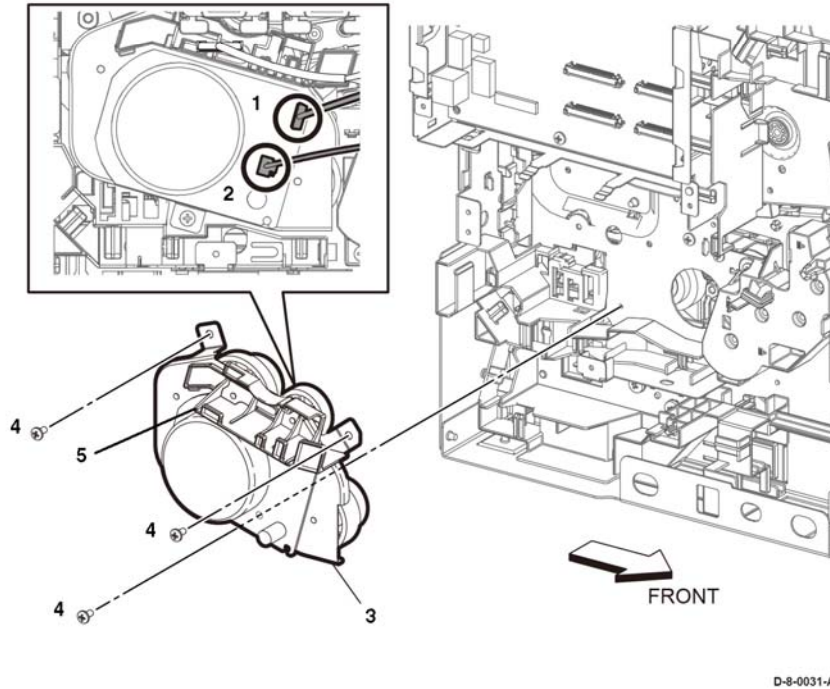
15. Remove the main 3 drive assembly, [Figure 1](#):
 - a. Release the harnesses from the harness guide (1).
 - b. Remove three screws (2), then remove the drive 2 motor assembly (3).

Figure 1 Drive 2 motor assembly removal

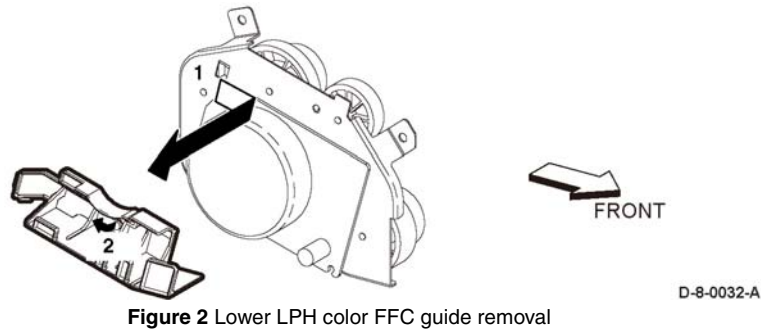
16. Release the hook (1), then remove the lower LPH color FFC guide (2), [Figure 2](#).

Figure 2 Lower LPH color FFC guide removal

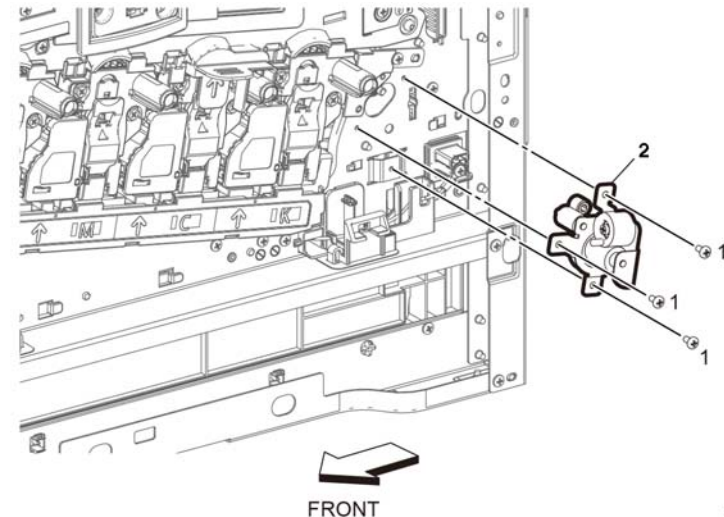
D-8-0034-A

Figure 1 Waste drive assembly removal

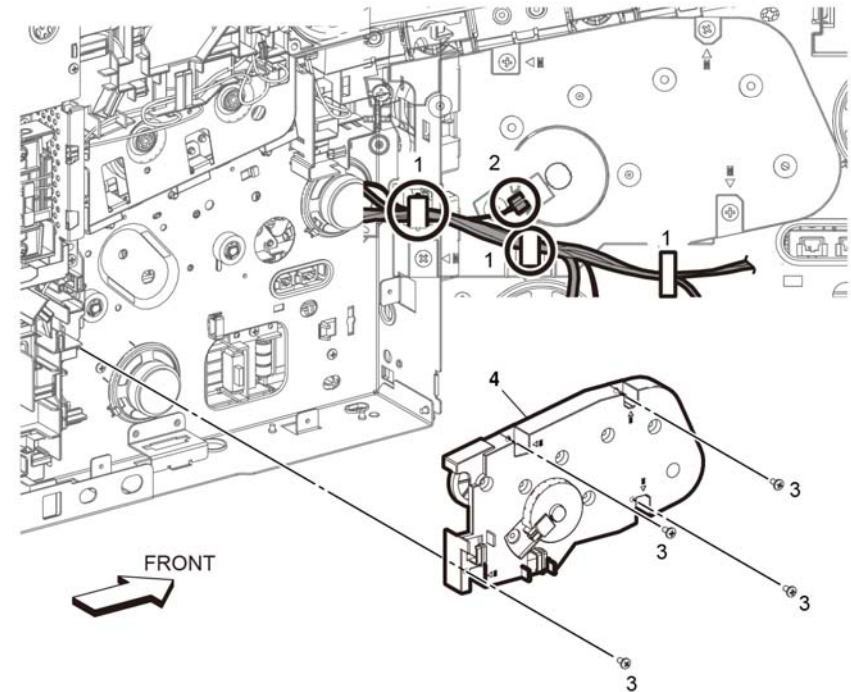
D-8-0035-A

1. Remove the 550 IOT cassette assembly, [PL 10.1 Item 1](#).
2. Remove the main MSI tray assembly, [REP 13.5](#).
3. Remove the toner cover assembly, [REP 19.48](#) / [REP 19.11](#) / [REP 19.33](#).
4. Remove the front left cover assembly, [REP 19.47](#) / [REP 19.10](#) / [REP 19.32](#).
5. Remove the left side cover, [REP 19.51](#) / [REP 19.7](#) / [REP 19.36](#).
6. Remove the LVPS PWB, [REP 18.35](#) / [REP 18.7](#).
7. Remove the LVPS plate, [PL 18.9 Item 20](#) / [PL 18.1 Item 20](#) / [PL 18.5 Item 20](#).
8. Remove the bypass (MSI) drive assembly, [Figure 1](#):
 - a. Release the harnesses from the harness guide (1).
 - b. Disconnect the connector [P/J481](#) (2).
 - c. Remove four screws (3), then remove the bypass (MSI) drive assembly (4).

Figure 1 Bypass (MSI) drive assembly removal

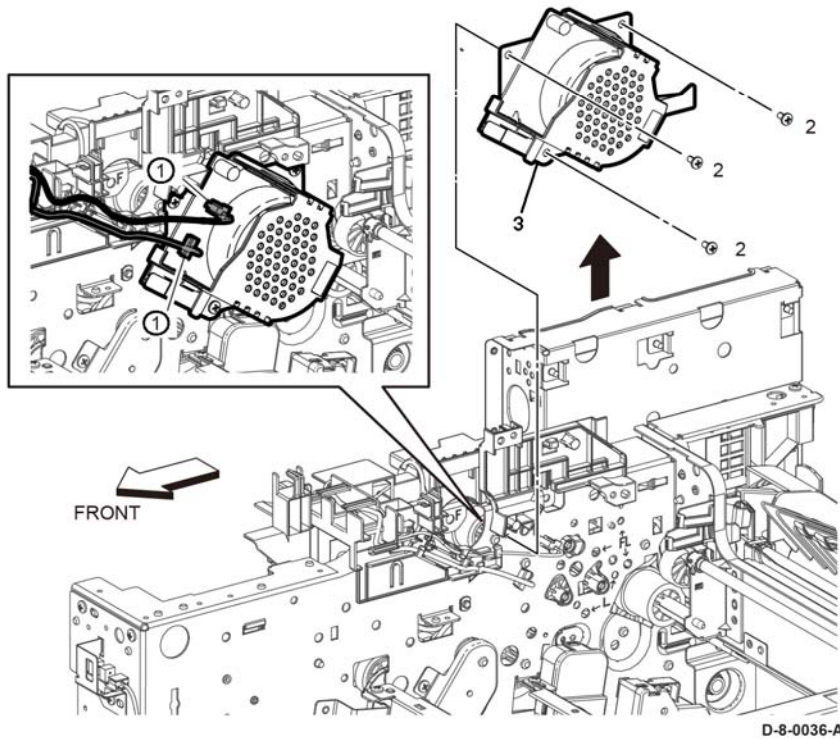
Figure 1 Drive motor assembly removal

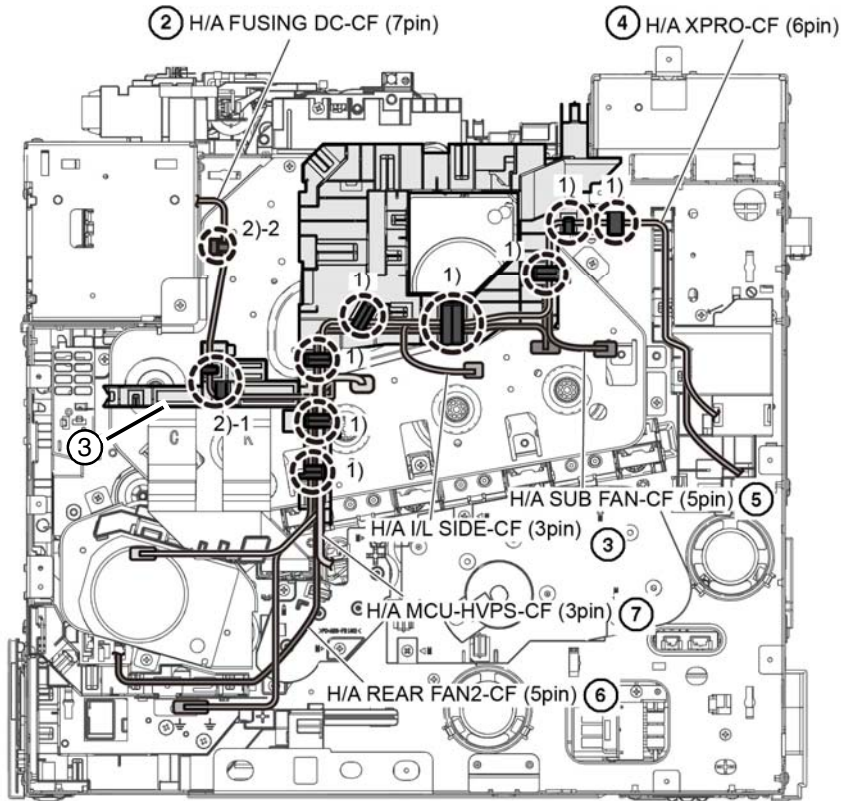
D-8-0026-A

- Disconnect the SIDE-CF I/L harness assembly (3), (PL 18.3 Item 5 / PL 18.11 Item 5).
- Disconnect the SUB FAN-CF harness assembly (5), (PL 18.4 Item 8 / PL 18.12 Item 8).
- Disconnect the R-FAN T-LED REGI-CF harness assembly (6), (PL 18.4 Item 9 / PL 18.12 Item 9).

Figure 1 DC harness guide harnesses

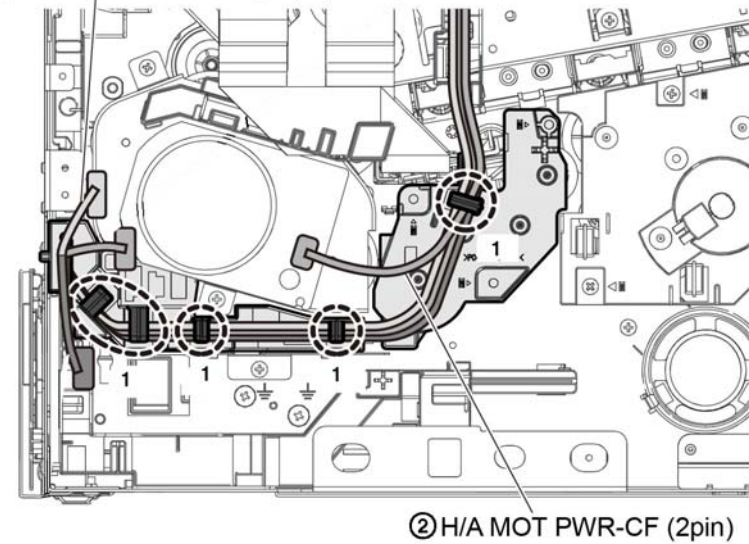
Figure 2 AC harness guide harnesses

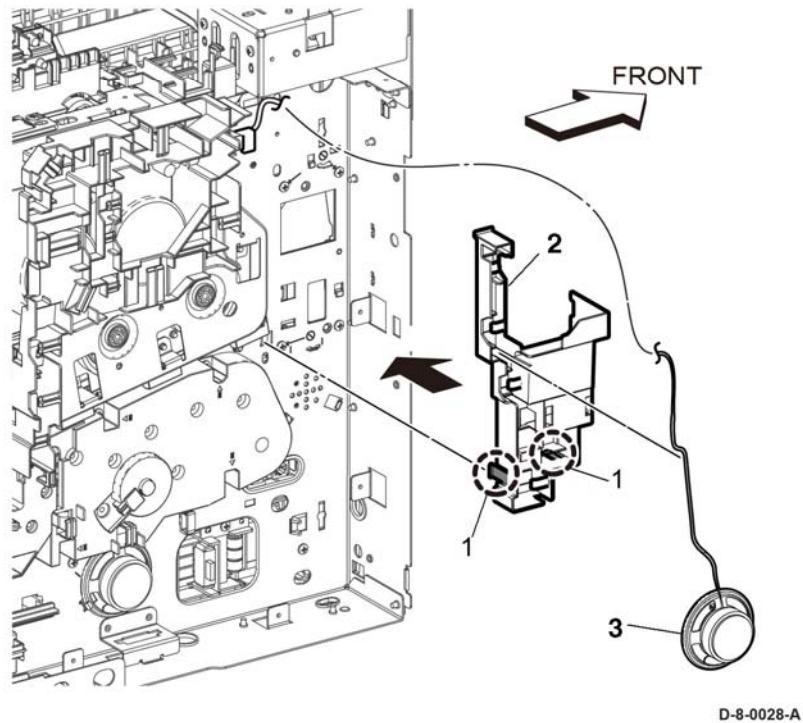
31. Release the main speaker harness, **Figure 3**:
- Release two hooks (1) of the duct harness guide (2), then slightly lift up the duct harness guide and the main speaker (3).
 - Release the harness of the main speaker (3) from the duct harness guide (2).
 - Install the duct harness guide (2) to the installed position.

Figure 3 Release the main speaker harness

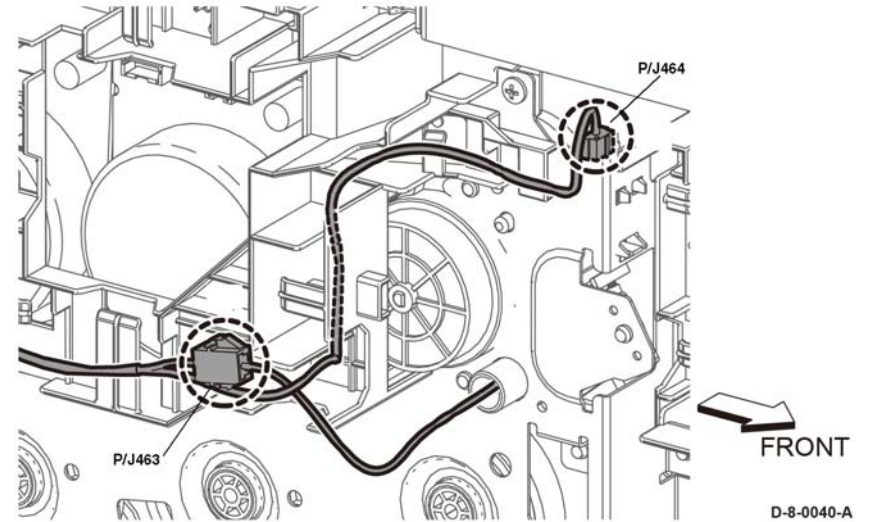
32. Disconnect the connectors (P/J463, P/J464).

Figure 4 Disconnect two connectors

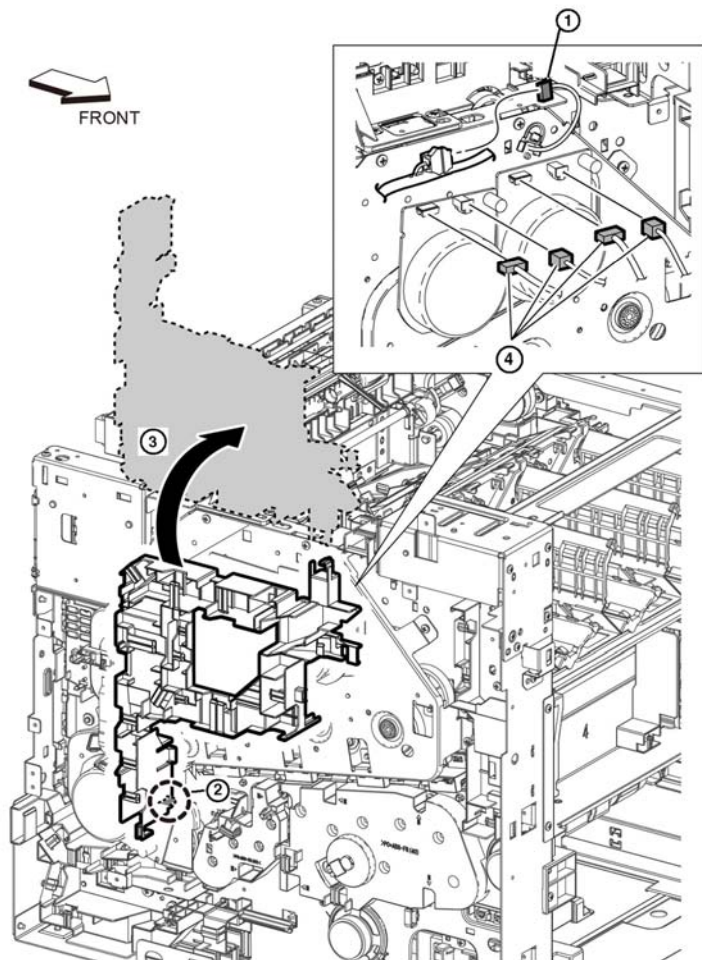
33. Remove the DC harness guide, **Figure 3**:
 - a. Disengage the connector **P/J468** (1).
 - b. Release three hooks (2) of the DC harness guide, then remove the DC harness guide.
 - c. Avoid the DC harness guide with cables in the direction of the arrow.
 - d. Disengage the connectors (**P/J571**, **P/J572**, **P/J573**, **P/J574**).

Figure 5 DC harness guide removal

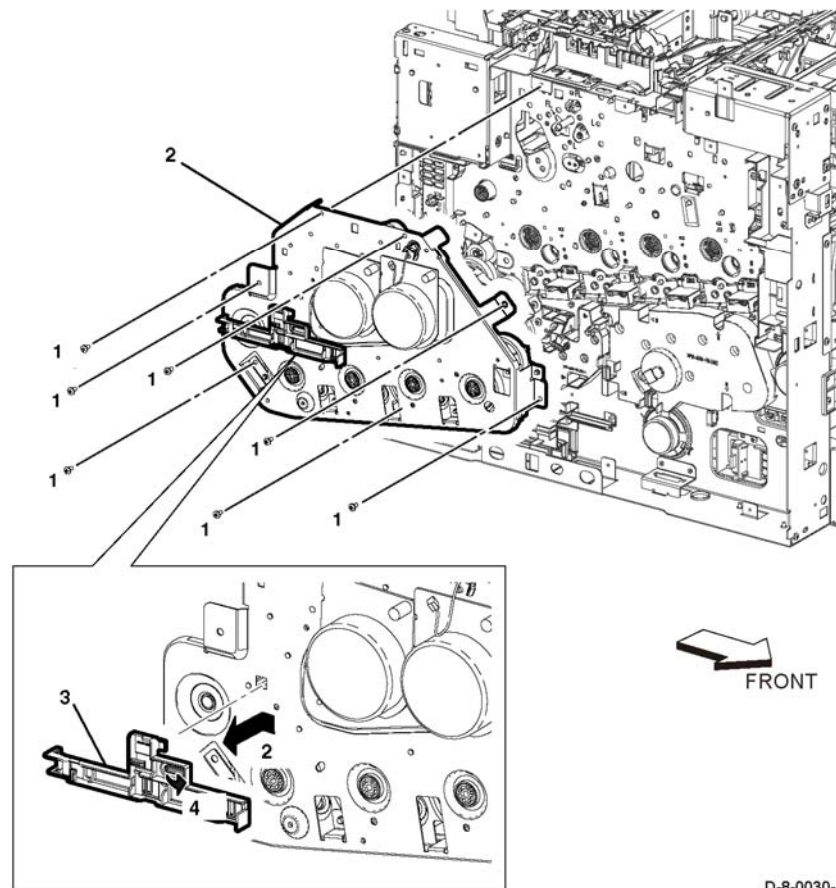
34. Remove the main L drive assembly, **Figure 4**:
 - a. Remove seven screws (1), the remove the main L drive assembly (2) with the rear interlock harness guide attached (3).
 - b. Release the hook (4) to remove the rear interlock harness guide (3) from the main L drive assembly (2).

Figure 6 Main L drive assembly removal

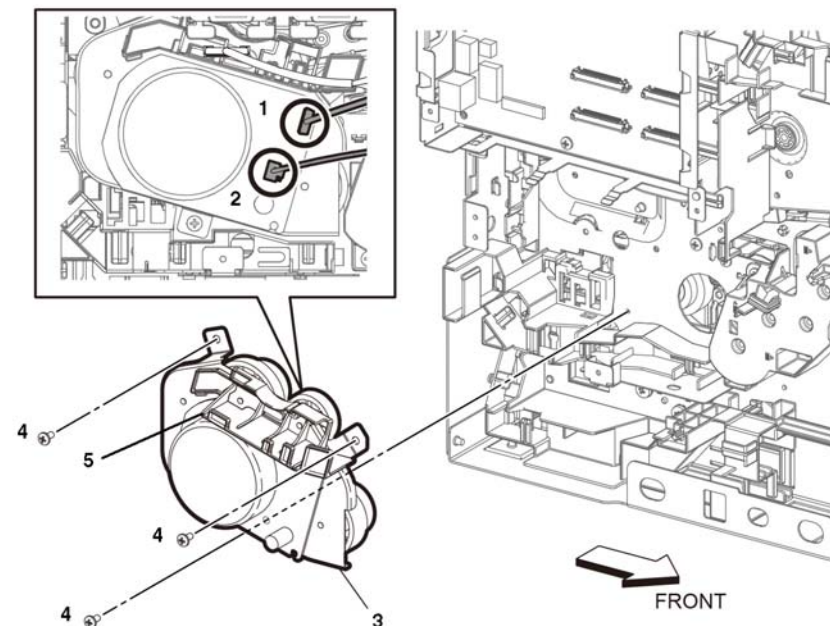
1. Remove the 550 IOT cassette assembly, [PL 10.1 Item 1](#).
2. Remove the main MSI tray assembly, [REP 13.5](#).
3. Remove the toner cover assembly, [REP 19.48 / REP 19.11](#).
4. Remove the front left cover assembly, [REP 19.10](#).
5. Remove the left side cover, [REP 19.47 / REP 19.7](#).
6. Remove the MCU PWB, [REP 18.31 / REP 18.1](#).
7. Remove the MCU plate, [PL 18.9 Item 21 / PL 18.1 Item 21](#).
8. Remove the LVPS PWB, [REP 18.35](#).
9. Remove the LVPS plate, [PL 18.9 Item 20 / PL 18.1 Item 20](#).
10. Remove the main 2 drive assembly, [Figure 1](#):
 - a. Disconnect [P/J560](#) (1) and [P/J561](#) (2) from the drive 2 motor assembly (3).
 - b. Remove three screws (4), then remove the drive 2 motor assembly (3) with the lower LPH color FFC guide (5) attached.

Figure 1 Drive 2 motor assembly removal

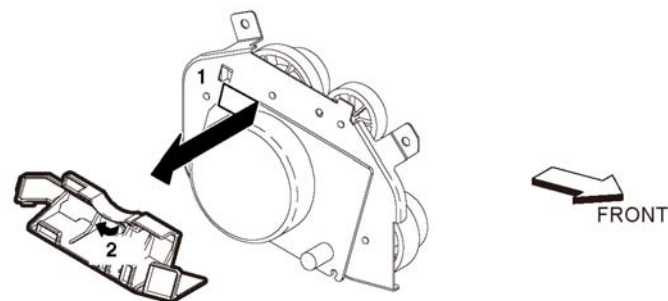
11. Release the hook (1), then remove the lower LPH color FFC guide (2), [Figure 2](#).

Figure 2 Lower LPH color FFC guide removal

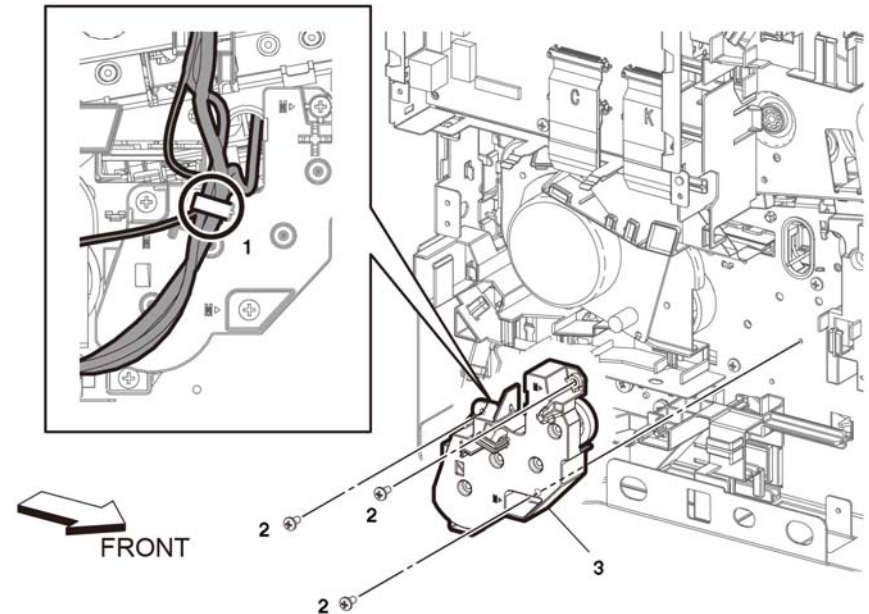
1. Remove the 550 IOT cassette assembly, [PL 10.1 Item 1](#).
2. Remove the main MSI tray assembly, [REP 13.5](#).
3. Remove the toner cover assembly, [REP 19.48 / REP 19.11](#).
4. Remove the front left cover assembly, [REP 19.10](#).
5. Remove the left side cover, [REP 19.47 / REP 19.7](#).
6. Remove the MCU PWB, [REP 18.31 / REP 18.1](#).
7. Remove the MCU plate, [PL 18.9 Item 21 / PL 18.1 Item 21](#).
8. Remove the LVPS PWB, [REP 18.35](#).
9. Remove the LVPS plate, [PL 18.9 Item 20 / PL 18.1 Item 20](#).
10. Remove the main 3 drive assembly, [Figure 1](#):
 - a. Release the harnesses from the harness guide (1).
 - b. Remove three screws (2), then remove the drive 2 motor assembly (3).

Figure 1 Main 3 drive assembly removal

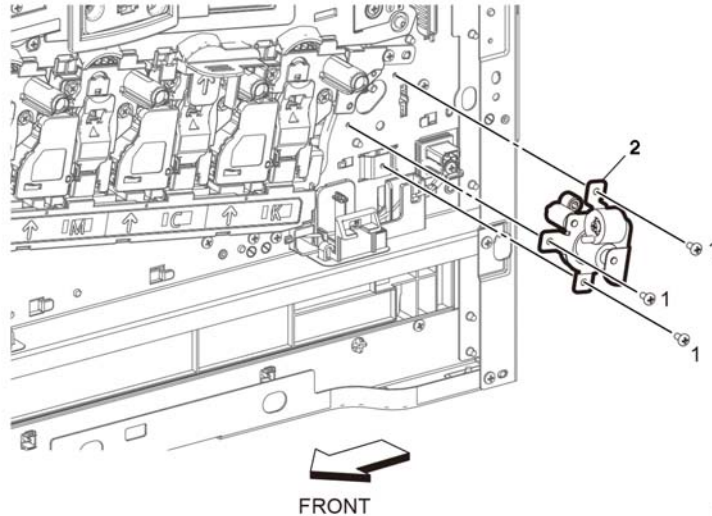
1. Remove the 550 IOT cassette assembly, [PL 10.1 Item 1](#).
2. Remove the main MSI tray assembly, [REP 13.5](#).
3. Remove the toner cover assembly, [REP 19.48 / REP 19.11](#).
4. Remove the right front cover, [REP 19.45 / REP 19.2](#).
5. Remove the right side cover assembly, [REP 19.49 / REP 19.11](#).
6. Remove three screws (1), then remove the waste drive assembly (2), Figure 1 >

Figure 1 Waste drive assembly removal

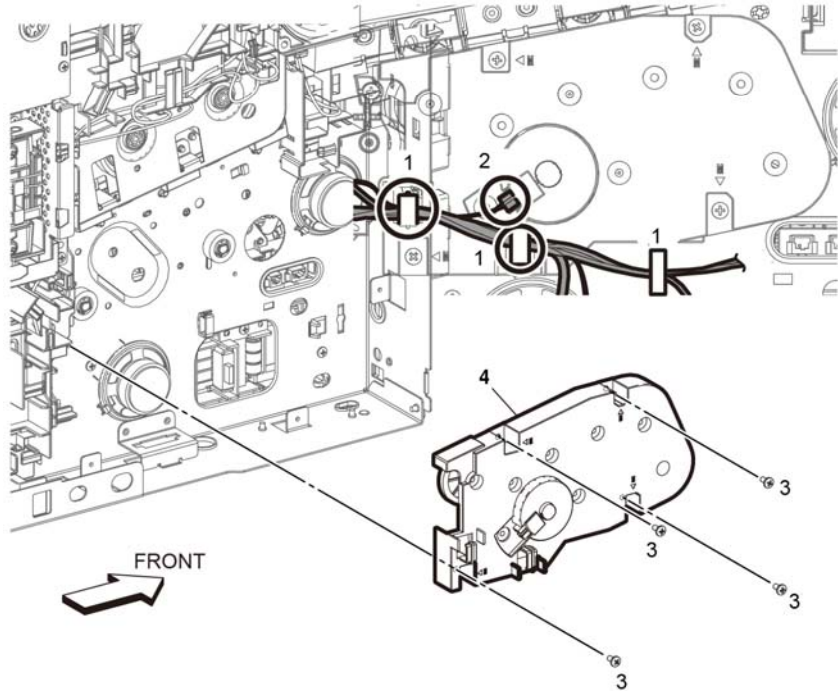
1. Remove the 550 IOT cassette assembly, [PL 10.1 Item 1](#).
2. Remove the main MSI tray assembly, [REP 13.5](#).
3. Remove the toner cover assembly, [REP 19.48 / REP 19.11](#).
4. Remove the front left cover assembly, [REP 19.47 / REP 19.10](#).
5. Remove the left side cover, [REP 19.51 / REP 19.7](#).
6. Remove the LVPS PWB, [REP 18.35](#).
7. Remove the LVPS plate, [PL 18.9 Item 20 / PL 18.1 Item 20](#).
8. Remove the bypass (MSI) drive assembly, [Figure 1](#):
 - a. Release the harnesses from the harness guide (1).
 - b. Disconnect the connector [P/J481](#) (2).
 - c. Remove four screws (3), then remove the bypass (MSI) drive assembly (4).

Figure 1 Bypass (MSI) drive assembly removal

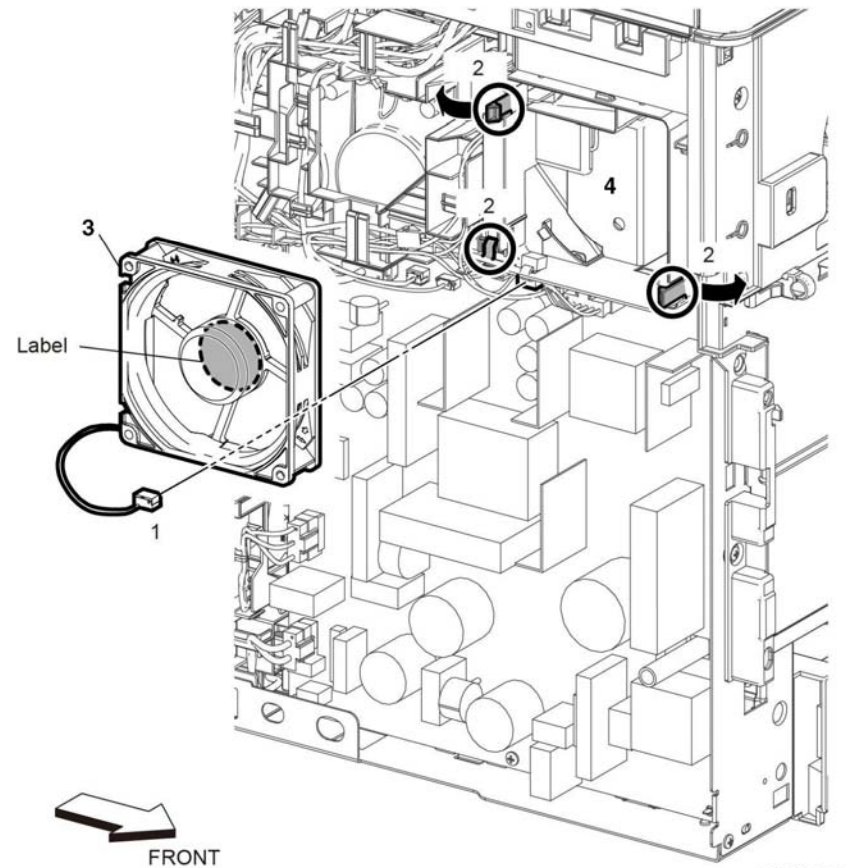
1. Remove the 550 IOT cassette assembly, [PL 10.1 Item 1](#).
2. Remove the main MSI tray assembly, [REP 13.5](#).
3. Remove the toner cover assembly, [REP 19.48](#) / [REP 19.11](#) / [REP 19.33](#).
4. Remove the front left cover assembly, [REP 19.47](#) / [REP 19.10](#) / [REP 19.32](#).
5. Remove the left side cover, [REP 19.51](#) / [REP 19.7](#) / [REP 19.36](#).
6. Remove the main fan, [Figure 1](#):
 - a. Disconnect connector [P/J289](#) (1).
 - b. Release three hooks (2) attaching the main fan (3) to the main fan duct (4), then remove the fan (3).

Figure 1 Main fan removal

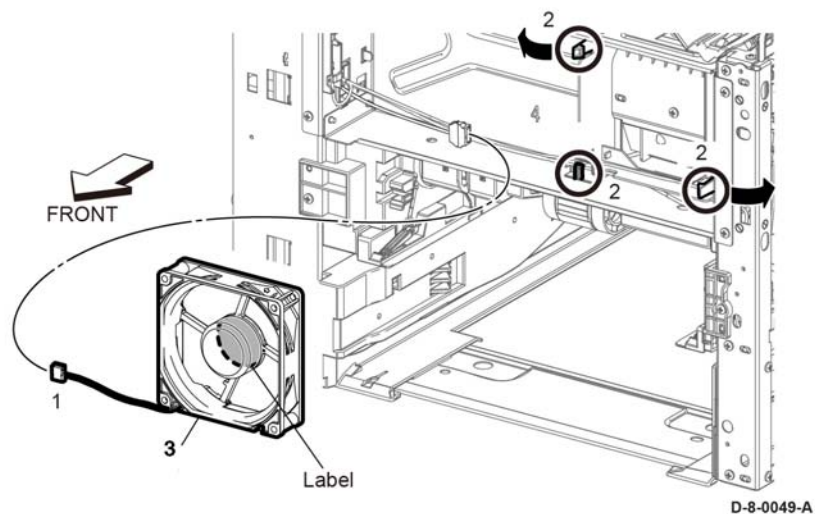
1. Remove the 550 IOT cassette assembly, [PL 10.1 Item 1](#).
2. Remove the main MSI tray assembly, [REP 13.5](#).
3. Remove the toner cover assembly, [REP 19.48 / REP 19.11 / REP 19.33](#).
4. Remove the front left cover assembly, [REP 19.47 / REP 19.10 / REP 19.32](#).
5. Remove the left side cover, [REP 19.51 / REP 19.7 / REP 19.36](#).
6. Remove the right front cover, [REP 19.45 / REP 19.2 / REP 19.21](#).
7. Remove the right side cover assembly, [REP 19.49 / REP 19.11 / REP 19.23](#).
8. Remove the main fan, [REP 4.1](#).
9. Remove the sub fan, [Figure 1](#):
 - a. Disconnect P/J249 (1), then release the harness from the harness guide.
 - b. Release three hooks (2), then remove the sub fan (3).

Figure 1 Sub fan removal

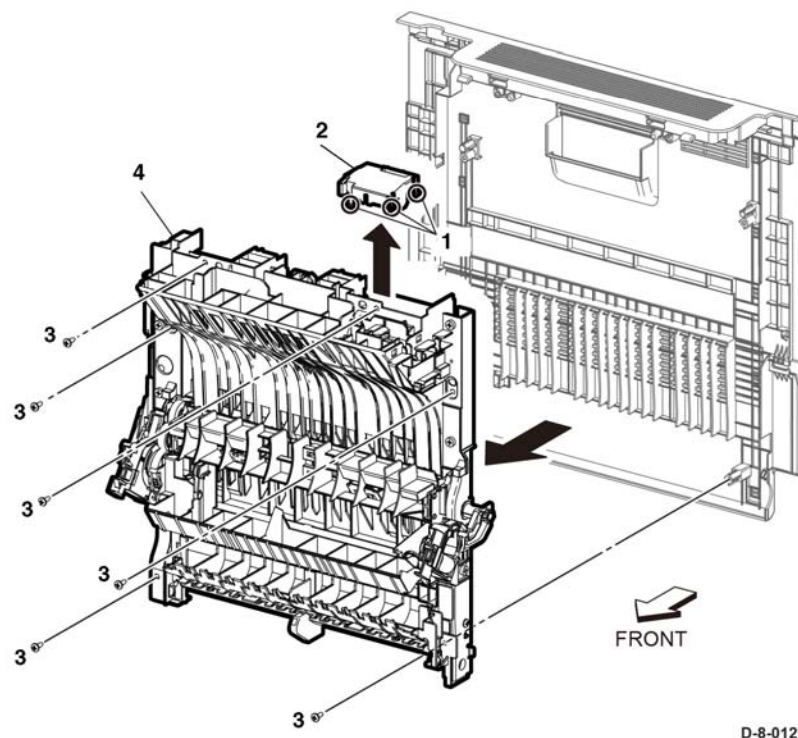
1. Remove the duplex assembly, [Figure 1](#):
 - a. Open the rear door, [PL 19.2 Item 99](#).
 - b. Release three hooks (1), then remove the rear fan harness cover (2).
 - c. Remove six screws (3), then remove the duplex assembly (4).

Figure 1 Duplex removal

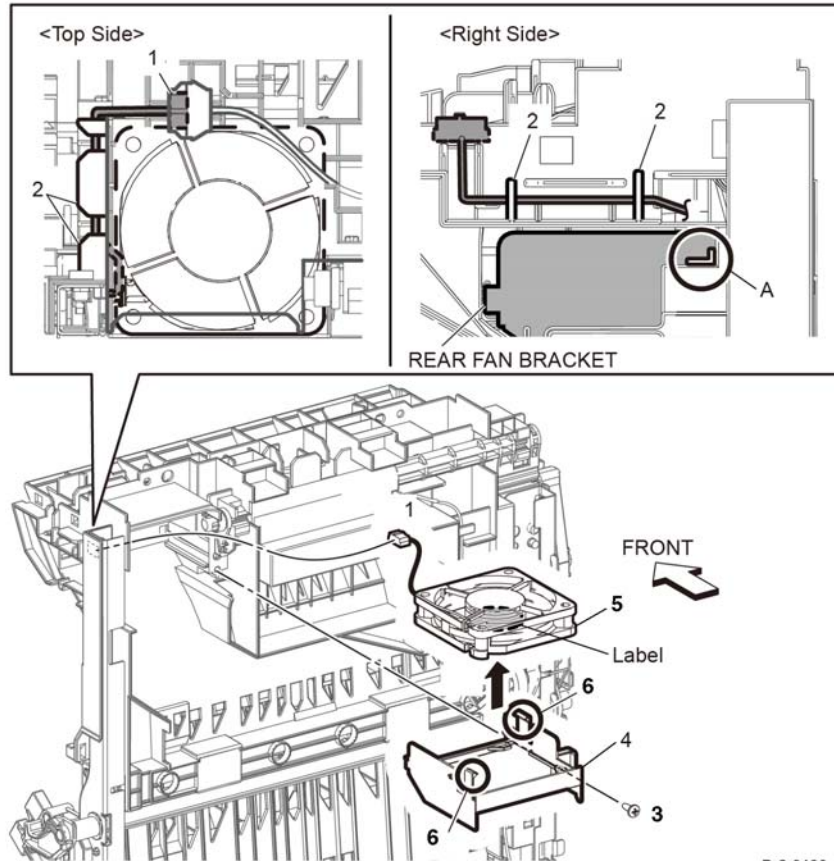
2. Remove the rear fan, **Figure 2**:
 - a. Disconnect P/J298 (1), then release the rear fan harness from the harness guide (2).
 - b. Remove one screw (3), push part A to remove the rear fan bracket (4) and rear fan (5), together.
 - c. Release two hooks (6), then remove the rear fan (5) from the rear fan bracket (4).

Figure 2 Rear fan removal

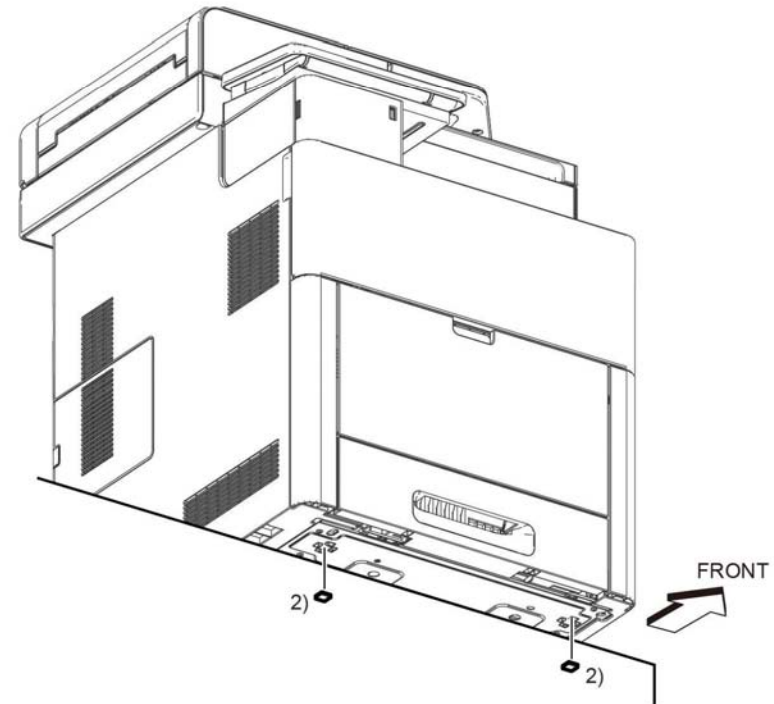
1. Position the front of the printer to overhang the edge of the workbench.
2. Refer to **Figure 1** to install the new front two feet.

Figure 1 Install new Front Bottom Feet

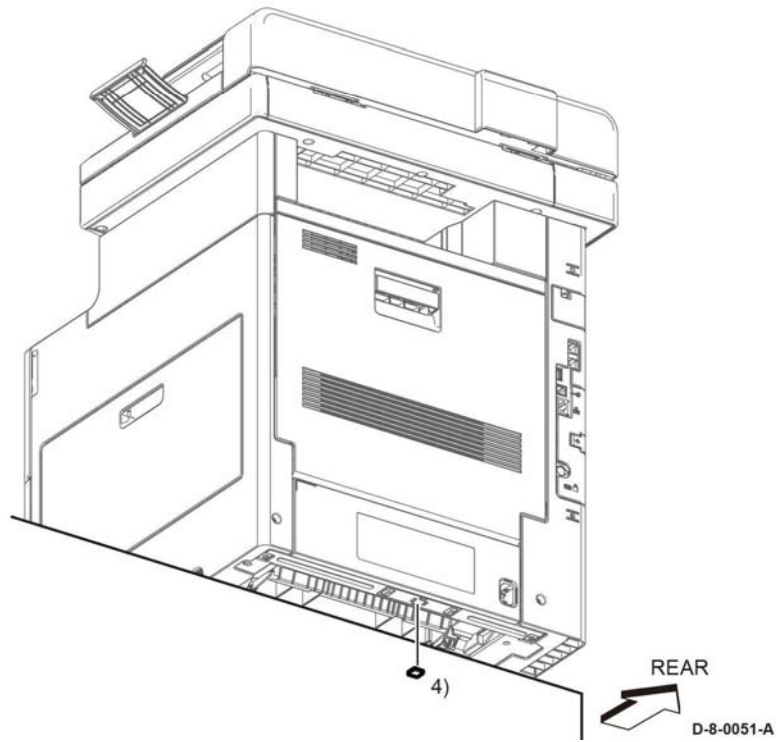
3. Position the back of the printer to overhang the edge of the workbench.
4. Refer to **Figure 2** to install a new back foot.

Figure 2 Install New Rear Bottom Foot

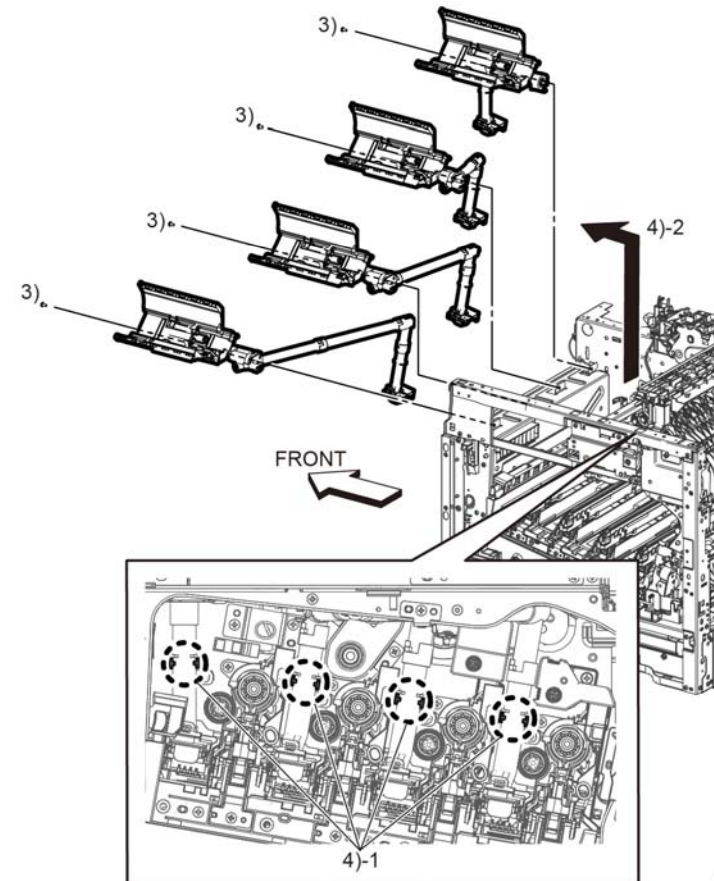
1. Remove the main exit drive assembly; [REP 17.2](#)
2. Remove the dispenser drive assembly, [PL 5.1 Item 1](#), except skip step 4 by leaving [P/J121](#), [P/J122](#) connected.
3. Refer to [Figure 1](#) to remove one screw (silver, M3x6mm) from the dispenser assembly (one screw for each Dispenser).
4. Refer to [Figure 1](#) to release the hook holding the dispenser assembly tube to the left-side printer chassis and remove the dispenser (one hook for each dispenser).

Figure 1 Remove the Dispenser Assemblies

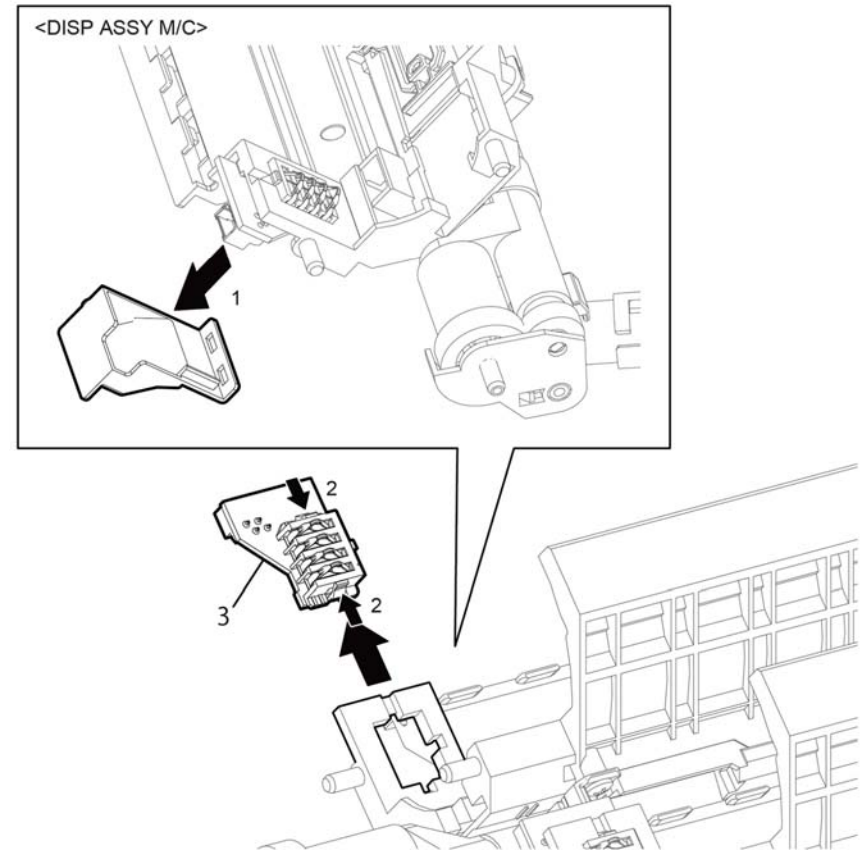
16. Remove the dispenser assembly (Y/M/C.K), [REP 5.1](#).
17. Remove the toner CRUM connector assembly, [Figure 1](#):
 - a. Remove the CRUM cover (1).
 - b. Release two hooks (2), then remove the toner CRUM connector assembly (3).

Figure 1 Toner CRUM connector assembly removal

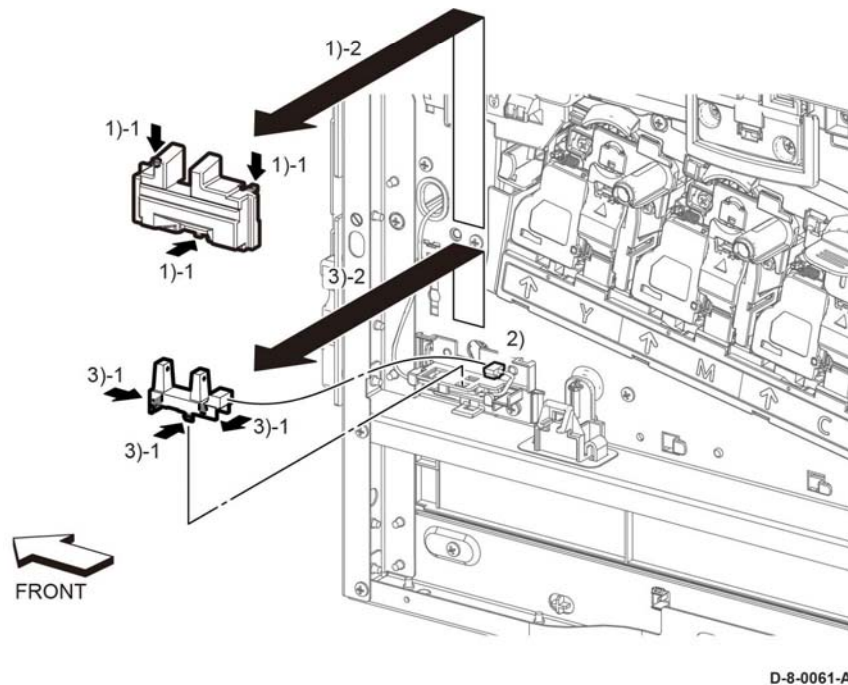
1. Remove the right side cover assembly; [REP 19.12](#).
2. Refer to [Figure 1](#) to release the three hooks on the Clear Cover starting with the bottom hook and remove the cover.

Figure 1 Remove the Toner Full Sensor

3. Refer to [Figure 1](#) to release the three hooks attaching the Toner Full Sensor to the sensor holder and remove the sensor.
4. Refer to [Figure 1](#) to unplug the connector ([P/J485](#)) from the sensor.

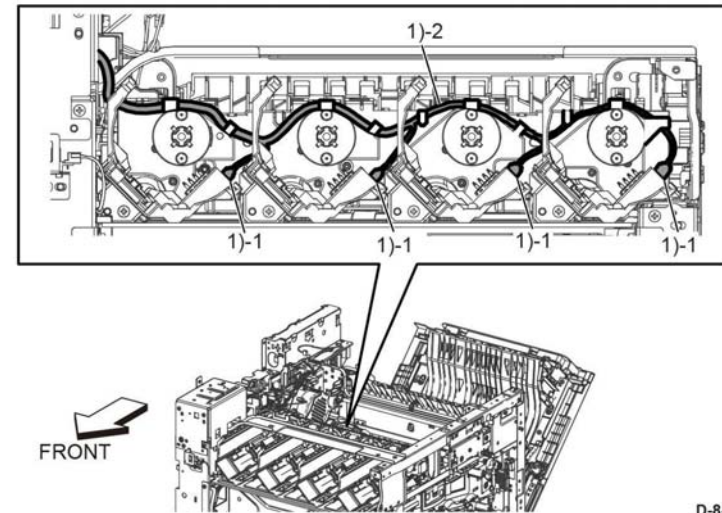
1. Remove the Main Exit Drive Assembly, [REP 17.2](#).
2. Refer to [Figure 1](#) to unplug the four connectors ([P/J111](#), [P/J112](#), [P/J113](#), [P/J114](#)) and release the Toner CRUM Harness Assembly.

Figure 1 Release the Toner CRUM Harness Assembly

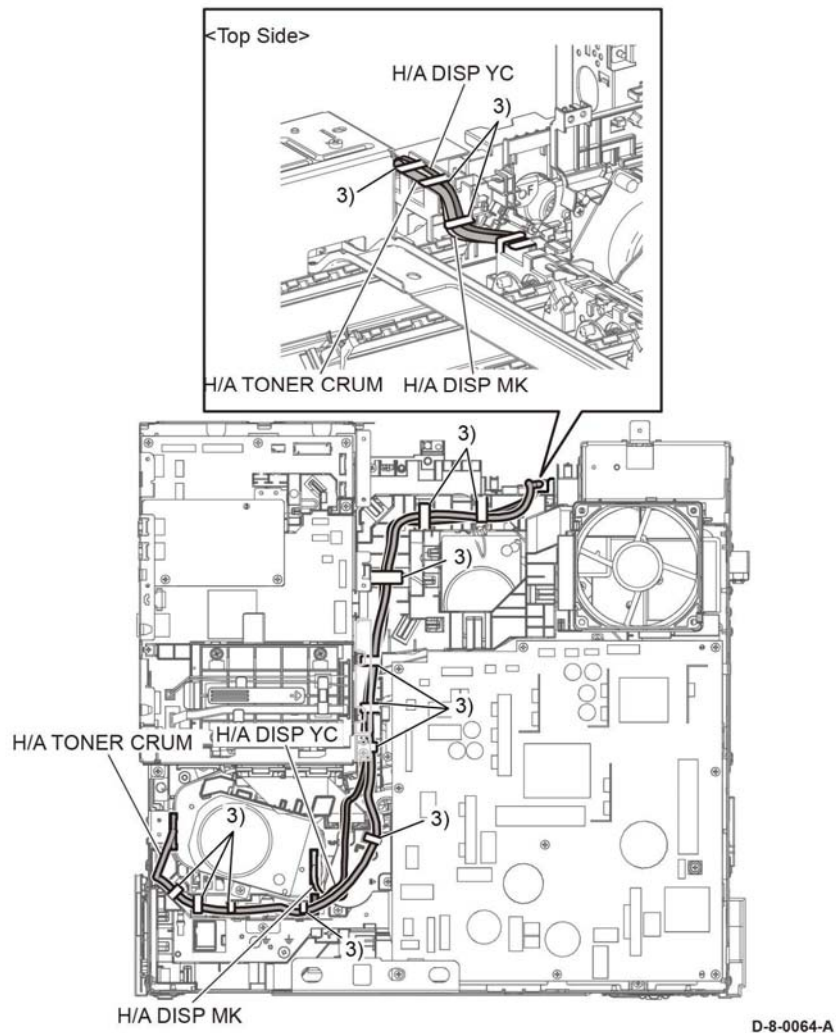
3. Refer to [Figure 2](#) to unplug the two connectors ([P/J110](#), [P/J120](#)) from the Dispenser Drive Harness Assembly and release the harnesses from the harness guide.

Figure 2 Release the Dispenser Drive Harnesses

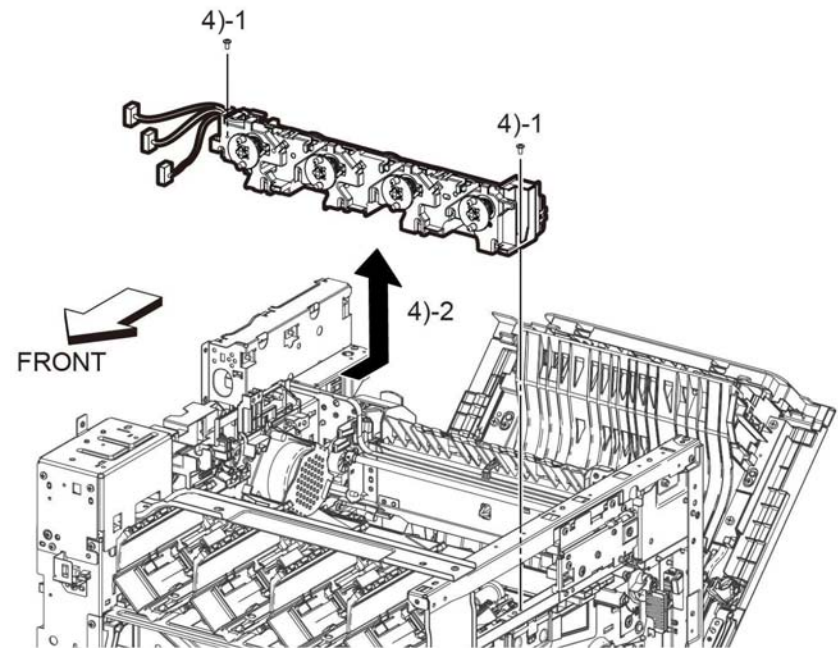
Figure 3 Remove the Dispenser Drive Assembly
